HISTORIC BUILDING  
RECORDING  
AT  
COURT FARM, HANLEY CHILD,  
TENBURY, WORCESTERSHIRE

27 July 2007

Project P3066  
Report 1561  
WSM 37302

## **Historic building recording at Court Farm, Hanley Child, Tenbury, Worcestershire**

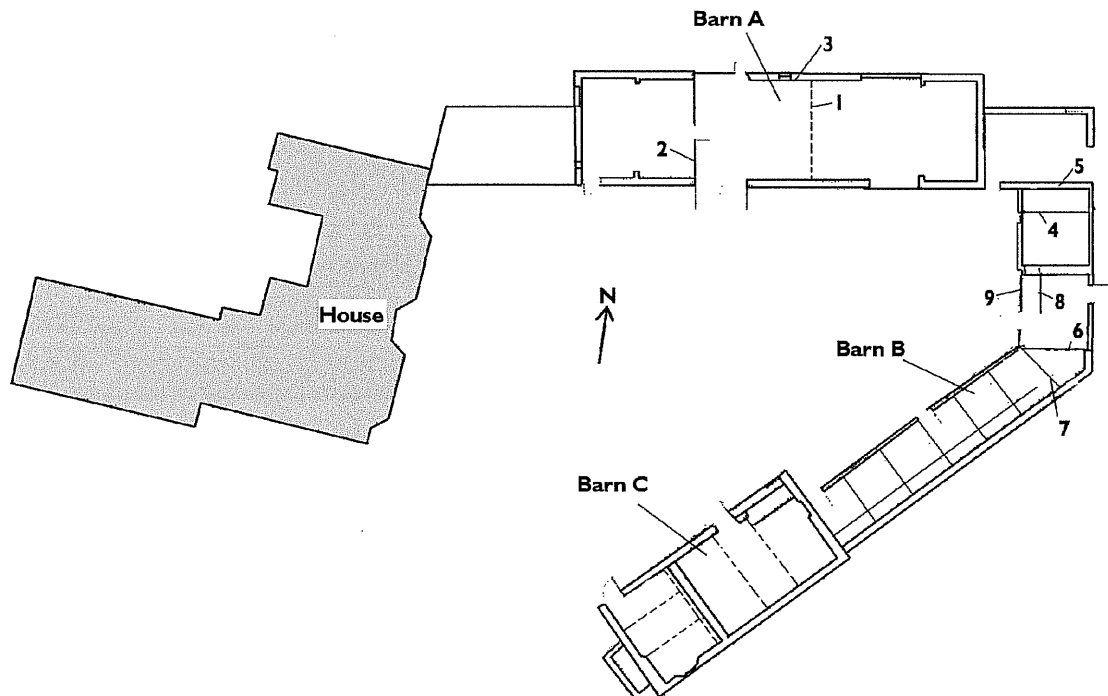
**Figure 1:** Plan of the Court Farm complex of buildings showing the approximate positions of timbers sampled for dendrochronology (adapted from an original plan by N J Teale)

Many timbers were found to be from fast-grown oaks, with even large tiebeams and principal rafters containing too few rings to be useful for dendrochronology. Some samples were taken in the large long barn (A), which has a variety of different truss forms, and from the trusses and wall-plate in building B. The trusses in B appear to have re-used timbers forming the principal rafters in many cases, there being large mortices that do not relate to the present structure. Barn C did not contain any timbers which looked to have sufficient rings for analysis, despite the large dimensions of many of them.

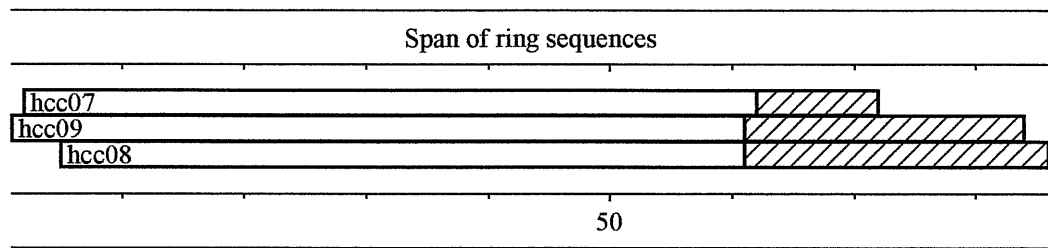
All the timbers sampled were of oak (*Quercus* spp.). Details of the locations of the timbers sampled are illustrated in Figure 1 and given in Table 1, along with other basic information. Three timbers from Barn B matched each other (Table 2) and were combined into an 86-year site chronology **hcc789**, but neither this nor any of the other individual series gave acceptable replicated matches against the dated reference material, and all the timbers therefore remain undated.

**Figure 2:** Bar diagram showing the relative positions of overlap of the three matching series from Barn B
