**An Archaeological Standing Building
Recording and Monitoring
at Dowd's Farm, Hedge End,
Southampton.**

F/11/69881
SU 4884 1466

Project No. CBAS0276

February 2013

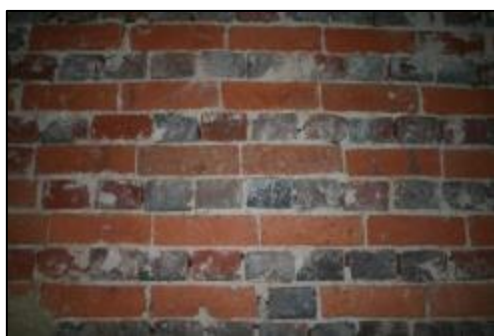
Plate 1: Interior brickwork Southern Wall

- 4.2 The exterior of the building was covered with plastic sheeting with a framework of scaffolding set very close to the walls of the house making the southern exterior wall of the property very difficult to examine. There appeared no timber framing in evidence in southern wall of the building, which had been completely rebuilt in brick which is painted white. It was noted during the survey of the interior of the building that the bricks were laid in English bond, and the courses of headers were of vitrified bricks (**Plate 1**). However, the architects drawings do show a post that had been revealed where the brickwork was missing. This would appear to be the principal post D-D located in the south-eastern corner of bay three, which is confirmed from the interior of the building. This is the only remaining principal post on the southern side of the building, all the others on this wall having been removed at the time of the construction of the replacement brick frontage.

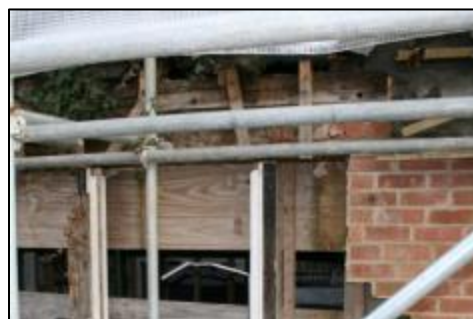
Plate 4: Side Girt West Wall

- 4.4** The western wall of the original building does have some timber framing still *in-situ*, at the northern end of this wall (**Plate 3**). This consists of the principal post A, with a wall stud to the south of the principal post. The principal post and wall stud are joined by horizontal beam which is mortised and pegged into both the post and the wall stud. Further south along the west wall there is the remains of a second wall stud on the northern side of the gap in the brickwork. This stud has an empty mortise on its southern face. To the south of the timber framing a large area of brickwork is missing, this revealing a length of the side girt (**Plate 4**). In the soffit of the side girt are two empty mortises with empty pegholes for walls studs. The upper part of the western wall was obscured by the plastic sheeting and ivy but appeared to be tile hung and devoid of features. The brickwork at the southern end of this wall was laid in stretcher bond, with the brick infill of the timber framing at the northern end being laid in a random bond. The brickwork at the southern end appeared to be a recent repair.

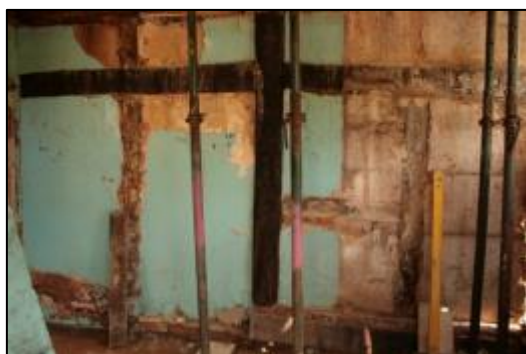
Plate 6: Framing in North Wall of Kitchen

- 5.1 The interior of the building at the time of survey was entered through the doorway in the northern wall of the fourth bay, which led into a small lobby to the north of the chimney stack. Both of the southern and eastern walls were of brick, with timber framing visible in the northern wall. This framing consisted of posts and rails consistent with small panel framing (**Plate 6**). The soffits of the timbers could not be examined as the framing had been in-filled with bricks and plastered over. The sole plate of the north wall was apparent at both the eastern and western end with the centre portion having been removed. The sole plate was 300mm above the current floor level, and had been under built with bricks. The western wall was the chimney stack, with a small range inset into an alcove in the southern end of this wall (**Plate 7**). To the north of the range was the staircase to the first floor. This was panelled-in on the eastern side with vertical planking. The staircase looks to be a simple 19th century replacement. There is a small

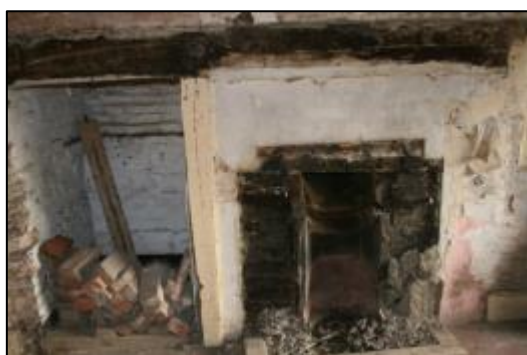
Plate 8: Inglenook Fireplace in Bay 3

5.3 Bay 3 is entered via a doorway at the western end of the small lobby to the north of the chimney stack; this entrance had no door fitted at the time of the survey, but there is a single strap hinge remaining near the top of the southern side of the door frame. The eastern wall has an inglenook fireplace that has had a later smaller fireplace inserted into the southern side of it (**Plate 8**). The later fireplace surround has been removed, revealing the brick construction of the chimney breast to the later fireplace. The original timber lintel of the inglenook fireplace is still apparent, and has been incorporated into the later chimney breast. To the south of the inglenook fire place is a small cupboard which was possibly a spice cupboard associated with the original fireplace. To the south of the spice cupboard there is a second high level cupboard. The wall to the south of the inglenook fireplace appears to have been re-built in brick, which sealed the alcove. Below this cupboard the wall showed signs of being repaired or possibly the cupboard was originally larger (**Plate 9**).

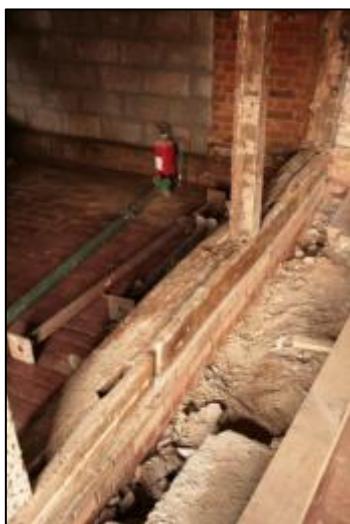
Plate 11: West Wall of Bay 3

- 5.5 There is timber framing incorporated into both the northern and western walls in both cases having been in-filled with brick. At the time of the second visit to the property the brick had been removed from the western wall with the timber framing left *in-situ*. The timber framing of the west wall consists of two wall studs with a cross beam above and the sole plate below. The sole plate had three empty mortises and a slot cut into the centre of its upper face. The slot was most likely to accommodate the wattle and daub panels, with the empty mortises being for wall studs. This implies that the two studs remaining in this wall are later additions (**Plate 11**). At the southern end of this wall there are two original 17th century doorways. The northern doorway giving access from Bay 2 and the southern doorway to the staircase to the first floor room of Bay 2. Both of the doorways have cranked heads carved into the cross beam. The southern doorway is 810mm wide while the northern doorway is wider at 1.1m, with the northern jamb of the northern doorway and the central jamb of the two doors being original timbers. The northern jamb and the cross beam above the jamb have their eastern facing surfaces roughed up, suggesting they were originally covered with daub or plaster.

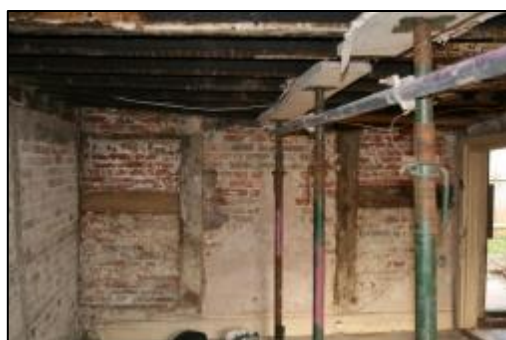
Plate 13: North Wall of Bay 3

- 5.6 In the northern wall the timber framing comprised two wall studs with a rail at approximately mid height running to the west from the western stud and the east from the eastern one. There is no visible timber framing in the centre of the northern wall (**Plate 13**). The ceiling in Bay 2 consists of eleven 17th century joists that have their lower corners chamfered and stopped at both ends, and measure 130mm wide with a depth of 100mm. The joists at the eastern end of Bay 3 rest on a beam running north south above the inglenook fireplace and on the western end rest on the floor boards of Bay 2. The floorboards of Bay 2 have their associated joists resting on the cross beam of the western wall of Bay 3 (**Plate 14**).

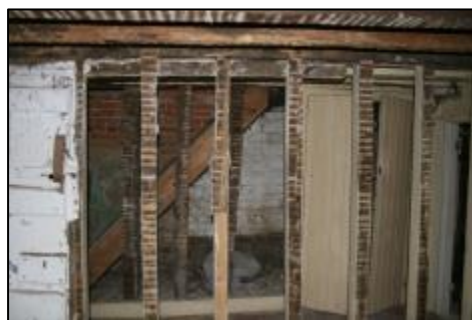
Plate 16: Northern Stud Walls of Staircase and Corridor

5.8 The staircase located at the southern end of Bay 2, and is in its original 17th century position. This is evidenced by the 17th century doorway from Bay 3. The staircase may also be of this date, but no dateable features were noted. At the time of the first visit only the studs of the northern wall of the stairwell remained. These exhibited the marks of lathes and plaster on the northern side of them. At the western end was an under stairs cupboard. To the north of the northern wall of the staircase was a second stud wall forming a small corridor. This wall had also had its covering removed and shows the marks of lathes on its northern face. At the time of the second visit to the site both of the stud walls and the staircase had been removed. The ceiling consisted of twelve joists on an east-west axis, measuring 115mm wide by 130mm deep. As with the studs the joists have the marks of the staves on them. The joists in Bay 2 must be original as they and the floorboards above support the joists in Bay 3 which are an original 17th century feature of the house.

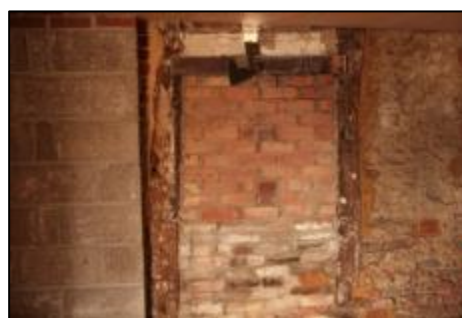
Plate 17: Possible Doorway in Northern Wall of Bay 4

5.9 Bay 1 is located at the western end of the house, and has timber framing in the western and northern walls. The western wall has two posts with a high set rail, which is possibly the door head to an earlier entrance into this bay (**Plate 17**). The framing in the western wall is that described in the exterior description. The lower part of principal post A (Fig. 6) is only visible on the exterior of the wall. There is no evidence for the sole plate in Bay 1, as it is possibly concealed by the modern concrete floor which has been laid in this part of the house. The ceiling is of exposed joists and is the same height as that in Bay 2, with them being set slightly to the north of the joists in Bay 2. This can be seen where the joists of both Bay 2 and 1 rest on the cross beam of the dividing wall between the two bays. The joists are on an east-west alignment, and appear to be of a modern date. In the centre of the joists there is a centre ceiling girder on a north-south alignment.

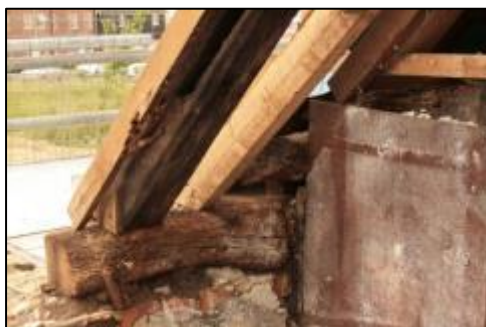
Plate 18: Wall Plate in Bay 4

- 6.1** The first floor room in Bay 4 has very low northern and southern walls as the room is built into the roof space on these two sides. Evidence for Bay 4 being a later extension is apparent on the wall plate at the top of the southern wall. The wall plate is noticeably lower, and is a separate timber from that in Bay 3 (**Plate 18**). On the second visit to the property the northern, southern and eastern walls had been demolished and the timber framing of the western wall had been revealed. This consisted of the tie beam with a downward brace rising from the principal post D-D (Fig. 6) at the southern end of the tie beam (**Plate 19**). Also apparent were a number of wall studs that appeared to be of a later date than the main framing; these exhibited the marks left behind by the lathes and plaster wall covering. The access to this room was via the staircase adjacent to the western wall, it was also noted that there did not appear to be access to the western part of the building from this room on the first floor.

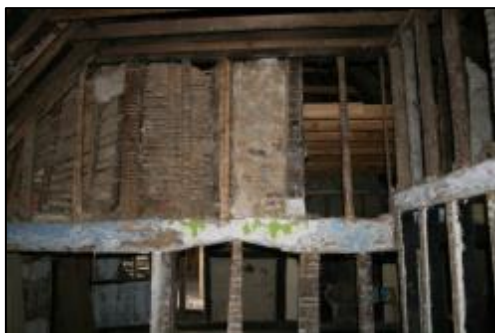
Plate 20: Door Head Between
Bays 2 and 3

- 6.2** Bay 3 on the first floor was accessed originally from Bay 2 by a doorway at the northern end of western wall. This was evidenced by the cranked door head carved into the soffit of the tie beam between these two bays (**Plate 20**). This was of the same design as the two door heads noted in the western wall of the ground floor of Bay 3. Either side of the door head the timber door jambs are *in-situ*, these have been mortised and pegged into the tie beam. A later wall stud has been inserted into the soffit of the door head, which implies that this doorway had been blocked at a later date. The eastern wall of Bay 3 consisted of the brick built chimney breast which had been panelled over with wattle and daub. In the centre of this wall was the remains of a fireplace, this appeared to have

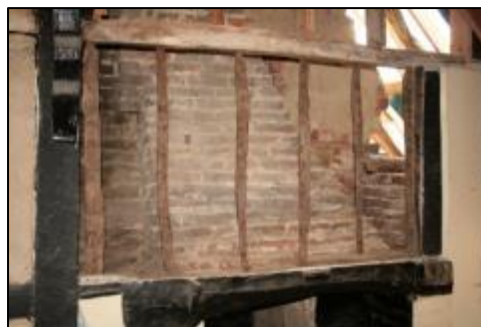
Plate 21: Lintel of Fireplace Bay 3

been blocked at a later date. Above the opening of the fire place there was a wooden lintel. The lintel had a slightly arched lower edge, which had also been chamfered. Above the fireplace an area of the wall covering had been removed revealing four staves and a wall stud at either end. There was also a single length of the wattle *in-situ* above the lintel at the southern end. At the northern end of the eastern wall to Bay 3 an area of the wattle had been exposed (**Plate 22**).

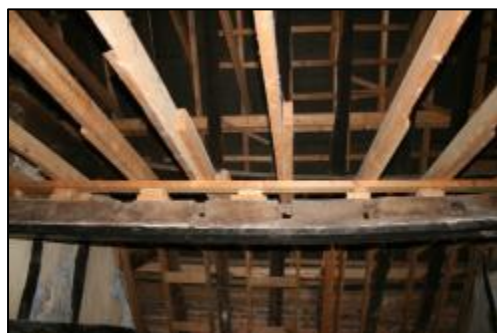
Plate 23: Ceiling Girder in Bay 3

6.3 At the time of the survey the first floor of Bay 3 was open to the roof but originally had a ceiling. This was evidenced by the ceiling girder located to the northern side of the fireplace (**Plate 22**). The girder was on a north south alignment and supported at either end by a carved wooden corbel. In both sides of the girder empty mortises were apparent for the joists.

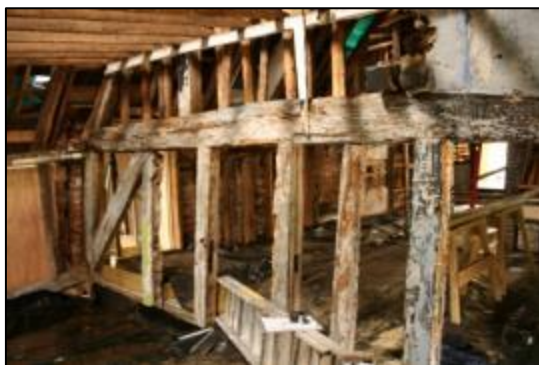
Plate 27: West Wall of Bay 2

- 6.5** The eastern wall of Bay 3 also serves as the western wall to Bay 2, and is described above. The western wall of Bay 2 is of similar construction to the eastern wall (**Plate 27**), and consists of the principal post B on the northern side which supports the tie beam (Fig. 6). The principal post B measures 200mm square and has a swelling jowl. There is an upward brace rising from the principal post to the tie beam, which measures 180mm wide by 90mm deep. The brace is mortised and pegged into both the principal post and the tie beam. The principal post B-B is again missing due to the re-built south wall, with the tie beam resting on the wall plate. Rising from the tie beam are two queen struts which are mortised and pegged into both the tie beam and the high set collar. The wall studs from the floor level up to the tie beam appear to be original, but the second and third wall studs are possibly replacements using reused timbers, evidenced by two empty mortises, and the third wall stud appears to be cut into the tie beam. The wall studs above the tie beam to the collar at the northern end are modern replacements, with the southern end of the upper wall retaining wattle and daub panels. The wattle is exposed in places.

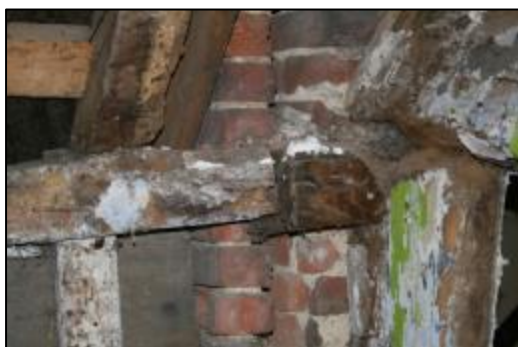
Plate 30: Joint in Northern Wall
Plate Bay 1

- 6.8** Both the northern and southern wall plates had been re-placed with new timbers just to the west of the junction between Bays 1 and 2. Both of these joints were rough scarf joints (**Plate 30 & 31**). It was also noted that both the northern and southern roof purlins had joints in a similar position (**Plate 32 & 33**). The northern wall is of modern

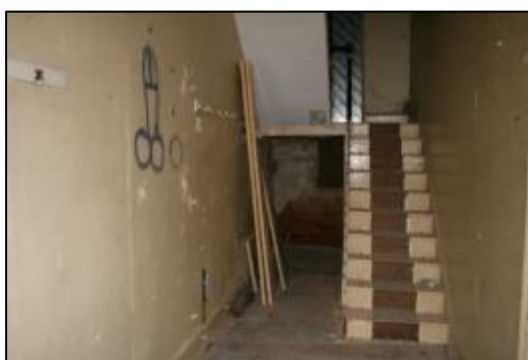
Plate 34: Corridor in 19th Century Extension

7.1 The ground floor of the 19th century extension on the northern side of the original building consists of a single large room, with a corridor housing the staircase to the first floor in the north-western corner (Fig. 5). The corridor measures 1.95m north-south by 6.8m east-west internally, with the entrance from the exterior of the building being located at the eastern end. Only the stairs remain of the staircase, the balustrade on the southern side having been removed (**Plate 34**). The staircase is has a dog leg with a half landing. The main room has the internal measurements of 4.9m north south by 6.8m east west. At the base of the southern and northern walls there is a wooden skirting board with a moulded top. All of the walls are plastered. The doorway to the room to the north is located in the eastern end of the north wall of the corridor and is fitted with a four panelled wooden door.

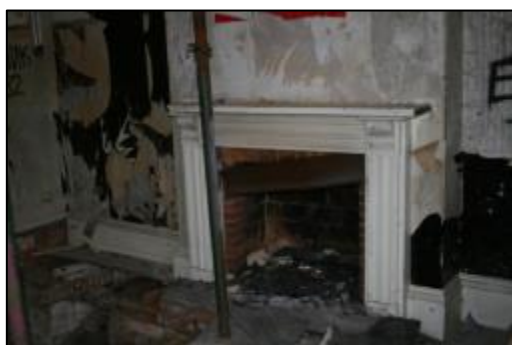
Plate 35: Fireplace in Main Room

7.2 The main room on the ground floor has the internal measurements of 4.9m north-south by 6.8m east-west. All the walls are plastered and have a moulded wooden picture rail and wooden skirting boards with a moulded top. In the centre of the western wall there is the chimney breast with moulded wooden fire surround. Above the surround is a wooden shelf supported by a wooden corbel at the top of the two sides (**Plate 35**). The room is lit by full height windows in the eastern and northern walls; the eastern window only has the outside frame remaining. Both of the windows have sliding six panelled wooden doors fitted to the inside which act as shutters (**Plate 36**).

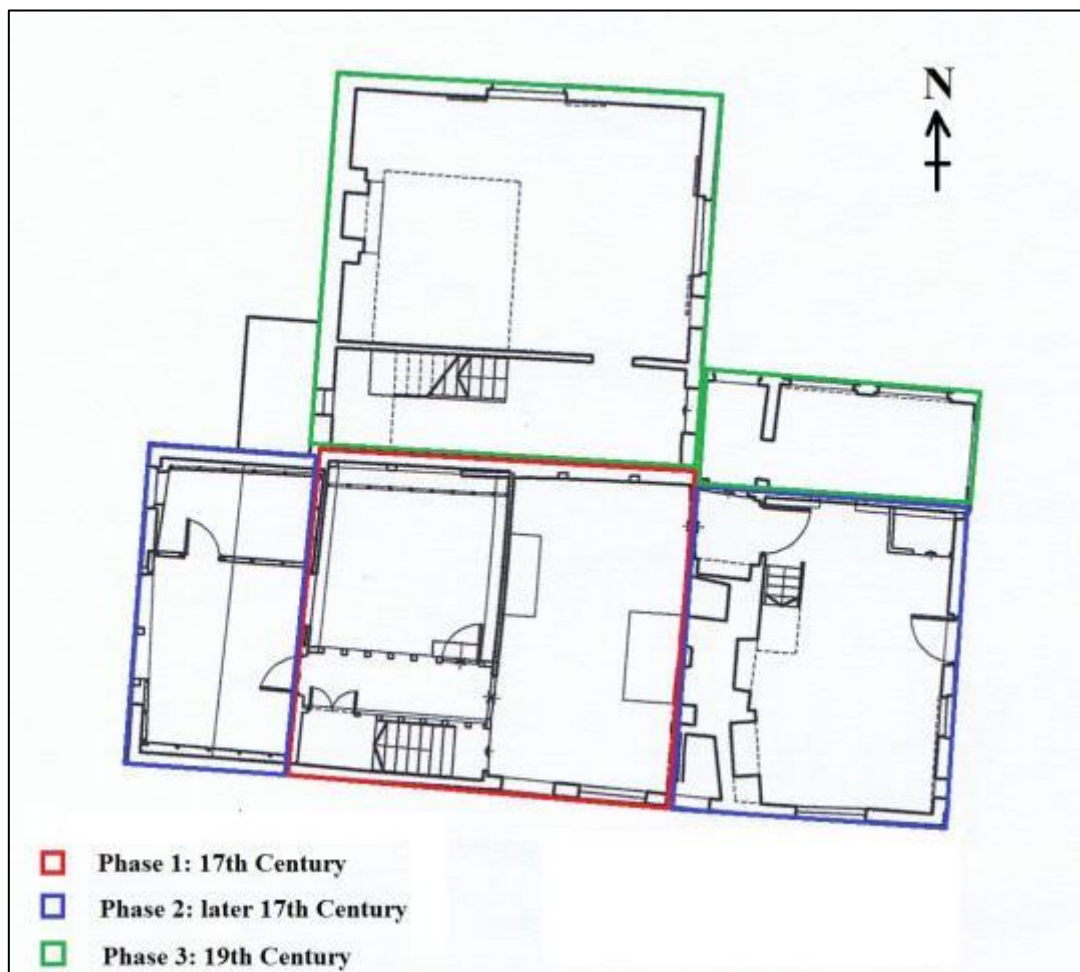
Fig. 7: Dowd's Farm, Hedge End: Phased plan
(Adapted from TKL Architects drawing)

- 8.2 The original building comprises a rectangular two or three bay house on two floors (Fig.7). Evidence from the remaining timbers incorporated into the northern wall of the original house would suggest small panel framing. This was also implied by the length of side girt revealed in the hole in the western wall of the original house where the spacing of the empty peg holes would also suggest this type of framing.
