**A Standing Building Survey
at Fishponds Barn, Hastings,
East Sussex.**

HS/LB/08/00145

Project No CBAS0270

June 2013

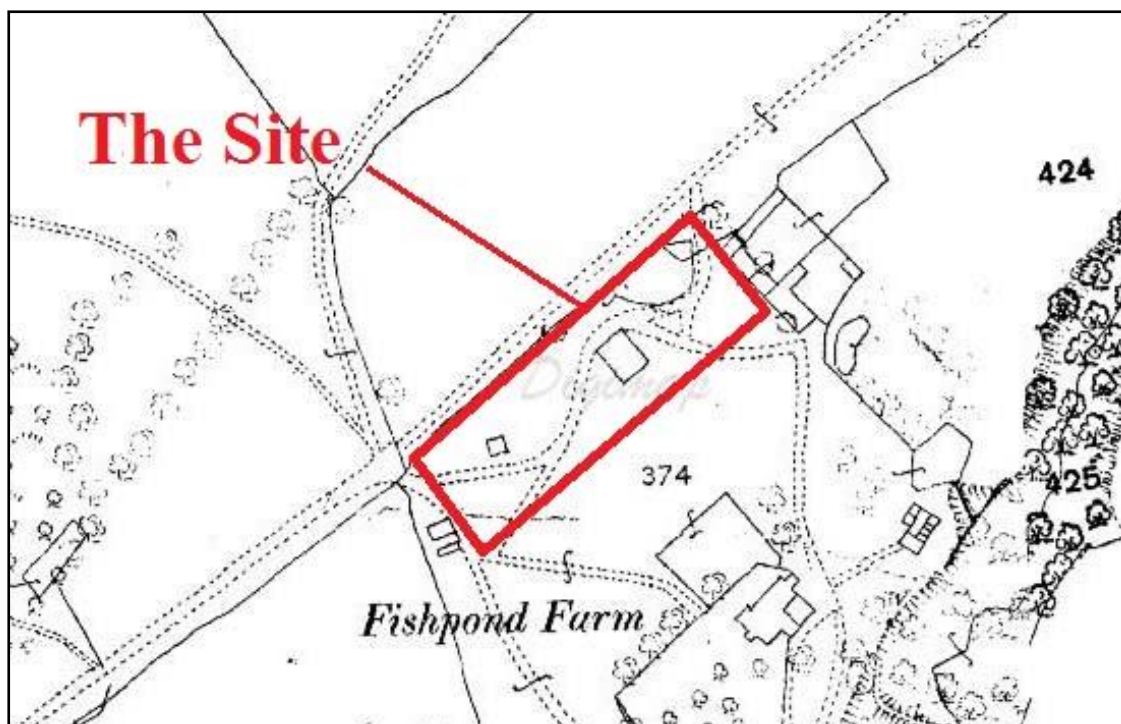
Fig. 3: Fishponds Barn, Hastings: 1st Edition OS Map (1873)

- 2.14** The barn is clearly shown on the 1st Edition OS map (1874), together with three smaller buildings to the west of the barn, one of which is within the site (Fig. 3). The 3rd Edition OS map (1909) shows the barn divided into two, and a small extension on its south-west corner (Fig. 4); the small building on its west side has now gone. The 4th Edition OS map (1929) shows a similar situation, although Fishpond Farmhouse is now a Golf Club House (Fig. 5).

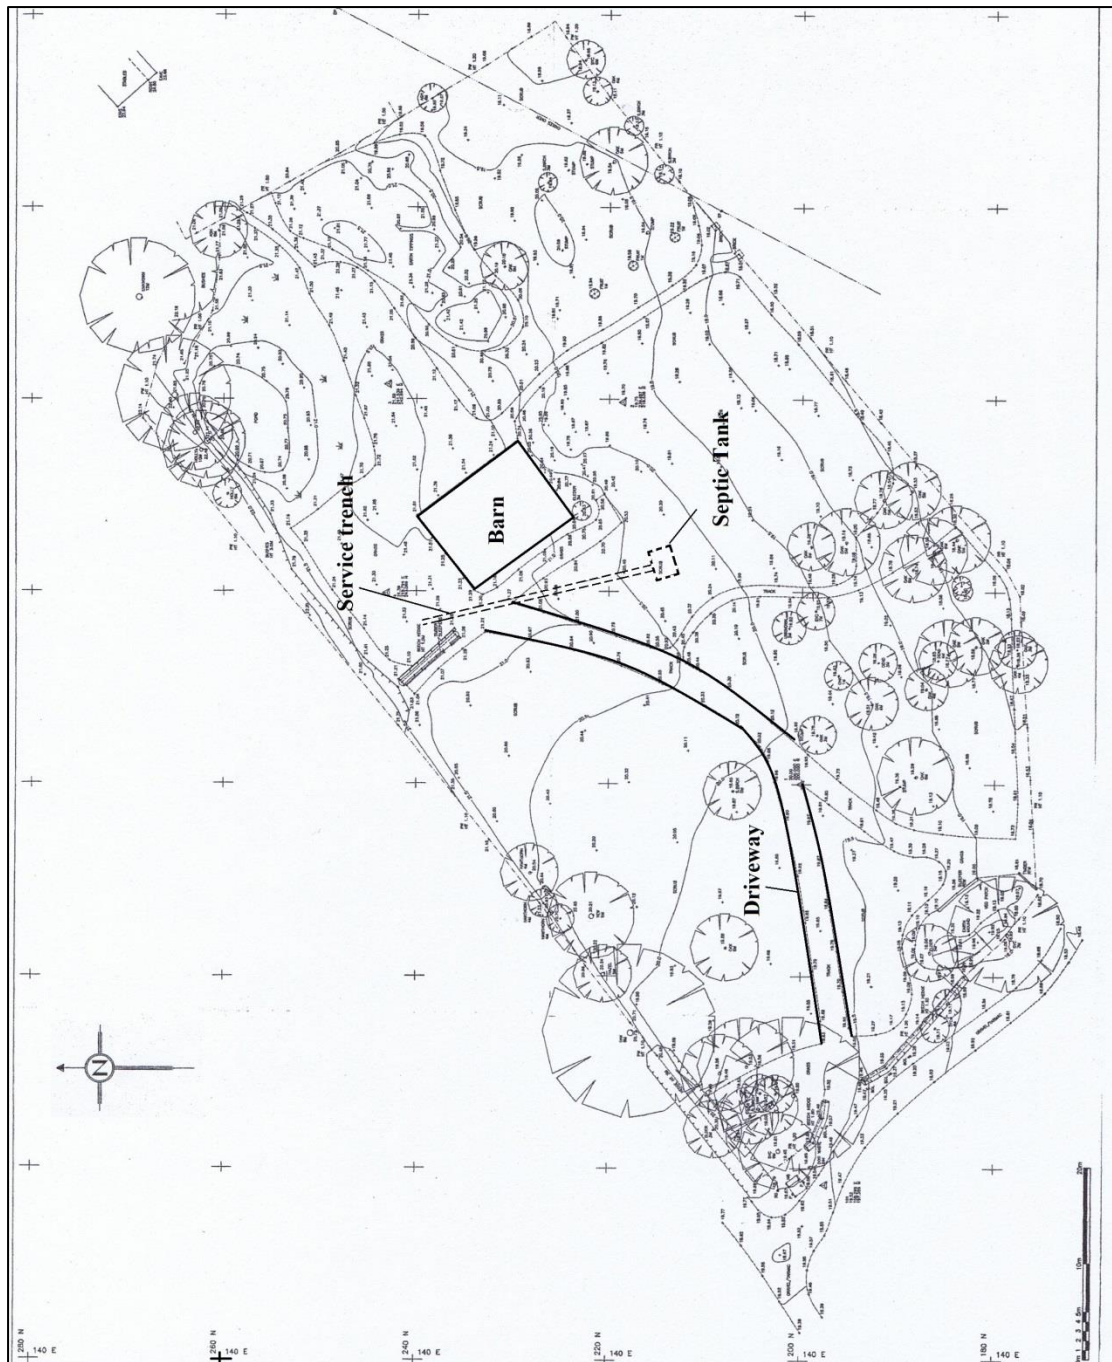
Fig. 7: Fishponds Barn, Hastings: Site Plan showing areas monitored

- 3.3** Work was monitored on two occasions (Fig. 7); on the first visit to the site a watching brief was maintained on the excavation of a trench on the western side of the barn which was to lead to a septic tank 9m to the west of the south-western corner of the barn. The trench was up to 600mm in depth and had a width of 300mm, with a length of 26.9m. During this visit a shallow excavation that had already taken place to re-expose the gravel surface of the existing driveway was inspected. The excavation of the septic tank hole was watched on the second visit to the site, this measured 1.9m east to west by 2.6m north to south and had a depth of 2m.
