**A Standing Building Survey of Two
Buildings at Warnham Brickworks,
(Site Ha)
Horsham, West Sussex**

Project No. CBAS 0382

by
Keith Butler PIfA

May 2013

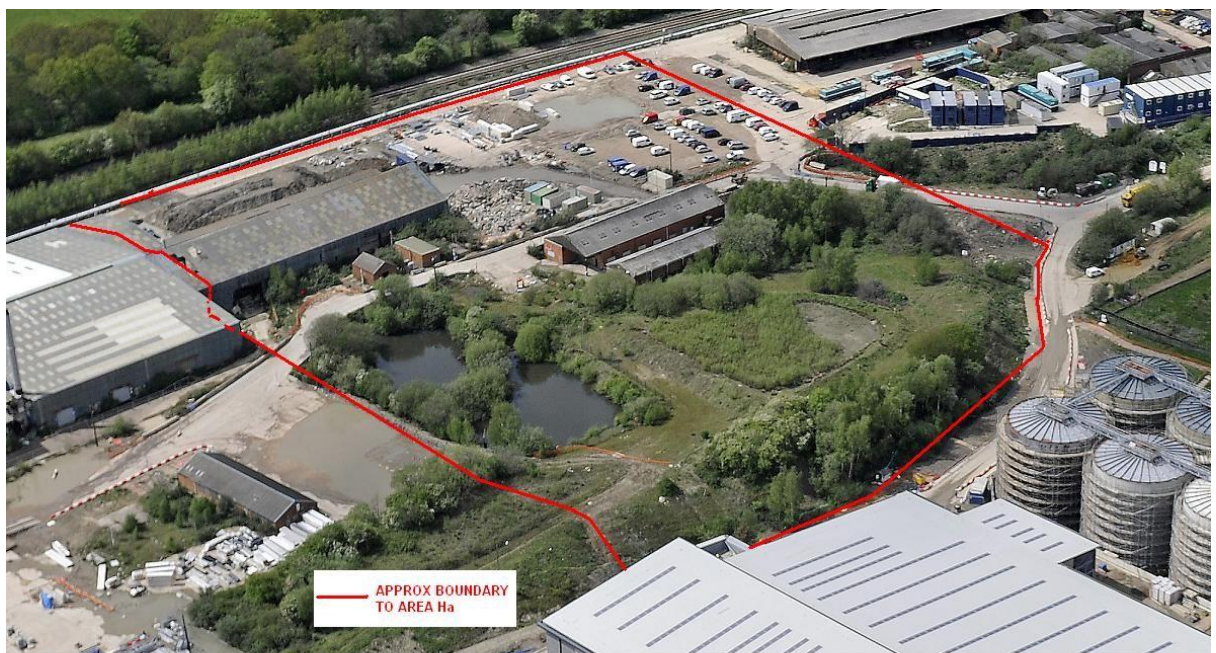
Aerial photograph of Site Ha, showing the two buildings in the centre of the marked area.

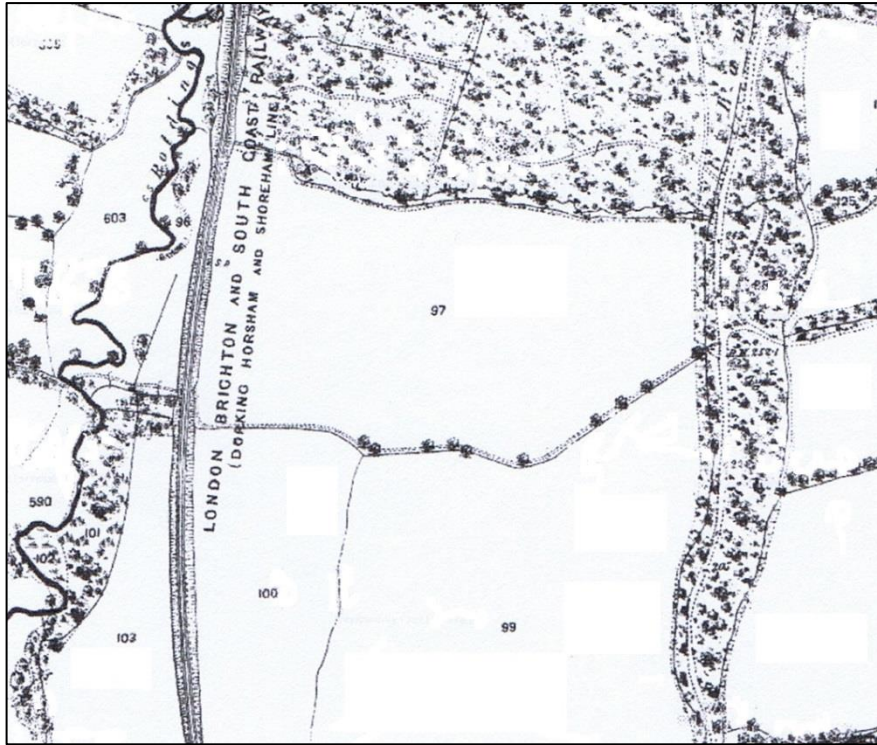
Fig. 2 Warnham Brickworks: 1st Edition OS map 1875

- 2.1 The 1st Edition OS map of 1875 (Fig. 2) shows the site of the later brickworks to open fields to the east of the London Brighton and South Coast railway line. Warnham Brickworks was first established c.1888 by Robert Peters on a site to the west of the railway line as can be seen on the 1898-9 2nd Edition OS map (Fig. 3), but by 1909 the main operations had moved to the east side of the railway line¹.

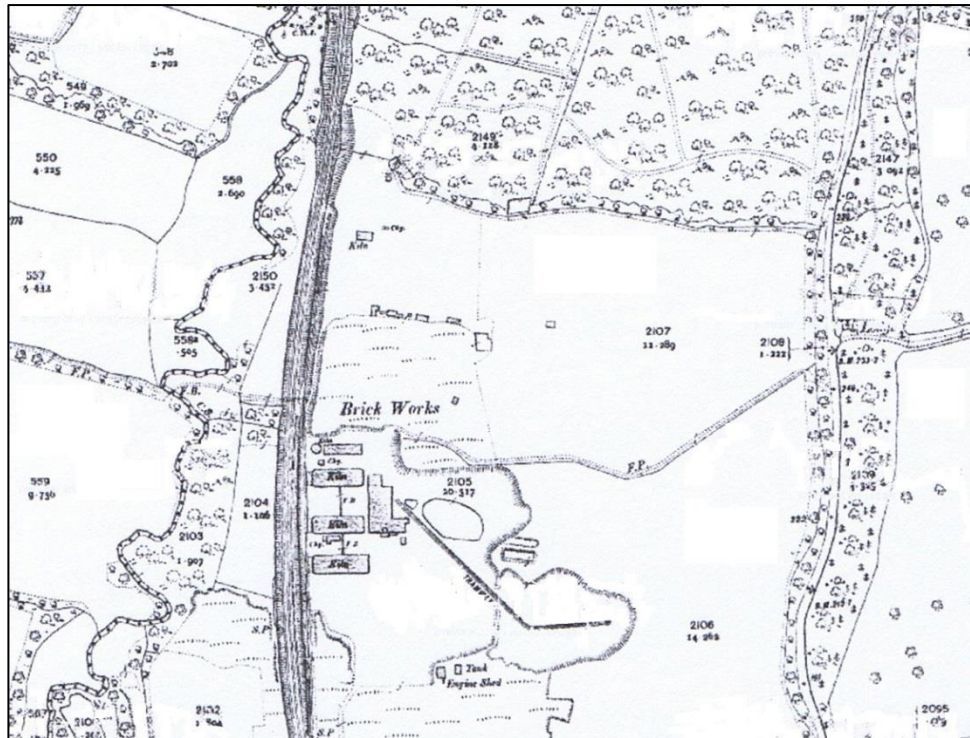
Fig. 4 Warnham Brickworks: 3rd Edition OS map 1912

- 2.2 In 1899 Warnham Brickworks was sold to William Belcher who established the Sussex Brick Co. Ltd, which then in 1903 became the Sussex Brick and Estates Co. Ltd. The 3rd Edition OS map of 1912 (Fig. 4) shows the brickworks with three Hoffmann type coal-fired continuous kilns, which were built in the first decade of the 20th century. Behind the kilns was a line of presses, fed with clay from a parallel line of grinding mills. In 1912 a steam excavator was introduced into the claypit, as part of a programme to achieve an output of 100,000 bricks per day².

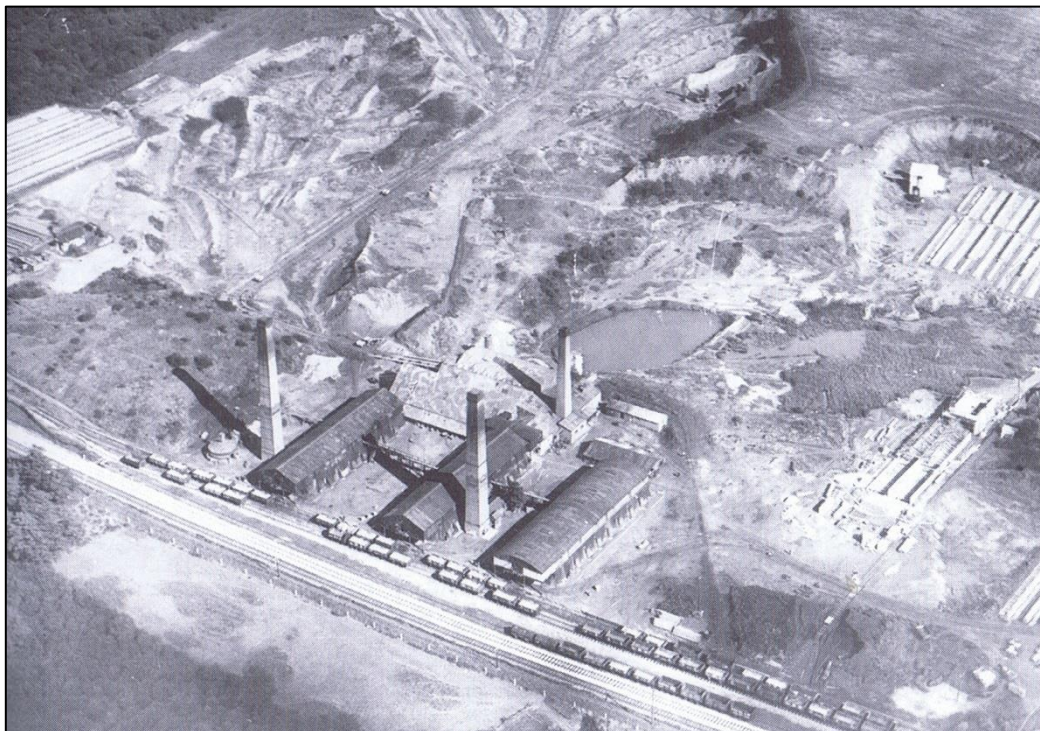
Fig. 5 Warnham Brickworks: 1928 Aerial photograph
(From Beswick, 2001)

- 2.3 An aerial photograph dated 1928 (Fig. 5) shows the same arrangement of kilns/buildings, with the location of the buildings that are the subject of this survey seemingly covered with piles of spoil. In 1935 a merger resulted in the formation of the Sussex and Dorking United Brick Companies which in turn merged with the Redland group in 1958/9³. No OS mapping of the site is available for this period.

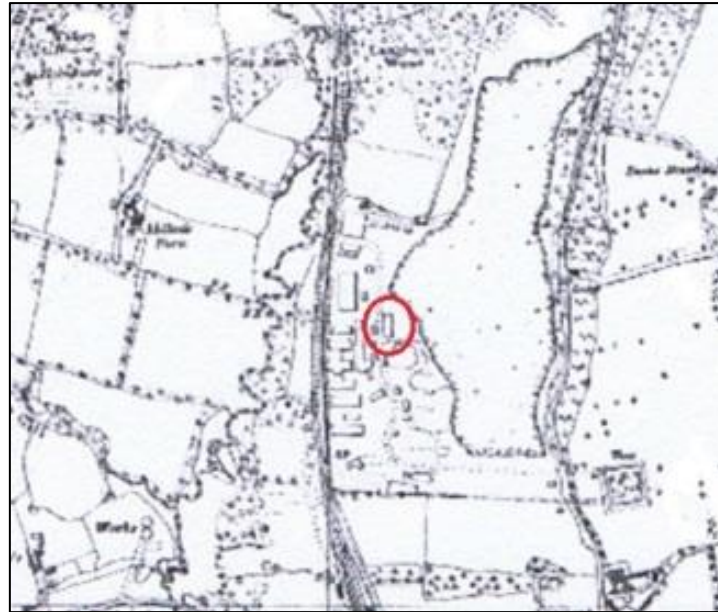
Fig. 6 Warnham Brickworks: 1961-2 OS map
Ordnance Survey © Crown copyright 1961-2. All rights reserved.
Licence number 100037471

- 2.4 The next available OS map of 1961-2 (Fig. 6) shows the larger of the two buildings present, and by the 1976 OS map (Fig. 7), both buildings are shown. Later OS maps show no change relating to these two buildings, although other buildings are added or removed during this time. It has been suggested that many of the 'modern' structures were erected around 1963 when new automatic moulding machinery was installed to make Wealden kiln stocks⁴. Brickmaking ceased in the 1990's.

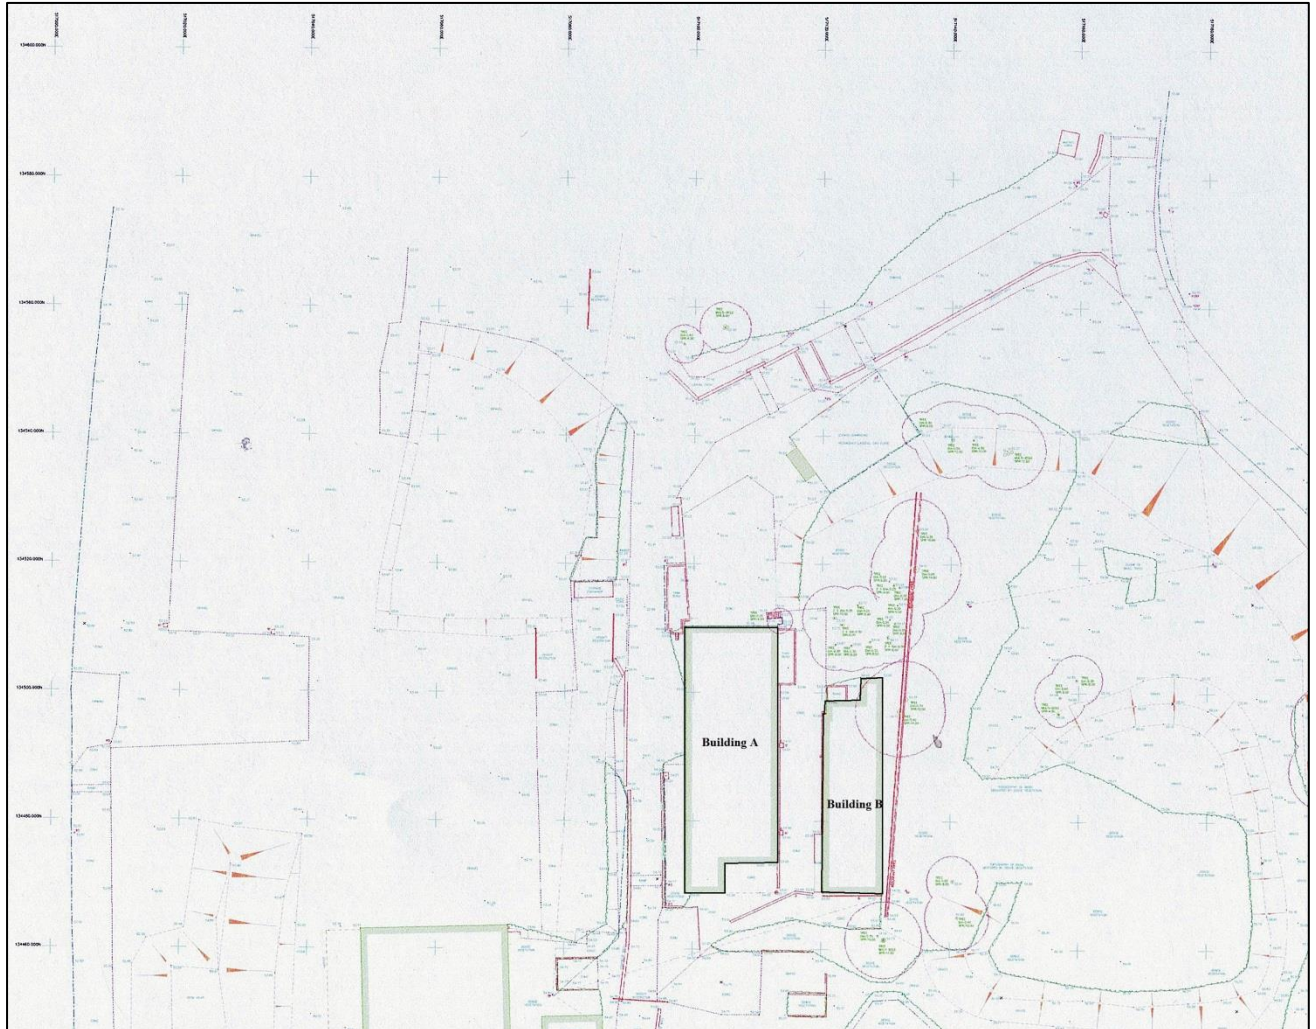
Fig. 8 Warnham Brickworks: Site Ha Plan
(Adapted from architects drawing)

3.1 The two buildings were located in Site Ha, which is situated to the north-east of the building housing the Hoffman-type kilns. For the purposes of this survey, the larger western building was designated Building A, and the smaller building to the east was designated Building B (Fig. 8).
