**A Standing Building Survey on  
the Buildings at Spells Yard,  
Worthing, West Sussex.**

Project No. CBAS0405

by  
Keith Butler PIfA

September 2013

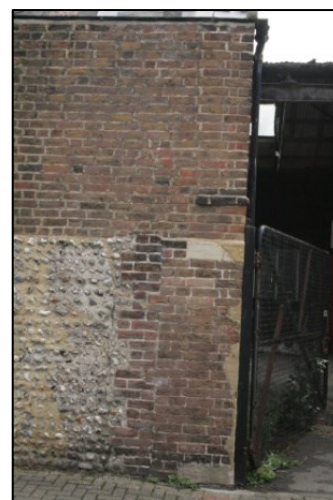
**Plate 4:** Western end of North Building A Wall

- 4.3** The northern elevation (**Plate 3**) of Building A faces onto Grafton Place and is constructed of flint below, with the upper part being of brick. The lower part of the northern wall incorporated the northern boundary wall of Spells Yard. The flint boundary wall making up the lower part of this elevation was coursed cobbles that had not been faced. The cobbled lower part had a height of 1.95m, after this the wall changed to brick. The bricks were laid in Sussex bond with three stretchers between each header. At the top of the brickwork just below the eaves in a central position was the sign 'R. SPELLS' in gold letters on a green painted wooden board. Below this in very faded paint could be seen the words 'BRIGHTON LTD'. At approximately 700mm from the base of the brick part of this wall the ends of two concrete beams could be seen incorporated into the brickwork. Two dormer windows were located in the northern slope of the roof, which were both with wooden framed dormer windows of three lights. The dormers had a flat roof above with slate clad sides. It was also noted that at the western end of the flint lower part of the wall there was a brick built quoin; this had been incorporated into a section of brickwork on its western side. This would suggest that the western side of the entrance to the yard had been reduced in width when this building was constructed.

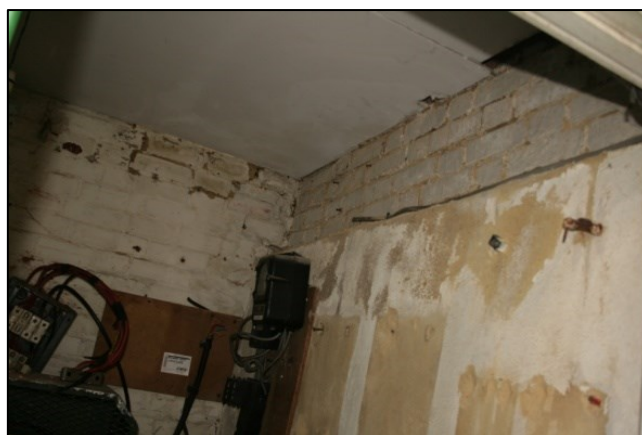
**Plate 8:** North Wall of the Compressor Room

- 4.8** The modern single-storey toilet block was located on the eastern end of Building A, and consisted of three rooms. The two rooms at the western end of the block were the ladies and gents toilets, and both were fitted with modern ceramic WC's and wash hand basins. All the walls in both of these rooms were plastered with the lower two thirds of the walls being covered with modern ceramic tiles. The ceilings were also plastered and both rooms had a floor covering of red ceramic tiles. The room at the eastern end houses two compressors with the upper one have a maker's plate with the name 'J and E Hall, Dartford' on it. The compressor room was accessed through a louvered double door in the centre of the eastern wall. The walls were all of painted brick laid in a random bond, except for the lower part of the northern wall which was cement rendered which slightly stepped out from the four courses of bricks visible above this (**Plate 8**). The northern wall incorporated the northern boundary wall to the yard.

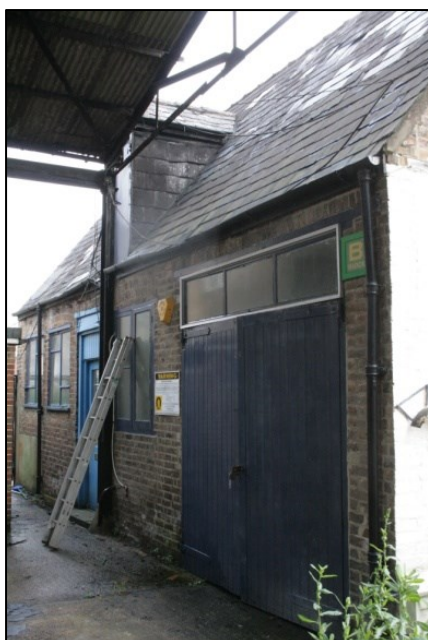
**Plate 9:** Western Elevation Building B

- 5.1** Building B was located in the north-eastern corner of the yard, and was rectangular in plan on a north-south alignment. The building was of a single storey height but had a first floor built into the roof space. The western elevation (**Plate 9**) was of brick construction, with these being laid in a random bond. At the southern end of this elevation at ground floor level, there were two metal framed windows, glazed with wired glass. Above these two windows was a slightly curved brick header of two courses. To the south of the two windows was an entrance fitted with a modern door with the upper part glazed. To the south of the door was a wooden framed casement window, with a slightly curved head of two courses of bricks. This window, as with the two at the northern end of the elevation, was glazed with wired glass. At the far south of this elevation there was a set of double doors, constructed of vertical wooden planks, with a window of three lights above. The double doors were acting as security doors to a slightly recessed wooden panelled area (**Plate 10**), which had a modern door at the northern end and a glass panel to its southern side.

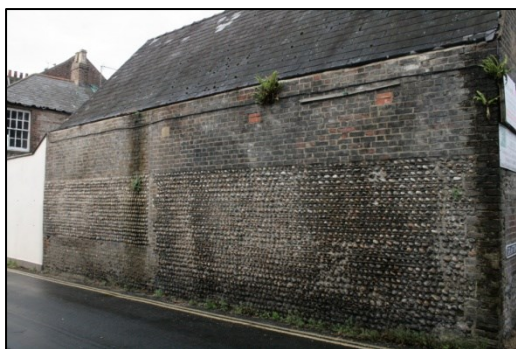
**Plate 12:** Eastern Elevation of Building **B**

- 5.3** The eastern elevation of Building **B** fronted onto Portland Road and was of the same construction as the southern wall of the building. The lower part of the wall being of coursed flint cobbles up to a height of 2.3m (the difference in height of the flint part of the wall from that of the northern elevation being due to the lower ground level). There was only a brick built quoin at the northern end of the wall, however there was a second brick built quoin apparent only in the flintwork at a distance of 6.2m from the northern end of the wall. This suggests that Building **B** was originally smaller and had later been extended to the south. It was also noted that the lower part of the flintwork in the lower part of the wall had a different appearance. The brickwork of the upper part of this elevation was laid in Flemish bond, and had three small square repairs in it between the northern end of the building and the brick quoin apparent in the flint of the lower part of the wall. The two repairs at the northern end were of modern brick with the repair at the southern end being of concrete. These were probably blocked vents.

- 11.7** This building shows that many alterations have occurred over time including the blocking up of three vents at the northern end of the eastern wall of the building. The placing of these only in the northern end of this wall, they do not appear after the brick built quoin would also indicate that the building is of two phases. There is also evidence in the form of two wooden lintels with brick repairs below in the southern wall that this originally had two opening at this end of the building.

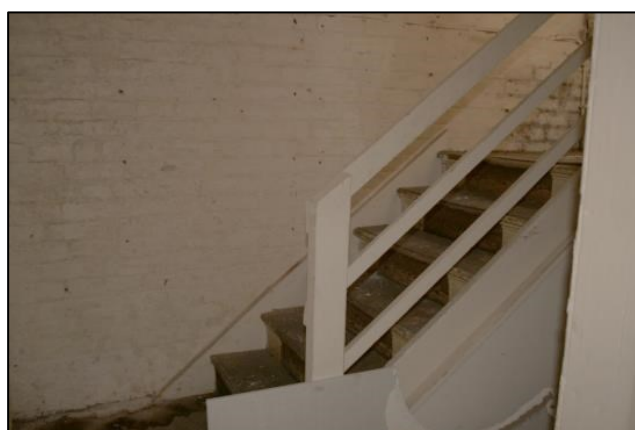
**Plate 17: Staircase B4**

**5.8** **B4** was located in the south-eastern corner of Building **B** and housed the staircase to the first floor of the building. The staircase was located adjacent to the eastern wall with a dogleg to the west at the top of the staircase. The staircase was of modern wooden construction with a square sectioned newel post on the western side of the staircase at its base and three horizontal planks of wood acting as balustrades (**Plate 17**). The western wall was the plasterboard partition wall seen in **B3**, with the other three walls of brick construction. The ceiling was of plasterboard, with the floor being of uncovered concrete.

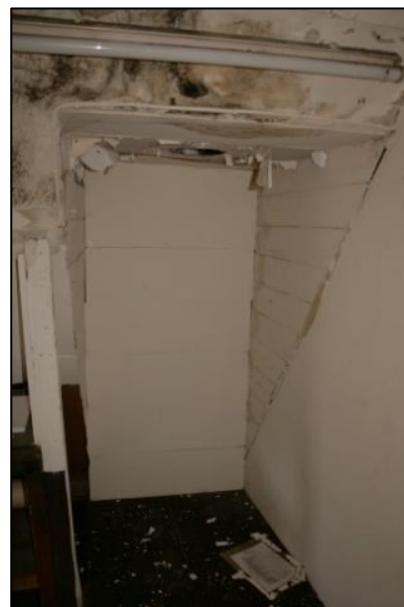
**Plate 19: Projecting Gable Structure B5**

**5.9** The first floor consisted of two rooms, which were built into the roof space. **B5** was located at the southern end of the first floor of the building (**Plate 18**) and was accessed by the staircase in the south-eastern corner of the room. The staircase was protected by three posts and three horizontal planks on its eastern side. The southern brick-built gable served as the southern wall and had a wooden framed window of two lights in a central position. The northern wall was a plasterboard partition wall dividing this room from **B6**. The eastern and western walls of the room were the sides of the roof, which had been covered with hardboard leaving only the side purlins and two collars exposed. Located at the northern end of the western side of the roof the projecting gabled structure was apparent (**Plate 19**). This was of horizontal wooden plank construction on its north and south sides, with the opening on the western side being boarded over with chipboard panels. This structure most likely housed a hoist but as noted on the exterior examination of the building there was no evidence for this. The lower part of slope of the western side of the roof had a work bench of wooden construction with shelves fitted under. The floor had been covered with hardboard sheets.

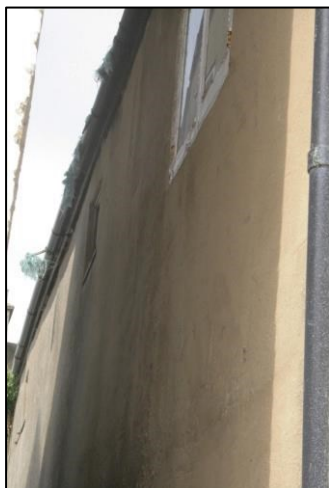
**Plate 21:** Southern Elevation of Buildings C and E from Alley

- 6.3** The southern elevation of this building backs onto a narrow alley. The southern elevation of this building has a painted cement rendered finish. There is no visible join between the eastern end of Building C and western end of Building E (**Plate 21**). The only features in this elevation are two windows which have been boarded over on the interior.

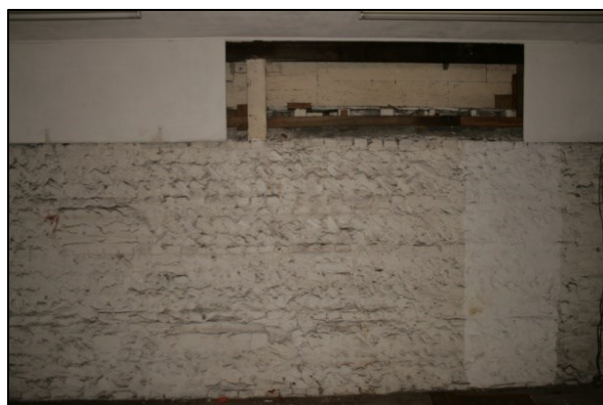
**Plate 22:** Eastern Wall of C1

- 6.4** The ground floor of Building C consists of one large room C1 with its south-western corner partitioned off. The partitioned off part of the building was sub divided to form a separate room. The partition walls were built of plasterboard which was nailed to a frame of studwork. The staircase to the first floor was located in the south-western corner of the room. The eastern wall (**Plate 22**) of C1 was constructed of faced flints and brick with five string courses of bricks laid in header bond. This wall had been heavily painted. This part of the wall was 2.2m high with what appeared to be a cement capping on its top surface. There appeared to be a brick built quoin southern end of the lower part of the wall. Above the flint and brick the construction of the wall changed to horizontal wooden planks, this had later been cover with plasterboard sheets.

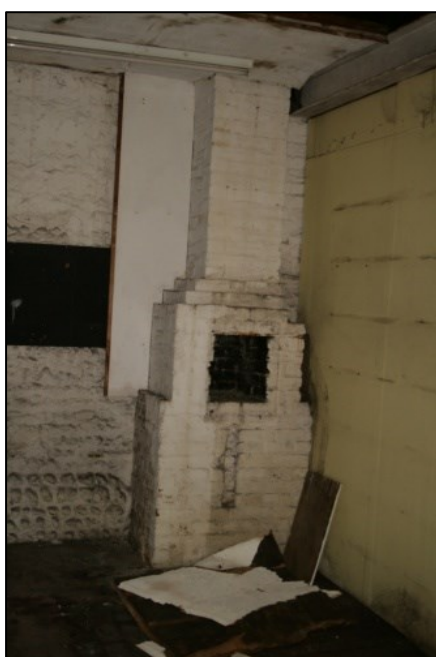
**Plate 23:** Small Forge or Oven **C1**

- 6.5** The southern wall of **C1** was of coursed flint cobbles with occasional brick inclusions, there is a small brick built pier 6.2m in from the eastern wall. Between this pier and the eastern wall of the partitioned off south-western corner there is a small brick built forge or oven (**Plate 23**). The forge or oven has a square opening located at 1.5m above floor level. The sides of the forge step in, forming a shoulder at approximately the same height as the base of the opening. The top of the forge has two stepped in courses of bricks reducing it size, above this it continues as a small internal chimney stack. The northern wall consisted of the double doors at the eastern end of this elevation with two windows and then a single door as described in the general exterior description. The ceiling was of hard board sheets with the three exposed wooden ceiling joists, either side of these was a RSJ. Both the RSJs and ceiling joist were on a north-south alignment.

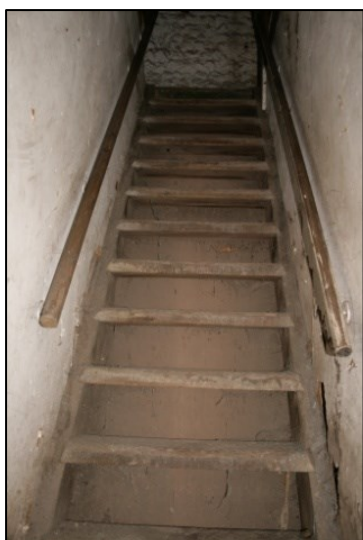
**Plate 24:** Staircase C1

- 6.6** As mentioned above, the south-western corner of the room has been partitioned off with modern walls of plasterboard and wooden panels. The eastern room is entered through a doorway in the north wall, this has no door fitted. The southern wall in this part has been plastered. The staircase (**Plate 24**) is located adjacent to the western wall of the eastern room and forms the eastern wall of the stairwell. The staircase is accessed from the eastern end of the south wall of the north room, and consists of a flight of thirteen steps. The staircase is very plain with the steps only consisting of the treads with no risers but the underside has been panelled. The western wall of the stairwell is constructed of plasterboard, with both of the walls at the side of the staircase being fitted with a wooden hand rail. To the west of the access to the staircase there is a modern four panelled door which is the entrance to the southern room. The western end wall of Building **C** is apparent in the northern room and the southern room which is partially below the staircase. The wall is constructed of brick laid in a random bond. The western wall also has a blocked entrance to Building **D** at its northern end (**Plate 25**). The floor of **C1** is of brick throughout.

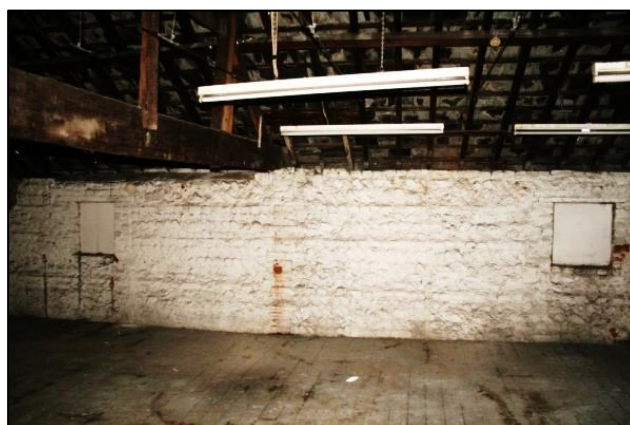
**Plate 26:** Southern Wall of C2

- 6.7 C2 is the single room on the first floor of Building C, and is open to the roof. C2 is accessed via the staircase in the south-west corner of the room. The staircase is protected by four posts with two planks of wood nailed to the posts. These are located on the northern, eastern and western sides of the staircase. The southern wall (Plate 26) is constructed of flint cobbles and brick at about 75%; there are four string courses of bricks laid in header bond. The bricks in the main body of the wall have been laid at an angle. There are two boarded-over windows in the south wall, both are boarded with wooden sheets. At the western end of the south wall is the small brick built chimney stack to the forge/oven seen on the ground floor in C1. 4.2m to the east of the chimney stack is a brick built quoin which would appear to line up with the brick built pier in C1.

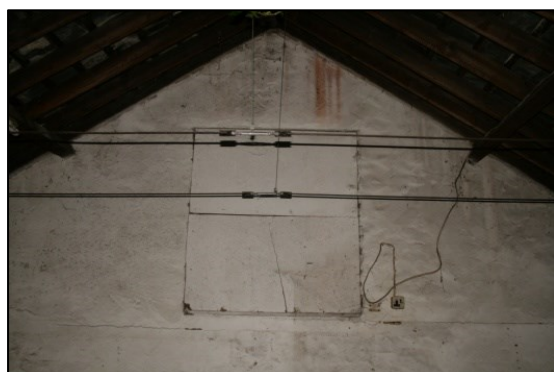
**Plate 29:** Western Wall C2

- 6.9** The western wall of C2 is gable-ended and has a plastered finish. In the centre of the gable is a window which looks over the flat roof at the southern end of Building D (**Plate 29**). This window has been sealed over with hardboard sheets. The eastern wall is of horizontal wooden planks with a RSJ at the top (**Plate 30**), and is the dividing wall between Buildings C and E. The plank wall only extends to the ceiling height of the rooms on the first floor of Building E; above this the structure of the roof is visible. At the northern end of this wall there is a modern panelled door leading into E2 on the first floor of Building E. The floor of C2 is of floorboards on a north-south alignment and is not covered.

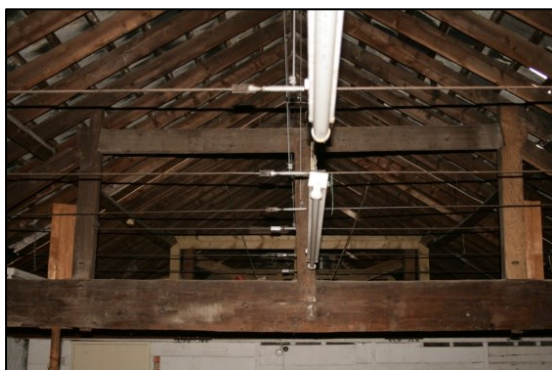
**Plate 31:** Eastern Trusses C2

- 6.10** The roof is gabled at the western end and continues above Building E. There are three trusses visible, with one located over the eastern wall line between Buildings C and E, one in the centre of C2 and a third just to the east of the blocked double doors at the western end of the north wall. The two trusses at the eastern end of the building are of the same design, which is a form of queen post roof with a centre post between the two queen posts (**Plate 31**). The western truss has been greatly modified incorporating a row of four windows between the queen posts (**Plate 32**). The western face side of the truss has been panelled over with perforated hardboard. The roof is constructed of common rafters with a purlin resting on the outer face of the brace which rises from the end of the tie beam up to the top of the queen post. All of the trusses have notches cut into their outer faces at the top of the queen posts and also appear to of been shortened, which implies that they have been modified

and that Buildings C and E have had their roofs replaced at some point in the past. At the apex of the roof there is a ridge plate.

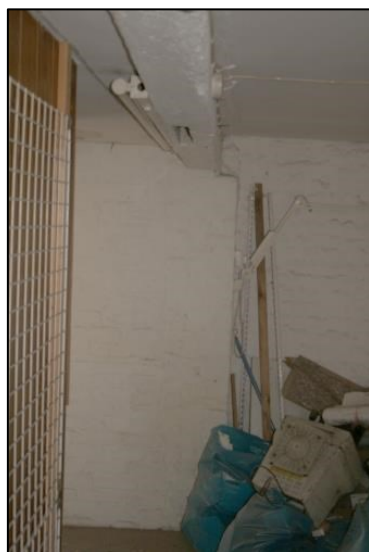
**Plate 34:** Plinth **E1**

7.3 **E1** is the single room located on the ground floor of Building **E**. The southern wall of **E1** is of flint cobbles with brick inclusions. There is a brick built plinth located at the eastern end of the south wall. There is a butted joint approximately 500mm in from its western end (**Plate 34**), with this part of the plinth supporting a wooden beam which runs across the entire eastern wall on a north-south alignment (**Plate 35**), and is located slightly to the west of the eastern wall of **E1**. The beam has a slightly arched shape to the soffit of the beam, and also has a large empty mortise at the southern end with a peg hole for the joint in its western face. This beam appears to define the original western wall and extent of 89 Portland Street. The eastern wall is plastered but a small section at the southern end reveals its construction of brick and cobble construction, the centre section of this wall also projects into the room and is covered in imitation vertical wooden planks. There is an entrance at both the southern and northern ends of this wall to the ground floor of 89 Portland Street, with only the northern entrance being fitted with a door, which is a modern panelled-over door. The northern wall is of wooden panelling with a centre positioned metal framed casement window. The ceiling is of plasterboard sheets and the floor is of un-covered concrete.

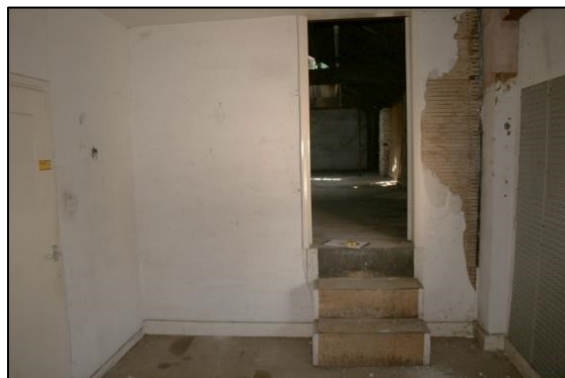
**Plate 36:** Western Wall of **E2**

7.4 The first floor of Building **E** can only be accessed from the entrance in the eastern wall of **C2** on the first floor in Building **C**. **E2** is located on the north side of the building, with its floor level being 770mm lower than that of **C2** in the building to the west, and has a three steps at the entrance to the room. The western wall of the room is of lathes, which have been covered with plasterboard (**Plate 36**). The north wall is of plasterboard with a wooden framed sash window in the centre of the wall. The eastern wall is plastered, with what appears to be a chimney breast at the

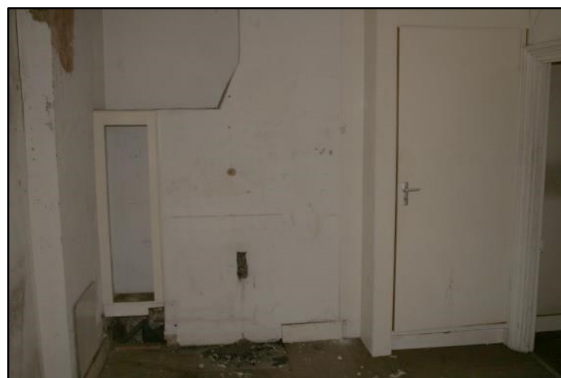
**Plate 37:** Chimney Breast East Wall **E2**

northern end of this wall. To the south of the chimney breast there is a built-in cupboard. The southern wall is of plasterboard with the entrance to **E3** at the eastern end and the entrance to **E4** at the western end. The eastern doorway is fitted with door of wooden vertical plank construction, and the western with a plain door. At the base of the walls there are modern skirting boards of various types. The floor is chipboard panels, and the ceiling is plastered.

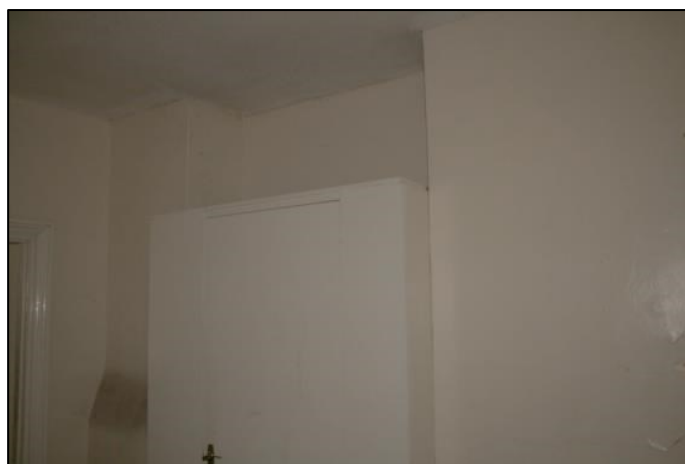
**Plate 38:** Eastern Wall of **E3**

- 7.5** **E3** is located in the south-eastern corner of the first floor of the building, and has all walls lined with plasterboard. The north end of the eastern wall has the continuation of the chimney breast seen in **E2**, with a second projection (possibly a second chimney breast) at the southern end of this wall (**Plate 38**). Between the two projections there is a built in cupboard. There is a single wooden framed window at the western end of the southern wall which continues into **E4** and has been cut by the dividing wall between **E3** and **E4**. The room has low modern skirting board of various types, with the floor having a covering of carpet. The ceiling has a coating of 'Artex'.

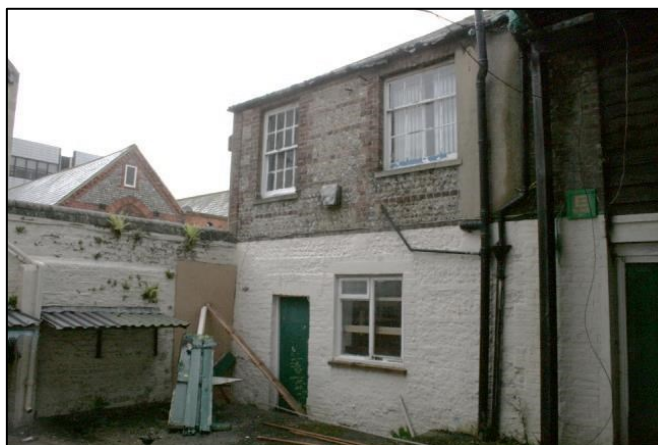
**Plate 39:** Northern Elevation of 89 Portland Road

**8.1** 89 Portland Road is located in the south eastern corner of the yard, and is of two storeys, with its northern elevation facing on to the yard. The northern elevation (**Plate 39**) is constructed of coursed flint cobbles, with the ground floor painted white. Within the flint construction of the wall there are eleven bands of bricks which are laid in header bond. There is a doorway at the eastern end of the ground floor which is fitted with a modern plain door. To the west of the door is a modern wooden framed casement window. There are two sash windows of different types at the first floor level in this elevation. The eastern window is deeper having the lower and upper sections being divided into eight lights each, whereas the window at the western end has the upper section being divided by glazing bars into a single row four lights, with the lower part being divided into two rows of four lights. The thin glazing bars in these windows suggest a 19<sup>th</sup> century date and are possibly original. All of the windows on both the ground and first floor have brick built jambs and flat heads of bricks which are laid in header bond. To the west of the western window there is an area of cement rendering over the original surface of the wall.

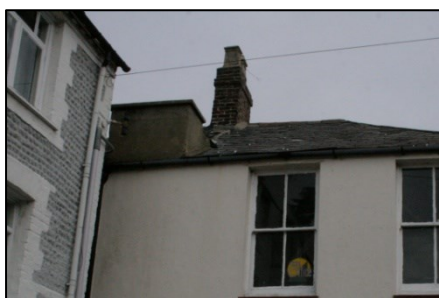
**Plate 41:** Chimney Stacks

- 8.4** The roof of 89 Portland Road is hipped at the eastern end and forms a continuous roof with Buildings E and C at its western end. The roof covering is of slate. From street level there are two chimney stacks visible (**Plate 41**), the first is located at the western end of the roof and is within the house and through the ridge. The chimney stack appears to be of two phases with a butt joint between the northern and southern sides of the stack, the southern side of the stack is two courses of brick higher (**Plate 42**). There are two chimney pots. Both are square in section with a decorative band at the top of the southern pot, on the northern chimney pot the pot extends above the decorative band. There is a second chimney which is located slightly to the west of the joint of 89 Portland Road with Building E. This is cement rendered and appears to have been capped.

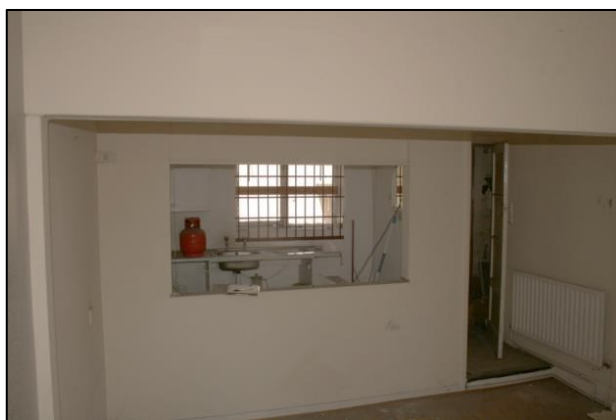
**Plate 43:** Northern Wall of **P8**

**8.6** **P8** and **P9** were originally a single room but the northern end of the room had been partitioned off from the main body of the room with a wall with integral counter. The southern, western and eastern walls of **P8** were plastered (**Plate 43**). The counter was constructed from breeze blocks covered with plasterboard on both faces. All the walls had modern low wooden skirting boards fitted. The ceiling was also plastered. To the south of the counter there was the stub of an original dividing wall of the room on an east-west alignment, which had also been boxed-in with plasterboard. The room was lit by two modern wooden framed sash windows in the southern wall, with modern radiators below. There was an entrance to Building **E** at the south end of the western wall, access by three steps up to the floor level of Building **E**. The entrance had no door fitted. The floor was of the bare floorboards with no covering being apparent.

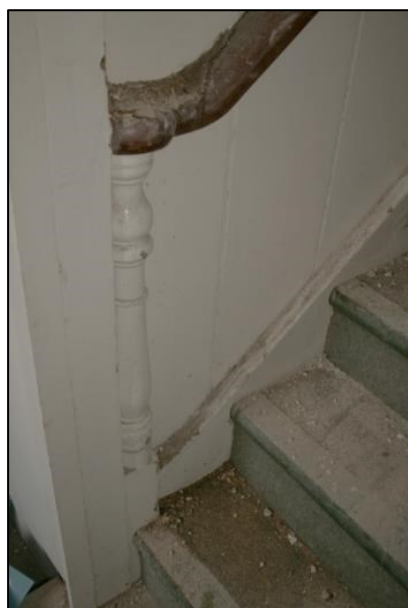
**Plate 44: Newel Post P7**

**8.9** To the north of **P7** was **P6**, which consisted of a small lobby at the southern end, with the staircase to the first floor at the northern end of the room. The small lobby had all walls plastered with the north wall of the lobby part of the room being of plasterboard. The access to the stairs was at the east end of this wall. All the walls of the lobby were fitted with low modern wooden skirting boards. The ceiling of the lobby was also plastered. The staircase consisted of thirteen steps and then a small landing with flight of three steps on the western side of the main staircase to the eastern side of **P2**. There was a newel post at the western side of the base of the staircase which was partially boxed-in with vertical tongue and groove planks. The balusters of the main part of the staircase were either concealed by the tongue and groove planks or had been removed. The newel post (**Plate 44**) was circular in section with decorative mouldings, except for the bottom block which was square in section. The handrail was still *in-situ*, and had rounded corners with the southern end above the newel post being circular in plan. There was a narrow moulded dado rail on the eastern and northern walls of the small landing at the top of the staircase. The landing was lit by a possibly original sash window in the north wall.

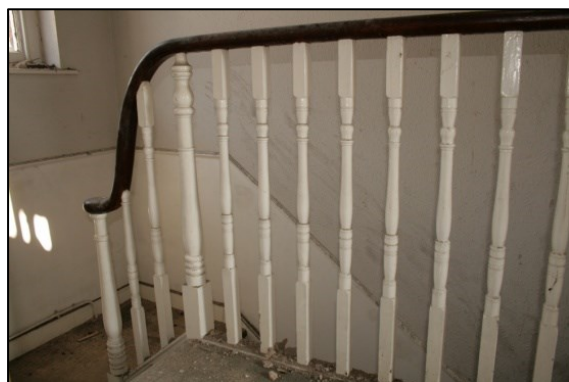
**Plate 45:** Newel Posts and Balustrades **P2**

- 8.10** The first floor of 89 Portland Road consisted of a landing, with a large room to the south of the landing, and a bathroom and a large airing cupboard to the north of the landing. The landing was in two parts with the area (**P2**) being located to the south of the staircase with the western end (**P3**) of the landing widening out to the north. The walls of **P2** and **P3** were all plastered except for the northern wall of **P3** which was a plasterboard partition wall. The area to the north of the partition wall was made up of **P4** and **P5**. The staircase was at the north-eastern end of **P2** and was protected by moulded balustrades, which were circular in section with square sectioned bottom and top blocks (**Plate 45**). The handrail and two newel posts were the same type as described in **P6**. These appeared to be of a 19<sup>th</sup> century date. In the centre of the western wall of **P3** there was a sealed doorway into the first floor of Building E (**Plate 46**).

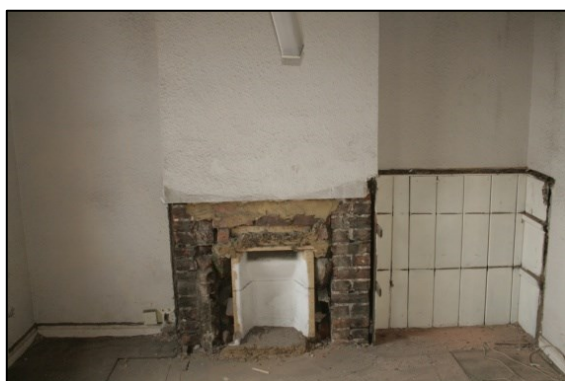
**Plate 47:** Western Wall of P1

- 8.11** **P1** was located at the southern end of the building and was the main room on the first floor. The southern eastern and western walls of the room were plastered, with the northern wall being of plasterboard. All the walls had a wall covering of woodchip paper. In the centre of the western wall there was a brick built fire breast, with the fireplace having been removed. The fireback remained *in-situ* and was of white coated ceramic. The remains of a cupboard or shelves were apparent in the lower part of the alcove to the east of the chimney breast (**Plate 47**). The room was lit by two modern wooden framed sash windows in the southern wall, with radiators below. The ceiling covering had been removed leaving the ceiling joist exposed (**Plate 48**), these had the marks of lathes and nails holes on their soffits. The joists were on a north-south alignment. The floor was of floorboards with the remains of carpet underlay covering them. The room had a low modern skirting board with a chamfered top.

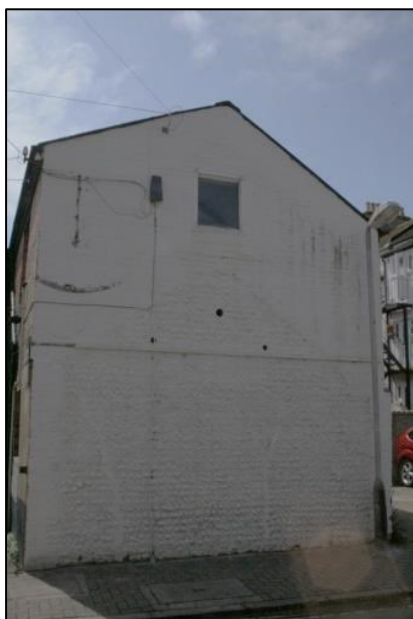
**Plate 50:** Northern Elevation

9.1 Building **D** is located at the western end of the yard. The building is now of two storeys, with the far southern end being of a single storey. The northern elevation fronts onto Grafton Place. The lower part of the northern elevation (**Plate 50**) is constructed of coursed flint cobbles, with the upper part being of brick. The bricks are laid in stretcher bond, with this elevation being painted white. The eastern and western ends of the lower flint part of the wall have brick built quoins. The upper edge of the flint built lower part of the wall describes an earlier gabled end to the building, which is at a much lower level than the building has now. There is also the ghost line of a second gabled end at approximately a metre below the current gable end. This would suggest that the building was originally a single storey structure that has been increased in height twice. There is a single wooden framed window located in the centre and near the apex of the gabled end. Approximately 5m below the join between the lower flint part of the wall and following the line of the original gabled end there are three circular holes.

- 11.9** Of all the buildings in Spells Yard, Building **D** shows the most alterations. On both the exterior and the interior of the northern gabled end there are the ghost lines of two previous roof lines. The building originally appears to have been a single storey structure with the roof height later being increased twice. In the ground floor rooms the dividing walls between the rooms were only built to ceiling height which also implies that this building was originally only a single storey high. This building's original use was possibly a stable, evidenced by the small block flooring and the possible stable division noted on the southern wall of **D2**.

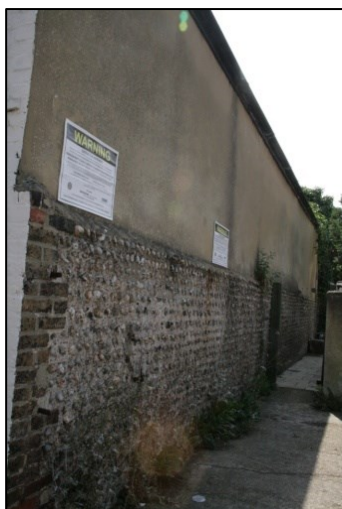
**Plate 51:** Western Elevation

9.2 The western elevation of Building **D** fronts on to a narrow alley to the west of the building, and is of coursed flint cobbles construction to a height of 1.67m above ground level. The upper part of the wall is cement rendered. The flint lower part of the wall steps out from the upper part of the wall by 90mm. There is a brick built quoin at the northern end of the wall, which has two pintles close to its northern edge, suggesting that there was originally a gate attached to the side of the building which closed the alley. There is a small tie plate low down on the wall approximately three metres in from the northern end, this is in the shape of a cross. The southern end of the western elevation was not inspected due to a heavy growth of shrubs and trees, for the same reason the southern elevation could not be seen.

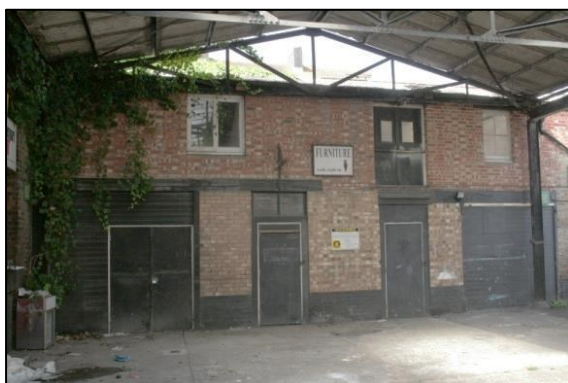
**Plate 53:** Eastern Elevation

- 9.3** The eastern elevation of Building **D** fronts onto the yard, and is of brick construction, with the bricks being laid in a random bond. The openings on the ground floor of this elevation consist of a set of double doors, which have been covered on the outer face with metal sheets at the south end. The area above and to the south of the doors has been panelled over with horizontal tongue and groove planks, suggesting that this entrance was originally larger in width and height. This is also suggested by a thick wooden lintel that extends over this doorway and the door to the north. To the north of these double door there is a doorway fitted with a door which also has its outer face covered with metal sheeting. Above this door there is wooden framed window of two lights. To the south of this doorway is another single doorway fitted with a door covered in metal sheeting. The area around the door has been infilled with wooden boarding. At the northern end of the elevation there is an area of horizontal tongue and groove infill, the original framework of a door is visible at the north and south ends of the infill area with pintles of the hinges *in-situ*. To the north of this there is a wooden door of vertical plank construction with a wooden framed casement window to its north. Within the brickwork, between the tongue and groove infill and the plank door, there is a panel of flintwork.

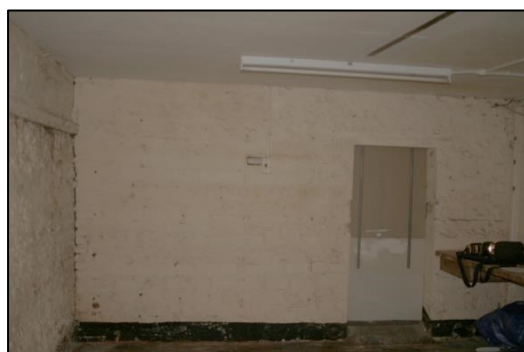
**Plate 55:** North Wall of **D2**

- 9.7** **D2** is located to the south of **D1**, and is entered via a door at the southern end of the eastern wall. The north and south walls of the room are both of coursed flint cobbles with bands of bricks, those in the northern wall are laid on end. Both of these walls only butt up to the western and eastern wall and only rise to the first floor level. At the eastern end of the northern wall there is a sealed entrance to **D1**. The western end of the southern wall has been cement rendered, with the upper edge being finished in a diagonal line. The shape of this area of cement render suggests a stall end of a stable. The western wall is of coursed flint cobble construction with the upper part of the wall being of six courses of brick. The eastern wall is of brick construction with the area of tongue and groove infill noted in the exterior inspection being covered with plaster board on its inner face. The suspended ceiling is of plasterboard. The floor at the north of the room is of brick which changes to concrete at 3.4m to the south.

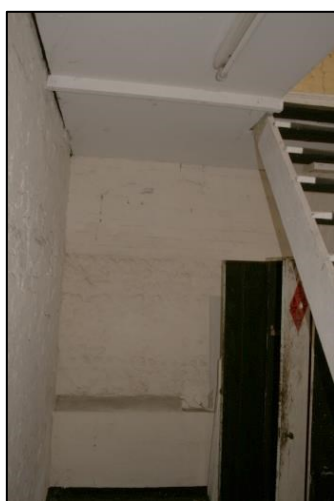
**Plate 57:** Western Wall D3

- 9.8** **D3** is located to the south of **D2**, with the access to the room from the exterior in the southern end of the eastern wall. The western wall of the room is has a plinth at the base which rises from the floor to a height of 630mm above floor level. The plinth steps out from the main body of the wall by 180mm. The lower part of the wall is of coursed flint cobbles up to a height of 1.8m, with the upper part being built in brick (**Plate 57**). The southern wall is of the same construction as the western wall. The northern wall is a mixture of cobbles and brick as seen in **D2**, with the eastern wall being of brick construction. There is a modern simple staircase to the first floor of the building, adjacent to the centre of the northern wall. The ceiling is of plasterboard, with the floor being covered in small square tiles.

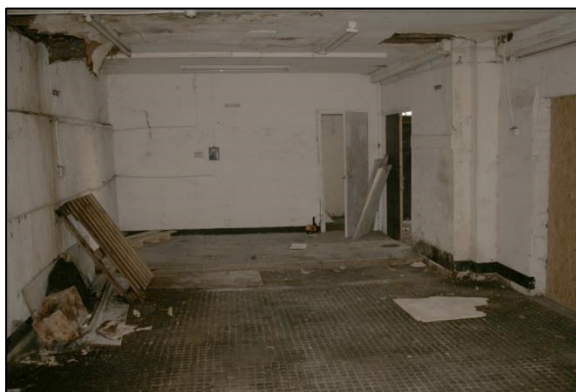
**Plate 59:** Room D4 from South End

- 9.9** **D4** (**Plate 59**) is located to the south of **D3** and is entered by a doorway in the northern end of the eastern wall. There is a second entrance to the room at the southern end of the eastern wall but this has been sealed with chipboard sheets. All of the walls have a thick coating of plaster on them, with the bottom of the western and southern walls stepping out by 100mm to form a plinth, 1.9m high. The ceiling is of plasterboard sheets, where the plasterboard has warped the ceiling joists on an east-west alignment can be seen. The floor is of the same small square tiles as seen in **D3**, with the northern end of the floor being covered in chipboard sheets which have been raised above the floor by 150mm.

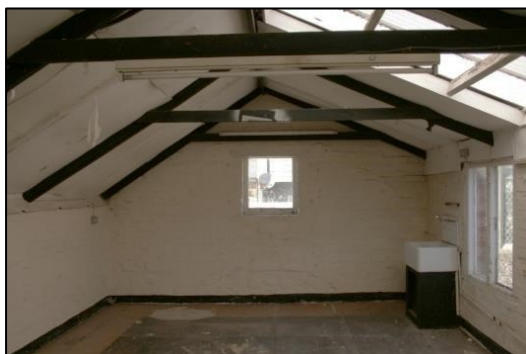
**Plate 60:** Northern Wall of **D5**

- 9.10** The first floor of Building **D** consists of four rooms, but appears to have originally been a single room, evidenced by the internal partition walls being constructed of plasterboard and wooden sheets. **D5** is located at the northern end of the first floor, with the north wall being the gabled end of the building. As seen during the external inspection of the building the ghosts of two earlier roof lines can be seen (**Plate 60**) on this wall. The eastern and western walls are of brick construction, with the room being lit by two wooden framed casement windows in the eastern wall. The southern wall is hardboard sheets over simple studwork; the entrance to **D6** is located in the middle of this wall and is fitted with modern double doors, and has a glazed panel to the east of it. The floor is covered in hardboard sheets, with the inner face of the roof being covered in the same material. There are three pairs of rafters left un-covered by the hardboard, these have low set collars. Also left un-covered is the ridge plate at the apex of the roof. These are the only parts of the roof structure visible in this room. There are two corrugated clear plastic sheets in the eastern slope of the roof acting as sky-lights. In the north-eastern corner of the room there is a Butler's sink with an open cupboard below.

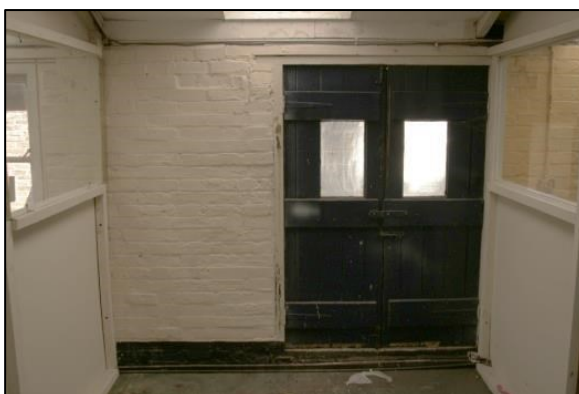
**Plate 62:** Double Doors in East Wall **D6**

- 9.11** **D6** is located to the south of **D5**. The north and southern wall are both modern partition walls constructed of hardboard sheeting over a simple studwork frame. The doorway to **D7** is located in the centre of the southern partition wall, and is fitted with a modern door with glazed upper panel. Both the eastern and western wall are of brick construction, with the eastern wall having the double doors as seen in the external inspection of the building. These doors are of wooden vertical plank construction and open inwards, and have a small glazed panel of clear plastic in their upper part. The roof structure has been boarded over with hardboard with only the centre ridge plate being visible in this room. There is a single corrugated plastic panel skylight in the eastern slope of the roof. The floor is covered with chipboard sheets.

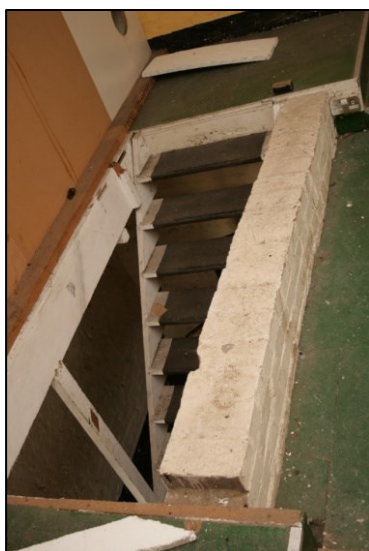
**Plate 63:** Top of Southern Wall  
of Staircase **D7**

- 9.12** **D7** is located to the south of **D6**, and houses the staircase access from the ground floor, located adjacent to the centre of the southern wall. The top of the wall on the southern side of staircase (this is the northern dividing wall between **D2** and **D3** on the ground floor) is apparent; this wall only rises to the floor level of the first floor and its upper face has been finished in brick (**Plate 63**). At the top of the staircase there is a low plinth of chipboard construction, this has two low steps on its northern side to the floor level of the room. The eastern and western walls are of brick construction, with the north and south walls being modern partition walls. The roof structure has been boxed-over with hardboard sheets, leaving only the centre ridge plate and a pair of rafters at the southern end visible. As in the room to the north there is a single corrugated plastic panel set into the eastern side of the roof. The floor is covered with chipboard sheets.

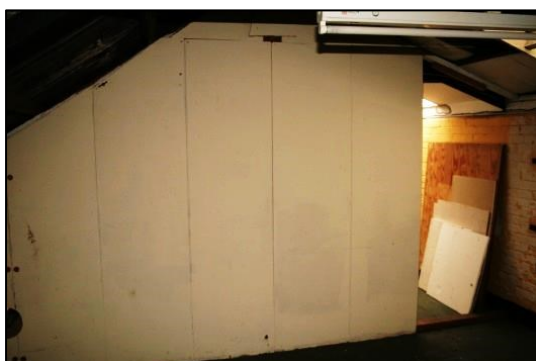
**Plate 64:** North Partition Wall D8

- 9.13** **D8** is located at the far southern end of the first floor of Building **D**. The south, eastern and western walls are all of brick construction, while the northern wall is a modern partition wall constructed of MDF sheets (**Plate 64**). The room is lit by a wooden framed casement window in the eastern wall. The roof structure is boxed-in with hardboard sheets as are the rooms to the north. This leaves two pairs of rafters exposed both with high set collars, together with the centre ridge beam. Some of the

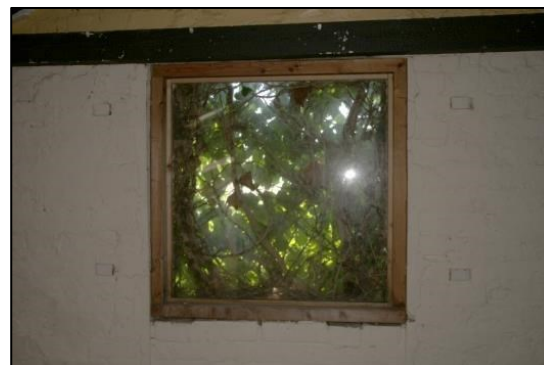
**Plate 65:** Window in South Wall D8

panels have been removed from the inner surface of the western roof slope, revealing that there are three purlins which are clasped to the inner face of the rafters with triangular shaped wooden brackets. Where the hardboard sheets were missing the corrugated asbestos roof covering was also revealed. The room is lit by a wooden framed casement window in the eastern wall, and a single wooden framed un-opening window in the centre of the southern gabled end which looks over the possible flat roof (the window was completely blocked by ivy) (**Plate 65**). There are two butt joints in the brickwork below this window suggesting that there was originally a door in this location. The floor is covered in chipboard sheets.

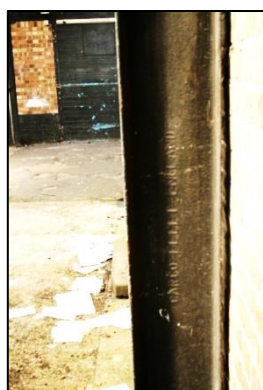
**Plate 66:** Trademark in Upright

**10.01** The canopy over the yard is on an east-west alignment. The northern and southern sides of the canopy are supported by four upright steel RSJ's, which are 'H' shaped in section. The RSJ measured 100mm wide by 230mm deep and had the trademark of 'CARGO IIII ENGLAND' moulded in them (**Plate 66**). The uprights are bolted on to a horizontal beam at the edge of north and south edges of the canopy; these are acting like wall plates. These are also 'H' shaped in section. Bolted onto the upper face of the side beams there are six English trusses (**Plate 67**); the beam at the base of each of the trusses is 'L' shaped, with the rest of the steel beams being flat in section. The roof covering of the canopy is of corrugated asbestos sheets, with seventeen panes of reinforced glass in both the north and south slopes of the roof which light the yard below.

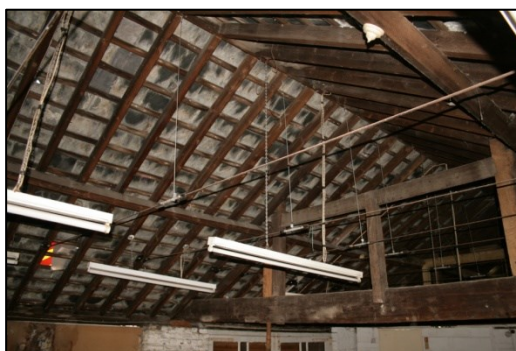
**Plate 68:** Continuous Roof Structure over Buildings **C** and **E**

- 11.8** Buildings **C** and **E** along with 89 Portland Road appear to have been used as a single unit, with the first floor of Building **E** only now assessable from the easternmost room in Building **C**. There appears to have been an entrance to Building **E** from the western end of **P3** in 89 Portland Road, but this is now sealed. From the evidence of the internal walls including the southern wall of both Buildings **C** and **E** and some of the internal dividing walls, it would seem possible that the construction, using both flint cobbles and bands of brick, that these walls could be contemporary with the house. This is not made any clearer from the examination of the southern wall from the alley to the south of the yard as these have been cement rendered obscuring any details of their construction. The roof structure was continuous over Buildings **C** and **E** (**Plate 68**).
