A Survey of the Hydraulic System at Sheffield Park Gardens, Sheffield Park, East Sussex

by
Keith Butler PCIfA

July 2015

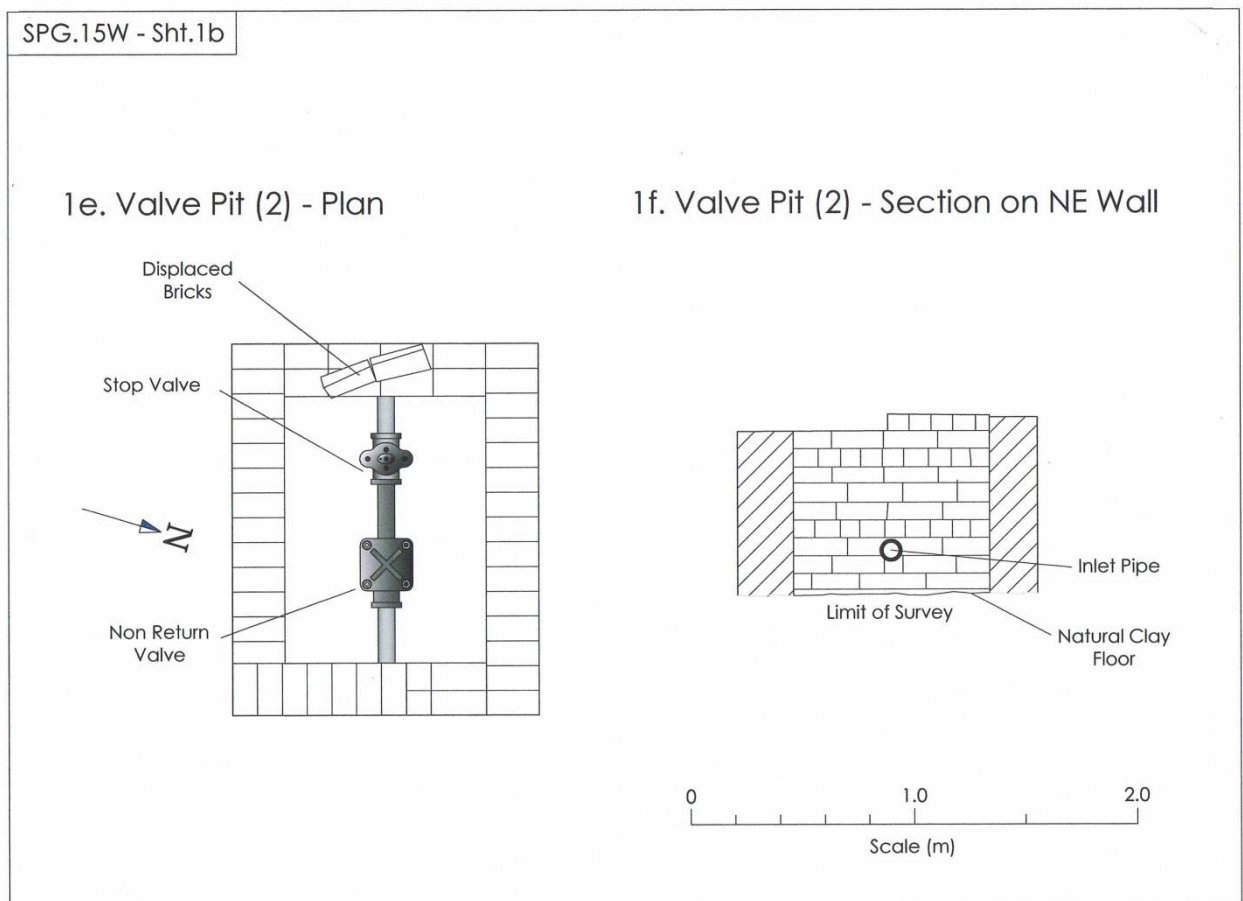
Fig. 4: Valve Pit Plan and section

3.3 Context 2 was a Valve Pit (**Plate 6** and Fig. 4) located to the west of the Wheel Pit (Context 2), (Fig. 2). The pit was rectangular in plan and had the external measurements of 1.3m north to south by 1.68m east to west and internal dimensions of 920mm north to south by 1.22m east to west, and was 820mm deep. The pit was of red brick construction laid in a random bond. The frogged bricks had the dimensions of 220mm for the stretchers, 110mm for the headers and having a thickness of 60mm, with a bonding material of a yellowish grey sandy mortar with no inclusions. Running through the centre of the pit on an east to west alignment was a metal pipe of external diameter of 75mm. This, although of a larger external diameter, lined up with the pipe inset into the western wall of the Wheel Pit. At the western end of the this pipe there was the Stop Valve for the flow of water from the Wheel Pit (**Plate 7**). At the eastern end of the pipe there was cast iron casing possibly containing a Non-Return Valve. This has a square cover plate bolted to the top of the casing with a two diagonal strengthening ribs on it (**Plate 8**). The pipe was supported on its underside on two bricks, which were laid directly onto the silty clay natural (**Context 3**). Context 3 was only apparent in the base of the Valve Pit and was an orange-brown colour. Although not excavated, the silty clay appeared to have no inclusions.
