A watching brief
at
RYCOTEWOOD COLLEGE
THAME
OXFORDSHIRE

K A Rodwell
for
JOHN MOORE HERITAGE SERVICES

November 2007

REPORT ON A WATCHING BRIEF AT RYCOTEWOOD COLLEGE, THAME, OXFORDSHIRE

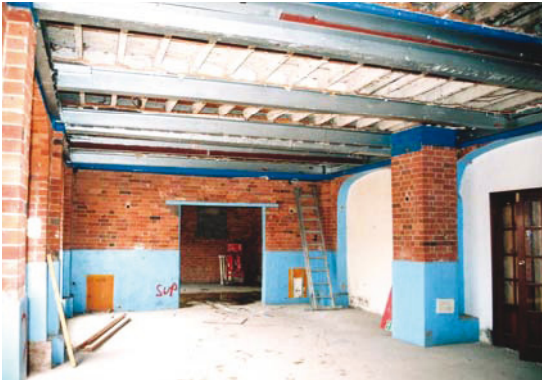
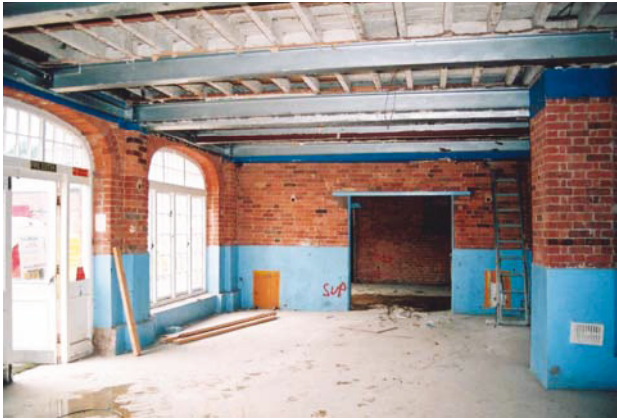
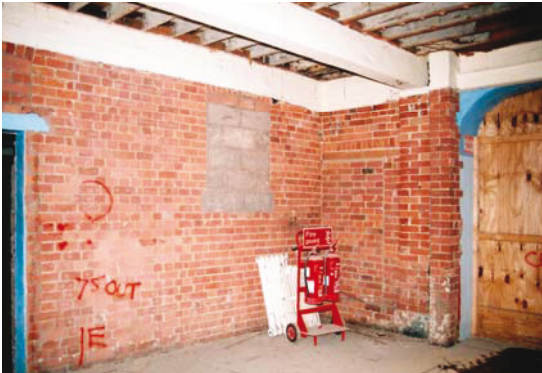
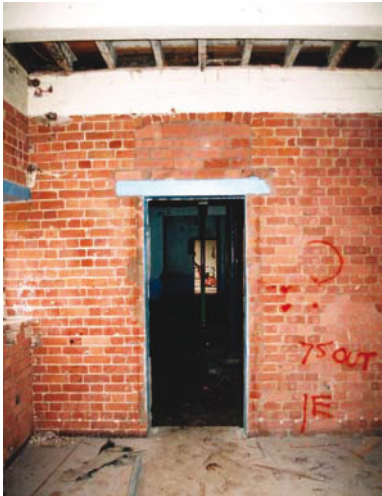
Rycotewood College
Fig 9

Central hub, ground floor - (JMHS 2005, 19) modern finishes were retained and only the ceiling joists were exposed. The six original cast iron columns have wide base-plates set on brick foundation piers; Fig 9.43-44.

is no evidence for the third window shown on the 1850 plan. There is an adjoining blocked door in the north wall and another, now a window, in the south; both are shown on the 1850 plan. The intermediate partition with a double door is butt-jointed at both ends; Figs 8/9.36-42
