HERITAGE IMPACT ASSESSMENT

GARLANDS FARMHOUSE AND CHEESEROOMS,

WEST CHALLOW, WANTAGE

DECEMBER 2014

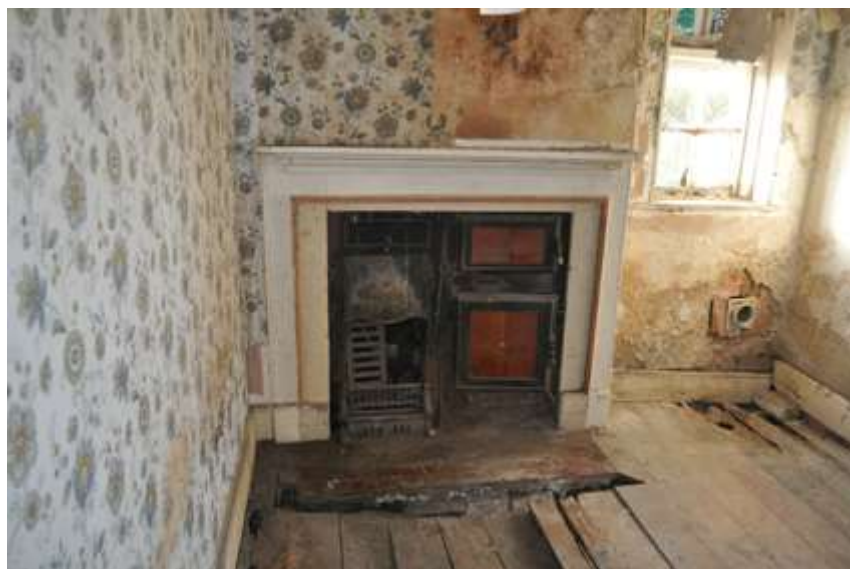
Plate 10: Fireplace in room G5

The main door on the northwest side of corridor G2 leads into room G5. It is likely that this room was the original kitchen of the property. In the southwest wall is an original fireplace with side stove (Plate 10). The mantle could be original. To the right of the fireplace is a square-headed mullion window. It is apparent that in the toilet room G5a that a similar window existed and that these two windows would have flanked the fireplace. In the northwest wall there is a mullioned window. In the northeast wall there is a built-in cupboard in the alcove, probably original. As stated, the toilet room G5a has been a later insert, which means that the door to it is a later insertion.

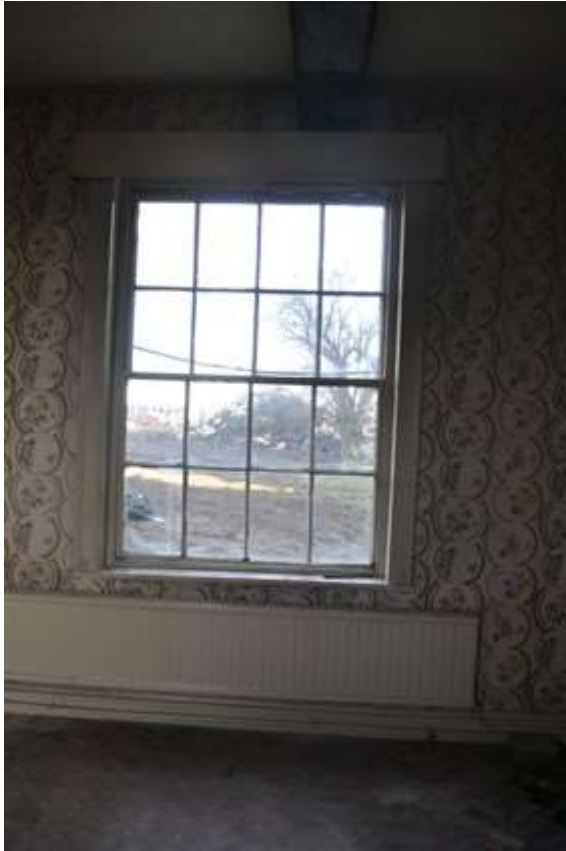
Plate 11: Room G6

The northwest door from the hall G1 leads into room G6. This has two beams in the ceiling, one of which may have a slight chamfer. The door from the hall is a panelled door with moulding, which could be original but has parallels with more recent architraves. In the northeast wall there is a square-headed sash window (Plate 11). In the northwest wall there is a mullion and transomed window. In the northwest wall there is a 1960s fireplace and to the left a panelled door.

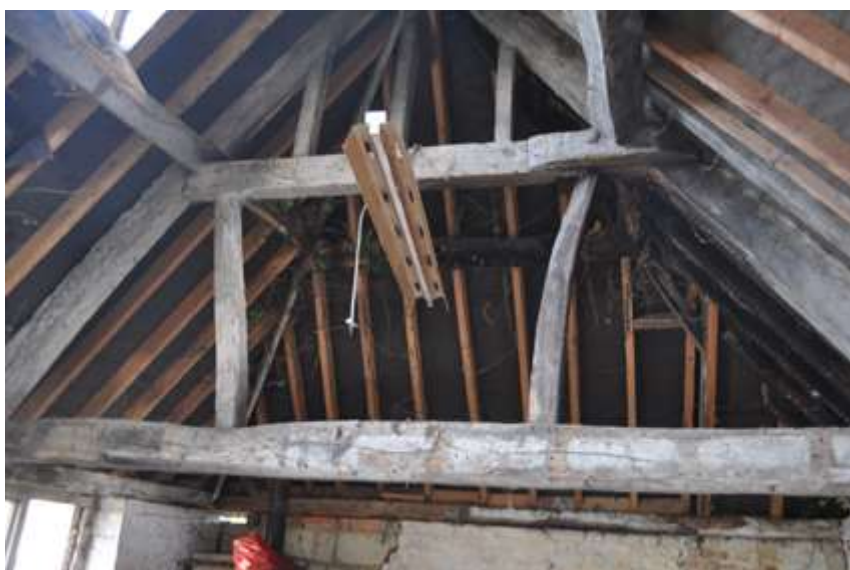
Plate 14: Truss in cheeseroom annex G8

The northwest doorway leads into the northeast extension room G8. There is a mullioned window in the northwest wall. In the southeast wall there is a planked door and a mullioned window. The room is dominated by a queen post truss with chamfer (Plate 14). There are two opposing dormer lights in the roof space. There is an opening in the southeast wall that leads into a breezeblock clad interior extension in room G9.

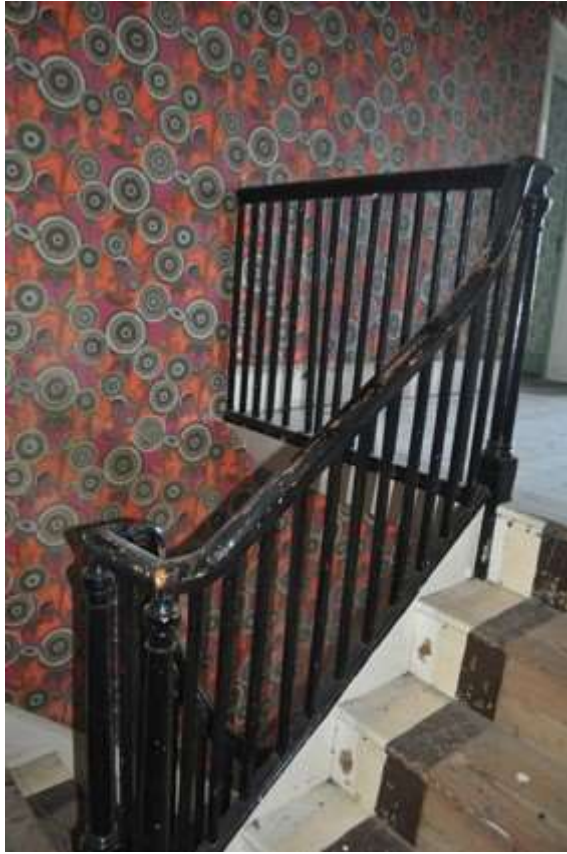
Plate 15: Dogleg stairs F1

The stairs from hall G1 lead on to the landing F1 (Plate 15). Four doors are located on the staggered part of the landing. On the northwest side there is a panelled door leading into a cupboard. In the southwest wall there is a door leading into room F2. On the southeast side there is a passage leading through an opening towards room F3, and on the side of this passage a further door into room F4. On the upper part of the landing there are two opposing doors in the northwest and southeast walls. In the northwest wall there is a square-headed 16 paned sash window.

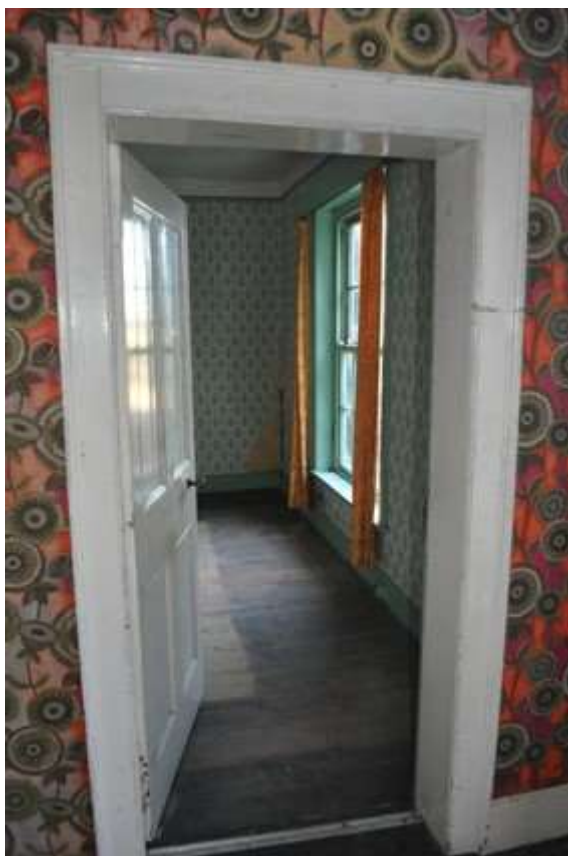
Plate 17: Door to F6

The panel door on the northwest side of the landing leads into room F6 (Plate 17), with original moulding. This has a square-headed sash window with moulded surround in the northeast wall. There is a panel door in the southwest wall of the room with original moulding. In the northwest wall of the room the fireplace has been blocked but the hearth stones survive in the floor.
