JOHN MOORE HERITAGE SERVICES

HISTORIC BUILDING ASSESSMENT

LOGG FARM

ODDINGTON, OXFORDSHIRE

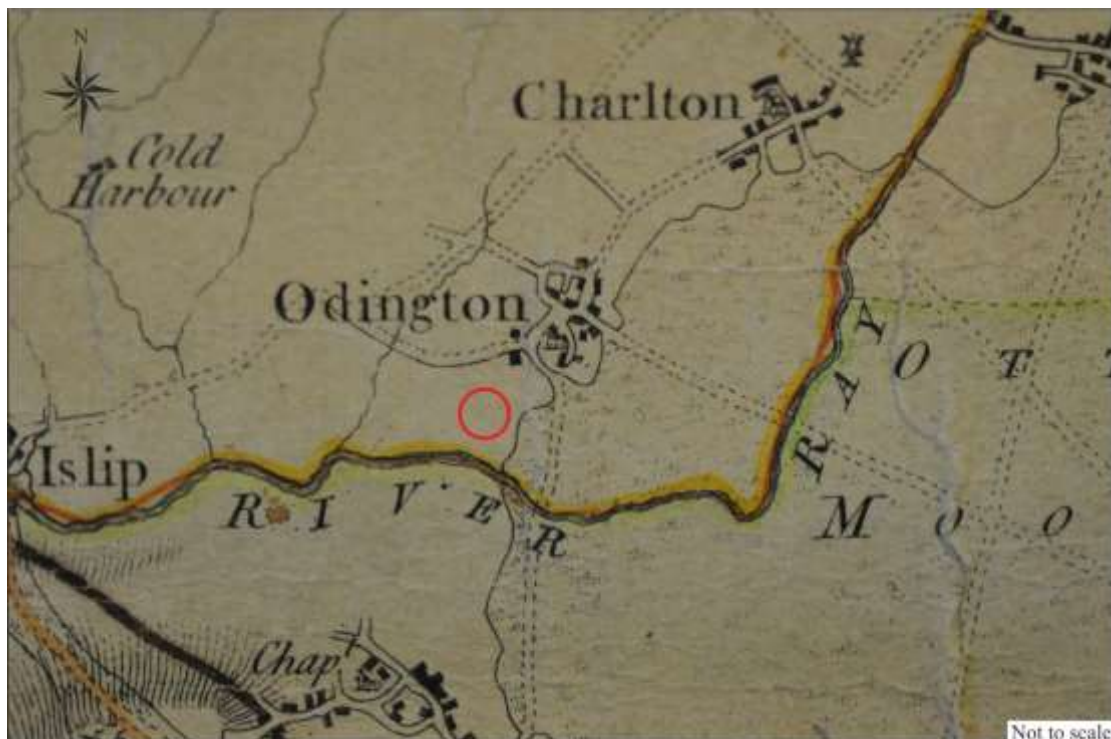
Figure 2 Jefferys' map of 1767

The earliest surviving map of the village is that by Jefferys' dated 1767 (CP/103/M/1). Here the village and church of Oddington are shown (Fig. 2). There is no building shown in the exact location of Logg Farm, but there are two structures shown either side of the road from Oddington to Islip; no buildings are known in these exact locations. It is

probably the case that the building on the south side of this road is a representation of Logg Farm as a square building.

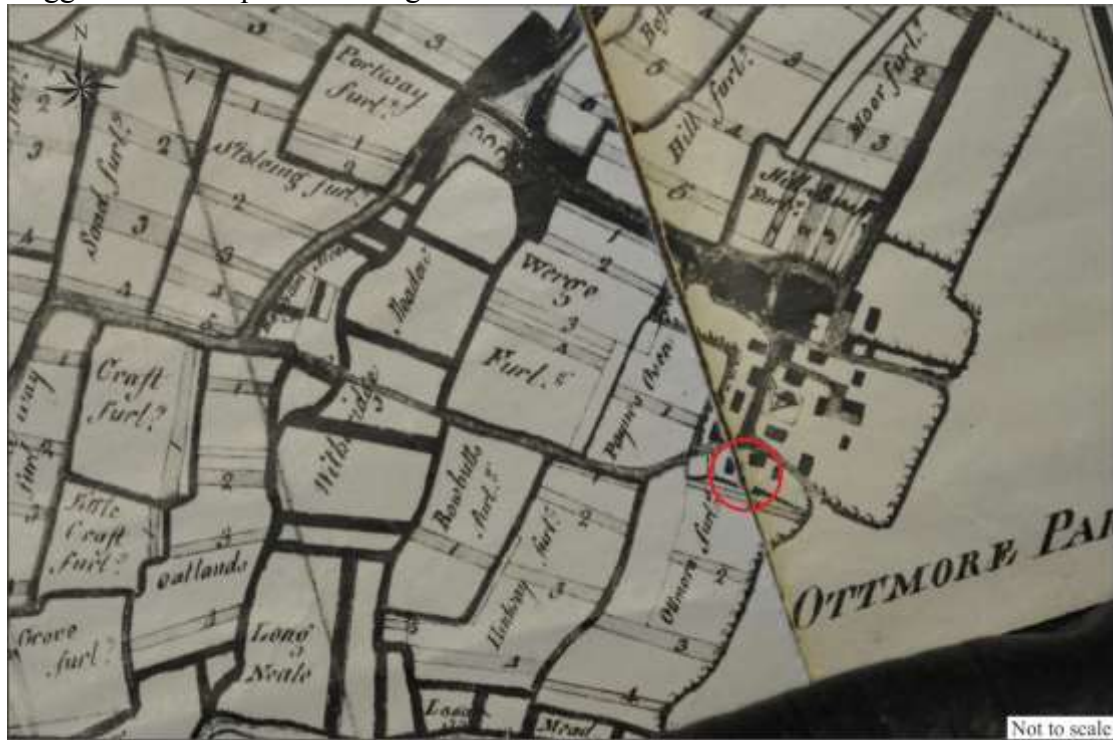
Figure 3 Map of 1768

A further map of the parish of Oddington was produced for Magdalen College, Oxford, and which has been dated 1768 (Photo54). This shows the village with the church (Fig. 3), but also shows a series of buildings located along the line of the road from Oddington to Islip. A road has been drawn in the location of the present track to Logg Farm, but is far

shorter with a rectangular building on the east side. Though this building does not appear to be in the exact location it is possible that this represents Logg Farm (see Fig. 4 for present location). One point of interest is that there is a field called Portway Furlong located at (SP 5465 1535). This is alongside the road that runs from Islip to Ambroseden and perhaps hints that this road was formerly the route of a Roman road that ran along the northwest side of Otmoor. This road is not noted in Henig and Booth (2000), such names are discussed by Gelling (1953, 2-3). In her account it is noted that the name Portway occurs in Charlton-on-Otmoor parish, and is assumed that it applies to the known Roman road from Dorchester to Alcester, but could apply to the Islip to Ambroseden road. The name Loog Mead is recorded on the north side of the River Ray, the earliest spelling of Log here may imply that the name originates not from English log but from an unrecognised earlier form. There is also the possibility that this map and the subsequent map are copied from earlier non-extant maps that no longer survive and would have omitted later additions.

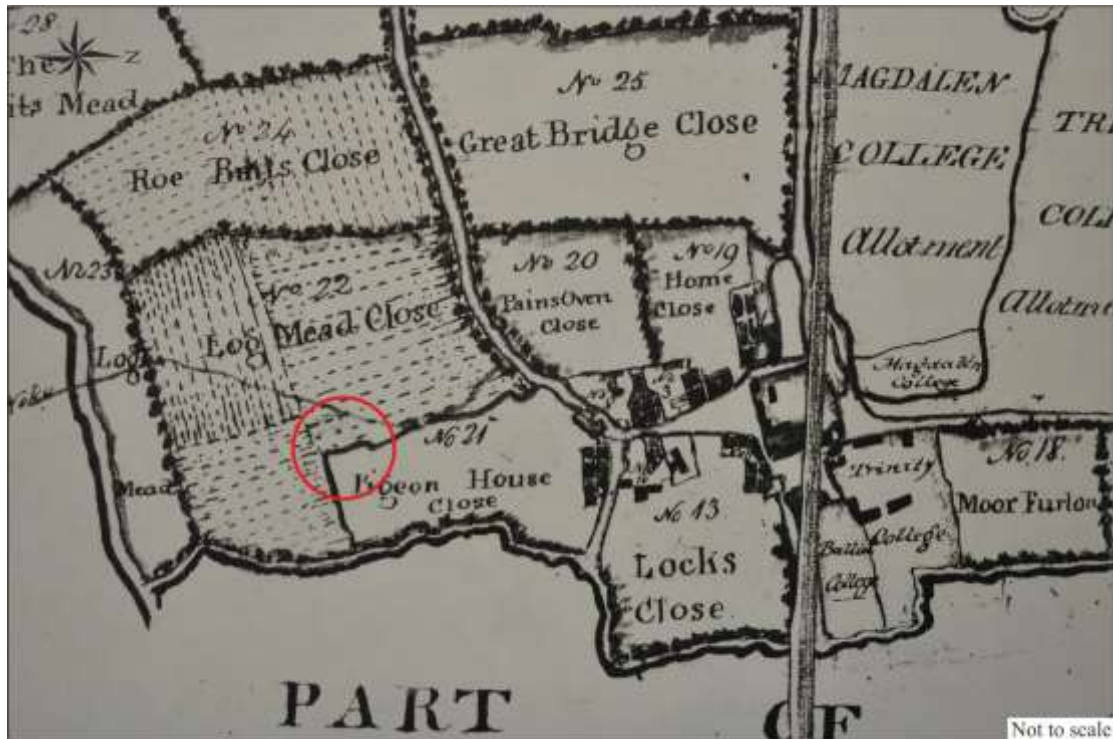
Figure 4 Map of Oddington of the Late 18th century

A further map of Oddington parish is dated to the late 18th century (E/200/M/1), (Fig. 4). This shows Pigeon Close (no 21), Log Mead Close (no 22) and Log Mead (no 23). The church and houses are located on the north side of Pigeon House Close. No house is shown on the map in the location of Logg farm, but it is possible that it may have been erroneously placed on the south side of the village alongside the Islip road. Log Mead Close has agricultural plots set out across it running north to south mainly, but there is a group east to west. There is on this map a field called Portway Close (SP 5450 1525), which is close to the earlier named furlong but not exactly in the same place. This name is not referred to in the Place-names of Oxfordshire, but there is a historical reference to Bradeweeforlange in 1235-6, which refers to the broad way (Gelling 1953, 234), which is normally a significant road or route way.

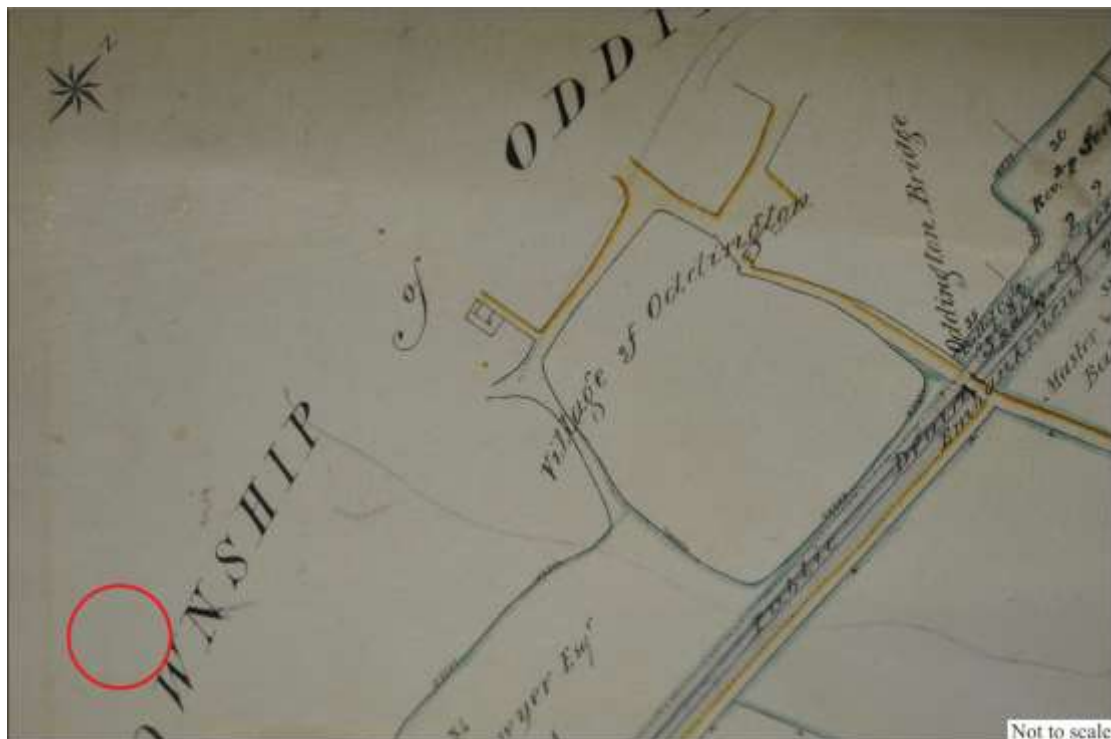
Figure 5 Otmoor Inclosure map of 1791

An outline of the Oddington village is shown on the Otmoor Inclosure Map of 1791 (QS/D/A/volE), (Fig. 5).

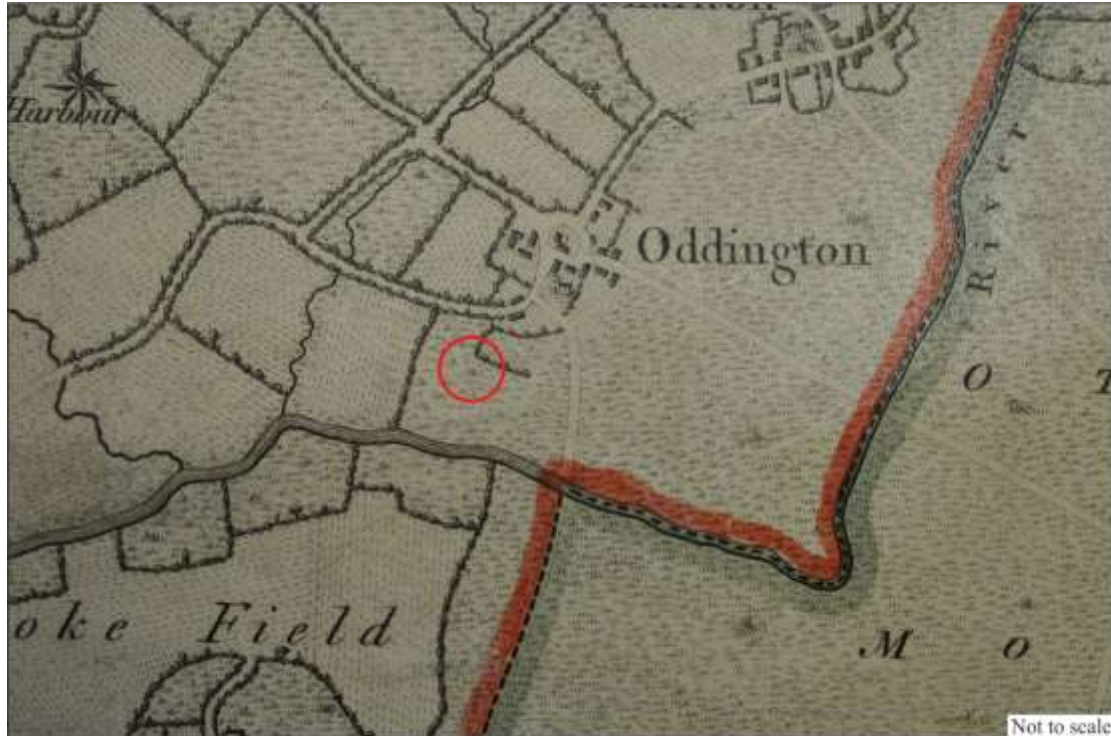
Figure 6 Davis of Lewknor's map of 1797

The last of the 18th century maps is that by Davis of Lewknor dated 1797 (CH.XX/2) which shows the village and the church (Fig. 6). There is a junction shown below the church, and there is a road leading from Oddington to Islip. There are two houses shown along this road from the village. These do not exist on current maps and it is likely that the southern one of these may represent Logg Farm.

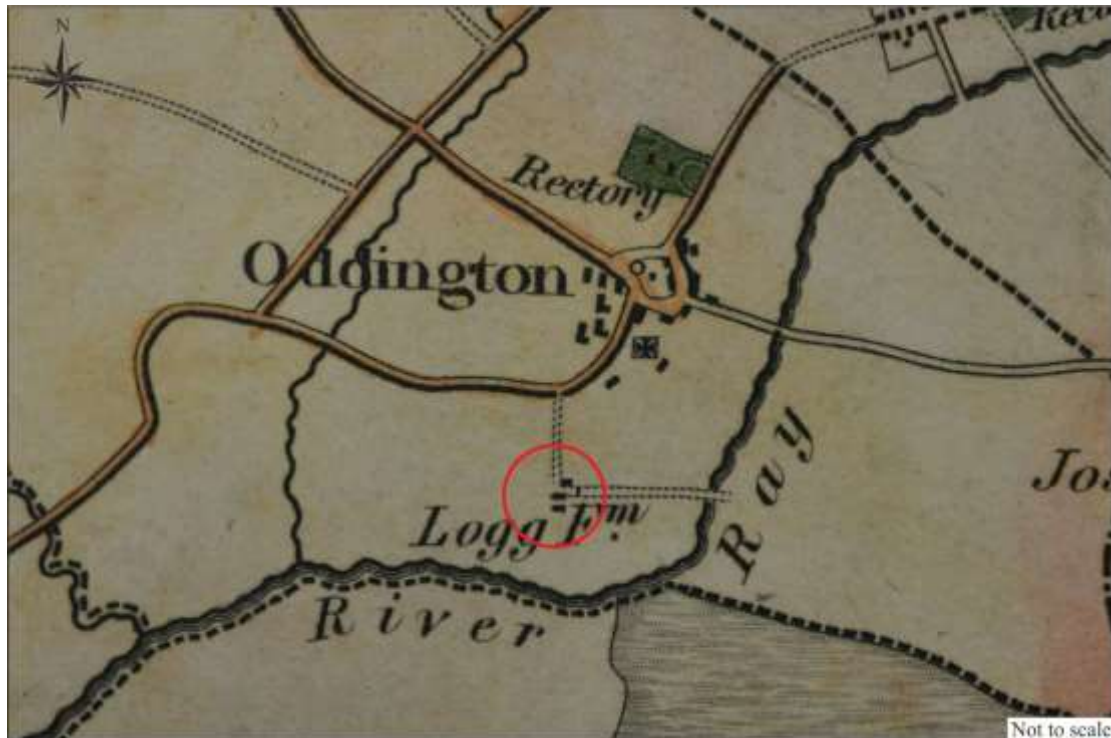
Figure 7 Bryant's map of 1824

Bryant's map of 1824 (P345/M/1) shows the village and church, and shows Logg Farm as a rectangular building in its correct location at the north end of a group of buildings (Fig. 7). The map shows two buildings to the south which are probably incorrectly orientated east to west.

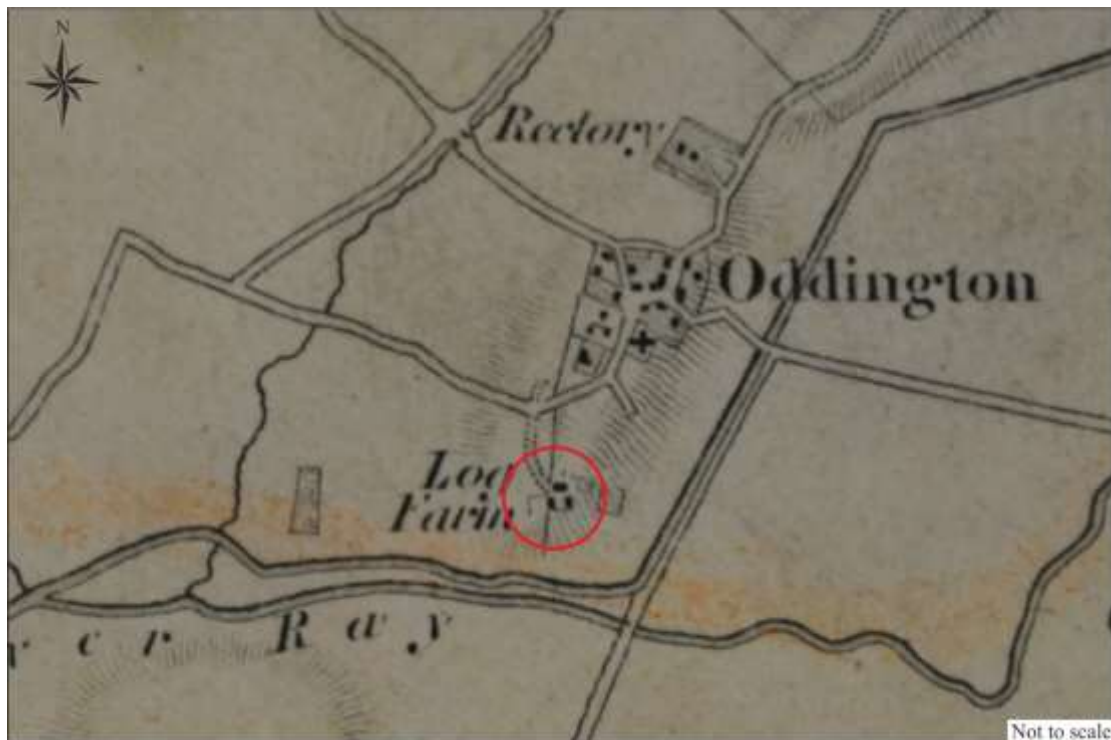
Figure 8 Ordnance Survey map of c. 1850

The Ordnance Survey map of c 1850 (CH.XXIV/4) shows Logg Farm as a block orientated east to west (Fig. 8); thus being located in its correct position. There are two buildings shown to the south that are orientated north to south. This map thus shows the alignment of the listed historic barn that is attached to Logg Farm in its correct position for the first time.

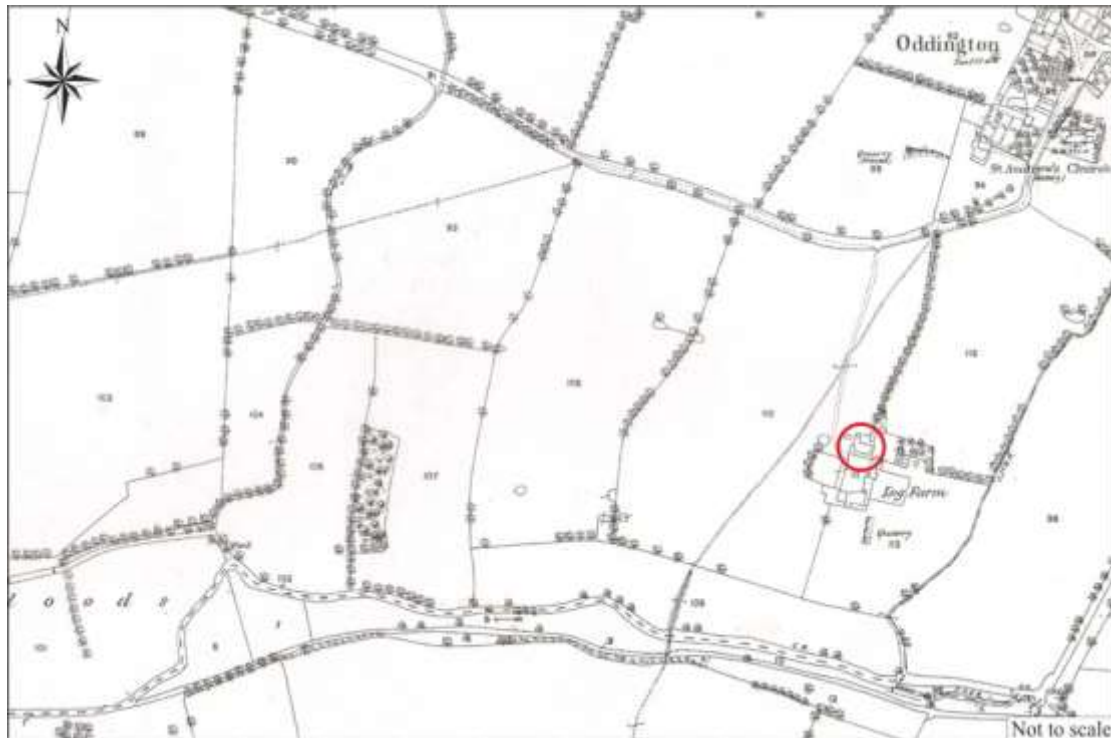
Figure 9 Ordnance Survey map of 1876

The First Edition map of 1876 (Oxon 27.12) shows the farmhouse complex to the south of Oddington village (Fig. 9). The farmhouse is shown in a plan which is indicative of it reaching its current outline and form by that date. The only feature missing is arguably the porch. There are a couple of outbuildings to the northeast, and one possible to the west. Some of the garden wall lines appear to have changed. The listed barn is located to the southeast. There is a further structure to the southwest, also of a long and linear nature. A quarry is marked to the southeast of the farm complex.

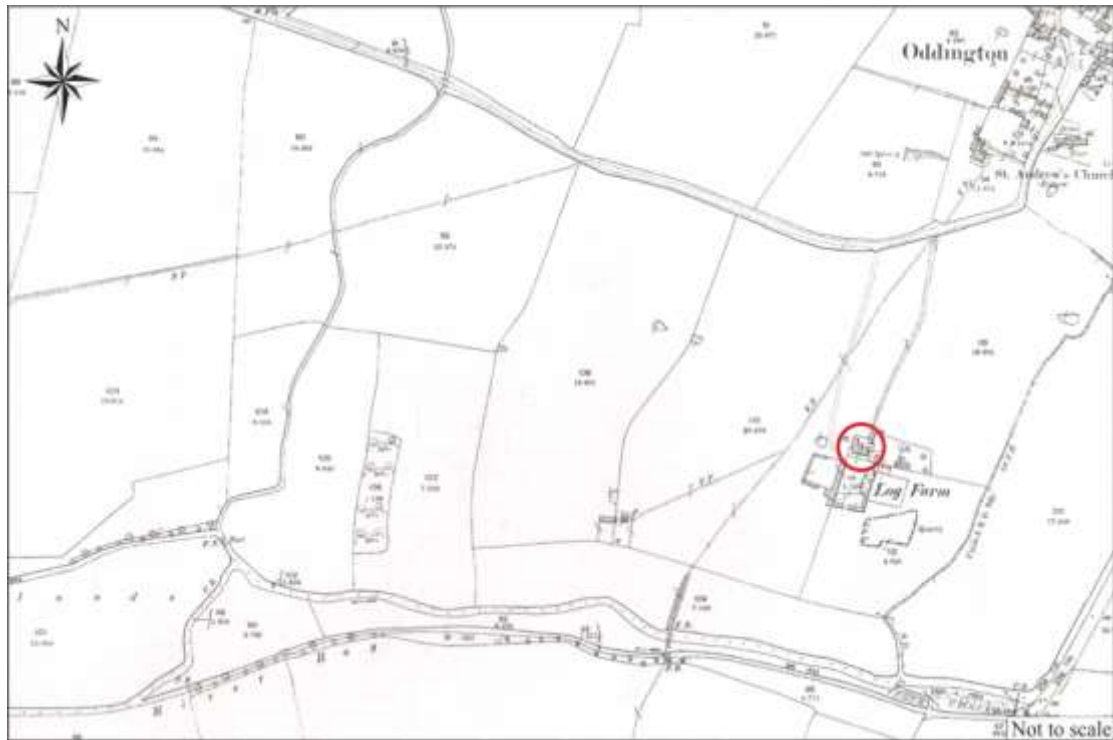
Figure 10 Ordnance Survey map of 1899

The Second Edition Ordnance Survey map of 1899 (Oxon 27.12) shows a layout much the same as that of the 1876 map. The farmhouse, here called Log Farm, is in its current form (Fig. 10). There are small buildings to the northeast and one to the northwest. Other structures can be noted to the east, also of a small design. The barn lies to the southeast, and there was another linear building to the southwest, both of which were on the First Edition. On the Second Edition map these structures appear to have been incorporated into two farmyards of various sizes. On this map the size of the quarry has been expanded significantly.

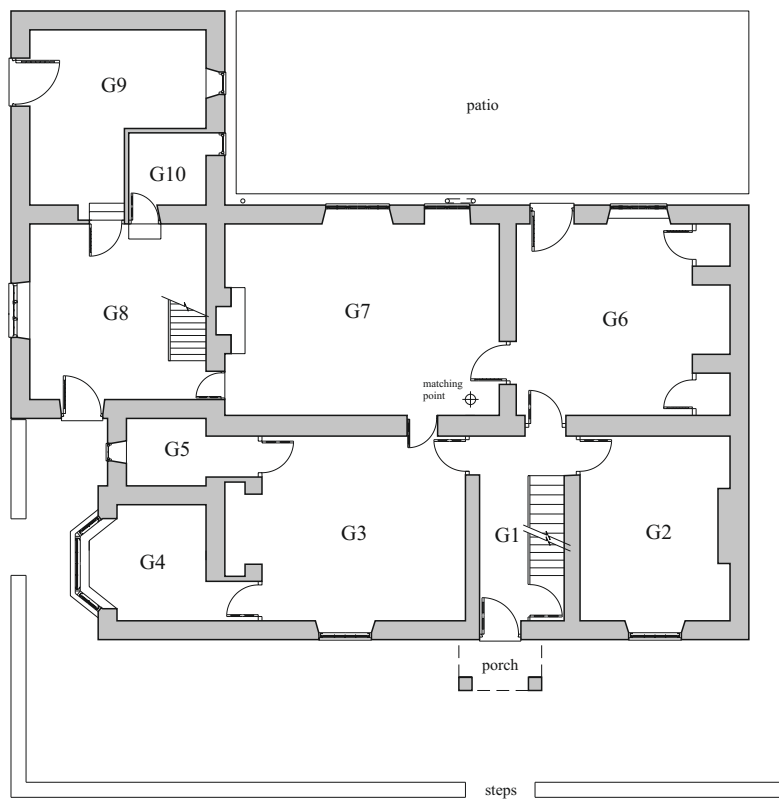
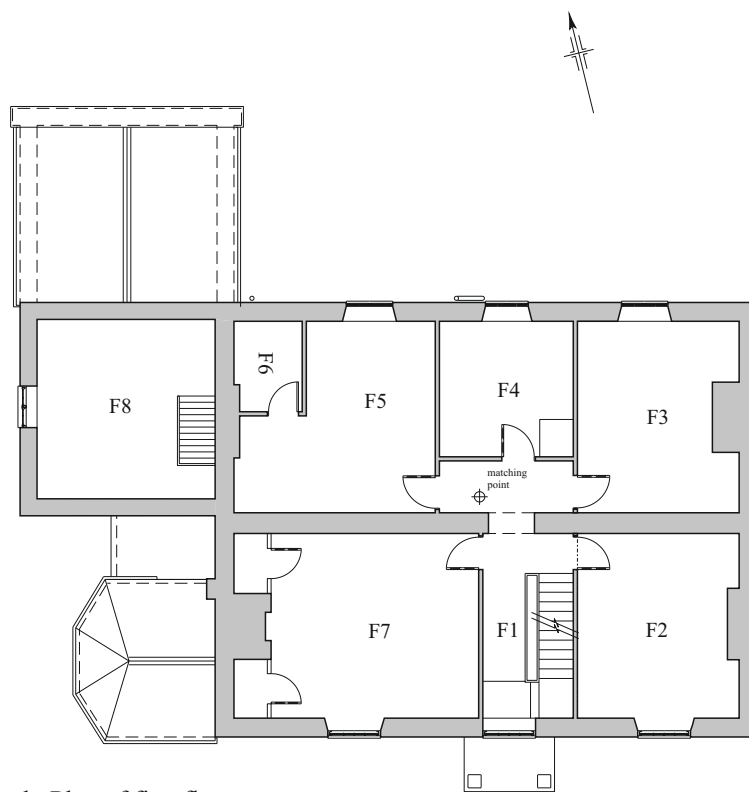
Figure 12: Plans of ground and first floor

The panelled front door leads into an entrance hall (G1), (plate 3). Adjacent to it in the west wall of the hall there is evidence of a butt joint. There is a panel door in the west wall, and a further door in the north and east walls. The staircase has ramped handrail and turned balusters. The floor contains flagstones of various sizes, and the walls have been largely stripped of their plaster. Under the staircase there is a further plank door that gives access to a stone staircase. This leads into a room with stone floor and walls. There is a window in the east wall. The ceiling contains a transverse timber beam that is a partially chamfered timber trunk.

The east panel door with original surround provides access from the hall to a rectangular dining room (G2) with a blocked chimneybreast in the east wall. There is a sash window in the south wall. A transverse beam is presumably boxed in. The skirting board is high and with moulding and could be original. The section is missing from in front of the removed fireplace.

The west panel door from the hall with original surround leads into a larger sitting room (G3) to the west of the hall. The north wall has surviving plaster, skirting and cornice rail, however, the other walls have been stripped of plaster and there are limestone flags on the floor. In the north wall there is a glass panelled door of a recent origin. In the south wall there is a sash window with wooden shutters. There are butt joints either side that appear to indicate that the window has possibly been reset or enlarged. The lintel above has either been reset or is indicative of their previously being a lower ceiling with common joist settings (plate 5). At the west end of the room there is a central fireplace with a cast-iron

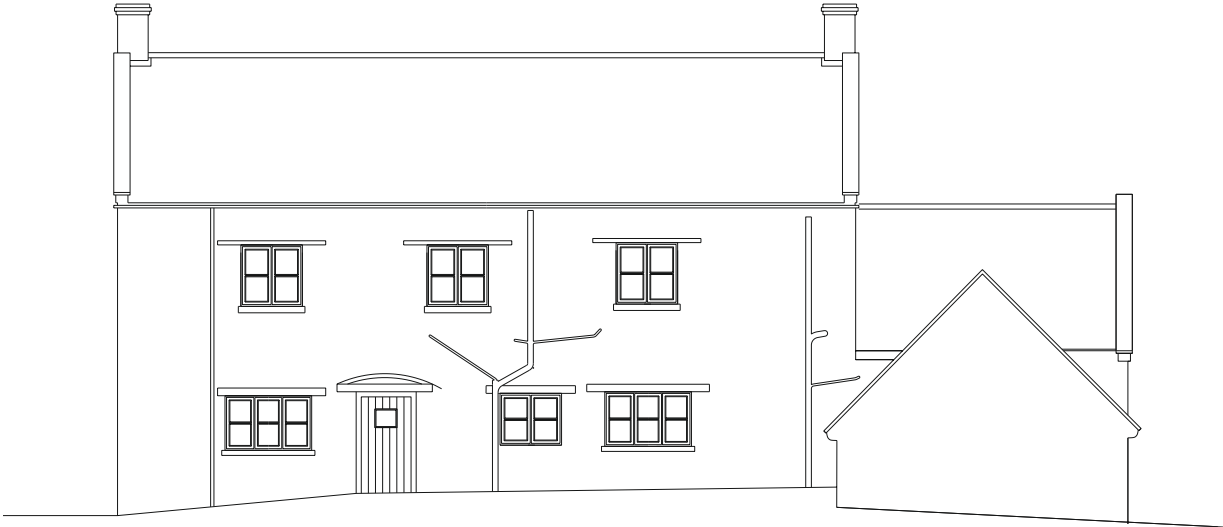
E.1: North elevation

The rear façade contains the main block of the two storey house on the left hand side (Fig. 14, E1; plate 2). This contains an irregular arrangement of bays. On the ground floor there is a plank door to the left of centre, with a glass panel. To the left of this there is a window with six lights. On the right-hand side of the door there is a four light window set centrally and to the right of this there is a six light window. The first floor contains three windows in a more uniform arrangement with the windows of the front of the house. These windows contain four lights. The door and all of the windows are square-headed with timber lintels. Most if not all of the window casements look new. There are variations in the material used to make the sills, which include engineering bricks and stone.

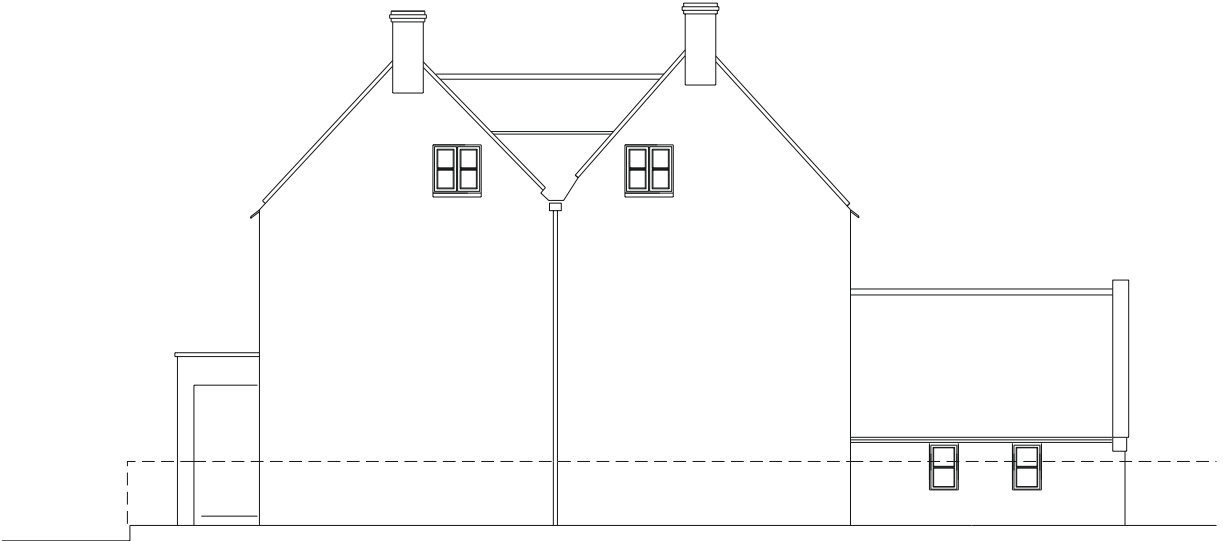
E.2: East elevation

The east wall contains a pair of gable ends on the main two storey part of the building (Fig. 14, E2). The wall is of limestone rubble and the gables have caped parapet walls and

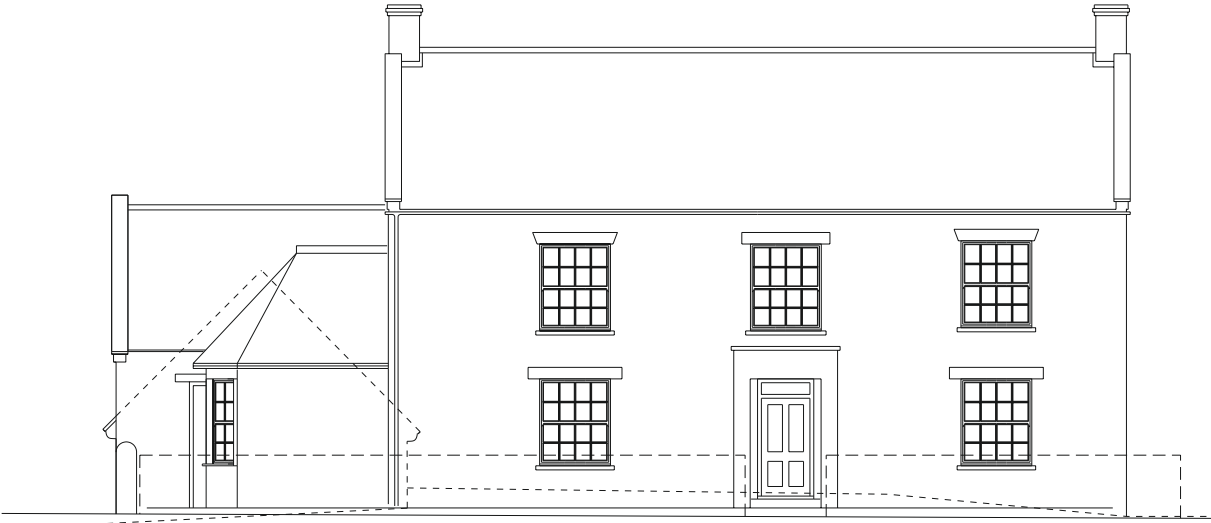
E.3: South elevation

The front façade contains a main range with three bays (Fig. 15, E3; plate 1). The central bay contains a door on the ground floor, which is an original panel door with window light above in a square headed arch. On the first floor there is a sash window with 16 lights in a square-headed arch. The square-headed arches all contain soldiered lintels. In-front of the door there is a porch with collapsed roof. The porch appears to have a more modern appearance, constructed of reconstituted blocks. Above this is a limestone slate roof with a steep pitch. At the end of each gable there is evidence of a parapet wall with capping stones. There are small brick chimneystacks located at either end of the roof.

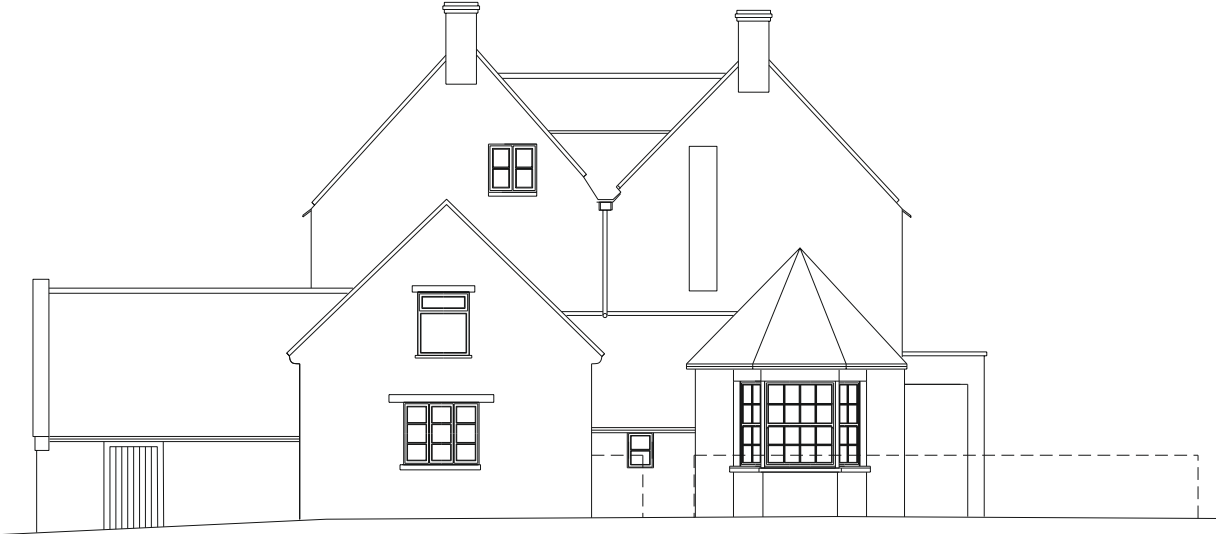
E.4: West elevation

The west façade of the farmhouse contains two gable ends with brick chimneys constructed of limestone rubble and containing capped parapet walls (Fig. 15, E4). The right-hand gable has an off-centre brick chimney added. The left-hand gable has a window

with a four light casement and timber lintel in the attic range. In front of this there are ground floor extensions. Under the right-hand gable there is a single storey hipped gable with composite bay-window containing sash windows. Below the left-hand extension there is a gable with parapet wall. This has a window in the ground floor with timber lintel. There is a narrower window above, which also has a timber lintel, but here it would seem that this is a replacement for a loft door, with the lower part filled in with breezeblocks. Between these two ground floor gables there is a lean-to structure with a small window in the ground floor wall. These two roofs have 265 x 165mm concrete tiles. There is a further extension running north from the left-hand ground floor gable, with original stone tiles. This has a plank door on the ground floor and a roof with gable end and parapet wall.
