JOHN MOORE HERITAGE SERVICES

HISTORIC BUILDING RECORDING

MALTINGS FARM OUTBUILDINGS, SOUTH STREET,

CASTLETHORPE

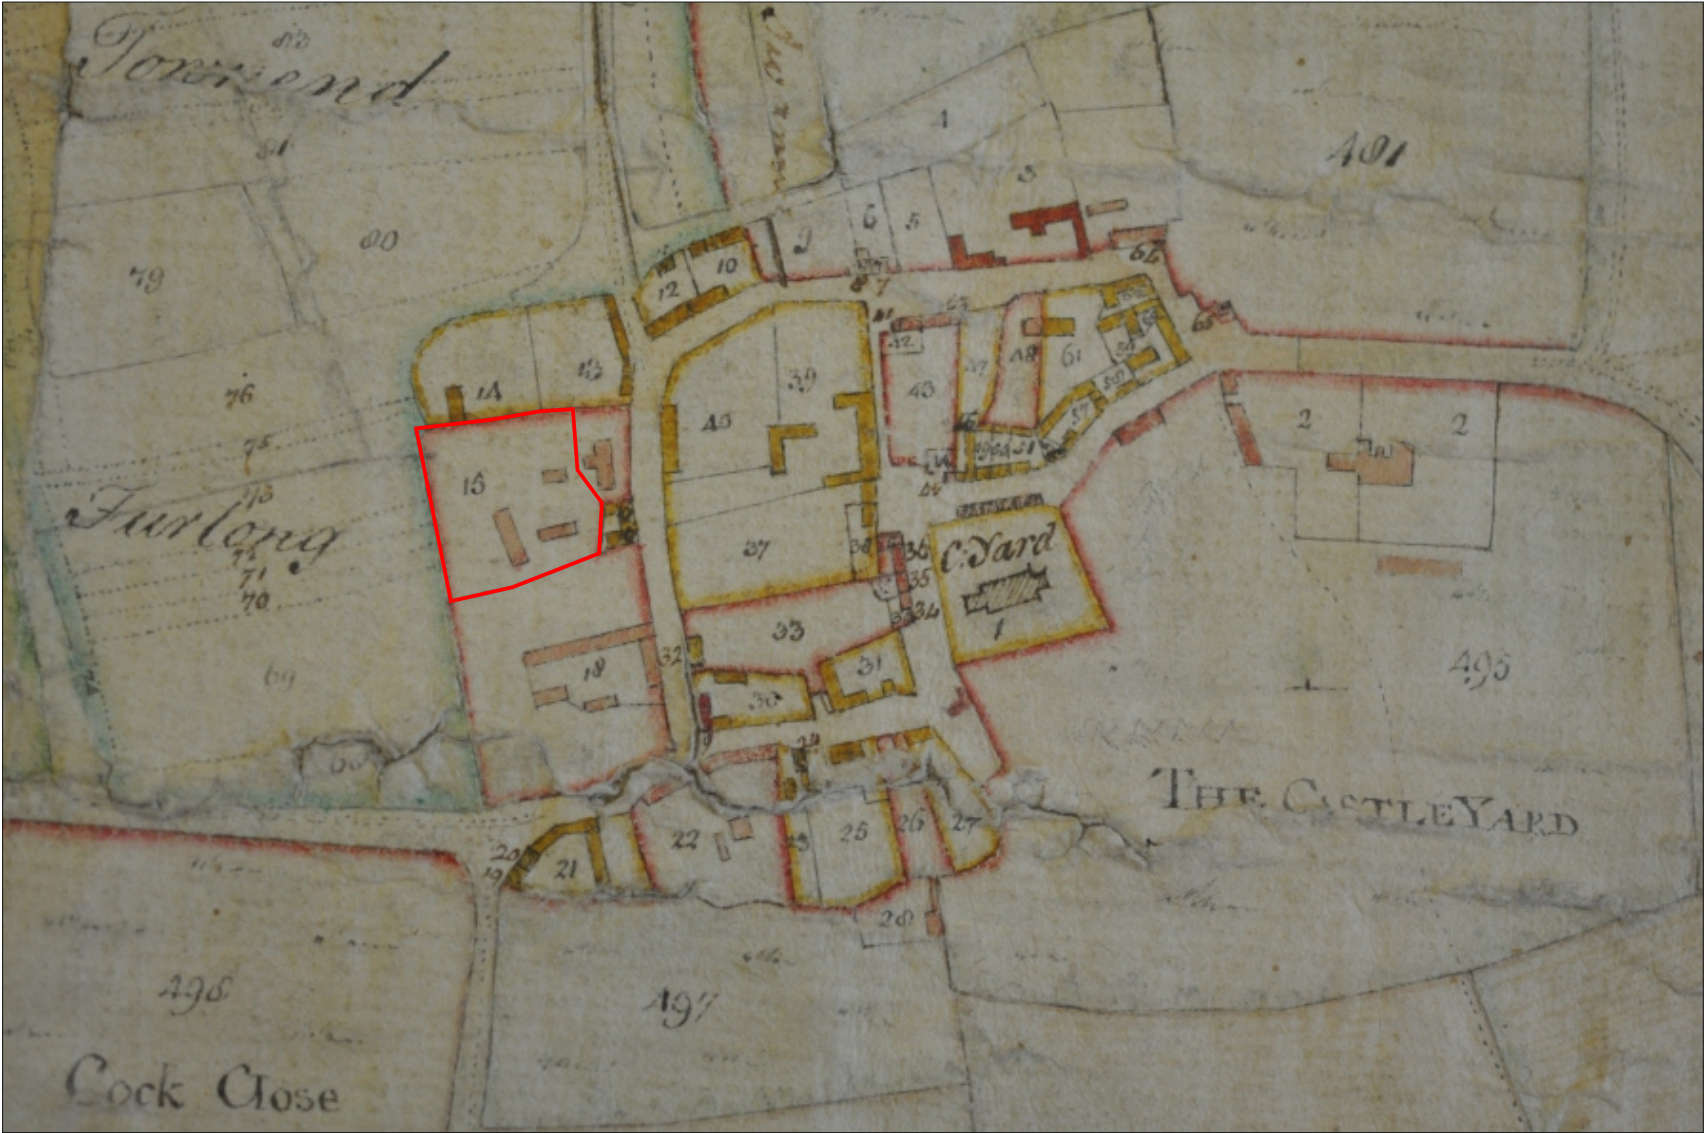
Figure 2. Estate map of 1761-5

The earliest detailed map of Castlethorpe is a map of 1761-5 (BRO Ma/33/1.T), which shows the farm building along with three outbuildings (Fig. 2). The location of the buildings to the east of the farmhouse on the Earl Spencer estate map matches with parts of the structures of Building 1, Building 2, and Building 3.

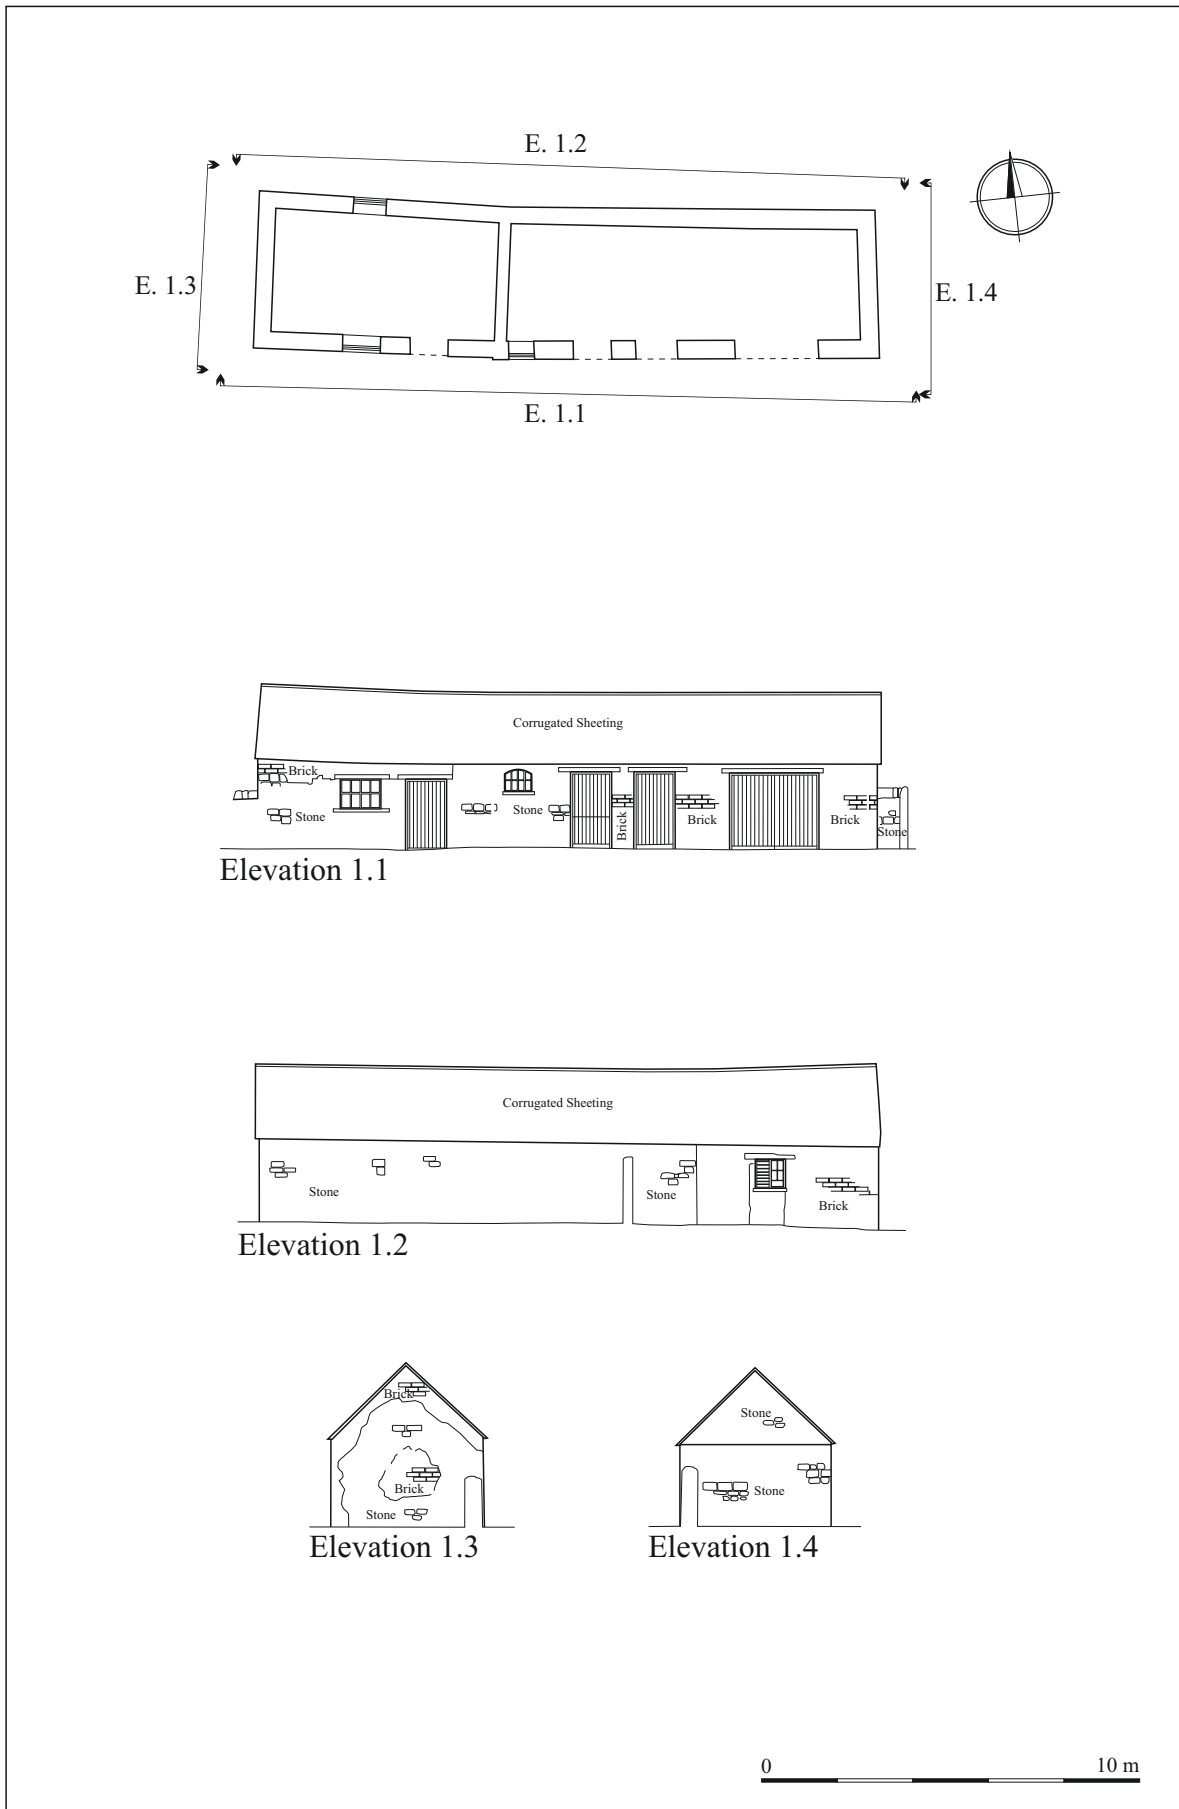
Figure 3. Building 1

The main façade is the south façade (Fig.3 E1.1), which fronts onto the farmyard behind the Maltings Farm house. The west end contains a structure built predominantly of stone. There is a central low door, to the left is a two casement window with four panes in each, and a wooden lintel (Plate 1). To the right is an eight paned window with segmental arch under a straight timber lintel. The upper part of this part of the structure is raised to roof level in brick. The east end contains three doors with modern brick walling between. The left door is a stable door, while the right door is a double door.

The west wall (Fig.3 E1.3) is a rubble limestone wall with patching in brick centrally. The roof level has been raised by the insertion of brick courses.

The north wall (Fig.3 E1.2) has had a large modern cowshed built alongside it on the northeast side. The wall is predominantly of rubble limestone, which is dominant in the eastern part of the structure. The western part of this wall has been rebuilt in brick and has a two light window frame, in part of which are louver timbers (Plate 3). The window is a replacement for an earlier door.

The east wall (Fig.3 E1.4) is of stone rubble with some brickwork on the south side (Plate 2).

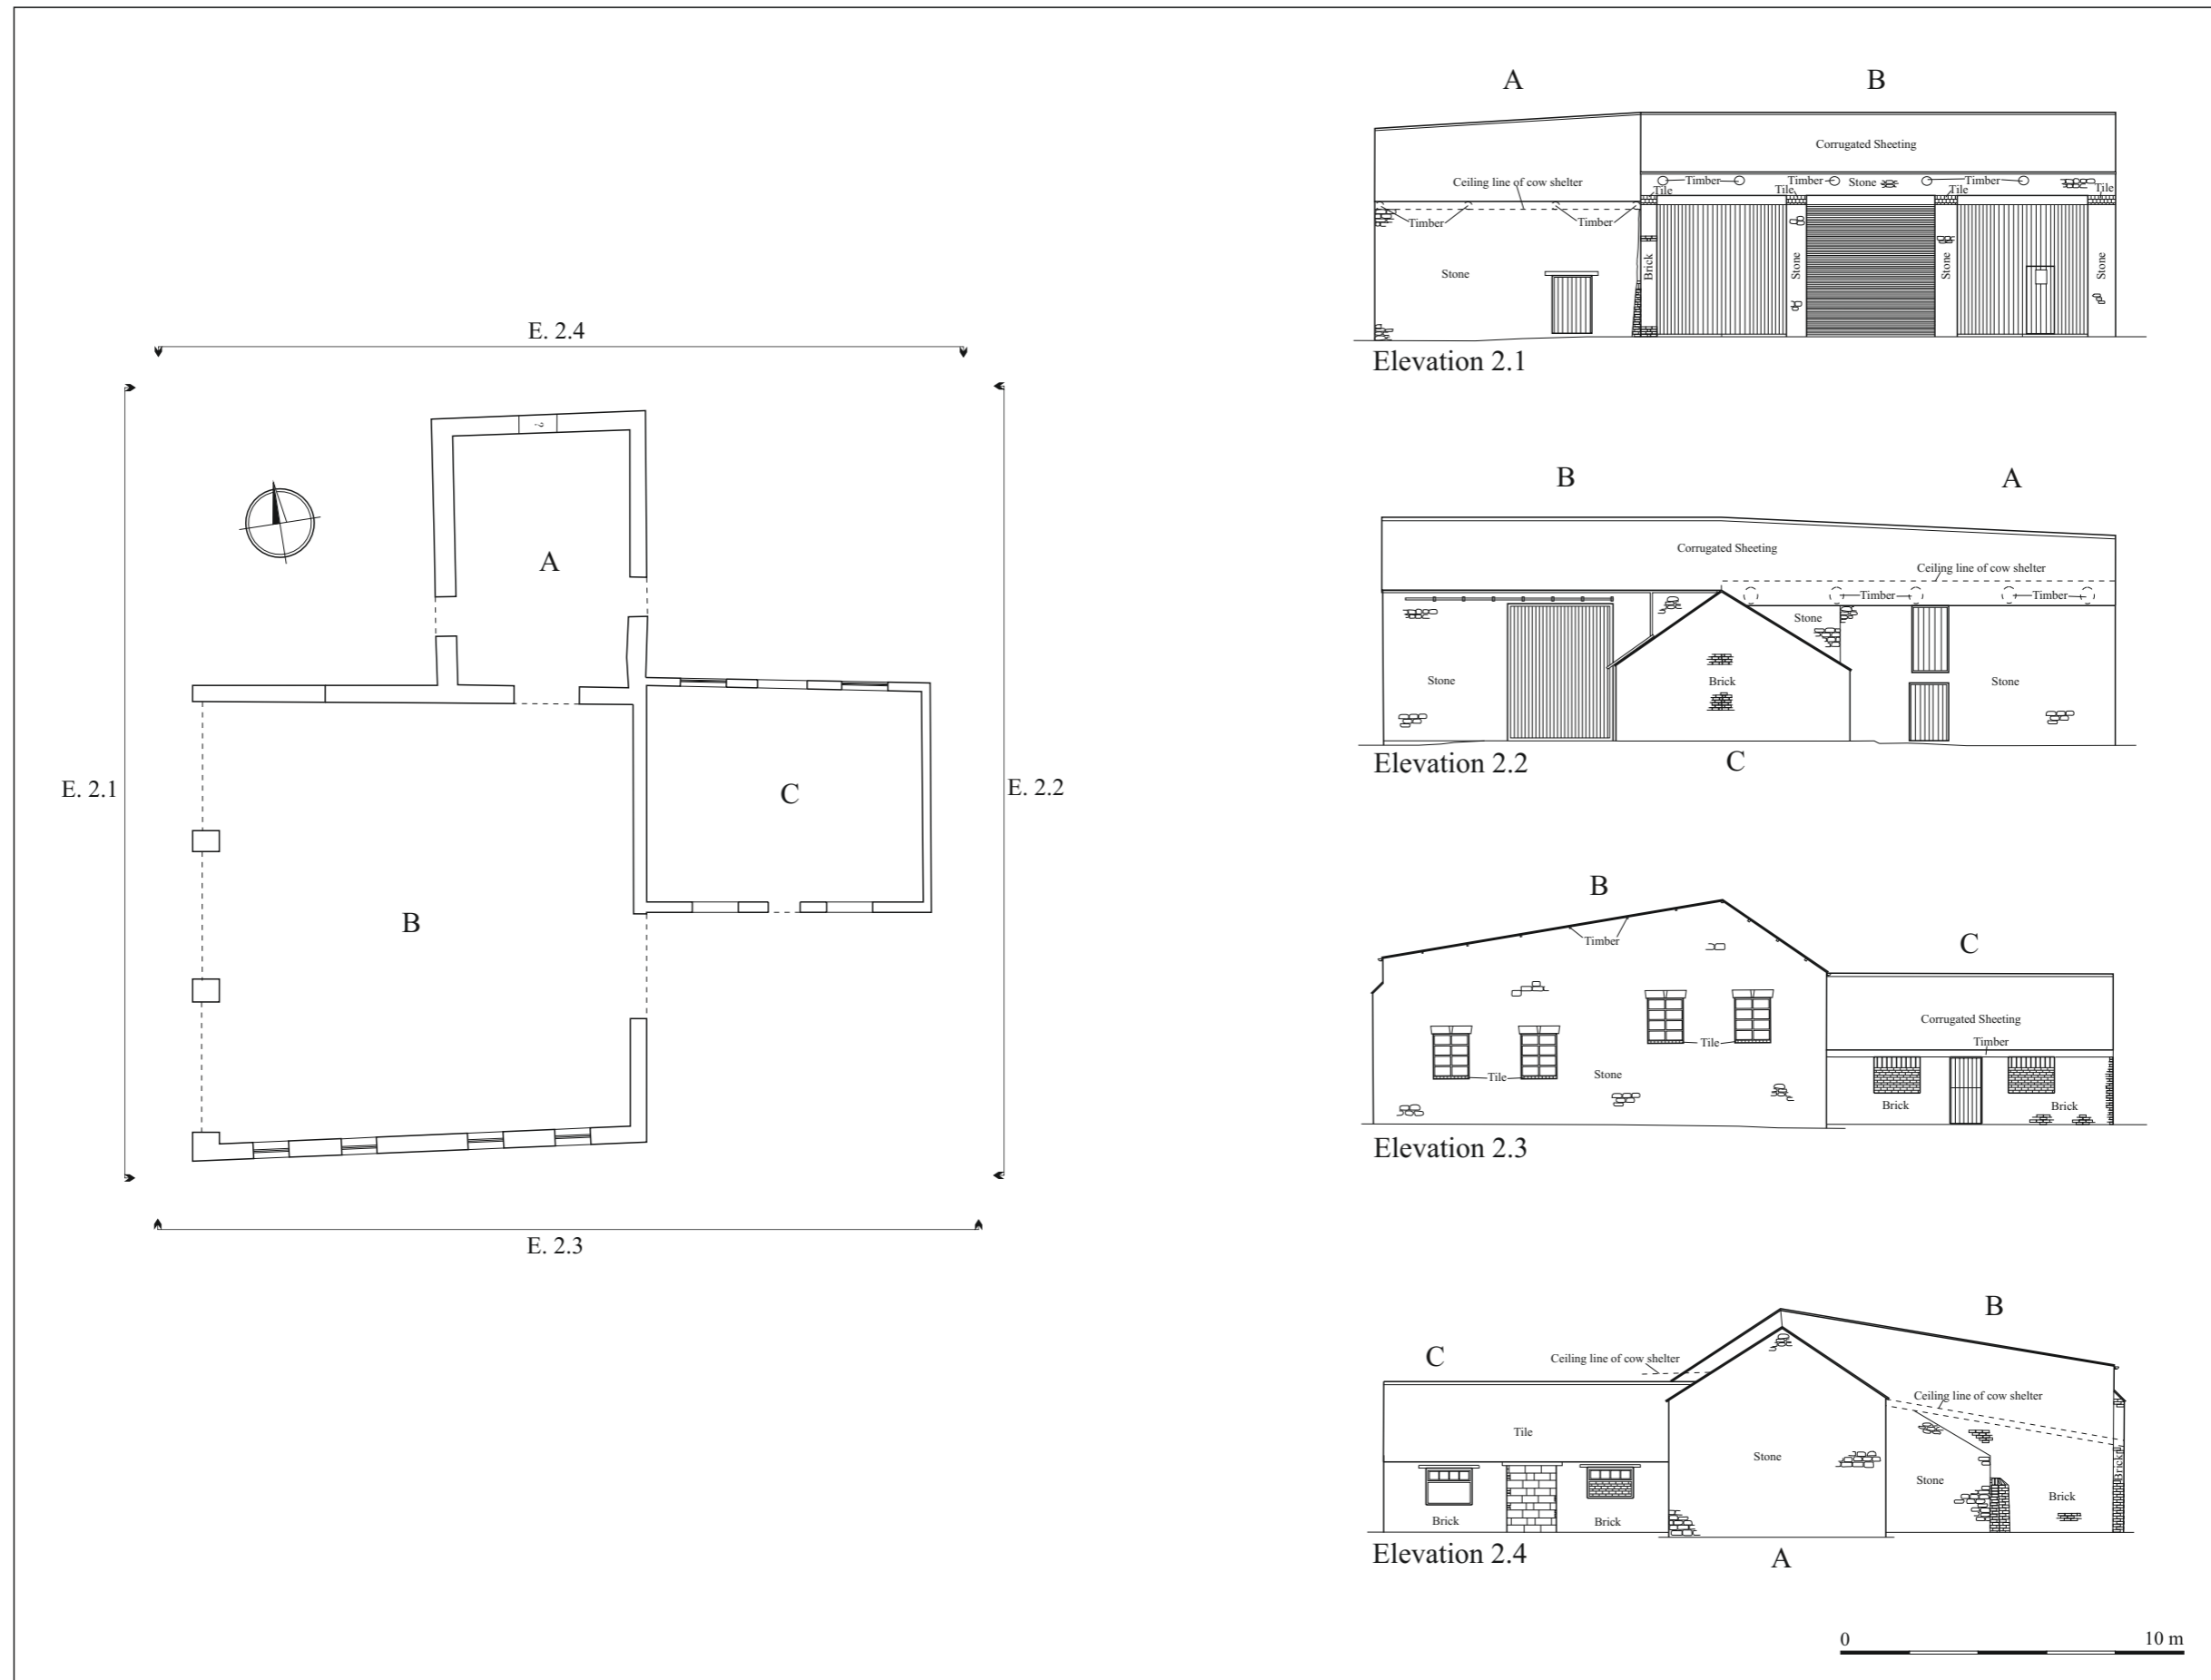
Figure 4 . Building 2

The east façade of Component B is also of limestone blocks and has the remains of a large sliding door located centrally (Fig.4 E2.2, Plate 6). Component C joins this structure on the north side, it may have originally butted the larger component of the barn (Component B), but this was dismantled and rebuilt in the latter part of the 20th century.

The north façade of Component B contains component A joined to its east side (Fig.4 E2.4). On the west side there is evidence of a lean-to structure that would have been located on the west side of component A (Plate 5). The wall is of limestone and the pitch of the roof shallow. Alongside this is a wall with brick in its lower courses and limestone walling above.

The north wall (Fig.4 E2.4) of Component A is a limestone wall forming a gable end (Plate 5).

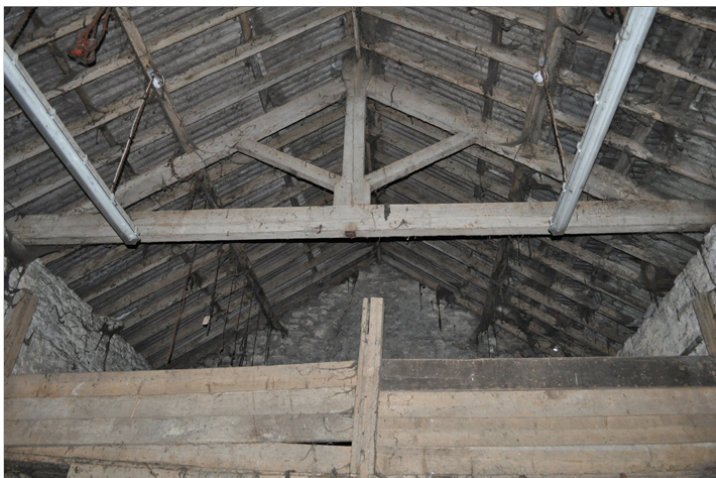
Plate 10. Building 2, Component A internal

Internally Component A has limestone walls which still contain whitewash (Plate 9). There is a concrete or mortar plinth around the lower part of the wall on the west, north and east walls. There is a single ground floor door in the west wall, two doors in the east wall, one ground floor and the other what would have been first floor. The stone wall of the west wall has two different widths suggesting the upper story is a later addition. There is a door in the south wall at ground level, this has brick quoining and looks like a later insertion. Above is a blocked doorway. A central timber (reused telegraph pole) supports a transverse beam that forms part of the hayloft at the north end of the building. None of this can be confirmed as being old. Above this is a roof truss which is formed by a king strut post. Though the design may be part of a traditional roof structure, the timbers have a newer appearance and may be replacements, either 19th century or even perhaps for the revamp of the barn in the 20th century (Plate 10).

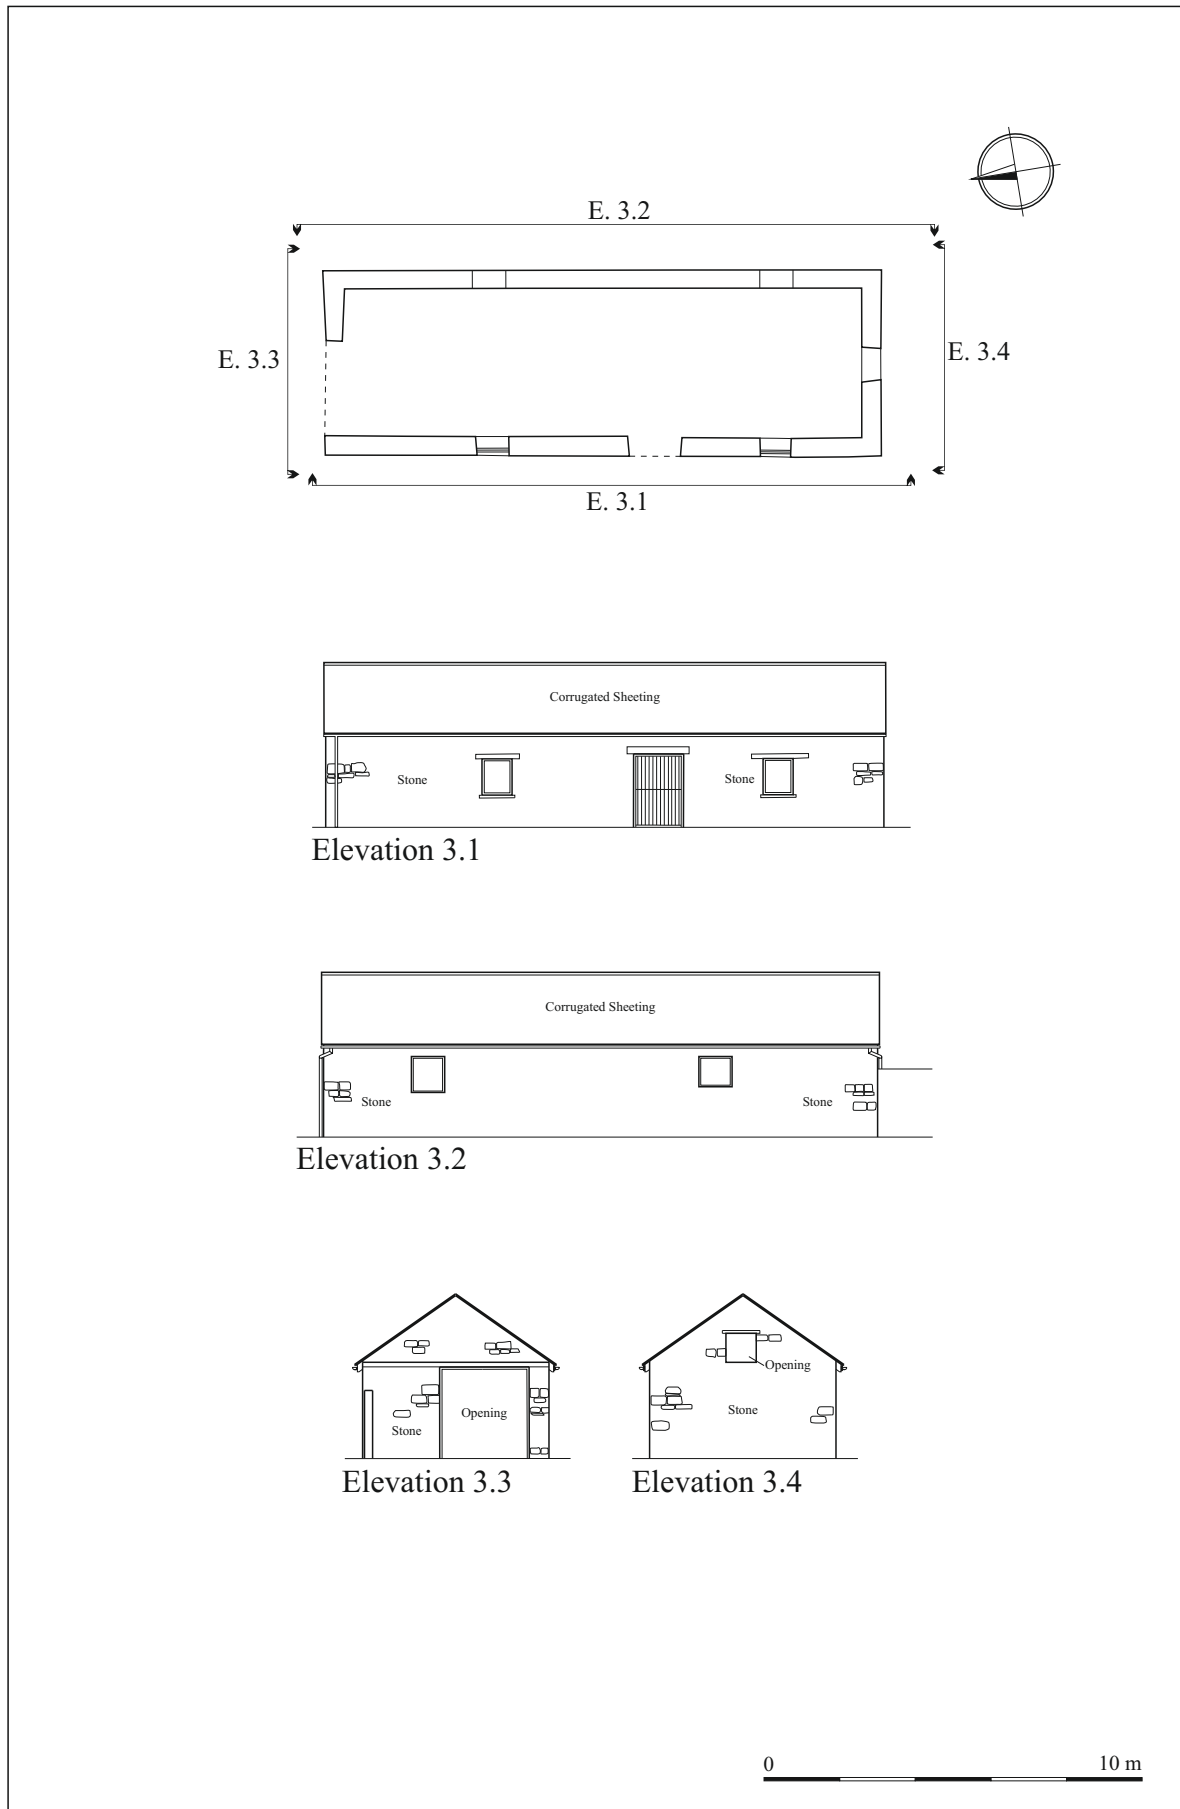
Figure 6. Building 3

The north façade is open, probably removed, with some timber framing inserted (Fig.6 E3.3).
