JOHN MOORE HERITAGE SERVICES

BUILDING ASSESSMENT

THE PERCH,

BINSEY, OXFORD

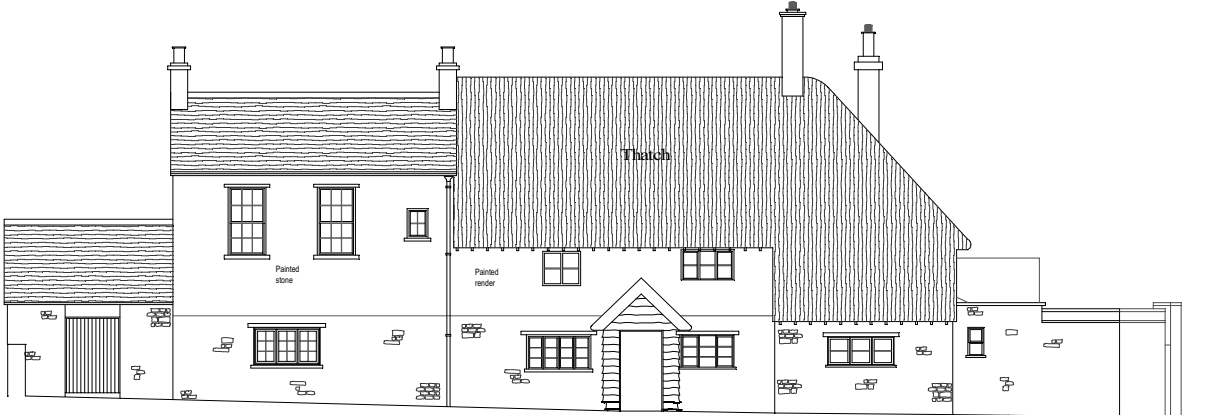
E.1: Southwest elevation

The main façade is the southwest one (Fig. 9 E1), which has at its centre a two story unit with central door with timber porch clad in weatherboard, flanked by windows in the ground floor and the first floor (plate 1). The ground floor wall is of limestone rubble, while the upper wall is rendered and coated in pale yellow wash. The main door is a panel door of a more recent origin. The window to the left of the door has

On the south side of the southwest elevation there is a limestone rubble extension, with a sloping thatched roof giving this the impression of being a lean-to with thatched roof. The timber frame visible under the thatch looks as though it has been replaced more recently, while there are timbers in the north wall that is older being weathered and gnarled (Fig. 9 E2). The west wall contains a window with timber lintel and two mullions (Fig. 9 E1).

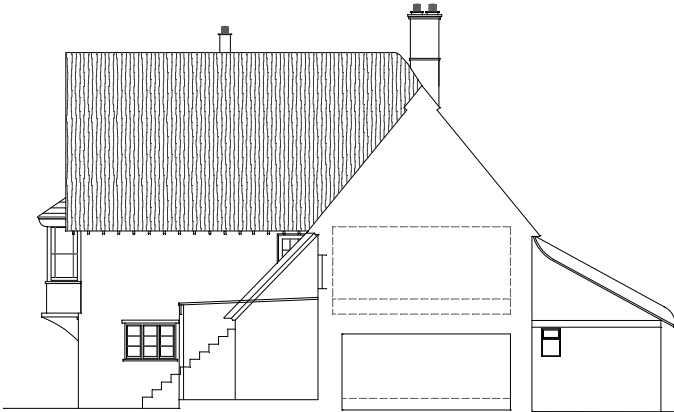
E.2: Northwest elevation

The northwest façade of the south range of the L-shape contains the side of a lean-to porch, and a series of external steps (Fig. 9 E2, plate 3). Adjacent to the base of the steps there is a window with timber lintel and on the first floor is a door at the top of the stairs, modern with glass window lights. The roof above is thatch.

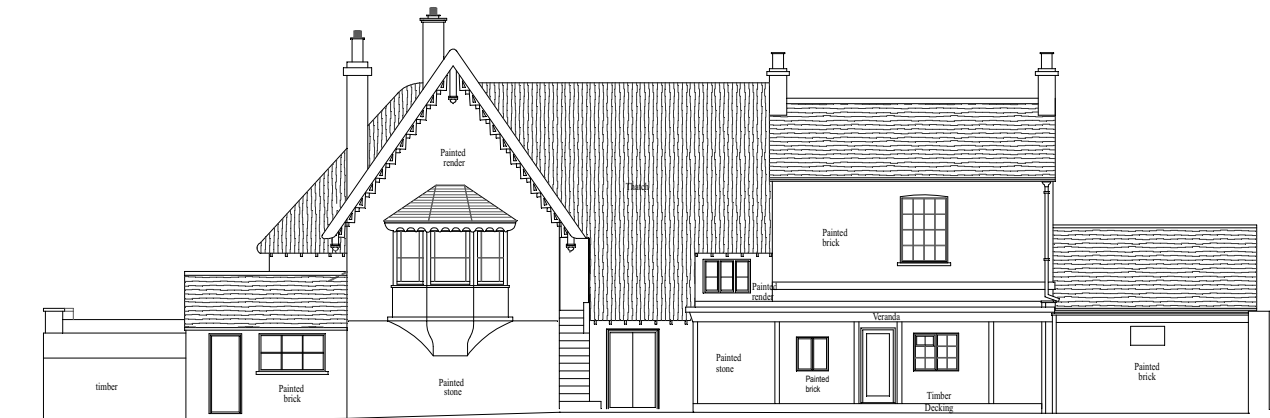
E.3: Northeast elevation

The northeast façade of the main range has a double door under the thatch of a lean-to porch, with a stairs to the left (Fig. 10 E3, plate 3). The wall to the north is mainly of brick, although some rubble limestone walling is evident. It has a central door with glass panels, and windows either side. The one on the right has a central mullion, and there is a sash window above also with a timber lintel. Above the window to the left of the door there is an offset window with two mullions set under the lower thatched eaves. The roof above the sash window is a slate roof with a gentler pitch.

On the rear of the building it is proposed to replace the rear veranda with a conservatory, which will see the digging of new foundation footings. The city archaeological officer has requested that an evaluation trench of 8-10m in length be made in the location of the foundations for the conservatory extension and that any further monitoring be carried on after this as mitigation.

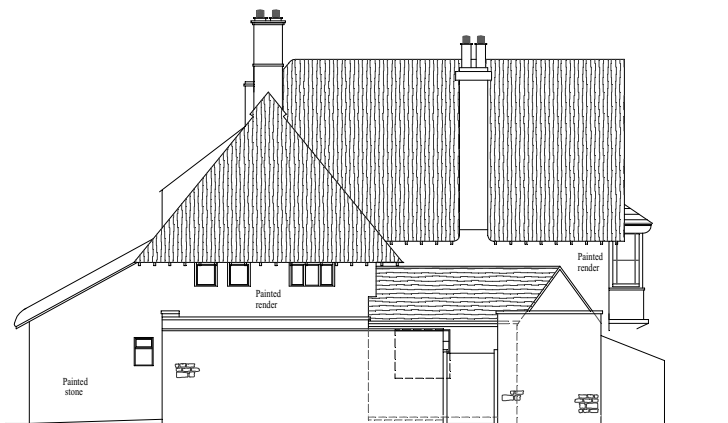
E.4: Southeast elevation

The east part of the southeast façade has a rubble limestone wall below the main elevation in which there is a gate, which leads into a small courtyard (Fig. 10 E4, plate 5). On the north side of the courtyard there is a brick structure with a slate roof, and window below. The west wall of the courtyard is breezeblock and contains a modern panel door. On the east side is a refrigeration unit that is set under a small brick gable. The wall above the lean-to is blank, the roof above this is thatched and there is a lateral chimney. There is a fish shape created as a decoration on the ridge of the thatch, presumably supposed to represent the perch. The remains of a hipped and thatched gable can be identified on the west side, which contains three windows, a larger two mullioned window on the east side and two smaller identical windows on the west side. To the west of the rubble limestone walls and thatched hipped gable there is a rubble limestone lean-to.

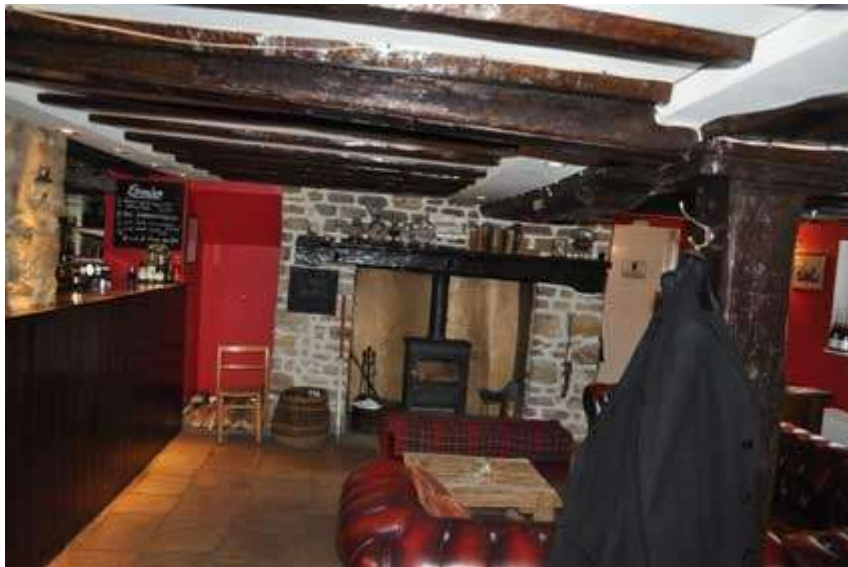
Plate 7 G1 fireplace

The front door, with a weatherboard porch, enters into a long room (Fig. 7, G1-2) which has been created with the removal of a wall and fireplace (plate 6). The room has two different levels with the north end being approached by steps. The lower southern part is larger (G1). The walls above must now be supported by RSJs. Timber framing has been inserted into the gap; presumably this is of a new date. There is a large fireplace with timber lintel at the south end, which contains a wood burner (plate 7). There is a central support running axially to the building, what is underneath part of this is not known, but presumably there was originally a timber here; part of a timber survives with cut for headroom and there is a central timber support (plate 8). The joists are roughly chamfered and may be early. The floor is of limestone slabs. In the

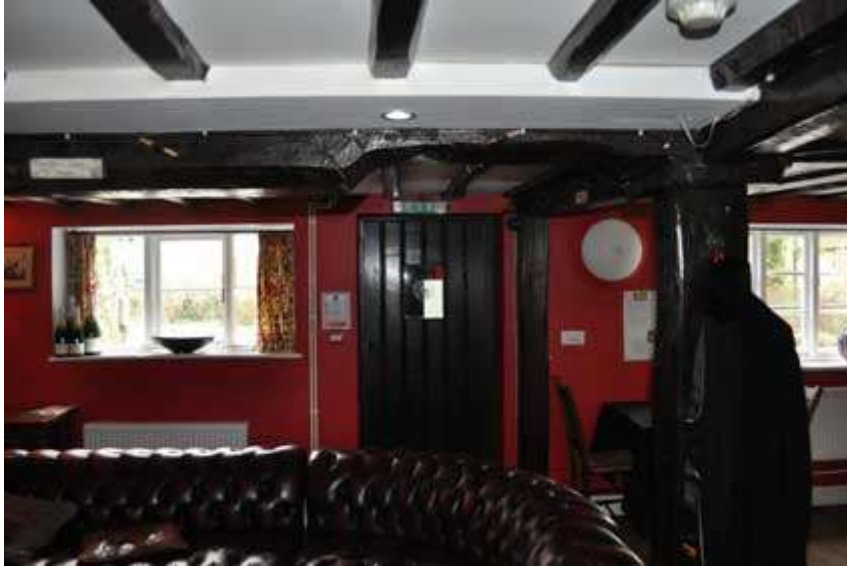
Plate 8 G1 axial beam

Phase 2 probably saw the structure turned into a three cell unit of a 16th to 17th century date, although parts of the walling were probably replaced at various later phases. There are surviving ceiling timbers in the bar area, axial timber and joists also show adze working technique. The axial beam also has a recess cut upward into it, which may be for a passage or door. This feature I have seen elsewhere, for example at Braceland Farm, Gloucestershire, which is unsatisfactorily dated but is on a map of 1608 (pers knowledge). These are treated as possibly part of phase 2 primarily because the base of the cruck only survive in the bar as stumps having been removed. This may imply that these beams were part of an earlier phase or part of some reworking.

On the whole the proposed alterations to the building do not cause that much damage to the historic structure. After negotiation and debate it can be shown that the minimal damage has been reduced. Alterations will be seen in the bar area, where the bar will be relocated to a known earlier location. The cellar will be located to the southwest wing of the building, with a new door inserted into the northwest wall. The toilets and baby changing facilities will be relocated and altered, but the redundant staircase will be retained as a feature. Alterations to the kitchen are a further undertaking, which are key to the functionality of the public house. Research has shown that this area was altered in the period after the fire in 1977 and that original features were lost at this time. These alterations will see the removal of a chamfered post.

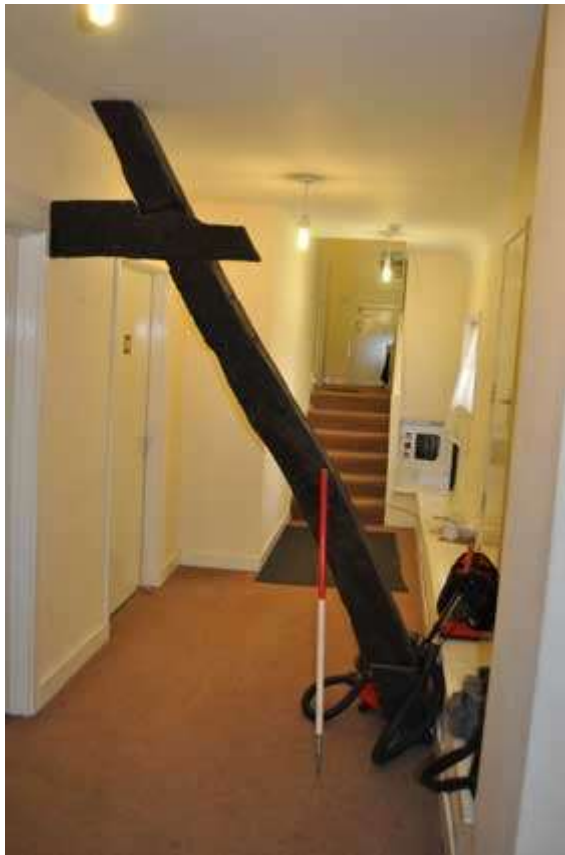
Plate 10 F1 Cruck

The first floor is entered from a rear external staircase through a recent glass panelled door. This leads into a T-shaped room staggered on a number of different levels (Fig. 8, F1). In the north south orientated passage are the remains of part of a cruck (plate 10), which was shaped using adzes. The passage has been created with the insertion of a modern studded wall on the left hand or west side. There are two doors, in this wall of the passage, each leading into a room (F2-F3). In the west walls of the rooms there are windows, in the wall that partitions them there is the remains of the cruck (plate 11). On the east side of the T-shaped passage is a window and a door leading into a cupboard in the roof space of a lean-to porch at the rear of the building.

frame cruck structure, loosely datable from the 12th to the 16th centuries, probably more conservative to place it in the later part of that date range for now. It cannot be properly assessed at this time of how the chimneys, if there were any at this early date would be connected to the building.
