The structural history
of
DANDRIDGE'S MILL
EAST HANNEY
OXFORDSHIRE

K A Rodwell
for
JOHN MOORE HERITAGE SERVICES
July 2007

THE STRUCTURAL HISTORY OF DANDRIDGES MILL, EAST HANNEY, OXFORDSHIRE

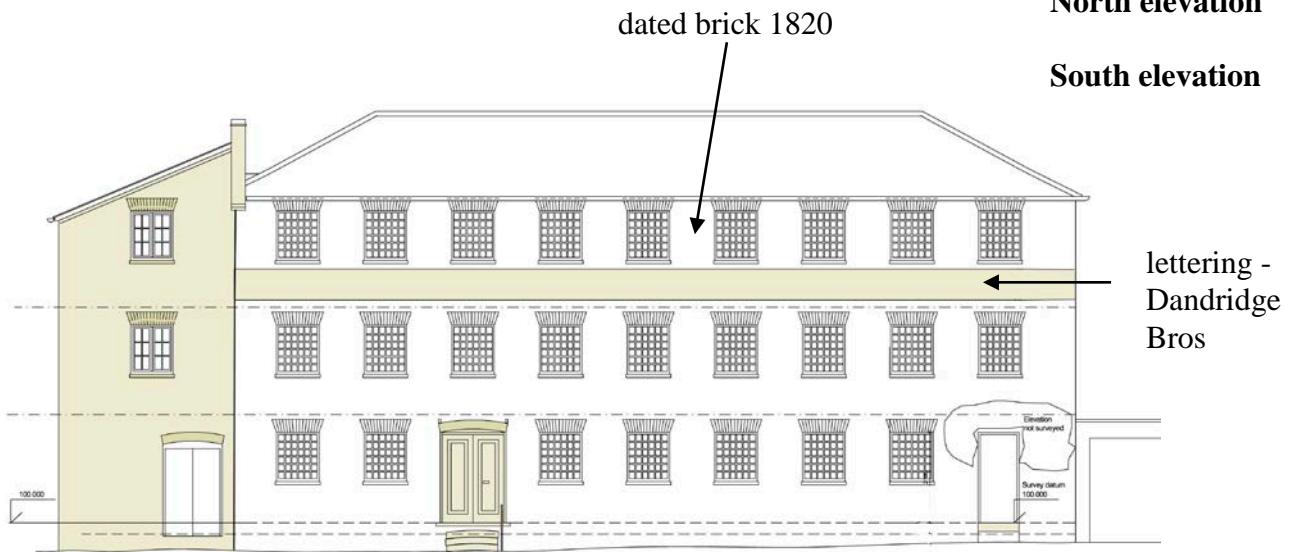
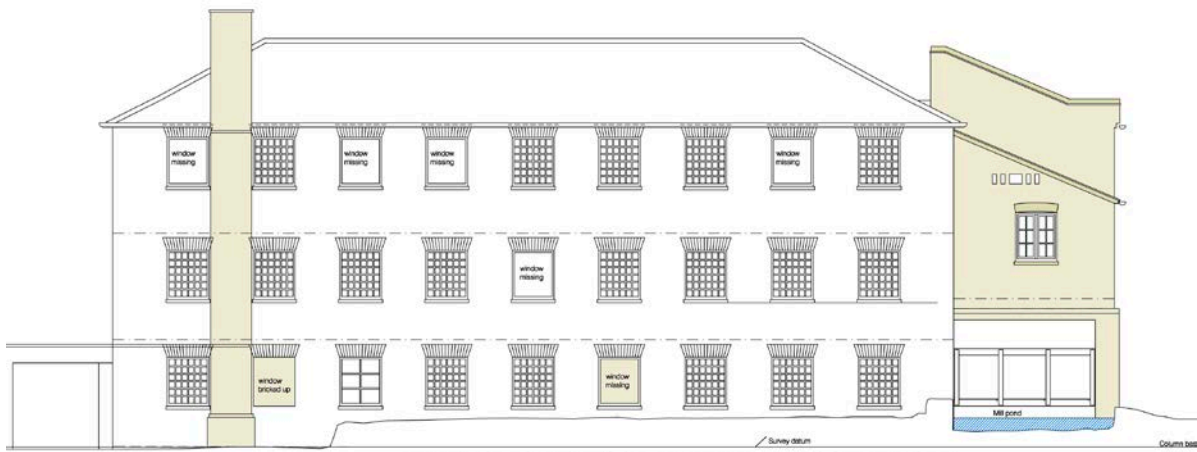
Fig 4

The north elevation is largely as built with an original door at the west end. The raised double door towards the east end replaces a window and has an arched grey brick head matching the eastern extension. Across the width of the original building between the first and second floor windows there is a painted band with shaded black lettering reading 'DANDRIDGE BROS. MILLERS, MALTSTERS, HAY, STRAW, CORN & SEED MERCHANTS'. Between the top floor windows west of centre there is a brick dated 1820, incised and filled with lime mortar, surrounded by a series of initialled bricks, B.H, R.C, B.L, J.B and C.S.

The south elevation is largely as built; some window frames are missing (but seem to be stacked internally), one has been reglazed, another turned into a door and a third blocked. This adjoins the brick chimney to the engine house, a later addition secured to the wall by iron bands; the adjoining wall has been reinforced with three long vertical iron plates between the windows. An old photograph (Fig 1) shows that there was a part-glazed lean-to on this corner of the building, indicated by painted brickwork. This extended onto the west wall, otherwise blind apart from an original central door.
