The investigation of a barn
at
DAIRY FARM, HIGH STREET
CHINNOR, OXFORDSHIRE

K A Rodwell
for
JOHN MOORE HERITAGE SERVICES

May 2006

THE INVESTIGATION OF A BARN AT DAIRY FARM, HIGH STREET CHINNOR

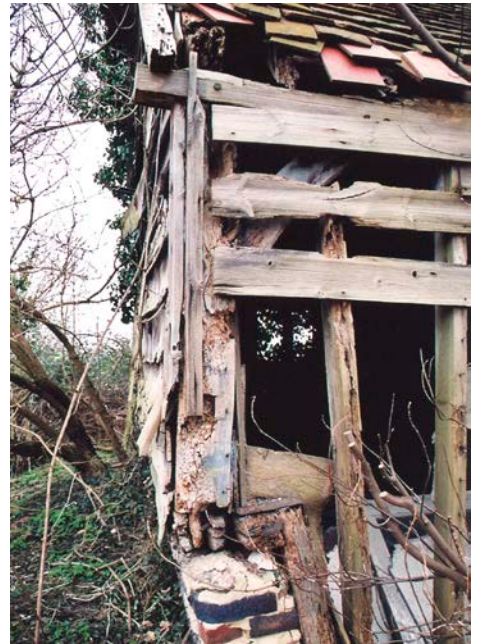
12

- 11) North-east corner (T1) showing rebuilt dwarf wall
- 12) South-west corner (T1) showing braced post
- 13) Truss 2 SW, hidden by later boarding
- 14) Door into bay 1 through boarding infilling T2
- 15) Graffiti on boards adjoining NE door jamb
- 16) Bay 1 looking south-west; secondary boarded partitions and ceiling
- 17) Bay 1 looking north-east; secondary boarded partitions and ceiling

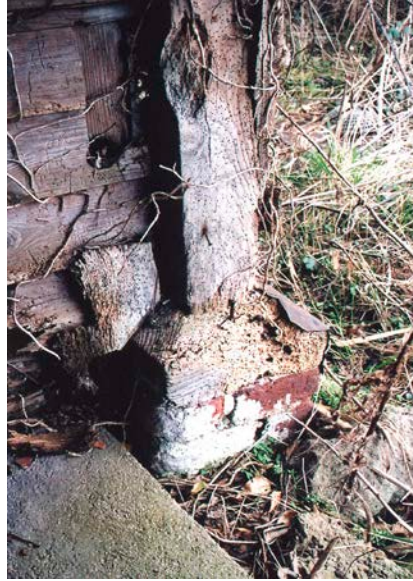
18

- 18) Bay 2 looking north-east
- 19) Truss 2 NE; original foot detail
- 20) Truss 2 NE
- 21) Truss 3 SW (encased in modern boarding)
- 22) Truss 3 NE (encased in modern boarding)
- 23) Bay 2; eaves detail south-west side
- 24) Bay 4 showing T4 NE with secondary boarding

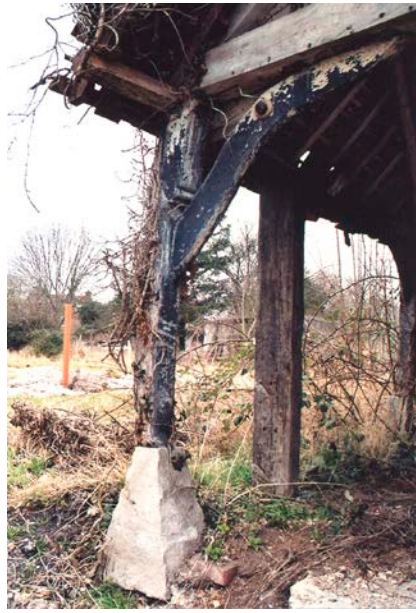
25

- 25) Truss 5 SW, post looking south
- 26) Truss 5 SW, post looking north
- 27) Truss 4 SW, post looking north
- 28) Truss 4 SW, post, bracing detail
- 29) Bays 3 and 4 looking north-west
- 30) Bays 3 and 4 looking north-east
- 31) Truss 4 NE post, bracing detail
- 32) Bay 4 looking south-west
