**AN  
HISTORIC BUILDING RECORD  
OF  
THE FORMER SMITHY,  
SMITHY COTTAGE,  
8 OTMOOR LANE,  
BECKLEY  
OX3 9UX**

*On behalf of  
Mr P. Sims*

**MARCH 2005**

**Site Code:** BESC 05  
**JMHS Project Number:** 1526

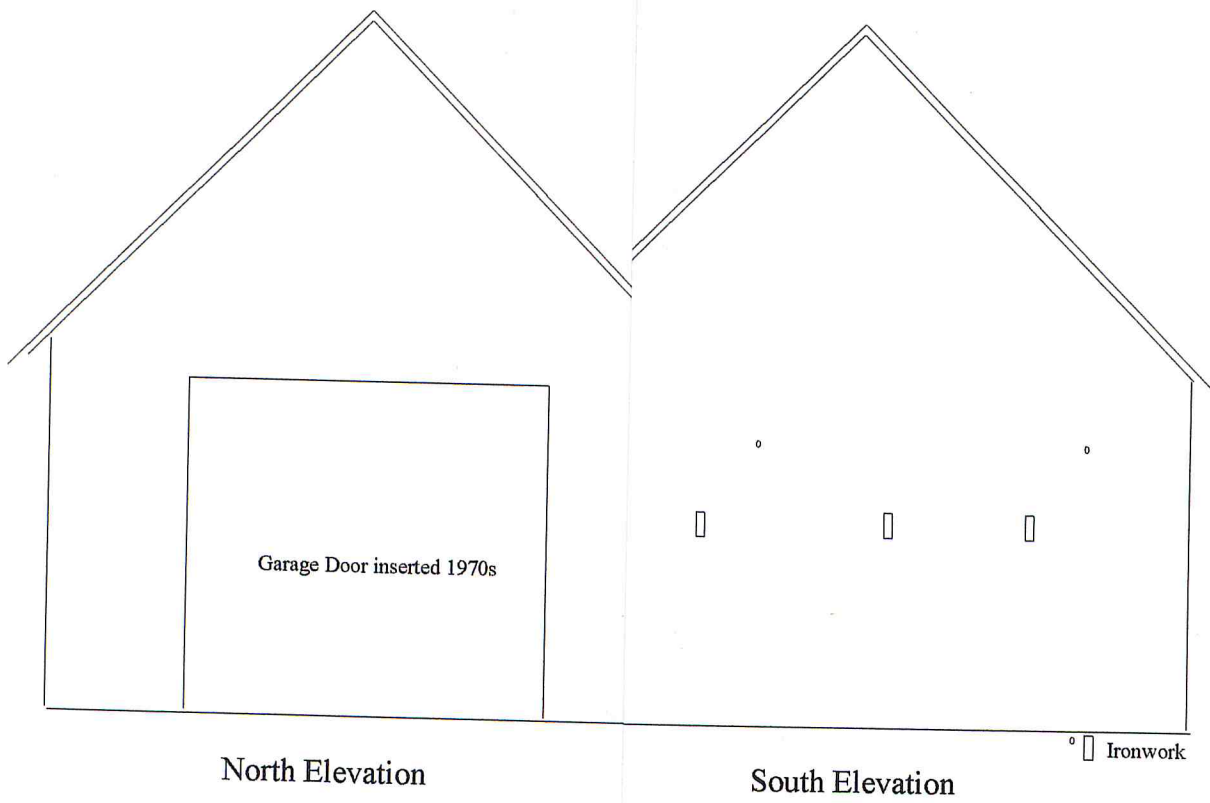
Figure 3: Site Plans and Elevations

The building is shown on the first edition Ordnance Survey map of 1876. Structures abutting the southern side of the building were pigsties (now demolished). Indications of the former location of the sties can be seen on the fabric of the gable (Plate 1, Figure 3).

The village residents remember sledging down the gentle slope to the rear of the Smithy prior to the extensive landscaping of the 1950s, in addition to horses being led into the Smithy from the lane, and following shoeing, out of the opposing doorway and up the hill (Mr P. Sims, *Pers. Comm*). Traces of the edge of the blocked doorway can be seen in the fabric of the east elevation, at the southern end (Plates 2 and 5, location also shown on east elevation in Figure 3).
