**ROMEYNS COURT,**

**GREAT MILTON,**

**LISTED BUILDING ASSESSMENT**

**MARCH 2004**

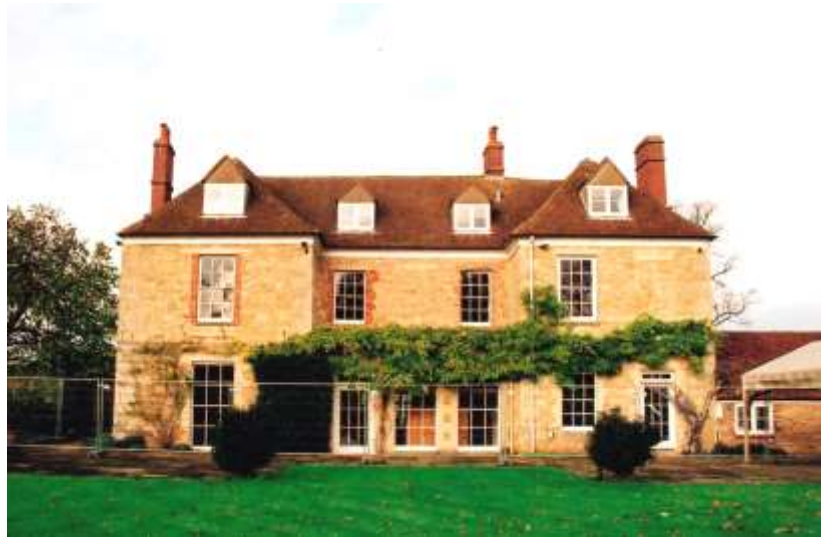
South east elevation showing alterations to windows (blue)

- Pink c.1700
- Blue 19<sup>th</sup> century
- Buff late 20<sup>th</sup> century

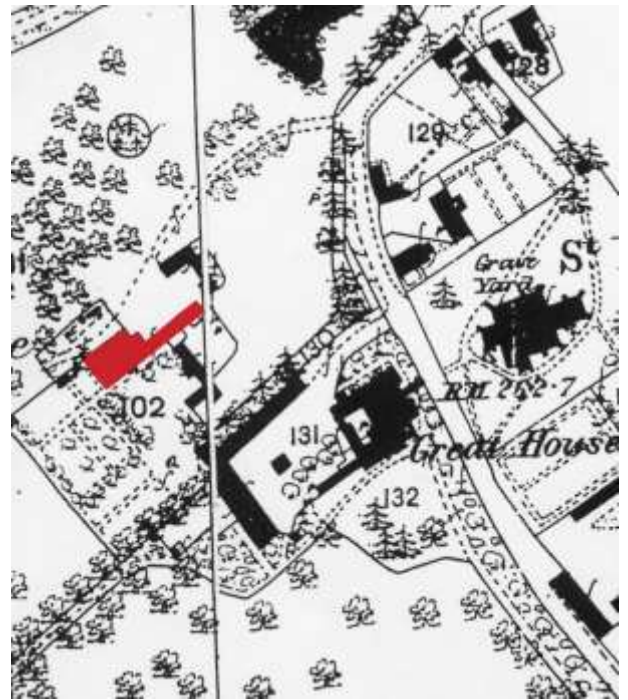
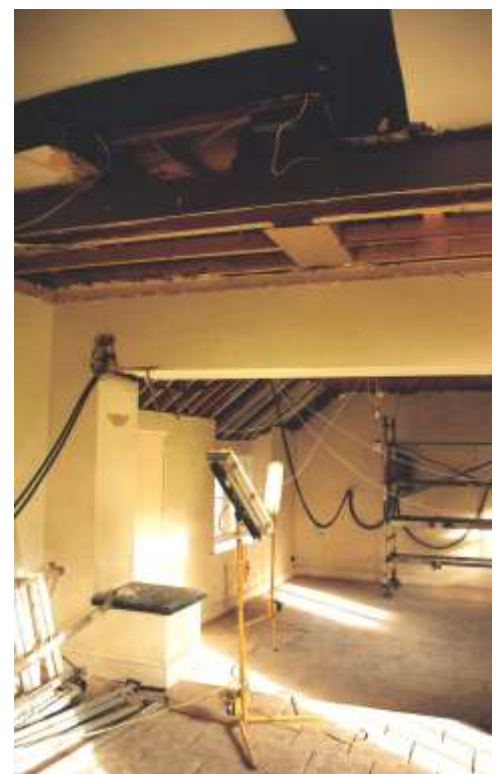
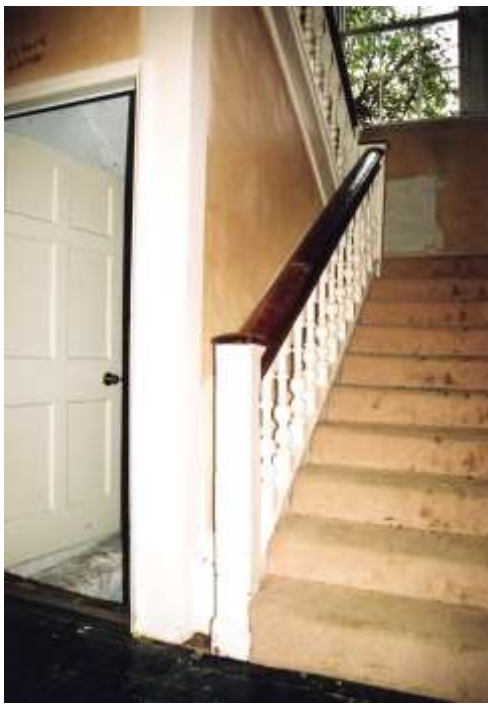
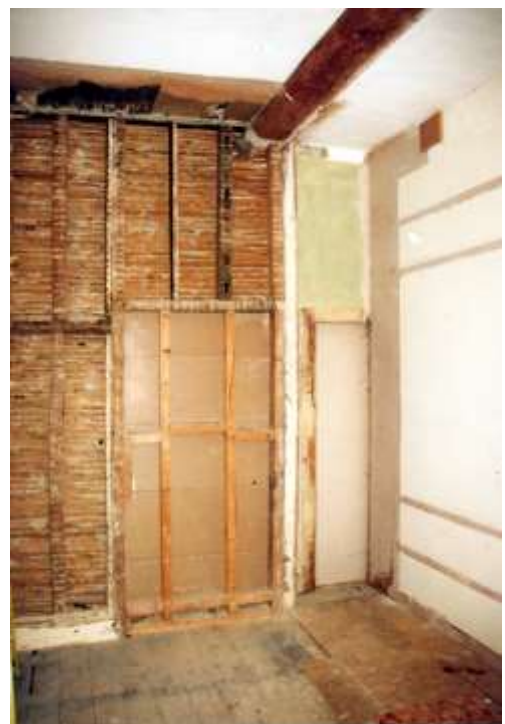
**Romeyns Court Fig 4 Interiors**  
(clockwise)

Cornice in study; missing section with modern ceiling plaster

Dressing room to bedroom 1 showing blocked doors and position of previous partition

Cupboard in bedroom 2 replacing chimney breast; original ceiling beams exposed
