**BUILDING INVESTIGATION AND PHOTOGRAPHIC RECORD**

**OF THE AIR RAID PRECAUTIONS SHELTER**

**ST CHRISTOPHER'S FIRST SCHOOL,**

**JUNE 2004**

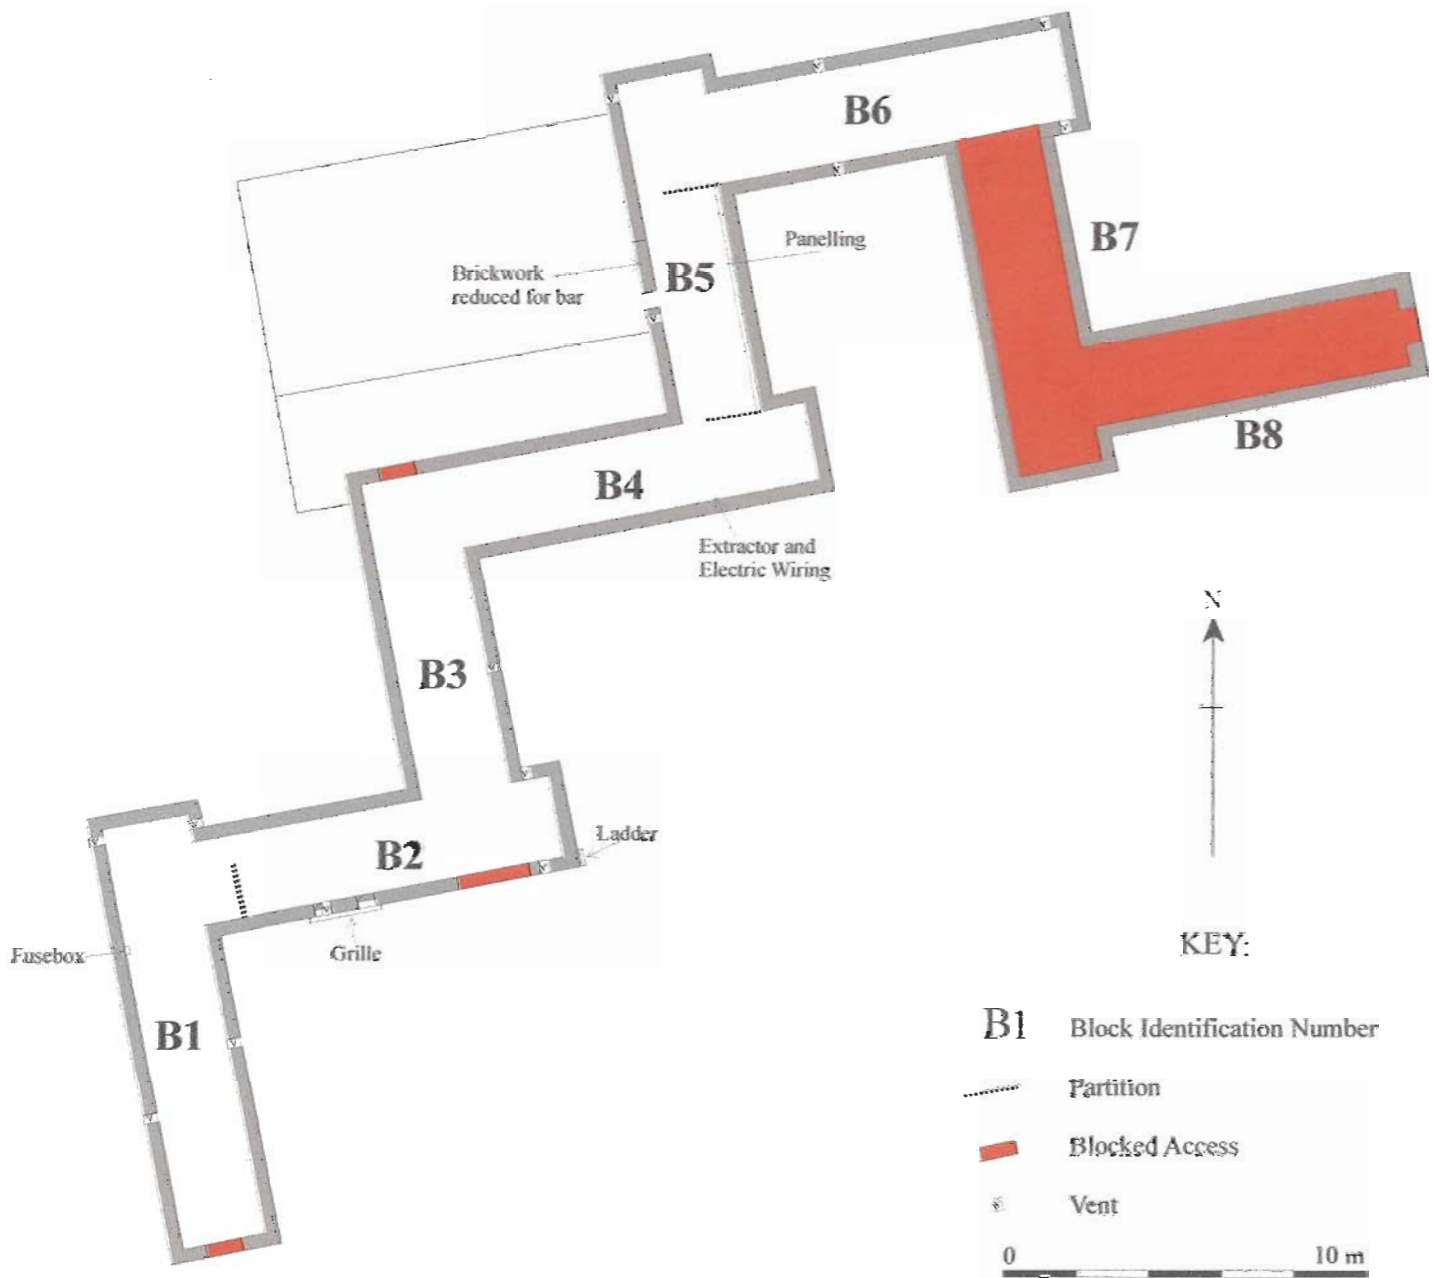
Figure 2: Location of Features and Blocked Access

A ladder that had originally provided access to the roof was the remains of an original feature observed on the exterior of the building (location shown on Figure 2). The remains were in poor condition, but the substantial bolts used to fix the vertical and horizontal members together had survived in good condition (Plates 5b and c). The ladder comprised timbers 0.10 m by 0.09 m in section. The maximum width of the timbers was 0.46 m and height was 0.88 m. There were originally three rungs, but the central timber was missing. The rungs were set 0.30 m apart and were fixed to the vertical members with iron bolts. The bolts were very substantial: 0.20 m in length, 0.04 m diameter head and 1.5 cm diameter shaft. Iron ties were fitted behind the rungs to strengthen the ladder. The ties were fixed with 1.5 cm square headed bolts at either side and the tie itself was 0.73 m in length. The base of the ladder had been set in concrete

A modern modification to the structure was the creation of a wider entrance to allow equipment to be stored with ease. A double sliding door was fitted on the south face of block B2 (location on Figure 2). This door was a later addition, the edges were the bricks had been broken through to create the access had been finished with a cement render (Plate 7). The door measured 1.97 m wide by 1.89 m in height, and was situated 1.35 m from the east end of the block. In addition to this, a further modern feature had been added to the building in the form of an extension abutting the west side of B5, demolished prior to the survey. This extension appears to have provided a toilet block and a bar facility: for the latter, a portion of the original shelter wall had been reduced to half its original height.

The majority of the internal fittings were recent in origin, the result of alterations to turn the shelter into a storage facility suitable for holding sub-aqua and boating equipment. Straps were fixed to the walls and storage shelves fitted. The early internal features comprised electrical apparatus. Light switches, a heater, fuse box and the remains of a makeshift extractor were still *in situ*. In addition the vents visible from the exterior had been fitted in the interior with hinged iron covers over the square holes in the brickwork. The covers could be opened to varying degrees or closed as required. The vents were situated in the locations marked on Figure 2 and were part of the original construction.
