# **BUILDING RECORDING**

# THE SAW BARN, MANOR FARM, CHURCH STREET, HAMPSTEAD NORREYS, WEST BERKSHIRE

JMHS Project No: 1967 JMHS Site Code HMMF 09

## **Building Recording**

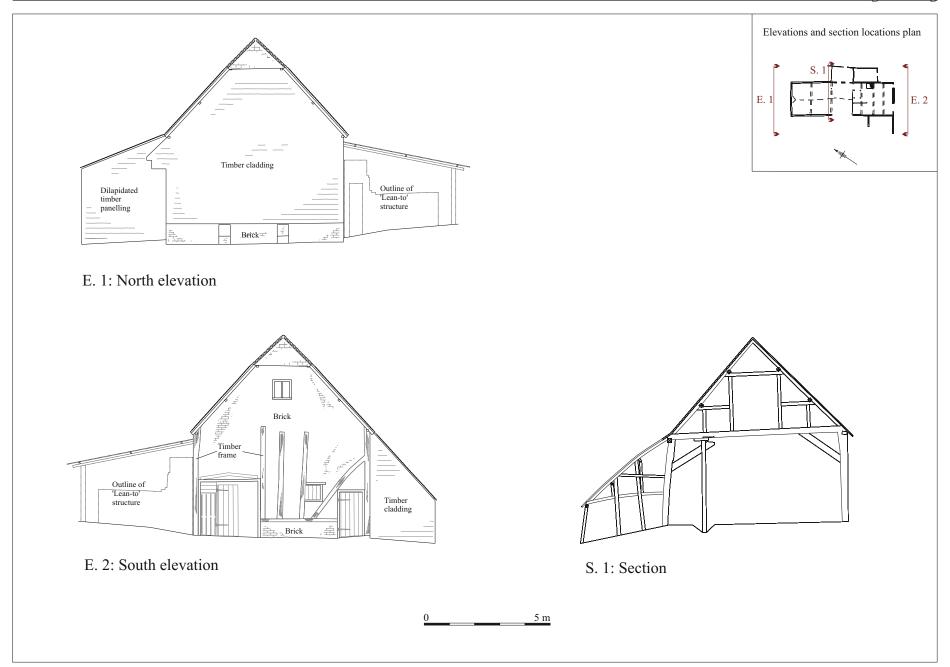
Figure 3. North and south elevations and section of Saw Barn

The north façade of the barn is a hipped gable end with a brick dwarf wall surmounted by a timber frame with external weatherboarding (Fig. 3, plate 2). The wall plates protrude under the eaves. On the left side of that façade it is apparent that timber framing and a section of weatherboarding continue thus indicating that the Ordnance Survey maps for 1877, 1899, 1912 and 1974 were correct in that the aisle or lean-to structure on the side did previously extend along practically the

The south façade is a hipped gable end (Fig. 3, plate 4). It is predominantly constructed of brick in predominantly a Flemish bond fashion. The external truss posts survive but parts of their associated framework have gone. Inside each of the two truss posts at ground level are the remains of two doorways. The one on the east side is narrow with a plank door with wooden frame. On the west side there is a wider doorway with part of a plank door and wooden frame. Above this door is a poor attempt at a segmental arch decidedly lacking in its execution. Between the doors are the remains of a sill beam. Other surviving timber frame features include a brace between the sill beam and east post and three stud posts. There is a small part of the tie beam showing also. Below the hipped roof there are the remains of a mullioned timber window.

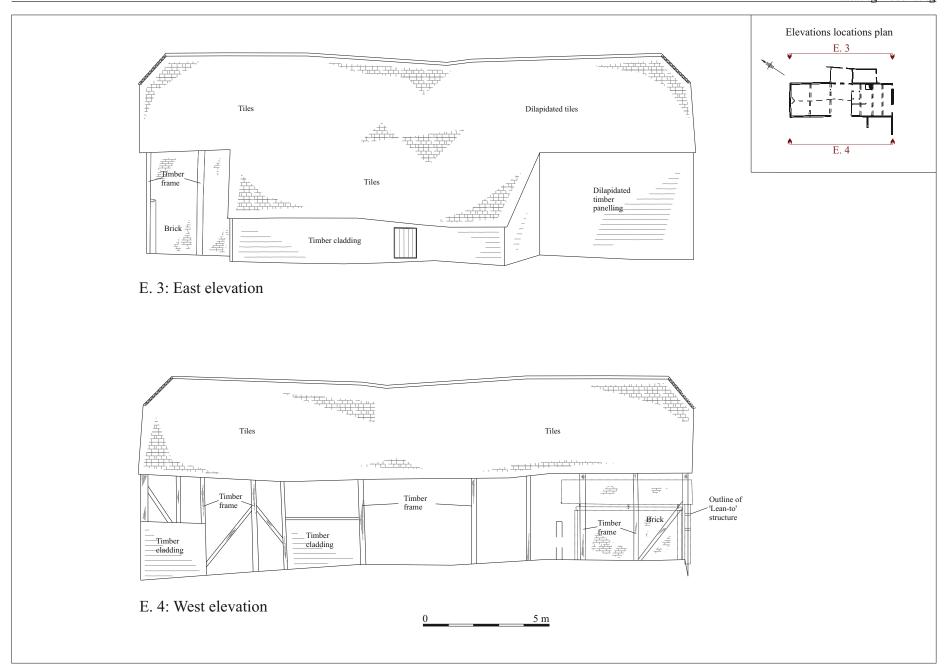
Figure 4. East and west elevations of Saw Barn

The west façade of the building is the main elevation; it contains a large central opening; the central one of five bays (Fig. 4, plate 1). This is the original barn opening. The wall to the north of that consists of a brick dwarf wall with a timber sill beam. There are the remains of two bays on this side. The main posts forming the box frame truss are braced in the side walls, with each panel having three upright stud posts, some of which cross the bracing timbers from the sill beams. This produces an Eastern English panelling tradition called vertical panelling. This wall would previously have been covered with weatherboarding, but most of this has now gone. On the south side there are a further two bays, which appear wider. A brick dwarf wall is evident here also, but the surviving timber frame has less surviving members. There are three beams supporting the truss and two middle stud beams. The wall (if it can still be called that) is in a bad state of repair, the wall plate is visible that supports the base of the frame for the roof over which is a red clay peg tile hipped roof.

The east façade of the saw barn consists of a number of different components (Fig. 4, plate 3), although from the evidence this is only a recent result. The northern two bays of the main building are now visible with the remains of a dwarf brick wall on which a sill beam is located. There are a number of timber uprights including the main posts in the trusses and a number of stud posts. The weatherboarding is particularly fragmentary here, but does continue under the wall plate and eaves.

The central section of the east elevation shows the side aisle with as a low timber framed wall with weatherboarding. The timber framing extended into the ground and it is for this reason that it is beginning to rot and then slump.

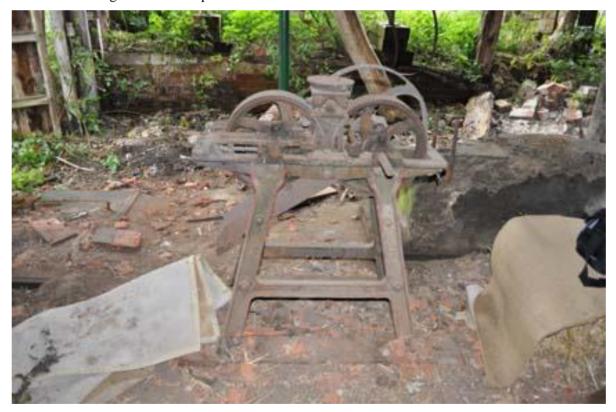
Plate 11: Machinery Spout Floor

The ground floor ceiling or first floor is supported by five transverse beams, supported on a number of upright posts. There are joists between these. There is a wooden set of ladder stairs on the east side located centrally on the ground floor (Spout Floor), which enters the first floor though a trapdoor (plate 12). There is a further trapdoor located centrally. At the north side there are two compartments that contain part of the gear mechanism for turning the mill stone (see below, plates 9-10). In the central area there is a large block of concrete with bolts, and a piece of iron machinery (plate 11) that turned the belts that would have driven the gears to rotate the mill stone.

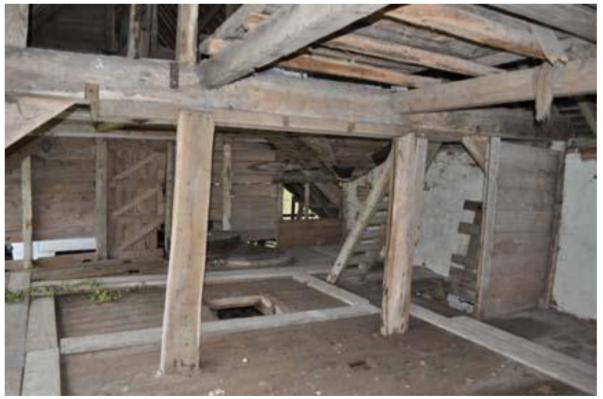
Plate 13: Stone Floor of the mill

On the first floor (Stone Floor) the walls are on the same construction as below, though it should be noted that the tie beam on the south wall is fully visible internally. The floor-boarding of the first floor extends across the whole area. There is a pair of mill stones located in the central northern part of the floor (plate 13-14). The trapdoor from the steps up lies on the east side, there is a further trapdoor located centrally. This appears to be in line with another trapdoor in the ceiling above. Four further holes of an unknown purpose are evident in the floor (square cut not rotted). Also by the east wall are some wheat feeder funnels (hoppers) to provide the wheat for the mill. Adjacent to the steps up from the ground floor there is a further set of narrower ladder steps extending up to the third floor. The second floor (Bin Floor) is also supported by transverse beams (tie beams), with posts, but this time there are only three with the bay to the south of the central bay of the barn containing the floor. On the south side of this bay there are wooden troughs constructed above the grain feeders, and in the central part a large fly wheel (plate 16). In the southern bay there are two axial beams that support a walkway to the mullioned window inserted in the south wall (plate 17). The bin floor is located in the attic space (plate 15).
