BUILDING RECORDING

UPPER PARK FARM,

BECKLEY, OXFORDSHIRE

NOVEMBER 2015

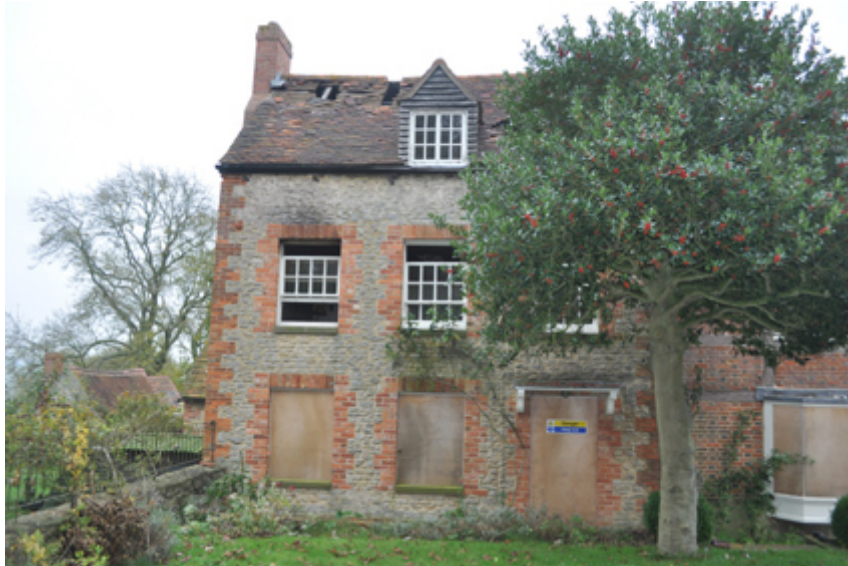
Plate 3: North side of the west elevation

On the north side of the front façade there is a two and a half story addition, which is of rubble stone with brick quoins (Fig. 11.E1, Plate 3). The bricks of the quoins are original and measure 215mm x 98-100mm x 52-55mm. The façade contains three bays. The main door is in the far right bay on the ground floor next to two eight over eight sash windows. The door contains a porch with a lead roof and with console supports. The bays and windows are echoed on the first floor with three eight over eight sash windows. The ground floor and first floor windows appear to have been reset evident by a different lighter brick surrounding them, which measures 228mm x 100mm x 70mm. There is a single course of red brick at ground level, and aligned to the ground floor and first floor windows there are lights to the cellar. On the left hand end there is the side of a gable end chimney that is constructed in limestone with brick dressing.

A tie beam is visible in the roof line on the front elevation. There is a small gable window in the roof with two windows of six panes, exterior walls covered in wooden cladding, no fire damage visible. The right section of the roof is badly fire damaged, though about ½ of the plain tiles still remain, on top of the charred rafters. Due to fire damage the support to the roof structure is compromised. At the level of the outer wall plate the tiles and roof appear intact up to the top of the dormer window frame. There is some smoke discolouration to the exterior wall above the windows on the first floor level.

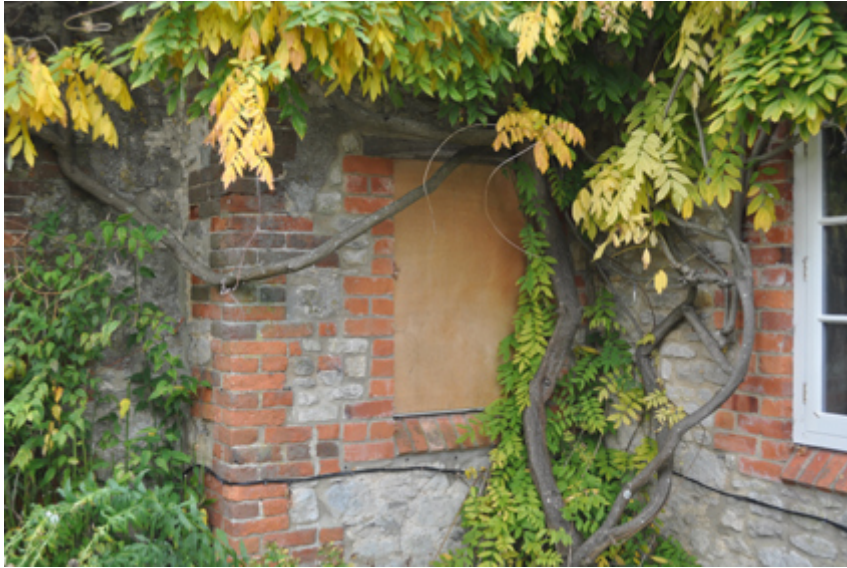
Plate 7: East elevation of Front Range

Beyond the south gable of the east elevation is the south part of the Front Range, which is the two storey timber framed structure (Plate 7). The brick wall is visible to the right of the south gable end. The Front Range also extends on the south side of the gable. Here the rear wall that is visible is constructed of limestone with brick dressing. On the ground floor there is a window. Extending on the south side of the building there is a gable end chimney.

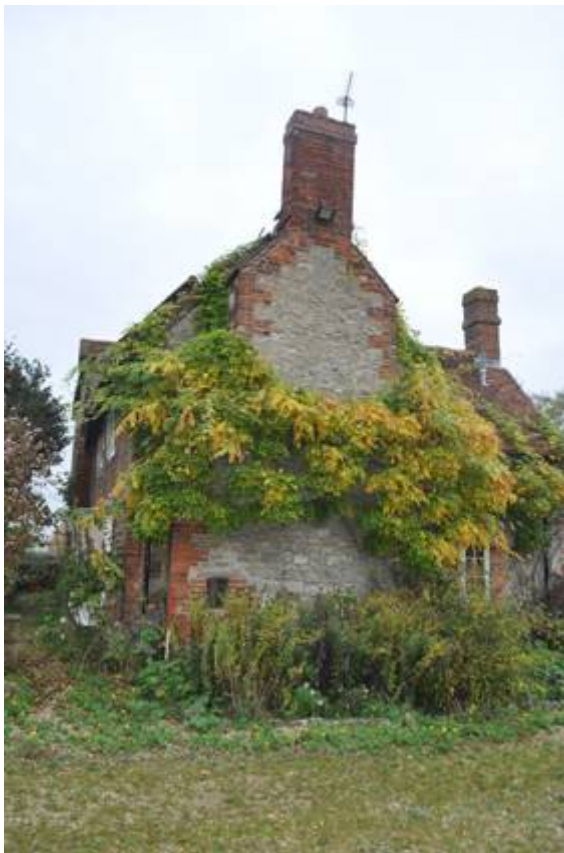
Plate 8: South gable end

The south gable contains three visible components. On the left hand side of the structure there is a two story gable end with projecting chimney stack (Fig. 12.E4, Plate 8). The wall is constructed in limestone rubble and red brick quoins. The chimney has two shoulders with tiled areas of run off and a water tablet. The brick chimney stack was probably remodelled in the early to mid-17th century, the brickwork is old, in places

deteriorated with small patches of concrete infill and the mortar lines are thin. Placed in the chimney stack to the left at ground floor level there is a small glimpse window, with a wooden lintel. The south elevation is largely obscured by wisteria which has grown across the width of the chimney breast and tall flowers grow up from the base of the building.

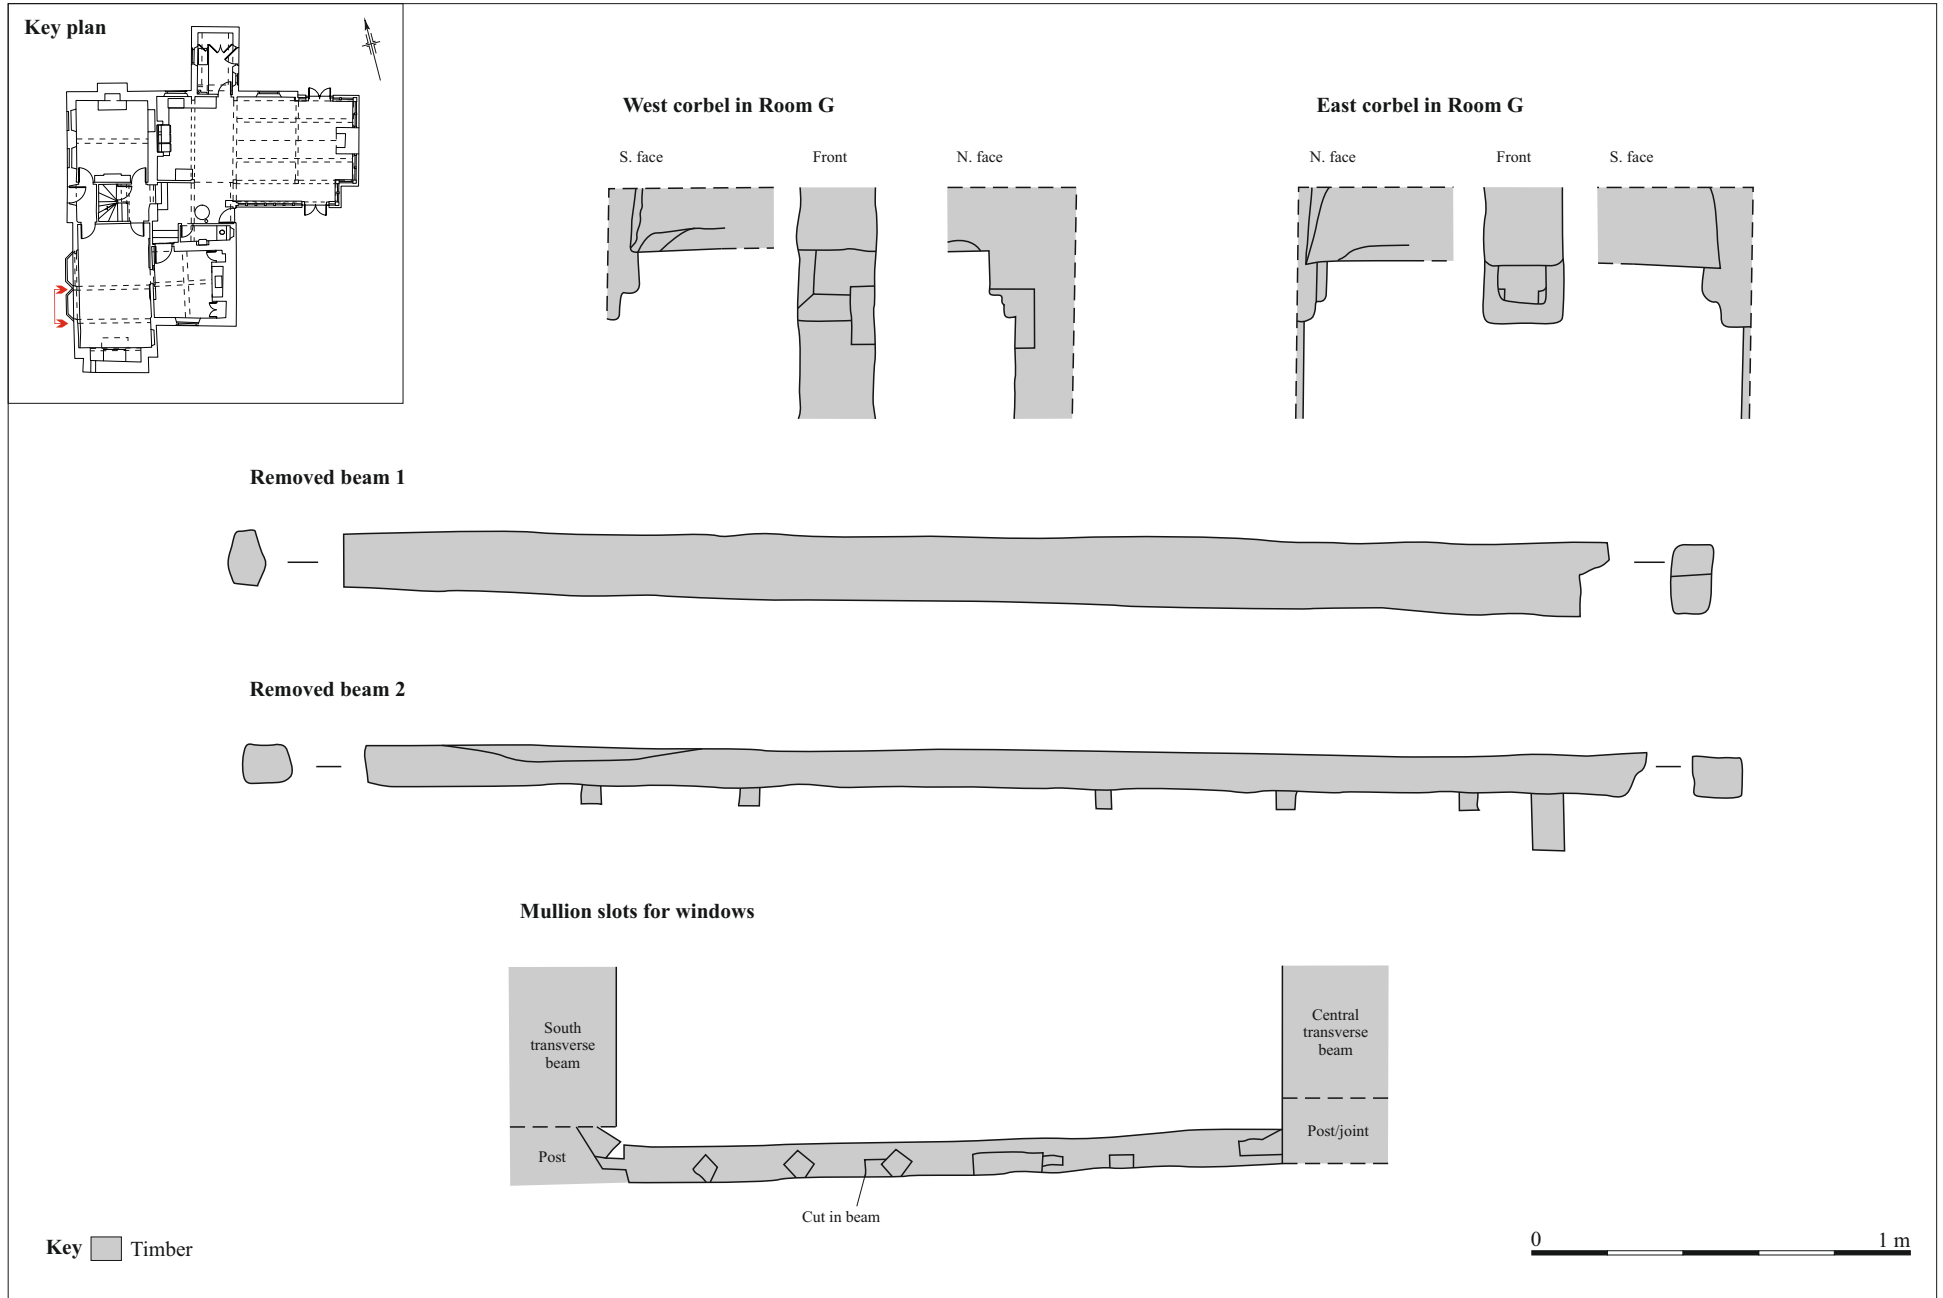
Figure 19: Timber details from room G5

saw cuts. The joists and ceiling is white painted, with the main beams left unpainted (Fig. 19, Plate 21). There is apparently a little water damage, as evident by the marks where the water has travelled through the ceiling cavity onto ceiling and beams.

The central transverse beam contains corbels and a chamfered beam (Figs. 17, 19, Plate 24). The corbel and lower portion of the post appear intact, but viewing from the right hand side (RHS) it is apparent that there is severe fire damage to the post's corbel on the east end. There is approximately 80mm of scorching into the 200mm depth of the post (DSA 2015); this damage travels above ceiling level and on the exterior of the axial beam and plate. Both the transverse beam and plate joining into the west frame are severely burned on the outer and inner sides.

This transverse beam is bowed in the centre and supported by two closely spaced props at the west end, a third centrally placed and a fourth at the east end underneath a historic vertical crack approximately 500mm from east end. This is pinned together with a fishplate, secured with three square headed bolts (still galvanised). There are two, one in the east and one in the west, wrought iron L-ties (no date) inserted into the posts and undersides of the transverse beam. The beam apart from the damage at the post junction in the west end has incurred little visible damage to the underside. There appears to be an upper transverse bearer, which has sustained some fire damage, on the west end along the top and some area in the first floor of the doorway at the east end.

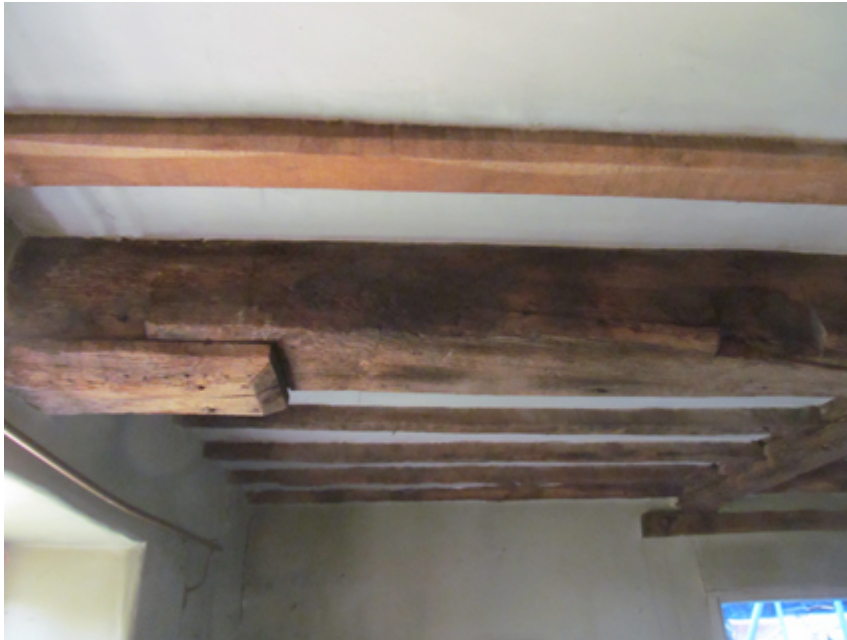
Plate 16: Ceiling timber in G4

The ceiling contains revealed joists, original north - south tiebeam plain stops with two notches cut at equal distance into the length of the southern portion (Plate 16). This would suggest that the beam has been relocated and reused, though probably as part of the original build. There is also a wooden rectangular plate attached to the underside of the beam on the eastern stop; the beam may be damaged underneath but if so the plate hides the damage. The eastern half timbers have been completely replaced with new timbers, probably 20th century. The floor consists of flag stones, possible of original date. There appears to be no fire damage in the dining room.

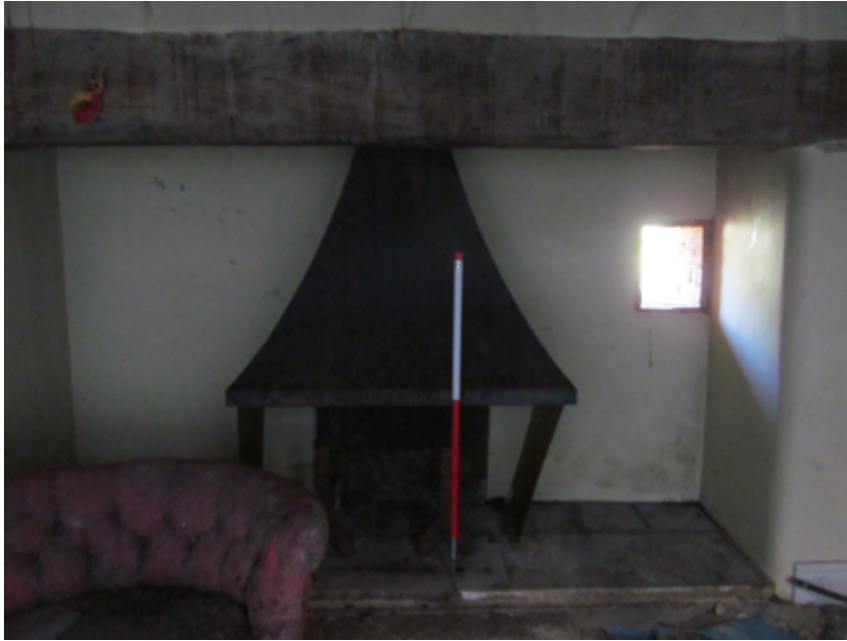
Plate 18: Fireplace in G5

The south wall contains a large inglenook fireplace approximately 0.75m deep and 1.5m in height with heavy bressumer beam overhead, cast iron chimney hood over fire grate and a glimpse window on right side wall of inglenook fireplace (Plate 18). This wall is

structurally sound and is to remain, there are no plans to produce this drawing as it is not to be touched.

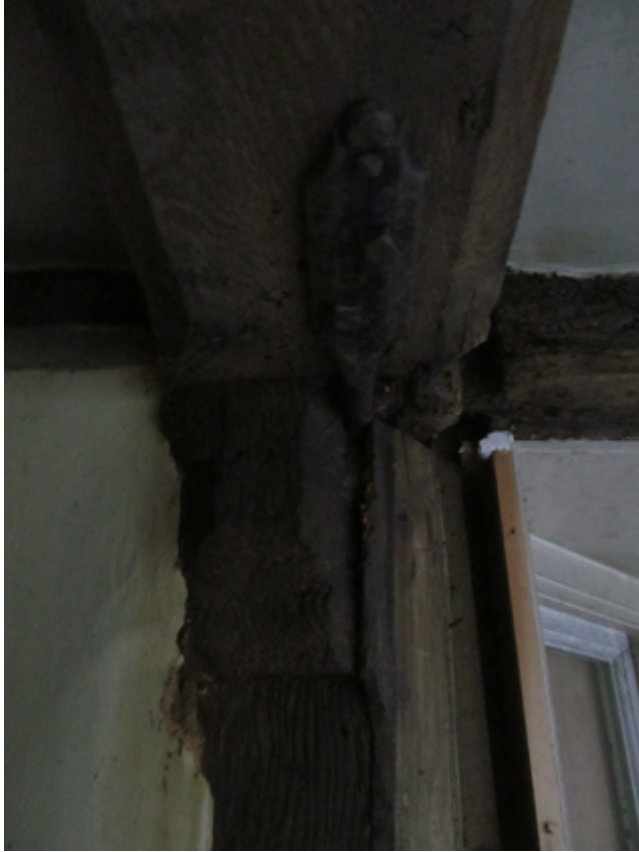
Plate 22: West south corbel

The southern transverse beam does not have any decoration at the stop on the western end. The western post has a corbel, supporting the transverse beam (Fig. 19, Plate 22). There is a historic wrought iron L-tie (no date), three iron pins inserted to the underside of the transverse beam connecting into the corbel, probably to stop the beam failing and provide extra support to the jowled head where it may have deteriorated over time. The transverse beam is chamfered symmetrically along its length, with a number of small square cuts into the beam and the remains of a narrow mortice joint in the eastern end of the beam. At the eastern end of the axial beam there are historic repairs to the beam using two scarf joints, a newer section extends from the wall providing support where the beam has suffered rotting. A built wall and not a post support the east end of the axial beam.

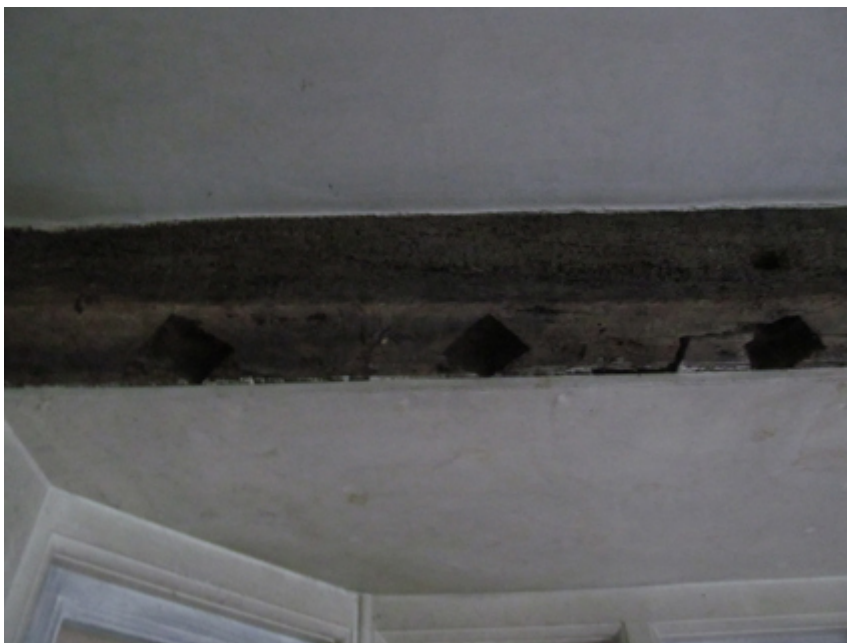
Plate 23: Cuts for mullions

Located between the southern and central transverse beam there is a joist directly in front of the bay window that has three square shaped cuts into the underside (Fig. 19, Plate 23). These could be the location for diamond shaped mullions, which are a primitive feature of Tudor architecture. There is a brief period of time from 1539 to 1567 when these features were used and the windows were essentially unglazed (McCann 2010). Examples have been recognised at Vale Farmhouse, Frostenden and Rose Brook Cottage, Little Warley.

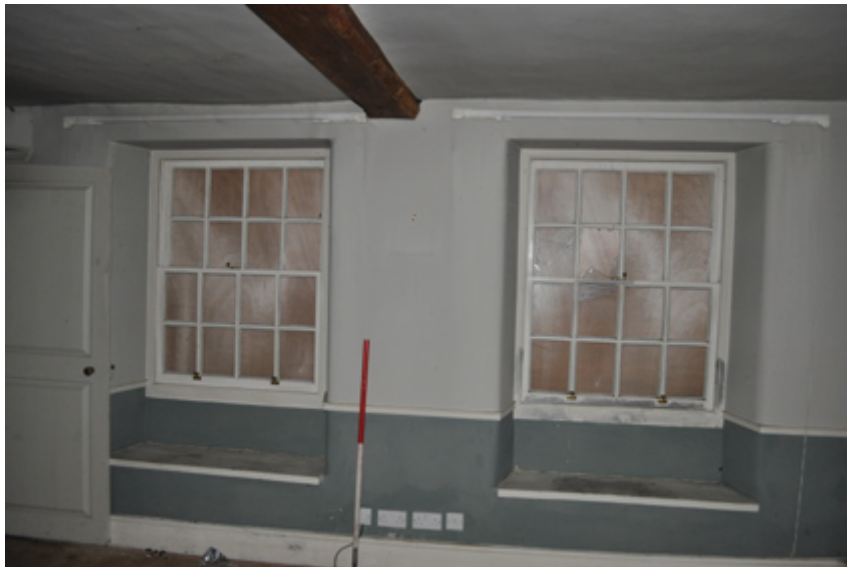
Plate 25: Windows in G6

The study (G6) has a dado rail around three of the walls, deep skirting board and no cornice (west, north and east walls). The west wall (Fig. 14.E5, Plate 25) has two eight over eight hung sash windows, with window seats beneath (boarded and all lights apart from one are intact). The north wall contains a modern centrally placed ornamental scrolled fireplace about 1.25m in height which houses an open fire containing an iron firebox, concrete base and tiled hearth (Plate 26). In the northern section of the east wall there is a sealed off window cavity containing four shelves (Fig. 14.E6). The south wall contains doors at both ends (Fig. 15.E7). The two-panelled timber doors are probably original. The doorframes are original, and slightly bowed under the weight of the upper floors towards the centre of the room, this is also echoed in the ceiling which has a shallow curve in the centre. On the whole of the south wall there is built-in shelving to the top half and cupboards to the lower half; this is a modern addition.

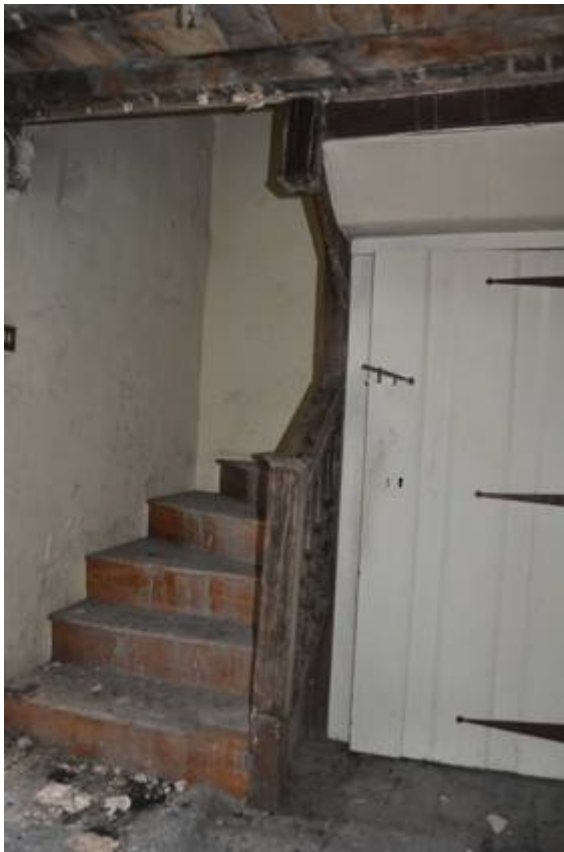
Plate 27: Stairwell at ground floor

there is a door leading into the lounge (G5). On the west side there is the main stairwell that contains a dogleg staircase rising two floors and ending in the attic space (Plate 27). There is a midrail timber in the wall between room G7 and room G6 the study. The timber line is uneven and looks aged.

The decorated newel post, turned balusters and carriage of the staircase are original; at the ground floor there is some trace of rot and aging as with the second floor junction on the newel base and balusters (Plates 27-28). The carriage of the steps rising up to the first floor landing appears to be an old piece of timber that has suffered some decay. The stairs are mentioned in the Historic England building listing, and as such it should be assumed that the referred to sections are original. When viewing the underside of the stairs from inside the cellar, there are machine cut timbers used to make the runners and risers at ground floor-first floor level, as well as a view from the first floor landing where the stair

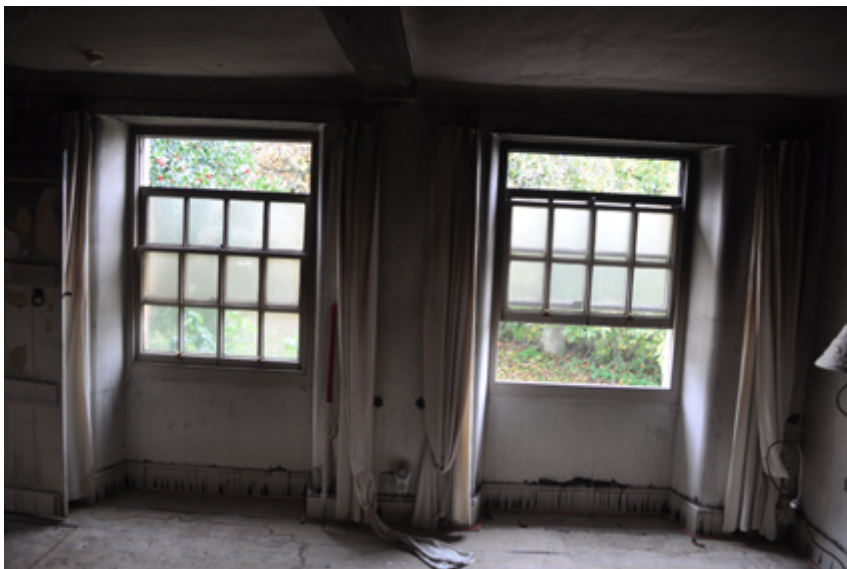
Plate 30: Windows in F1

Bedroom F1 contains high skirting boards approximately 150-200 mm deep, and rounded off walls. In the south wall there are two doors (Fig. 15.E7). Some cornicing can be seen around the top of the room. This would need closer inspection to determine its age, as there is a lot of smoke damage. The west wall has two windows which are 20th century eight over eight double hung sash windows (Plate 30). The north wall has a blocked up

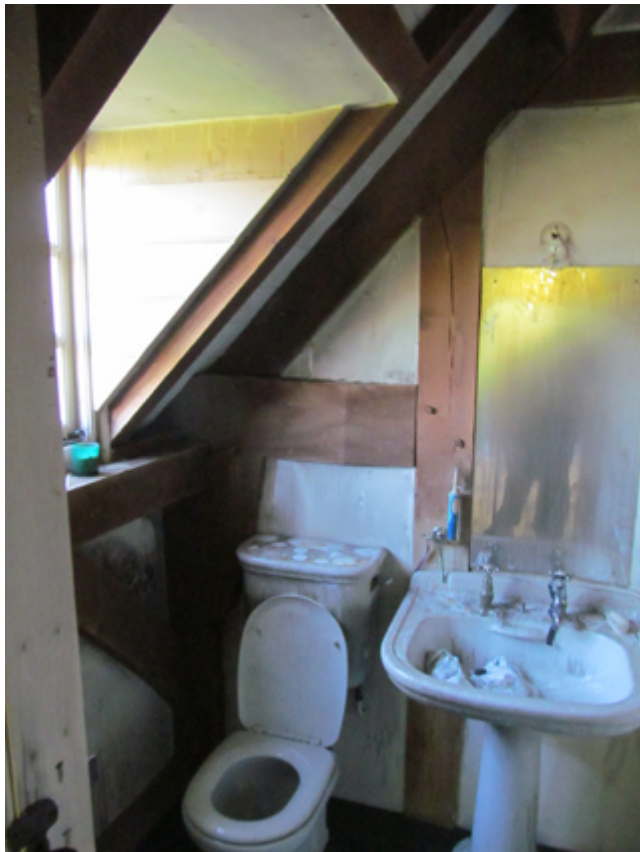
Plate 31: Timbers in F1b

The en-suite room F1b is a small room entered by the door in the east wall of room F1. The room is constricted by the eaves on the north side and entered by two steps down. In the north wall are revealed rafters, and a centrally placed dormer with a four light casement window inside, a wooden sill and arched brace beneath (Plate 31). On the east wall there is a queen strut and interrupted collar. This is a modern extension built in 1993, there appears to be smoke damage to the room but no fire damage. The fittings are 20th century.

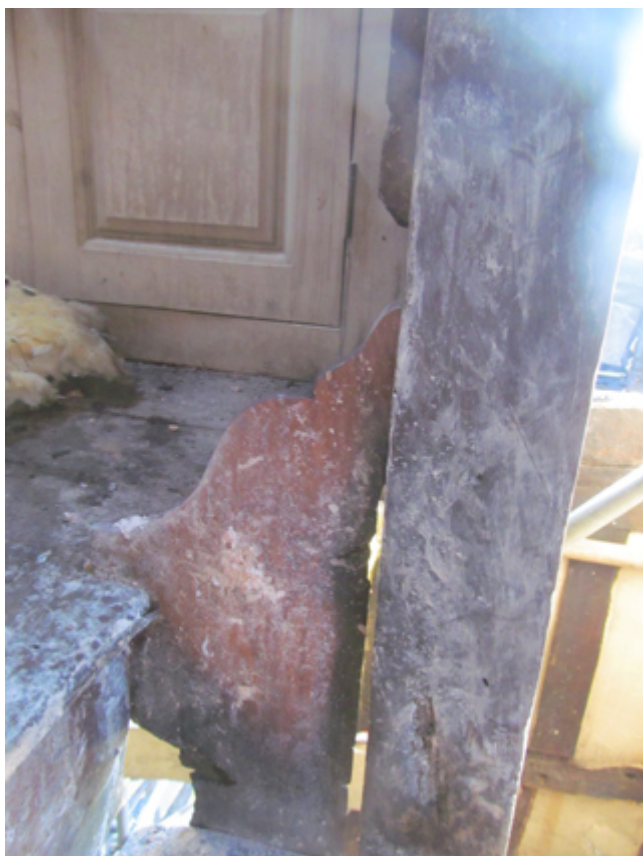
Plate 38: Backplate on stairs

At the top of the stairs between the final tread and floor level there is a decorative carved plate, a red wood which has been attached as a separate piece onto the side of the staircase, possibly serving as a backplate to the stair and covering space between the tread and riser (Plate 38).

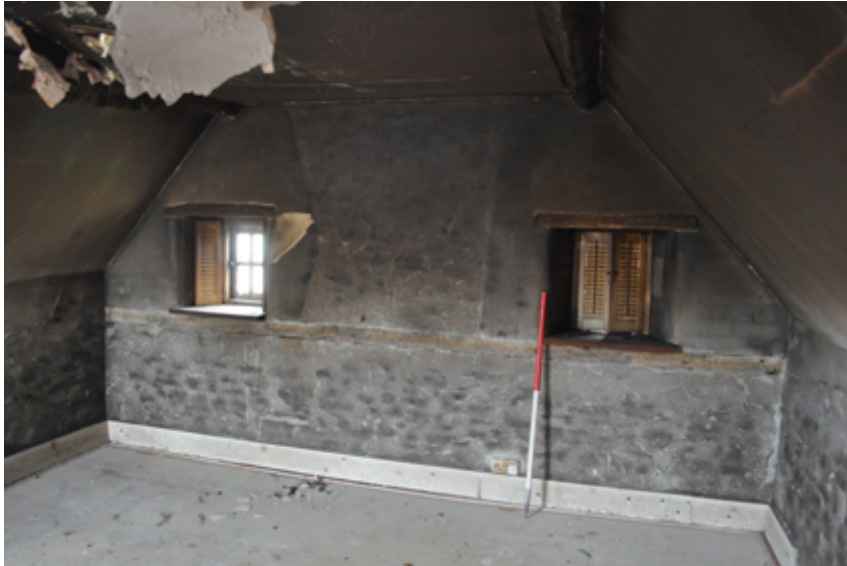
Plate 39: North wall of A1

The main attic room (A1) is set within the roof space. There is approximately 1m wall height before the line of the eaves reduces the headroom. In the south wall there are two doors one on the east side and the other on the west (Fig. 15.E7). On the west side (Fig. 14.E5) there is one dormer with casement, two times eight pane windows, another smaller single light casement window sits in the north façade. There is an original plate beam which runs below the casement window, the beam is an irregular shape suggesting it is not machine cut. This is probably a timber used in the 17/18th century construction. The north wall has two windows located either side of the chimneybreast (Fig. 15.E10).

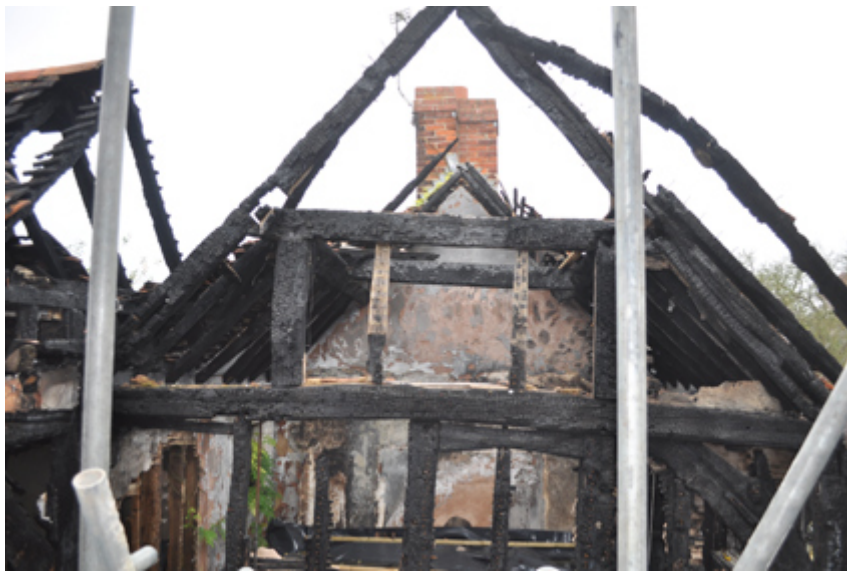
Plate 41: Central truss

The attic area of the room above part A (room G1) had a stone south wall, and timber framing in the north wall. The central truss looks like a queen post truss with collar beam and tie-beam (Fig. 17, Plate 41). There are two smaller struts internally to the queen posts. In the south part of the structure there is a truss simply with a collar beam and tie-beam.
