JOHN MOORE HERITAGE SERVICES

**ADDENDUM TO  
BUILDING RECORDING  
ON  
UPPER PARK FARM,  
BECKLEY, OXFORDSHIRE  
NGR SP 57246 11417**

**MARCH 2016**

## **ADDENDUM: UPPER PARK FARM**

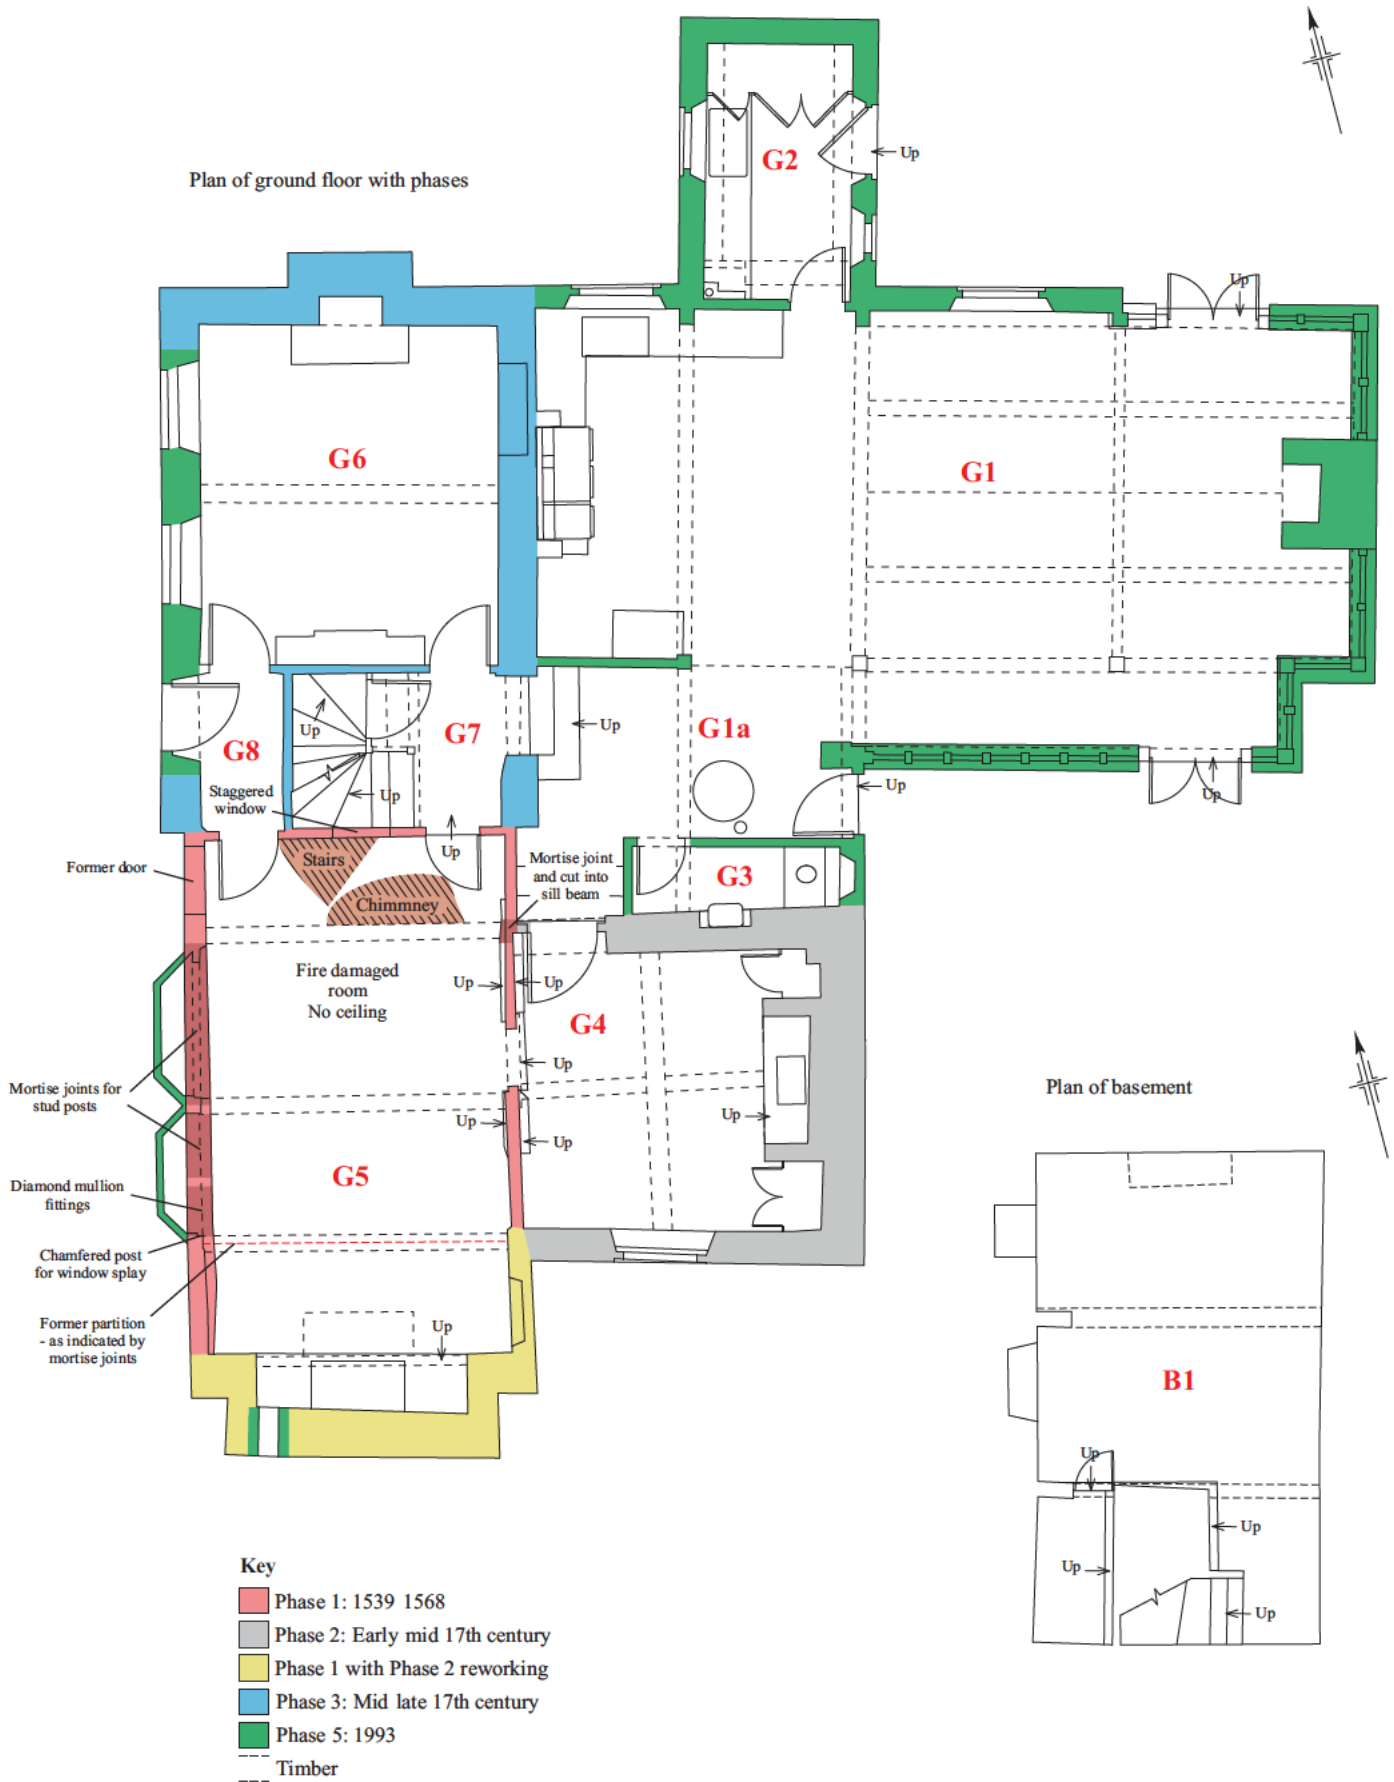
Figure 20: Basement and ground floor plans

This is an addendum to the report produced on Upper Park Farm, and contains a reworking and clarification of points raised by the Conservation Officer for South Oxfordshire District Council. These alterations concern reworking of parts of section 3 and 4 that concern the development of the 16<sup>th</sup> century structure. Observed features have been noted on the following plans (figures 20-21)
