**HISTORIC BUILDING RECORDING AND WATCHING
BRIEF**

SCHEDULED MONUMENT NO: SM OX 182, HE 1006329

THE BULLCROFT, HIGH STREET,

WALLINGFORD, OXFORDSHIRE

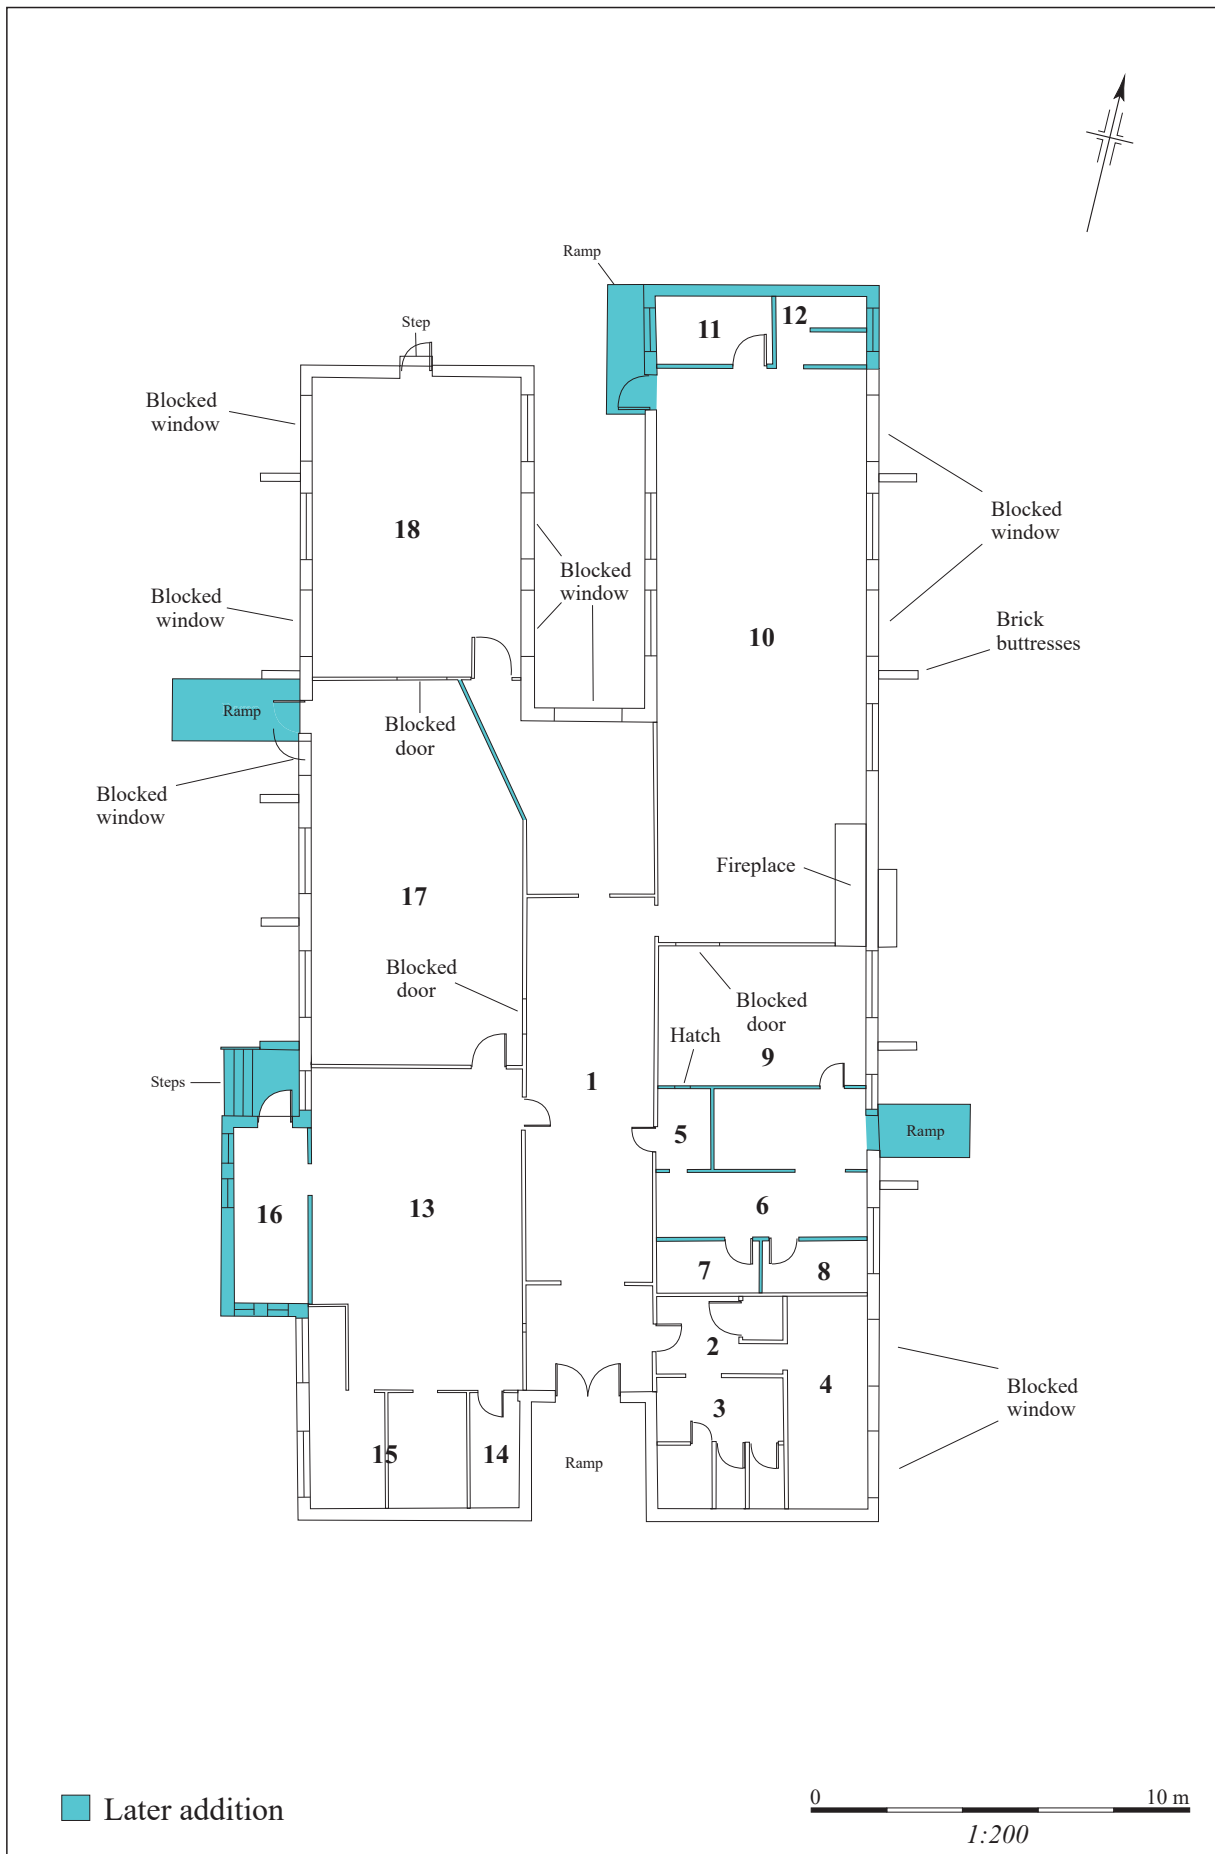
Figure 3: Plan of The Recreation Rooms

Internally the three blocks are divided into a series of separate rooms. The central block, which contains the main entrance to the building at its southern end, forms a central corridor from which the eastern and western blocks are accessed (Plate 9). The corridor, Room 1, provides access to Rooms 2, 5 and 10 in the eastern block and Rooms 13 and 18 in the western block. The ceiling in the central block (Room 1) is a later suspended plasterboard ceiling while the walls are plasterboard.
