**HISTORIC BUILDINGS ASSESSMENT**

**THE OUTBUILDING TO THE REAR OF  
76 HIGH STREET, LONG CRENDON,  
BUCKINGHAMSHIRE**

**February 2008**

**JMHS Project No:** 1896

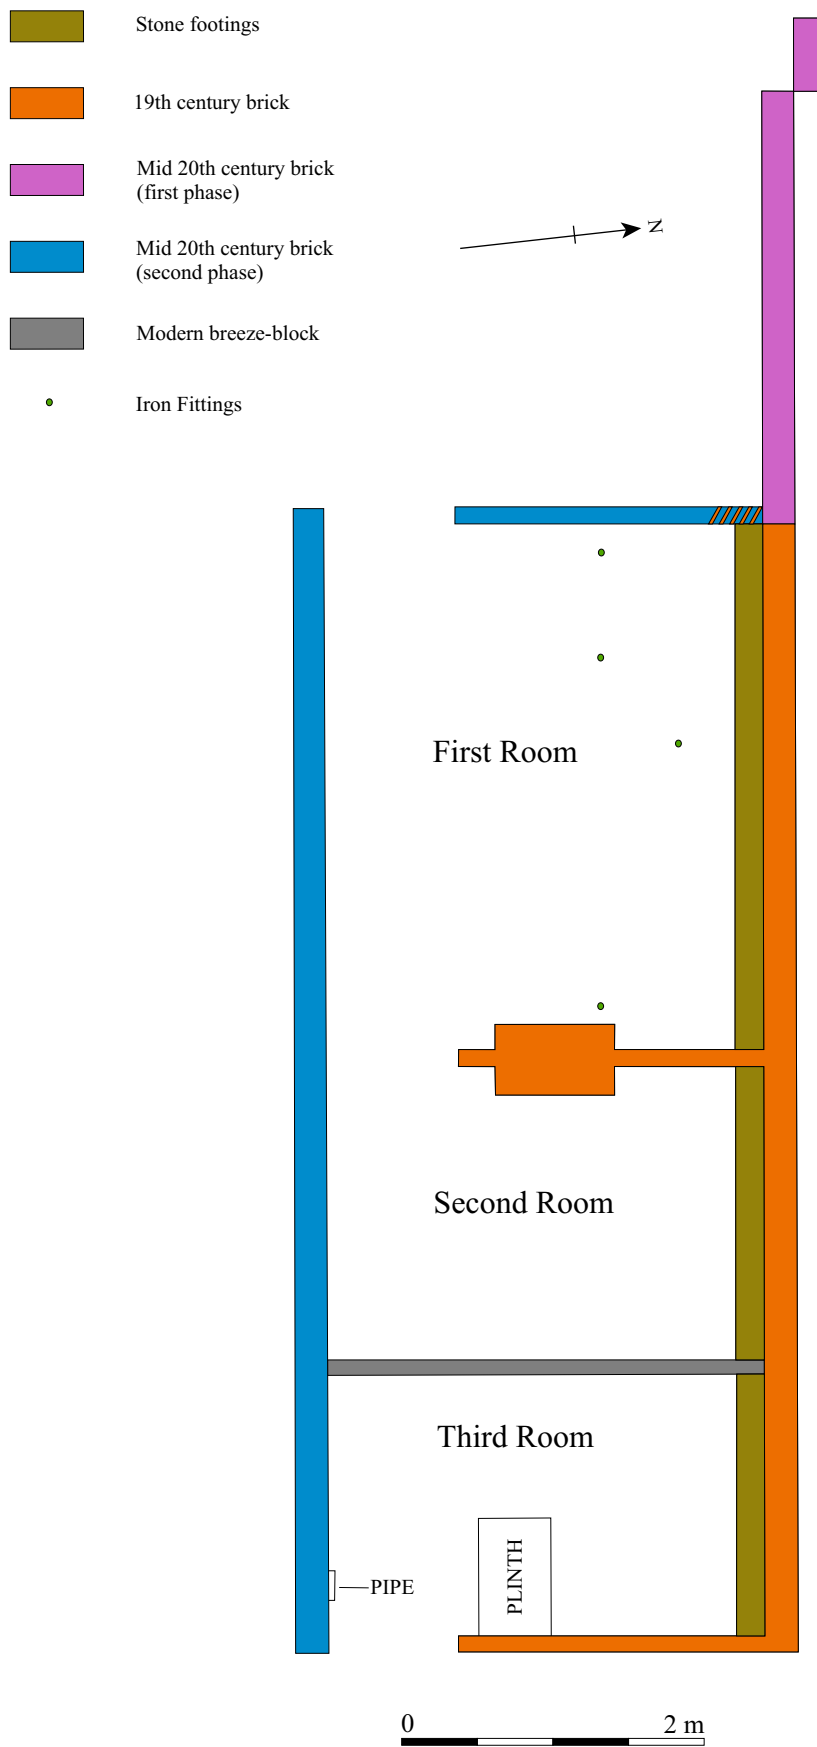
Figure 2. Annotated Plan of Building

The interior is at present divided into three rooms. The western door leads into the first room which in turn leads into the second. The third room is reached via the eastern door (figure 2).

An internal wall divides the first room from the second. This is clearly bonded into the fabric of the northern wall. It displays a thickening to accommodate the back of a fireplace.

The upper four courses of bricks on all three of these walls are recent additions with the three courses below these showing signs of being relayed and repaired.
