Archaeological Building Recording
at
OLD MOAT FARM HOUSE
STOKE MANDEVILLE

Buckinghamshire

K A Rodwell
for
JOHN MOORE HERITAGE SERVICES

September 2008

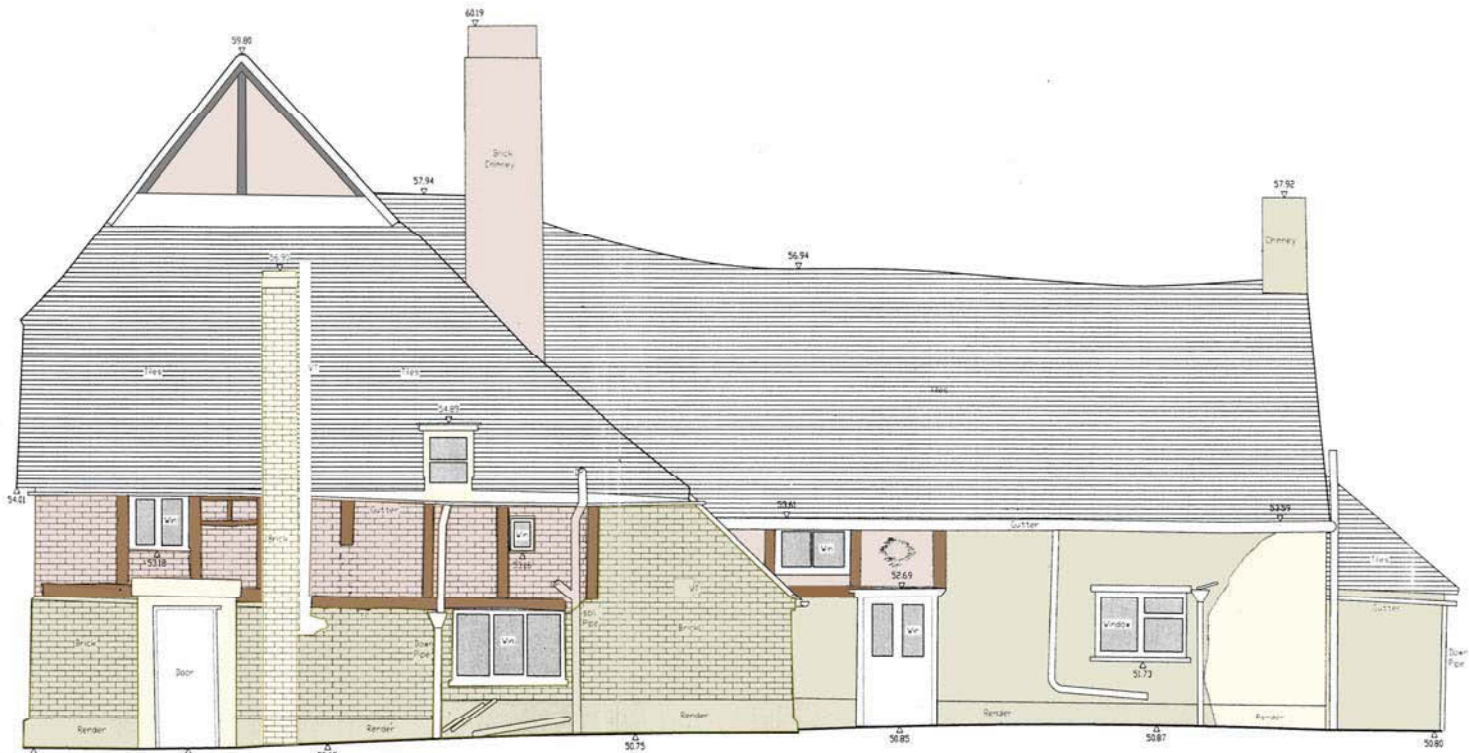
North East Elevation

The north-west elevation of the adjoining wing is single-storied and wholly brick-built under a deep catslide roof. This build returns onto the adjoining north-east elevation where it underpins a timber-framed extension to the main cross-wing. This is a two-storied range with a hipped roof which has exposed timber framing infilled with thin bricks at first floor level. Butted onto the underbuilt brick ground floor there is a projecting porch and a chimney stack of 20th century date.

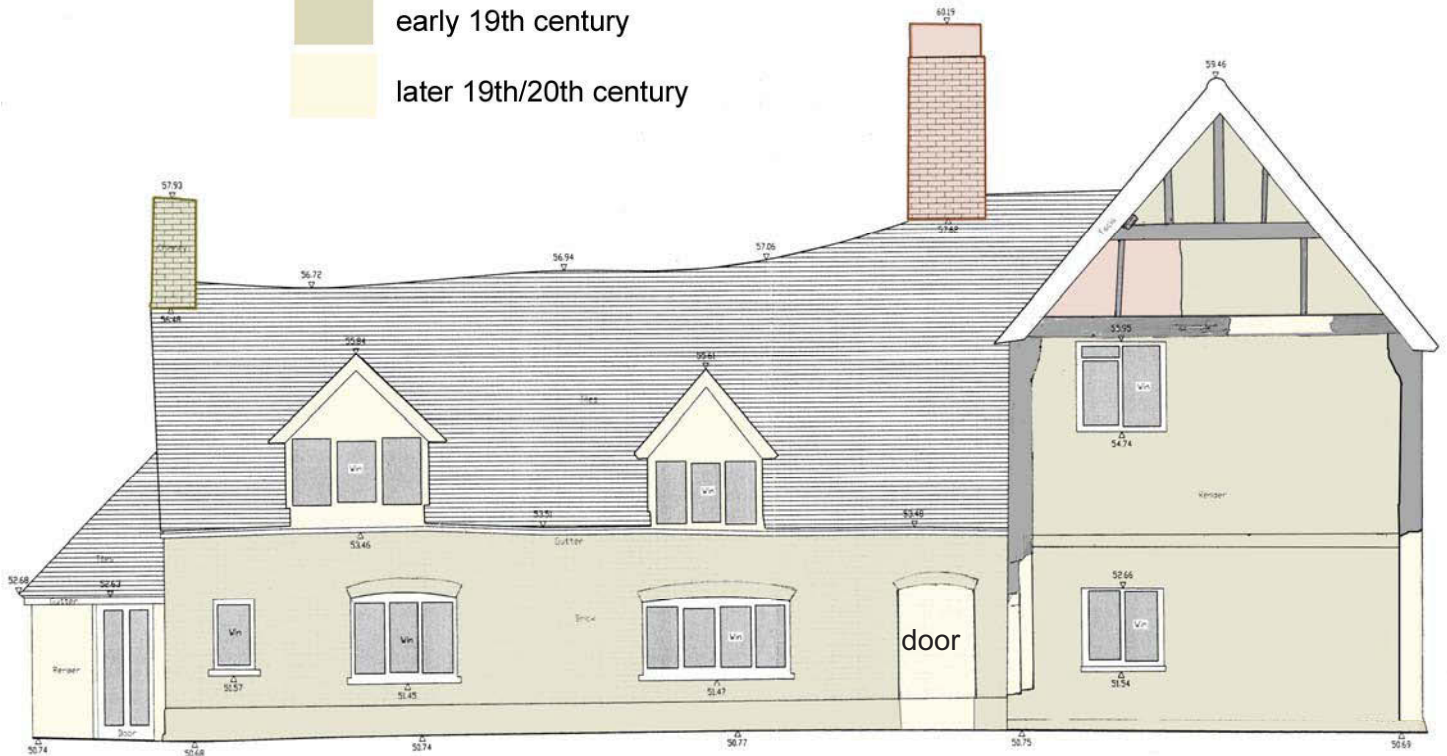
South West Elevation

Rendering was also stripped from the south-west gable wall of the wing. The corner posts were indicated by decayed voids packed with bricks at ground floor level but survived in poor decayed condition at first floor level and had jowled heads. The tie-beam was also very decayed and was partially patched in modern brick. Two extant studs linked the tie-beam to the collar and the position of another was indicated by differential brick infill. There were three further studs in the apex of the roof above the collar. The wall below the tie-beam was rebuilt in brick in English bond with a course of edge-set headers at storey height; some of the brick panels in the gable were of the thinner older type.

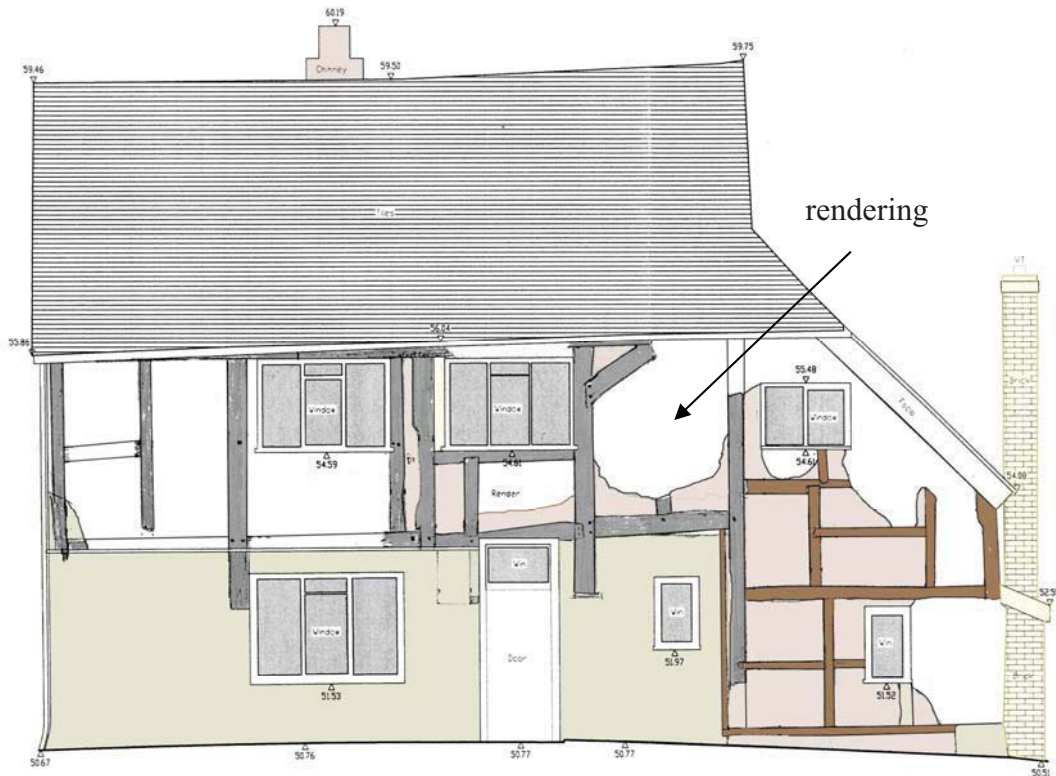
South East Elevation

The south-east elevation of the cross wing and its extension was cement-rendered throughout and has a near central door with an irregular pattern of 20th century three-light casement windows.

Building Works – modern rendering was stripped from the south-east elevation to expose timber framing infilled with brick; the poor condition of the underlying wall meant that some patches of render could not be stripped from the brickwork in advance of repair work, although the frame was exposed. The ground floor of the wing was wholly rebuilt in brick but the framing survived at first floor level; this included the mid-rail, five posts forming four bays, the wall plate and one brace. There are two 20th century windows at this level; one has an extant rail forming the

cill, the other has mortices for a missing rail and a separate stud forming the northern jamb which suggests that this is a historic window position. The timbers were generally in poor decayed condition, particularly the south-west corner post which was heavily eroded. The north-east corner post survives to nearly its full height and has the slighter secondary framing to the outshot butted against it. This was probably brick-nogged from the outset as the bricks are thin, often vitrified and mainly laid as stretchers.

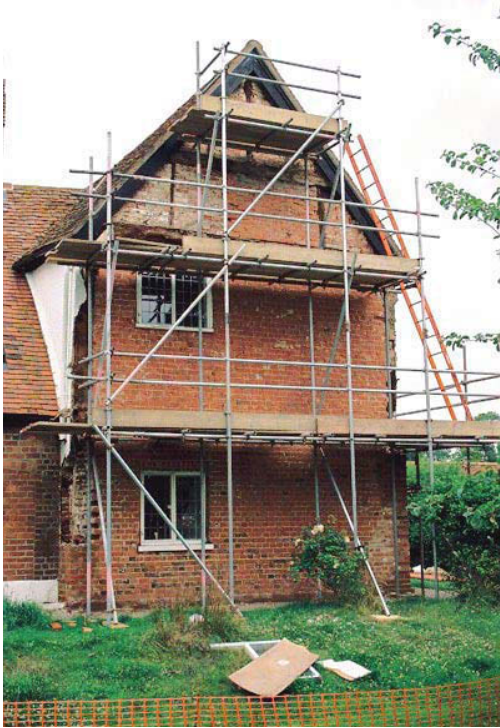
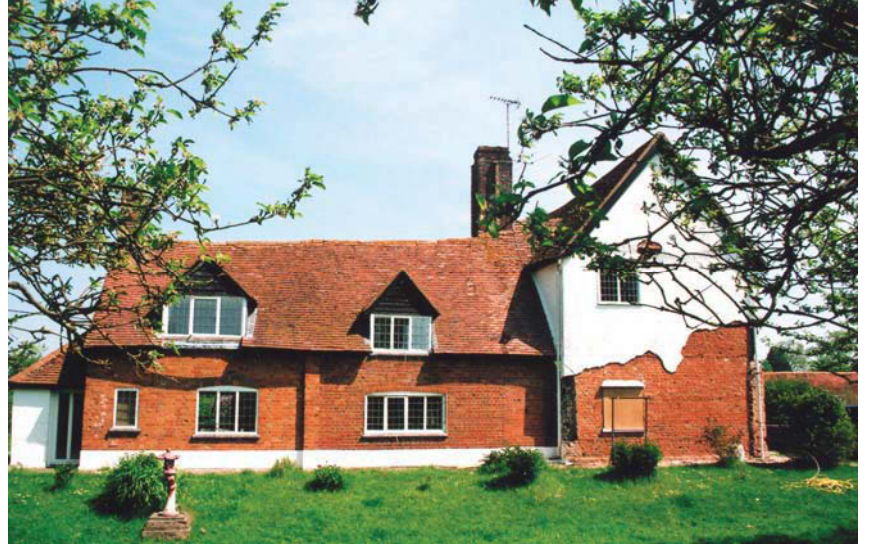
Fig 5 Exteriors
(clockwise from above)

- South-west elevation with rendering partially stripped from wing
- North-east elevation
- View from the north
- North-east elevation to wing
- South-west elevation, wing detail; jowled NW corner post & tie beam
- South-west elevation, wing detail; NW corner post void
- South-west elevation with rendering stripped from wing
