A Historic Building Survey  
of Farm Buildings  
at  
HOME FARM, ISLIP ROAD,  
BLETCHINGDON  
OXFORDSHIRE

K A Rodwell  
for  
JOHN MOORE HERITAGE SERVICES

July 2009

**A HISTORIC BUILDING SURVEY OF FARM BUILDINGS**  
**AT**  
**HOME FARM, ISLIP ROAD, BLETCHINGDON, OXFORDSHIRE**

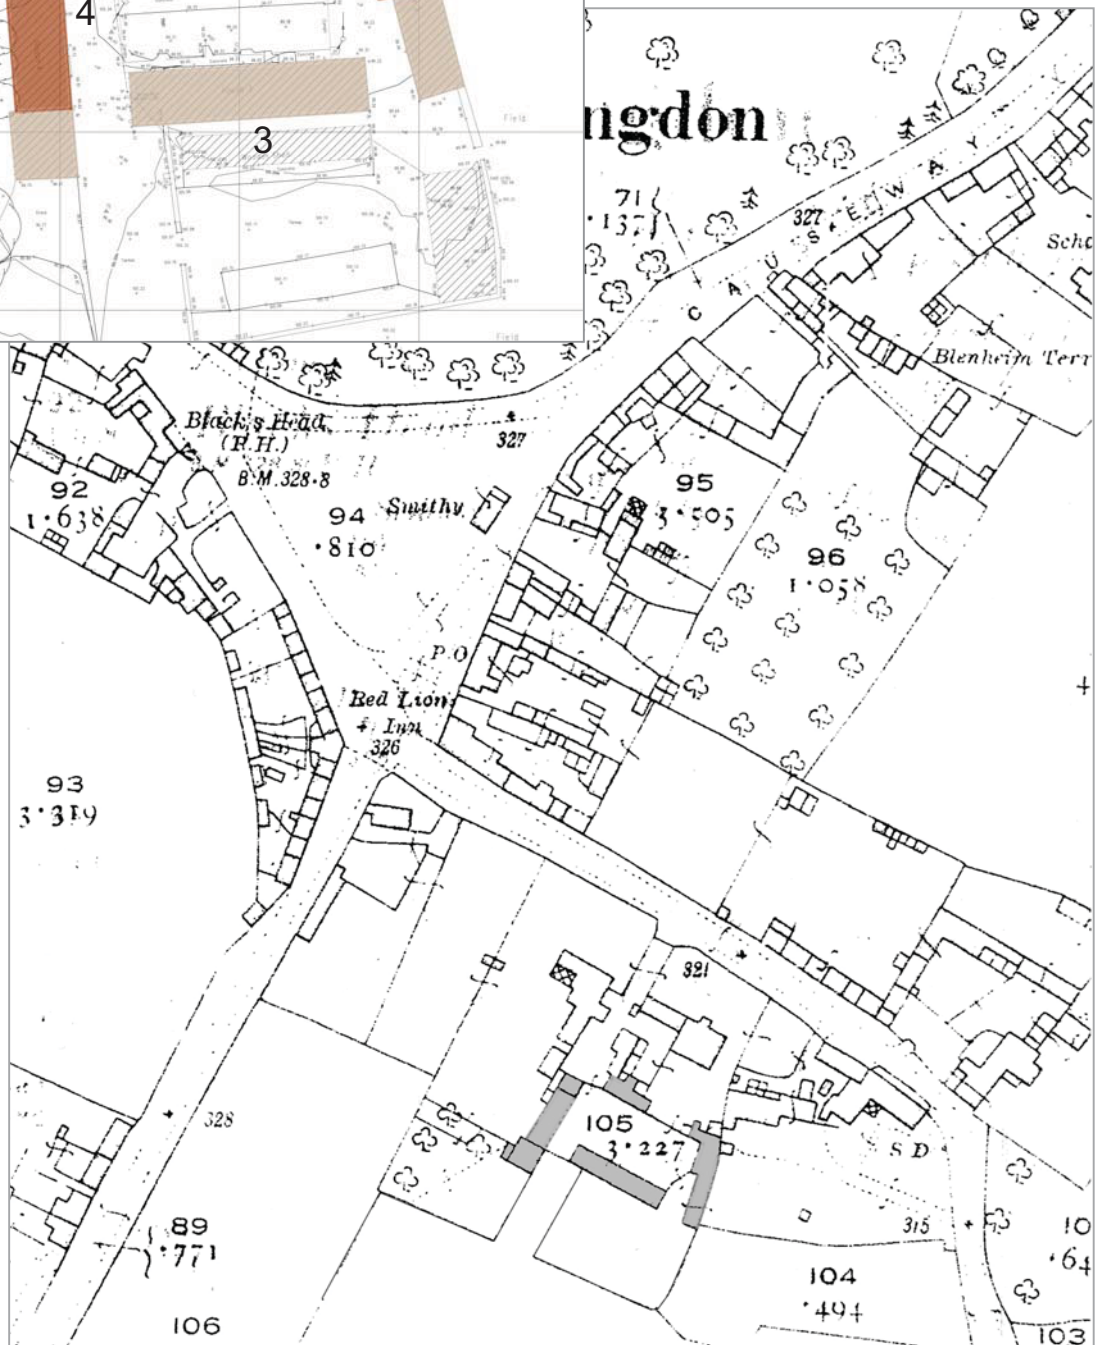
**Fig 2**

The buildings are all plainly constructed without closely dateable features and several have lost their original roofs. However the first phase of construction probably dates to the later 18th or early 19th century (Fig 2). This includes the main part of building 2 (raised in the 20th century), the open-fronted section of building 4, which appears originally to have been at least one bay longer, and the north end of building 5. The fragmentary earlier phase of building 3 may also date to this time.

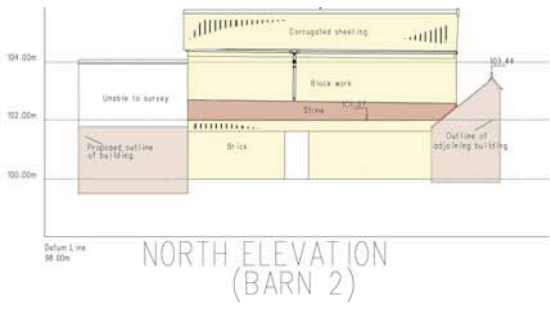
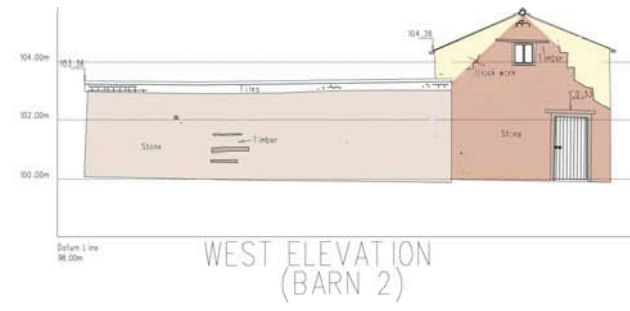
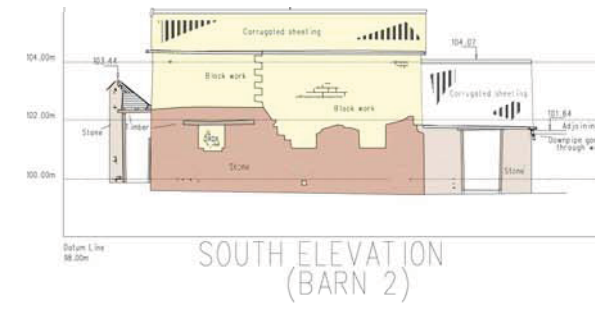
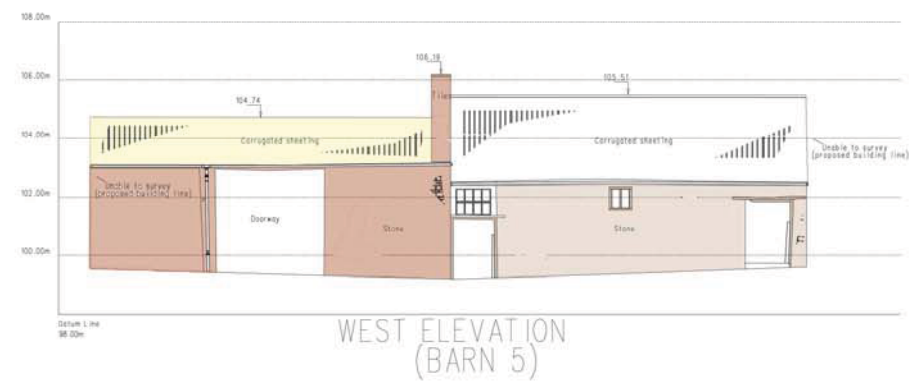
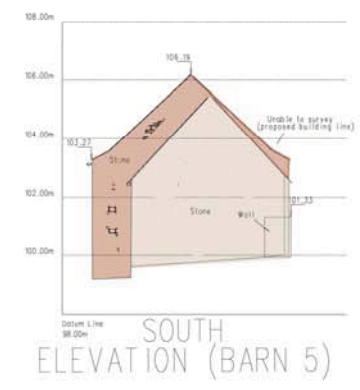
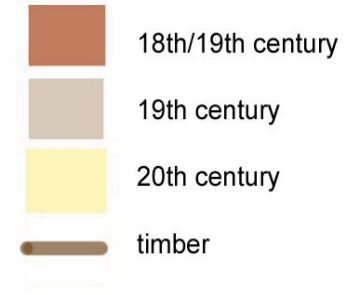
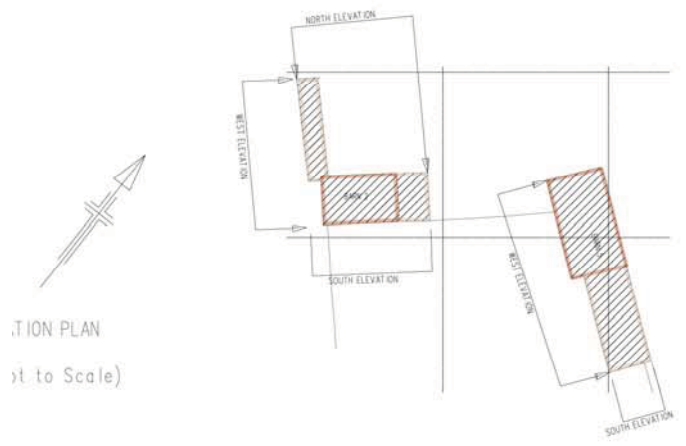
**Fig 3 Buildings 2 & 5**

**Building 2** (Figs 2-3, 6). This is set on the north side of the yard with the west gable wall adjoining the entrance. It is built of random rubble and originally had a steeply pitched roof with low eaves which have been raised in blockwork; PH 1951 is

inscribed in cement mortar at the apex. There is an original door with a pegged frame and a gable light under a long wooden lintel. Above the door is a line of joist sockets probably for a lean-to roof. The south elevation originally had three windows, all infilled with blockwork when the wall was heightened; one retains its lintel. The interior of the main building repeats the structural sequence visible externally and has a pitched limestone floor with a drain. The inserted upper floor and the roof are modern.

**Building 5** (Figs 2-3, 10). This is set on the eastern boundary of the yard and is in two sections. The southern unit is the later and is built of more regularly coursed rubble with a full-height doorway at the north end, a smaller door at the south end and a high-level window. There are no openings in the south and east walls. Internally it has three original roof trusses, probably elm, of pegged construction with substantial tie beams and slighter waney collars, two tiers of purlins halved over the principals and a sequence of chisel-cut carpenters' marks. The rafters are contemporary with the corrugated asbestos roof. The floor is concrete and there are two concrete block stall partitions.

The northern unit is constructed of thinner greyer rubble and is three bays long with a wide central cart door in the west wall; this has a concrete lintel. In the opposite wall there is a smaller doorway with a wooden lintel; this has been blocked in brick and concrete and has a pair wooden shutters. The roof is corrugated asbestos on 20th century angled steel trusses at a lower pitch than the original; the south gable wall survives to its original height. There is a brick floor and paired pens of concrete blockwork in the end bays.

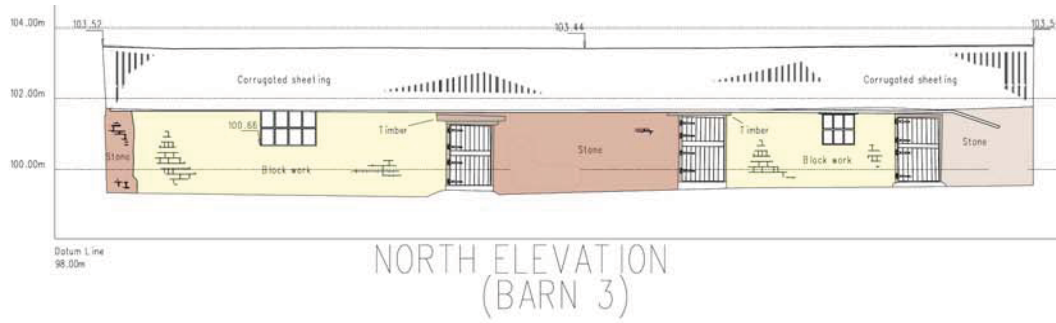
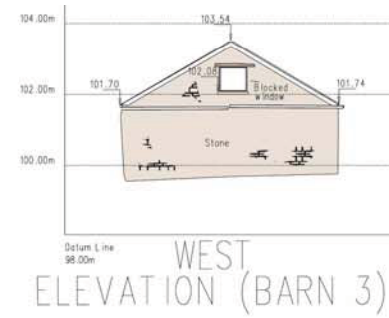
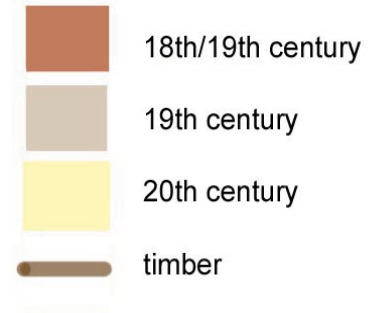
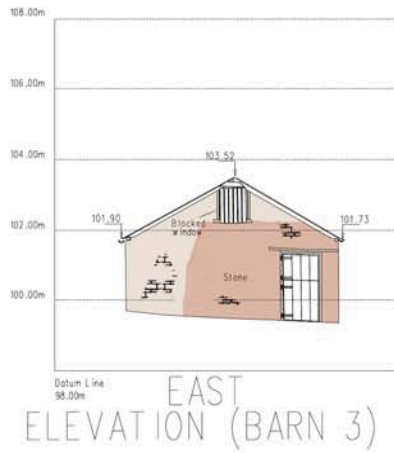
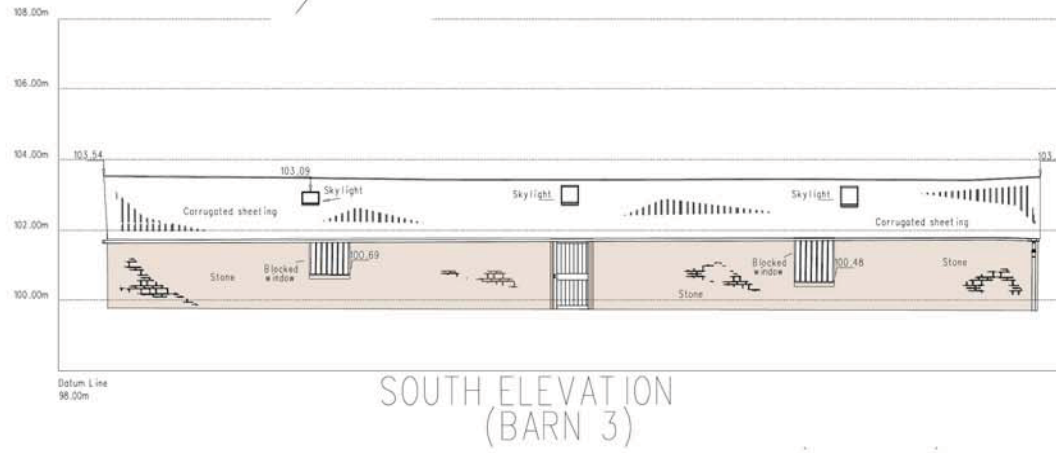
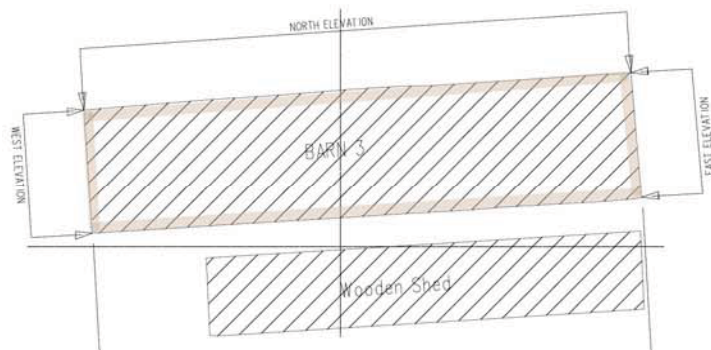
**Fig 4 Building 3**

**Building 3** (Figs 2, 4, 7-8). This single-storeyed building is set across the southern side of the yard and is free-standing with open space to the south. It is constructed of coursed and roughly squared limestone rubble set in soft brown mortar and has a corrugated iron roof. The south wall is of uniform construction with a central door and two evenly spaced windows; these have pegged pine frames and secondary yellow brick cills; the door is boarded. The east gable wall has two builds; the south end and apex are like the south wall but the remainder is random rubble with a door at the north end. The quoin of the north wall is also random rubble but the majority of this elevation is concrete blockwork. In the centre there is a length of random rubble walling between two doorways and the west end beyond a third door is also rubble. The split boarded doors have pegged pine frames of 19th century type and pitched

limestone paving externally. The west wall is coursed rubble throughout with a gable light.

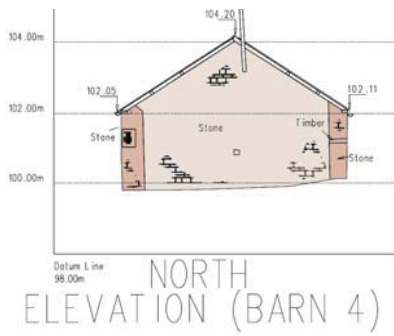
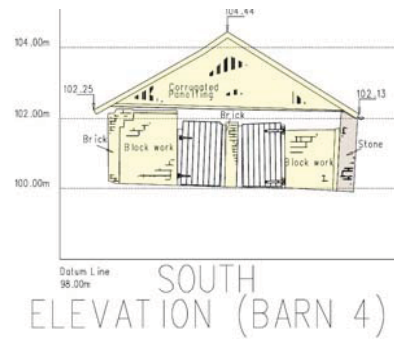
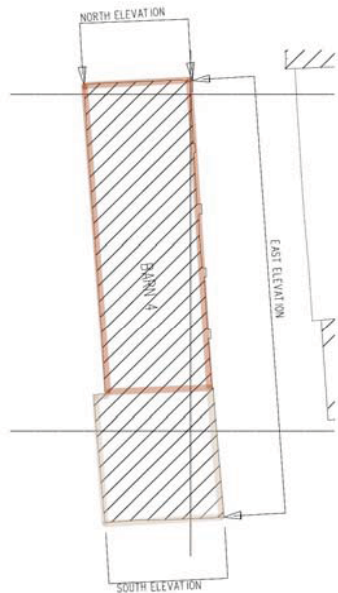
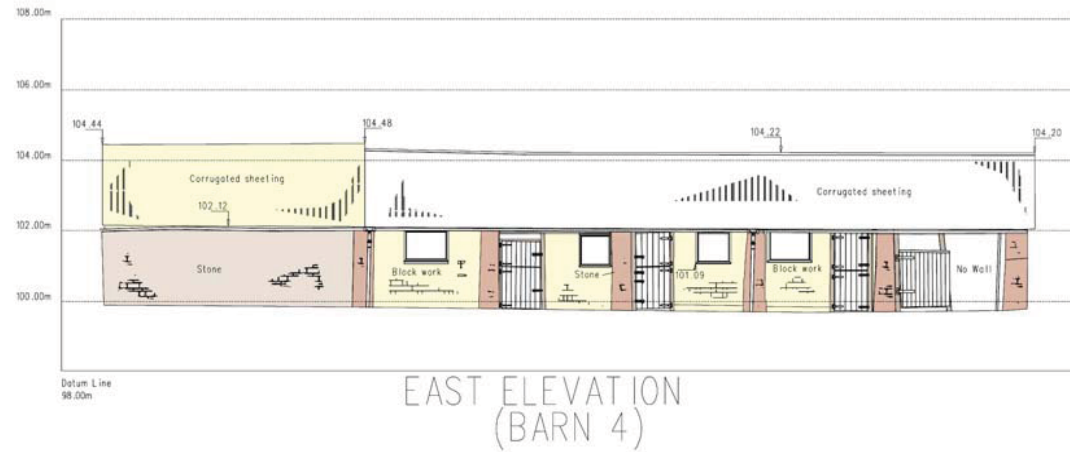
**Fig 5 Building 4**

**Building 4** (Figs 2, 5, 9). This is set on the western boundary of the site and is single-storied. The main part is five bays long and was originally open fronted with square rubble piers, now infilled with concrete blockwork. The west wall is plain rubble and there is a corrugated iron roof. The north wall is rubble but is infilled between the back wall and a pier, indicating that the building was originally longer. Internally it is divided on the bay lines by concrete block partitions and has roof trusses of machine-sawn pine with nailed diagonal struts and edge-set purlins. One of the compartments has a blocked opening in the west wall which has had a stone trough inset. This was fed by a square-headed lead pump with a spout and foliate ornament in low relief. Other units have blockwork mangers built against the west wall.

The south end is later and consists of two deeper bays originally open to the south with a coursed rubble east wall and a west wall partly rebuilt in brick. The interior is

divided longitudinally by a brick wall in English bond; this is not full height. There is a modern corrugated steel roof and trusses.
