NUNHIDE FARMHOUSE SULHAM BERKSHIRE

An Architectural Investigation

IMOGEN GRUNDON

September 2011

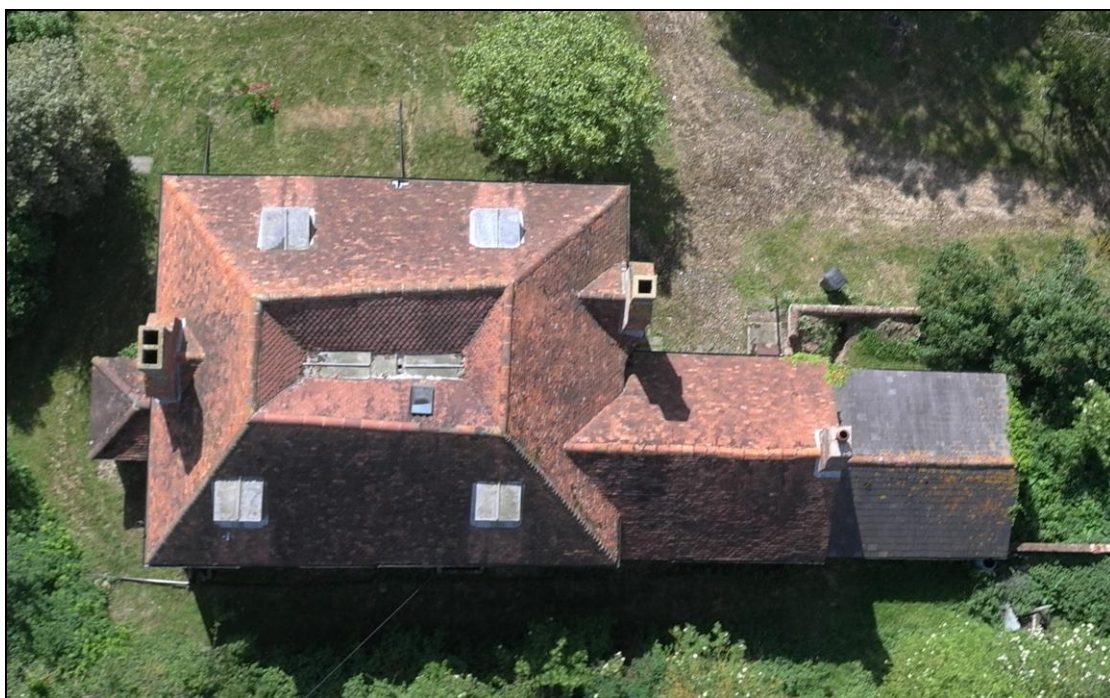
The hipped roof is an attempt to unify the two phases of the main building apparent externally. This gives ample space for an attic floor which is lit on the west side by two dormer windows. An aerial view of the house shows the irregular form of the roof needed to tie these two parts of the structure together (Fig 3). Where there is a valley between the north and south ridges there would normally have been a flat leaded roof in a single-build double-pile house of this date. As will be seen later, this led to some very inconvenient drainage arrangements within the attic storey.

Fig 3. Aerial photograph of Nunhide Farmhouse

Also dating to this phase, is a very peculiar feature to find inside a building. When the hipped roof was built, it left a hollow in the centre rather than give it flat top. This was necessitated by the difference in dimensions between the earlier roof to the north and that to the south (Fig 3). This created a problem of drainage from the hollow. The inelegant solution was an open wooden storm water channel lined with lead (Fig 52) which descends from the hollow of the hipped roof down through the interior of the room to be drained through the down water pipe (with the hopper dated 1696 or 8 beneath the eaves) between the two phases of construction on the west side of the building.

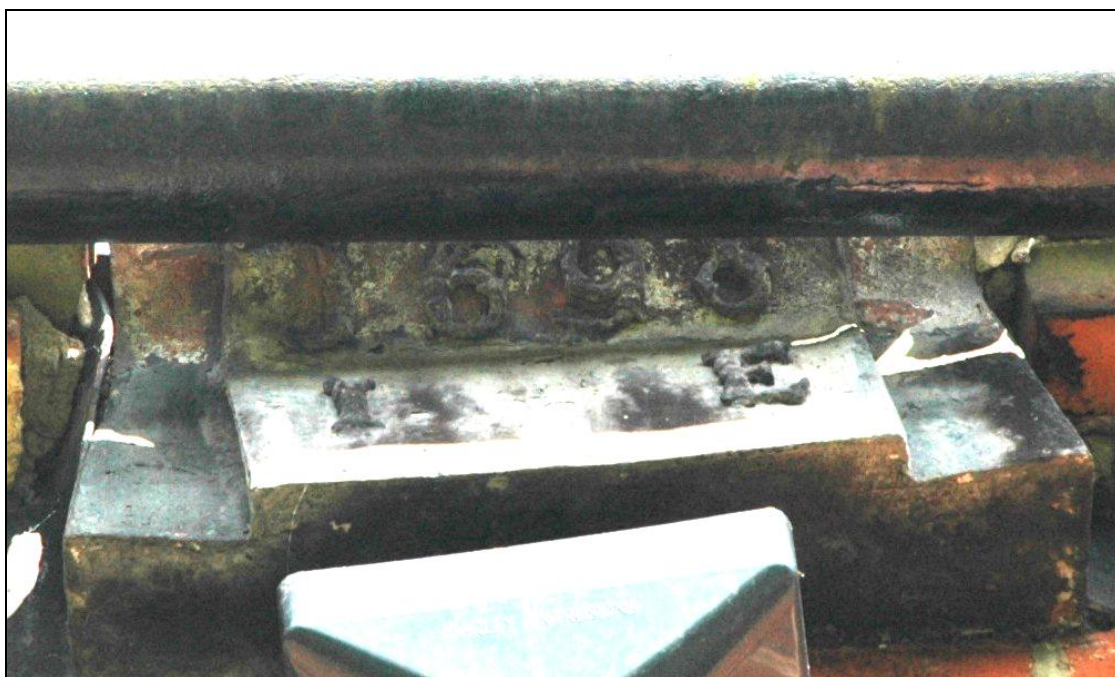
Both halves of the building on this and on the east elevation have been properly finished off with closers with no attempt at bonding. The only disguise on this façade is a drain pipe which covers the junction of the two builds. As the two halves have settled differently, there is a discrepancy between the verticality of each half. The drainpipe is of importance because it has a lead hopper draining the eaves guttering embossed with the initials IE beneath the date 1696 or 1698 (Fig 4) - the gutter obscures the last digit. However, this would strongly suggest a date for the building of the southern half of the building.

Fig 4. The dated drain hopper with the letters IE and date 1696 or 1698

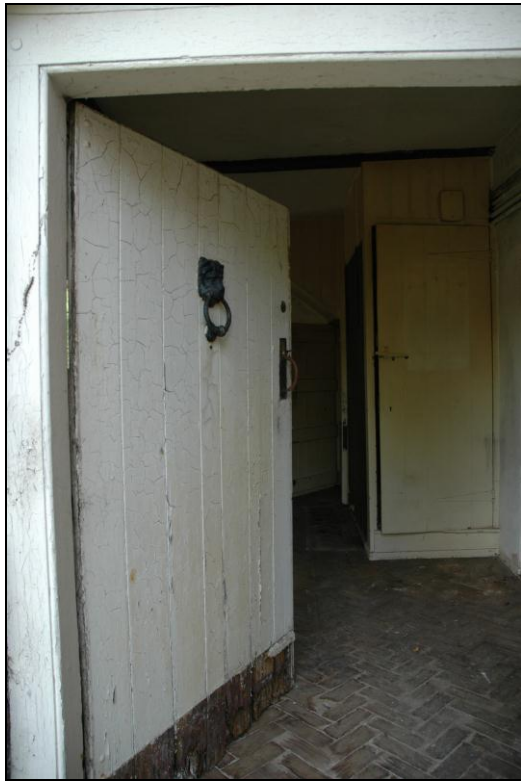
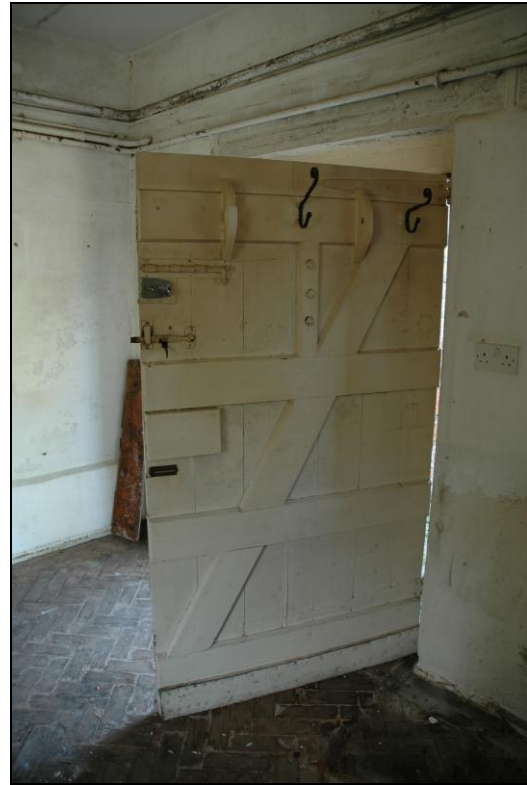
The door (Figs 14 & 15) and window openings on the ground floor are contemporary and have matching segmental arches above. The broad doorway (1m in width) is in a plain pegged frame and the door leaf is of a plain batten construction with a cast iron knocker and latch. The base has clearly rotted in the past and been repaired. The reverse of the door is battened horizontally with diagonal bracing and an upright batten to which the cast-iron knocker is heavily bolted.

Figs 14 & 15. The farmhouse door.

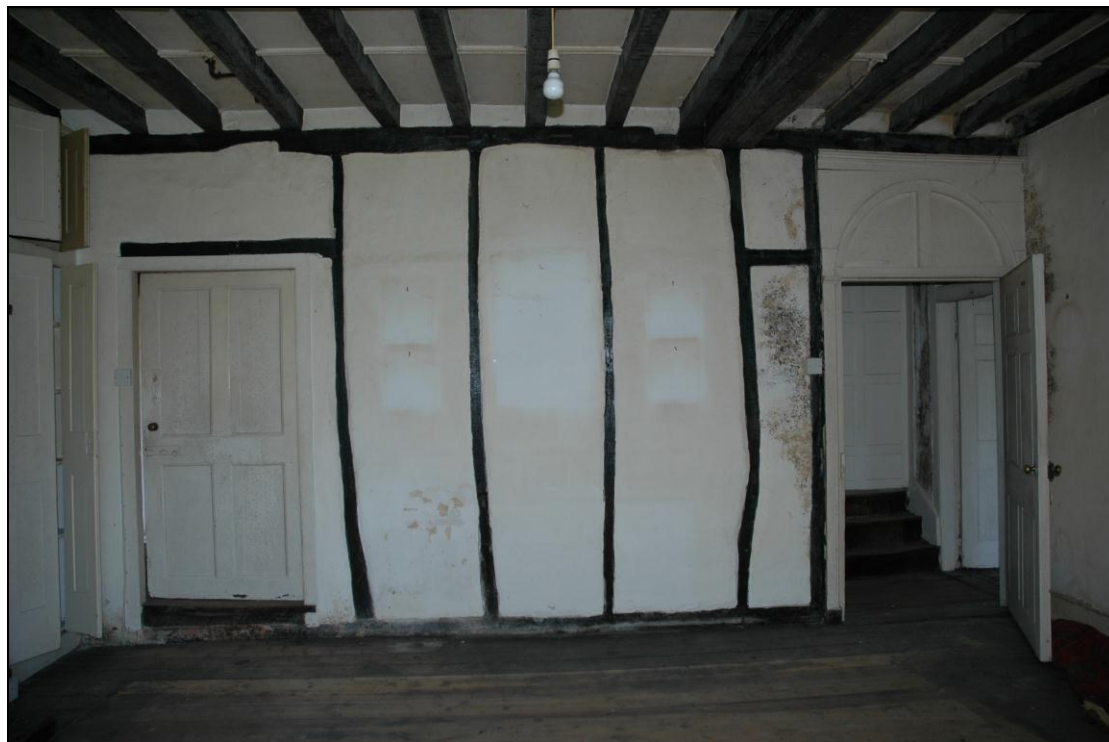
It is unusual that the timber framing visible in the east wall of this room is quite different to that seen in the corridor, though they are the same wall. In the room, the struts are spindly and insubstantial. They also seem to respect the current door frames. It is possible therefore that the two sides of this wall represent two separate phases of the timber building, with the east face of the north-west reception room being added to support a wall plate and a second storey. At the north end, above the door, is a scarf joint and there is new wood in the door's lintel, adding to the evidence that at least the north end of the east wall was rebuilt.

Fig. 19. The east wall of the north-west reception room

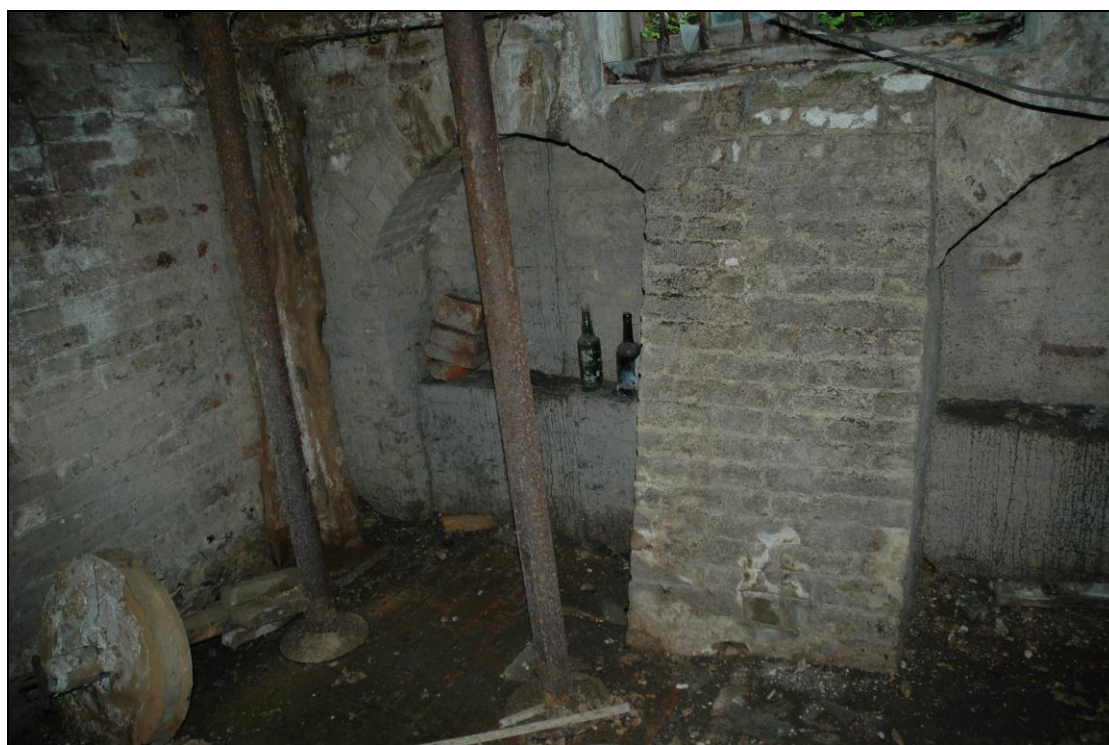
Fig 21. The internal buttress and relieving arches with window above in the west wall.

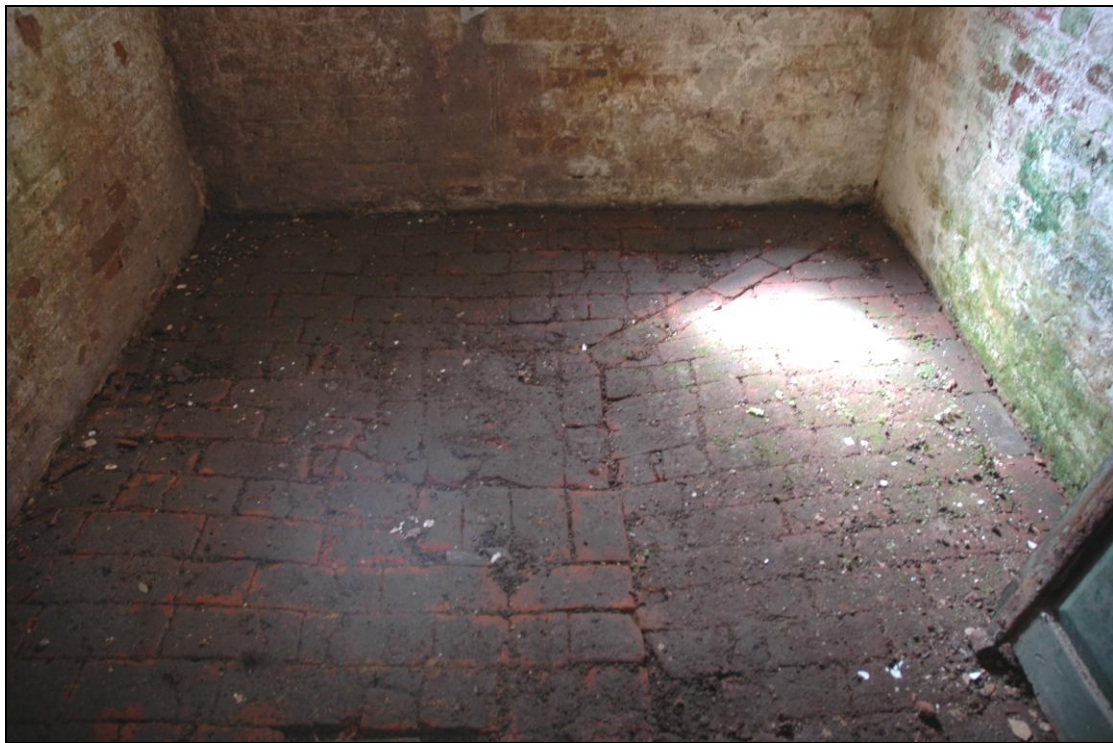
The brick floor at the west end of Cellar B2 is paved in such a way to indicate that the room needed drainage and that it was used for some sort of wet process. There are the remains of a wooden shelf on the north side of the room of a depth of 0.60m. This is comparable to those still extant in the dairy/larder on the ground floor. The

Fig 23. The east end and brick-paved floor of Basement B2

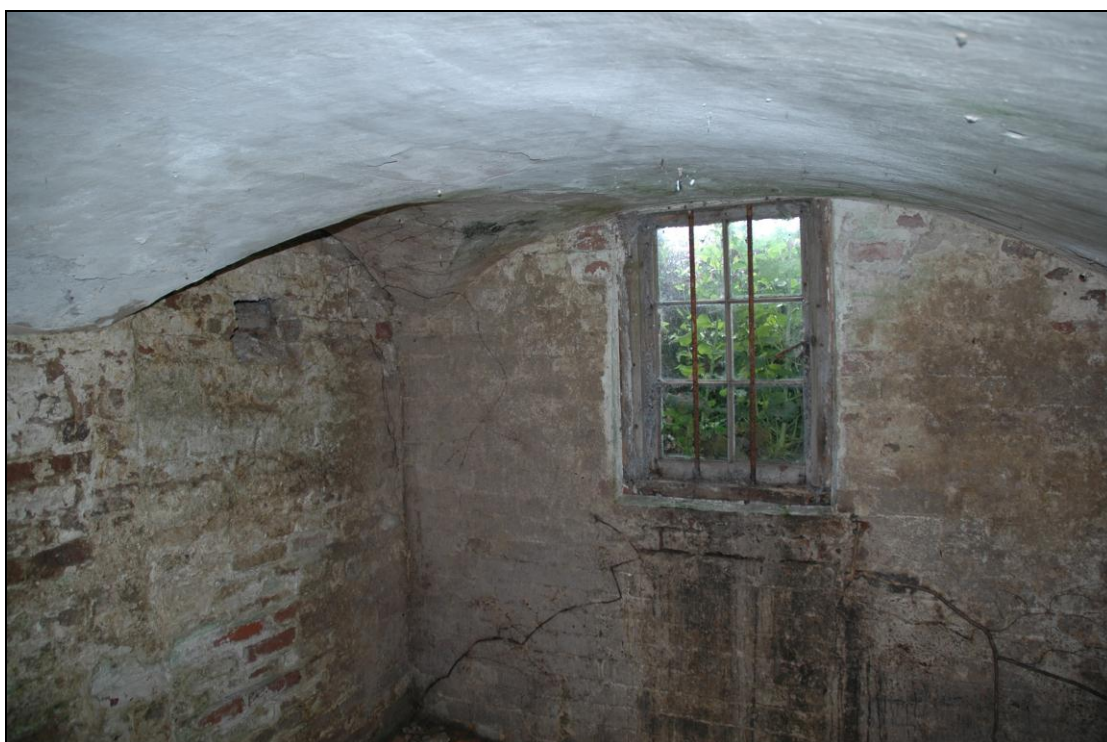
There is a doorway in the south-west corner of the southern barrel-vaulted cellar (B3). It has been bricked up, but retains the vaulting above it (perpendicular to the main vault) to allow headroom into the cellar at its highest point (Fig 25). This may have been the door to the vaults during construction, but it is more likely that this was an original outside door at a level comparable with the level of the lawn just outside to the west. This doorway, however, was eventually blocked and built over with the construction of the southern half of the main house, which has no basement.

Fig 25. The east end of Basement B3, showing blocked door to the left (north) and the barred side-hung casement window at the east end.

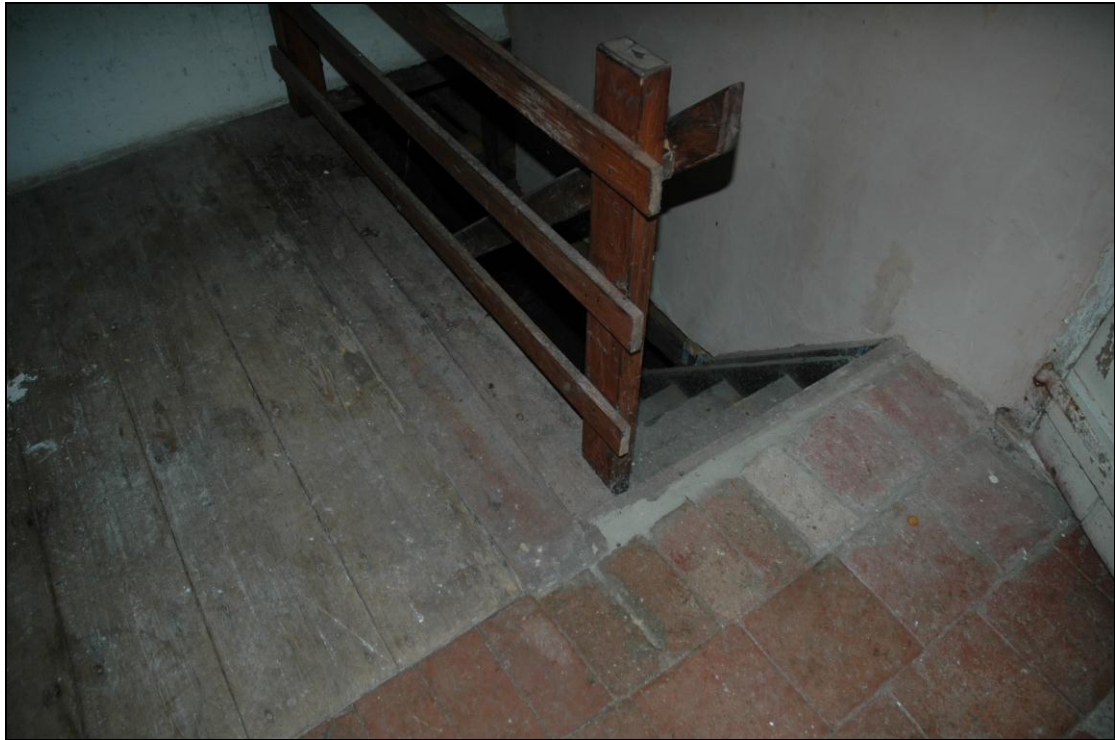
The southern side of the room is very different. The floor is of wooden planks through which the present stair down to the basement (B1) has been cut (Fig 27). This appears to have been done fairly recently and the west wall against which it rests has been recently re-plastered. The southern half too is shelved in heavy wood supported on struts projecting from the west and south walls. At the west end, the shelf rests on the modern stair rail.

The surviving planks on the north side are not new and it may well be that there was a partition and a door between the two halves of this room. The other possibility is that the beams below would not hold the tile floor. In the part that survives, there is scaffolding beneath to support it. Perhaps some sort of collapse led to a re-thinking of the circulation between ground floor and basement.

Fig 27. The north side of the floor of the dairy/larder, showing the difference between the tiled floor on the south side and the timber floor on the north and the present cellar stair cut through the latter.

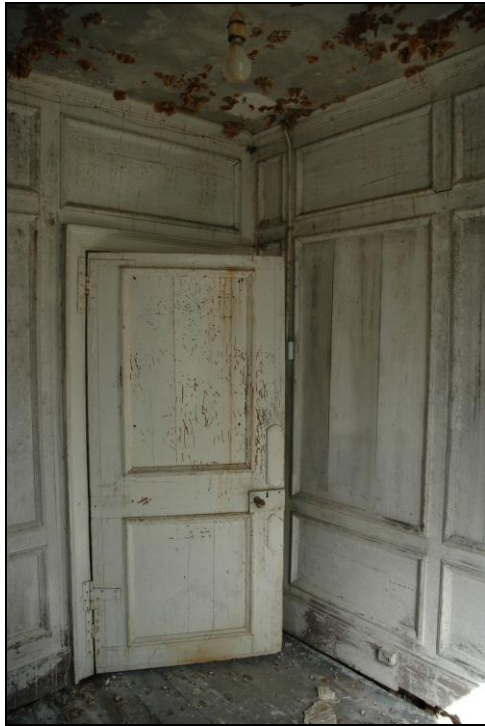
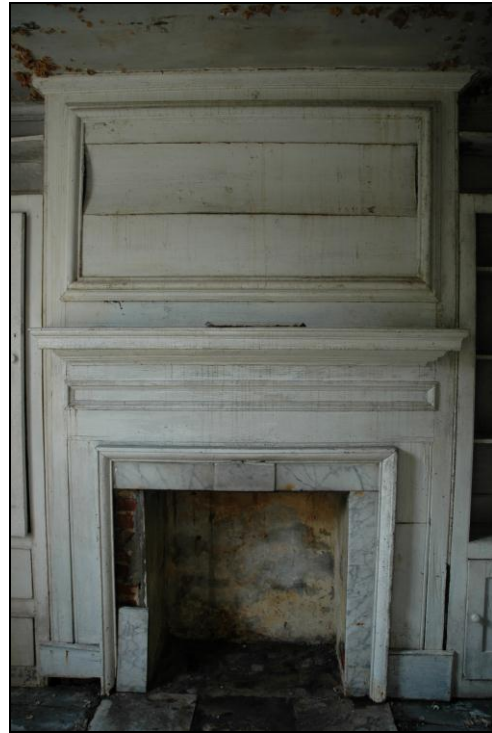
The panelling is raised and fielded with skirting and cornice mouldings enclosing a dado, upper panel and frieze. There is none of the bolection moulding apparent in the other panelled room, the reception room G6, except a faint trace of it in the panel above the mantel of the fireplace. This is very much an 18th century room without any of the heavy late-17th century overtones of G6.

Figs 36, 37 & 38. The Small Parlour: window, entrance with panelling and fireplace.

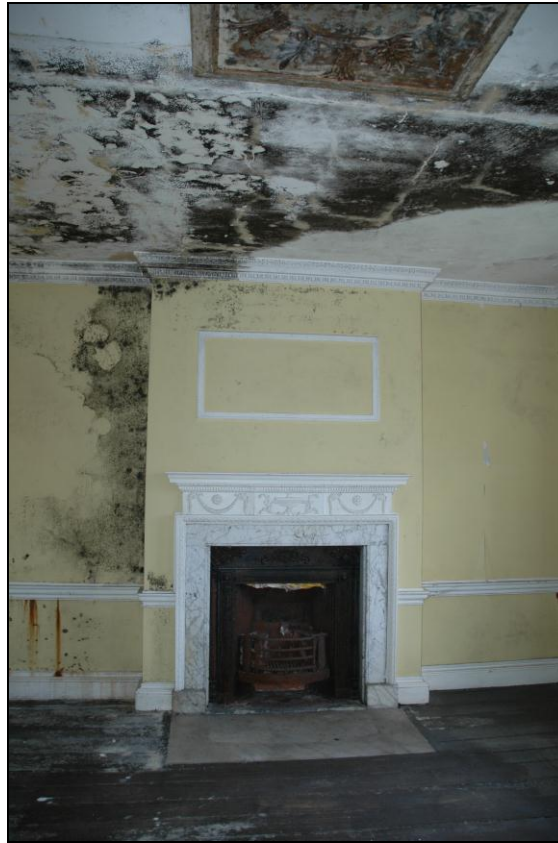
Fig 40. The late 18th-century fireplace of the principal reception room F2, with its Adam-style surround

The large room is far more restrained in its decoration, with all the decorative attention focussed on the late-18th century Adam-style fireplace, with a wooden frame carved with swags and urns (Fig. 40). The mantel shelf itself is dentilled while the grey/white marble surround above which it sits is rimmed with a decorative anthemion moulding picked up again in the cornice along with an egg and dart theme. The interior surround and grate of the fireplace are of cast iron with moulded details in keeping with the wood and marble surround.

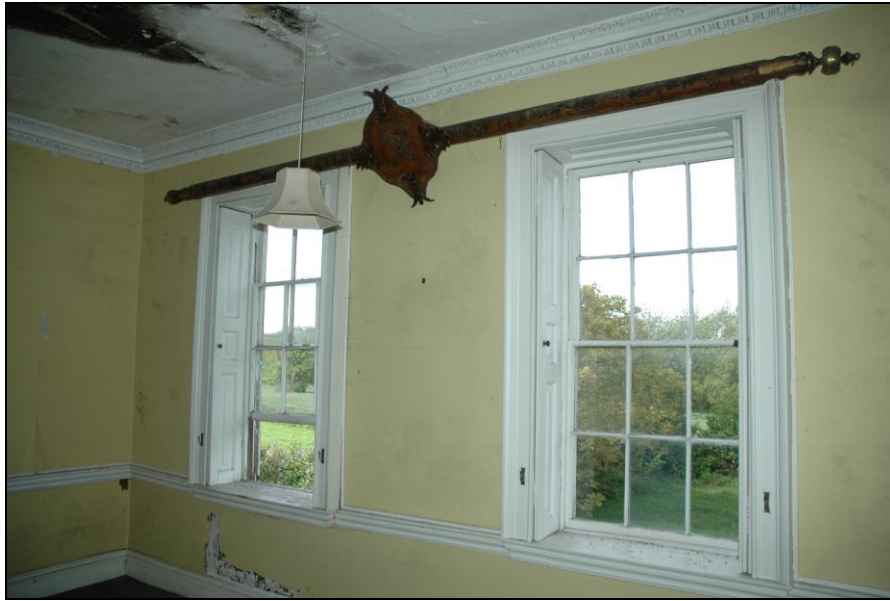
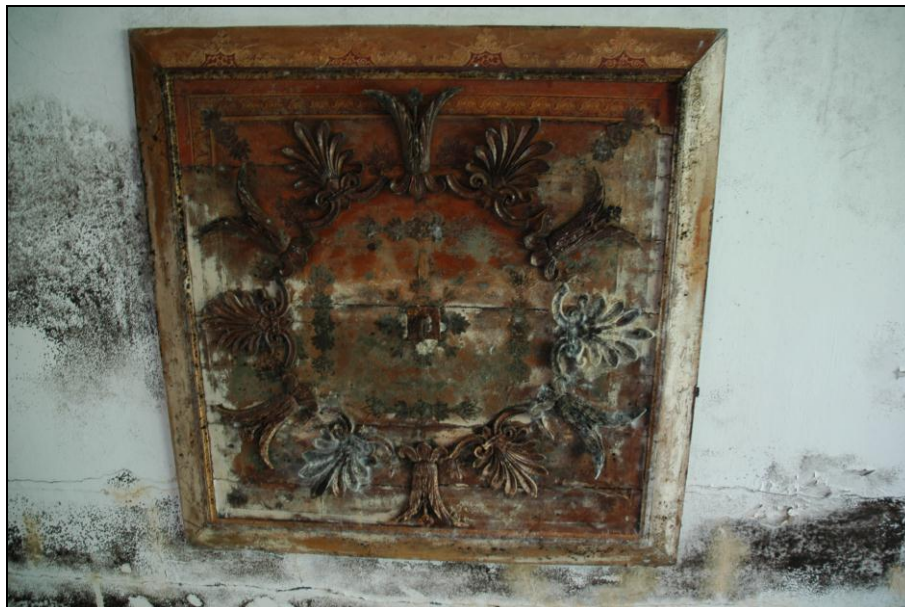
The room itself is quite plain with only a moulded skirting, dado and cornice. The cornice has egg and dart and an anthemion moulding that echoes the surround of the fireplace, but is nonetheless understated in the later 18th century style. The windows are 12-light sashes with shutters but no window seats (Fig. 41). The heavy bamboo style curtain rail which surmounts them probably dates to the 1870s, a small attempt at Scottish baronial style. This goes also for the ceiling centrepiece which, like the curtain rail, has nothing to do with the 18th-century design of the rest of the room (Fig. 42).

Figs 41 & 42. The sash windows on the west side of the first-floor reception room F2 and the ceiling plaque of c. 1870.

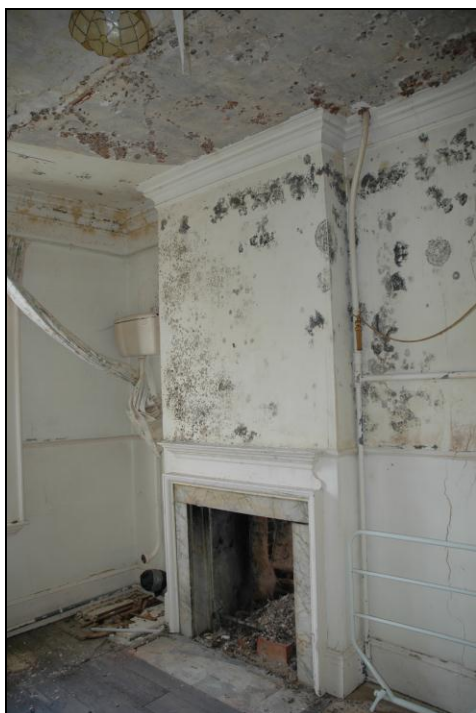
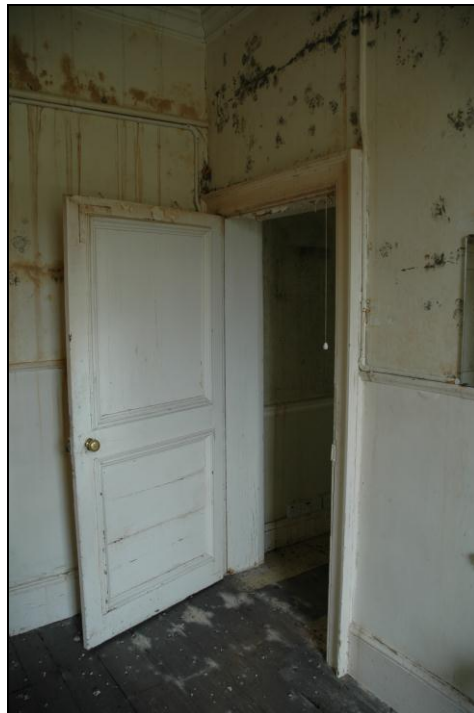
Though this was most recently a bathroom, it is clear by the elegant fireplace that this was once a bedroom, albeit a small one. The fireplace, with its marble surround and slight mantel, shows that this was not a very important bedroom (Fig. 43). The dado is unusually high up, at the same height in fact as the top of the mantelpiece. The cornice is more substantial than in other rooms and may perhaps indicate that this room's décor is 19th century in date.

The 12-light sash window has plain shutters, a feature again suggestive of a bedroom. The door leaf has two panels and is older than the décor of the room to which it gives access (Fig. 44). The plain form and the size of the two panels suggest that this is of late 17th-early 18th century date. Nothing else in this room of this early a date.

Figs 43 & 44. The fireplace in the bathroom F5, showing that this was once in fact a bedroom, and the earlier door

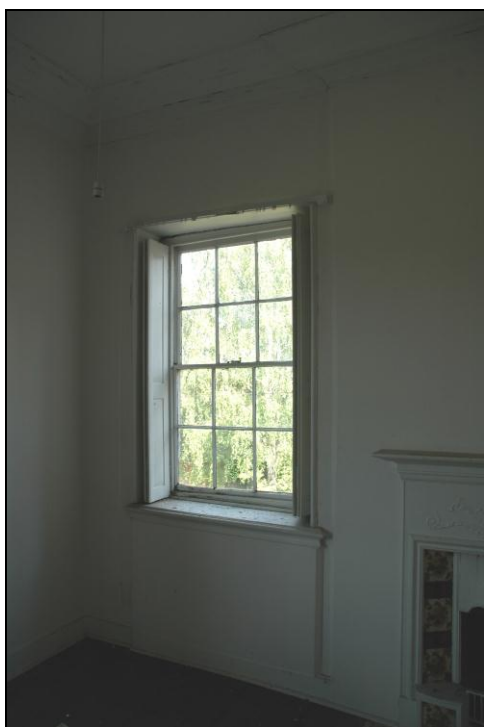
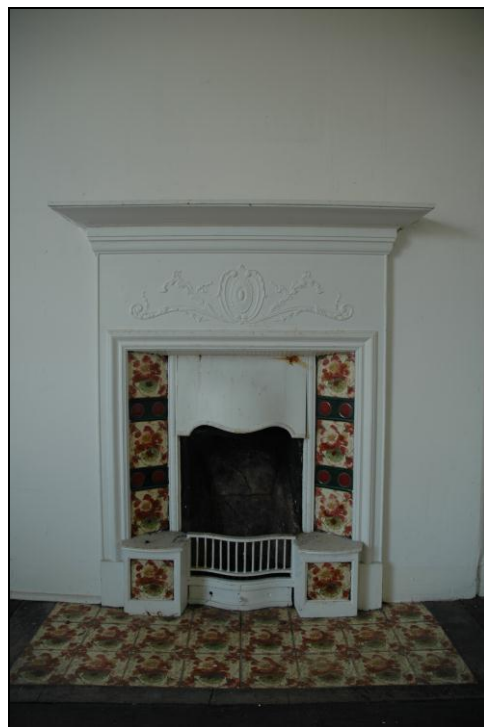
Figs 45 & 46. Bedroom F3: The north sash window and fireplace

The external brickwork shows at the sides and bottom of the window that the present one is a later alteration and the form of the window suggests that it was done in the 19th century. The second window, in the north wall, is an ordinary sash window which is conversely narrower than the original. Again, the external brickwork shows that the original opening, as defined by the brick closers, has been made narrower on the eastern edge. The form of this window matches that of the west window indicating that both alterations were done at the same time. The logical conclusion is that both windows were prefabricated and the sizes non-negotiable.

There is a very small fireplace on the north wall, adjacent to the window. It has a small cast-iron grate clearly designed for coal rather than wood. The grate is flanked by decorative tiling which is matched in the tiled equivalent of a hearth stone. The fireplace is very slight and is clearly a late 19th-century insertion into the pre-existing stack. There is no chimney breast to speak of and the surround and mantel barely project into the room at all.

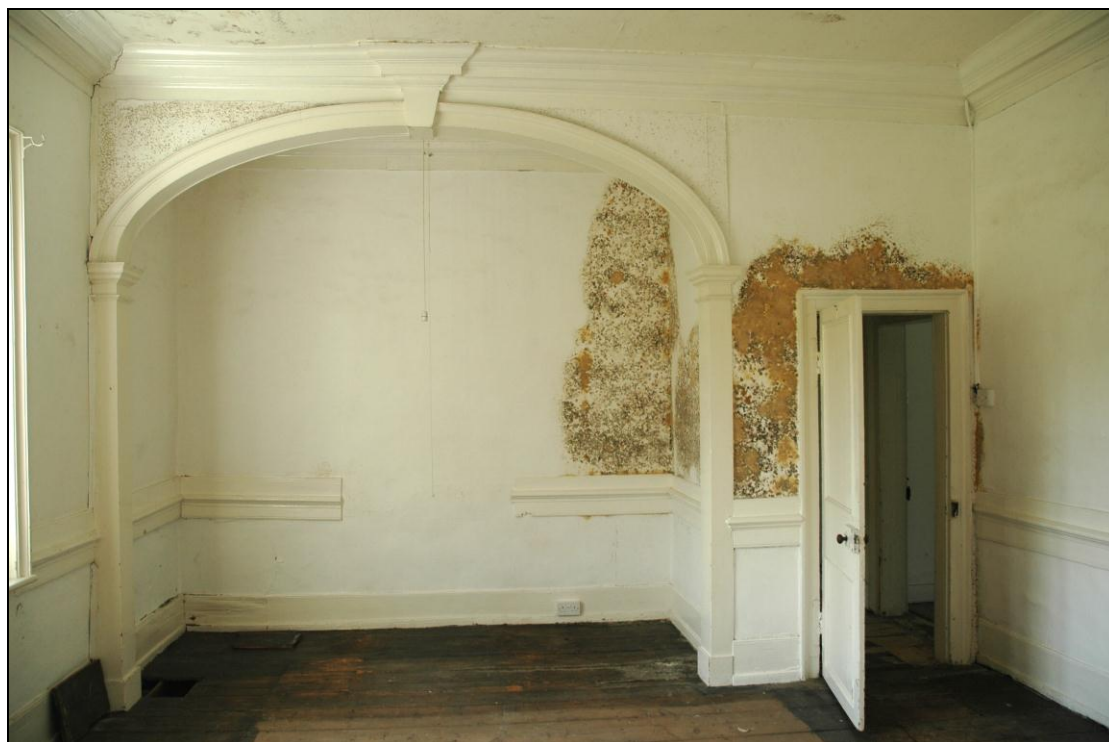
This room appears to be the principal bedroom. It is entered from an extension to the southern end of the room. This creates a recess which has been flanked with pilasters and topped with a segmental arch. The projecting key of the arch has been integrated with the cornice of the main body of the room, a self-contained cornice being used within the recess. A deep dado runs round the room except for a gap in the recess, presumably for the bedhead for a single bed. Given the size and grandeur of the room, it is probable that the original intention was for a double bed. The skirting is very plain and patchy and appears to be a later replacement. It is possible that the boarding above and below the dado are later.

Fig 47. The north-east bedroom with its southern bed recess and entrance

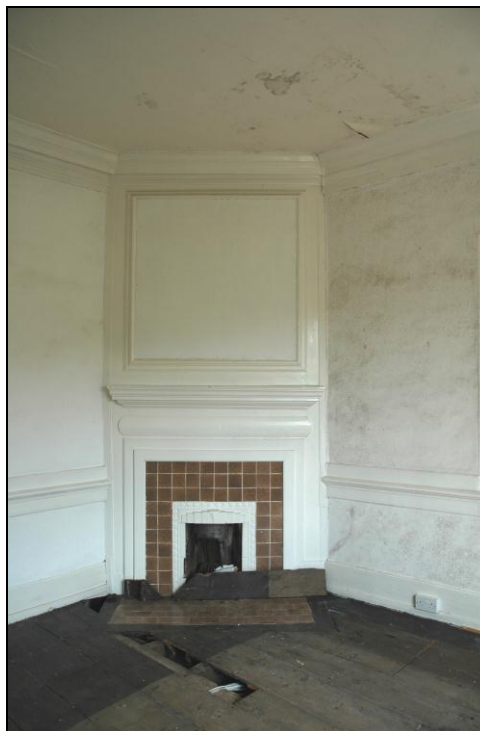
Cutting across the north-west corner of the room is the fireplace (Fig. 48). This has a pulvinated frieze, with moulded mantel and a panel above defined by bolection moulding. This design is very typical of the late 17th-early 18th century and is in this case probably early 18th century in date. Brown tiling surrounds a small art deco grate of the 20s or 30s.

A clumsy ceiling arrangement had to be created on the ground floor beneath to support it, but it is part of the original brick phase of the building rather than a later insertion. It is one of the compromises needed to retain the earlier parts of the building at this north end of the house. It shares the chimney stack serving the north-west rooms and corbelled bridging brickwork was constructed externally to join the two (Fig 12).

Fig 48. The corner fireplace in Bedroom F4. Just at the right edge of the photograph can be seen the recess of the blocked north window.

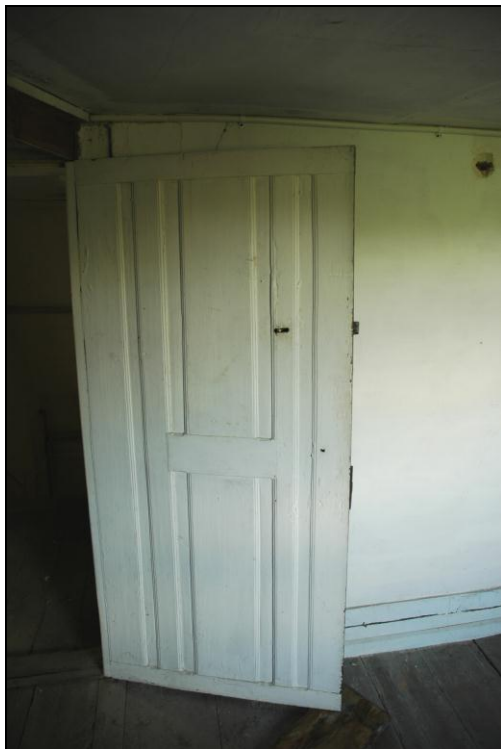
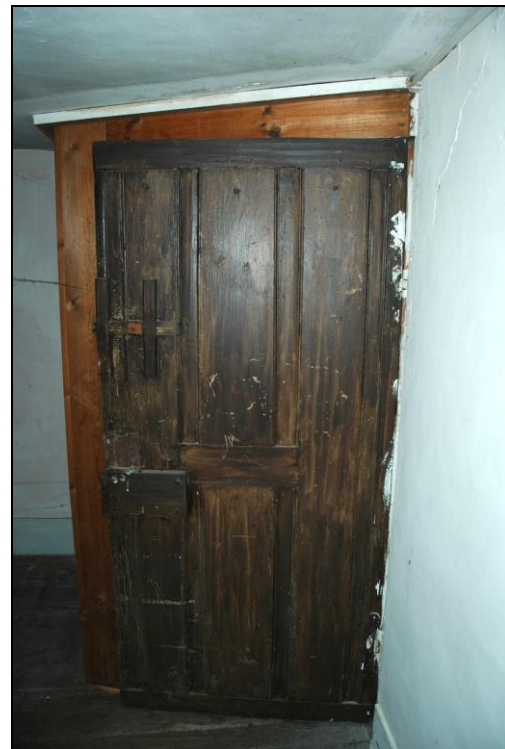
The single most interesting feature of this room is the door. Now attached to the tongue-and-groove partition of the lobby which sits within the north-east corner of the room, it clearly used to be hung on the doorway from the landing. The door leaf incorporates 17th-century joinery, which may be original to the door, but could have been made from salvaged panelling (Rodwick 2009). This possibility in itself is interesting as it suggests that the panelling may have come from the timber-framed building that superseded the brick north end. The farmhouse was too remote for it to have come far.

Figs 49 & 50. Both faces of the door of Room S2

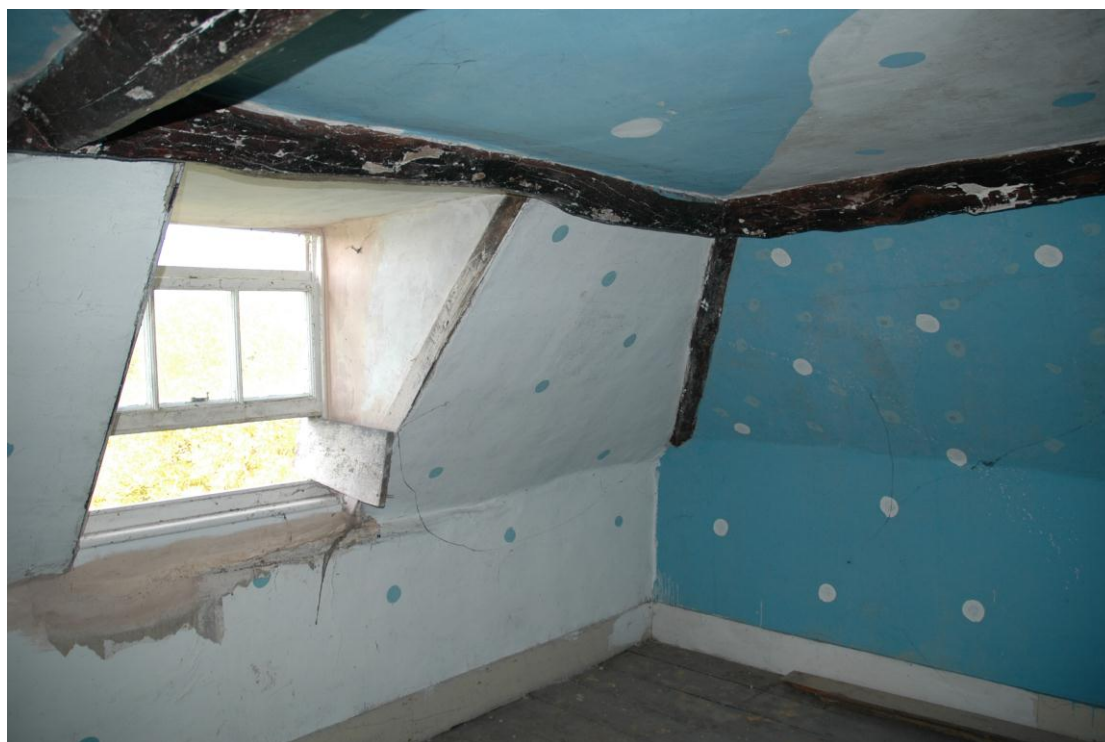
This room is part of the older north part of the house and this is immediately visible in the timbers of the principal rafters. These are in keeping with the timber-framed phase of the house pre-dating the brick-encased phase. The timbers are crude and heavy and are probably of 17th century date. They do however show that the original building with its east-west axis had a hipped roof at both gable ends.

Fig 51. The north-west room S3, showing dormer window and the rafters of the roof

The dormer window, like that in room S2, is a very plain sash window with just six lights. This looks out on the west side of the building. It is clearly a later insertion, dating to the time when the two halves of the building were united under the hipped roof.

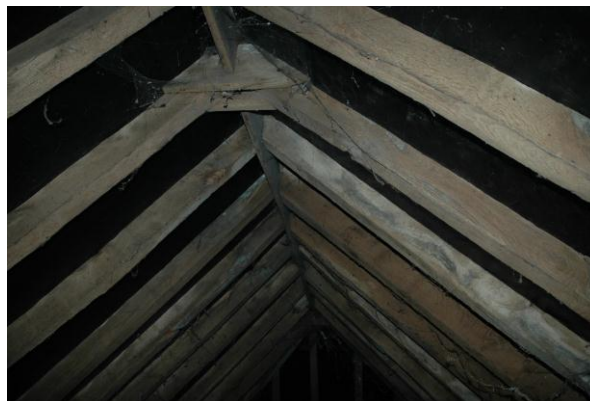
This forms the east end of the original building and again shows the timbers of the earlier hipped roof frame (before it was a double-pile house). The dormer sash window is a much later insertion beneath the end purlin. The room is otherwise plain. It does however give access through a trap in the ceiling to the roof space. Unfortunately, only the principal rafters and purlins visible at second-floor level are original, the others are recent, as is the roof ridge.

Fig 53. The roof space of the north part of the house, looking west

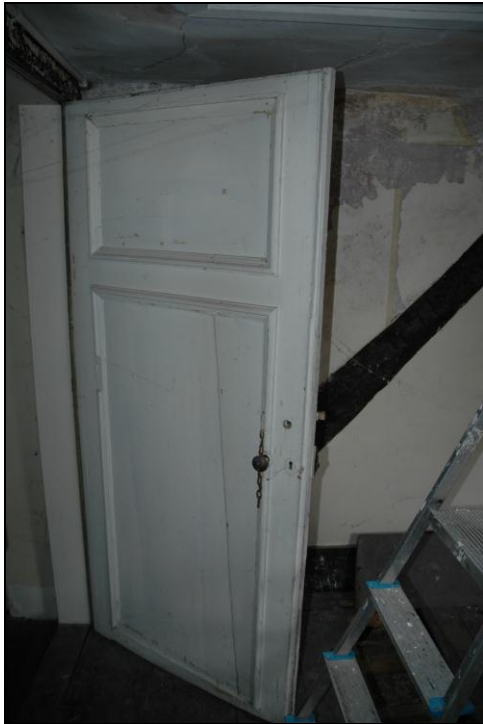
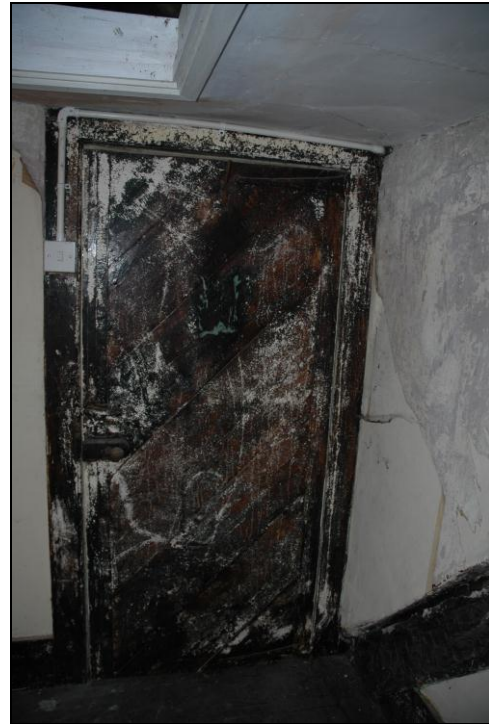
The door is of some interest and is probably early 18th century. Its north face is diagonally planked, while the south one has two fielded panels.

Figs 54 & 55. Both faces of the door to Room S4, with an early rafter visible to the right in both pictures.

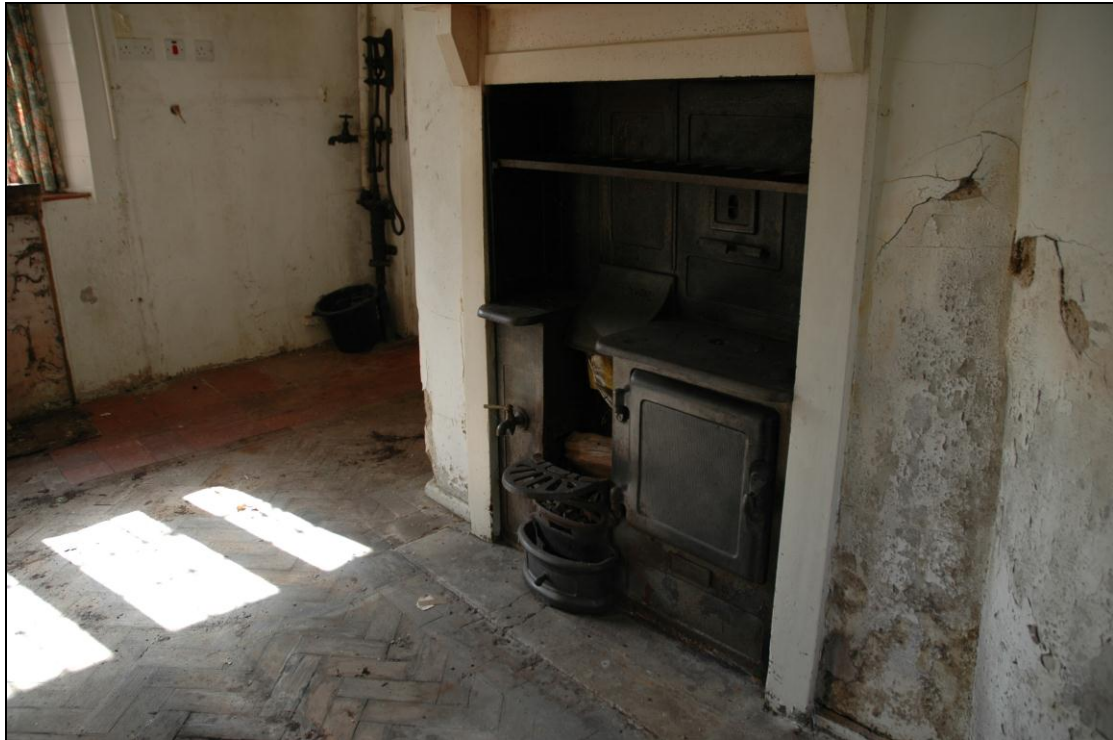
Fig 57. The kitchen range, showing also the herringbone parquet floor and the hand water pump in the corner with tile floor surround.

The room has been stripped of most of its furnishings, but the early 20th-century cast-iron range survives at the north end. It is set into a projecting chimney breast, but projecting even further to the east of it is the curved wall that forms the rear of the bread oven in room G10 in the second extension (see below).

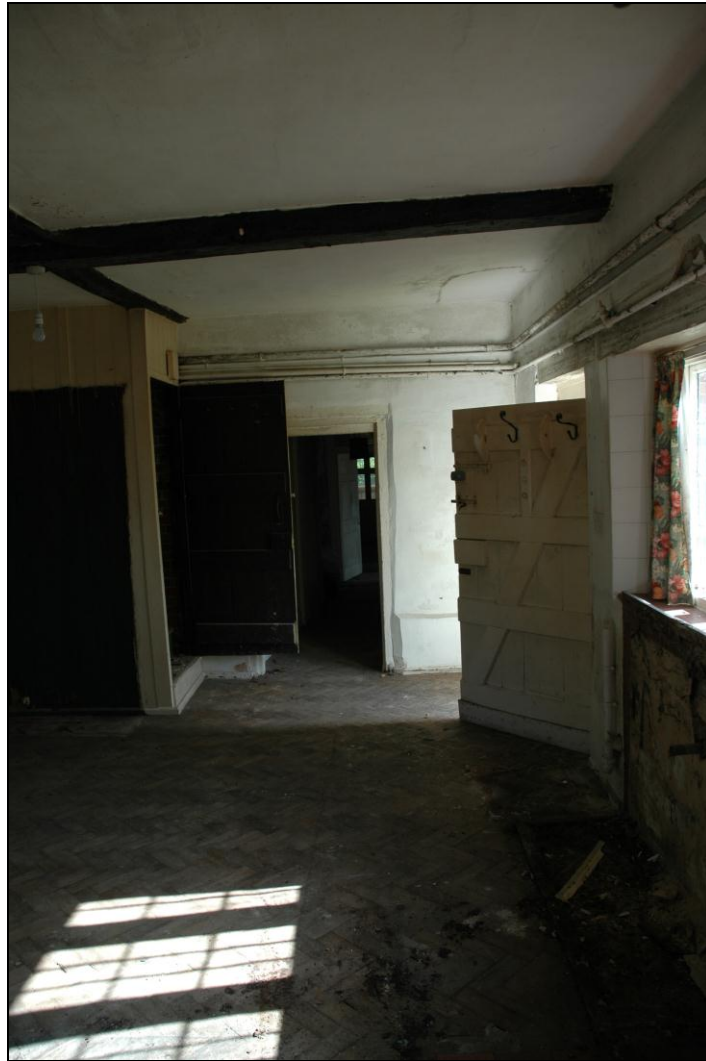
Fig 58. The south side of the kitchen G9, showing the entrance to the house on the right, the door to the main house in the centre and the entrance to the wooden stair to F6. Also shown are the ceiling beams.

Two ceiling beams cross at the centre of the space. The principal beam runs east-west and is chamfered with no stops. The secondary beam is stopped and chamfered, but at the south end is partially concealed by the boxed stair.

The door into the old part of the main house has no door, but it does have a pintle at the foot on the west side. This indicates that this once had a substantial heavy door, which would have been the main entrance to the first house and a rear entrance to the double-pile house before the building of the first extension.

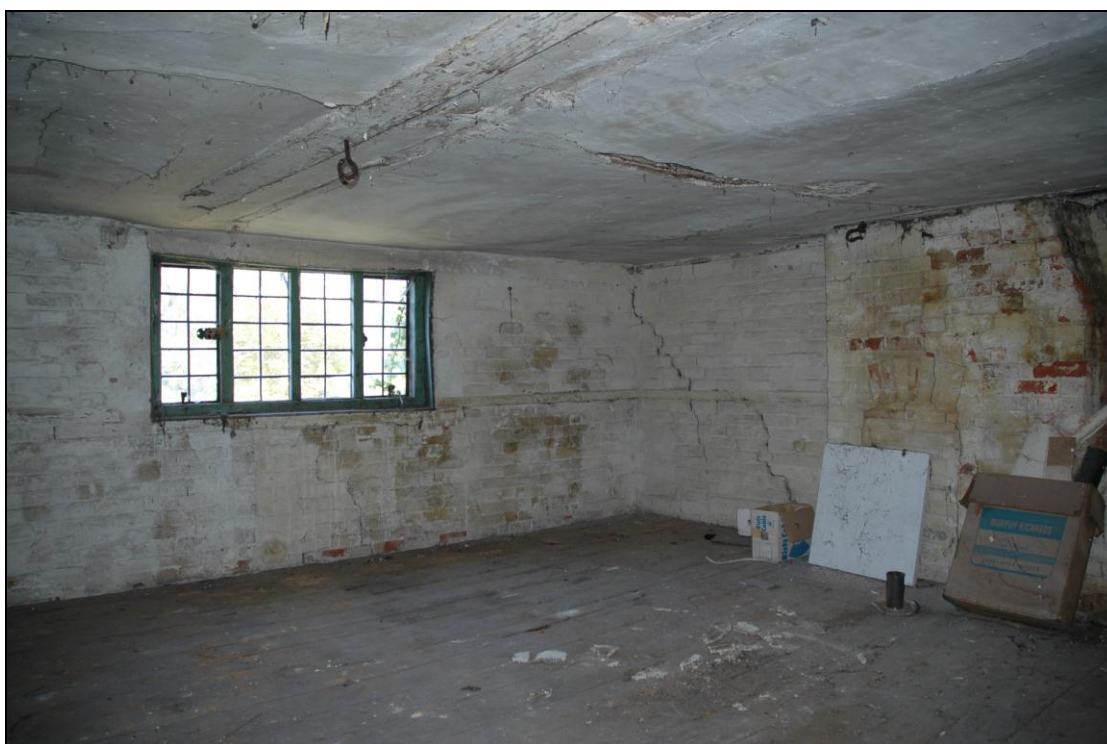
There is a fireplace at the north end (Fig. 60), which does not tie in with this as a storage space for dried meats, but maybe for dried goods and perhaps even a farm office.

Fig 60. The north end of F6, showing the window, chimney stack and small blocked fireplace.

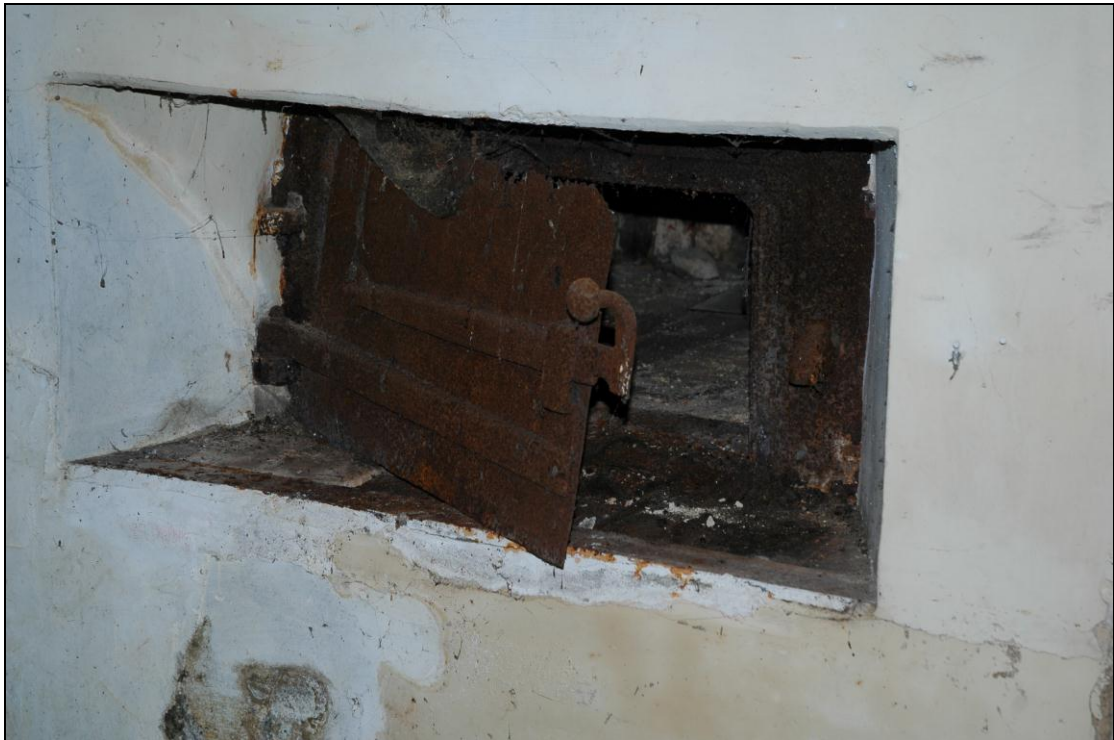
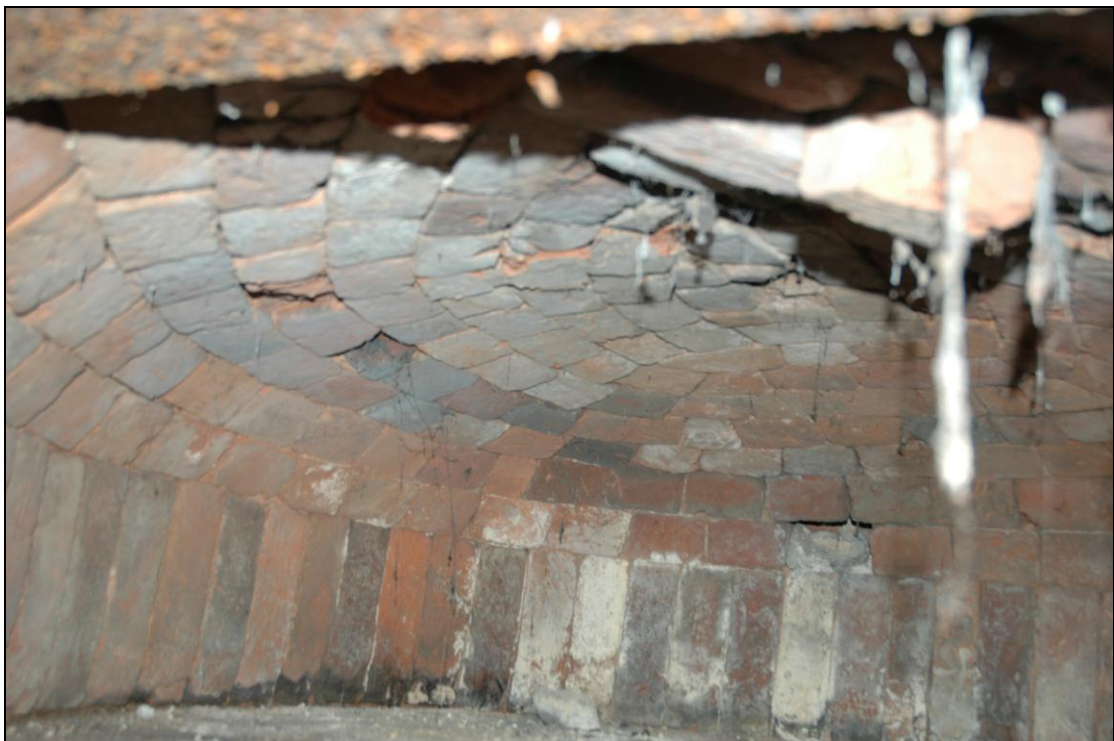
In the south-east corner of the room is the bread oven, the rear of which was noted in the kitchen G9. The door to the oven is cast iron with an iron rim to the shelf and soffit. The interior is all brick.

Figs 63 & 64. The cast-iron door and brick interior of the bread oven in room G10.
