# **Management of prehistoric monuments on Helvear Down, St Mary's, Isles of Scilly**

## **Archaeological monitoring**

**Report No: 2011/04**

**June 2011**

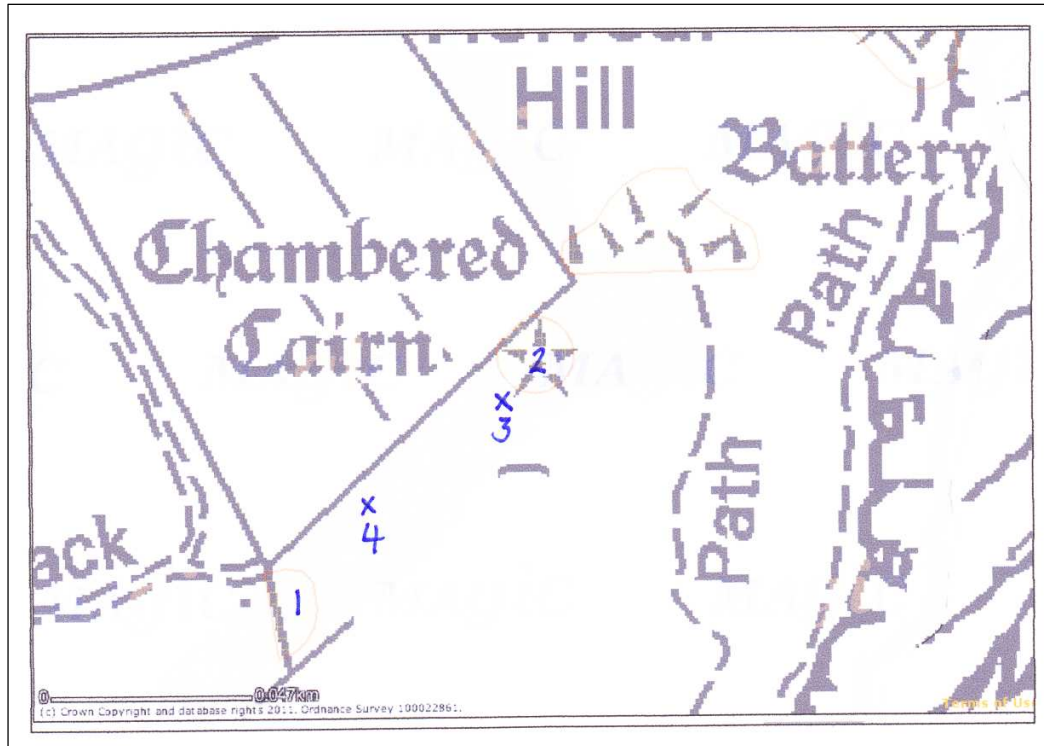
### 8.6.3 Map of project area showing locations of identified sites

(1 – round cairn, 2 – kerbed platform cairn, 3 – possible entrance grave, 4 – possible structure)
