GAINSBOROUGH WATERMAINS RELAY
GLADSTONE ST, MORLEY ST, COBDEN ST,
BRIGHT ST & LORD ST.
ARCHAEOLOGICAL WATCHING BRIEF
(Order No.E9 62156 NTHN)

LINDSEY ARCHAEOLOGICAL SERVICES
FRANCIS HOUSE SILVER BIRCH PARK GREAT NORTHERN TERRACE LINCOLN LN5 8LG

Lindsey Archaeological Services undertook an archaeological watching brief during trenching for the installation of a water main along Morley St, Cobden St and Bright St, terminating under Lord St (Fig.1); reference MOR92 (Morley St). Work commenced on September 16th and was completed on September 29th 1992. This was a continuation of trenching in Gladstone St (GLA92), during which recording was undertaken between June 30th and July 8th 1992. The main purpose of both watching briefs was to record any features considered to be of historic relevance to Gainsborough Old Hall.

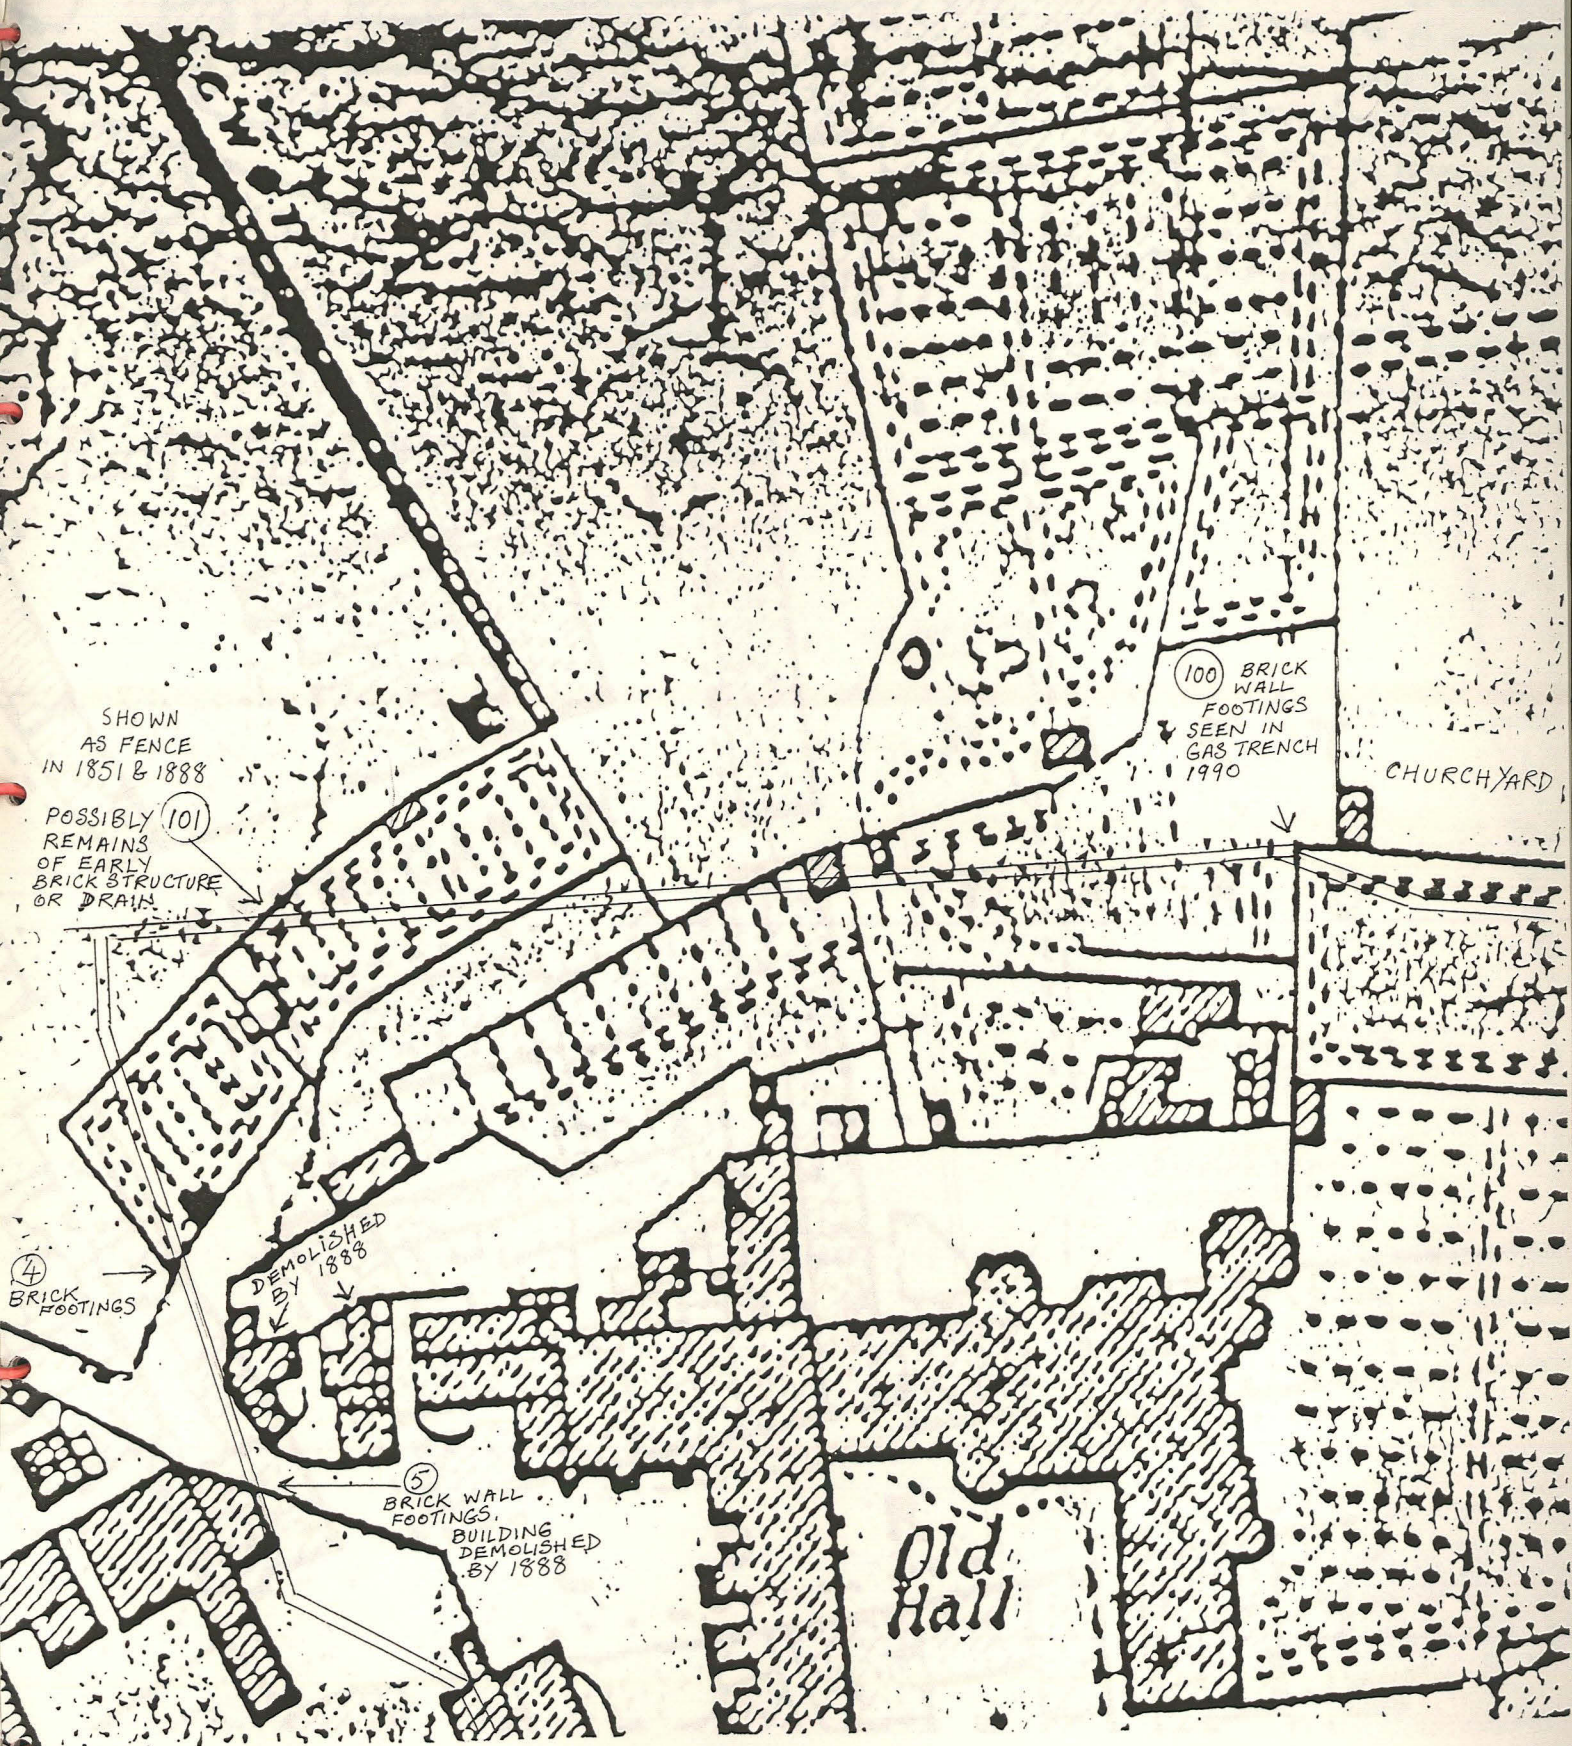
Fig.13 Pipe trench (north) on 1851 map showing relevant brick features
