**REPLACEMENT WATER MAIN  
CHURCH LANE, NORTH THORESBY,  
LINCOLNSHIRE**

**ARCHAEOLOGICAL WATCHING  
BRIEF REPORT**

Site code: CLNT 06  
NGR: TF 2888 9862 -  
TF 2911 9850  
LCCM Acc No: 2006.137  
PCA Job No: 06-229

Report prepared for  
Anglian Water  
Services Ltd.

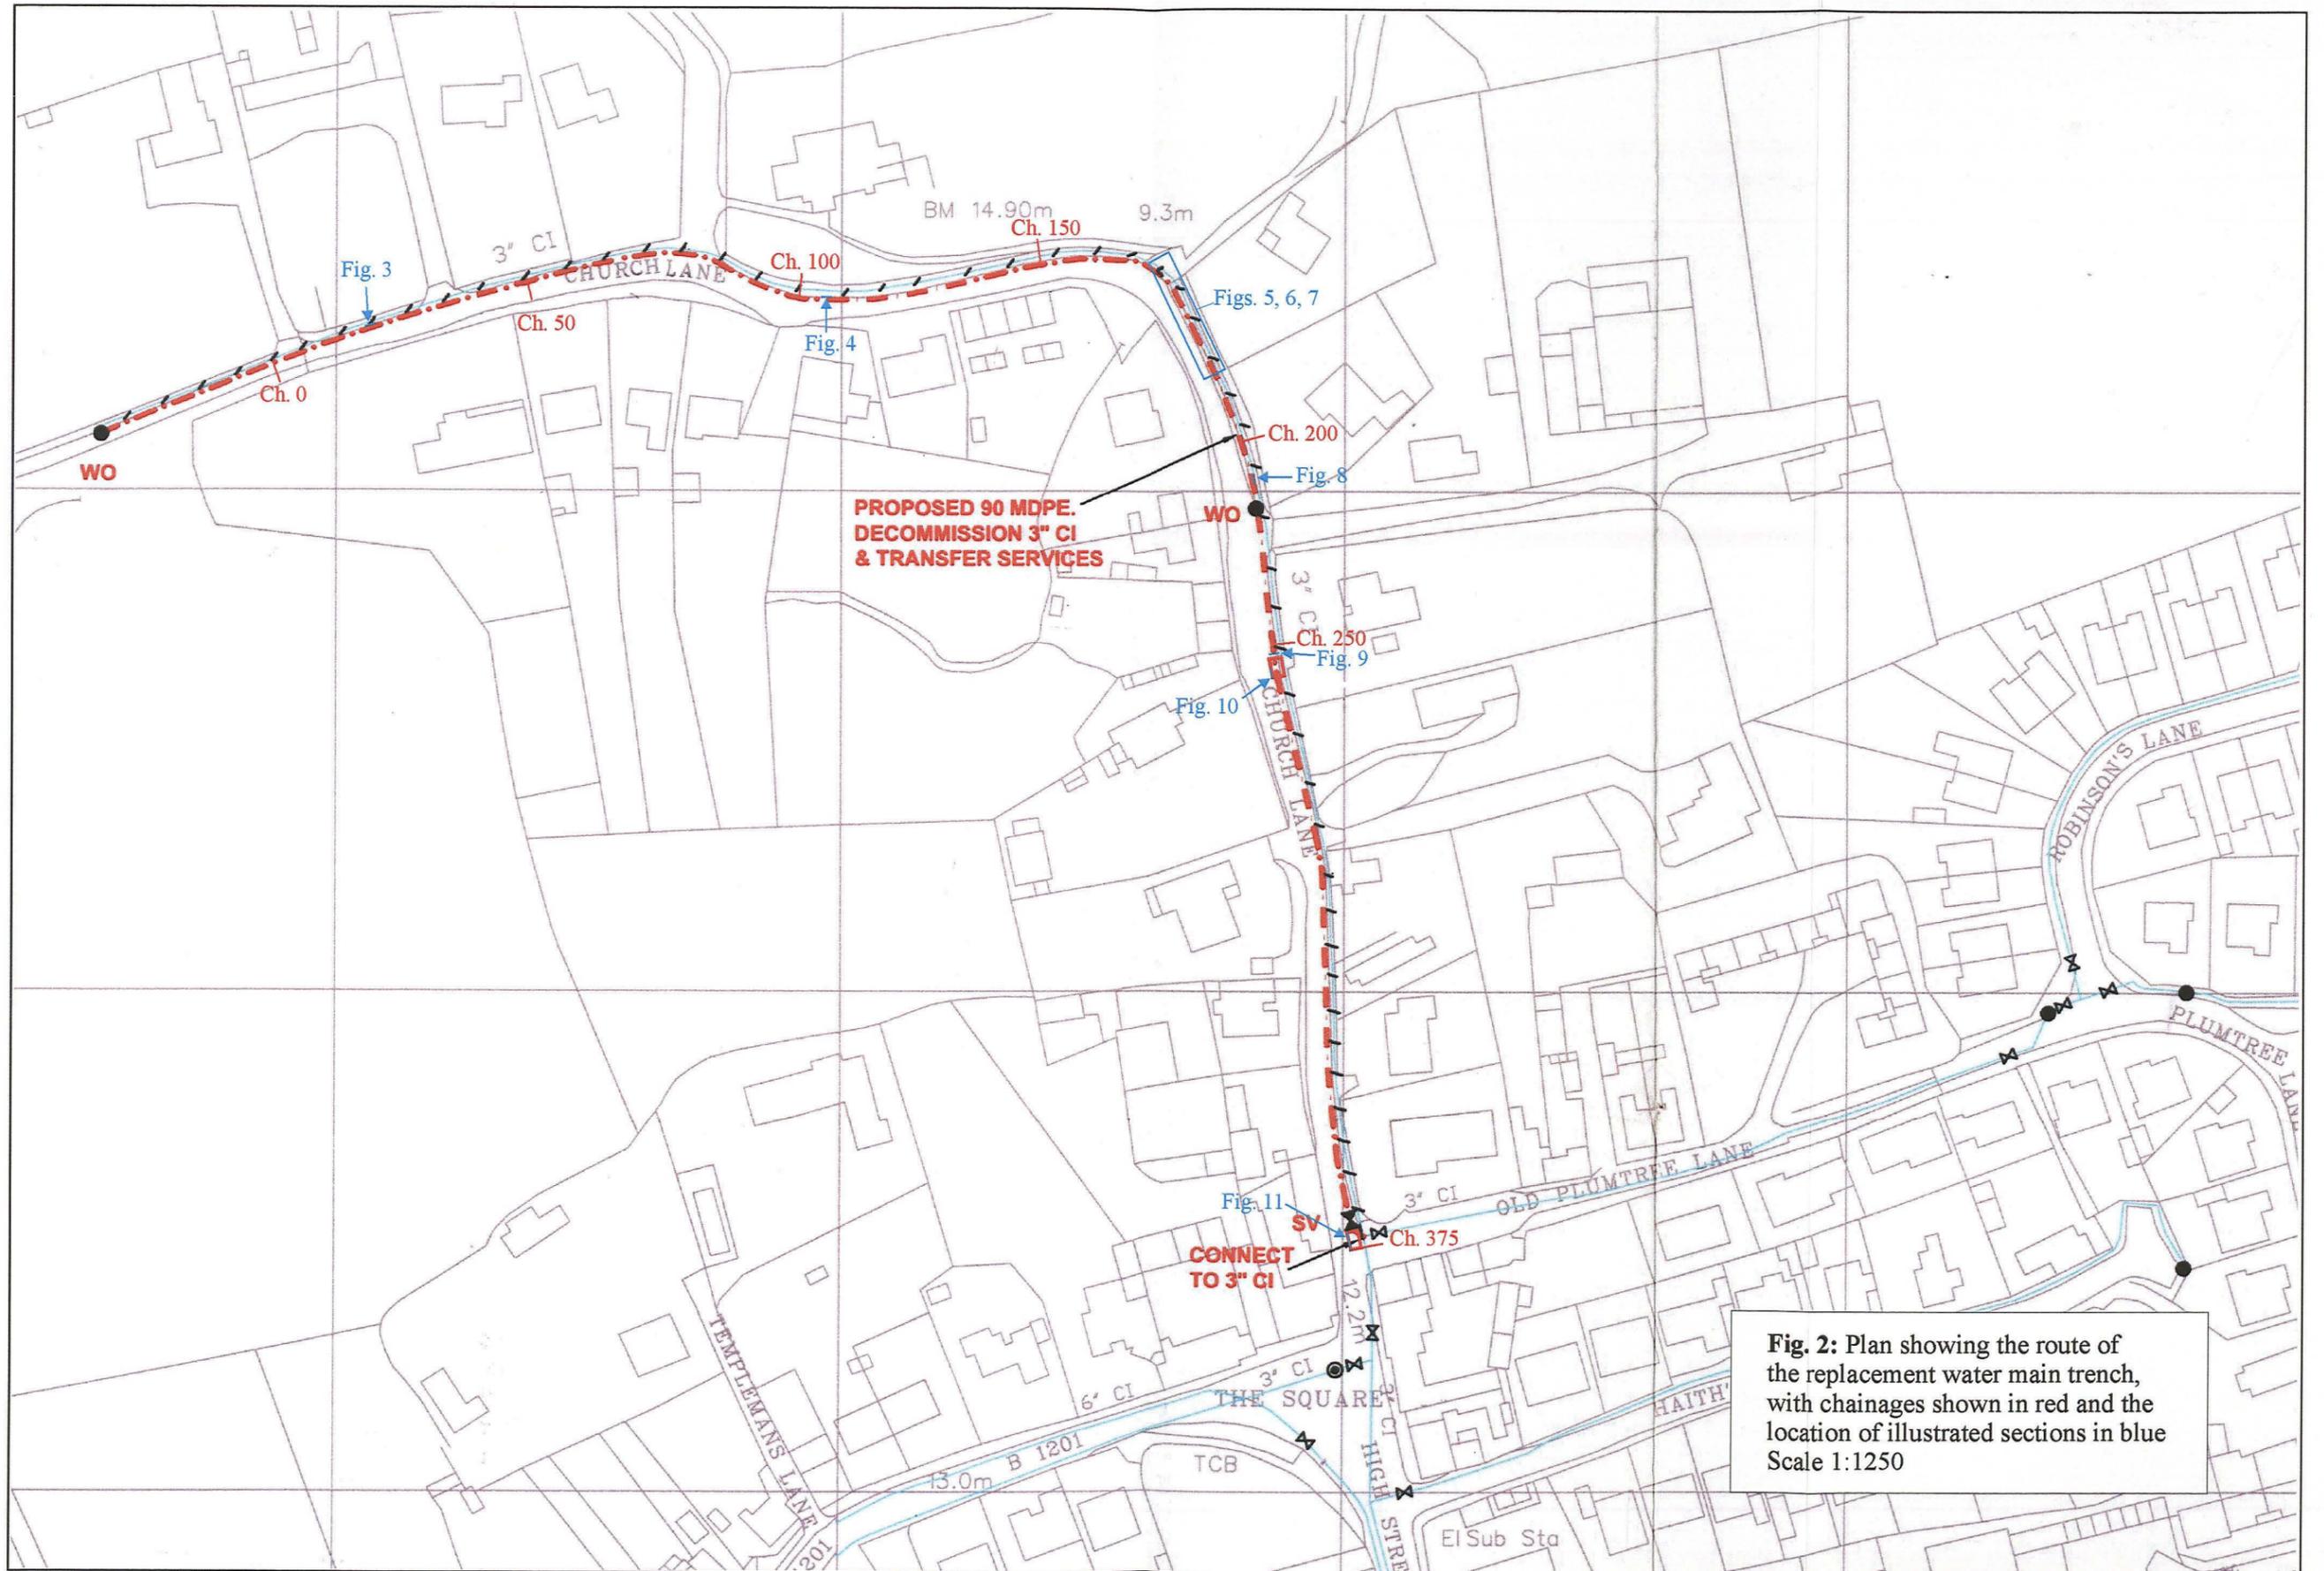
**Fig. 2:** Plan showing the route of the replacement water main trench, with chainages shown in red and the location of illustrated sections in blue Scale 1:1250

Church Lane runs north from The Square in the centre of the village for some 230m, before turning to the west and passing to the south of the parish church. The water main was started at the north western end and laid in a trench for a distance of some 260m, before being directionally drilled for the final 115m.

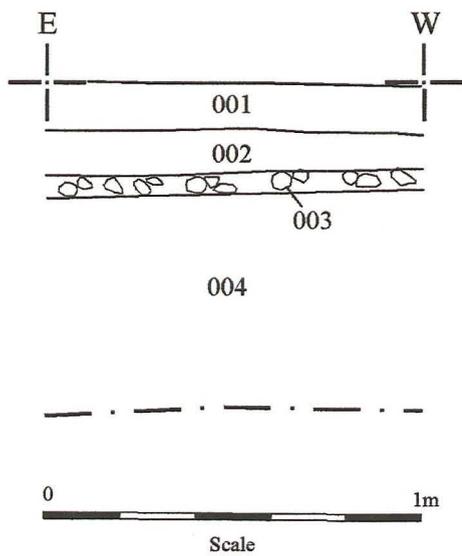
**Fig. 3:** North facing sample section of the pipe-trench, recorded at ch. 20. Scale 1:20

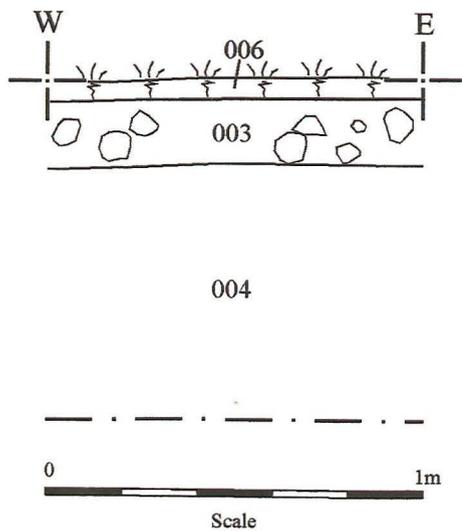
**Fig. 4:** South facing sample section of the pipe-trench, recorded at ch.100. Scale 1:20

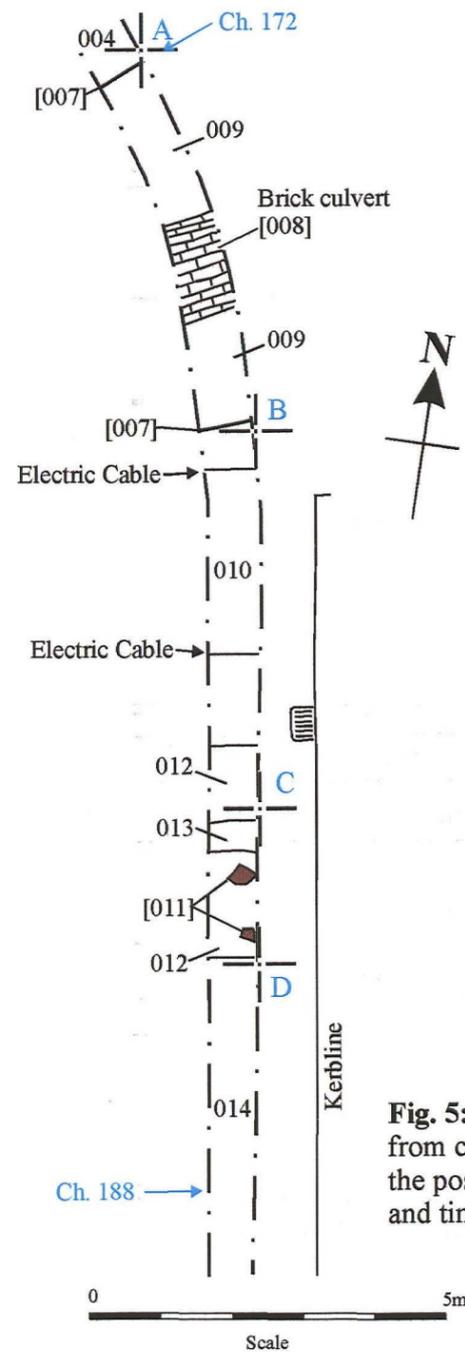
**Fig. 5:** Plan of the pipetrench from ch.172 to ch. 188, showing the position of brick culvert [008] and timber posts [011]. Scale 1:100

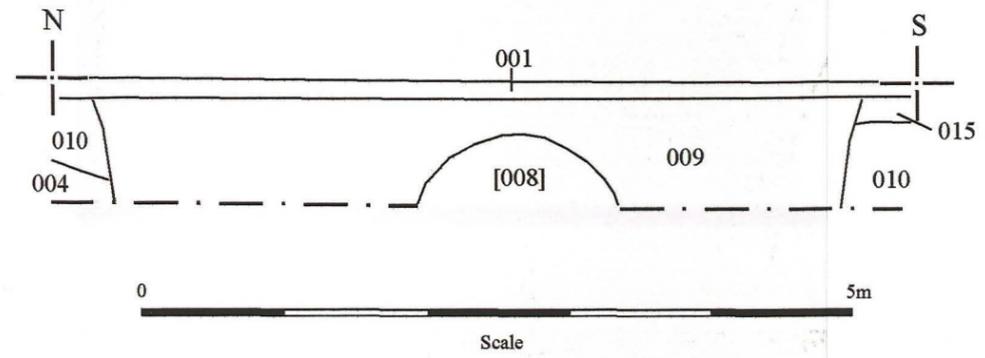
**Fig. 6:** West facing section at ch. 172 to ch. 178, showing brick culvert [008]. Scale 1:50

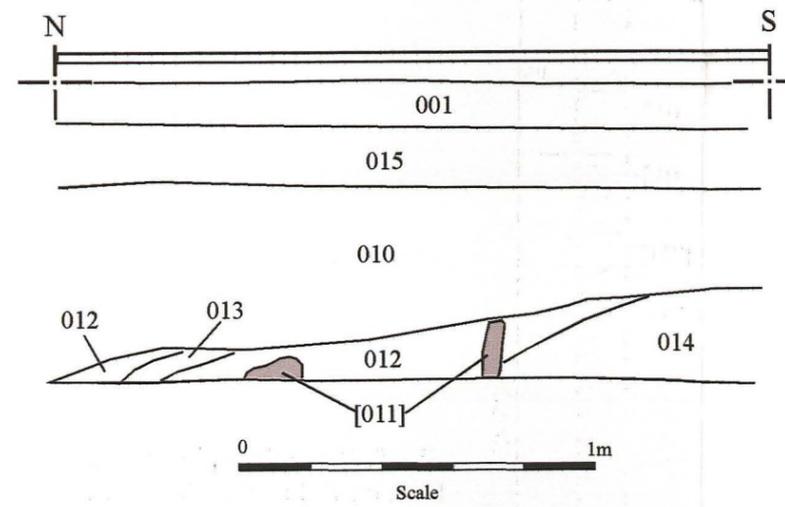
**Fig. 7:** West facing section at ch. 183 to ch. 185, showing timber posts [011]. Scale 1:20

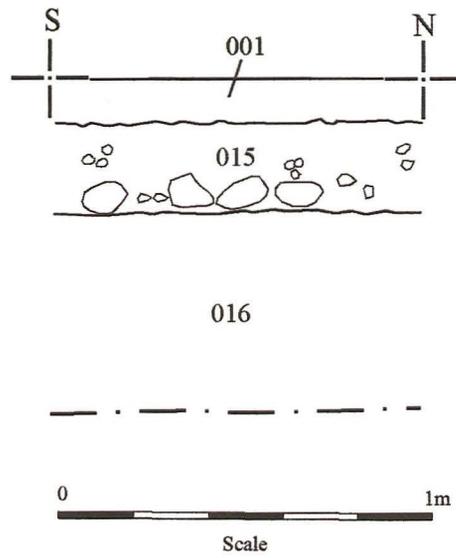
**Fig. 8:** East facing sample section of the pipe-trench, recorded at ch.210. Scale 1:20

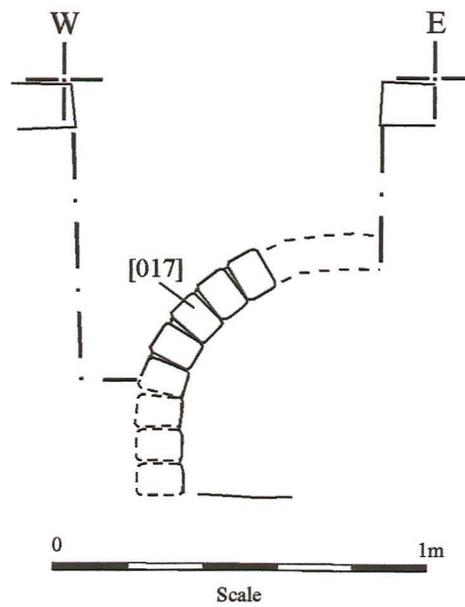
**Fig. 9:** South facing profile of the brick storm drain, recorded at ch.254. Scale 1:20

A brick storm drain [017] was encountered on the east side of the trench at ch. 220. This veered gradually to the west over the next 30m, until it occupied most of the trench, and it was decided to thrust bore the remaining distance, so as not to cause further damage to the storm drain. The trench was widened at ch. 260 to facilitate the thrust-boring.

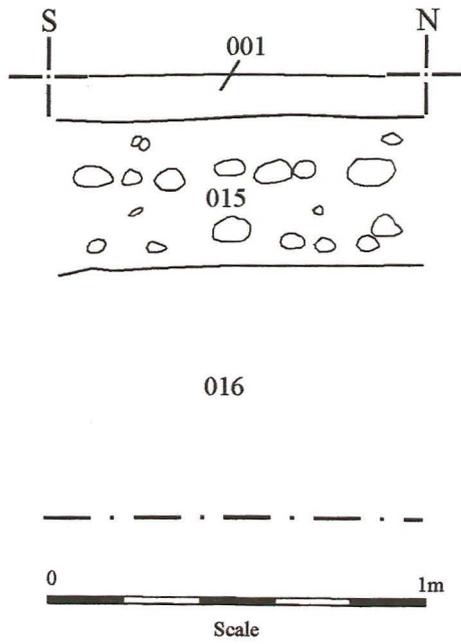
**Fig. 10:** East facing sample section of the pipe-trench, recorded at ch.260. Scale 1:20

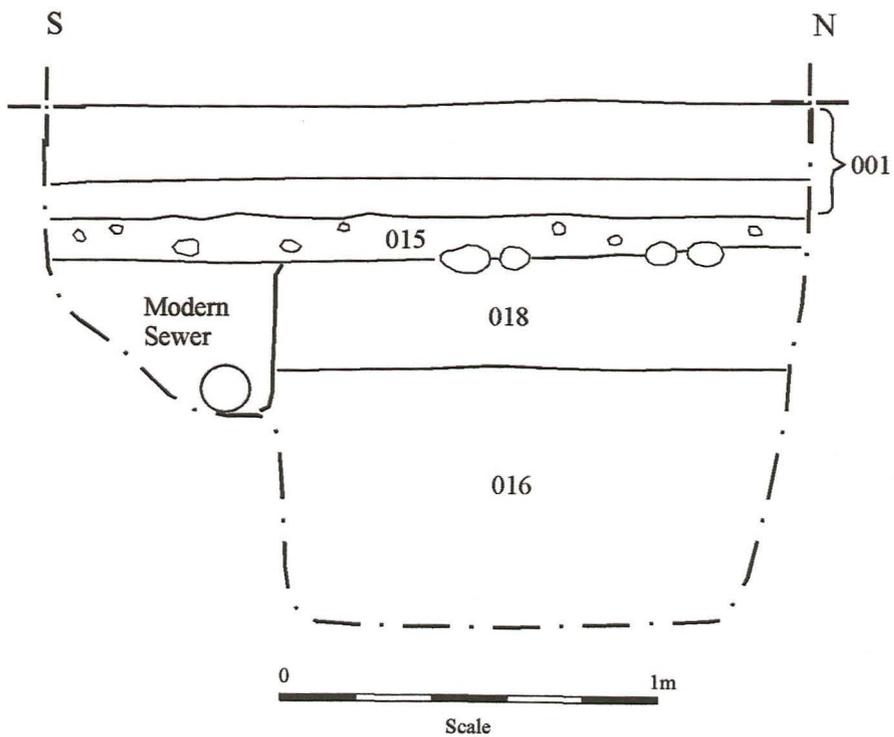
**Fig. 11:** East facing section of the reception pit at ch.370. Scale 1:20

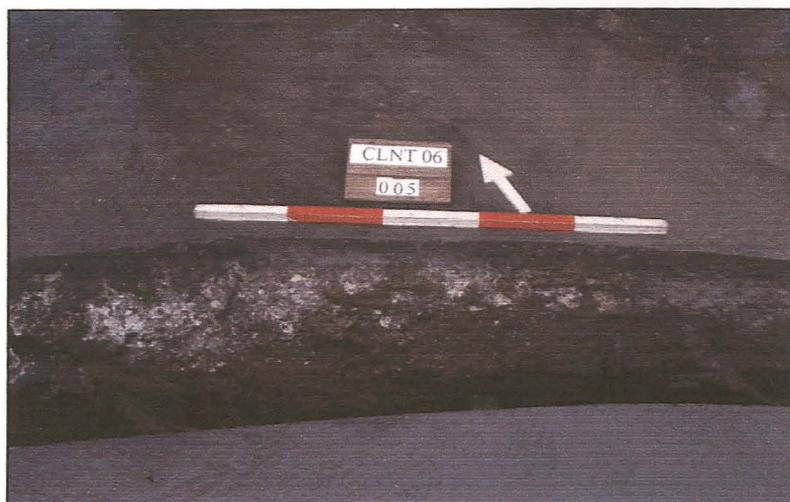
**Plate 4 (left):** Section through road surface (005), looking north east.

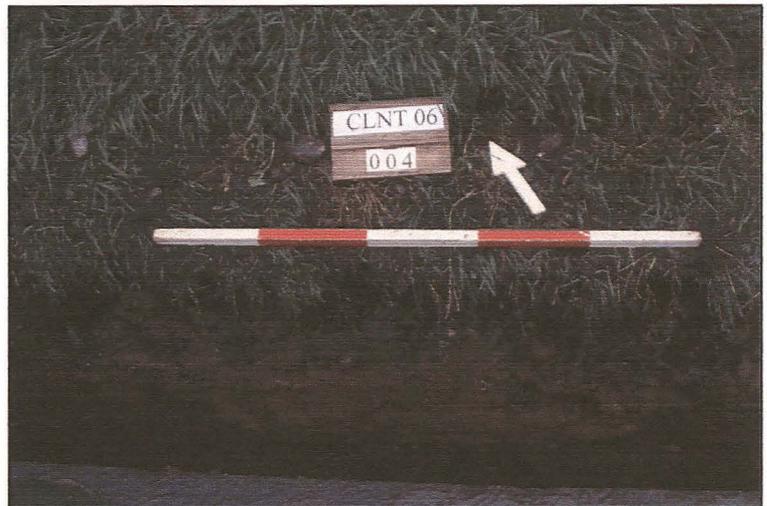
**Plate 6 (right):** Sample section at ch. 100, looking north east.

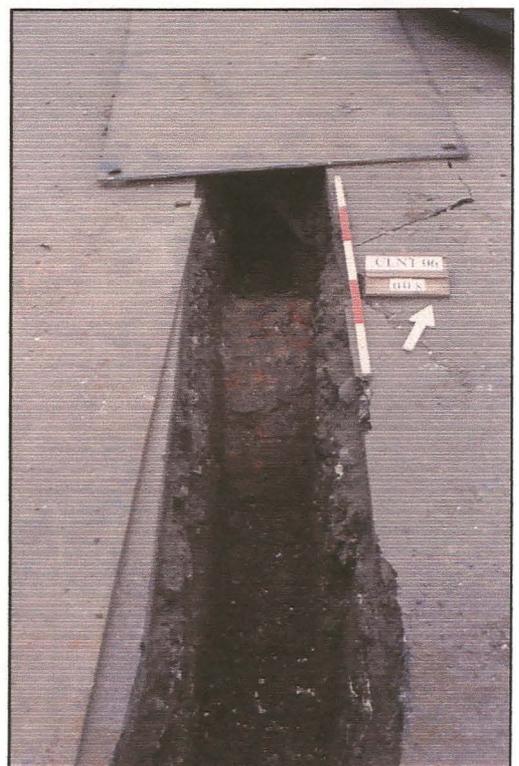
**Plate 8 (right):** Brick culvert [008], exposed at ch. 175, looking north.

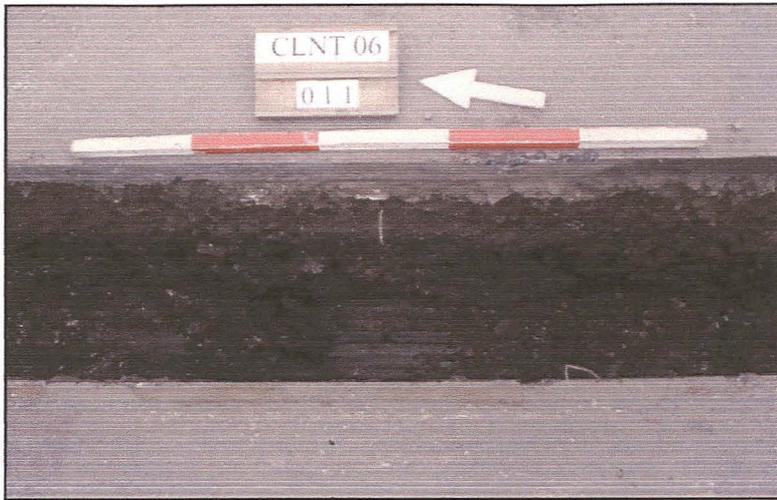
**Plate 9 (left):** Section at ch. 184, showing (012) and the remains of timber posts [011], looking east.

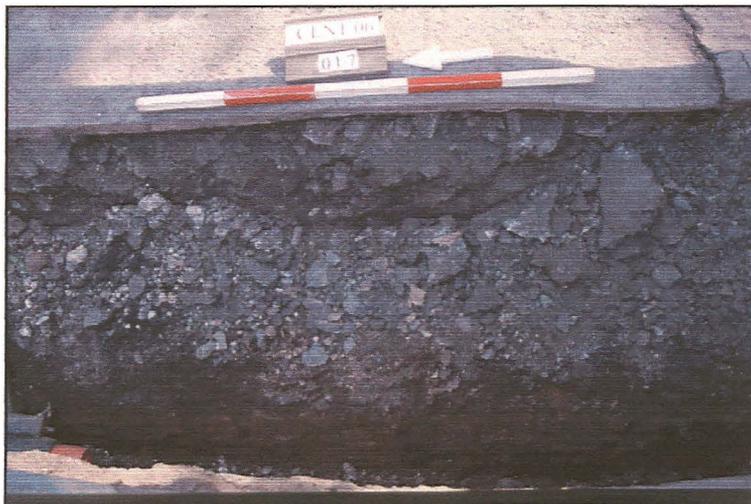
**Plate 11 (left):** Sample section at ch. 255, the brick storm drain [017] can be seen at the base of the trench.

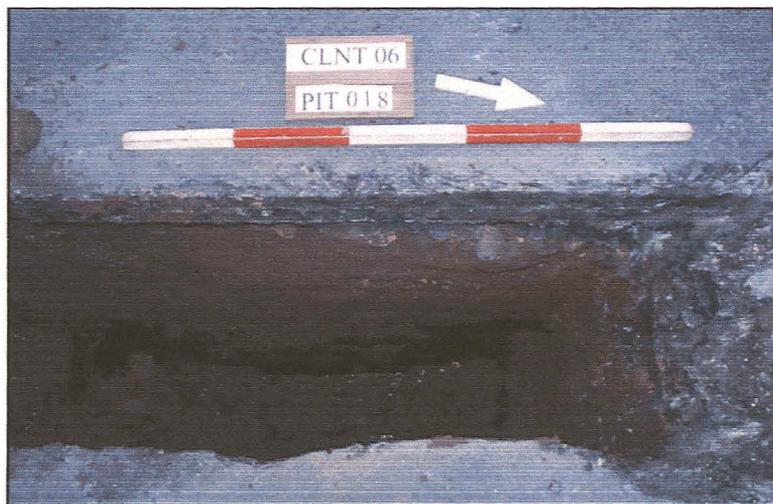
**Plate 13 (right):**  
Sample section of the  
reception pit at ch. 375,  
looking west.
