**ROYAL
COMMISSION
ON THE HISTORICAL
MONUMENTS
OF ENGLAND**

HISTORIC BUILDING REPORT

**Bay Hall
Hall Lane
Benington
Lincolnshire**

September 1991

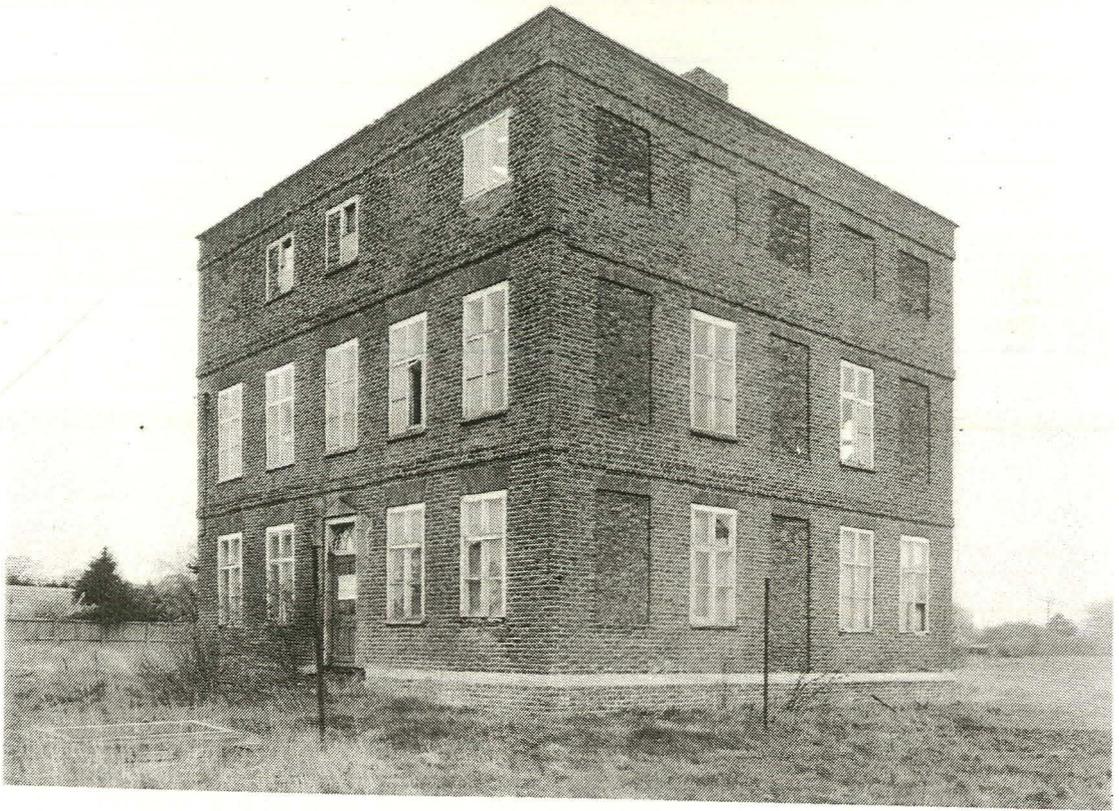
View from south-west

Bay Hall is a three-storeyed brick house of double-pile form. It is of five bays on west and south fronts, the main elevations of the building, but on the east and north sides there are only three bays. Brickwork is in Flemish bond, there are projecting brick bands over ground, first and second floors, and stone is used in a chamfered plinth and parapet coping. Windows have pegged oak frames of cross form and splayed brick lintels, deeper on the west front than elsewhere. The present roof is flat and of modern date. It probably replaces a hipped roof, perhaps with a central well.

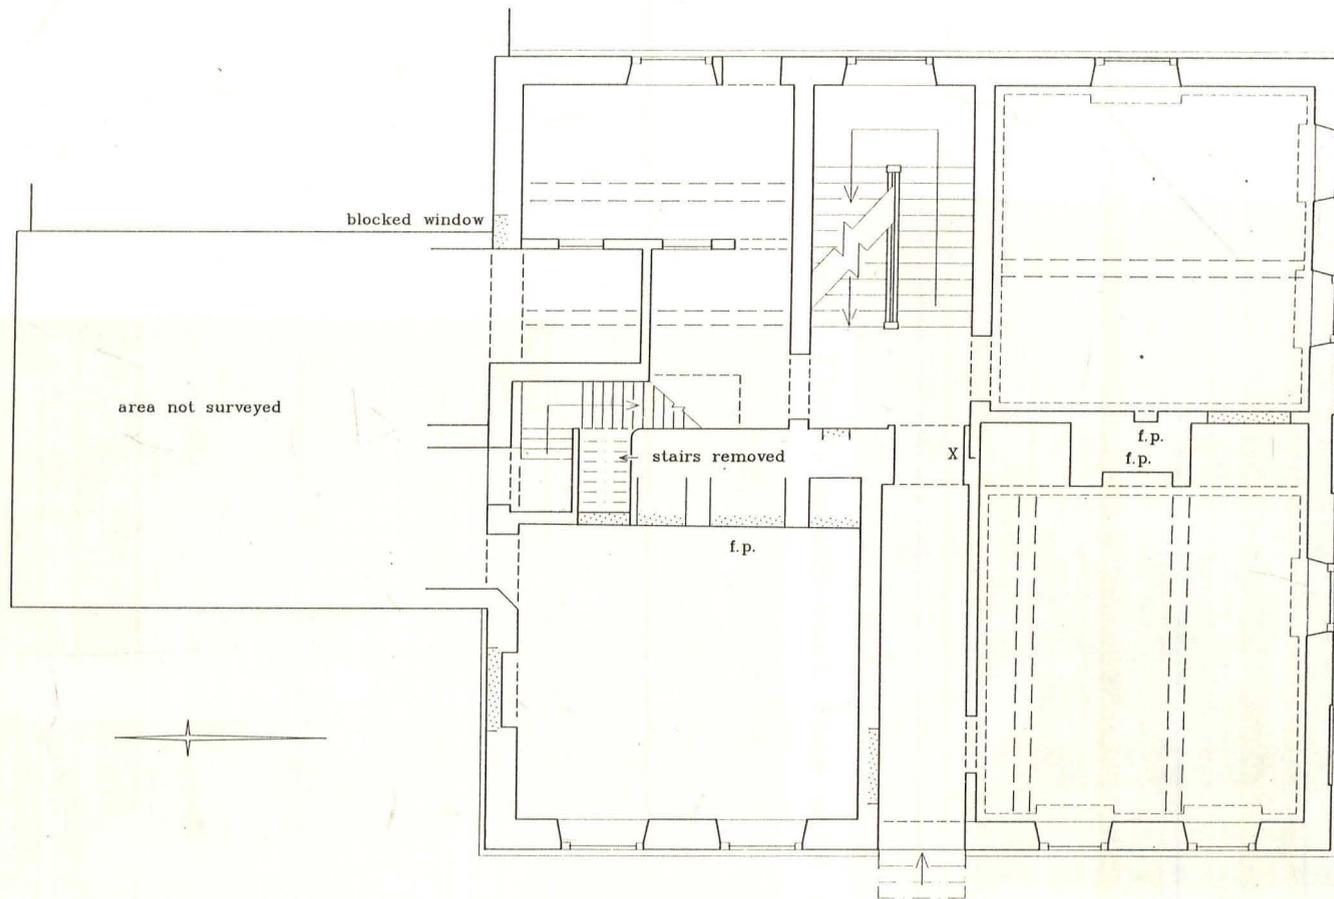
Bay Hall, Benington, Lincolnshire.

Ground floor plan

The plan of the house is unusual in so far as the principal entrance front was not lined with the best reception rooms, for on the ground floor it had a kitchen to one side. The common functional division between reception rooms to the front and lesser rooms and service accommodation to the rear does not apply at Bay hall, where on the ground floor at least the division is between the sides of the house, with better rooms to the south and lesser rooms to the north. The principal doorway on the west front therefore lies at the junction of these areas. It opens now into a single-bay entrance passage. This is probably the result of a later alteration and it is likely that the doorway originally gave direct access to the south-west room, the hall. Beam spacings here suggest that the area of the passage was part of the room, and the position of the fireplace, off-centre within the present room, lends support to this argument. Furthermore, the wall dividing hall and passage is not bonded into other walls at either end, suggesting that it is an insertion. Decorative details within the reduced hall are thus likely to result from a refurbishment following the creation of the passage, but some raised fielded panels within recesses to either side of the fireplace may survive from the original room.

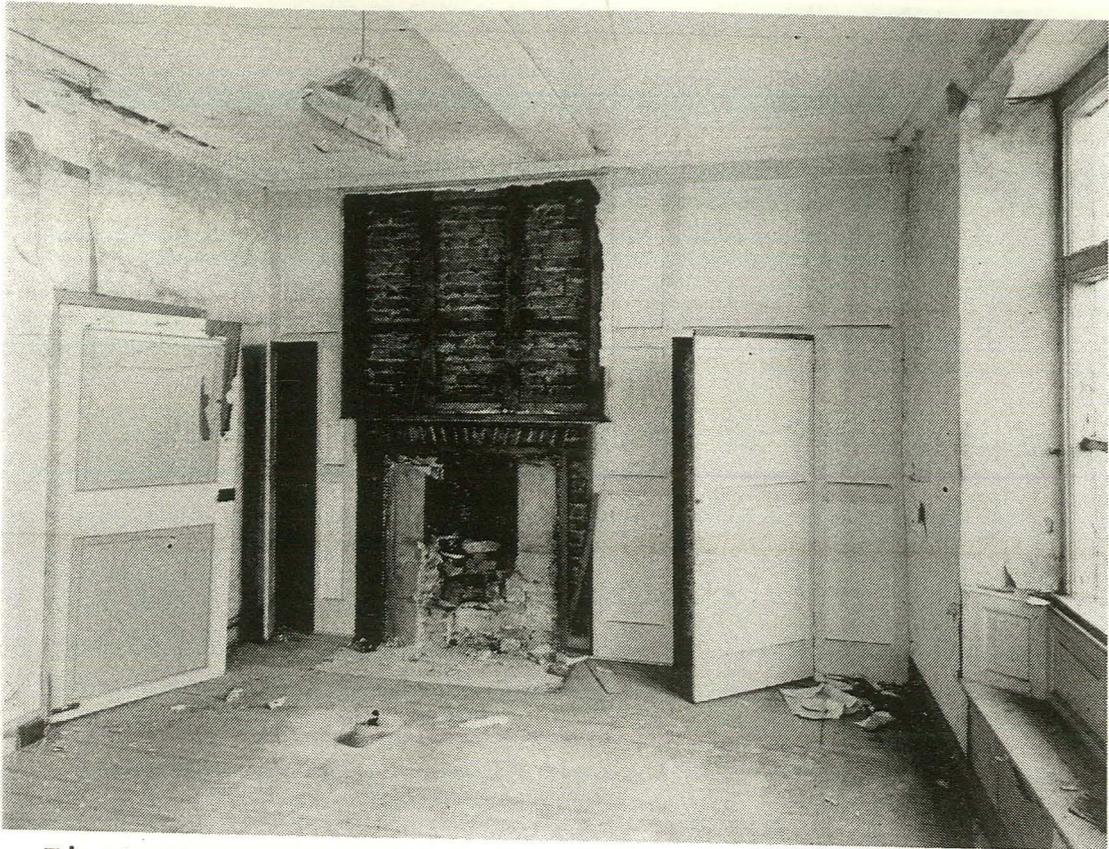
First floor, south-west room with inserted partition

On the first floor the major change was the reduction of the south-west chamber from three bays to two and the creation of a dressing room in the extra bay. As a result of the change the fireplace heating the chamber is markedly off-centre. The fireplace wall was lined with plain panelling, three panels to the height of the wall.

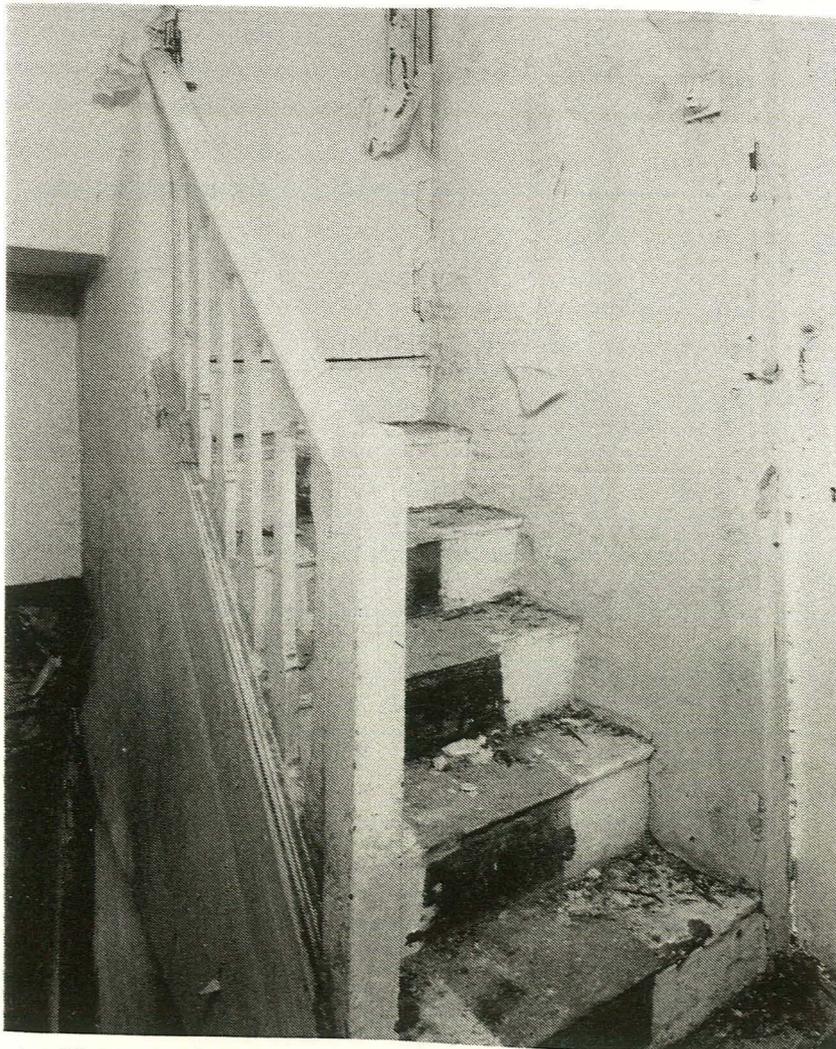
First floor, service stair rising to second floor

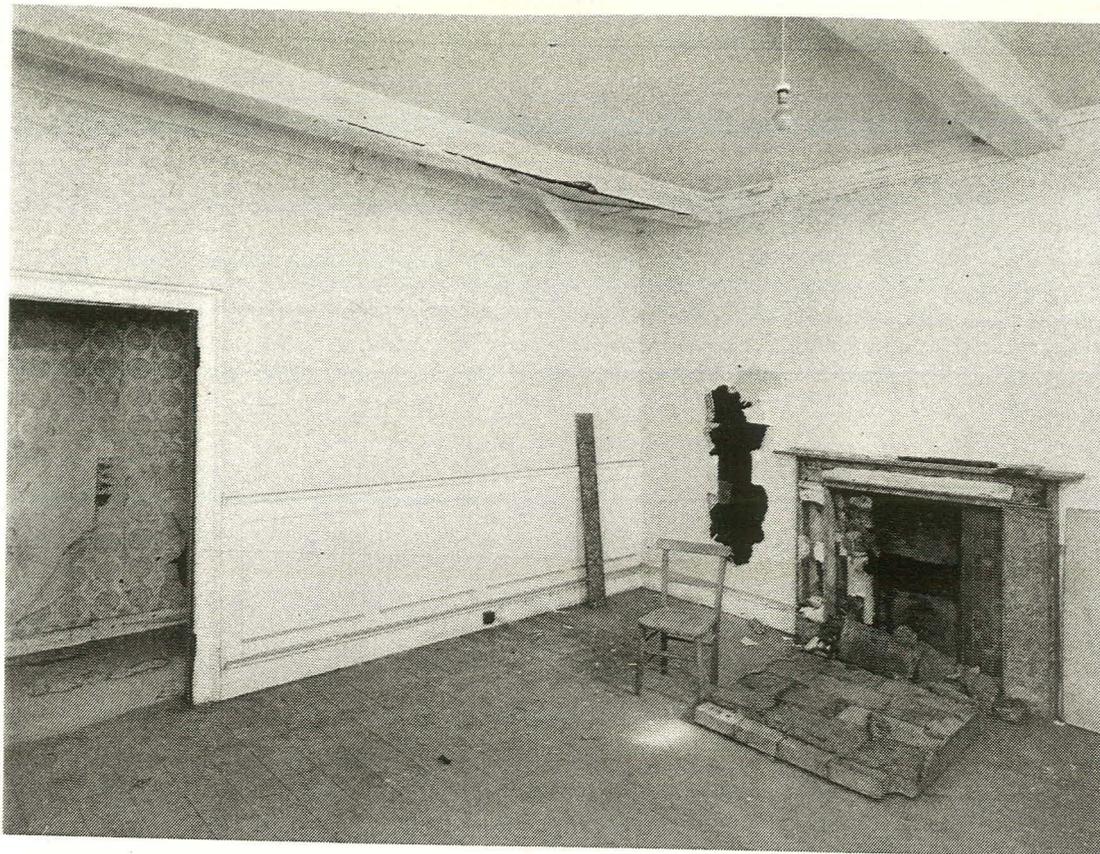
South-west room (hall) with later inserted partition

On the ground floor the principal alteration was the creation of an entrance passage, contrived by reducing the hall to two bays. The panelled arched opening through to the stair hall probably dates from this period, as do the panelled dado and plaster cornice in the reduced hall. The dado has simple plain panels, contrasting with the raised

and fielded panels of the earlier work. The plaster cornice defines a hall of reduced size, being present on the inserted wall, and breaks forward at the windows. The south-east room has a similar cornice and a plain panelled dado and therefore appears to have been re-fitted at this time.

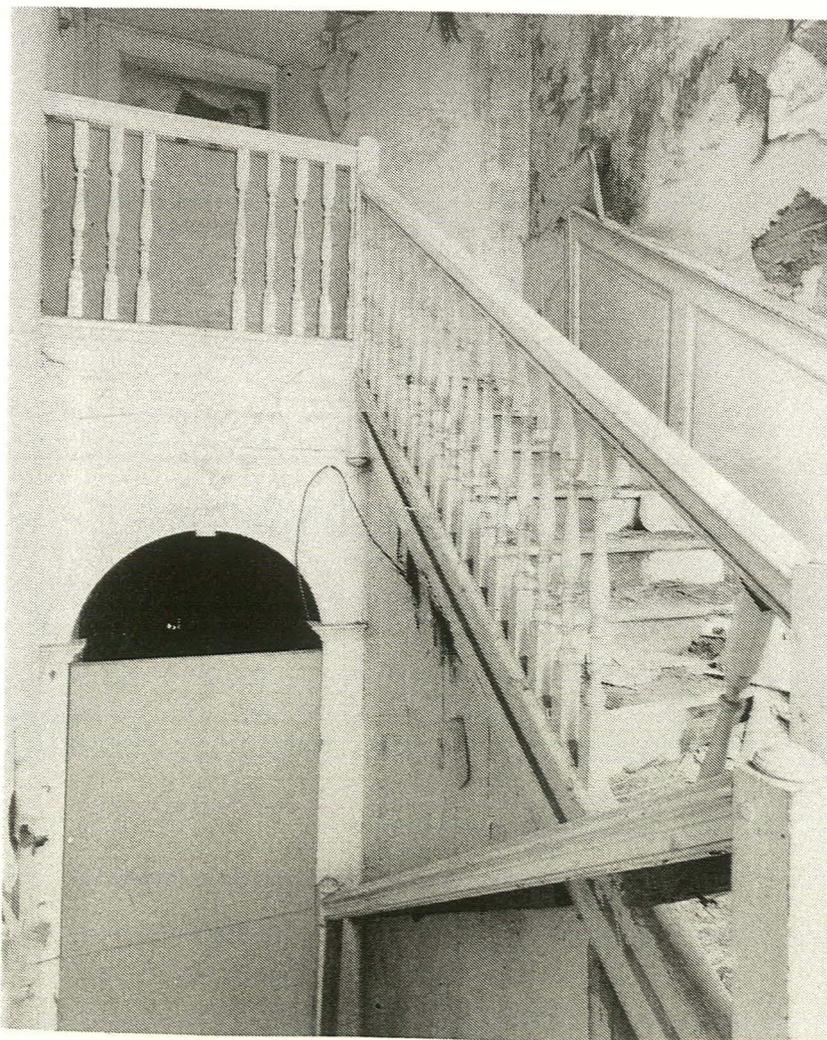
Principal staircase rising to first-floor landing

The principal staircase rises to the first floor only. It is of dog-leg form and has square newels, moulded handrail, closed string and slender bulbous turned balusters. The stair hall retains some raised and fielded panels below a dado rail. The first-floor landing originally opened into heated chambers in the south-east, south-west and north-west corners of the building and into a second landing at the head of the service stair. The principal chamber was that over the hall. Like this room, it was originally of three bays, later subdivided to give a dressing room; its fittings and decoration date from this subdivision. The size of the original room and the limited number of reception with drawing room when the house was first built. Other rooms are smaller and were probably the best bedrooms. The service stair rises to the second floor and retains some splat balusters. On the second floor are two further heated chambers and two unheated rooms. The partial decay of the plaster lining has exposed the internal face of the brickwork on some walls, and the absence of evidence for blocking in some places demonstrates that the blind windows which form part of the composition of the walls externally have never been openings and belong, therefore, to the original design.
