Shildon Little Engine House

Shildon by Blanchland, Northumberland

Community Excavation

Data Structure Report

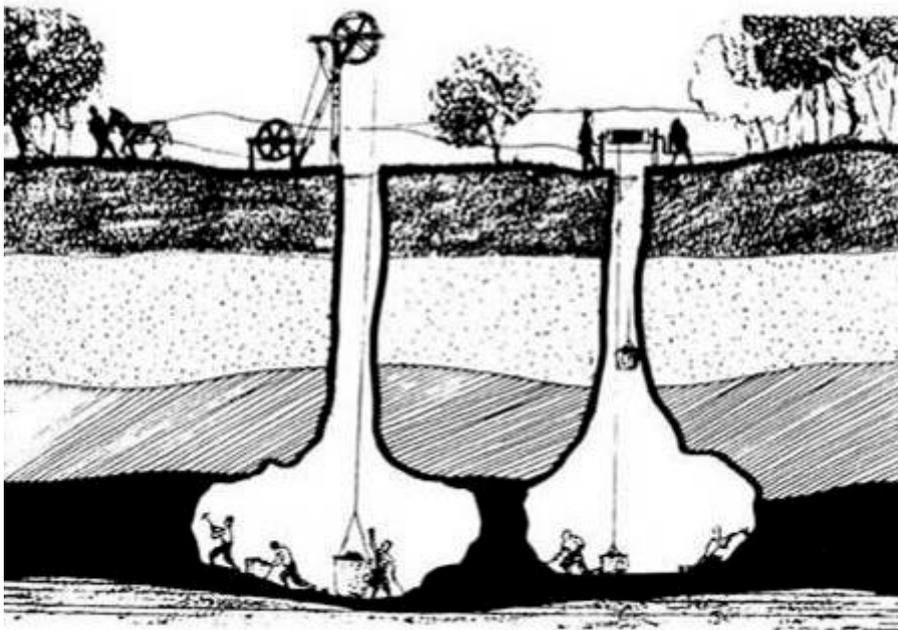
Figure 2 Bell pit mining section.

The earliest method of mining lead with bell pits was used in the Blanchland area from ancient times until the 18th century. A shaft was dug, and then worked outwards into the veins of ore. These workings were small scale, as the shaft might have been only 10 metres deep, and the workings became unsafe beyond a few metres out from the shaft. There were also no systems for ventilation or water removal. Each pit would be quickly exhausted, requiring another shaft and pit further along the vein. This method of extraction was very labour intensive, and was only able to exploit veins close to the surface.

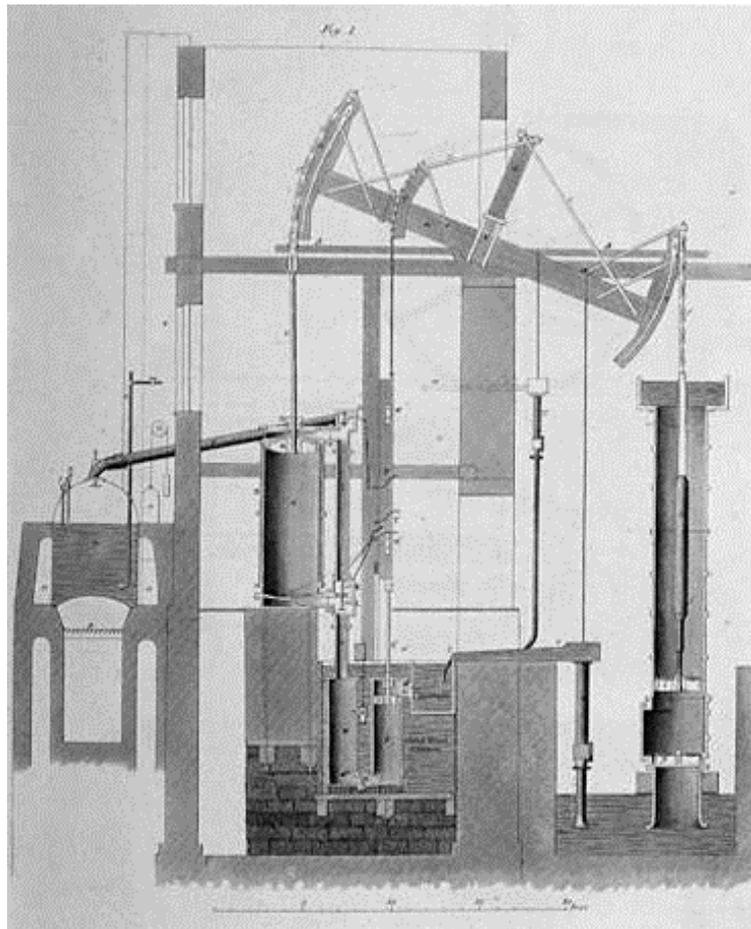
Figure 3 Boulton & Watt single-acting pumping engine, 1788 (Science Museum)

Steam, generated by the boiler on the left, is supplied to the vertical cylinder, pulling the piston, and the left hand end of the beam down. This draws up the right hand end of the beam and the pump connector rod, which pulls water up the pump cylinder, deep in the mine shaft. The condenser is in the centre, below the cylinder.

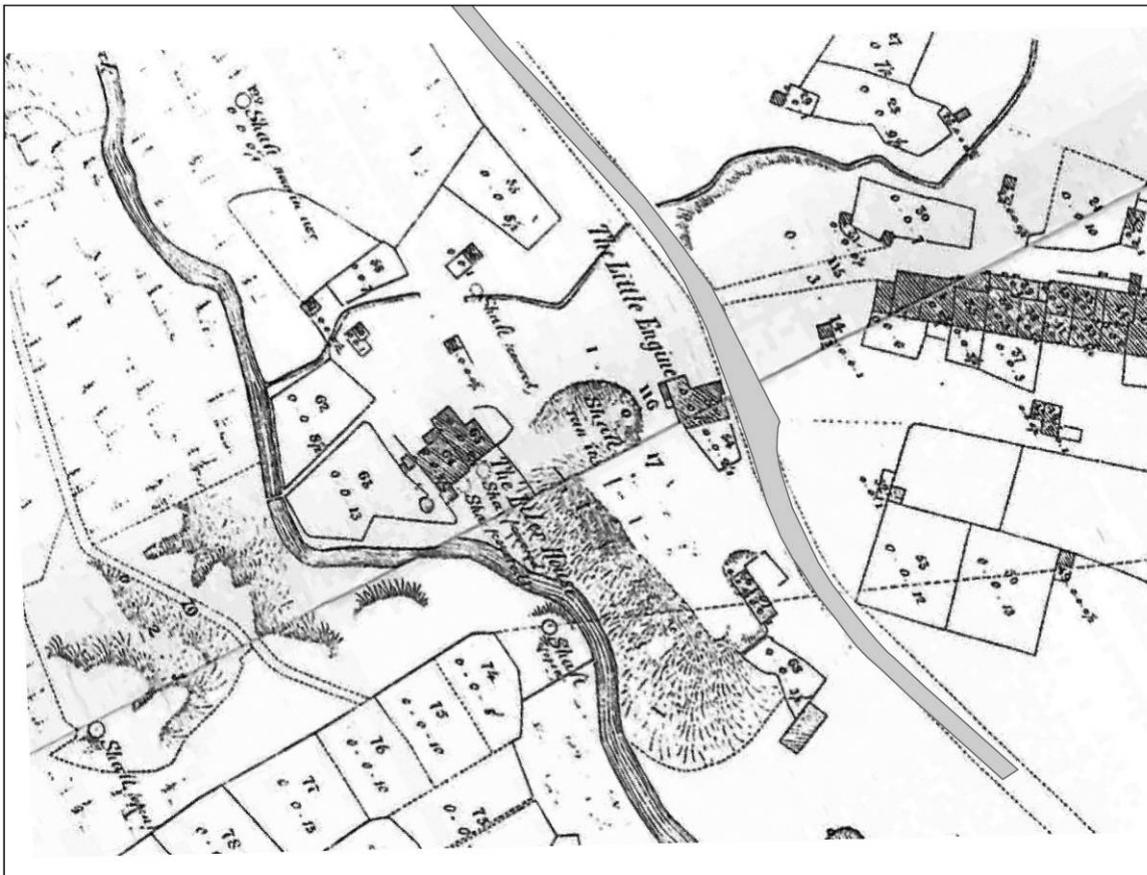
Figure 4 19th century plan of Shildon and adjacent mine workings

Although begun simultaneously, it was the location of a possible corner stone visible protruding from the topsoil in the area laid out for Trench 2 that assisted placement of Trench 1. A 19th century map of Sildon and the mine workings (*figure 4*) was superimposed upon the modern topographic survey undertaken during an earlier phase of the project. This gave some points from which to base rough triangulation measurements aimed at pinpointing the NE corner of the Little Engine House. These measurements combined with the dimensions taken from the cartographic resource indicated the area in which the NE corner should be located.

The cartographic evidence was a little inconsistent as to the shape of the Little Engine House complex in this location. The 19th century map of the settlement of Shildon and the adjacent mine workings held by the Lord Crewe's Charity (*figure 4*) seems to show the chimney to step out to the NE, and stand proud of the main building in this area. Conversely the OS maps seem to show the chimney as flush with the E elevation of the complex (*figure 7*). Neither however are particularly clear.

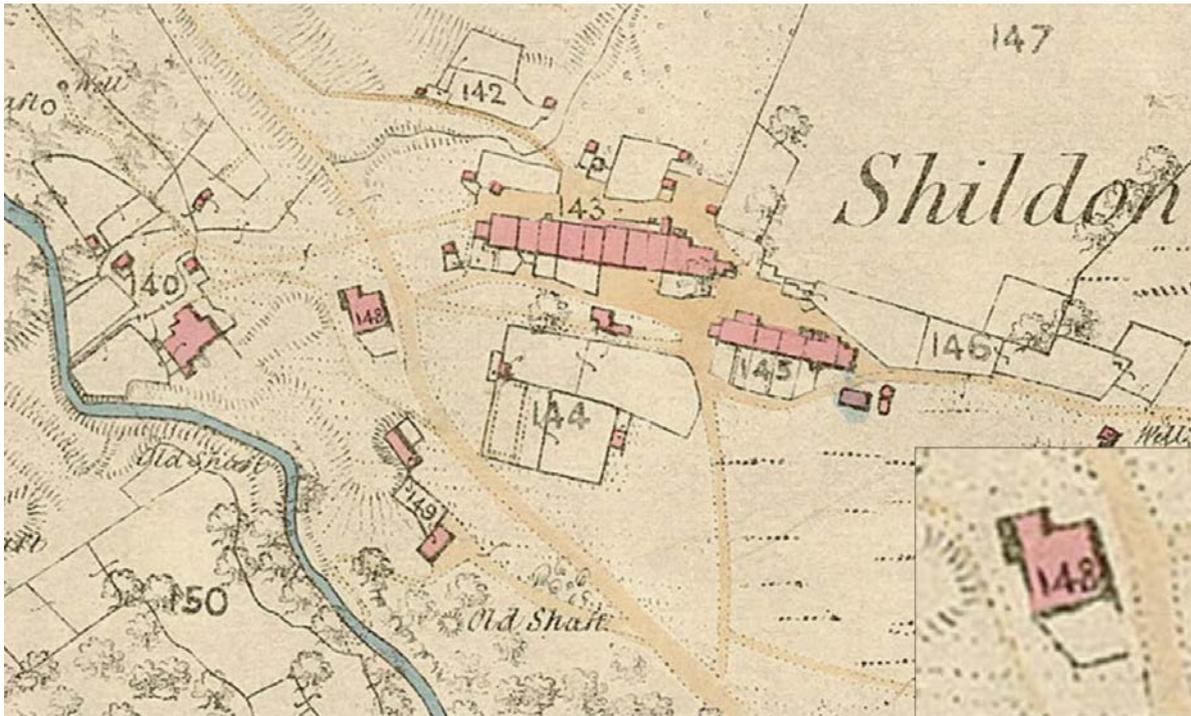
Figure 5 First Edition Ordnance Survey, surveyed 1861. Note the Little Engine House marked 148 and shown in the inset (County Series: Durham)

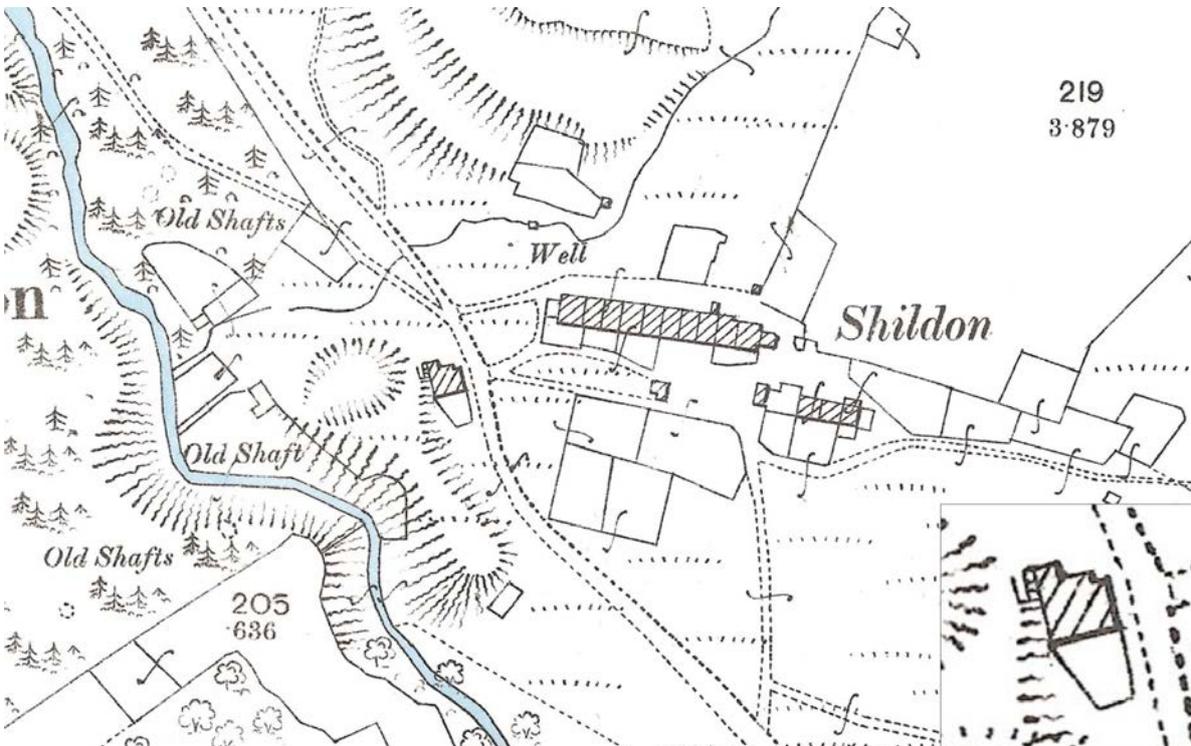
Figure 6 First Revision Ordnance Survey, surveyed 1898 (County Series: Durham). Note the Little Engine House (inset). The structure is essentially the same, but with a small indentation to the NE corner. This edition records a landscape heavily populated with abandoned mine workings, shafts, rail, and waterways.

However, the date of the building defined by {2004} is a matter open to conjecture. At first glance this seems clear enough. The Ordnance Survey map of 1898 (*figure 6*) shows the S side of the building to be flush and does not portray an extension which does not run the length of the main building (as shown in *figure 16*). Conversely the picture of c.1901 clearly shows this extension to have been in place. Thus it must be assumed that the extension and thus {2004} were constructed between 1898 and 1901. This however seems too clear cut and does not stand up to scrutiny. The mining industry in the area was at its most productive in the mid 19th century, but by 1901 the industry had all but ceased and the population fallen dramatically. The Derwent Mining Company had gone into liquidation in 1883 and whilst the Large Engine House is recorded as having become accommodation by the 1860s, by the picture of 1901 it sits derelict and roofless (*figure 8*). Likewise two of the cottages to the E of the Little Engine House sit as roofless shells, and although the Little Engine House appears as complete and roofed, it does not seem likely that in such a situation the occupants (if such were present) would have built a small extension onto what is already a large building. An explanation is available with a comparison of the 1898 Ordnance Survey map (*figure 6*) with that of 1920 (*figure 7*). The 1920 version clearly shows the small lean-to building alongside the structural divisions and extensions to within the structure, arguably supporting the idea that this had been constructed post-1898. However, if the 1920 map is overlaid upon the earlier, it is clear both the buildings and the small courtyard area have the same dimensions. This suggests the 1898 map does not contain the same level of detail as the 1920s version and cannot be relied upon to give the exact layout of the building. In all likelihood the building as it stands in the 1901 postcard is the same as that surveyed and printed in the map of 1898, but the detail on the 1898 OS First Revision is somewhat lacking.

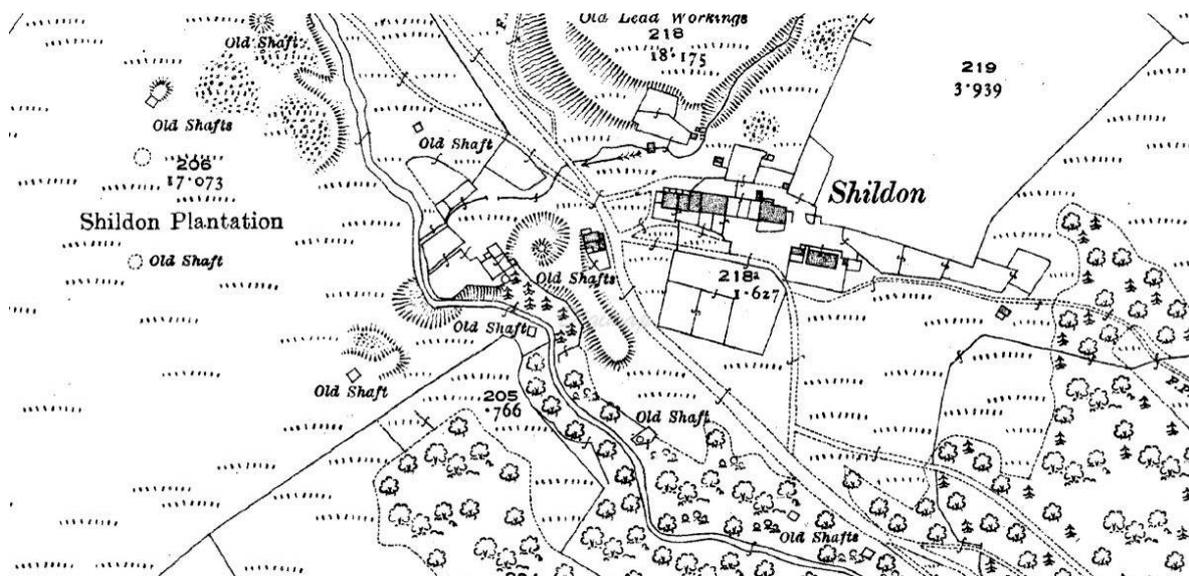
Figure 7 OS 2nd edition dated 1920. Shows the Little Engine House in some detail (County Series: Durham)

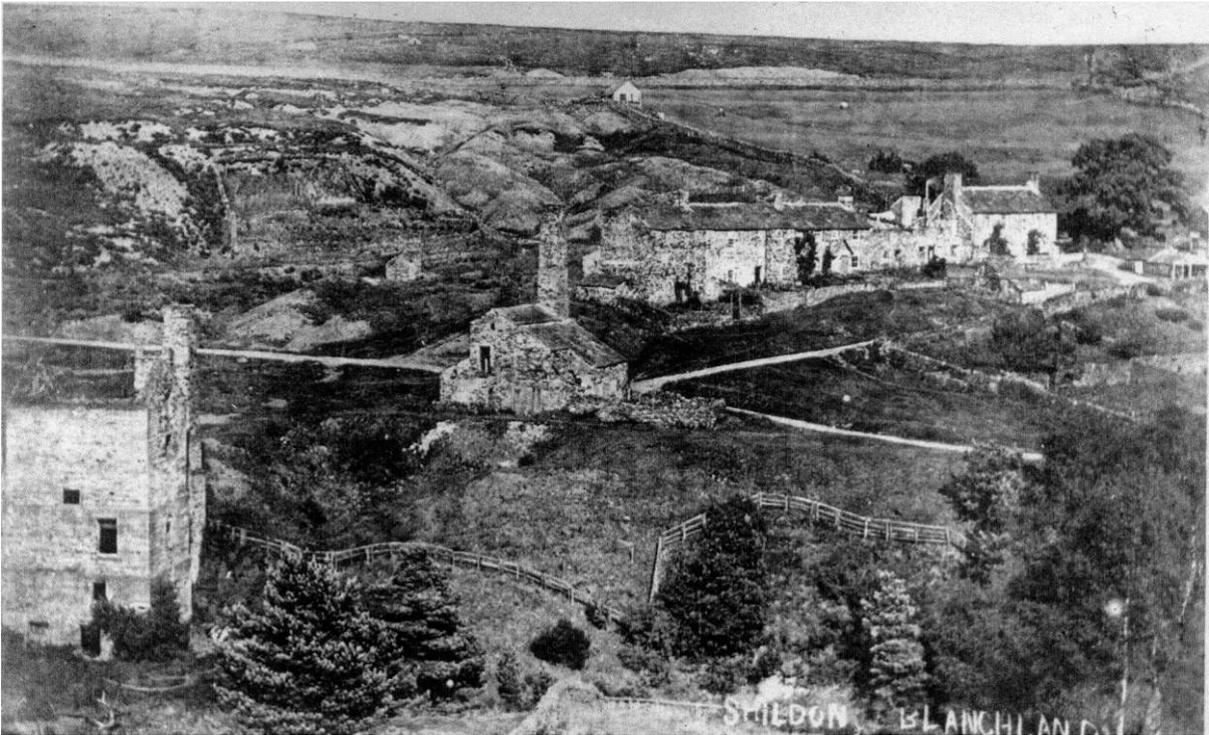
Figure 8 Historic picture of Sildon from a postcard postmarked 1901. The Little Engine House is in the centre of the picture. Note the phases of construction to the right of the building. Evidence of these was discovered in Trenches 2 and 3

The earliest image (*figure 8*) is from a postcard postmarked ‘1901’. This is obviously the date at which the postcard was mailed and the picture may indeed be earlier, but it provides an excellent view of Shildon at the turn of the 20th century. It is interesting to note the Little Engine House is almost completely intact with the roof still covering the entire structure. This is in sharp contrast to the larger Engine House in the foreground and two of the cottages in the background. It is known that after the mines fell out of use the larger Engine House was used for flats, but this is not recorded for the Little Engine House. The image from 1901 indicates that if these were not used for accommodation, the Little Engine House complex must have remained in use in some form to have retained its roof and walls intact.

The archaeological evidence seems to support the latter, and there may be an inconsistency in the cartographic resource. Although not particularly clear on this matter, the postcard post-dated 1901 (*figure 8*), the undated photograph (*figure 9*) and the painting showing the ruin in 1946 (*figure 10*) seem to indicate the E wall of the complex to run flush with the chimney,

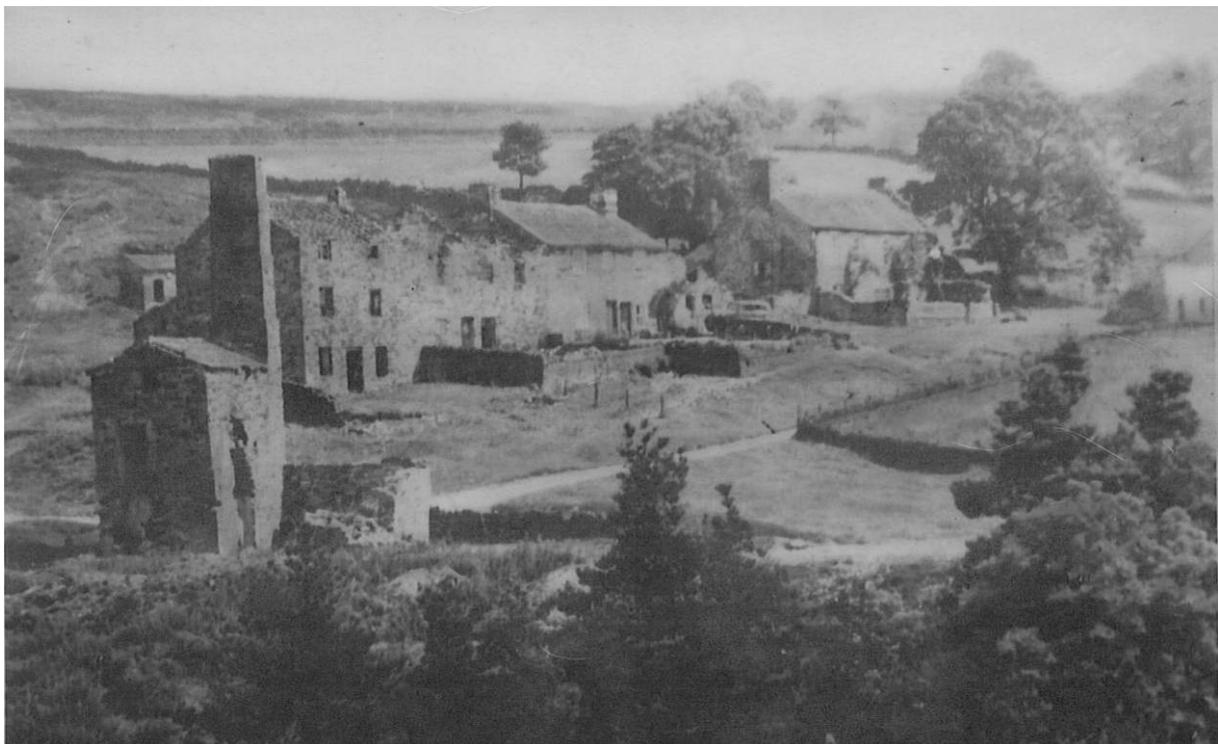
Figure 9 View of the Little Engine House from a picture of uncertain date, but thought to have been taken in the 1940s from comparison with Figure 10. Taken from roughly the same angle as Figure 8, in conjunction the two show the deterioration of Sildon and in particular the Little Engine House in the twentieth century. Also compare to Figure 11. (Paul Frodsham and Shirley Lee)

The second picture of the Little Engine House (*figure 9*) is undated, but it can be deduced from comparison with the painting by Eric T Huntley from 1946 (*figure 10*) that this picture was taken at some point in the 1930s or 1940s. The image shows the marked decay of the Little Engine House complex, with the main building and chimney surviving but shorn of the lean-to additions and walls still intact in 1901 (*figure 8*). The lack of stone around the structure indicates this had likely been recovered for use elsewhere, although it is remarkable given the deterioration of the complex and the houses in the background that the main body of the Little Engine House has retained its roof.

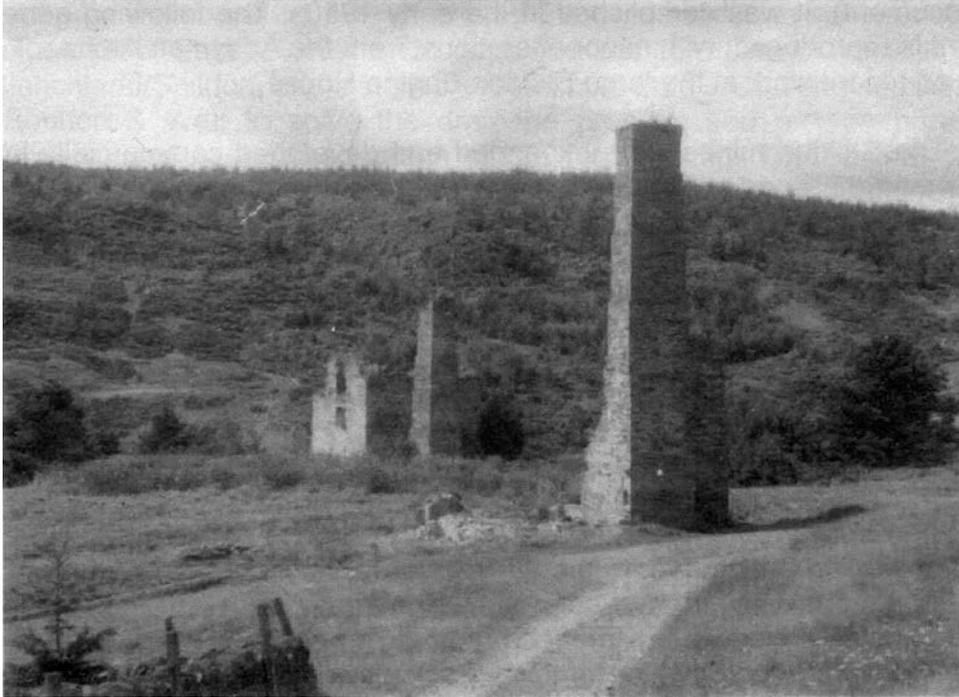
*Figure 11 View of The Little Engine House in the 1950s prior to the destruction of the chimney
(Paul Frodsham)*

The final view of the Little Engine House (*figure 11*) comes from a photograph of the 1950s. Taken at a different angle from the others, *figure 11* shows a significant change in the site since Huntley's painting of 1946. The chimney remains intact, but virtually all of the Little Engine House itself is gone. Although some rubble is clearly visible, it is likely that the majority of the building material was re-used elsewhere. The exact date of this image is unknown, but local resident Shirley Lee remembers the chimney being pulled down in the 1950s. Alarming by modern standards, this was completed by a tractor tying a rope around the chimney and pulling it over. It must be assumed that *figure 11* was taken just prior to the removal of the chimney stack, although the rate of collapse and deterioration between 1901 and the 1950s is remarkable.

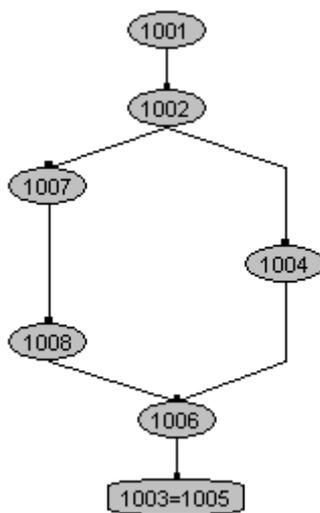
Figure 12 Harris Matrix showing relationship of contexts in Trench 1

b. Description (figures 12 and 13)

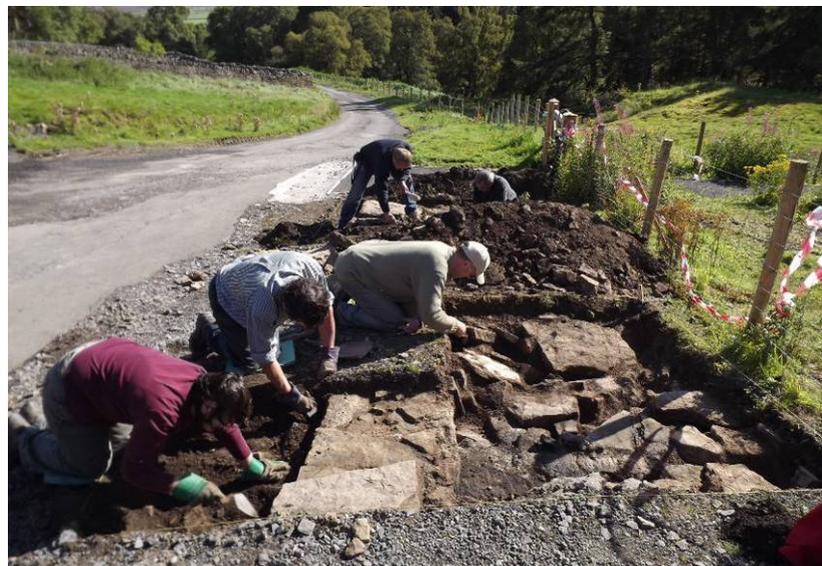
Plate 5 Working shot from the N showing Trench 1 during excavation (Photograph 034)

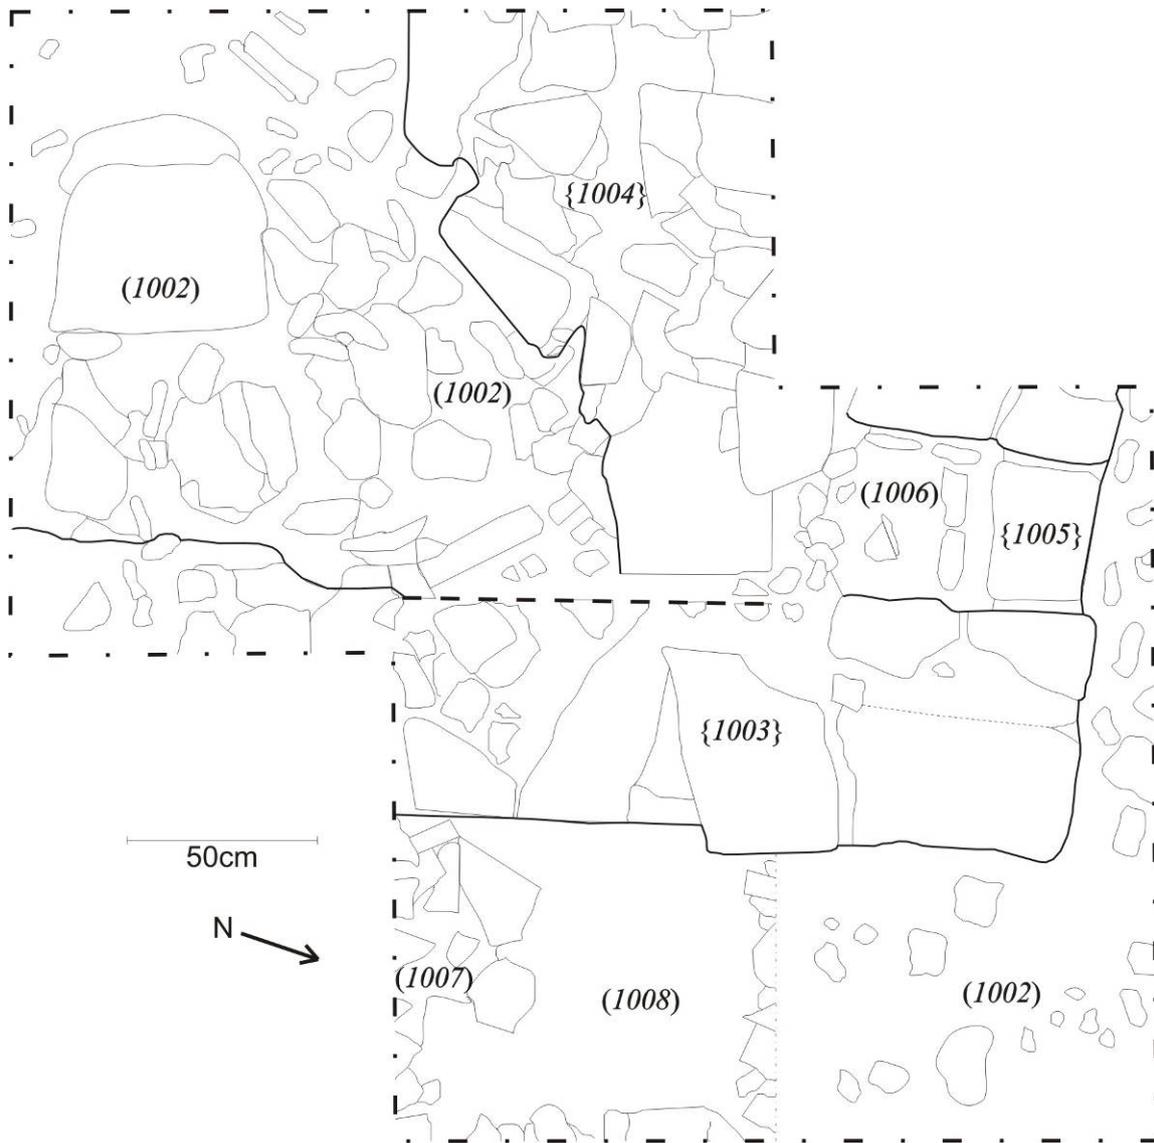
Figure 13 Post-excavation plan of Trench 1. Drawn at 1:20.

The stoke-hole likely indicates the presence of the chimney within the area of Trench 1, but pinpointing its exact location has not been straightforward. It was initially interpreted that the stoke-hole was blocked by the placement of rough masonry and lime mortar, with the flat stone to the S of {1005} perhaps doubling as a domestic fireplace during the late 19th century re-use of the mining complex at Shildon for accommodation. Concurrently with this re-use of the ‘flue’ opening, the large area of rough, lime bonded masonry {1004} was initially interpreted as a rough and disrupted floor surface dating to this secondary phase. Assessment in post-excavation has shown this analysis to be flawed and the alignments of the stones make it more likely {1004} is in actual fact a wall core with facing stones visible to the W end. This interpretation explains the problematic inclusion of a curved stone, set into {1004} (see *figure 11*). The placement of this stone would line up with the widening of the ‘flue’ opening as it enters the centre of the chimney. The lime mortar/plaster facing identified on the W facing elevation of {1003} (plate 6 and 7) is in actual fact bonding material from the disrupted course of wall {1004} where this met {1003}.

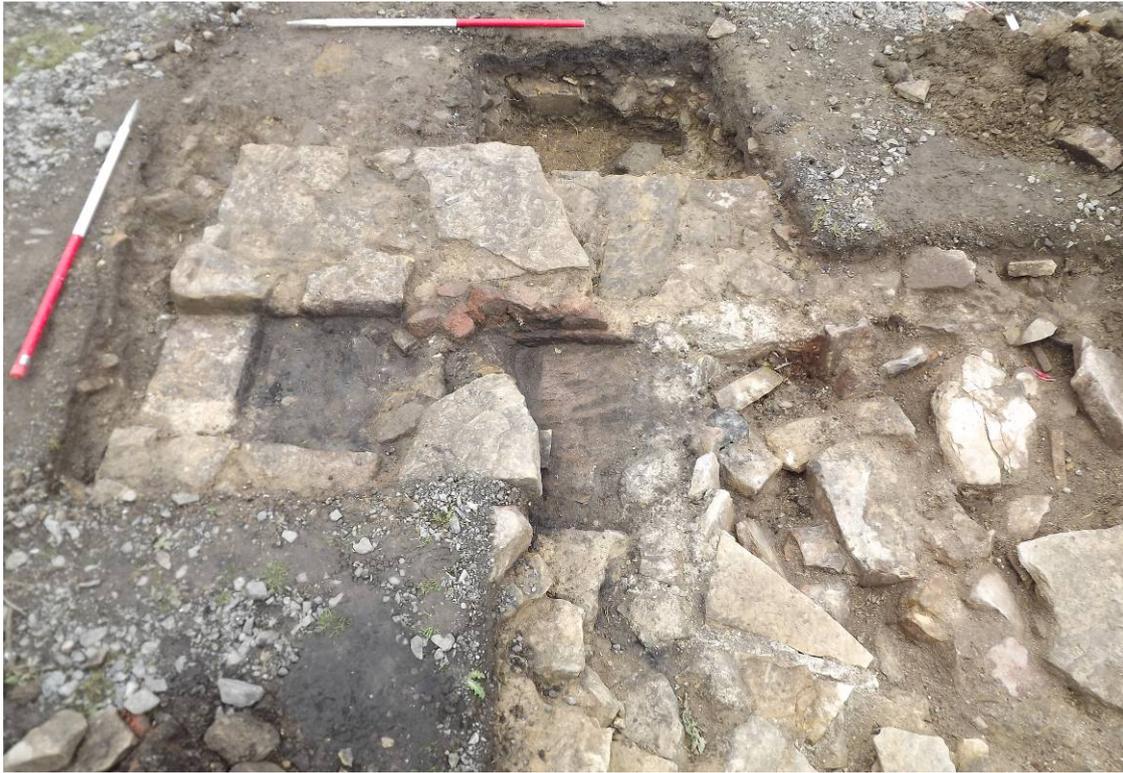
Plate 6 Trench 1 viewed from the W showing {1005} with black soot (1006) visible within. Note the cut/curved stone forming the widening of the stoke-hole. (Photograph 096)

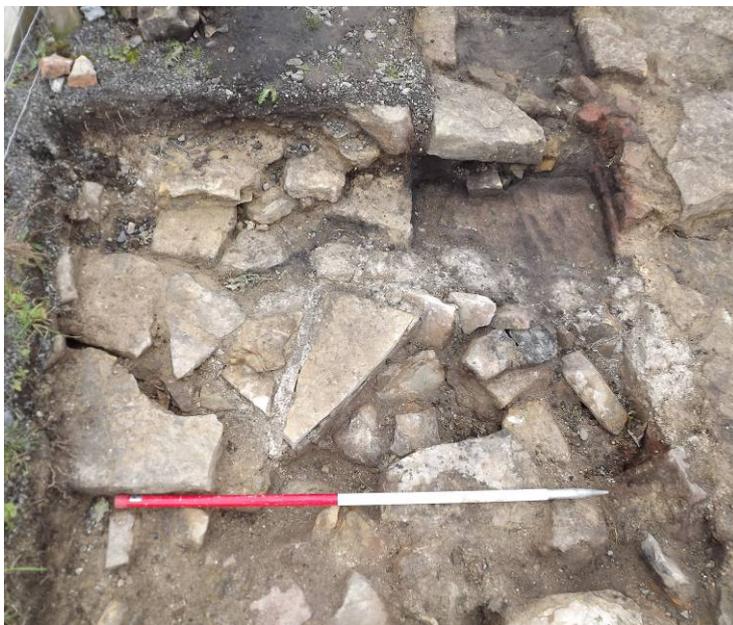
Plate 7 Trench 1 looking N showing the stoke-hole {1005} (top of picture) and cut stone where this feature enters the chimney. The line of wall {1004} can tentatively be discerned above the scale. (Photograph 103)

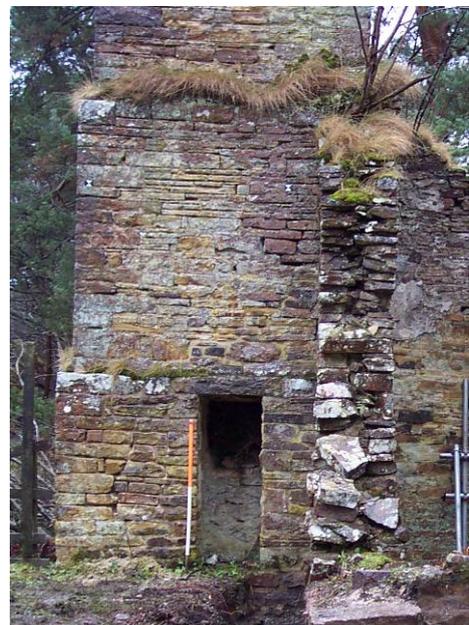
Plate 8 Example of similar stoke-hole opening in chimney of upstanding Engine House to the W

As touched upon, this interpretation seems to be borne out in the archaeological evidence. Wall {1003} lines up with {2003} in Trench 2 (*figure 18*), demonstrating this to be either the same, or a continuation/extension of the same wall. Feature {1005} within the SW return of {1003} has been interpreted as a stoke-hole into the chimney, a point emphasised by the existence of fine black soot deposited in the bottom of this opening. NNW facing, this opening is mirrored on the upstanding chimney of the existing engine house to the W. The two opening are of similar size and orientation.

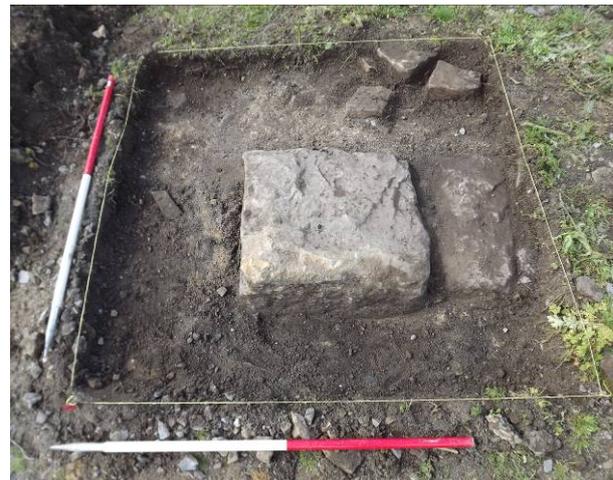
*Plate 10 Mid-excavation photograph of Trench 2
looking W showing large stones {2005}
(Photograph 014)*

{2003} was indeed shown to be the SE corner of the Little Engine House, but conversely did not include the large cubed stone initially noted on arrival on site (*plate 10* and *11*). This large stone formed one of a pair of large, pitted sandstone blocks placed against the E side of the SE corner of {2003} and was recorded as {2005}. Measuring, as a pair, 0.94m by 0.55m by 0.40m, the larger of the two was roughly twice the size of its neighbour to the N and abutted the wall of the Little Engine House – {2003}. The demolition deposits within the structure formed by {2003} were noticeably different compared to those located to the E and S, outwith the building.

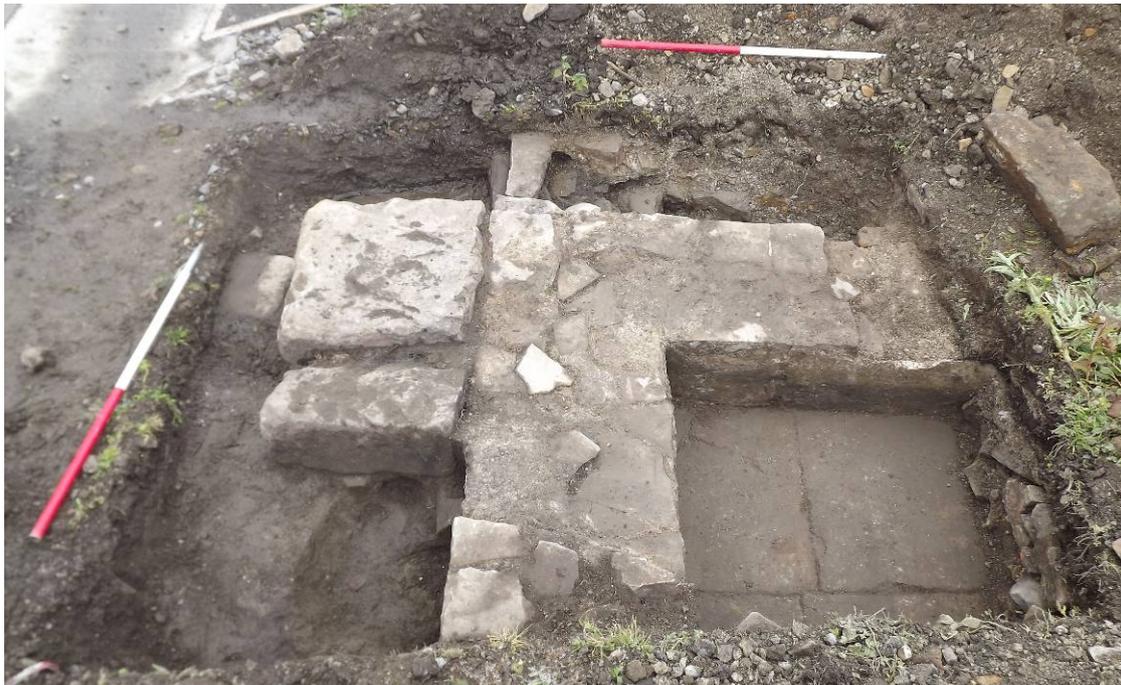
Plate 11 Post-excavation plan of Trench 2 looking S. Note the plaster on the interior face of main wall {2003} and presence of two large sandstone blocks {2005} set against the corner. (Photograph 058)

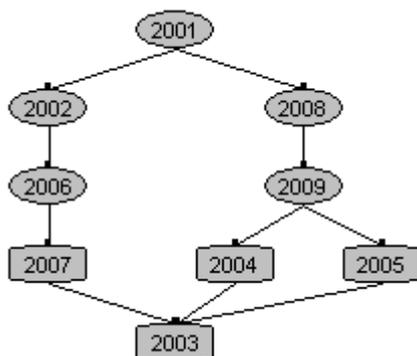
Figure 14 Stratigraphic matrix showing relationships for Trench 2

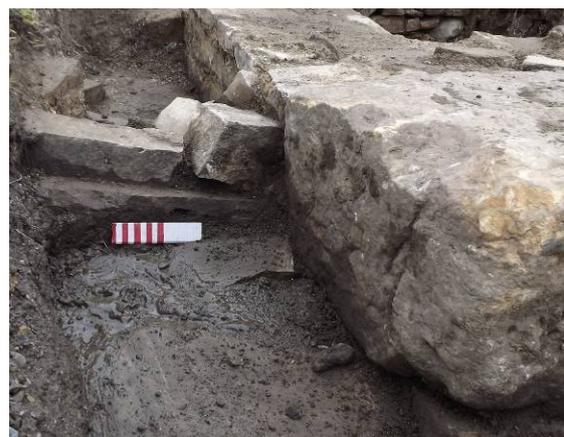
Plate 12 View from the E of {2004} abutting {2003} with {2005} in the foreground. (Photograph 062 – cropped)

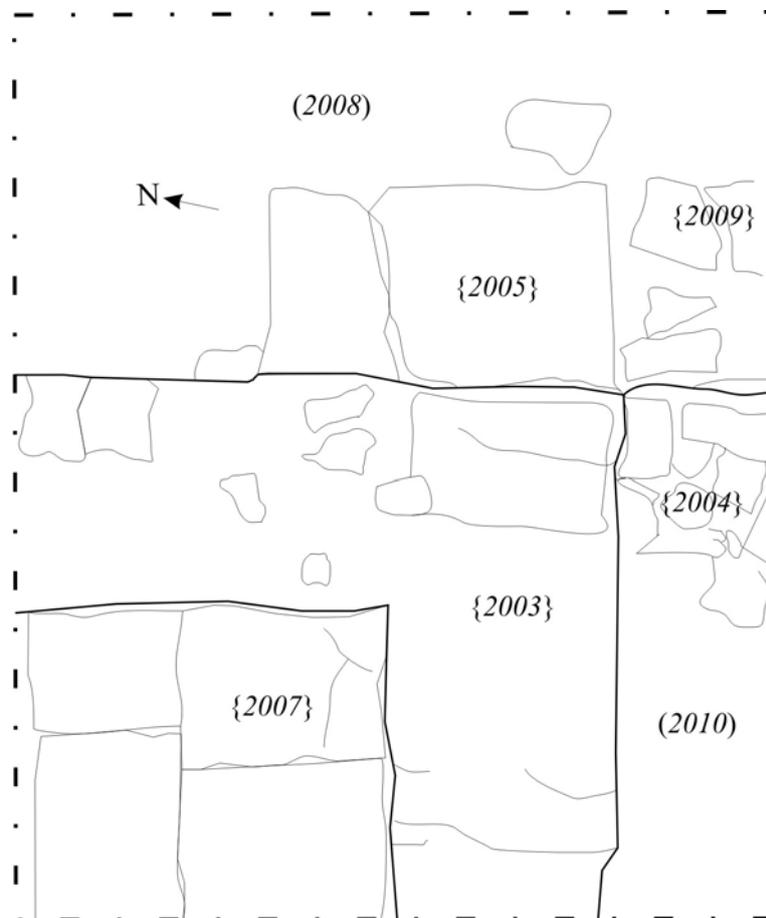
Figure 15 Post-excavation plan of Trench 2 re-produced at 1:20

In assessing the trench, the most obvious of these is the function and location of the large pitted sandstone blocks {2005} which had initially been interpreted as the corner of the main building, protruding through the topsoil at the side of the road. As discussed above, excavation revealed that these stones were not part of the wall itself, but instead had been placed hard against the ENE facing elevation of the corner. The reasons for this are unclear, but discussion on site presented a number of plausible possibilities. The stones have clearly been placed specifically in this spot. They do not overlap the corner, but instead run flush with the line of the SSW facing elevation of the main building (see *plate 11*). It was hypothesised on site that the stones could represent a mounting block, a raised area on which to place a milk churn, or indeed stones set against the corner to protect this vulnerable spot from the passage of large vehicles on the trackway. In lieu of a confirmed purpose, all such suggestions are equally valuable, but all are made less likely by the actual location of the stones. In the first two instances, such articles would not readily appear on the corner of an industrial building, and whilst the third may well be found on a spot such as this, it would be expected to be round, somewhat marked by the passage of vehicles, and not set back from the corner to run flush with the SSW wall of the Little Engine House. The most likely explanation is that {2005} form some sort of later buttressing, built as a secondary addition in an attempt to strengthen {2003}. This could perhaps have happened when heavy machinery was brought to site as new innovations changed the way the Little Engine House was used. Whilst purely hypothetical, such machinery could easily have caused instability in a building not designed to house it. Although in no way certain, this explanation seems the most acceptable explanation for the presence of {2005}.

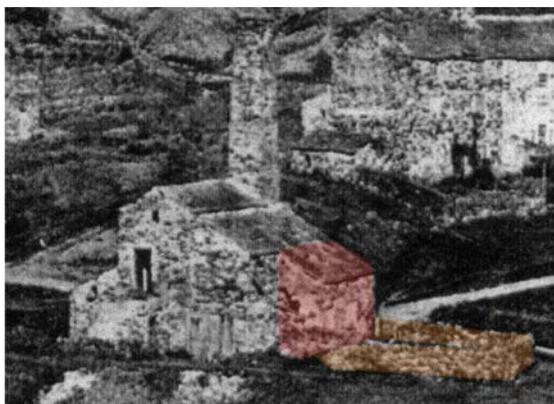
Figure 16 The small lean-to on the southern side of the Little Engine House complex as depicted c.1901 (marked red) {2003} is likely to be the far wall adjacent to the road. The walled compound is depicted orange.

Wall {2004} was another that required further discussion as to its function and place within the Little Engine House complex. During excavation, it was accepted that due to its poor quality this wall represented the vestiges of the open-air, penned area to the S of the Engine House (*figure 16* – depicted orange). This enclosure is visible both on the early picture of the site c.1901 (*figure 8*), and the 19th century map evidence (*figures 4-7*). However, a re-appraisal of the stratigraphy and relationships across the site make it clear that {2004} is likely to be the remains of the small lean-to building built onto the SSE elevation of the Engine House. This building can be seen clearly on the 1901 image (*figure 16*), running roughly halfway along the S side of the existing structure before returning inwards and creating a stepped effect.

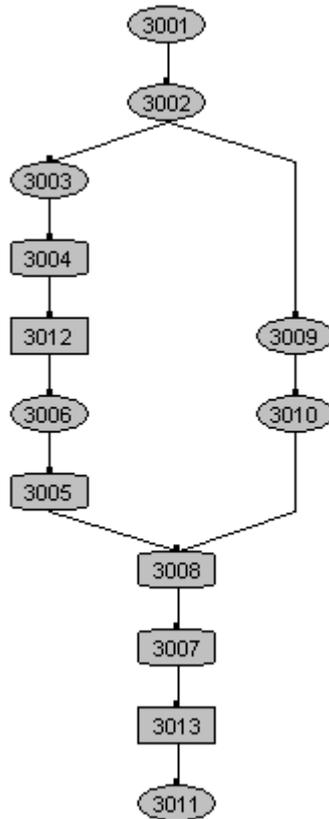
Figure 17 Stratigraphic matrix for Sondage 3

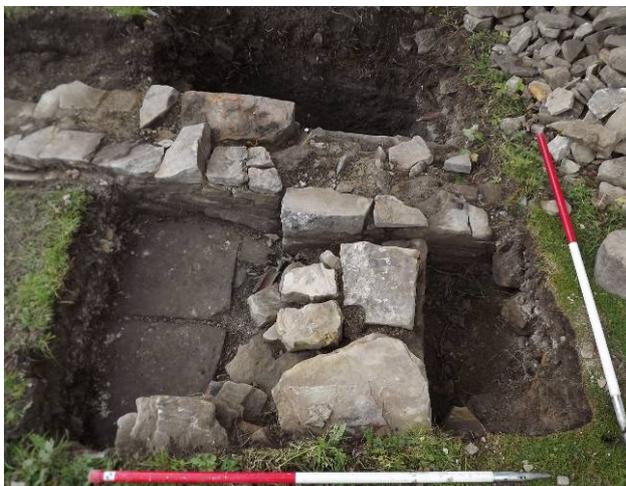
Plate 14 Overview of Trench 3 looking W and showing the relationship between {3004} (centre aligned W-E) and {3007} (top left) abutting {3008} (top right)

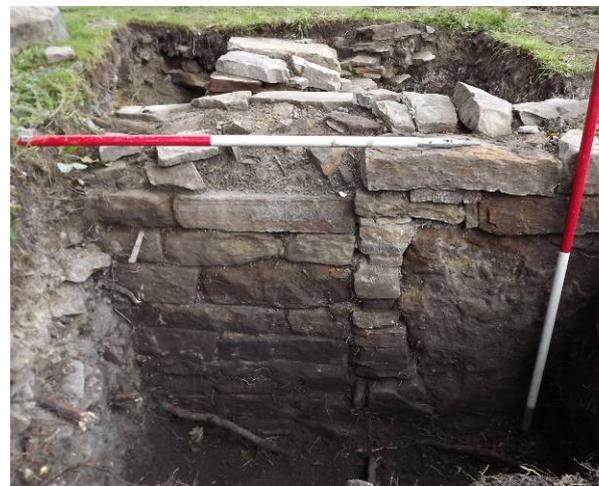
Plate 15 E facing elevation of {3008} (left) and {3007} (right). Note the thin 'ladder' of stones between the two.

As predicted, the line of the exterior wall of the Little Engine House was clearly pinpointed running NW-SE across Trench 3. Fortuitously, Trench 3 was also placed at a junction where three walls met. The earliest of these is {3007}. This wall of lime mortar bonded sandstone slabs survived to eight courses on its E facing side, with five of these courses revealed on the W facing side. Built in the local style, {3007} was abutted to the SE by {3008}. This masonry had a similar construction, but incorporated a large, irregular and pitted sandstone block similar to {2005} in Trench 2. This large block sat some 0.10-0.15m from the terminus of {3007}, with the space between the two filled with a

curious ‘tower’ of 12 stone slabs (see *plate 15*). The third wall {3004} runs NE-SW at right angles to both {3007} and {3008}, butting against {3007}. This wall is single-faced, with only the W facing elevation constructed to any presentable standard. This W face is abutted by (3003), a demolition deposit of moderately compact dark brown gritty silt with frequent stone inclusions – clearly placed after the construction of {3004}. To the E {3004} is roughly constructed and shaped around the construction cut [3012] into which it is placed. [3012] is high in the stratigraphic sequence, cut from just below the topsoil.

As can be seen in *plate 15*, {3007} terminates in a vertical face and has not been truncated by the placement of {3008} which butts against the SE facing elevation. However, the elevation of {3008} revealed in Trench 3 is not constructed in a uniform manner and contains a large pitted sandstone block of irregular shape. This stone does not sit against {3007} and the space between the two is filled by a precarious looking ‘tower’ of twelve small stone slabs. Obviously this is not an ideal situation to provide structural integrity in a foundation. It is clear that the large sandstone block within {3008} has been placed there intentionally, and is not, as was postulated on site, a naturally occurring stone incorporated within the foundation. The alignment of the stone is too exact with the rest of the wall and it does not appear to have been significantly shaped in order to achieve this. The presence of the large sandstone block {2005} pressed against wall {2003} in Trench 2 demonstrates that stones such as this are available in the immediate vicinity of the Little Engine House, perhaps mined from

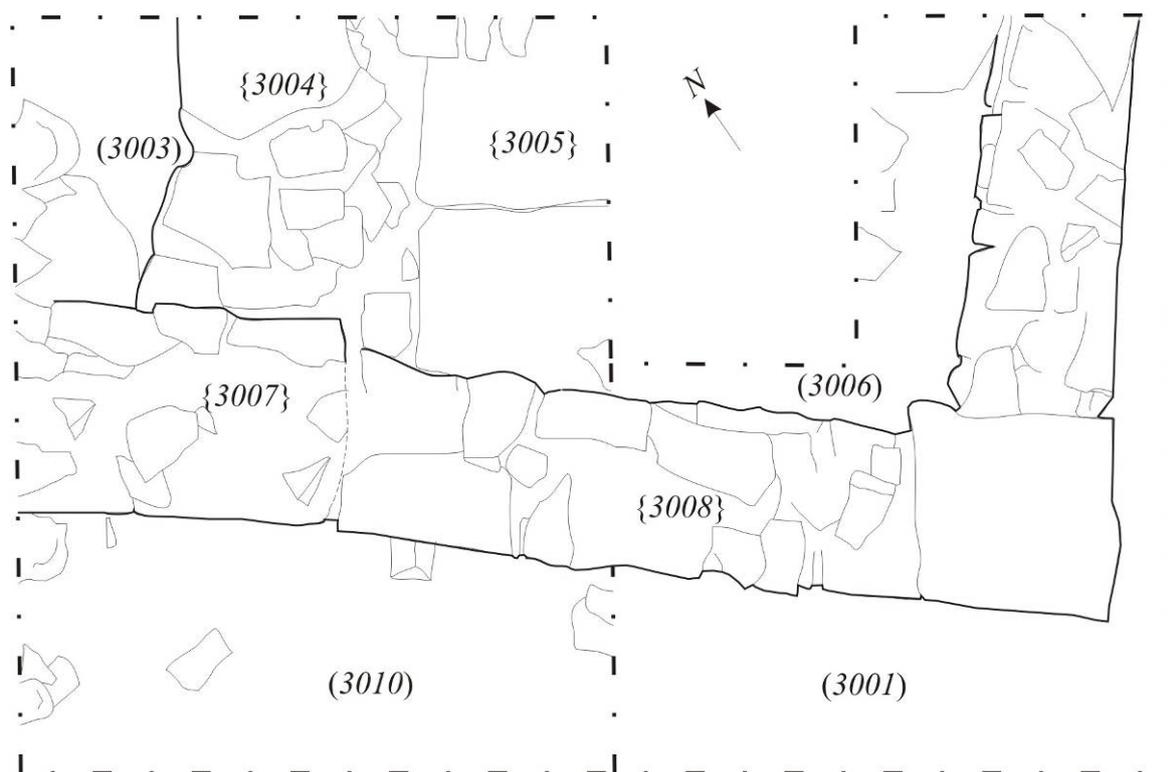
Figure 18 Post-ex plan of Trench 3 drawn at 1:20

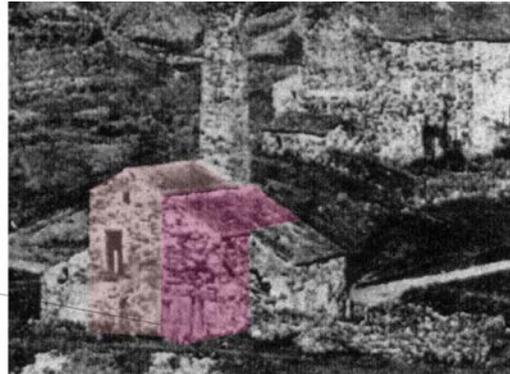
Figure 19 The 1901 postcard showing the junction between {3007} as depicted left, and {3008} as depicted right.

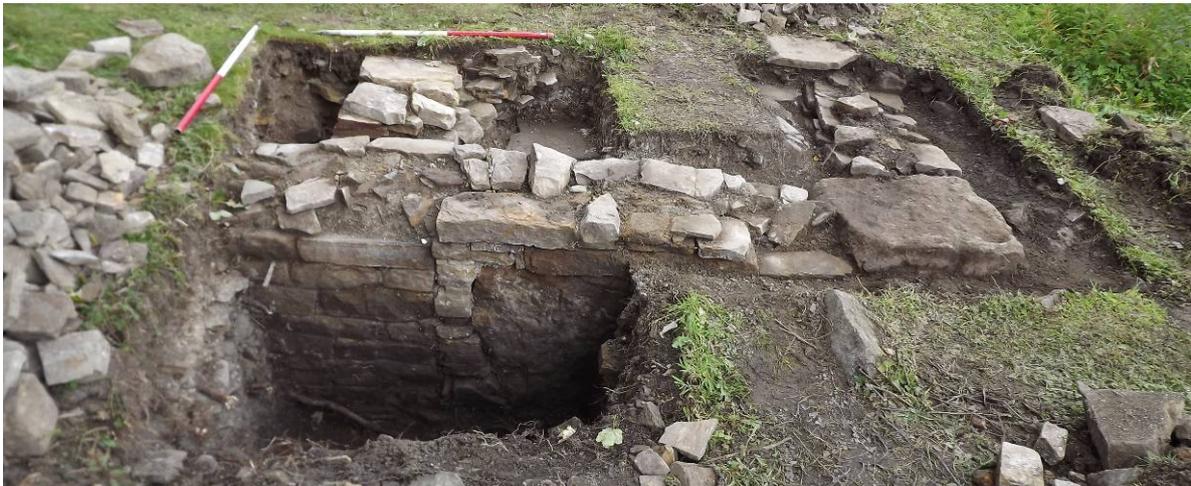
Plate 16 Post-excavation view of Trench 3 from the W (Photograph 079)

This remains problematic. Excavations in Trench 3 (whilst not directly revealing the whole length of the other side of the wall at this point) showed no indication of any construction breaks, or re-builds in the structure of {3007} externally (*plate 16*). It could be argued that {3007} was re-built at some point, overlying the existing flags {5006}, but the evidence in the wall itself does not support this. Another possibility is that the flagstone floor was incorporated into the wall itself as it was constructed, perhaps to provide extra strength in the area where the machinery relating to pumping the mine shaft was located. This was assumed to be the case on site, although if accepted this interpretation struggles to accommodate the presence of the thin layer of soil (5003) between the flags and the wall.

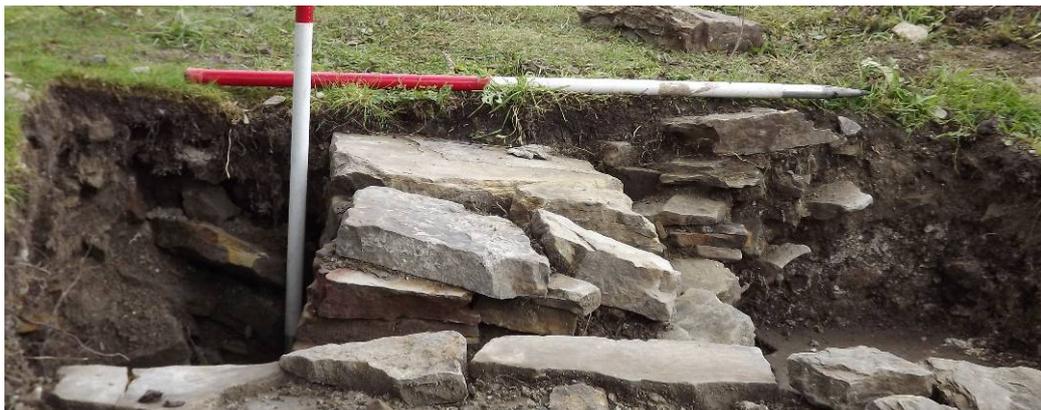
Plate 17 W facing section of Trench 3 showing {3004} (running away from shot). Note the cut [3012] filled by the rough rubble S face. The appearance in this photograph of a uniform E facing elevation is misleading

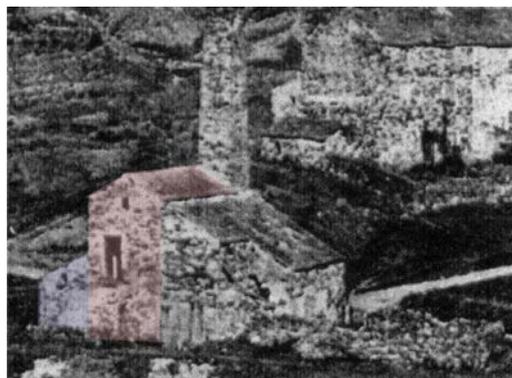
Figure 20 The 1901 postcard showing the lean-to structure built against the N elevation (purple) and the main building (pink). {4003} lies near the junction of the two, likely within the purple section.

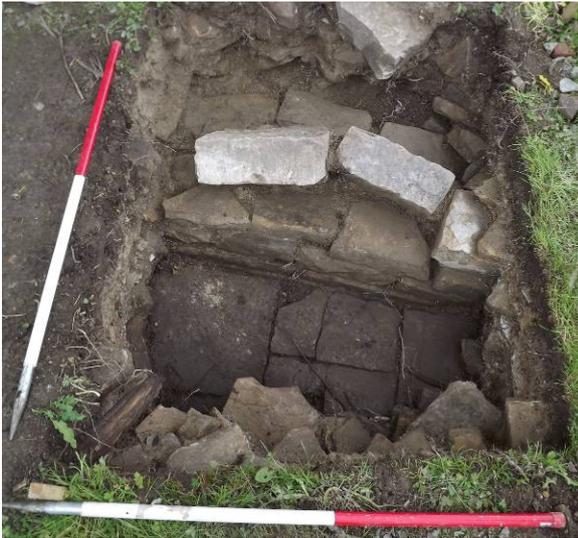
Plate 18 Post-excavation view looking SW across Trench 4. Note the SW leaning tipping of {4003} (Photograph 067)

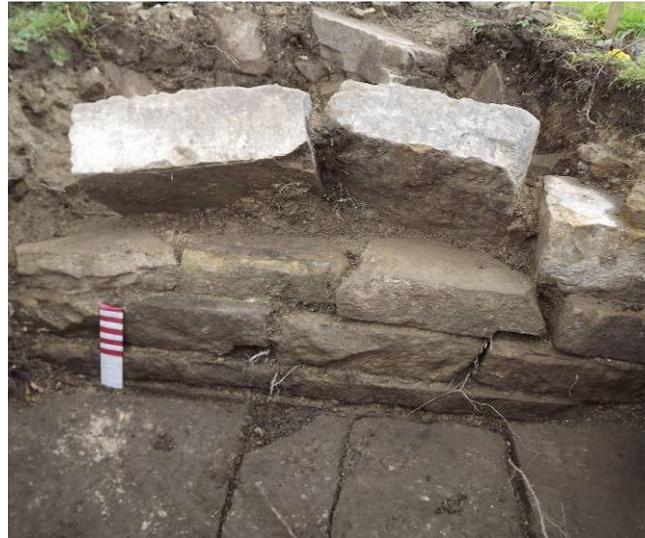
Plate 19 NE facing elevation of {4003} showing tipped stones (Photograph 091)
