Shildon Little Engine House

Shildon by Blanchland, Northumberland

Community Excavation

Data Structure Report

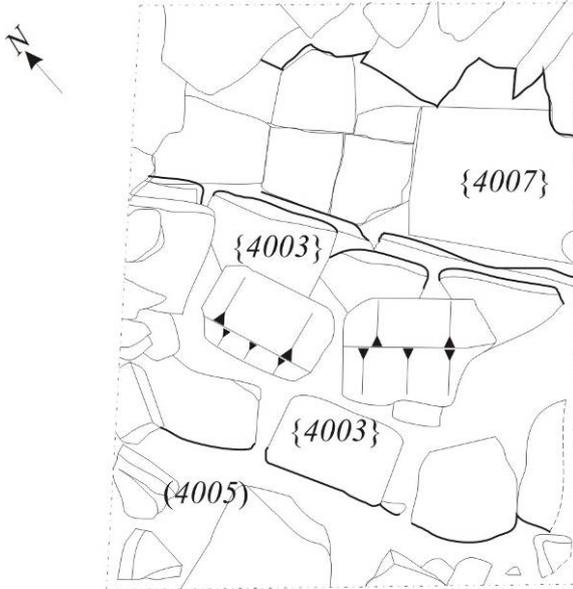
Figure 21 Post-excavation plan of Trench 4 drawn at 1:20

Recorded as {4003}, it cannot be said with certainty that this wall is the same as {3007}. However the alignment of the walls on the ground, their construction style and assessment of the cartographic resource indicate this to be the case. The placement of {4003} is uncertain and it is equally possible the wall forms the western side of the later extension built onto the northern edge of the Little Engine House (see *figure 20*). Constructed of large sub-rectangular blocks averaging 0.40-0.30m in length, {4003} survives to four main courses and had a width of 0.60m. Two large blocks from the top course rested at what appeared as a precarious angle, tipping backwards to the W (*plate 18*). Despite first appearances, these stones proved perfectly solid, still held in place by lime mortar and rubble around their base. Indeed further analysis of {4003} showed that the entire wall had a slight slump towards the SW, with each course on the E facing elevation slightly set back from that below. Subsequent excavation W of the wall revealed further smaller stones in a similar precariously tipped angle to those visible on the top of the wall (*figure 21*).

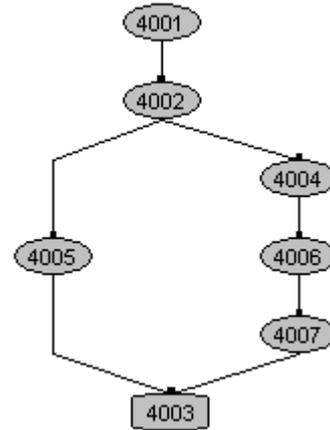
Figure 22 Stratigraphic matrix for Trench 4 showing relationships between the deposits

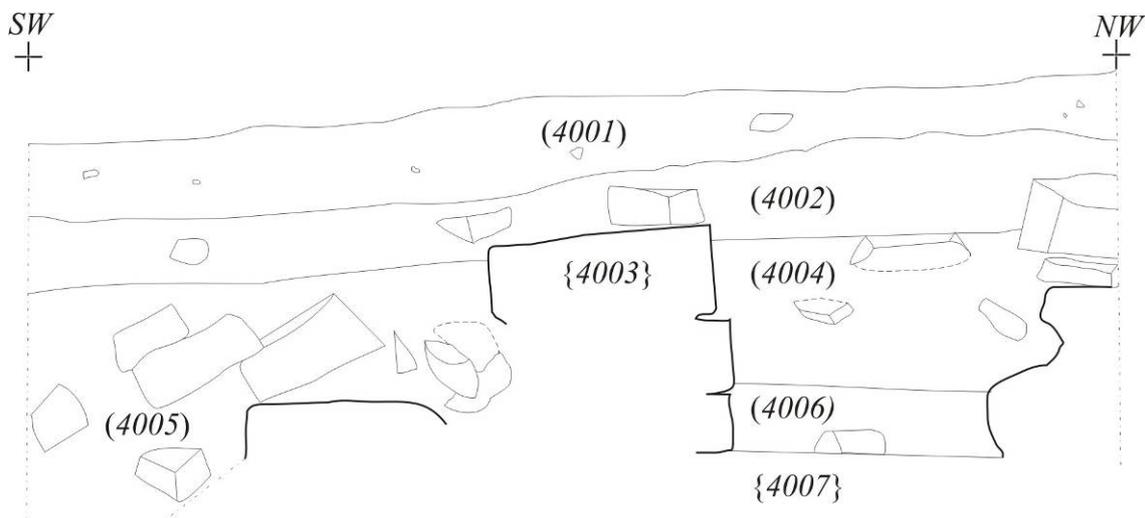
Figure 23 SE facing section of Trench 4 showing alignment of and slump of {4003}. Drawn at 1:10

The curiously tipped stones atop {4003} also require further discussion. It is clear from the unusual angle in which these stones are inclined, as well as the smaller stones visible in the SE facing section (figure 23) that the upstanding wall was tipped whilst complete and the stone subsequently robbed and re-used.

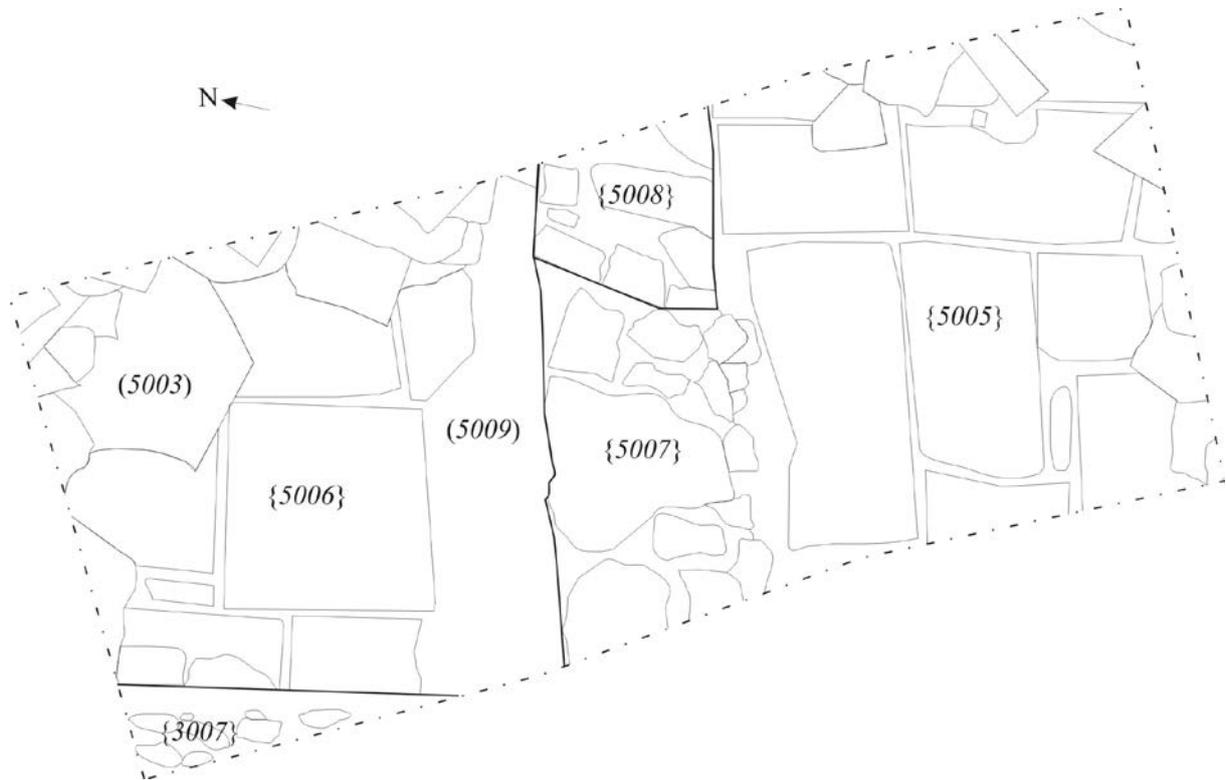
Figure 23 Post-excavation plan of Trench 5 reproduced at 1:20

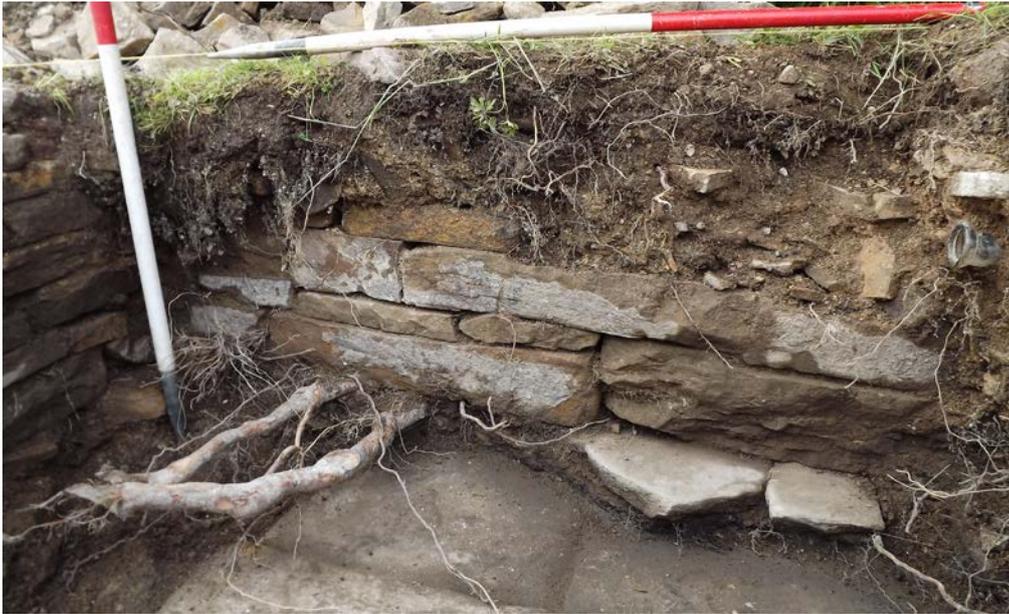
Plate 21 {3007} in the ENE facing section of Trench 5. Note the flagstones {5006} underlying the wall with (5003) visible above

As {5006} was cleaned it became apparent there was an unusual relationship with wall {3007} to the W. Revealed running NNW-SSE, {3007} was clearly the same wall revealed in Trench 3 and numbered as such. However, the flagstones {5006} did not seem to abut the wall as anticipated, but instead seem to underlie, or be built within the wall (*plate 21*).

As discussed above, questions remain as to the placement of the flagstone floor {5006} in the stratigraphic sequence. As seen in *plate 21*, the wall seems to overlie the flagstones, yet no

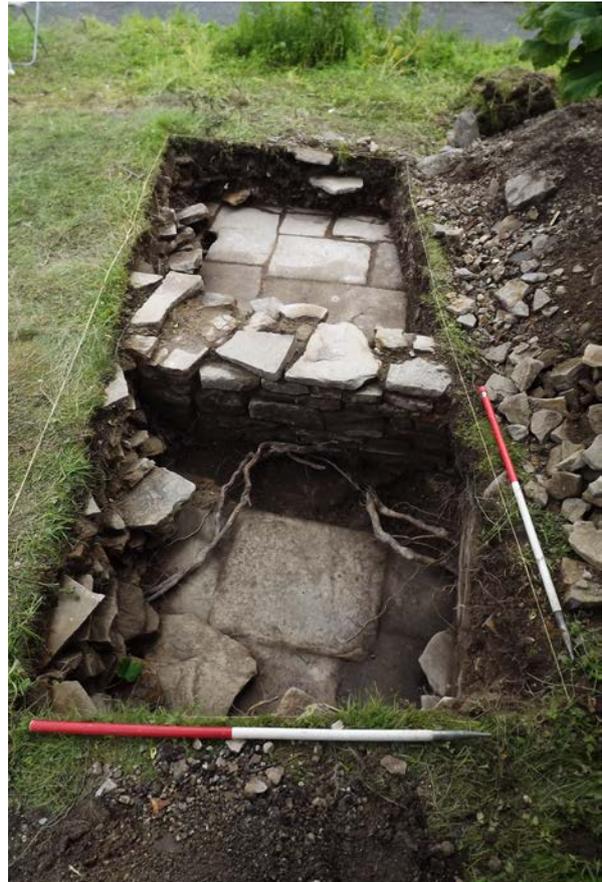
Plate 23 Post-excitation view of Trench 5 looking SSE (Photograph 186)

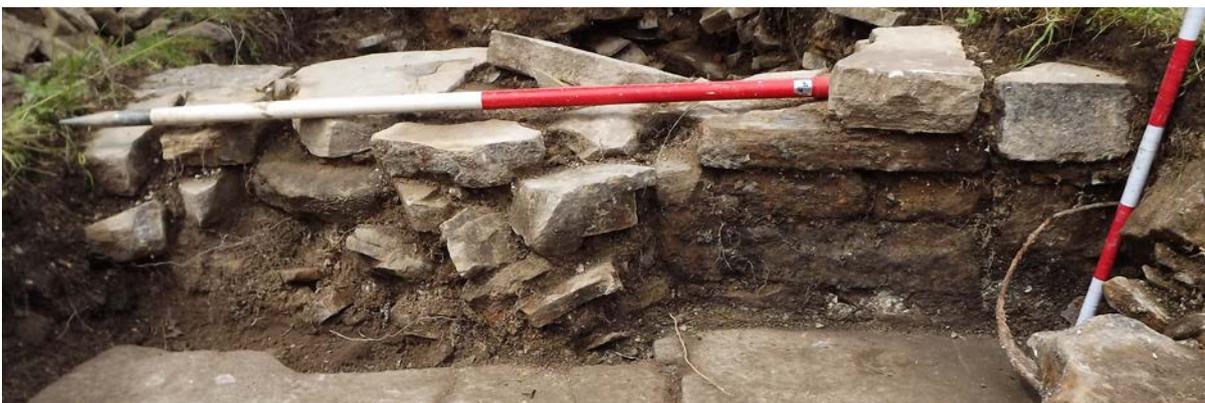
Plate 24 S-facing elevation of {5007} (left) and {5008} (right) (Photograph 194)

It is clear that {3004/5007} is a later blocking of an entrance within the main circuit of the original engine house structure. This opening was splayed to the E at {5008}, but ran flush with {3007} to the W. Indeed if the location of the opening is assessed in conjunction with the pictorial evidence, it can be seen in the undated photo of the 1930s to 1940s (*figure 24*).

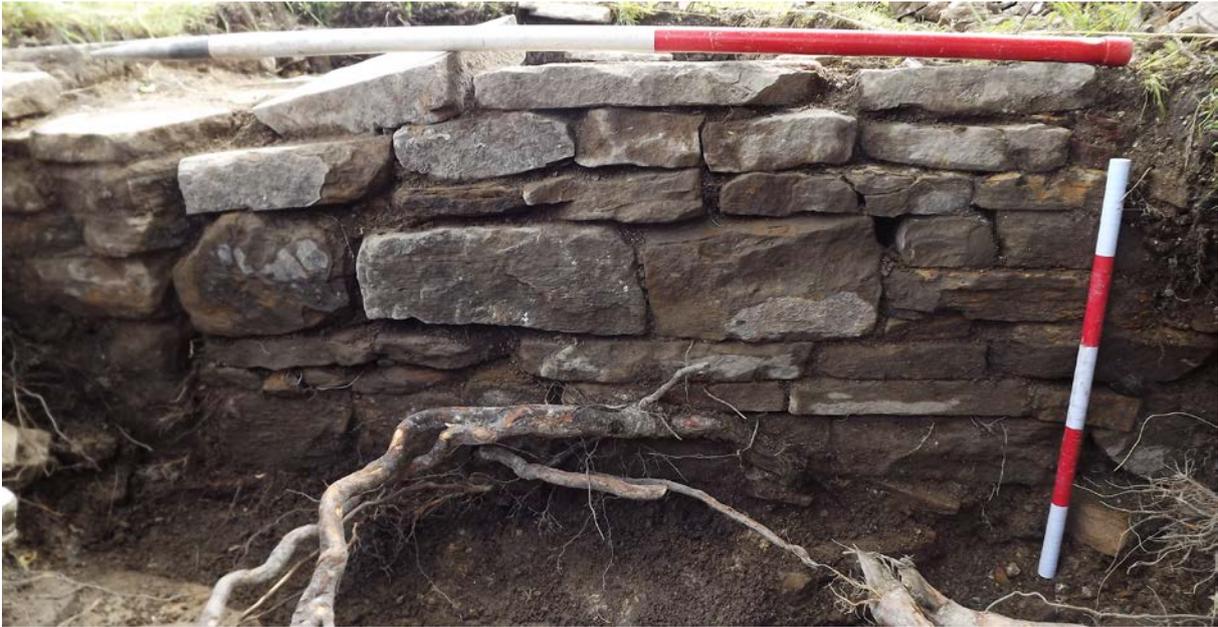
Plate 25 N facing elevation of {5008} (left) and {5007} (right) (Photograph 195)

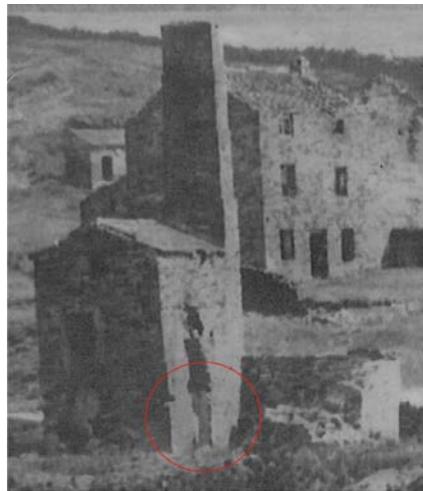
Figure 24 The undated photograph showing the location of the doorway as located in Trench 5

The picture (*figure 24*) also helps explain why the blocking is so late in the stratigraphic sequence. Although the entrance is still clearly open in the photograph, the main building remains roofed and it can be surmised that the blocking was put in place after the outbuildings had crumbled and the doorway became superfluous. Thus the blocking is cut through (3006/5004), the demolition material within the outbuilding as defined by {3008}, but not the demolition infill of the main building (3003/5002) which butts up against the blocking.

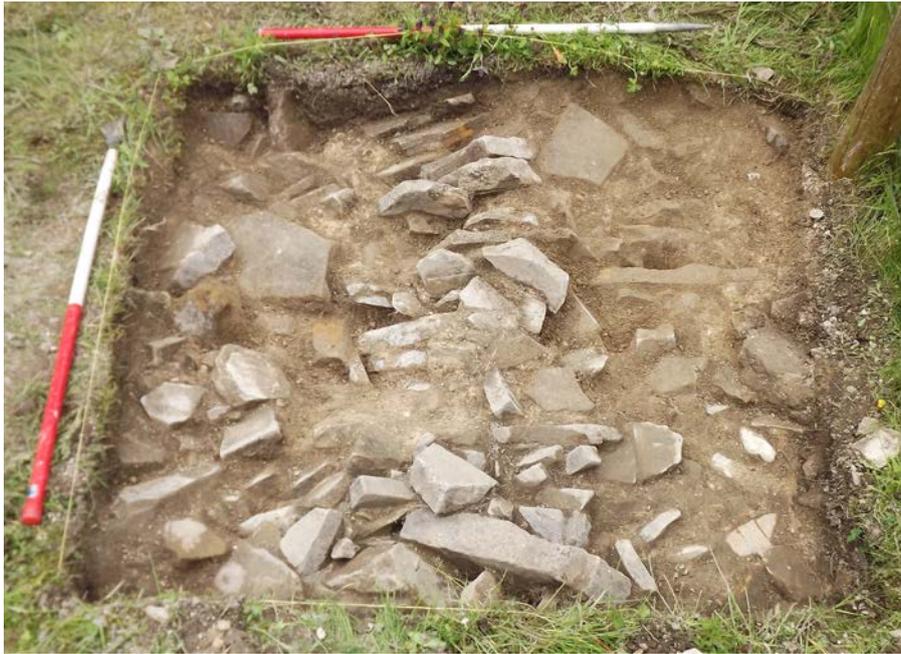
Plate 26 (6002) in Trench 6 (Photograph 140)

Trench 6 was almost wholly populated by demolition rubble and did not yield the line of wall {1003} from 2011 as anticipated. After removal of the topsoil (6001), a curious demolition deposit of lime mortar and sand with an abundance of large sandstone slabs set on end was encountered (6002) (plate 26). The slabs were so close together and aligned W-E that they initially began to take on the appearance of a dry-stone wall. This deposit was 0.35m deep and directly overlay (6003), a very similar deposit essentially devoid of the larger set stones found throughout (6001).

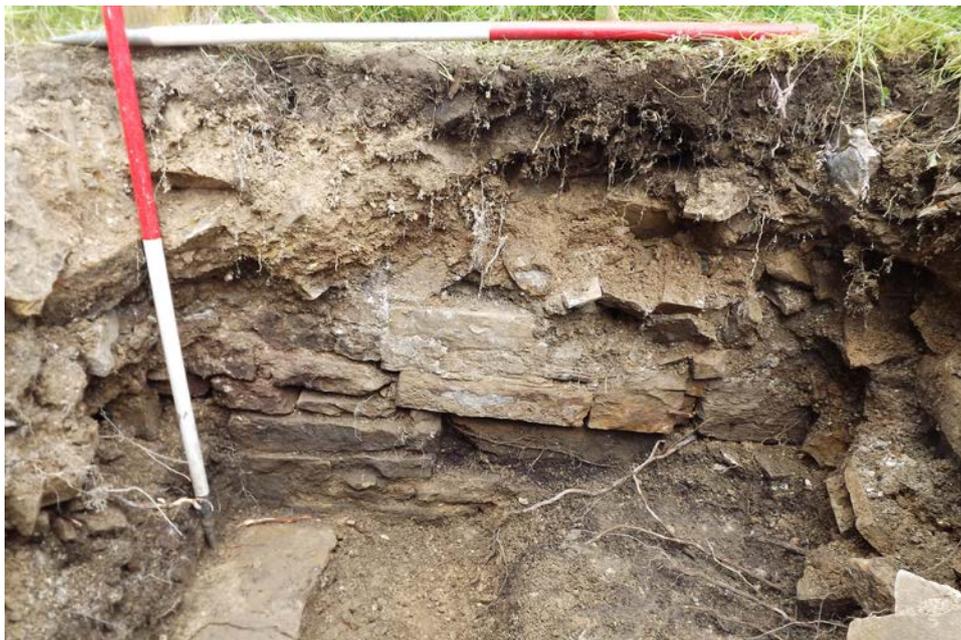
Plate 27 S facing section of Trench 6 showing {6006} (Photograph 171)

As excavation progressed it seemed likely that no masonry would be encountered, but a collapse of the S facing section of Trench 6 revealed the face of a W-E aligned wall just beyond the limits of the trench. Recorded as {6006}, this wall had some apparent complexity; unfortunately because of time constraints it was not possible to examine the feature further. Directly above the dark layer (6004), an area within the walling was clearly recessed.

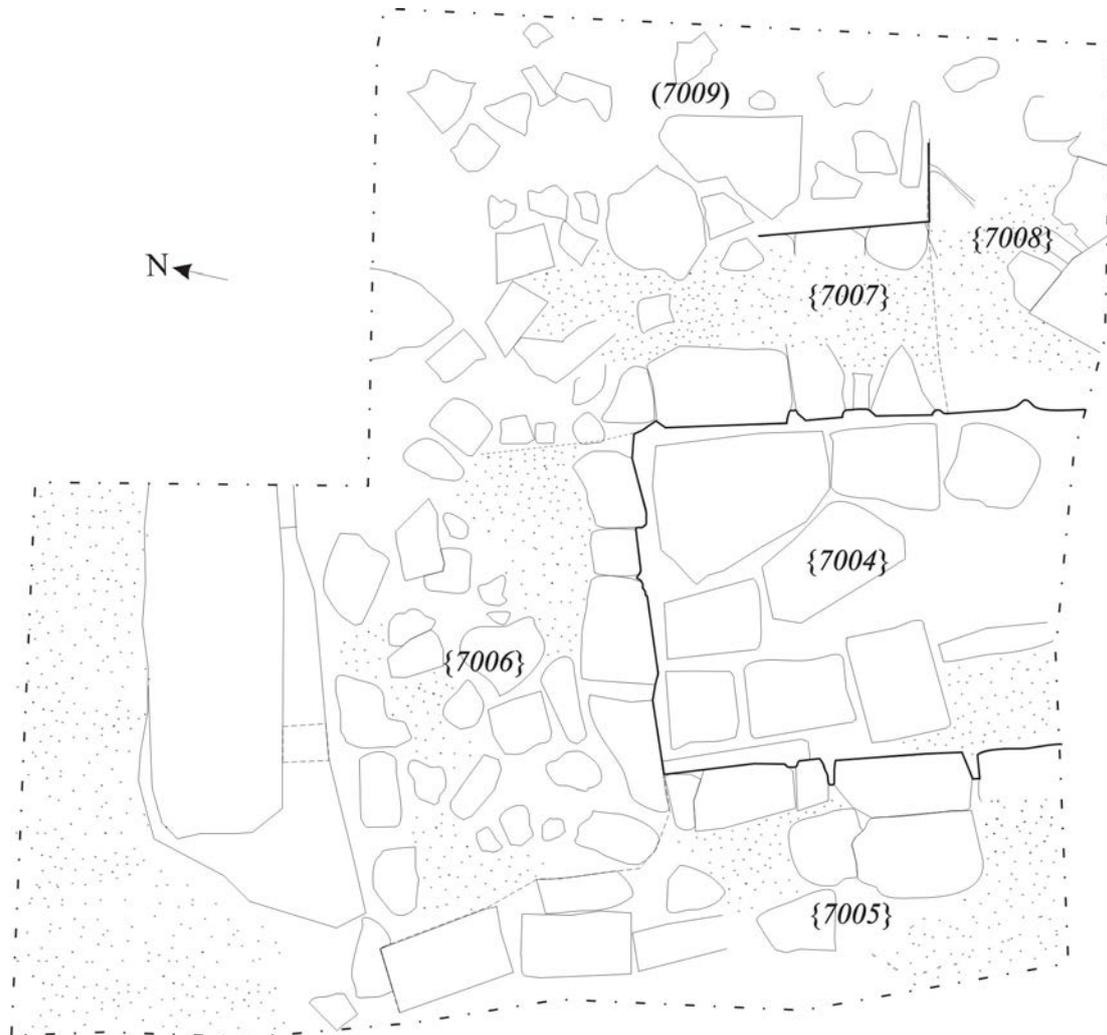
Figure 25 Post-excavation plan of Trench 7. Drawn at 1:20

(7002) and (7003), within the interior of the square setting, both comprised demolition material akin to that across the site, but bottomed onto an irregular flagstone surface {7004}. Further cleaning revealed the series of walls to comprise four different phases of build (figure 25), each abutting one another. All walls are similarly constructed in the local style, of mortar-bonded slabs with only {7008} in the SE corner of the Trench of a superior quality. {7008} was a continuation of {4003}, but within trench 7 returned E to align through to wall {8003} in Trench 8. This corner in Trench 8 is abutted by {7007}, running northwards, which in turn is earlier than {7006} aligning W-E across the northern end of the trench.

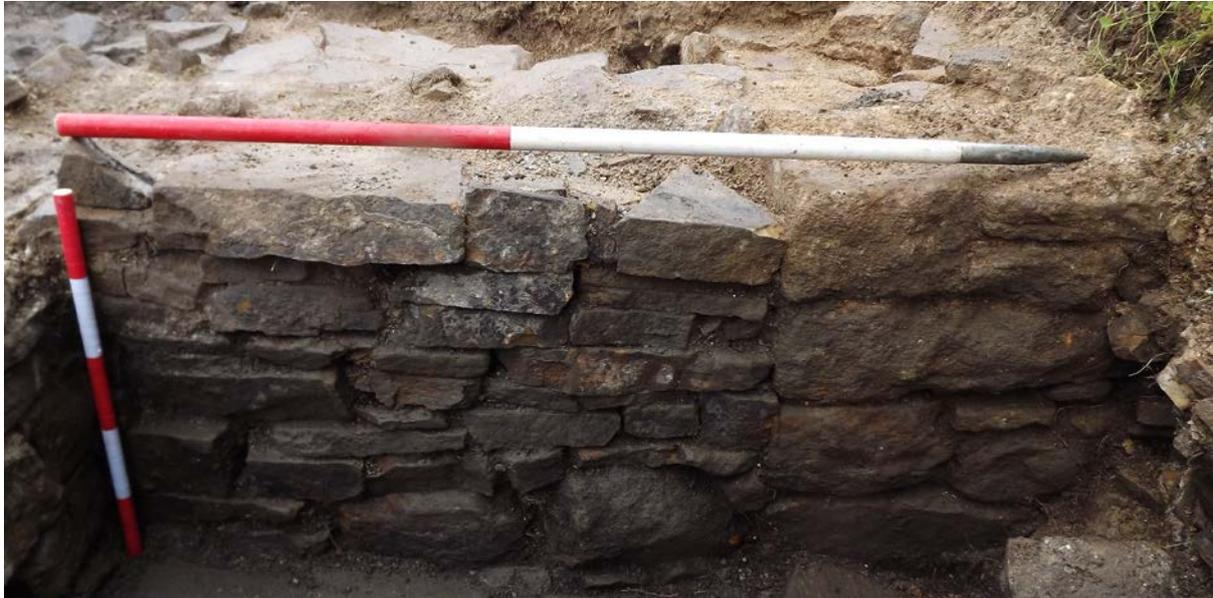
Plate 29 W facing elevation of {7007} (left) and {7008} (right) (Photograph 157)

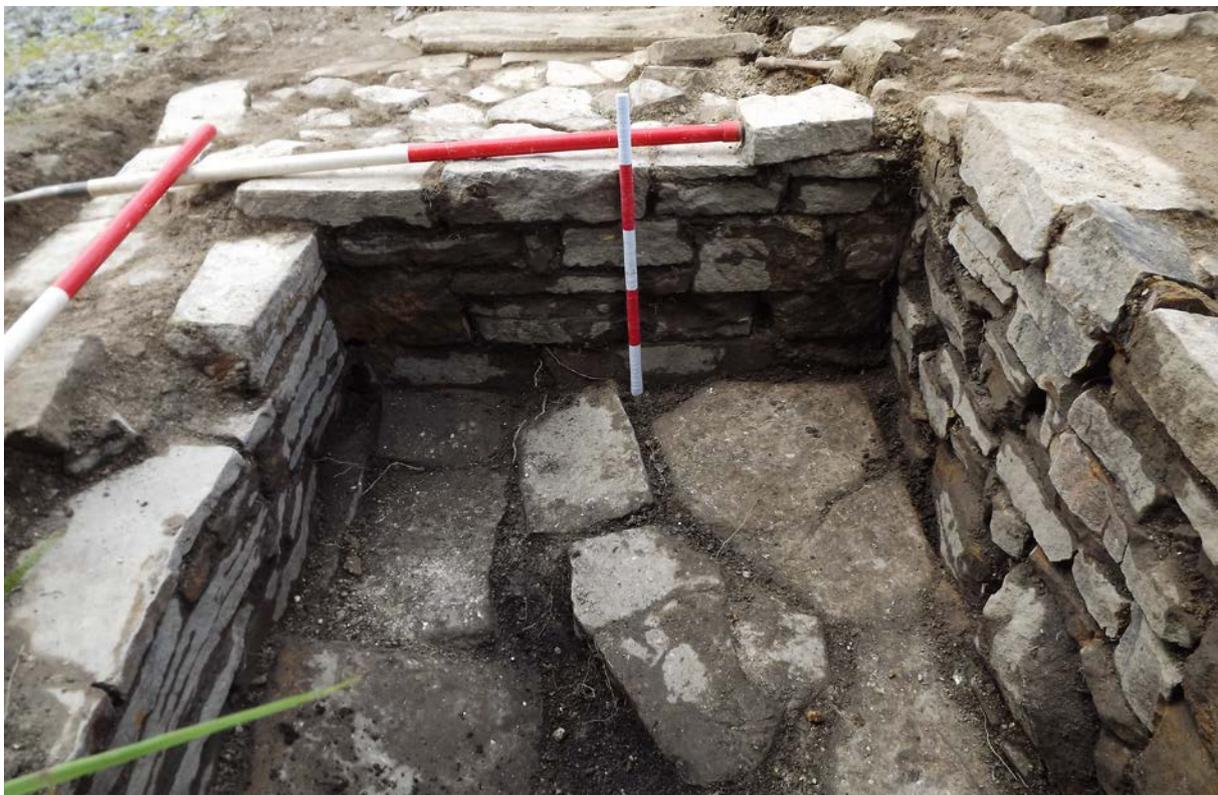
Plate 30 S facing elevation of {7006}. Note {7007} to the right and {7005} to the left abutting {7006} and overlying the floor {7004} (Photograph 211)

{7006}, {7007} and {7008} are all respected by {7004}, the irregular sandstone slab floor, but this clearly underlies {7005} which forms the S side of the 'square'. This wall is unusual in that it seems to wrap around the western end of {7006}. {7006} in turn appears to have had no rear face (N side), and is some form of revetting wall with bonded rubble behind. To the rear of this bonded material a large, possibly cut, horizontally laid stone slab was recorded, with a possible groove cut into the stone.

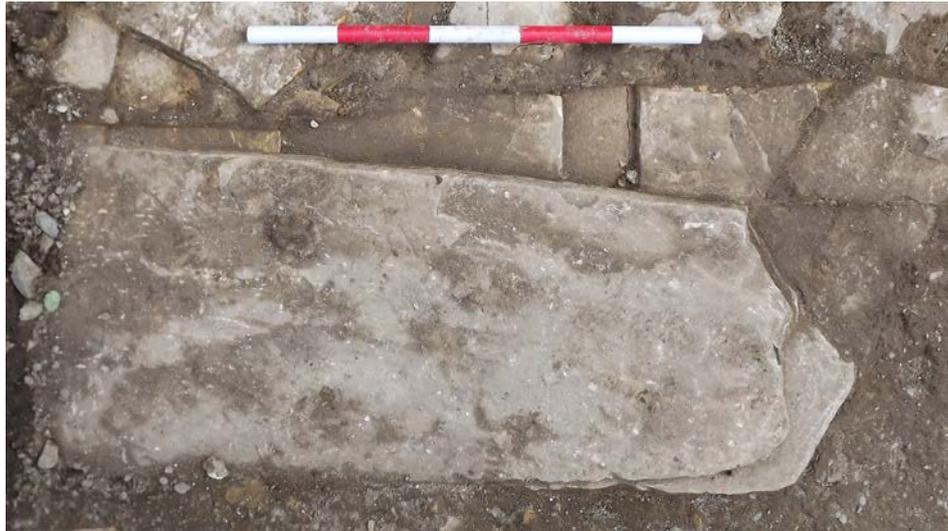
Plate 31 Large, possibly carved stone at rear of {7006} (Photograph 220)

Wall {7006} requires a little further discussion in that it seems to have been a retaining wall with no face to the N. The large stone slab (*plate 31*) seems to have been cut and placed specifically and it is assumed this was to house some form of machinery. Perhaps the weight and use of this machinery led to the need for a strong revetment wall {7006} to the S.

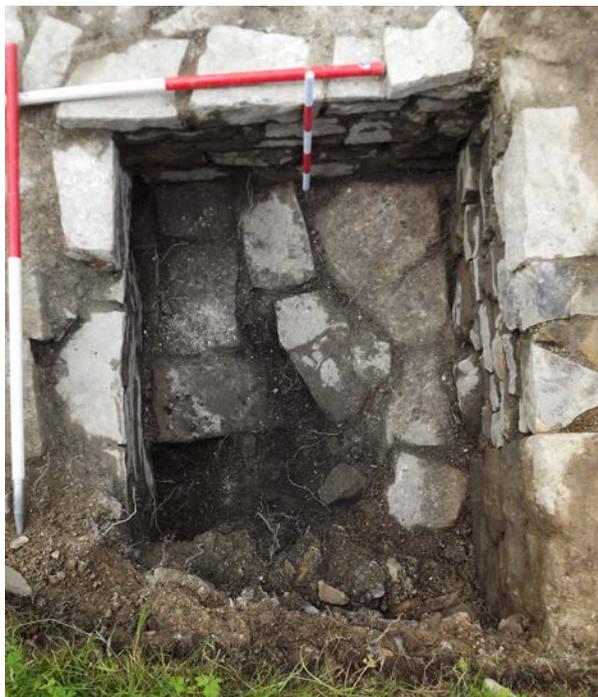
Plate 32 View looking N onto {7004} (Photograph 213)

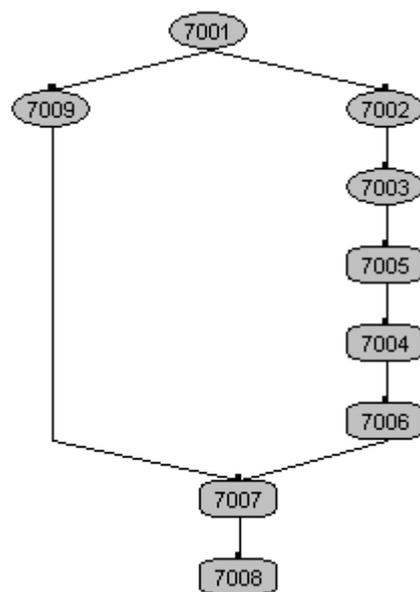
Figure 26 Stratigraphic matrix for Trench 7

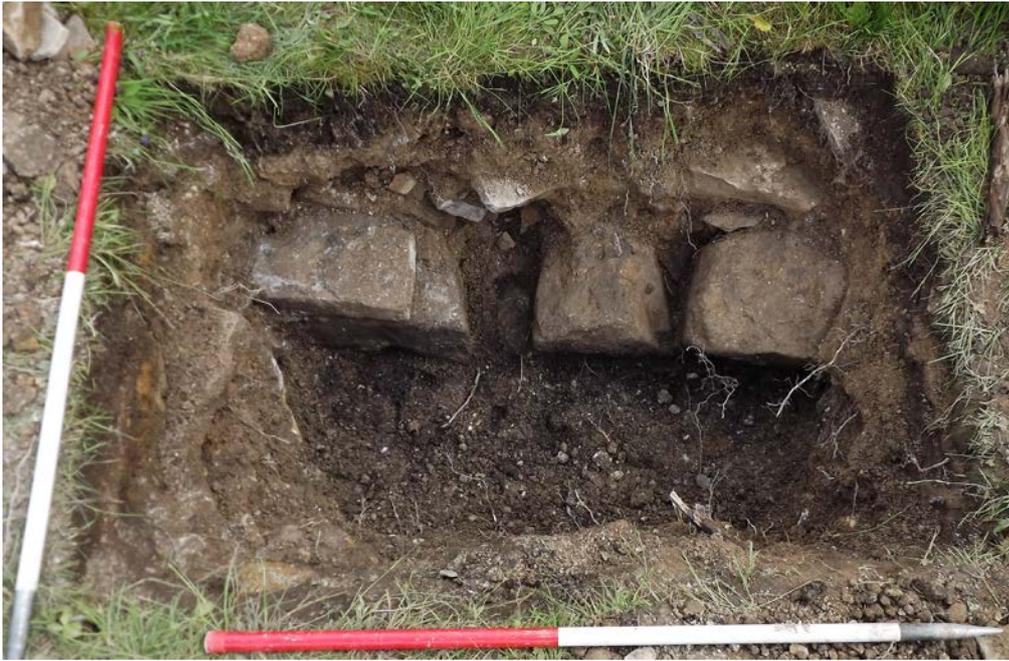
Plate 34 Post-excavation view looking c.SSE across Trench 8. Note wall {8003} (Photograph 229)

The soil deposits in Trench 8 were uncomplicated stratigraphically and essentially comprised topsoil (8001) overlying the lime mortar rich demolition rubble (8002) found across the site generally and related to the demolition of the Little Engine House. Within this demolition deposit, a W-E aligned wall {8003} of large sandstone slabs and sub-angular stones was apparent, lying almost directly beneath the fence line.

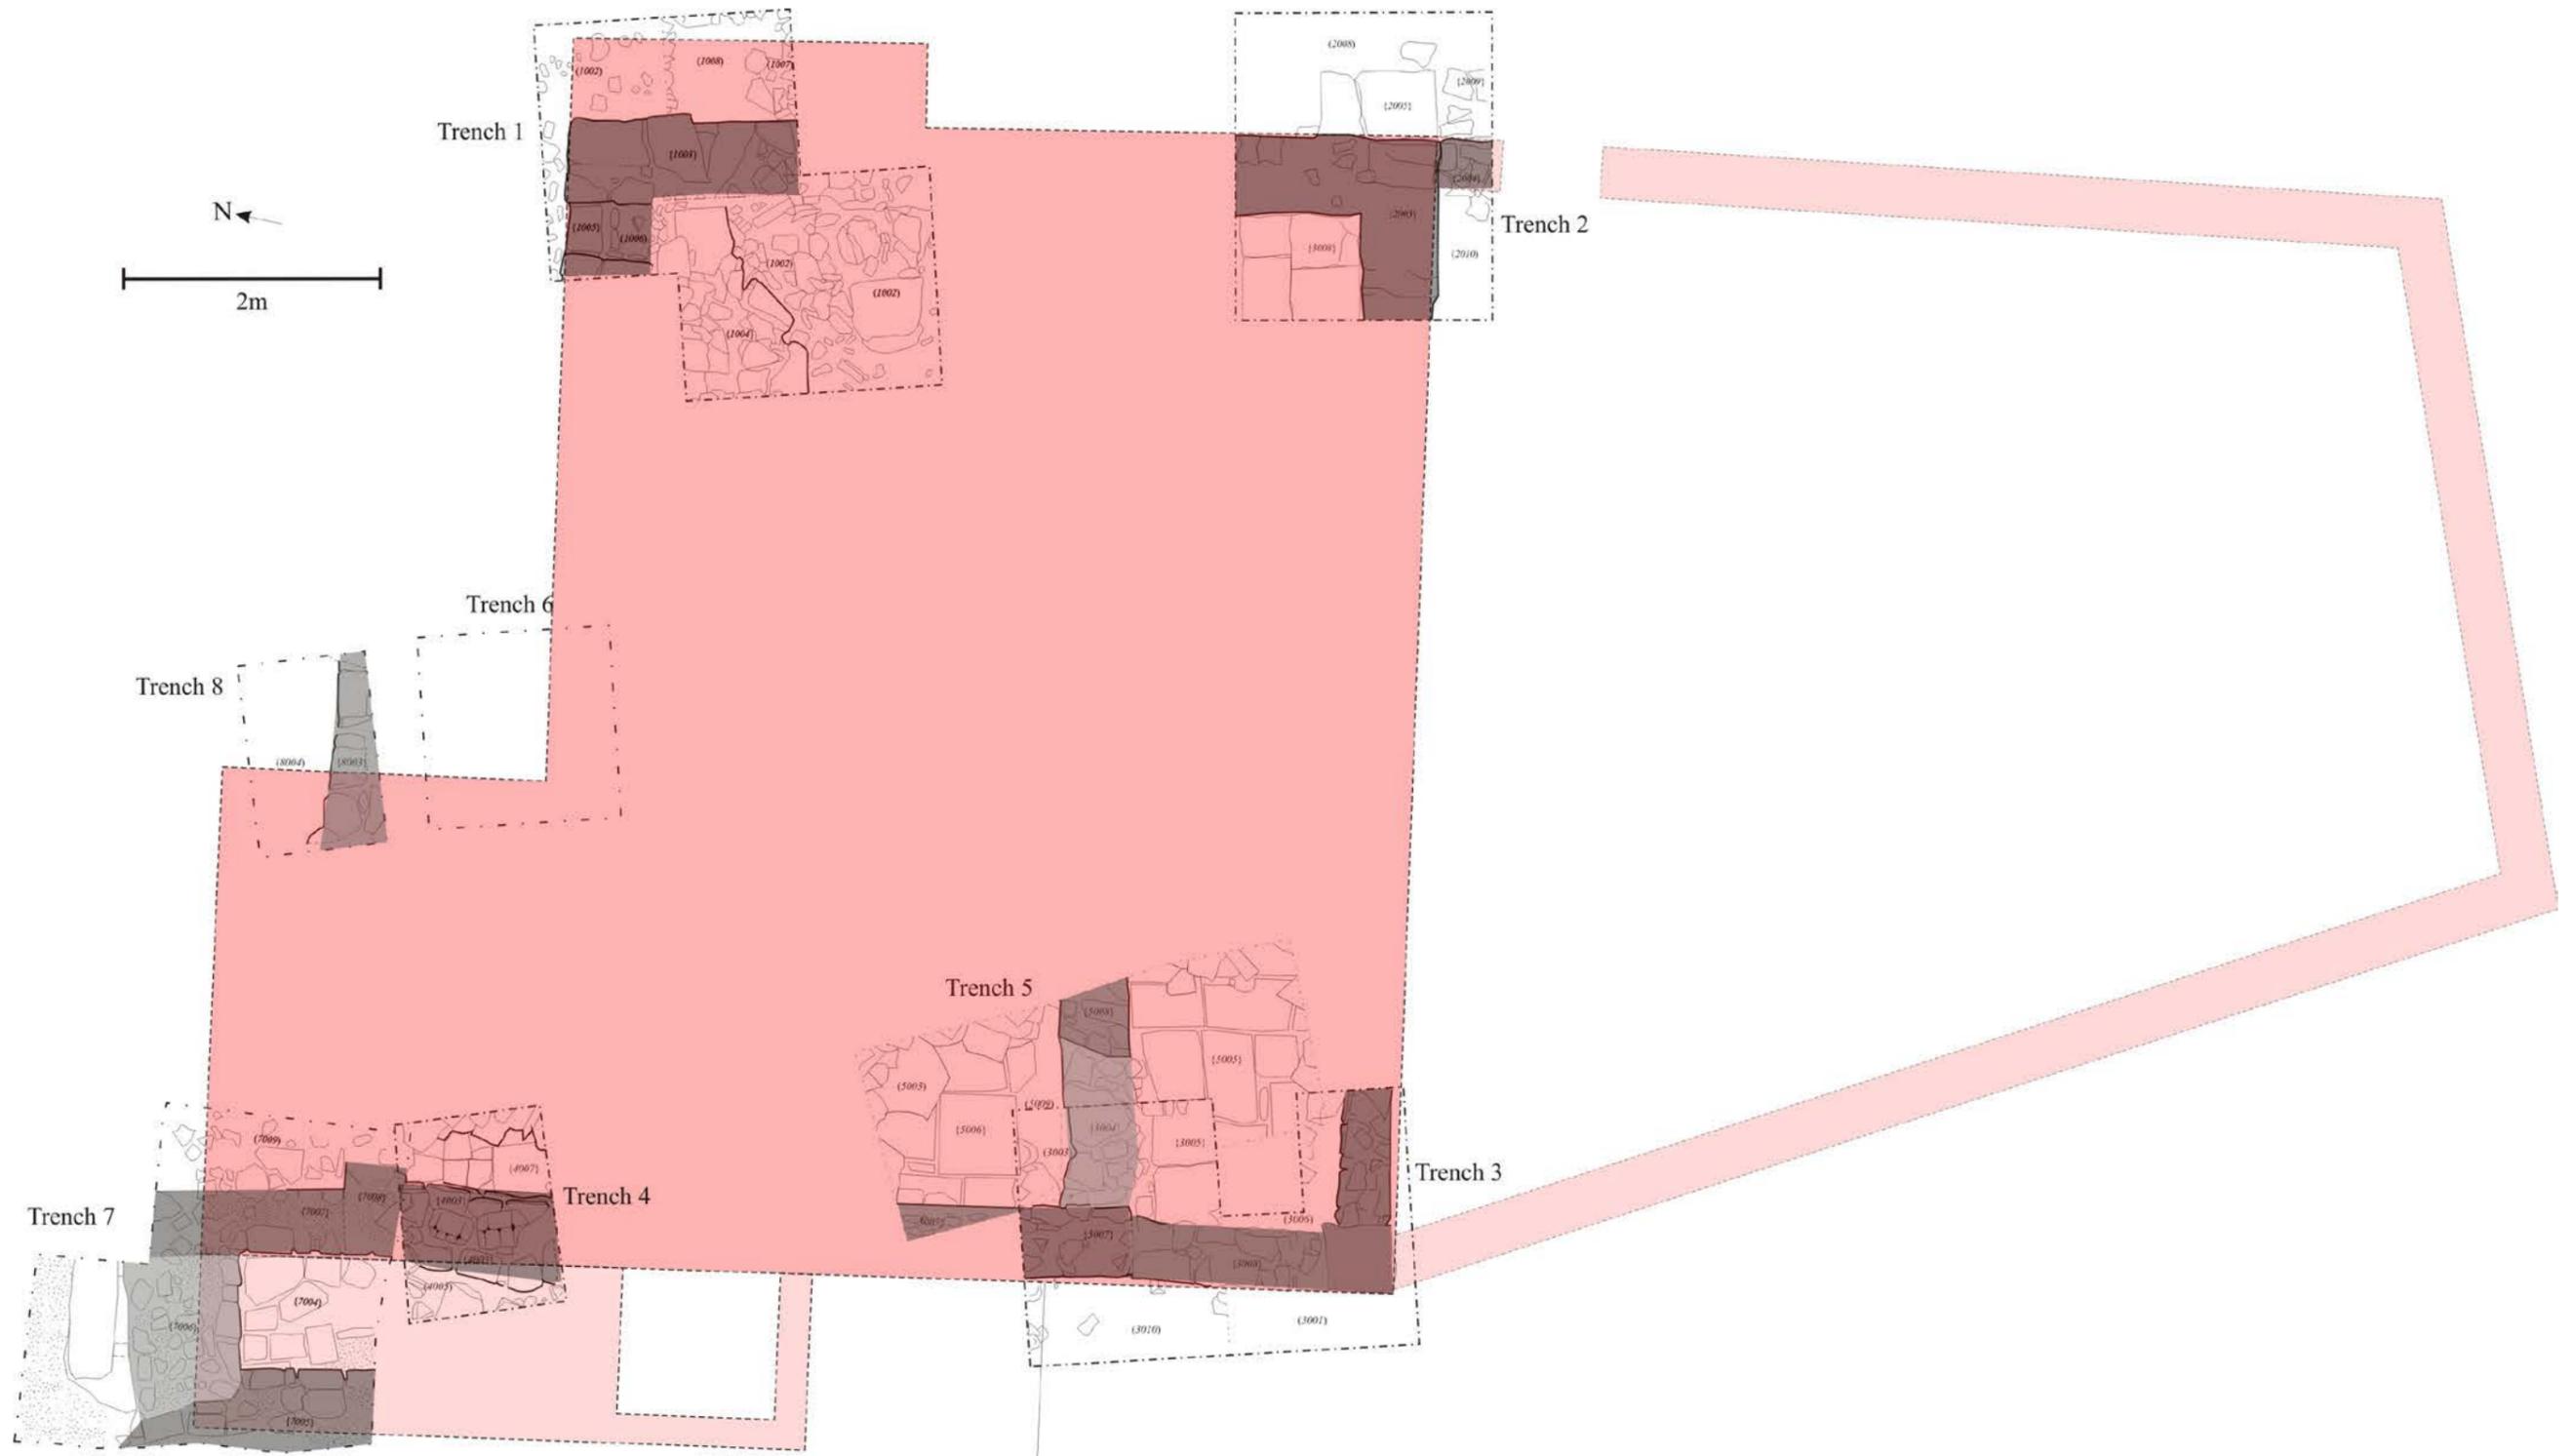
Figure 27 Trench location plan showing trench locations plotted against the building outline as shown on the 19th century plan of the site (figure 4)

Wall {8003} clearly forms the northern perimeter of the Little Engine House, but the location is somewhat confusing when plotted against the existing maps of the Little Engine House complex (*figures 27 and 28*). As shown in *figure 27*, all of the trenches sit perfectly atop the depiction of the Little Engine House from the 19th century map held by the Lord Crewe Trustees. However the wall alignment in Trench 8 is not close to matching with any of the wall alignments. When the record of the building from the Ordnance Survey data is plotted against the trench plan (*figure 28*), the trenches do not fit as appropriately as *figure 27*, but do show {8003} to be the back wall of the Little Engine House complex at this time.

There are various reasons for the discrepancies in *figures 27 and 28*. It is important to remember the Little Engine House was essentially not one building, but was rather a series building units successively constructed, renovated and demolished over the site's life. The maps we have provide a mere snapshot of how the building appeared when surveyed and do not provide all the detail of building's complex history. The maps themselves are also not entirely accurate as the two do not match up perfectly when placed together, so some distortion will be present. In addition the trench locations were hand-drawn by volunteers over two seasons and measured off a baseline which was re-

established in the second season. All of these factors combine to provide the distortions to *figures 27* and *28*, although taken in conjunction with the pictorial evidence and archaeological interpretations it becomes clear which parts of the buildings the walls in the trenches represent. Wall {8003} clearly represents the northern boundary of the Little Engine House, although whether this is the N wall of the structure depicted as purple in *figure 20*, or the real wall of the main building as depicted pink, is unclear.

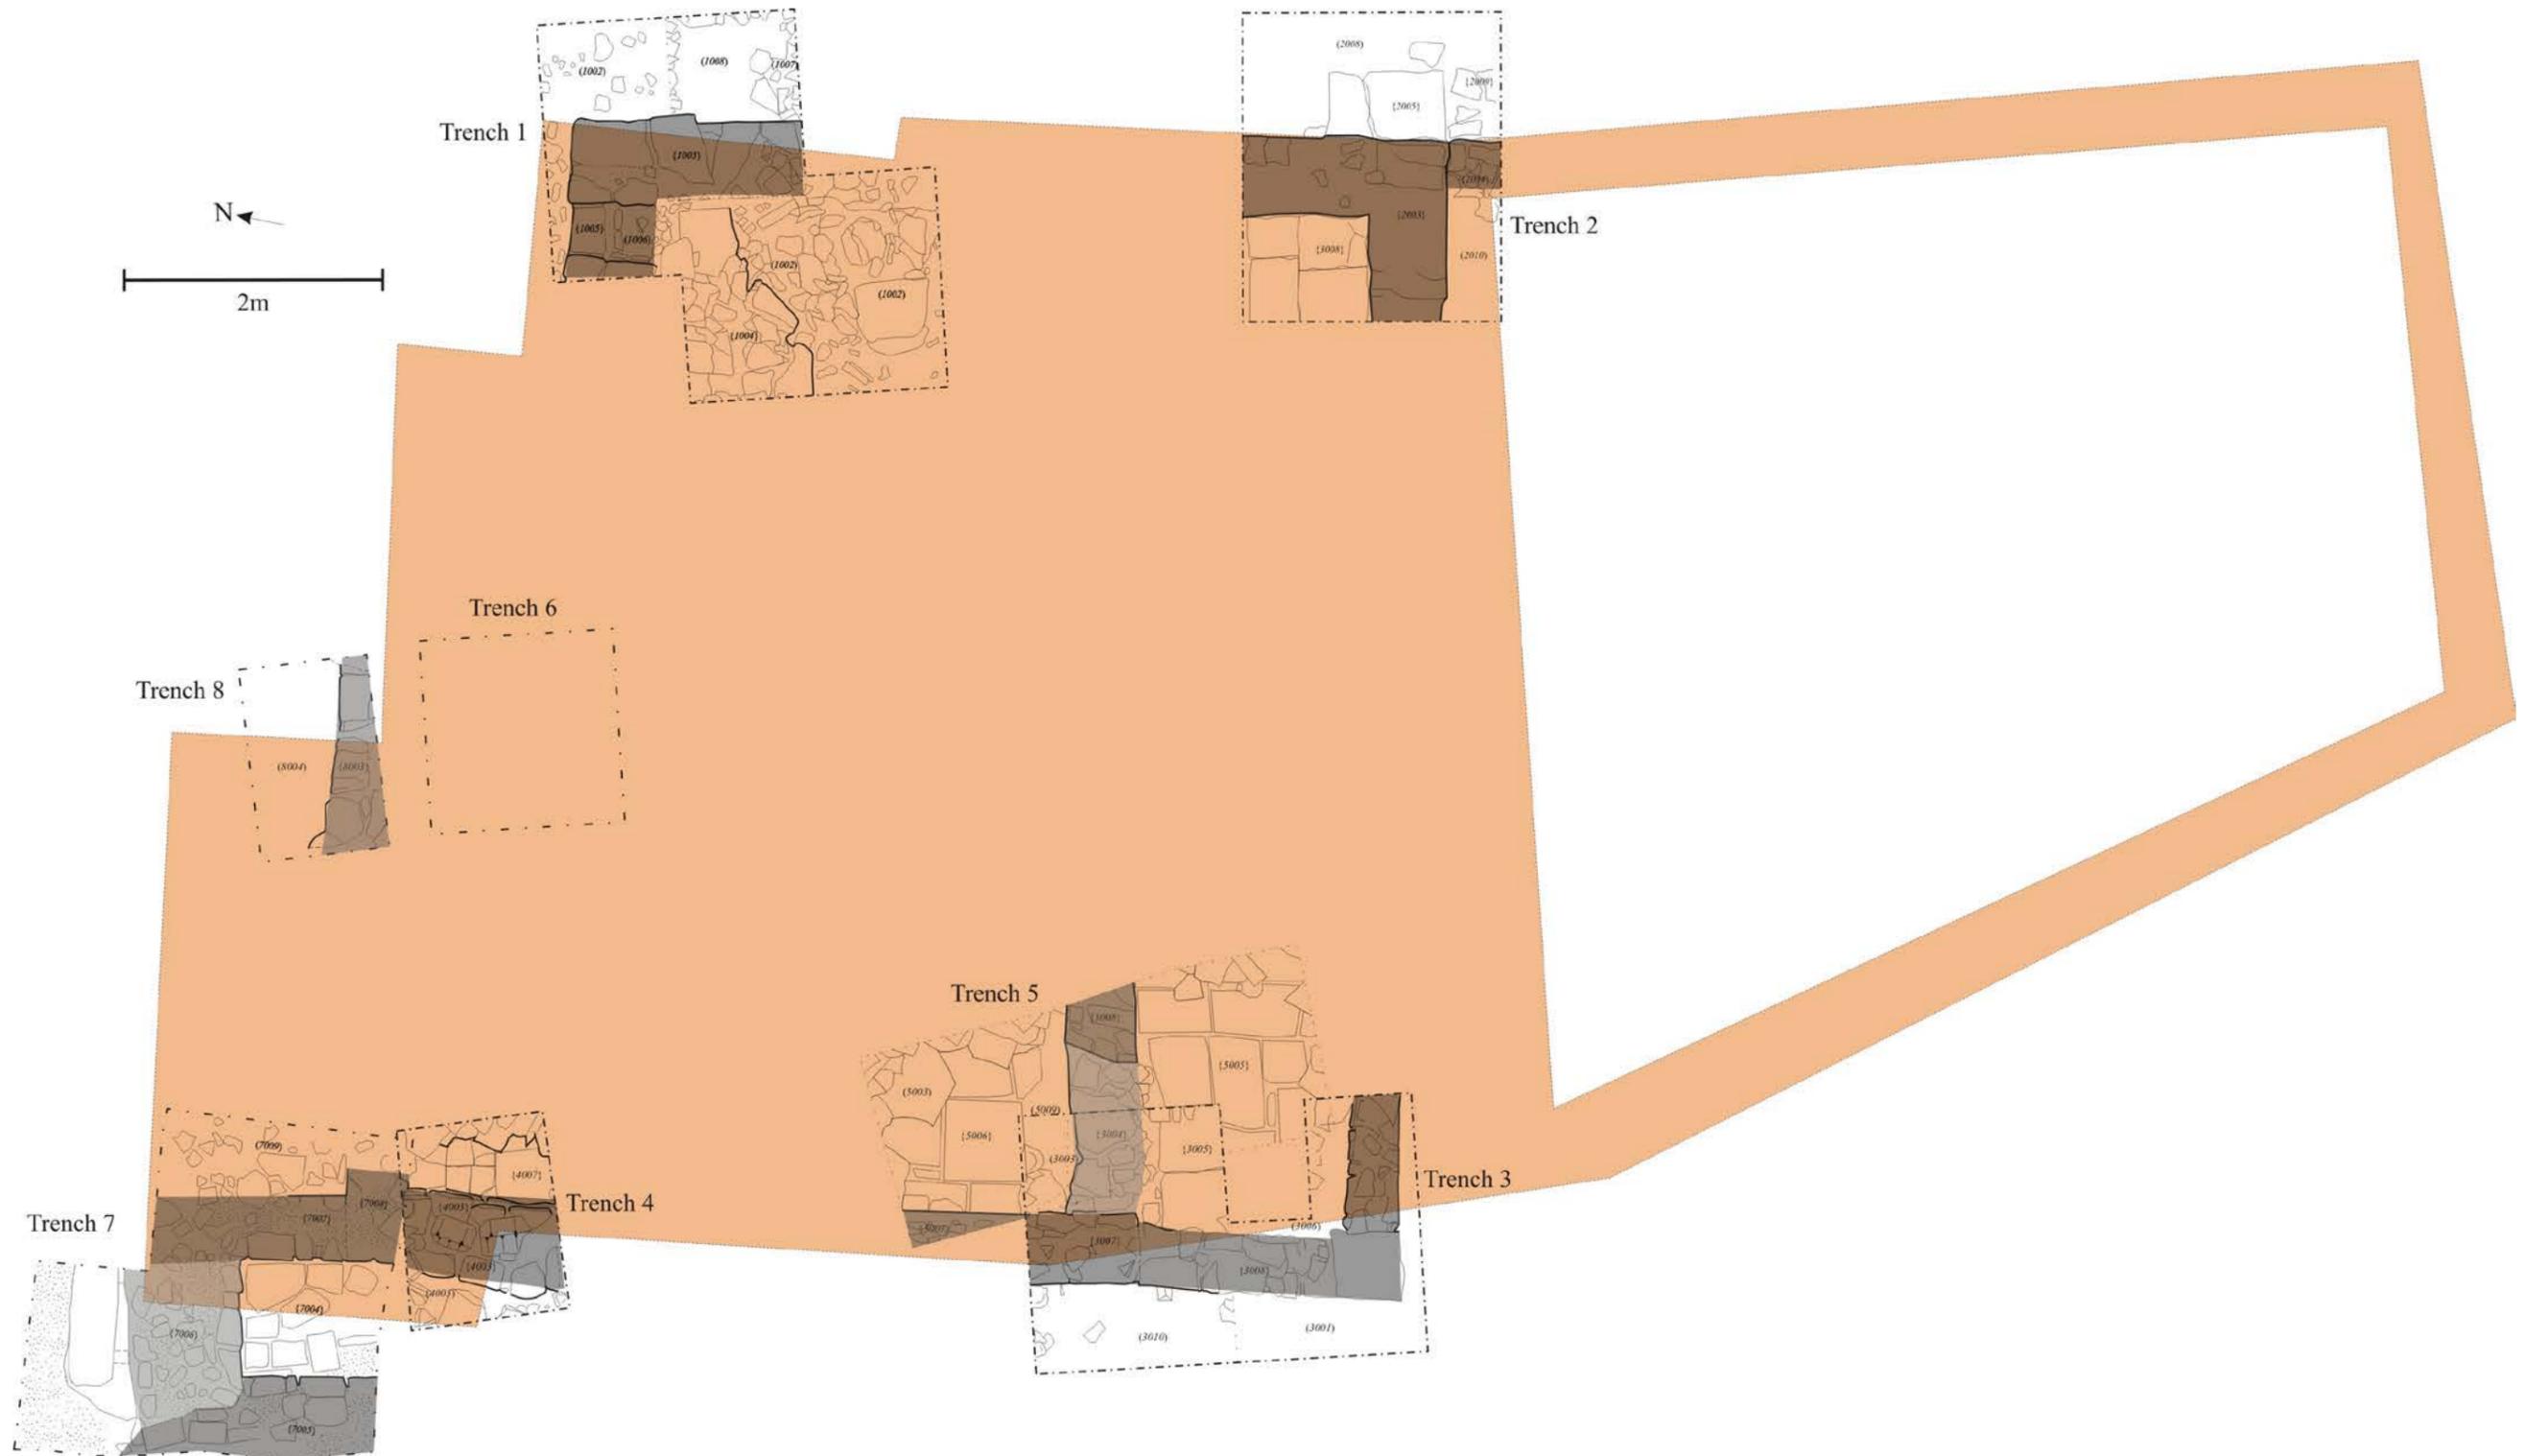
Figure 28 Trench location plan showing trench locations plotted against the building outline as shown on the 1920s Ordnance Survey plan of the site (figure 7). Note the orientation of the building has been skewed slightly to provide the best fit.

Wall {6006} is the same as {8003} encountered in Trench 8 and {7008} in Trench 7, but is not on the correct alignment to be {1003} from Trench 1 in 2011. Analysis of the Ordnance Survey data (*figure 28*) shows this is likely to have been the N wall of the Little Engine House, and it remains unclear if floor surfaces or indeed further walls would have been revealed beneath (6005).
