BRADING
ROMAN VILLA

Fieldwork Report
for an Evaluation on the line
of a Proposed Land Drain to protect
BRADING ROMAN VILLA, Isle of Wight (SAM 35)
(Isle of Wight Site Code 1017, CAS Project Code 531),
carried out by the
Central Archaeology Service

by
P A Busby

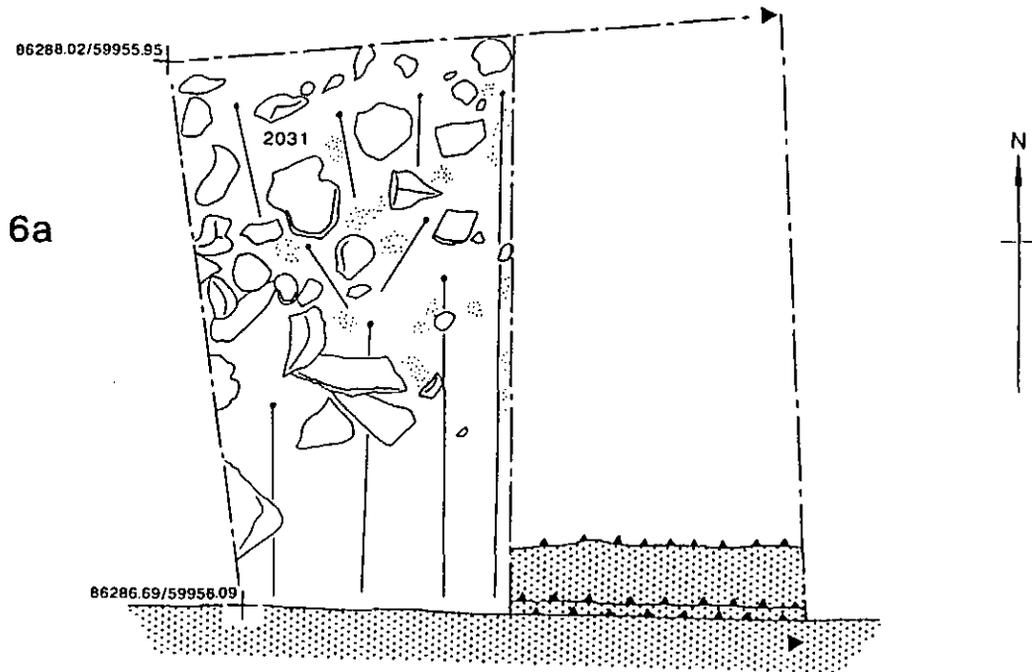
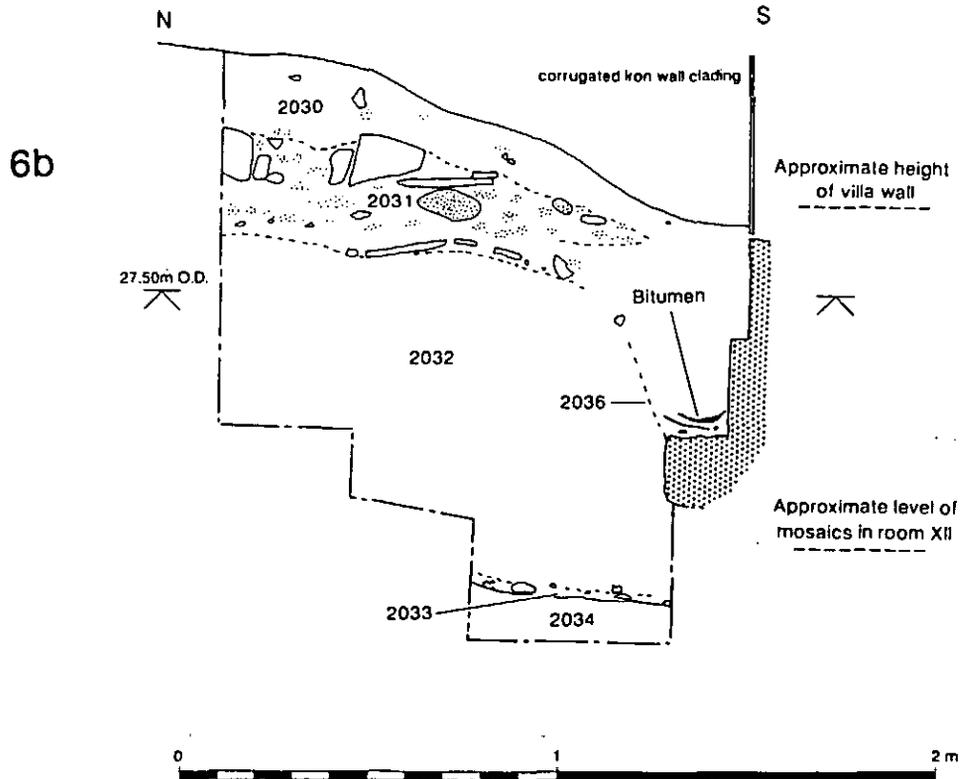
Figure 6a. Plan of test pit 6

Construction trench 2036 appeared to be a linear cut up to 300mm wide running east-west, parallel to the stepped concrete foundations 2037 of the 1900s cover building. Its soil fill was a dark yellowish brown sandy loam, containing occasional pieces of tarred roofing paper. The feature was poorly defined as its fill merged with the top soil layer 2030 and was almost indistinguishable from the layer 2032 through which it was apparently cut.

The initial step of the concrete foundations 2037 appears to fill the base of the construction trench 2036, implying the wet concrete was simply poured into the construction trench. The subsequent two steps both have smooth, slightly wood patterned outer edges implying that they were shuttered to produce a thinner foundation to protect the upstanding Roman wall on its inside edge.

Under the top soil layer 2030, there was the substantial rubble layer 2031. It was 270mm thick against the northern edge of the test pit and consisted mostly of assorted large stones and lumps of mortar, with a suggestion of horizontal layering within this deposit. The southern edge of this layer was very diffuse and lay over the northern limits of the construction trench 2036 with the rubble in the southern portion of this layer apparently dipping in to the construction trench, suggesting that this layer was later than 2036.

Figure 6b. West facing section of test pit 6

Section see figure 6b

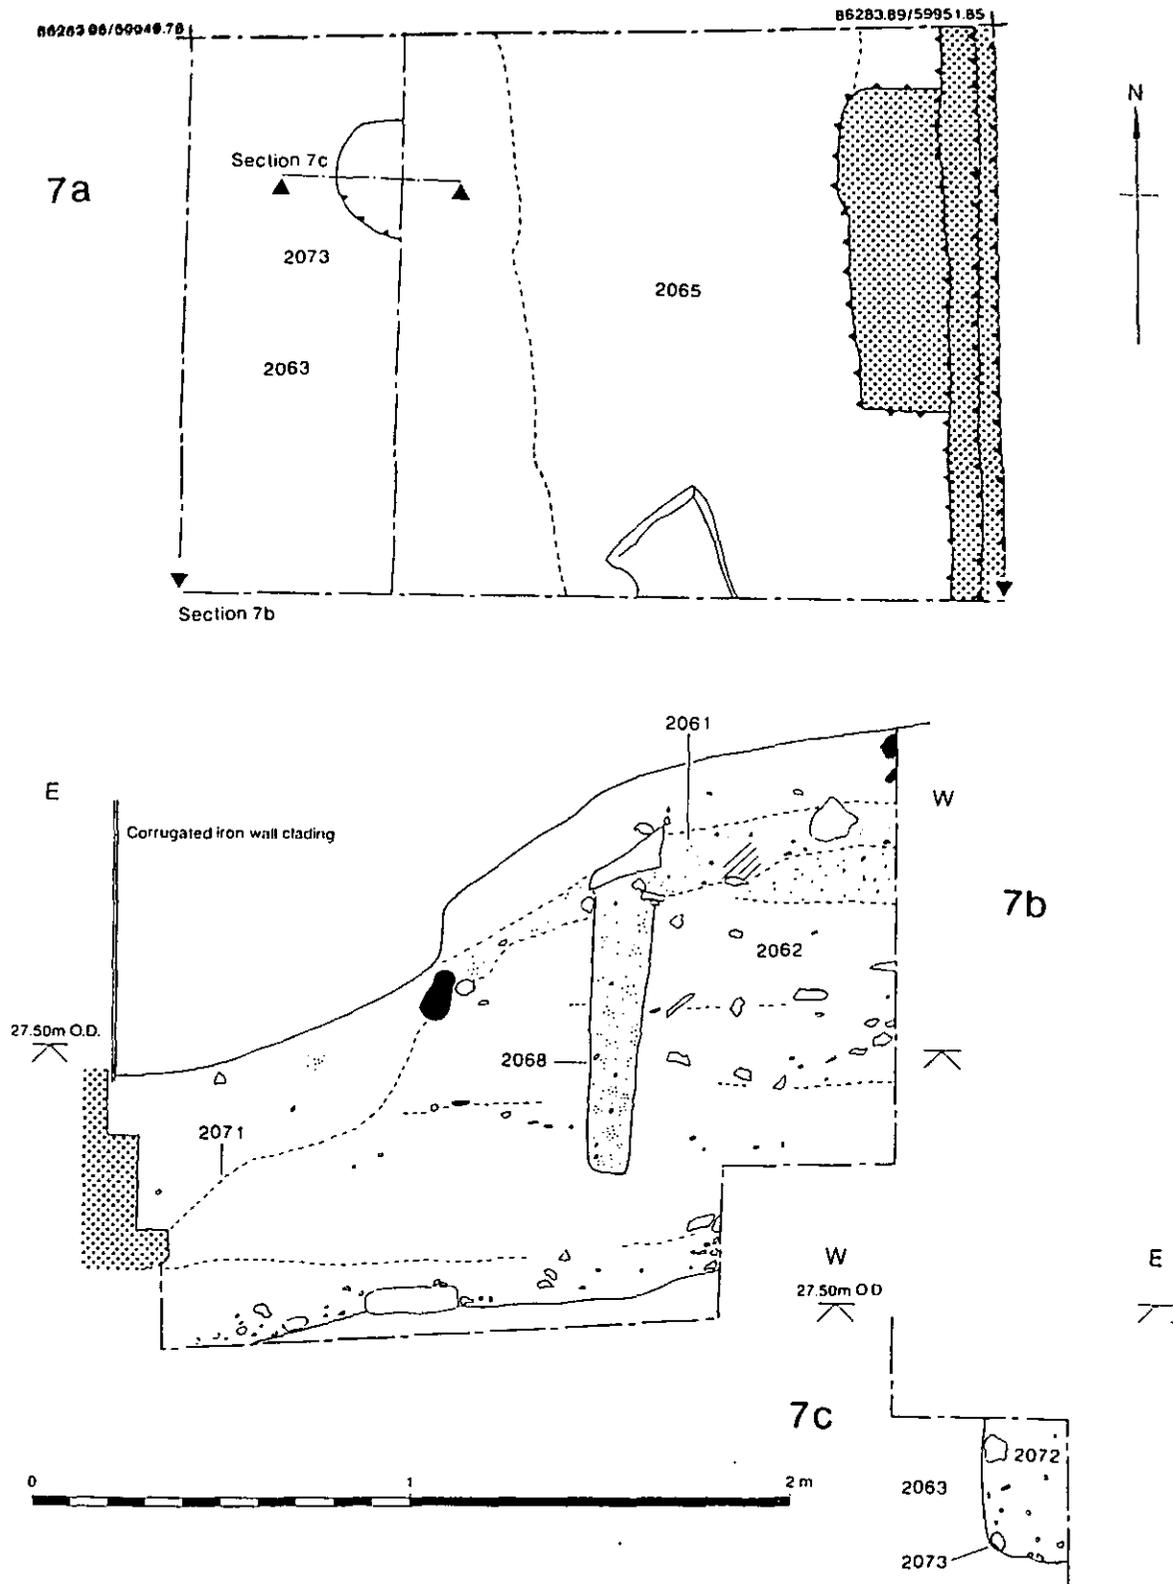
Figure 7a. Plan of test pit 7

Figure 7b. North facing section of test pit 7

Figure 7c. South facing section of post hole 2073

Construction trench 2071 appeared to be a linear cut up to 750mm wide, running parallel to the stepped concrete foundations 2070 of the 1900s cover building. It was a poorly defined cut, because its fill was a dark yellowish brown sandy loam, merged with the surrounding layers.

Sections see figure 7b and 7c

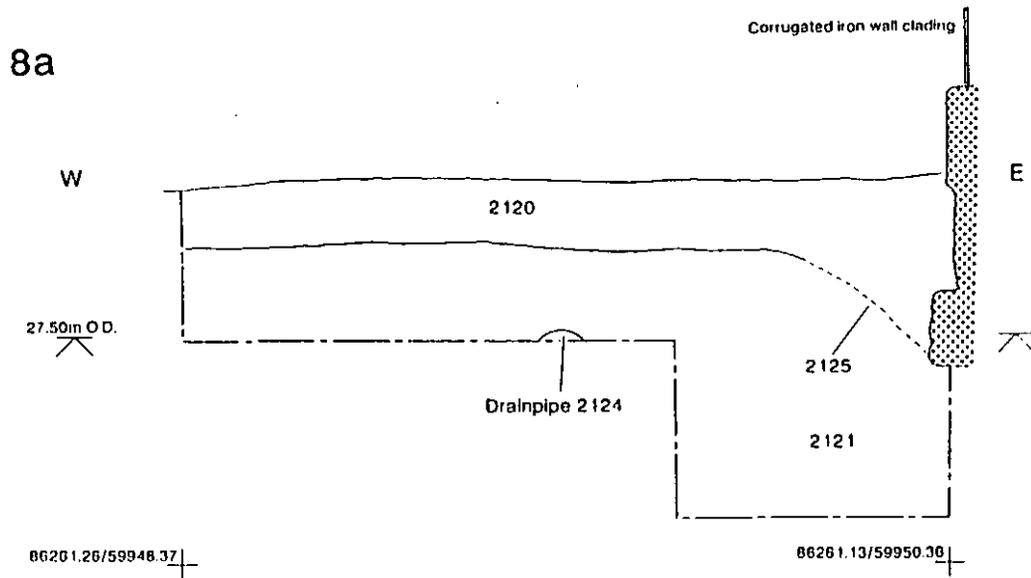
Figure 8a. South facing section of test pit 9

There was no evidence from this test pit to indicate that the wall lines of the small rectangular structure to the west of the main villa building extended to the east, although it is more than possible that the test pit was to one side of a possible continuation. On the last day of the fieldwork it was suggested (*pers comm* the Custodian), that many of the linear rubble lines and other lumps and bumps in the area were largely the result of John Oglander (grandson of current owner) constructing stone 'long barrows' etc. Also it would appear that the archaeological sequence is truncated vertically to a point probably comparable to the surface of layer 2032 in test pit 6, ie. all Roman and later deposits have been removed from the area of the test pit by the excavations to the west of the main villa building. The foundations for the cover building and its associated drains have cut in to the pre Roman soil 2121 in a more localised way.

Section see figure 8a

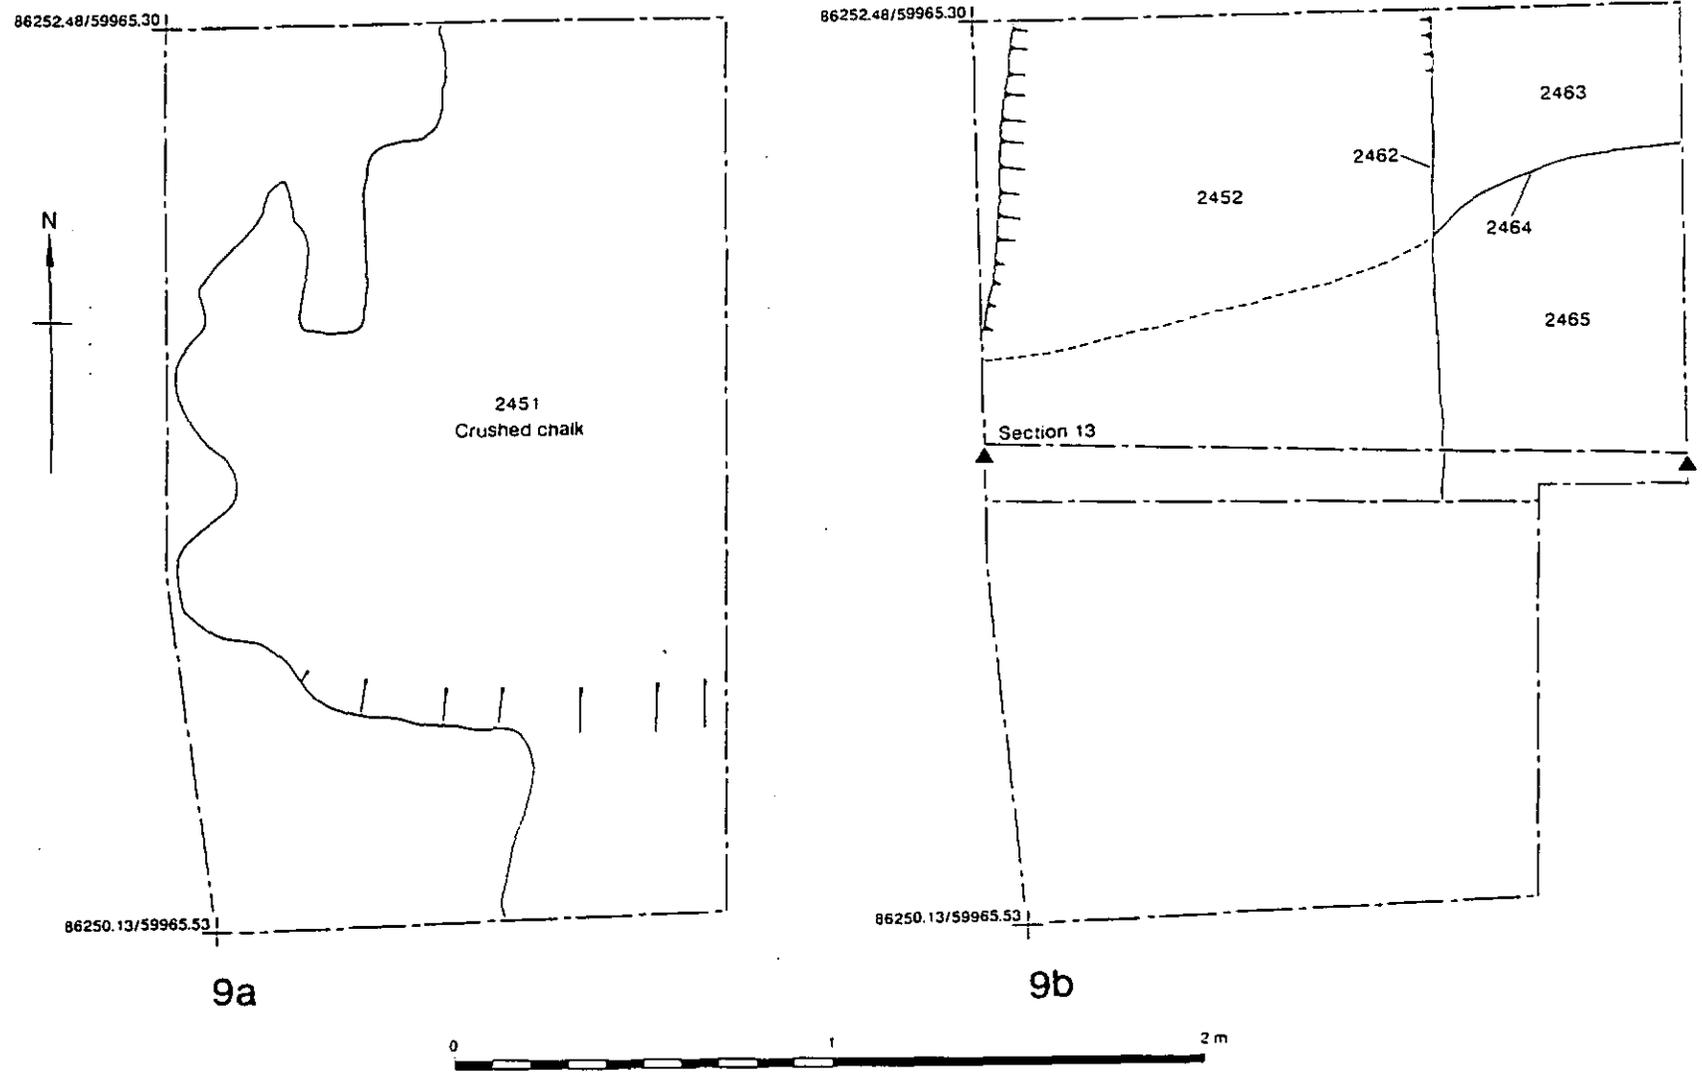
Figure 9a. Plan of crushed chalk layer 2451, test pit 20

Underlying this rubble layer were a number of brownish yellow sandy clay loams (contexts 2453-2459), with varying amounts of small inclusions, forming dump 2452, both sealing and filling the two linear features 2462 and 2464. Linear feature 2462 ran north-south along the expected line of the courtyard wall between the main villa building and the southern range. It had an almost vertically sided, flat bottomed profile, 1.20m wide and 650mm deep, and contained no structural remains in the excavated portion. The other linear feature ran east-west, across the line of 2462. It was only partially excavated and had a more irregular profile, 790mm wide and 450mm deep, with its eastern end giving the impression that it undermined the surrounding layers slightly. Also its fills appeared to have been cut by 2462, although this was by no means certain given their similarity.

The most likely interpretation for these sediments would appear to be Victorian back fill, with the linear feature 2464, in our view, being a prospection pit for the courtyard wall. This explains why its sediments appeared to have been cut by 2462. This linear feature on the other hand would appear to be the wall trench for the courtyard wall, which had been emptied by the Victorian excavators, implying this wall had been robbed out prior to the Victorian excavations.

Figure 9b. Plan of fully excavated test pit 20

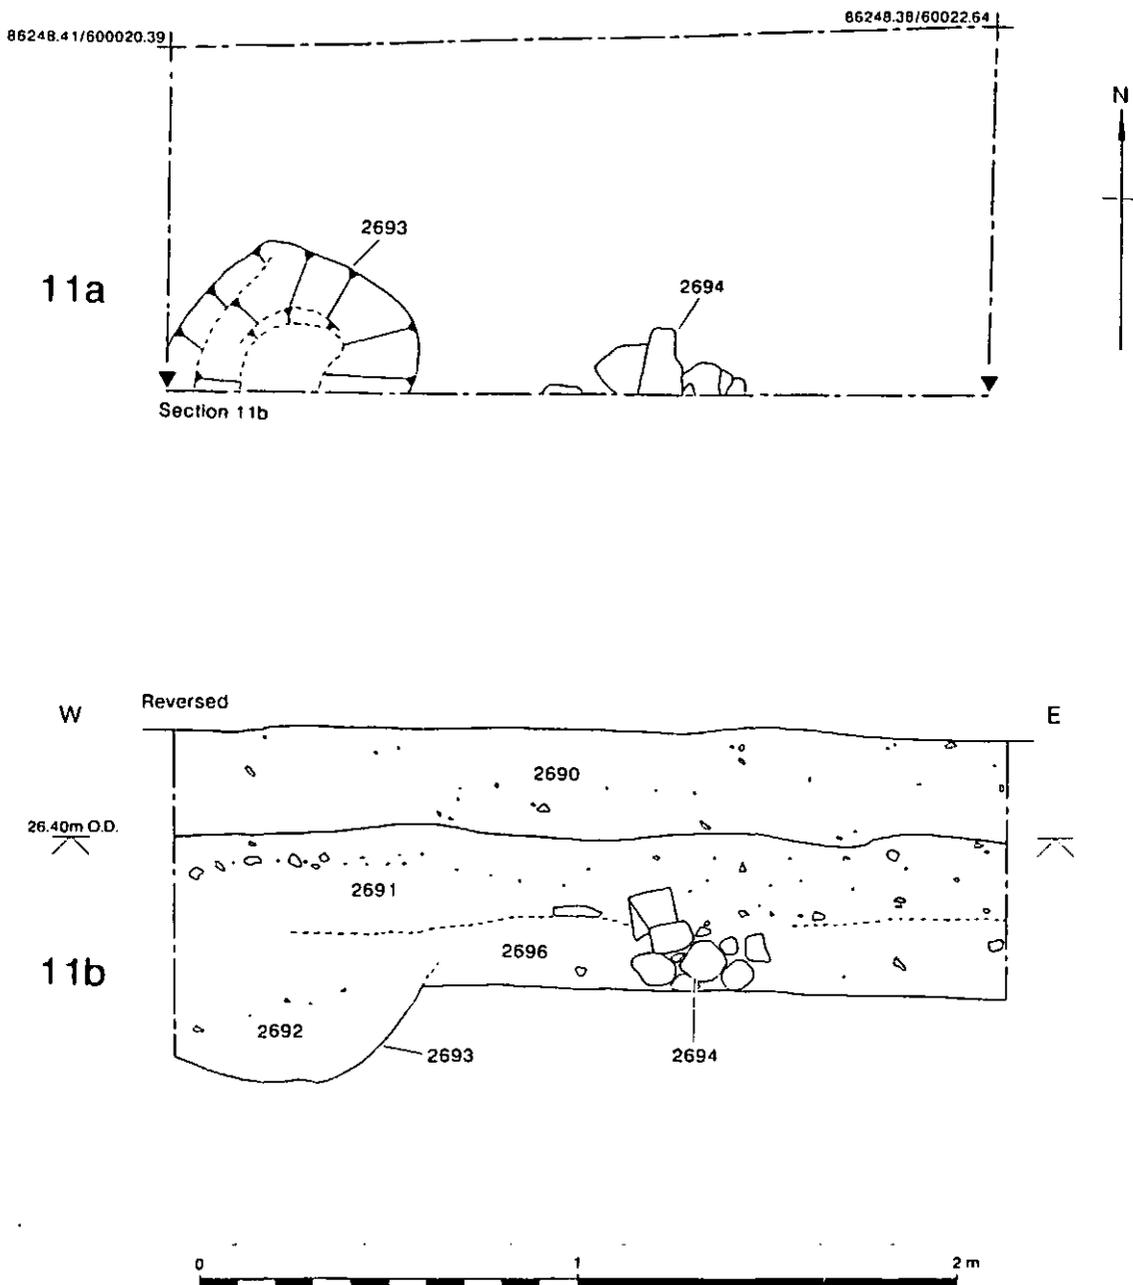
Figure 11a. Plan of test pit 28

A likely interpretation of layer 2696 is that it represents the remains of a soil contemporary to, or earlier, than the courtyard wall. An interpretation corroborated by the functionless pit 2693, which appears to have cut the lower portion of this layer. However it is possible that this layer is also Victorian back fill, like the overlying layer 2691. The pit had an irregular cut approximately 700mm in diameter and 320mm deep,

Figure 11b. North facing section of test pit 28

Section see figure 11b

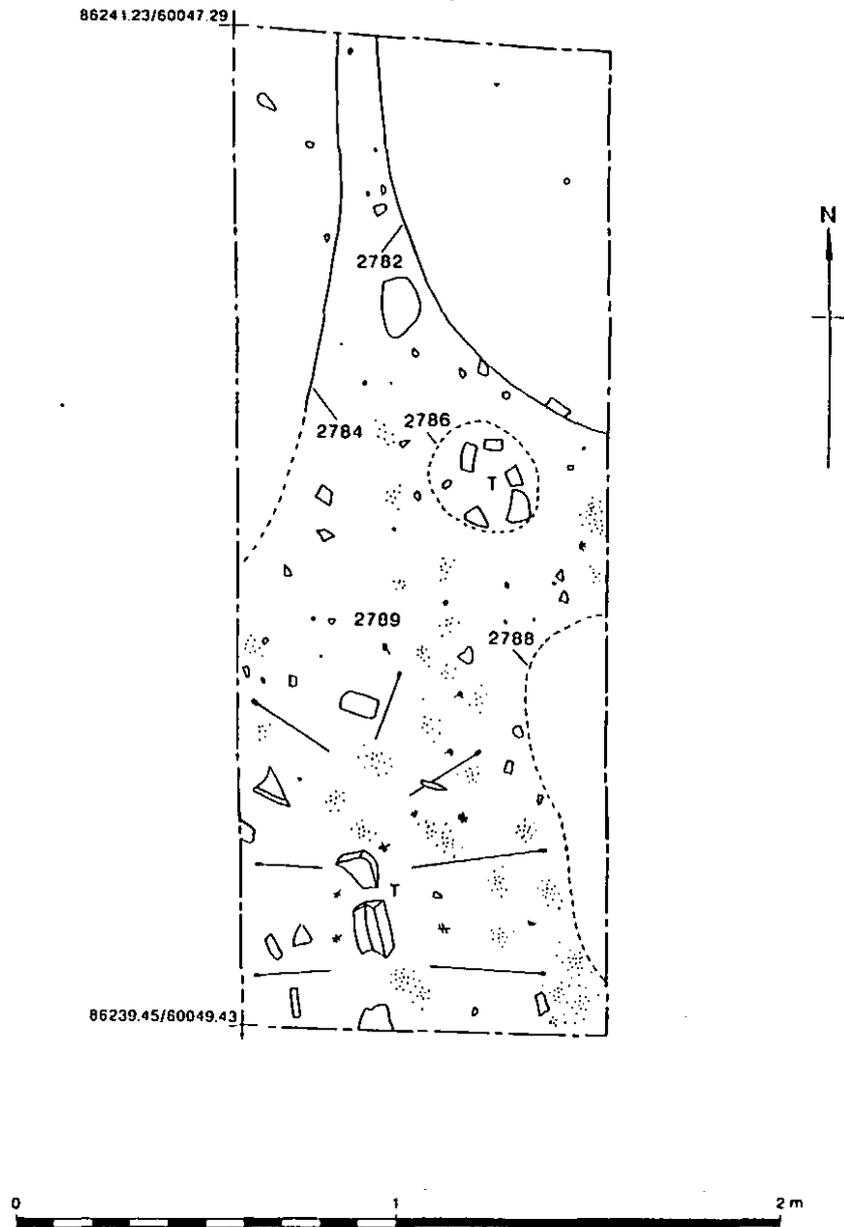
Figure 12. Plan of test pit 31

The most recent phase of activity probably consists of three undated pits, with an unknown function. This would appear to be preceded by a post hole structure of unknown size and shape, which in turn cuts a dumped layer, forming the final phase of activity recognised within in this test pit. However, as the dumped layer was not removed, it need not be the base of the archaeological sequence in the area and it may conceivably obscure any eastward continuation of the walls of the bathhouse, located at the eastern end of the southern range of the villa.

Plans see figures 4 and 12
Contexts 2780 to 2790
photographs 3522
