The Dover Bronze Age Boat

edited by Peter Clark

Edited by Peter Clark

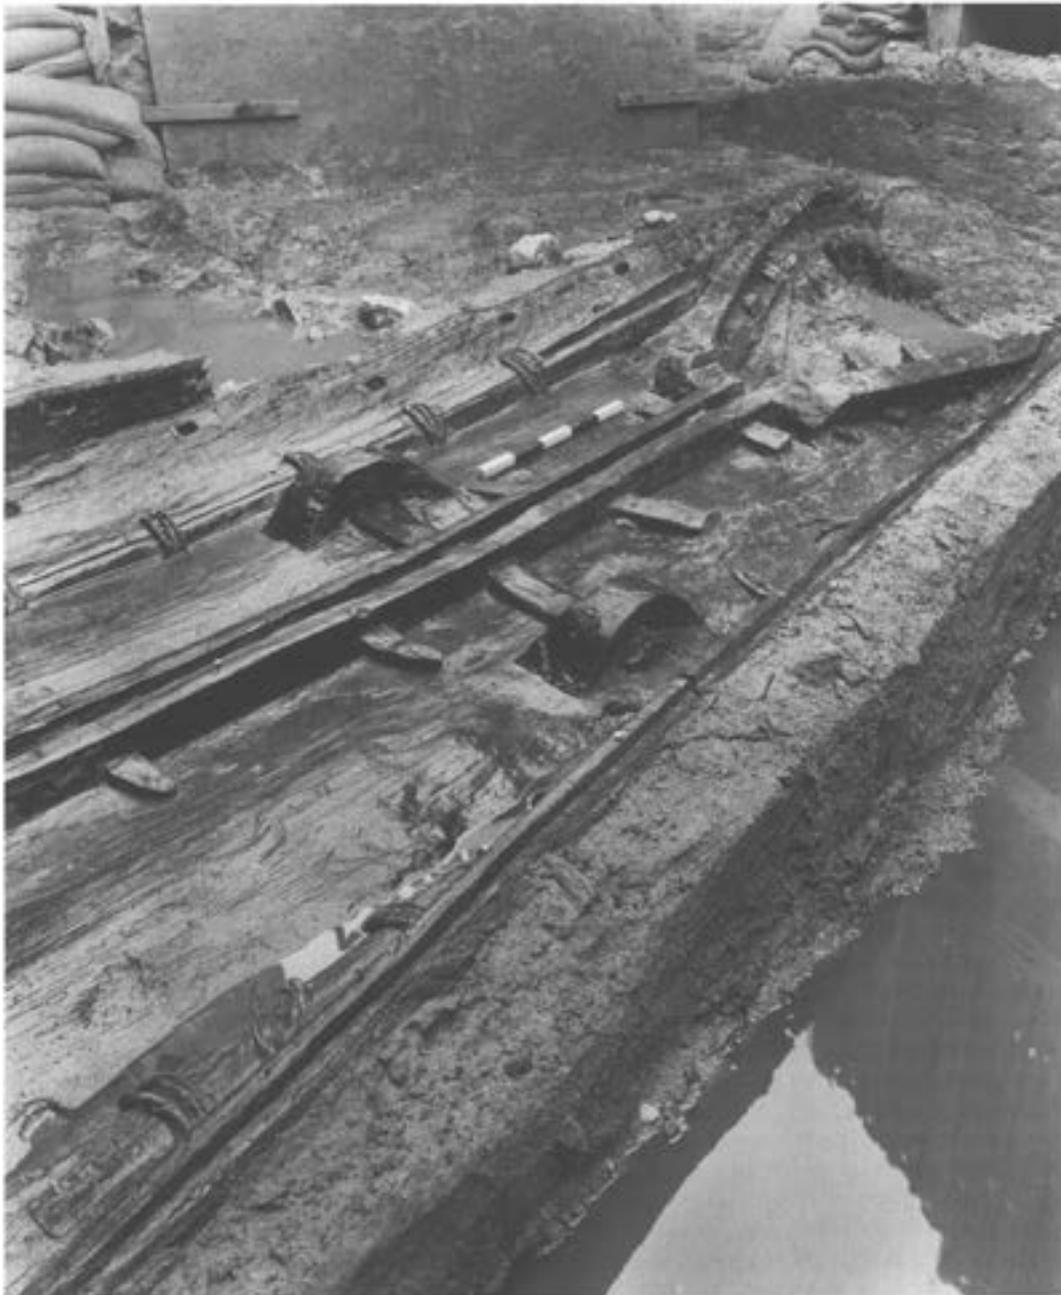
Figure 1.1

The boat in situ. Here, the astonishing preservation of the timbers can be seen clearly; note the tool marks on the upper surfaces of the bottom planks. When first exposed, the timbers were a golden brown in colour, but turned dark brown or black in front of the excavators' eyes – probably the result of ferrous ions reacting with residual tannins in the wood.

The Dover boat always appeared as an extremely impressive structure (see Fig 1.1). The details of the construction readily made it clear that the vessel must have been the product of a master boat-builder working within a long established tradition. Indeed, the complexity of the craft served as a startling object lesson to all those excavators with previous experience only of dry-land prehistoric sites, devoid of any surviving timber remains. Exactly as Ted Wright found with the Ferriby boats, 'to convey adequately the astonishing intricacy and craftsmanship' as first revealed, is extremely difficult (Wright 1990, 195).

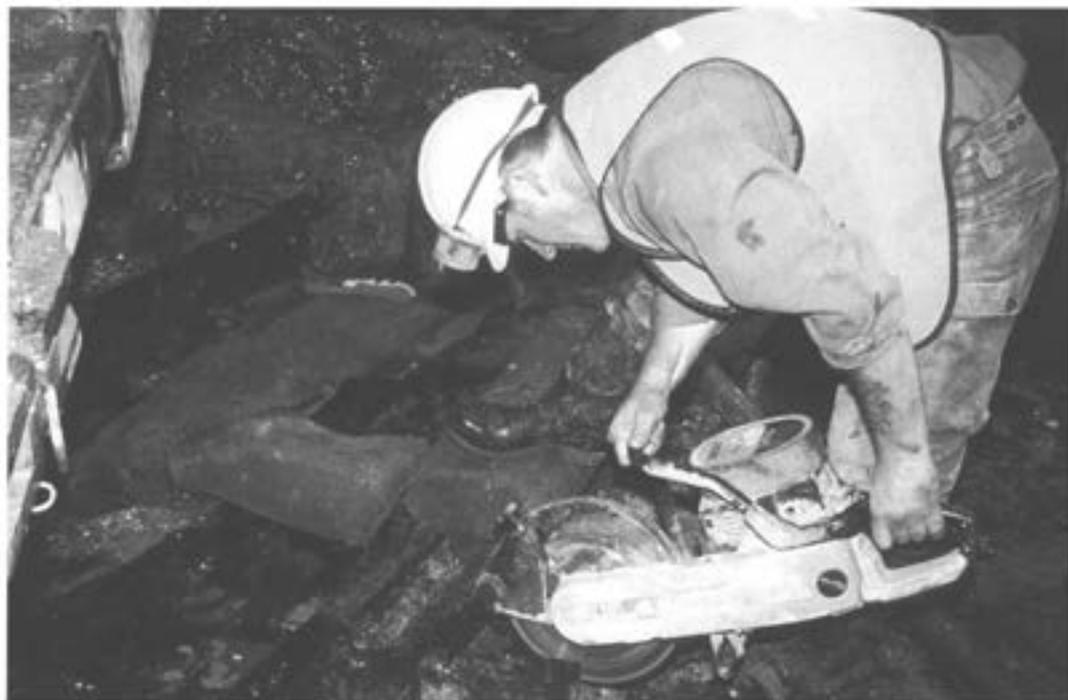
Figure 3.5
Cutting the boat timbers. The boat was cut into thirty-two pieces with a diamond-tipped rotary saw, each cut carefully positioned to preserve the fragile and complicated seams between the planks.

Because the boat had to be removed in order to allow the contractors to complete the shaft, and because time for detailed examination and recording in the ground was very limited, the excavation team decided early on that the craft must be lifted in order to allow more careful study off-site. A group of specialists was hastily called to a consultation meeting in Dover. The question to resolve was whether to attempt to lift the boat in one, or whether to cut it into sections and remove these individually. Opinions were divided, but it was finally agreed that – owing to the limited time available (only one-and-a-half days were then remaining), the fairly fragile nature of the construction and the damage already sustained – the only practical solution was to cut the boat into manageable segments, thereby safeguarding key structural features, and lift these out of the excavation separately for further examination (Figs 3.5; 3.6).

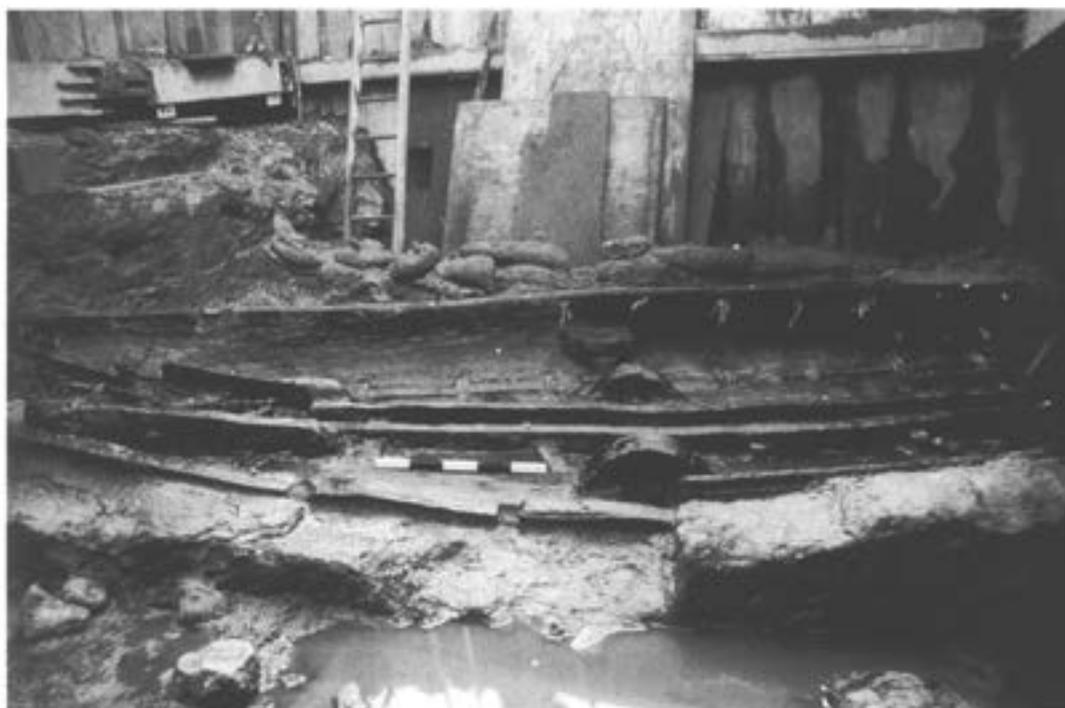
Figure 3.7
The second part of the boat revealed in Cofferdam II. By an astonishing mixture of luck and judgement, the second shaft uncovered one end of the boat in its entirety. Note the severed withies on the upper edge of the ile plank, evidence for an upper side plank.

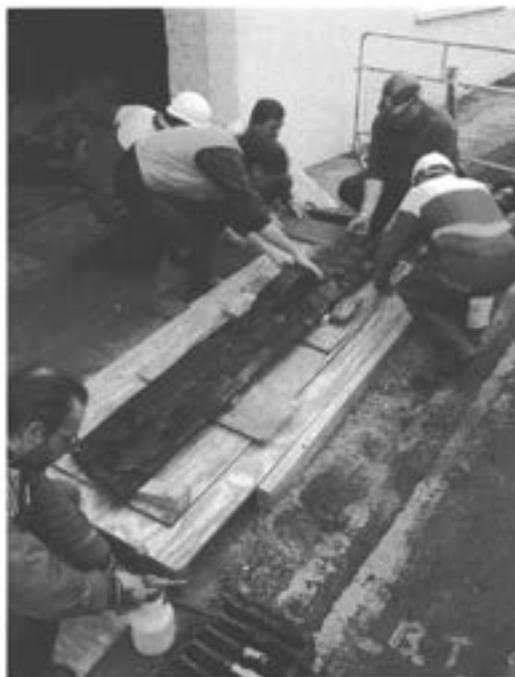
Figure 3.10 (above right)
Primary treatment of boat pieces. Staff from Canterbury Archaeological Trust, Dover Museum, English Heritage and Dover Harbour Board, together with local volunteers, cleaned, supported and consolidated the timbers immediately after their excavation.

The timbers were then lifted clear of the excavation and taken by a Harbour Board lorry to the nearby storage facility where they were received by a second team, including staff from Dover Museum, English Heritage and Dover Harbour Board. Members of the reception team cleaned the loose sediment from the individual timbers, carried out emergency first-aid work on damaged sections, wrapped each timber section in plastic sheet and immersed them all in the storage tanks (Fig 3.10). Work to prepare the boat timbers for immersion continued late into the night on both lift days.

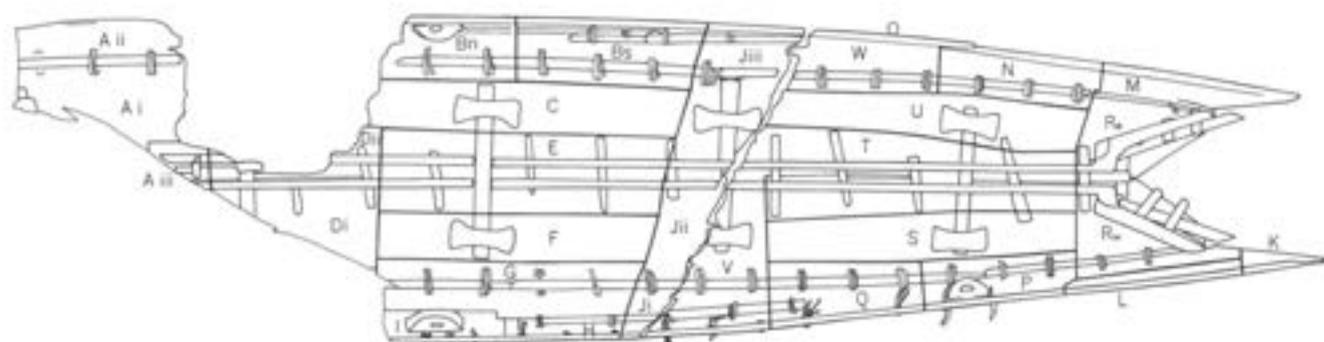
Figure 4.2
A 'piece plan' of the boat,
showing the thirty-two
pieces into which it was
cut, together with their
letter codes.

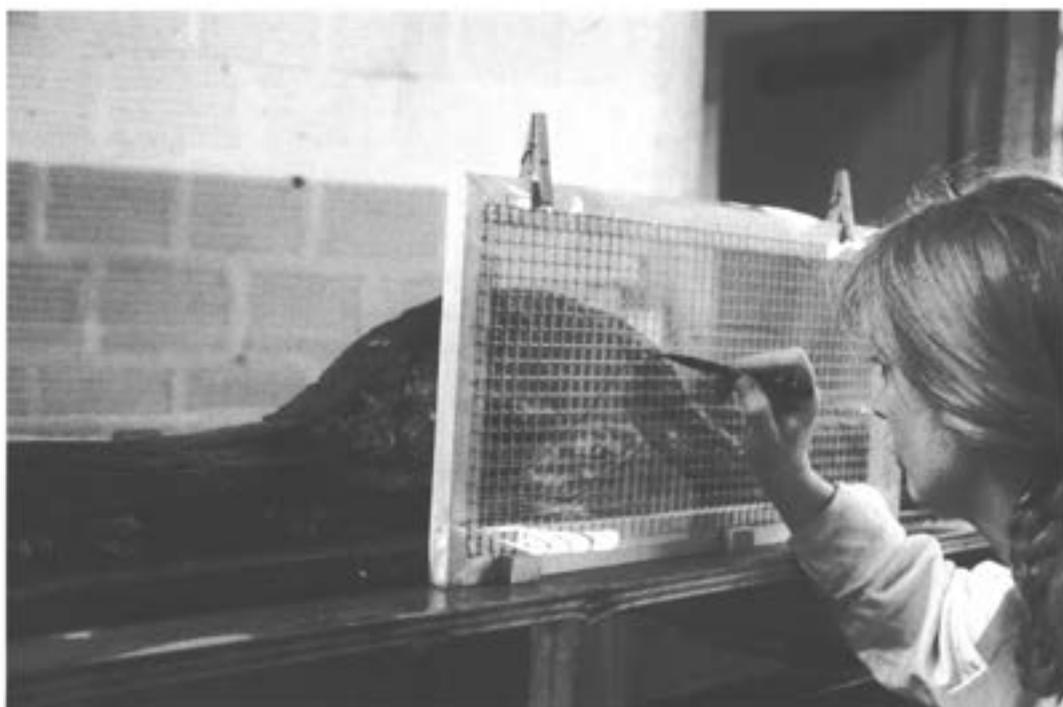
Figure 4.4
Drawing the boat pieces. Here, Caroline Caldwell uses a custom-built mini-recording frame to draw the profile of one of the bottom cleats accurately.

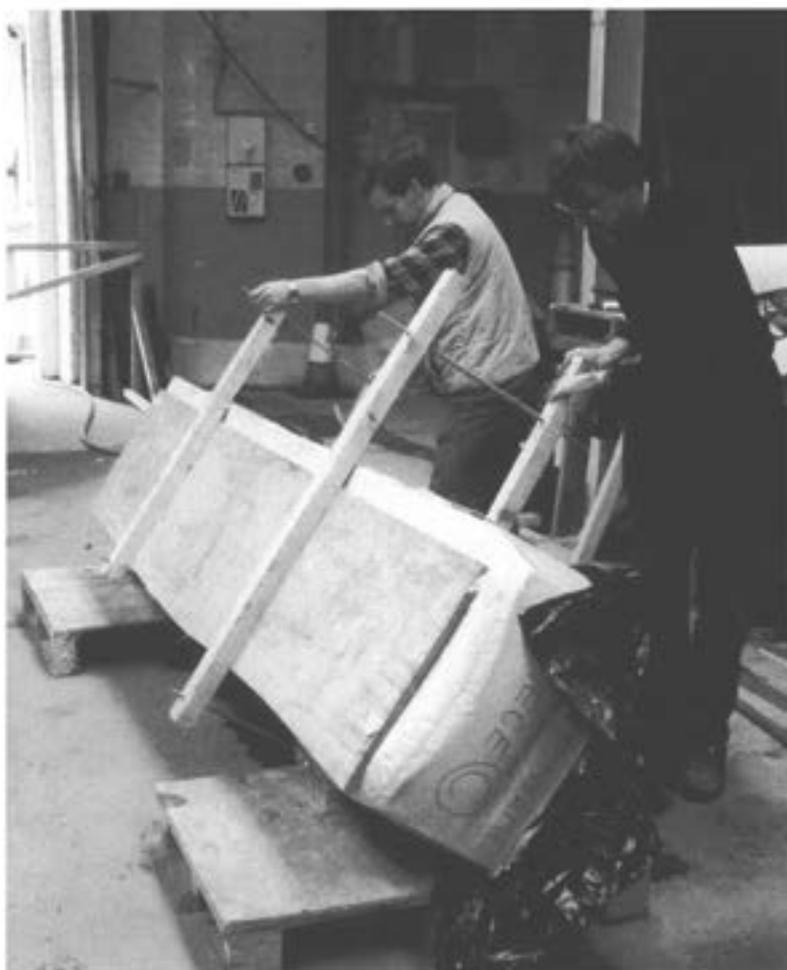
Figure 4.5 (above)
Inverting the pieces:
turning the support.

With the clamps in place, the box was slid, on its baseboard, to one side of the pallets. Using the clamps as handles, the box was rolled over onto its side and again onto its top – now the base. The 180-degree rolling manoeuvre, albeit in two stages, was performed smoothly, with no awkward jerky movements (Fig 4.5).

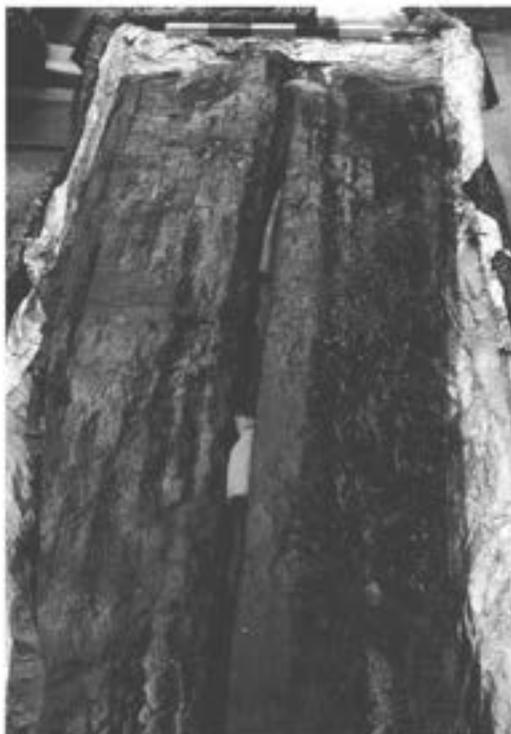
Figure 4.6
Inverting the pieces: the
outboard surface revealed.

remaining sediment was then removed and kept as a bulk sample, revealing the outboard surface of the timbers, which could now be recorded (Fig 4.6). Water was added to the box to keep the timbers waterlogged.

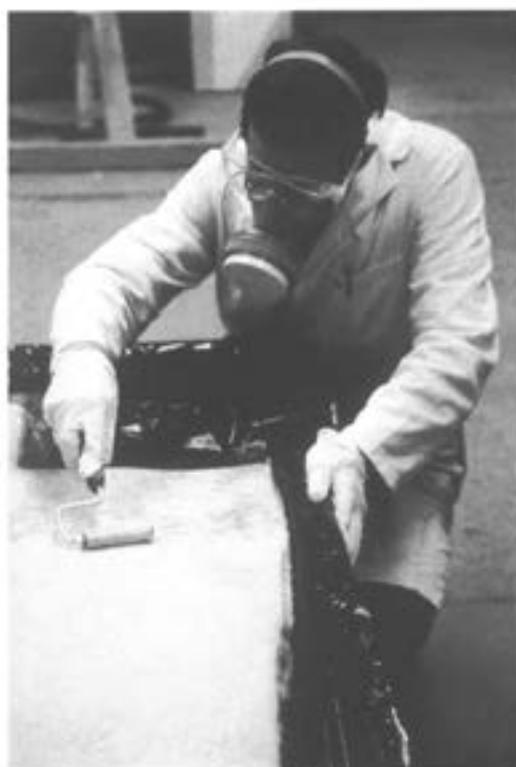
Figure 4.7
Creating the fibreglass
support cradle.

A layer of fibreglass matting was laid on the polythene sheeting and resin applied with a paintbrush, stippled into the mat. A sheet of coremat (a bulking material) and a further sheet of fibre were placed over the coremat and more resin applied, taking care to remove all air bubbles (Fig 4.7). After curing, the primary, load-bearing cradle was complete.

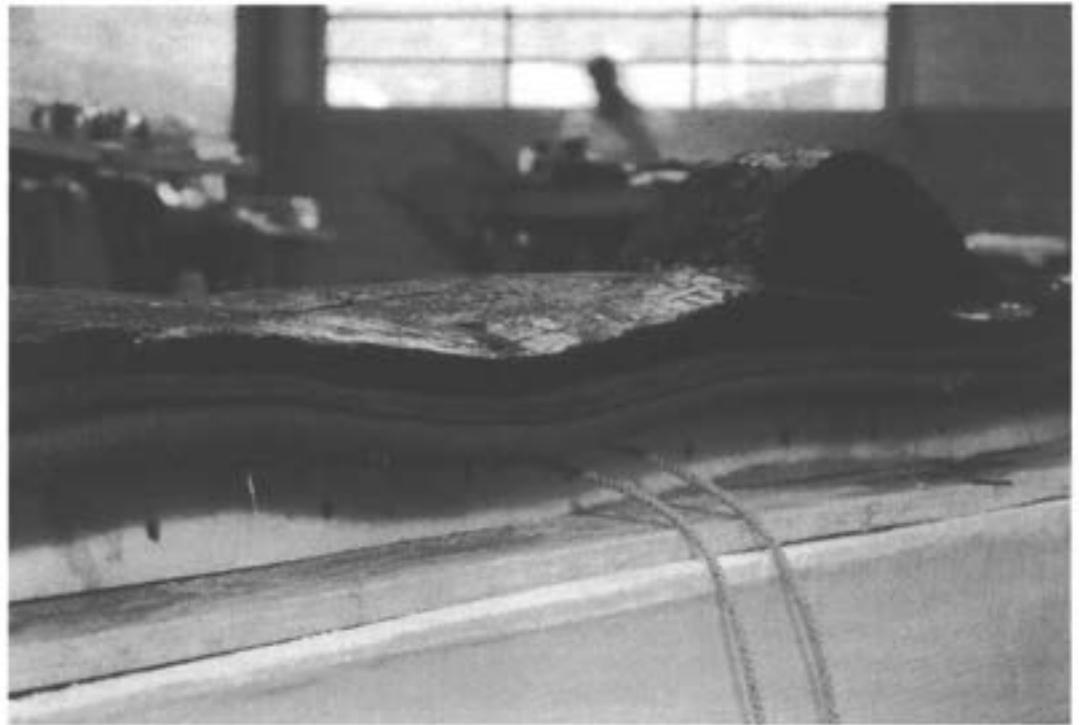
Figure 4.10
A boat piece on its
fibreglass cradle, showing
the undulations of the
original plank.

The technique for returning the boat timbers to their original position on their respective cradles was broadly similar to that of their inversion. The foam box was lifted off to reveal the boat timber sitting on the cradle, covered in tissue paper, plastic sheet and aluminium foil. These layers were removed and the timbers rinsed with fresh water before being returned to the main water tanks to await conservation (Figs 4.9; 4.10).

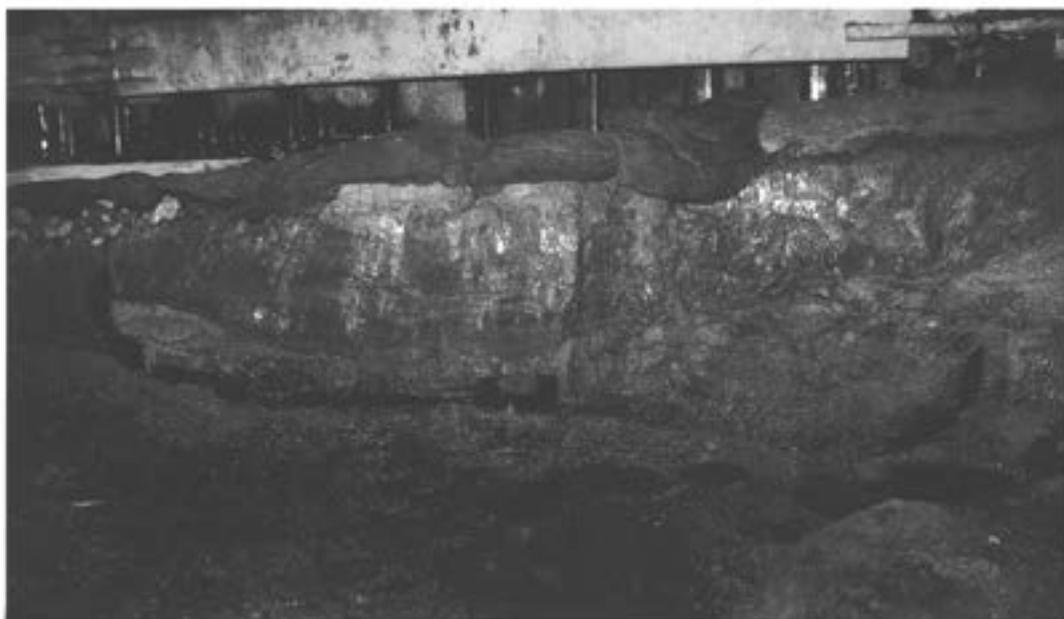
Figure 5.2
The cross section through the boat revealed in section (Piece J). This was the last piece to be excavated in Cofferdam I, removed in just twenty minutes with the help of a shovel and fork.

The shape of any boat is represented by a series of transverse and longitudinal profiles of its *outboard* face, but it was not possible to record these *in situ* when excavating the Dover boat, because they remained buried. Consequently, all that could be seen of the outboard face of the vessel was the top of its sides, its south end, and its profile seen in the single cross section of the vessel drawn while *in situ* (Fig 5.2).

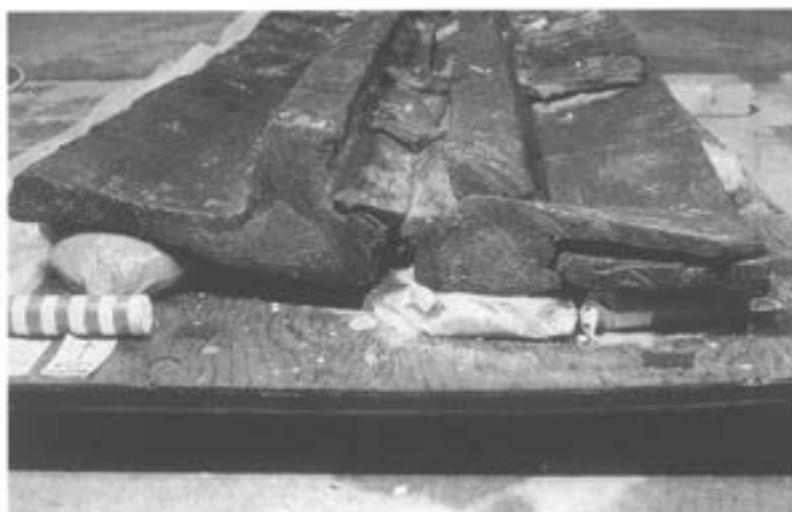
Figure 5.7
Detail of the central seam, showing how the central butt joint had opened up after abandonment. The upstanding central rails flanking the seam can also be seen.

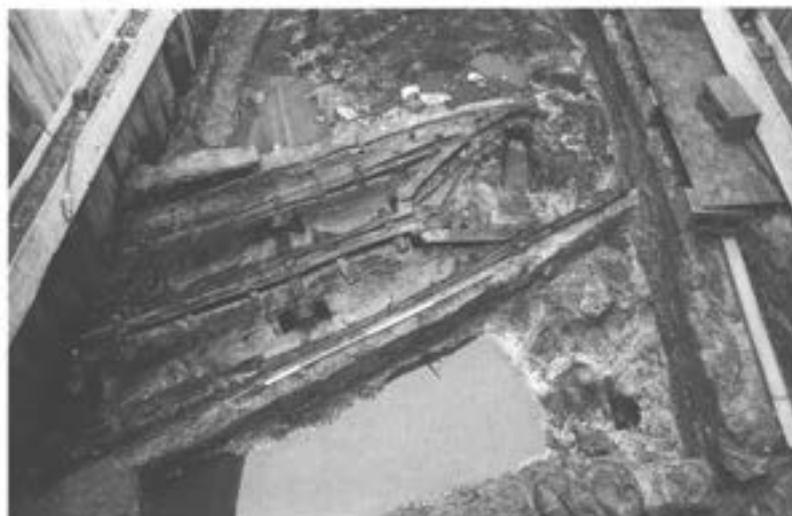
Figure 5.8
An overhead shot of the boat in Cofferdam II, showing the transverse timbers and wedges running under the bottom cleats and central rails.

The two central rails had another function – as part of the process by which the two bottom planks were attached to each other (Fig 5.8). Slots had been roughly cut by axe through each rail to enable a series of oak 'wedges' to be inserted to fasten the rails to each other (Fig 5.9). These were at average intervals of 501mm. The shapes of the wedges showed that they had been driven into place in pairs from opposite directions. On their own, these would probably not hold the bottom planks together in rough water, but the boatbuilder cleverly inserted them at different angles, effectively 'locking' the bottom planks to each other at the centre line.

The flat bottom was maintained by 'transverse timbers' of oak, which acted as embryonic frames or ribs (Fig 5.8). These timbers were on average about 115mm wide, about 35mm thick, and spaced about 1.68m apart from centre to centre. A highly elaborate mechanism was used to fasten the transverse timbers to the bottom planks, which meant that the timbers, although quite wide, had to be relatively thin. The mechanism was to slot the transverse timbers through a roughly cut hole in a rounded 'cleat' left standing on the inboard face of each bottom plank. These bottom cleats were carefully carved and, in general, each was 372–460mm long, 110mm wide and about 120mm high in the centre, with 'fish-tail' ends about 190mm wide. As each transverse timber

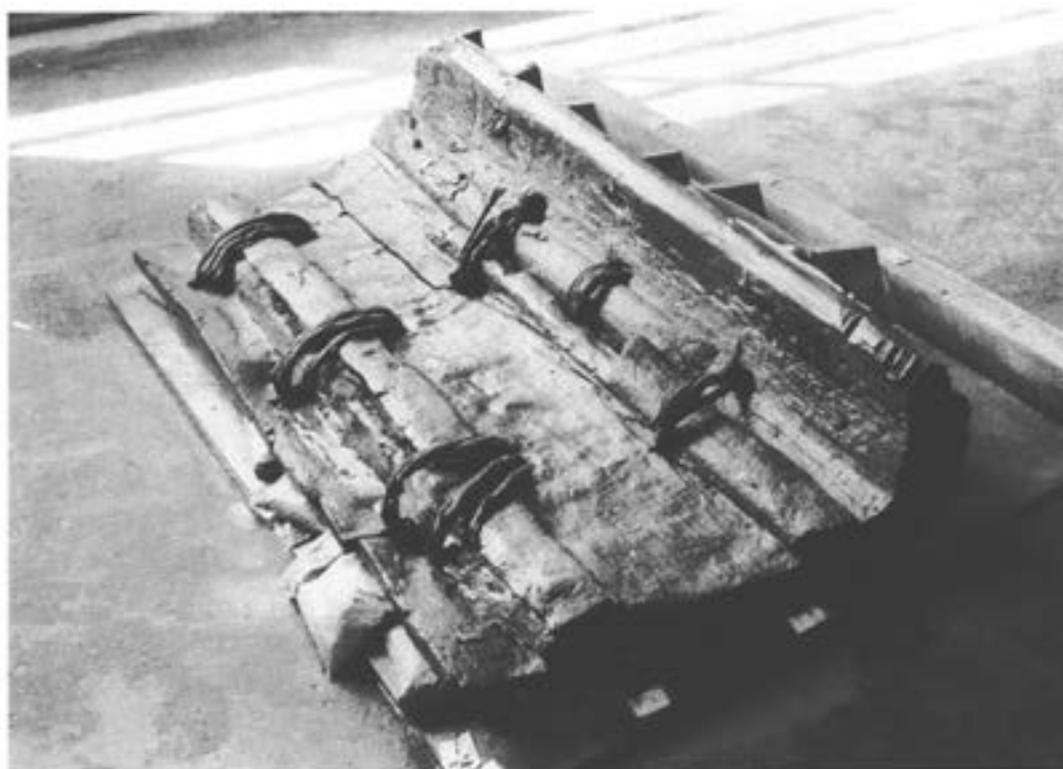
Figure 5.14

Piece B (S), showing the rebate on the upper ile edge.

inboard corner was bevelled (see Fig 5.14). It is not clear how the missing upper plank was once fastened to the ile, but it is certain that there was a plank there because some of the stitching that once held it remained. These uppermost stitches lay in oval-shaped holes cut near the upper edge of the plank, and, as the curved upper end of one stitch had survived, it is clear that the stitch holes in the missing upper plank lay 100mm above the seam with the ile plank.

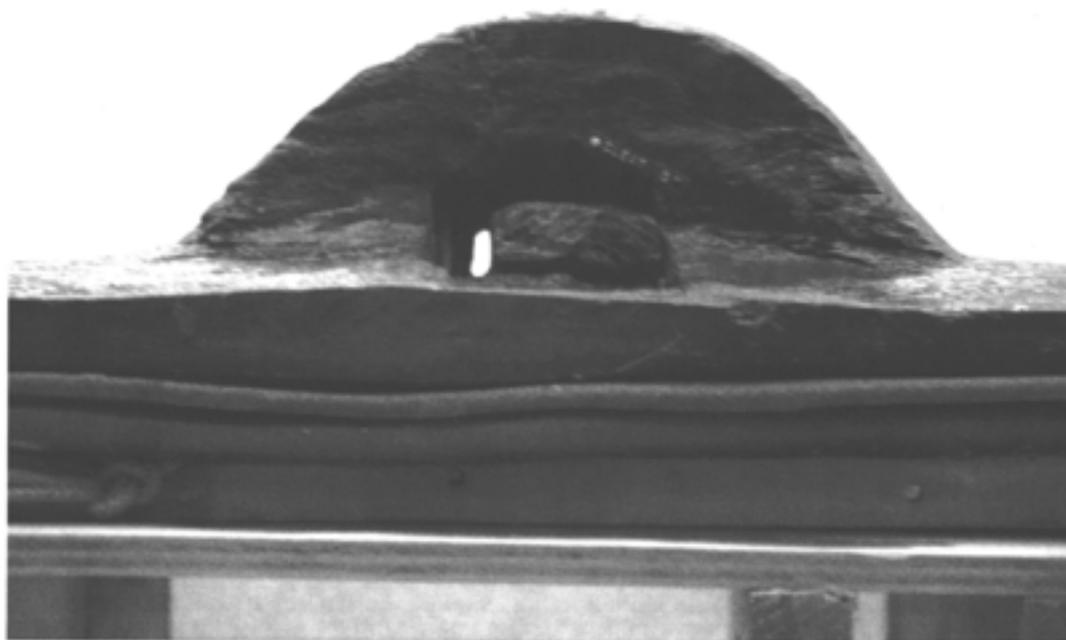
Figure 5.29
An example of one of the
bottom cleats (310).

to cleat 318. Cleat 313 is incomplete, the northern part having been broken away when found. All three discovered cleats are an integral part of the log from which plank 300 was fashioned. They are all rounded lumps aligned fore and aft along the centre of the plank, and each has a narrow waist in the high centre and broad 'fish-tail' shaped ends on the plank face (see Fig 5.29). Through the centre of each is a roughly cut hole to take a transverse timber.

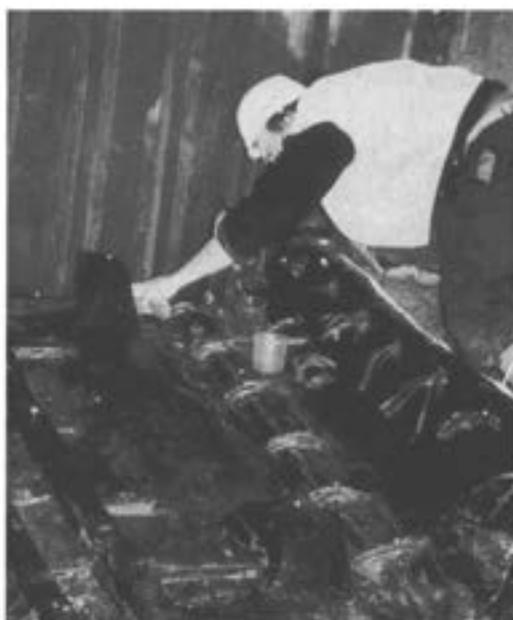
Figure 5.40
Here the severed stitches along the upper side of the ile plank can be seen, evidence for the existence of an upper side plank. The stitches had been deliberately cut through at the time of the boat's abandonment.

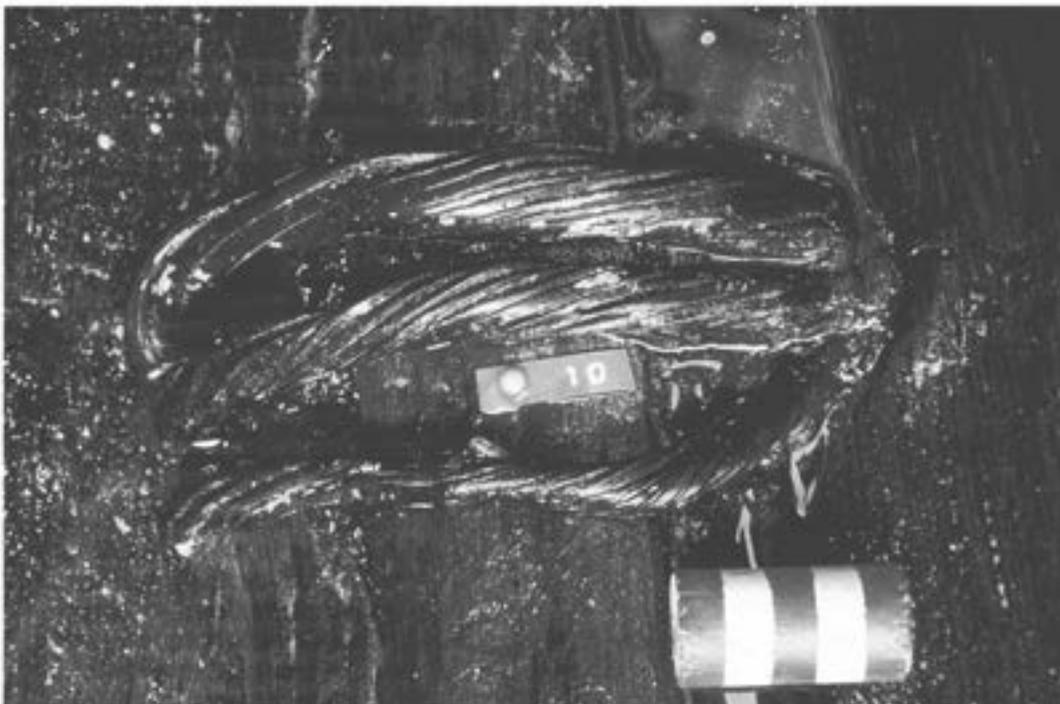
Figure 5.47
An example of one
of the yew stitches
(inboard view).

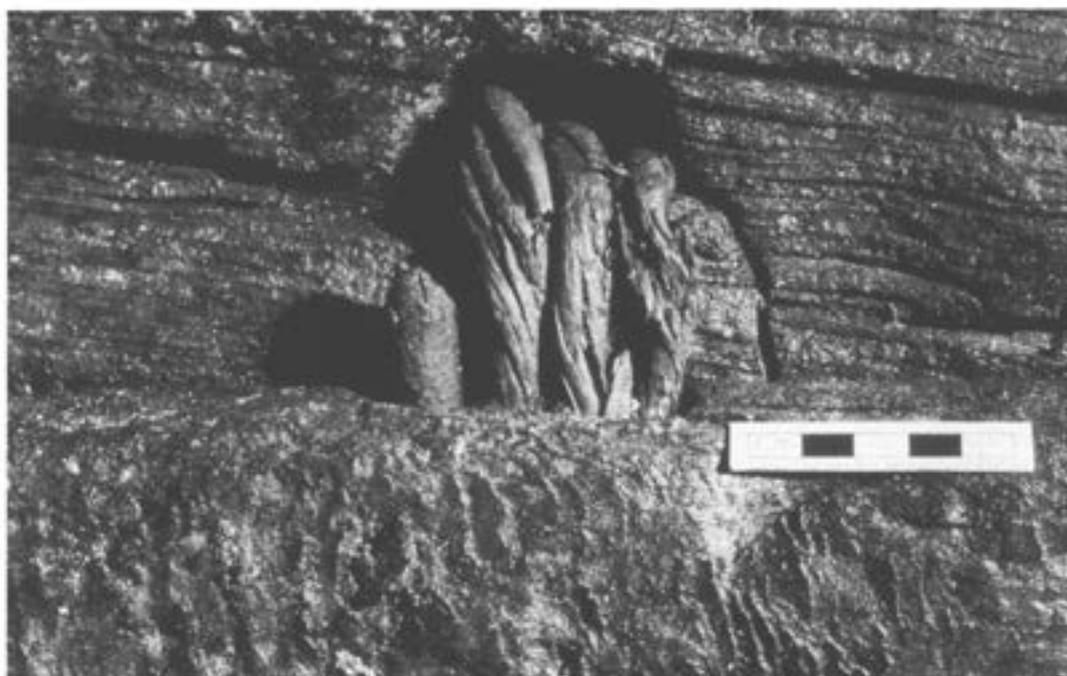
Figure 5.48
An example of one
of the yew stitches
(outboard view).

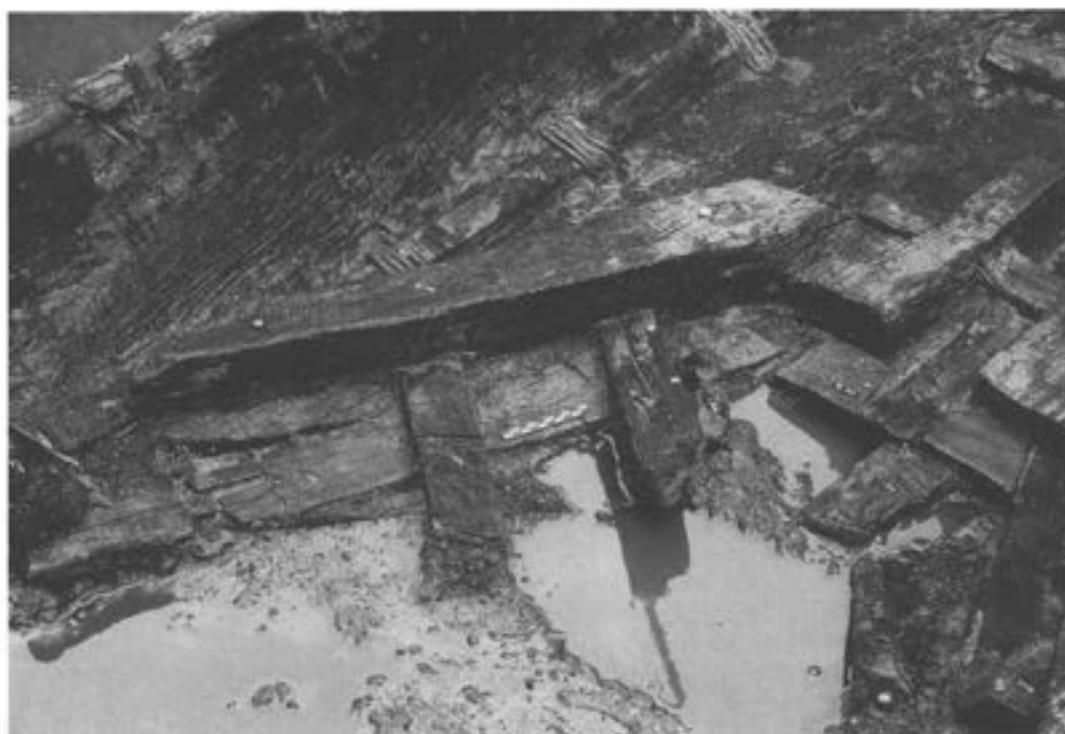
Figure 5.54

Southern end showing wedges and laths. Note that the western wedges have not been cut through, unlike those on the eastern side.

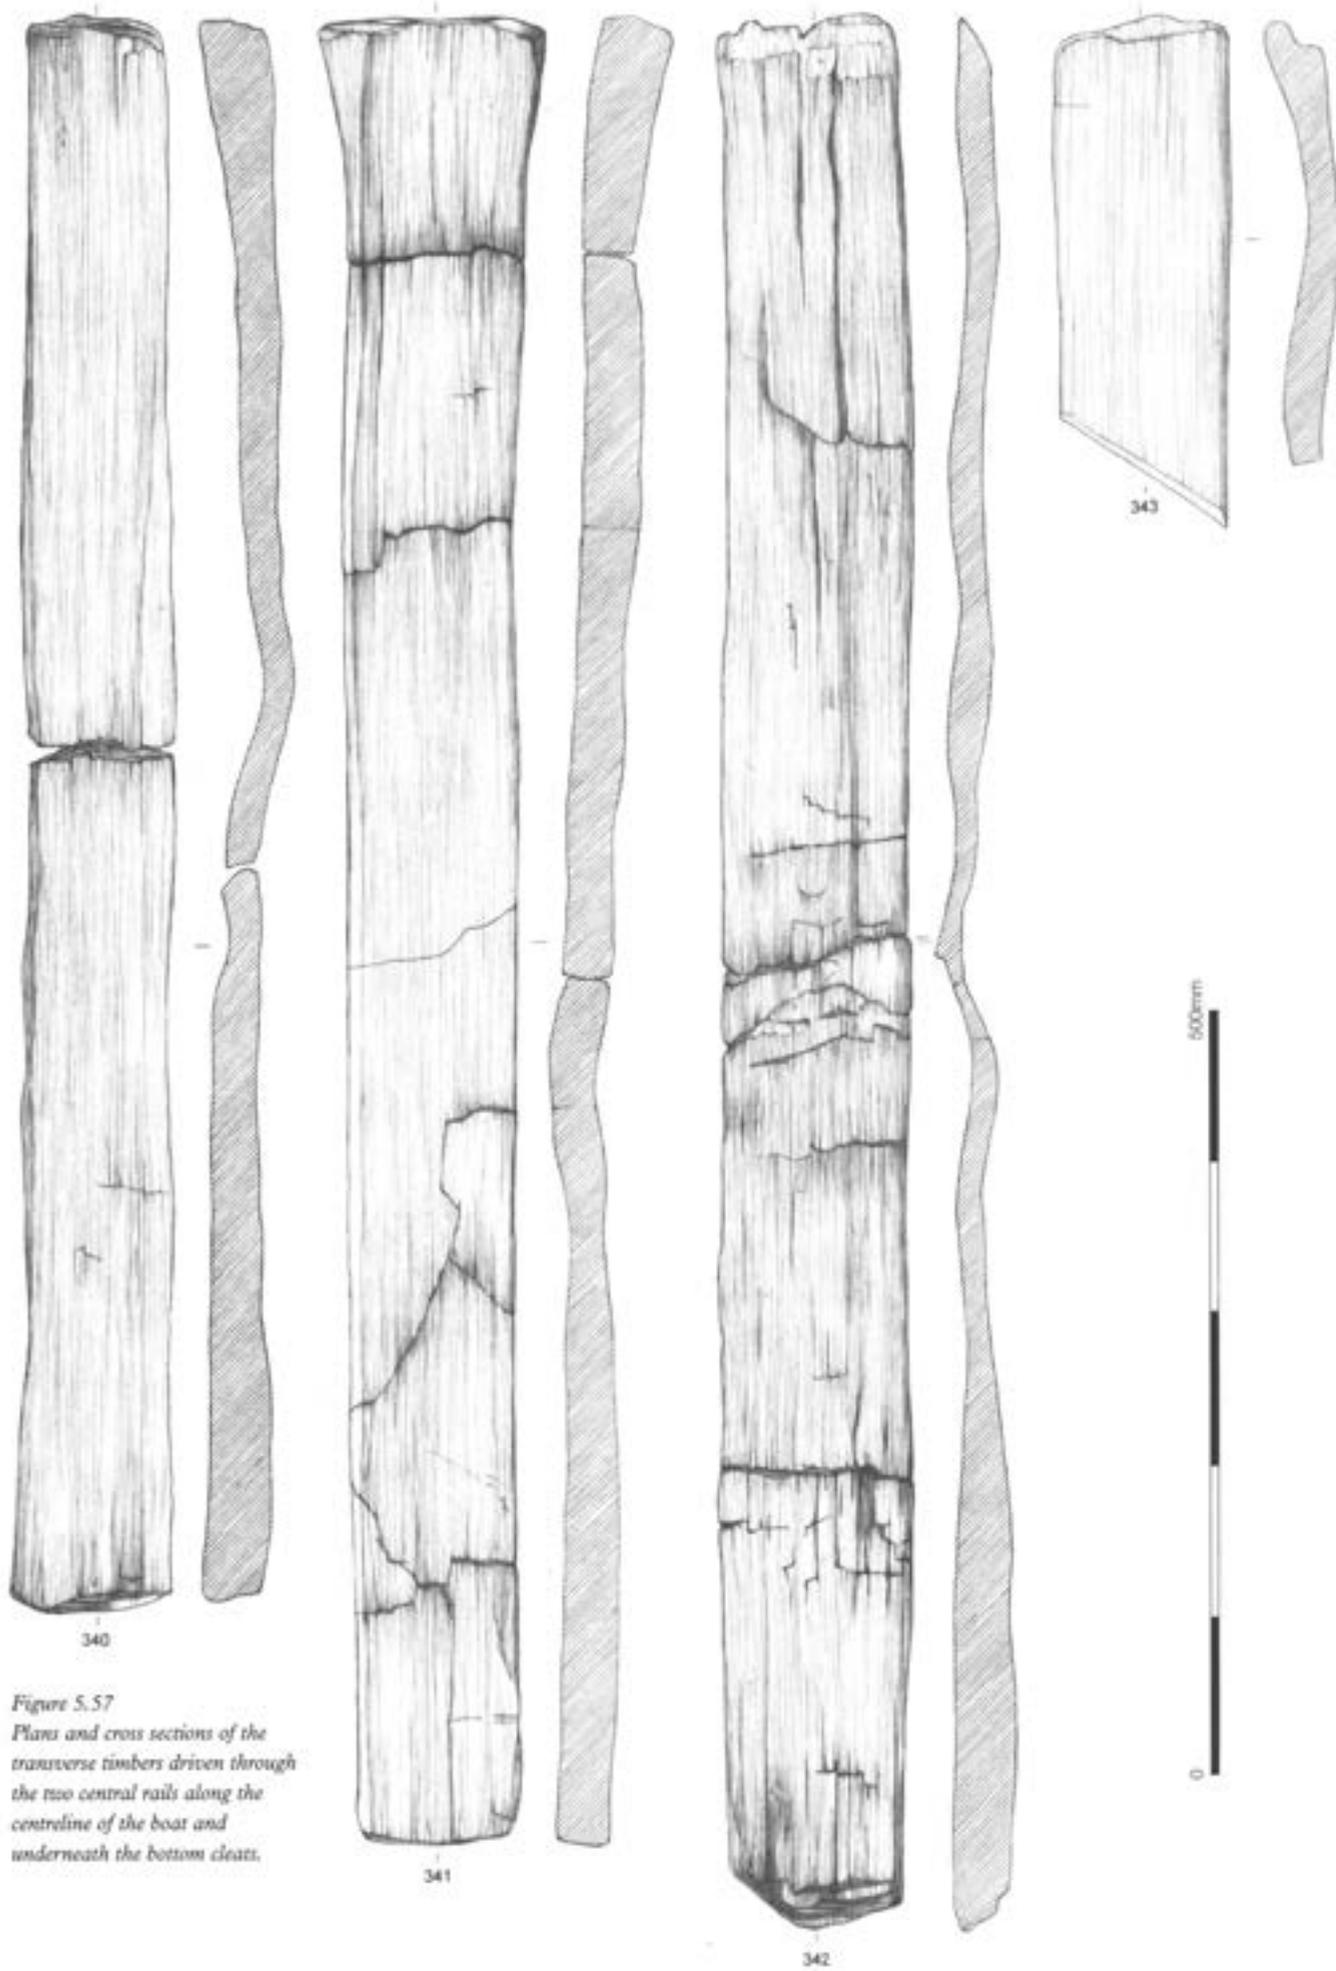
Figure 5.57
 Plans and cross sections of the
 transverse timbers driven through
 the two central rails along the
 centreline of the boat and
 underneath the bottom cleats.

Five transverse timbers were found joining the two bottom planks 300 and 303 (see Figs 5.42; 5.57).

- 340 This oak timber, rectangular in cross section and with squared ends, is [1.08]m long, and passes through cleats 310 and 311. Its width varies from 85mm in the centre to 90mm at cleats 310 and 311. However, it is 35mm thick at cleat 310, 30mm thick in the centre and 26mm thick at cleat 311, showing that it is slightly thinner at its west end.

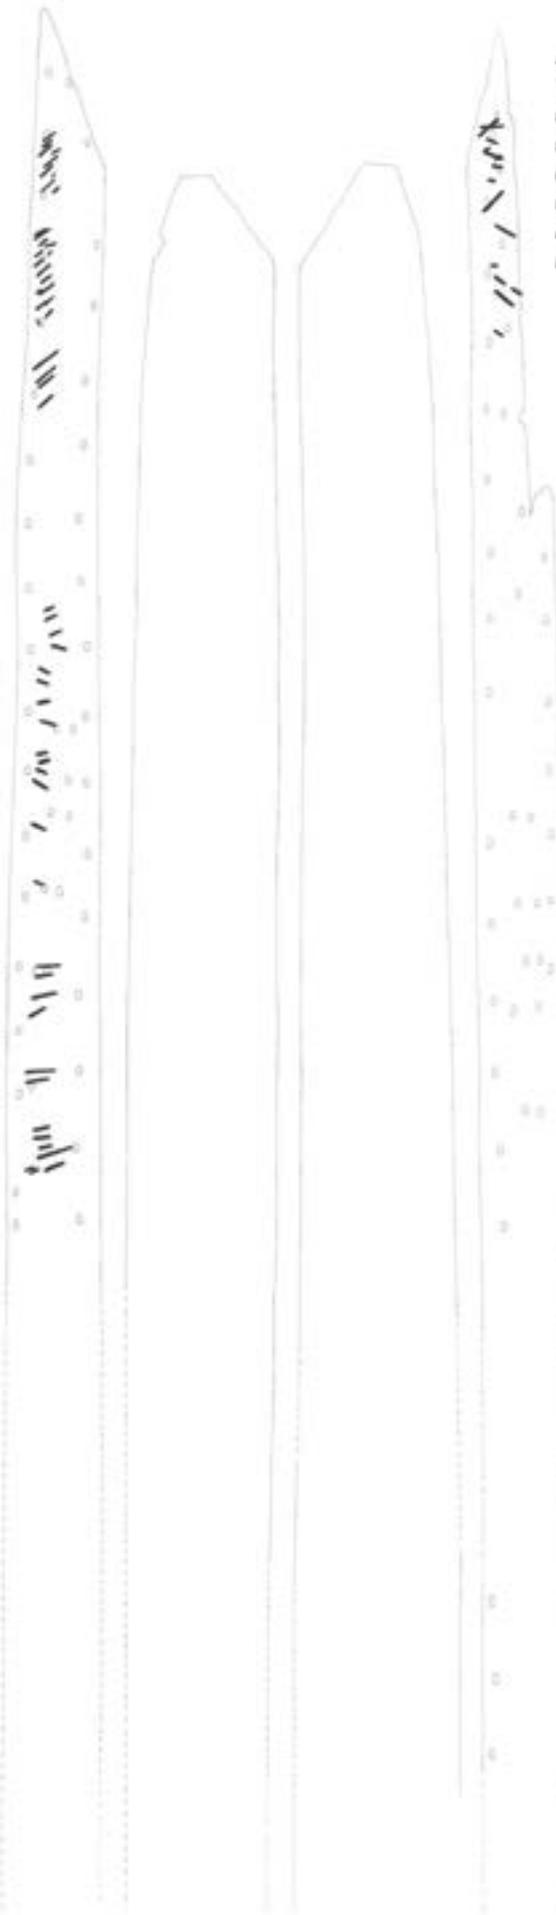
Figure 5.59
The outboard faces of ile planks showing score marks. Perhaps these had been created by the boat's rocking fore-and-aft against a natural or man-made waterfront.

The upper half of this plank has a horizontal zone of score marks that appear to have been made during the use of the boat (Fig 5.59). They were found while cleaning the boat after the vessel had been removed from the site, and so cannot have been caused during the excavation. As they lie where the plank face is more vertical, it is curious that they generally lie at an angle of roughly 45 degrees to the waterline, though a few are at right angles. As no study of the wear marks on the outboard face of a recent boat has been carried out, it is very difficult to suggest how these ancient marks were caused. A possible theoretical explanation for their oblique angle is that they were caused by the boat's rocking fore and aft against a waterfront, whether natural or man-made. At one point near the south end of the plank, the lower part of the outboard face is damaged by deep pitting. This is in marked contrast to the face of the adjacent bottom plank 300 and raises the question whether or not the bottom plank was a replacement, or perhaps suggests that the ile plank 301 was an old plank. The wear seems to relate to grounding, as it ceases on plank 301 in a line about 11cm from the

The pattern of scoring on the outboard face of the east ile is somewhat different from that on the west ile (Fig 5.59). Instead of there being a zone of marks, there are far fewer scores in the zone just below the top of the plank. The few marks are mostly diagonal. Instead, most of the marks exist in the lower half of this plank at the south end where the plank was almost horizontal, and they are presumably a result of the vessel having run aground. The pattern is interesting as the marks do not run fore and aft, as would be expected, but instead sideways. Perhaps this reflects a sideways and fore-and-aft motion to the boat while aground. The scores vary in length, some being only about 40mm long, but others are longer. In particular, two run intermittently for a vertical distance of 180mm, and other score marks are up to 260mm long. In the area of stitch hole 572 there is a locally depressed area that suggests impact. This lies on the underside of the ile plank at its extreme south end and, together with the score marks, suggests that the boat grounded at this end. What is puzzling, however, is that there are no comparable score marks in a similar position on the bottom of the ile on the other side of the boat. Just above repair stitch 620, there is a major oblique depression about 400mm long, running downward towards the south end of the boat. This suggests an impact, and may have caused the fracture that was repaired.

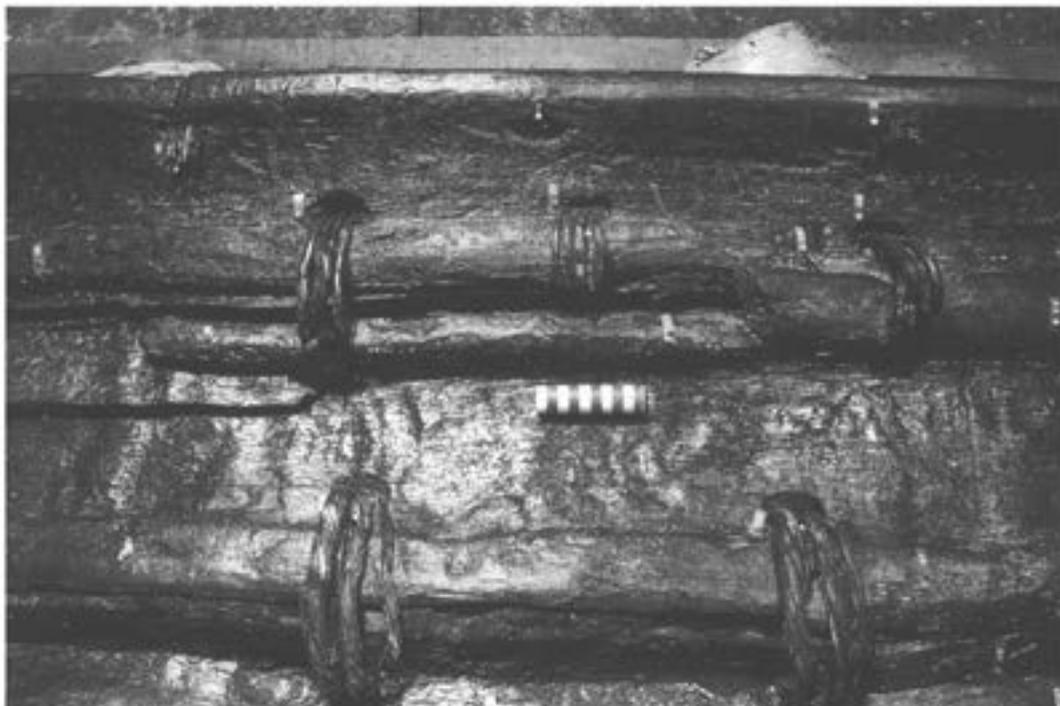
Figure 5.62
Repairs to the eastern side
of the boat; a total of four
oak laths of differing sizes
had been stitched over
cracks in the ile plank,
compressing pads of moss to
make the repairs watertight.

There are two stitched repairs to splits in this plank, each with their respective laths (792/793 and 790/791; Fig 5.62). Where the two laths lie side-by-side, there are two stitches that pass over both (619 and 621), but there is also a third stitch (620), which overlies only the upper lath. This indicates that the upper repair is the earlier.

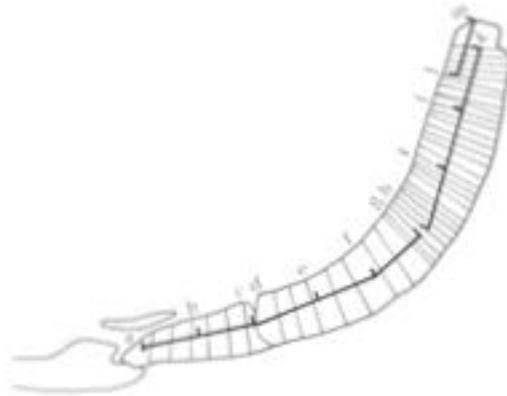
Figure 6.13
Calculation of the average medullary-ray spacing for the timber cross sections. The medullary-ray counts at *ab*, *bc*, *de*, *ef* and *fg* (where the rays were vertical) were used to calculate the average original medullary-ray spacing. This enabled the counts in areas *hi*, *ij*, *jk* and *lm* to be corrected for the compression that had occurred there.

The average spacing of medullary rays in the uncompressed areas of each ile-plank cross section was calculated (Fig 6.13). Then, areas of compression (where medullary rays run more closely together) were redrafted by pulling the rays out to fit with the spacing of medullary rays in less compressed areas (Fig 6.14).

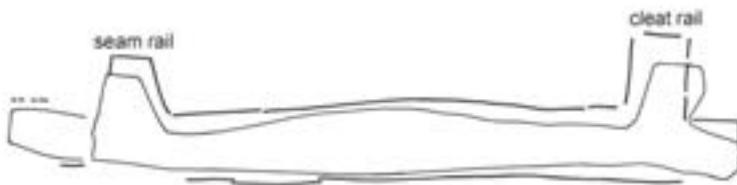
Figure 6.19 (left)

Revised shape of a bottom plank. The fine lines represent the excavated shape; the heavy lines are the estimated original shape following corrections to the medullary rays. Gaps in the heavy lines are areas where no correction could be estimated.

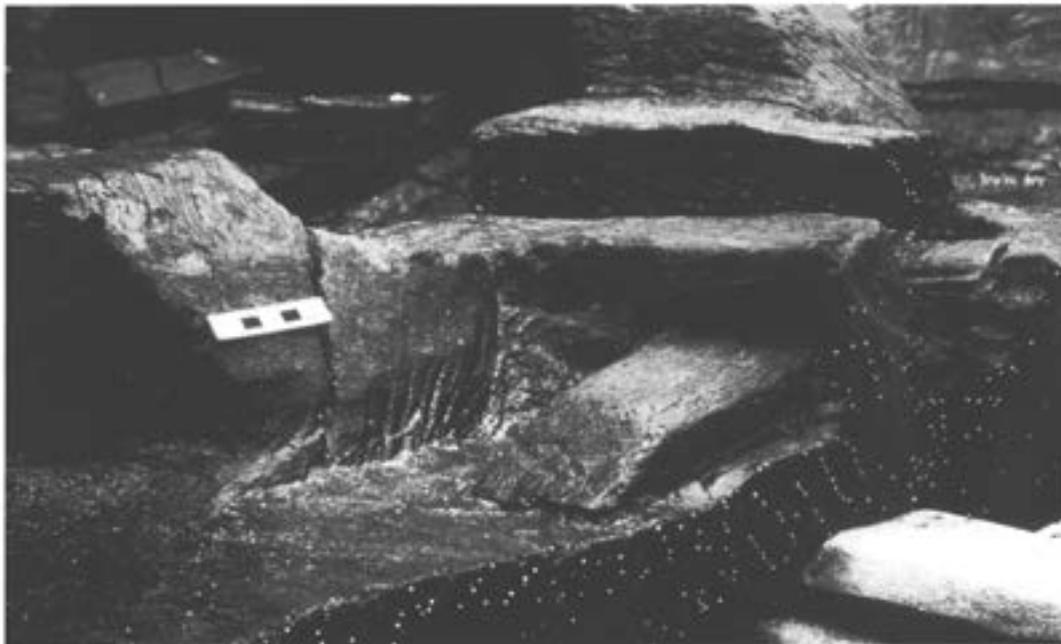
Figure 6.20

A section through the complex southern end of the boat, showing how stainless-steel pins were used to trace the medullary rays in cross section.

In the lowest side plank at the south end of the boat, the compressed horizontal medullary rays lie at the bottom of the section, indicating that the lowest side plank is cut at an angle across the timber at this point. However, lack of annual-ring evidence makes it difficult to discern the exact position in the cross section of the tree at which the ends of the lowest side planks have been cut (Fig 6.20).

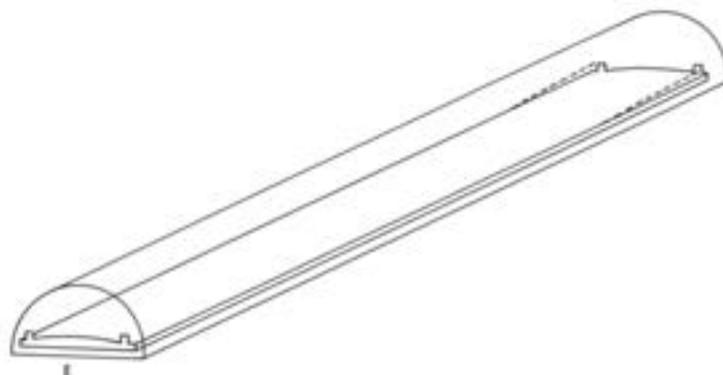
Figure 7.5

Here the tree is perfectly straight, but the plank has been carved down towards the centre at end E. In both cases, the annual-ring data and the ray data would be identical. In this case, the bottom planks would be tensioned when attached to the ile.

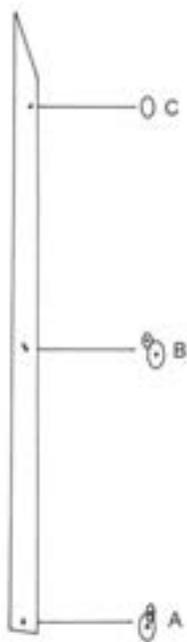
Figure 7.14
There are three knots on this ile timber. These are small knots, of less than 30mm diameter, and smaller towards the outside of the tree, indicating moribund branches. Only knots A and B can be seen on both faces of the ile timber, these knots were growing at an angle of forty-five degrees to the trunk.

There are three knots on this timber. These are small knots, less than 30mm in diameter, and smaller towards the outside of the tree, indicating moribund branches. Only knots A and B (see Fig 7.14) can be seen on both faces of the ile timber; these knots were growing at an angle of 45 degrees to the trunk.
