The Dover Bronze Age Boat

edited by Peter Clark

Edited by Peter Clark

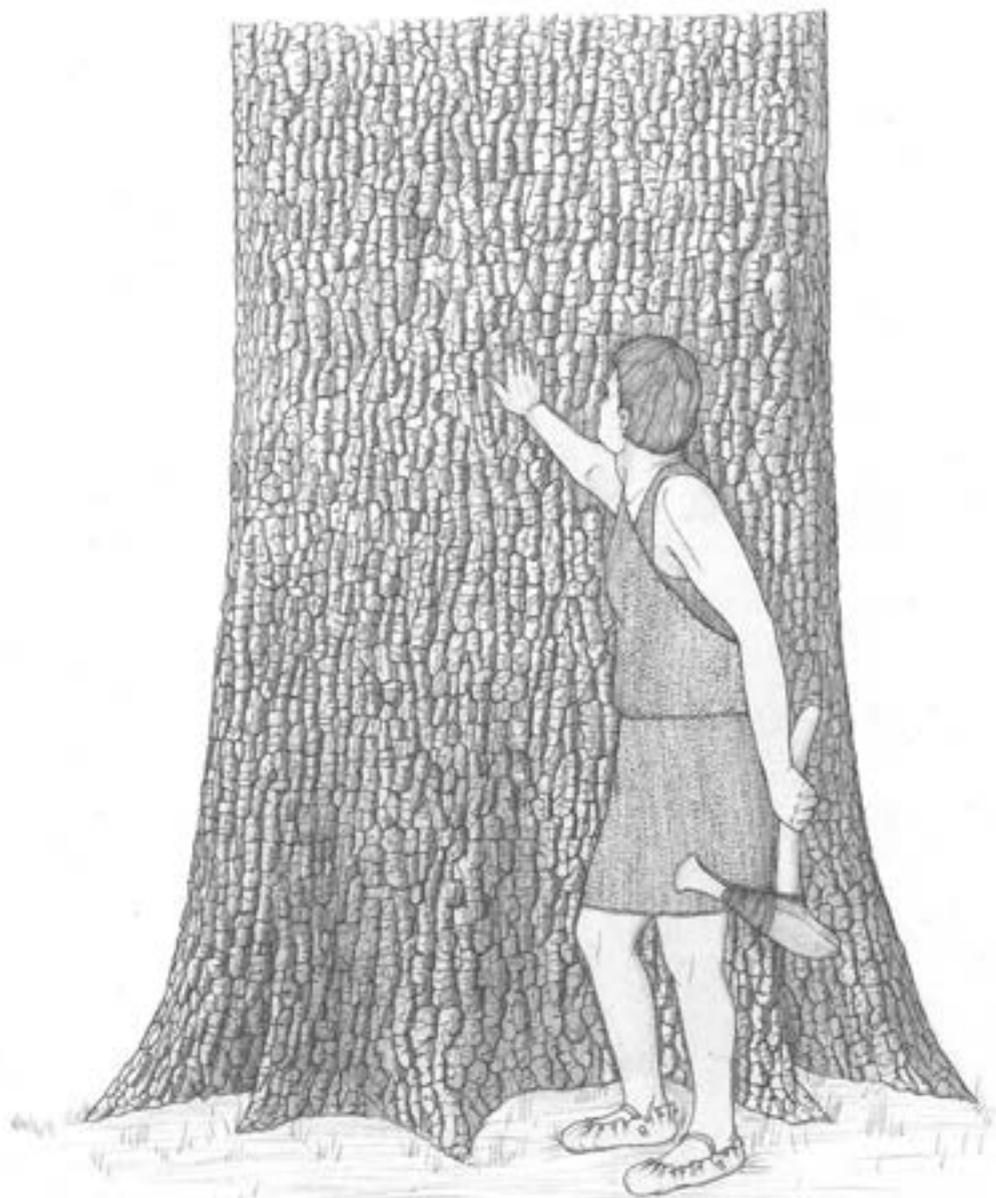
Figure 7.16

Examining the tree bark. Although the quality of timber would have been imperative, it seems likely that the selection of the trees for the boat would have been accompanied by ceremony and ritual.

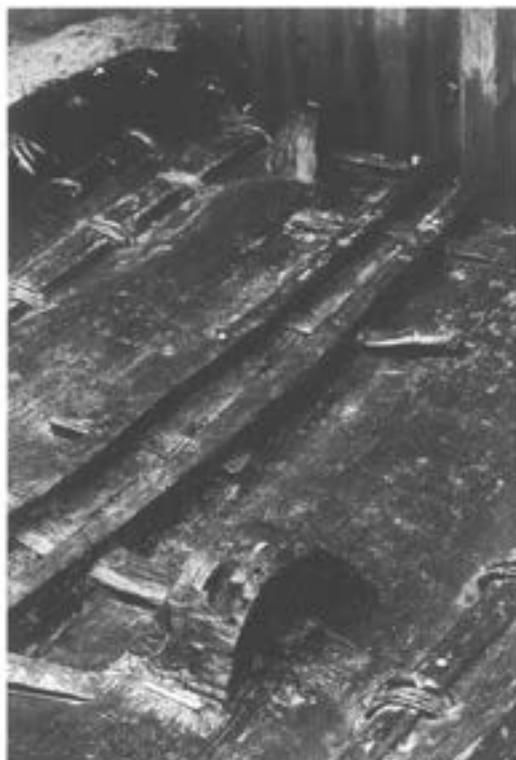
The larger-scale features of the tool marks on the oak timbers – such as incuts, stop marks, facets and lines of facets – were variably preserved. As is usually the case, the best-preserved marks generally survived on end grain and in protected areas. In the Dover boat, the end grain on the cleats preserved many clear marks, the general patterns of which could be quite varied (Fig 8.1).

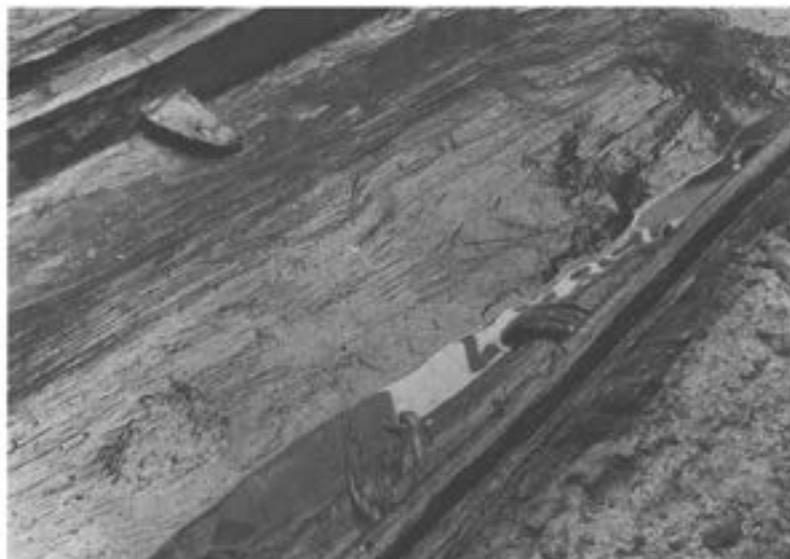
Figure 8.2
The longitudinal fluting on the inboard surfaces of the boat was almost certainly created by the use of palstaves hafted as adzes to flatten the timbers.

discussed below; Fig 8.2) were still very clear on the wider, less-protected surfaces of the bottom planks, both inboard and outboard, and also, occasionally, on the inboard surfaces of the ribs. Despite very careful handling of the timbers subsequent to exposure, some of these patterns of marks were less visible during off-site study, except on some parts of the outboard of the bottom planking. The partial survival of these patterns of marking is particularly significant and is discussed below. However, it would be reasonable to say that the tool-mark preservation on the Dover boat was much better than that noted for the Ferriby, Caldicot or Brigg prehistoric boat finds (Wright 1990; Nayling and Caseldine 1997; Heal 1981). It was not as good, however, as those recorded in detail on Late Bronze Age and Iron Age crannog timbers by Rob Sands (1997).

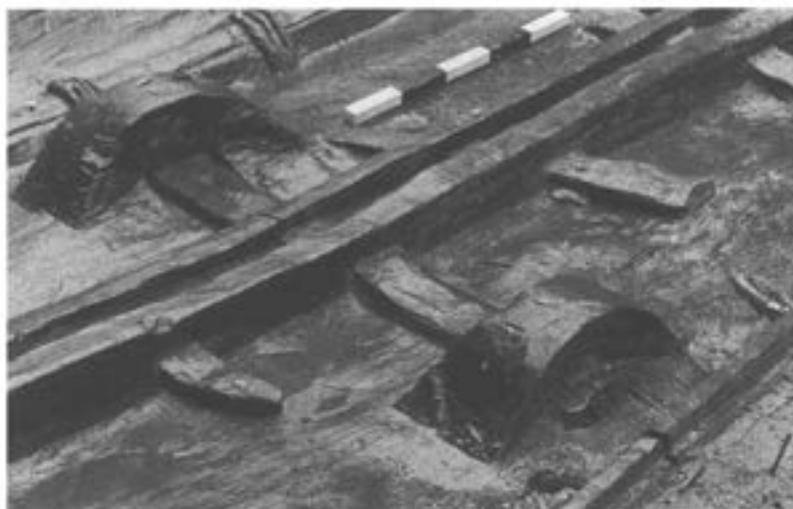
Much of the freshly exposed inboard and outboard surface of the bottom planks and ribs was covered with shallow, parallel, concave fluting. This was created by a series of blows from a tool, or tools, following the grain in fairly straight lines (see Fig 1.1). These flutes were abraded and, therefore, not quite their full width and depth. Where best preserved, as on the outboard face of the boat, the width of the flutes was approximately 60mm and the depth approximately 5mm. These lines of facets indicate the use of a convex cutting edge around 60mm wide, as no places were found where both corners of the tool had dug in. We can suggest that the blade width was probably about 60mm in total, and, allowing for some wear of the timber surfaces, rounded by at least 7mm. Some of the wedges also showed faint traces of shallow, parallel fluting, but here it appears that a fairly smooth surface was intended, rather than a corrugated one (Fig 8.4).

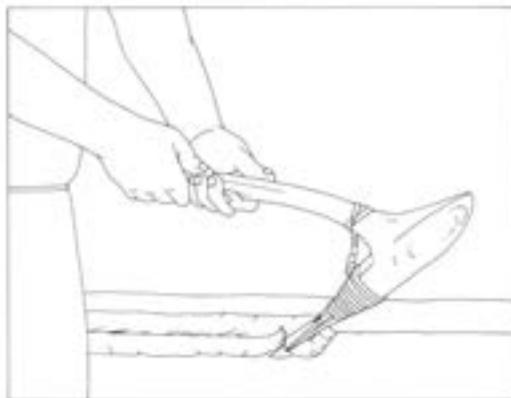
Figure 8.5 (left)

The timbers worked show that the blade or blades used must have been hafted as adzes (Fig 8.5), rather than axes that could not have been manipulated to produce the accurately aligned facets on such wide surfaces. This is a significant finding, as

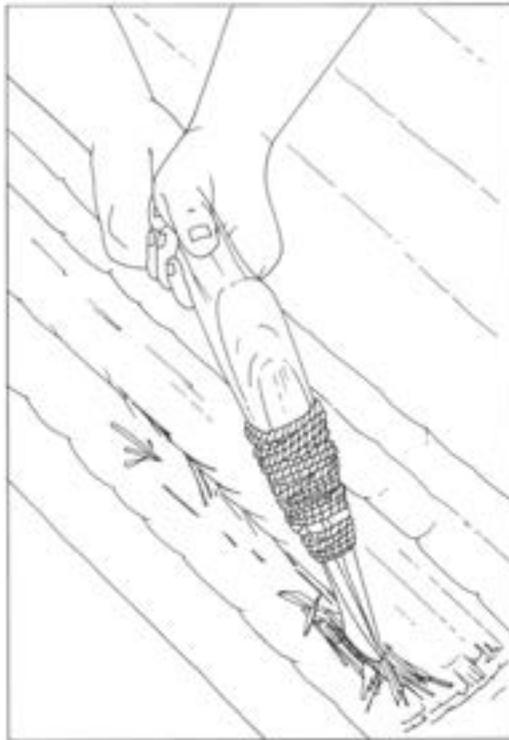
Figure 8.6
A palstave hafted as
an axe.

In the case of the stop marks on the vertical sides of the hewn rails in the bottom planks of the Dover boat, the angle of the marks suggests the use of a blade hafted as an axe used at an angle across the grain (Fig 8.6). It is unlikely such marks could have been left by the use of a blade hafted as an adze, as this would have been rather awkward, and impossible near the cleats. The marks indicate the careful and controlled use of the tool(s) for paring and final trimming of the vertical faces of features hewn in solid, such as the rebates. The type of metal blade used for most of this work was closely similar to that used for producing the fluted finish on the main hull timbers.

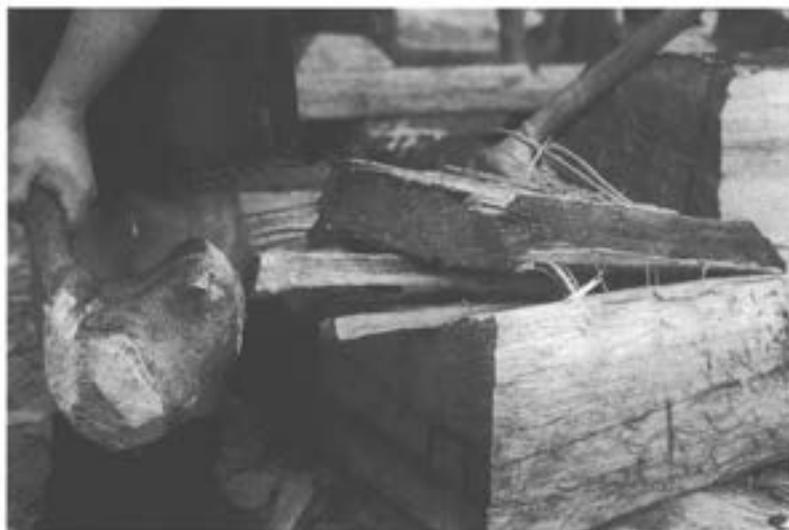
Figure 8.9
Using a holly maul and
wedges to split off waste
wood in the reconstruction
experiment.

Large mallets (mauls) would have to have been used to drive wedges for the initial conversion of the parent oak logs by cleaving in half and also for subsequent splitting out of large blocks of waste (Figs 8.9; 8.10). It is likely that these were of dense, tough woods and probably made in one piece using a branch stem junction. An example of such a one-piece maul (of

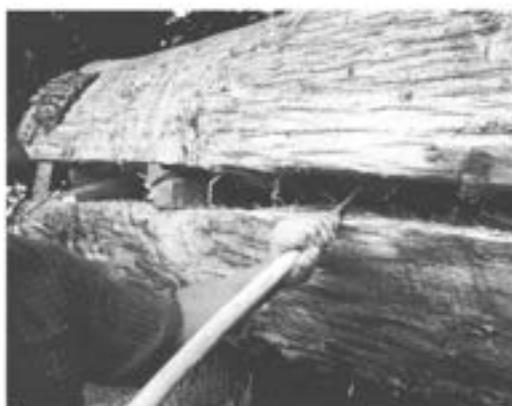
Figure 8.11 (left)
Using a long-hafted bronze chisel to help split the logs.

Experimental work shows that during the cleaving of large logs of oak, tough, fibrous slivers of wood sometimes hold a split together with surprising strength. In straight, even-growth oak, these slivers are less common, but the occasional knotty areas in the timber used for the bottom and ile timbers of the Dover boat would probably have presented some problems. Thin blades of some form are likely to have been used to sever these awkward fibres. The experimental reconstruction showed that palstaves are too bulky to reach into the splits easily, but palstave-like bronze chisels, bound onto long hafts, are quite effective in this role (Fig 8.11).

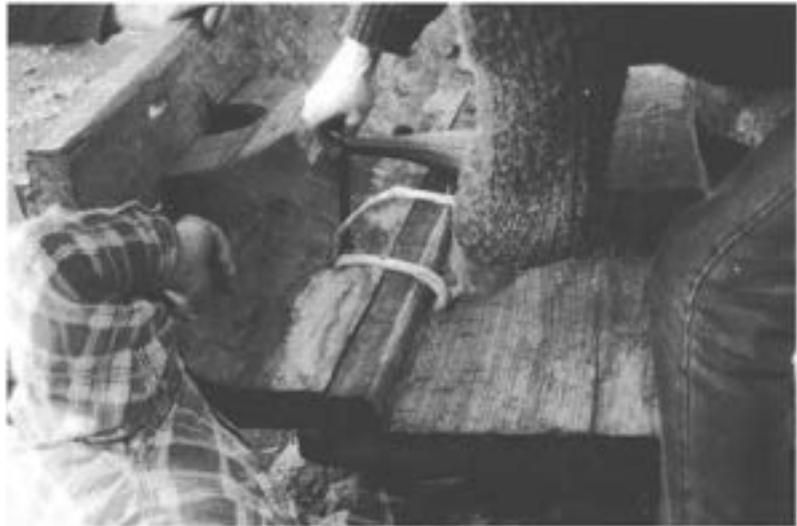
Figure 8.12
Driving a twisted yew
withy through a stitch hole
with the aid of a bodkin.

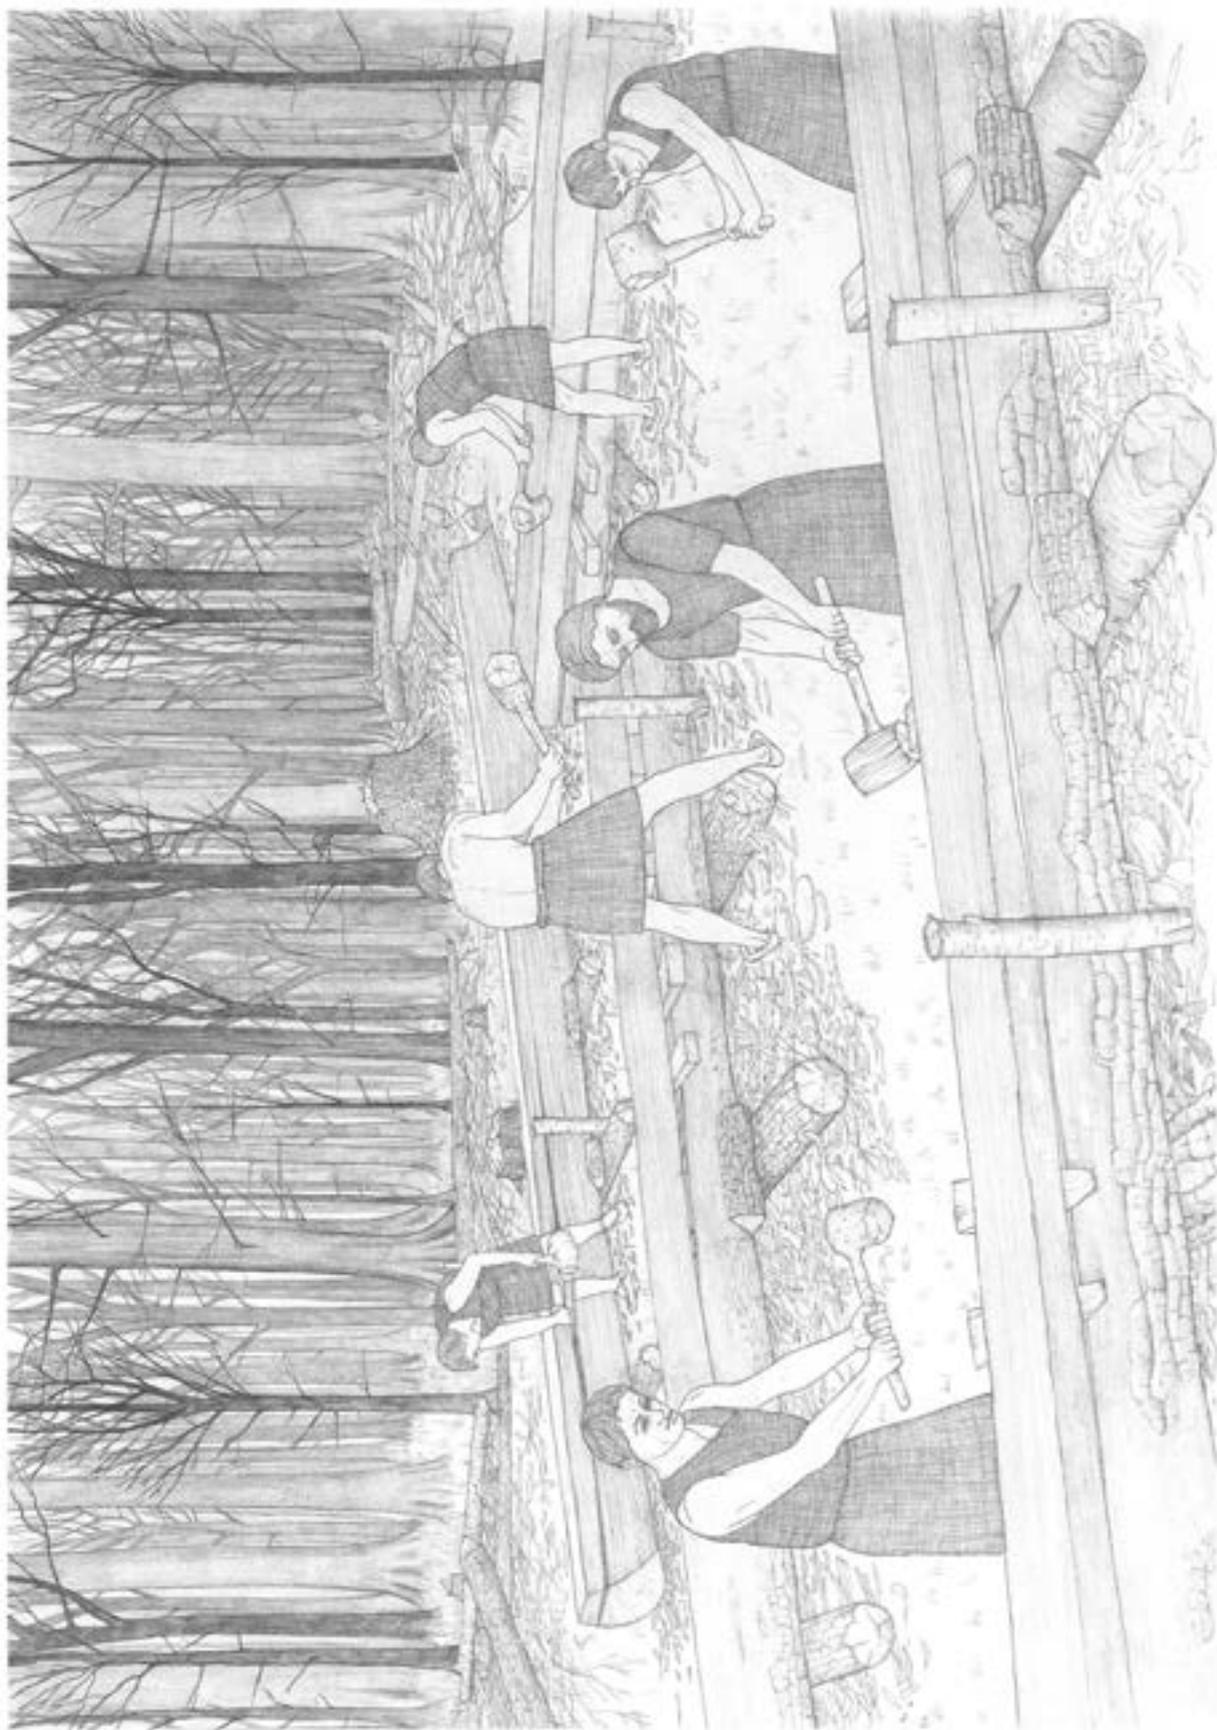
Figure 8.15

The felled trees would have been split at the place they were cut down, using wooden wedges hammered in with heavy wooden mallets. Much of the primary preparation of the logs was done here in order to reduce the weight of the timbers, which had to be dragged from the wilderness to the final assembly point.

half with wooden wedges and mauls (see Fig. 8.15).

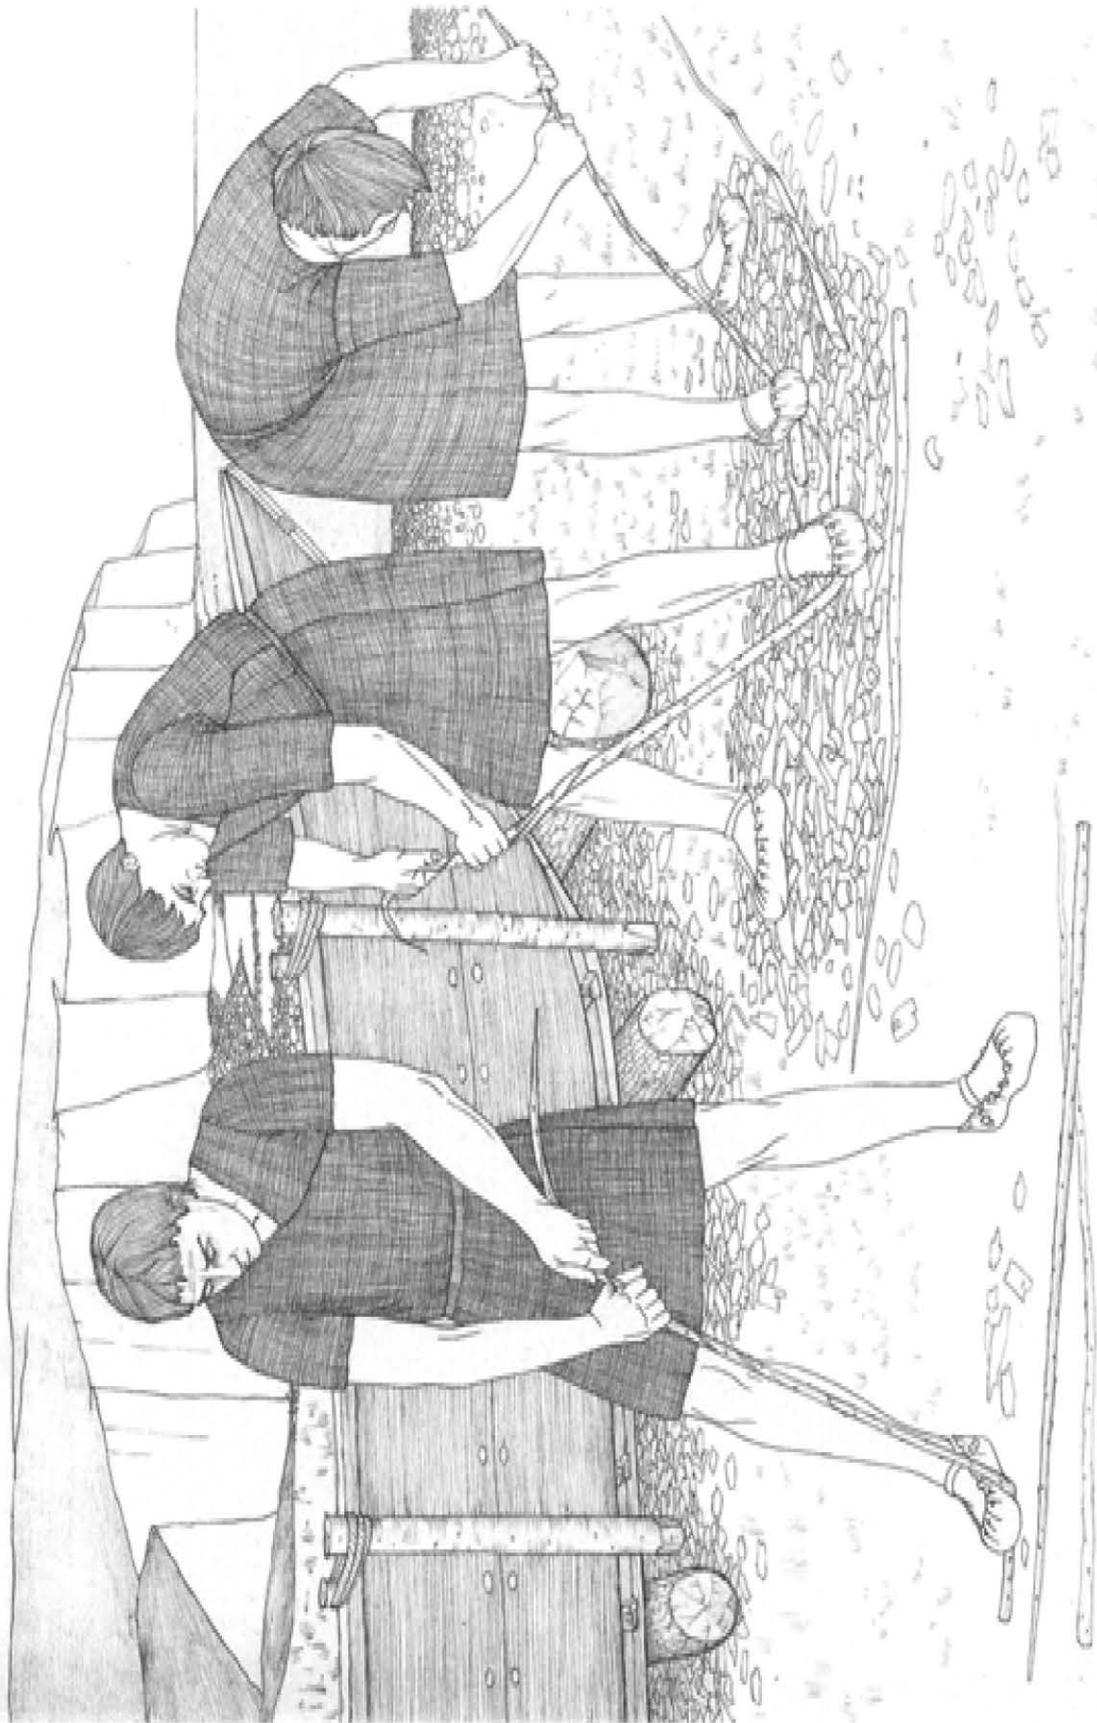
Figure 8.25

With the bottom planks joined together, the end board could be inserted – propped in position while the side planks were offered up. The yew withies for stitching the ribs to the bottom planks were assembled, together with baskets of moss used for waterproof stopping. The worker on the left has a bodkin close at hand to help feed the withies through the stitch holes to create the stitches.

- The end boards would then be trimmed and fitted, well supported by shores (see Fig 8.25). The wedges locating the southern board (Chapter 5; Timber 306) could not have been fitted after the *iles* were in place.

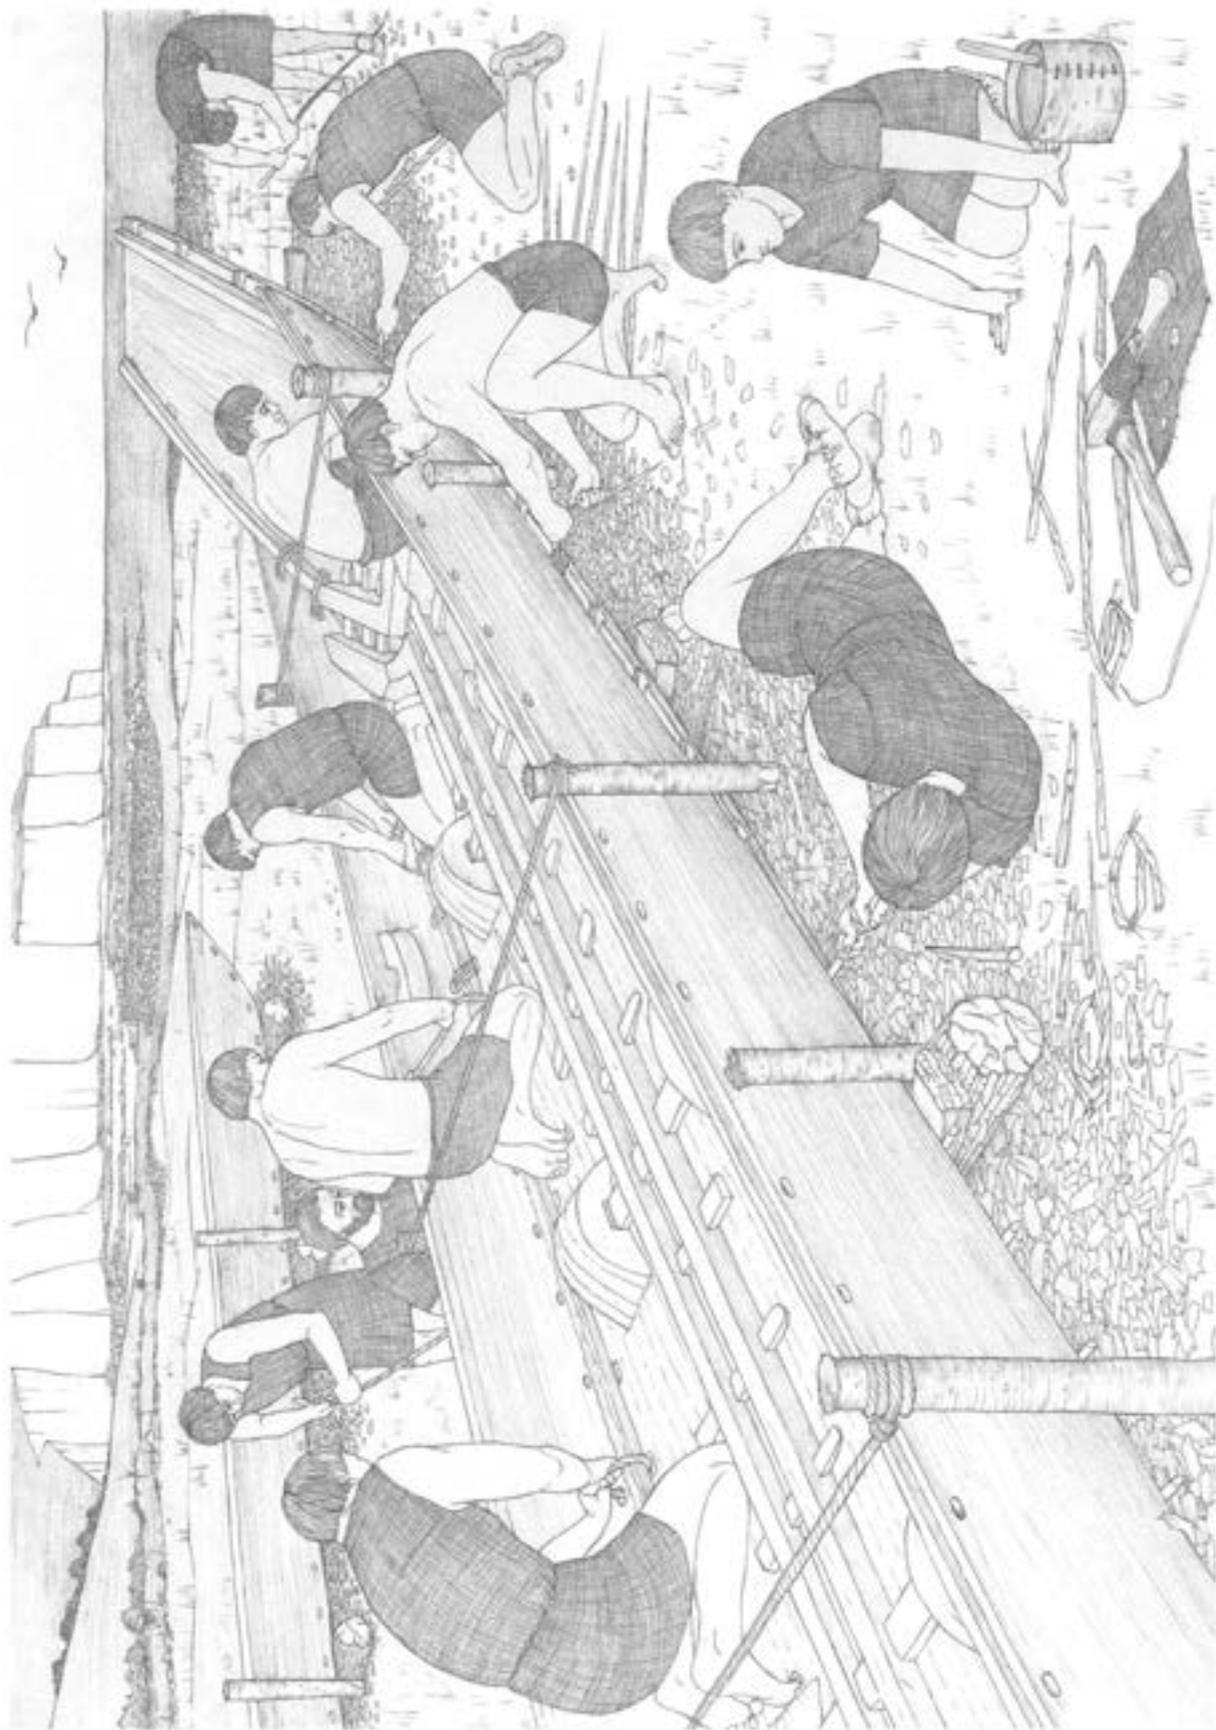
Figure 8.26

Woolly reusings: the slender yew branches had to be twisted to break the fibres of the wood and make them flexible enough to be threaded through the reed holes to create stitches. The most efficient way to do this appears to be to anchor the thick butt end of the reed into the floor while twisting the branch with the bare hands.

seams, stitches twisted and fitted (see Figs 8.26; 8.27), and the moss and seam laths driven into position (see Fig 8.28).

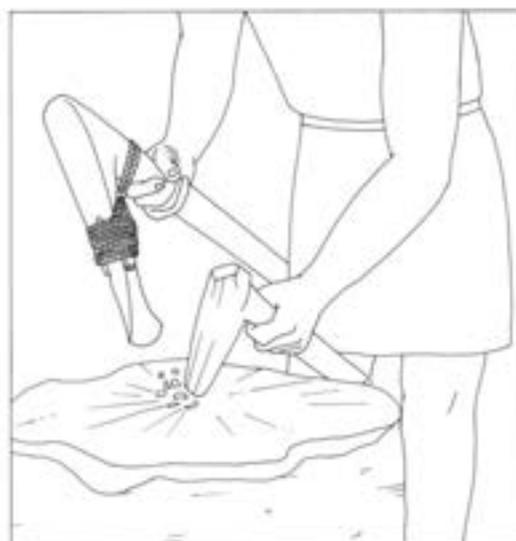
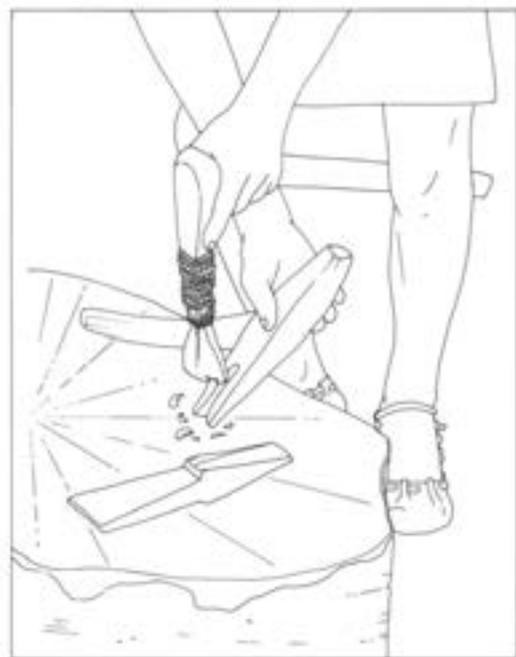
Figure 9.4
Shaping a haft for an
axe. A notch is cut into
the beak of the haft to
receive a palstave.

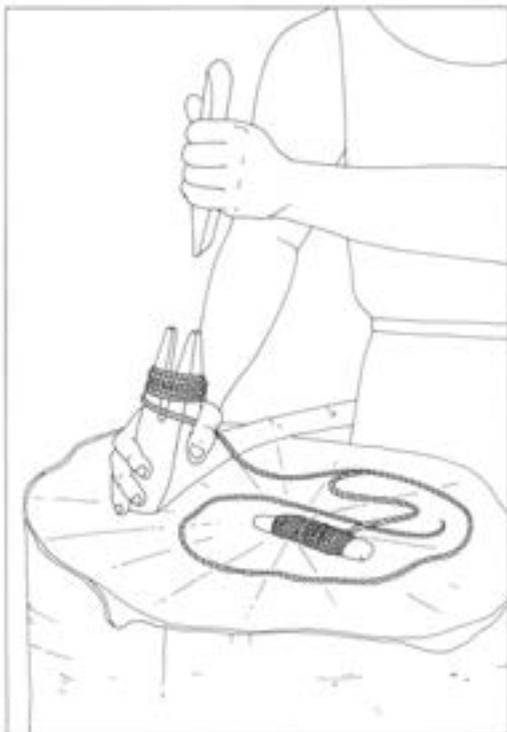
Figure 9.7 (below)
A replica adze used in the reconstruction experiment (type D2).

The handle of blade D2 broke after twenty-eight hours of hard use; it was rehafted as D2(2) (Fig 9.7). The heads of both the holly and plum mauls eventually broke during use, and were rebound with twine to prevent complete disintegration. At least 100 wedges were broken and discarded during the reconstruction. There was also some human damage from working with the unfamiliar tools; several working days were lost as a result of wrist strain caused by working intensively with the bronzes axes and adzes. Sharpening the tool blades was a good opportunity to have a constructive rest from the job of hewing (see Fig 9.8).

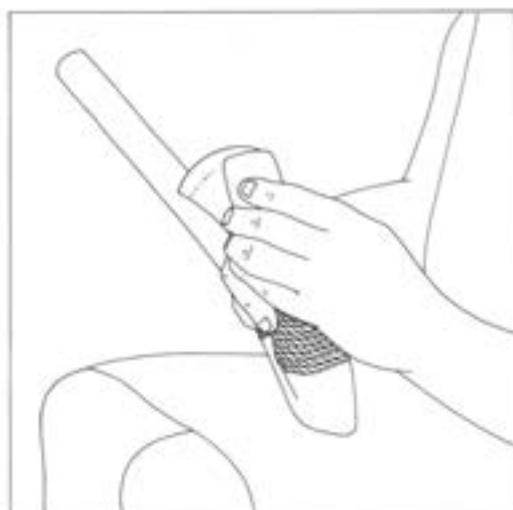
Figure 9.8
Honing an adze blade.
The tools used in the
reconstruction had to be
repeatedly resharpened to
maintain their edge.

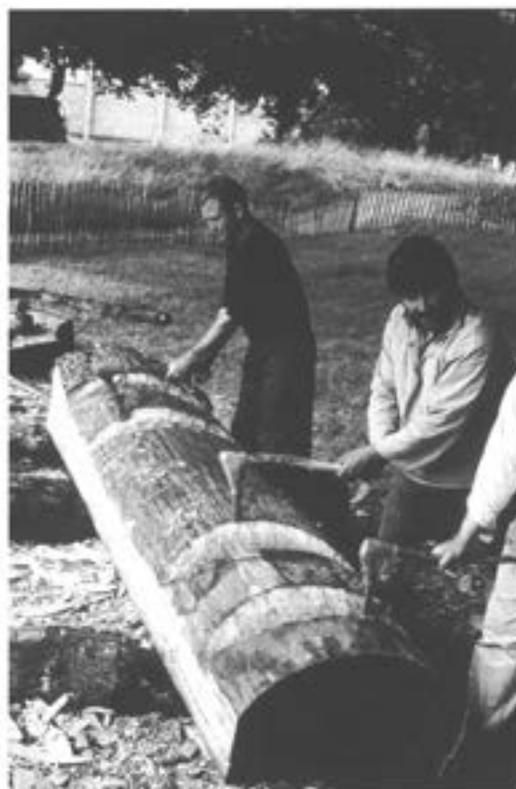
Figure 9.15 (right)
Cutting notches into the curved side of a half log prior to splitting off unwanted timber with wedges. Note the edges of the half log have already been trimmed and flattened.

The flat surface for the boat bottom was achieved by marking out (see Figs 9.14a; 9.14b) and cutting notches across the grain with axes and adzes (where the grain was straight) to within 25mm of the marked surface (see Fig 9.14c). The wood between the notches was then split off with wedges (see Figs 9.14d; 9.15). This was possible only where the wood was thick and straight-grained enough; where the grain was uneven or ran into the marked surface, the wood between the notches was cut away with adzes. Where only thin pieces of wood needed to be removed, it was possible to score across the grain with adzes or axes, then hew off the loosened wood with adzes (see Fig 9.16). Finally, adzing along the grain produced the final, fluted finish of the surface (see Fig 9.17).

The roughing-out of the inboard face and cleats was achieved through a series of stages. To begin with, the position of the cleats was marked out and notches were cut on either side of the cleats down to the lines marking the tops of the rails (Figs 9.15; 9.19a). The wood both above and between the cleats was split off, using curved wedges (Figs 9.19b; 9.19c), notching along the grain and splitting off the wood beside the cleats (Fig 9.19c). The surface along the top of the rails was smoothed by fluting with an adze, and the position of the rails was marked in, notching inside the rail and splitting out wood with curved wooden wedges, and scoring and adzing down to the level of the inboard face, between and alongside the cleats.

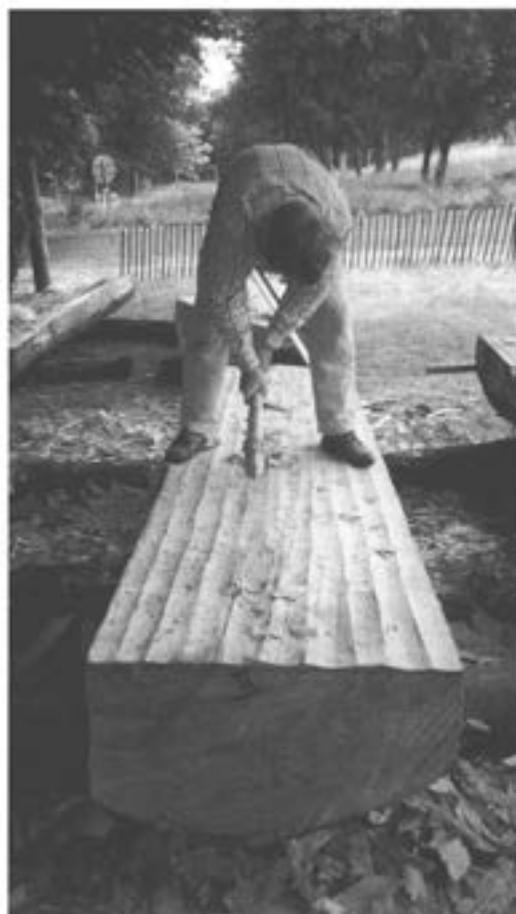
Figure 9.17
Adzing along the grain. The characteristic fluting created by the adze on the bottom of the planks was exactly the same as that seen on the bottom of the boat.

our work with that of the original boat surface, we found that the flutes were exactly the same width. Interestingly, these flutes were up to 5mm wider than the D-adze blade used to produce them.

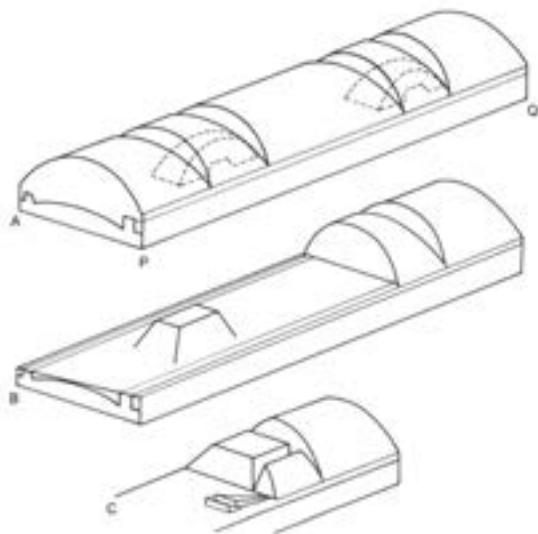
Figure 9.19
Notching and splitting.
A: notches cut down to line PQ marked on the sides.
B: wood split off around cleats, and the lines of the tops of the rails were marked on the surface (the whole surface would be flattened before these lines were marked in).
C: notches were cut on either side of the cleats and the waste split off with curved wedges.

on the sides. Bark was removed from this surface and the position and heights of the cleats were marked in. Deep notches were cut down on either side of the cleats so that the wood inbetween could be split out. Each of these notches was 0.23m deep, 0.75m long and 0.2m wide at the top and took between one-and-a-half and two hours to cut with axes (see Fig 9.19). The wood between these notches was split out with wedges. Further pieces were removed by cutting more notches and by scoring. It took thirty-one hours to rough-out this upper surface on plank I, 14 hours of which was spent cutting notches. The final green plank weighed approximately one fifth of the weight of the half trunk from which it was shaped. Three quarters of that wood was removed by notching and splitting off as pieces weighing between 20kg and 1kg.

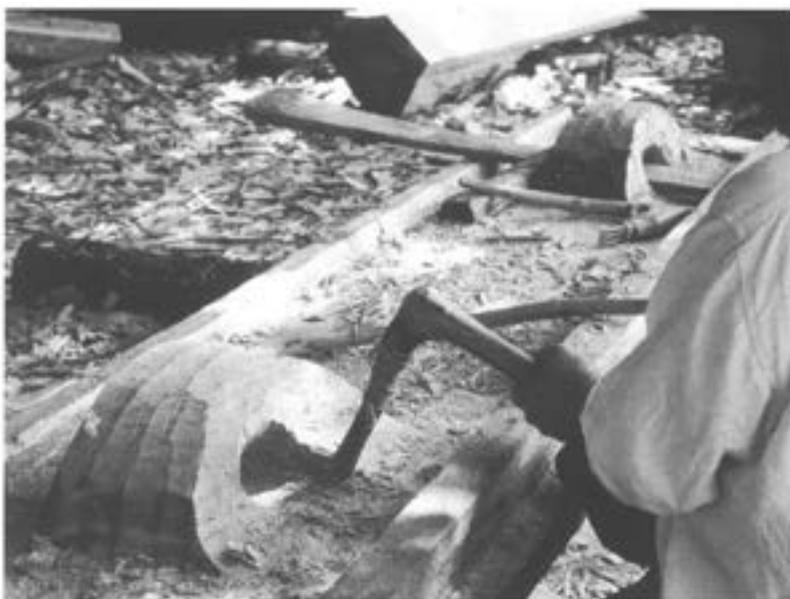
Figure 9.21 (bottom)
Shaping one of the cleats on a bottom plank.

The cleats were marked out by hand and shaped with axes and adzes. It was very easy to finish the cleats with a smoother surface than that found on the originals (Fig 9.21), despite the fact that the team had been working with the bronze tools for only eighteen days (the implications of this are discussed in Chapter 8).

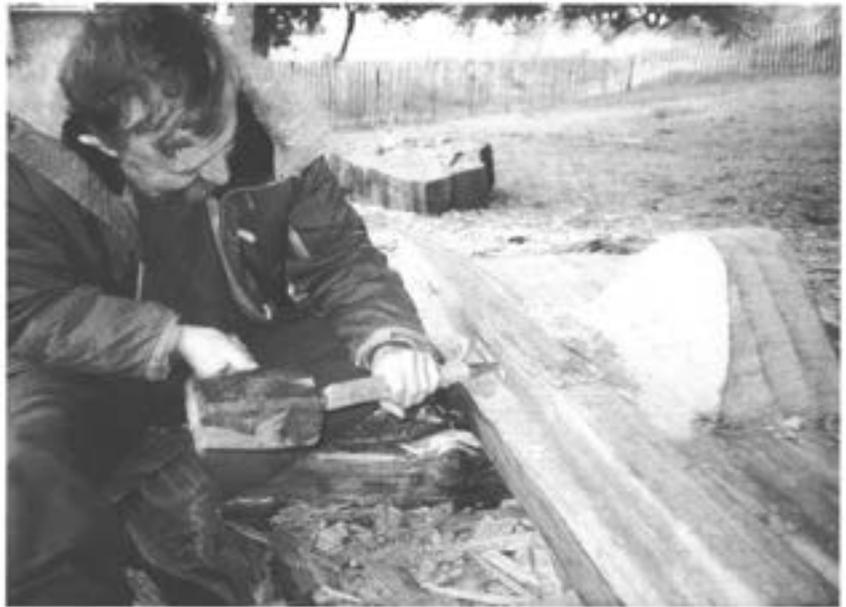
Figure 9.22 (above)
Cutting a wedge slot through the central rail of one of the bottom planks; great care had to be taken not to split off the rail by accident.

The wedge slots were marked on the rails, allowing space for the laths to run underneath them, then cut out (Fig 9.22). The wedge slots on the bottom planks were cut with a chisel and mallet. Once the technique had been mastered, each hole took less than fifteen minutes to cut with chisel F1. The top of the wedge slots were left curved, so that the wedges would bear only on a small area. The stitch holes under the seam rail were more difficult to cut, as they were much longer, having to be chased into the ile seat first, then cut under the rail which (because it is chamfered on its inner face) is almost 100mm wide. This hole was at the limit of the length of hole that could be cut with the socketed bronze gouges G and H (Fig 9.23). The handles broke off in the gouges a number of times, and the gouges also got stuck in the holes.

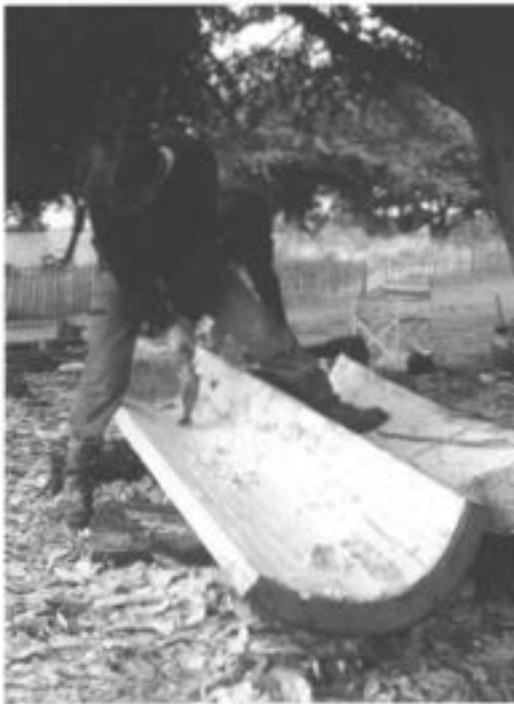
Figure 9.25
Shaping one of the ile planks using an adze.

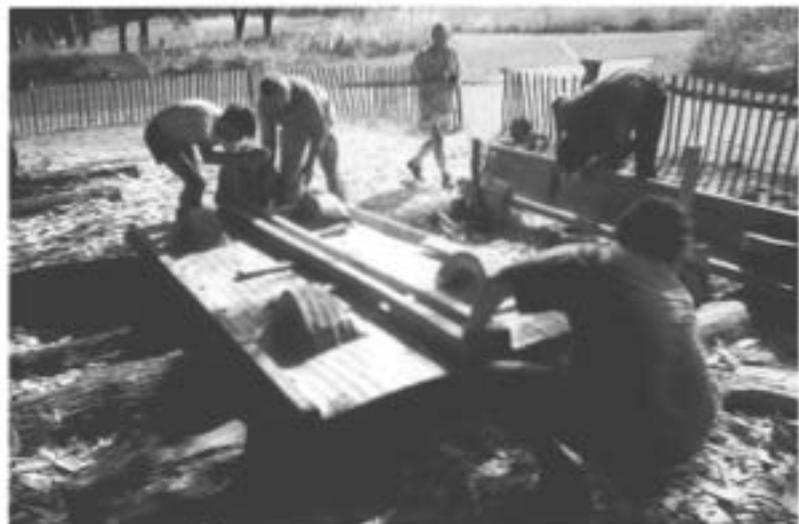
Figure 9.26
Assembling the boat: the two bottom planks offered up to each other.

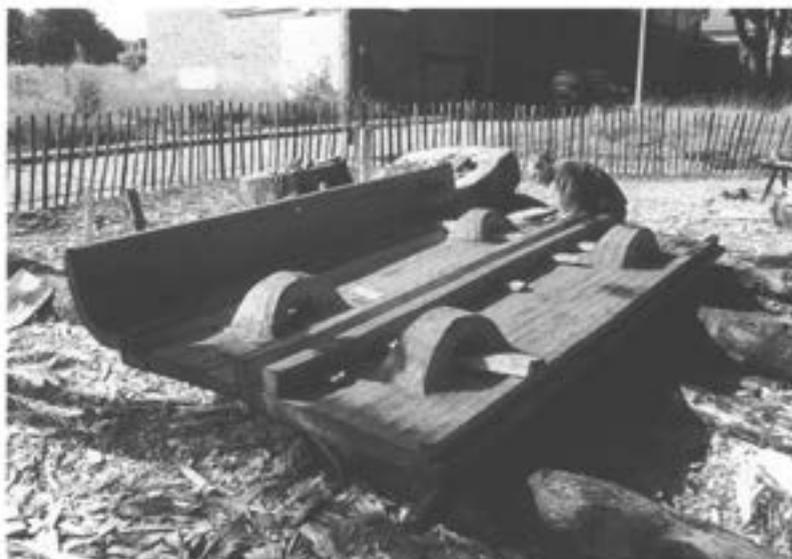
Figure 9.27
Assembling the boat: one of the ile planks in position.

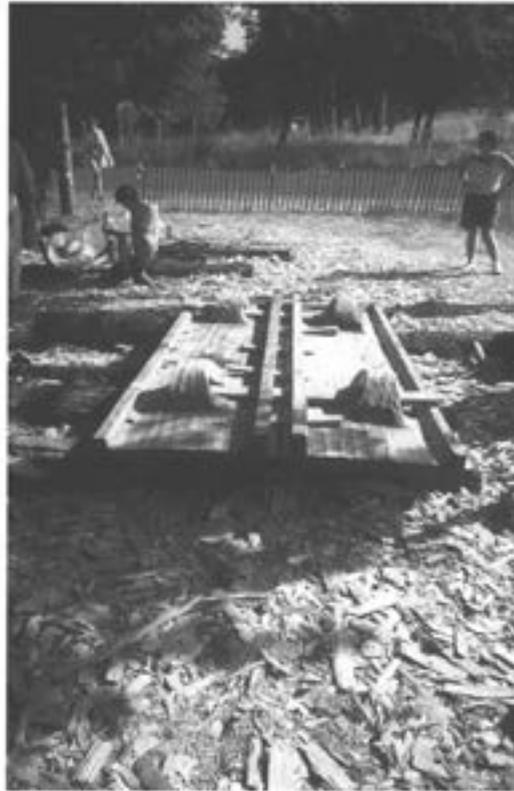
Figure 9.32
Inserting transverse timbers over the seam rail and beneath the bottom cleats and central rails.

The transverse timbers were fitted from alternate sides of the boat, as they would have been in the original boat (see Fig 9.32). The timbers are most supple at their thin ends, but, as they alternate, this will

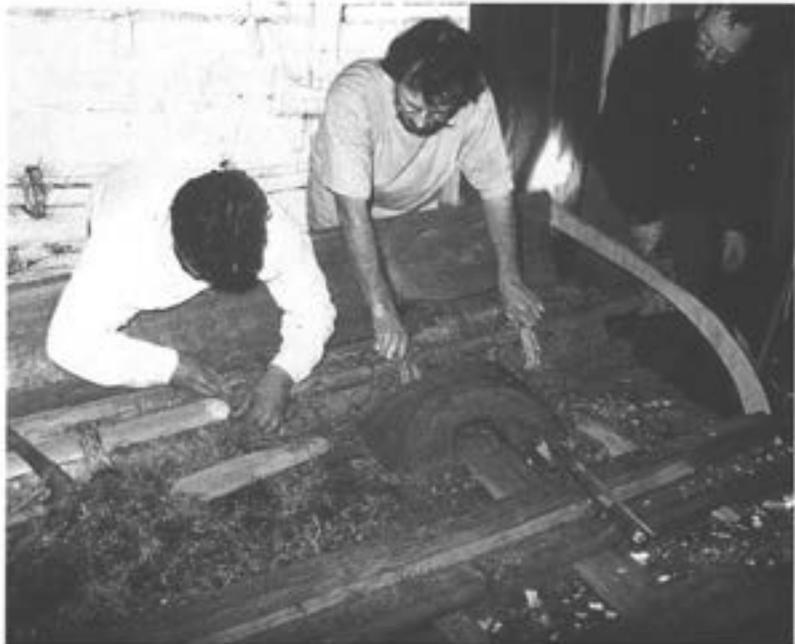
Figure 9.33
Fitting the seam laths. Large quantities of moss were needed even for this short section of the reconstructed boat.

After four or five stitches were completed, a lath with moss under it was driven under all the stitches, helping to tighten the stitches and the joint (Fig 9.33). The moss was attached to the lath with lard and slid along the seam with the lath. If the moss was placed on the seam first it was pushed out by the lath. We later found that the moss was best fed under the lath during driving home. Only after the lath had been driven under all the stitches was the next group of stitches completed. The stitches had to be fitted in groups matching the lath lengths, as it was impossible to drive in the laths with moss on them if they had to ride over stitches rather than slide along the top of the seam rail. The laths were made with a thickened end for hammering; this was removed with an adze after fitting, and the tapered end of next lath was driven over the end of the previous one (Chapter 8).

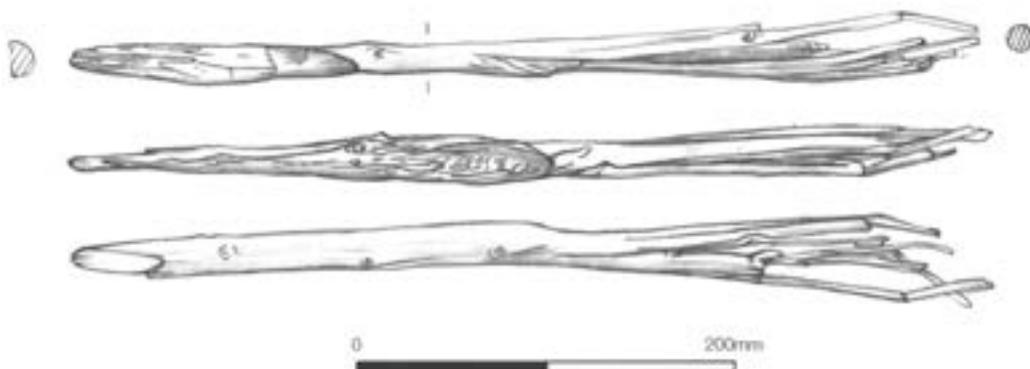
Figure 11.4
A fragment of an unused yew withy found in association with the boat.

Recovered from sediments adjacent to the boat was a fairly straight, yew branch (unnumbered), about 431mm long and 18mm in diameter, with several small knots (Fig 11.4). Its original position is unknown. A section 150mm long at one end has a smooth, concave facet 45mm long, the remaining 105mm being very rough, as though the branch was part cut and part torn from its parent tree. On the opposite side to this break is a small, shallow facet 45mm long. About halfway along the length of the branch is a section of apparently natural damage about 140mm long. This probably represents the scar of a branch torn off in antiquity. At the opposite end to the tool marks is a section 150mm long where the branch has been twisted, separating the wood fibres, in exactly the same way as the yew withy stitches in the boat had been twisted.

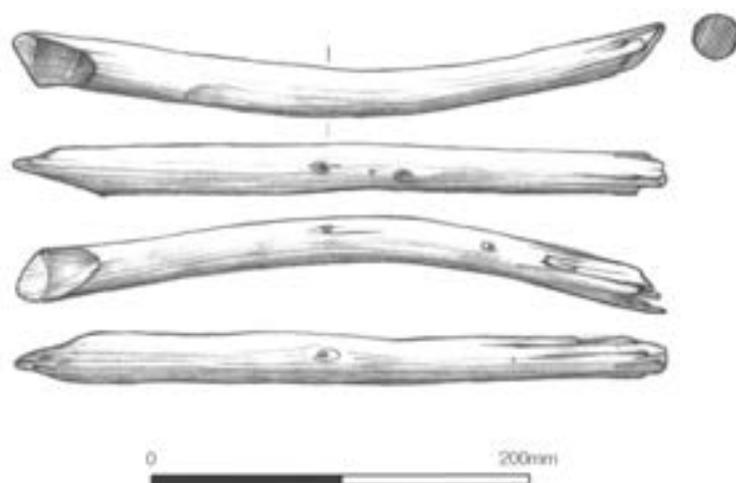
Figure 11.5
Timber 165 – probably
part of a yew wishy end cut
off during the dismantling
of the boat.

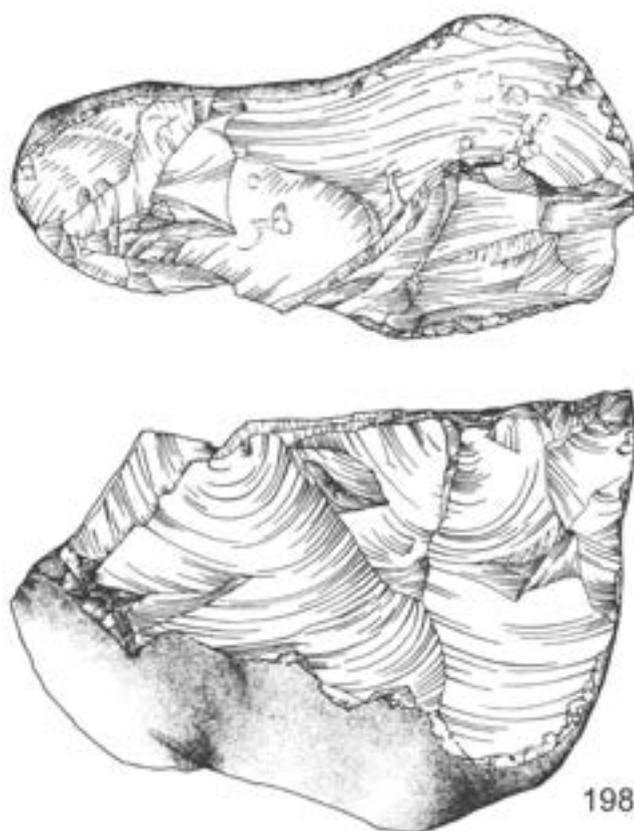
Figure 11.11
Cores. A small single platform example (134.21) and an example demonstrating numerous mis-hits on the striking platform (198) (scale = 2:3).

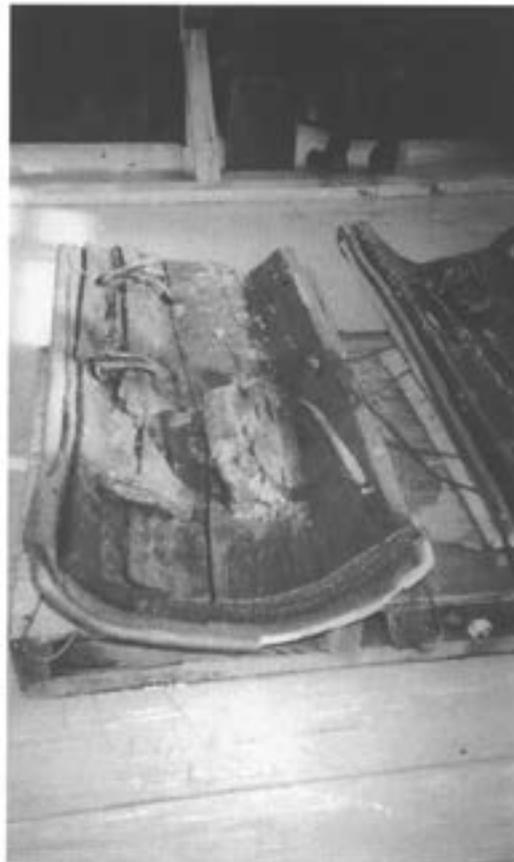
Figure 17.1
Articulated section of the
boat on custom-made poly-
ester and glass fibre cradle.

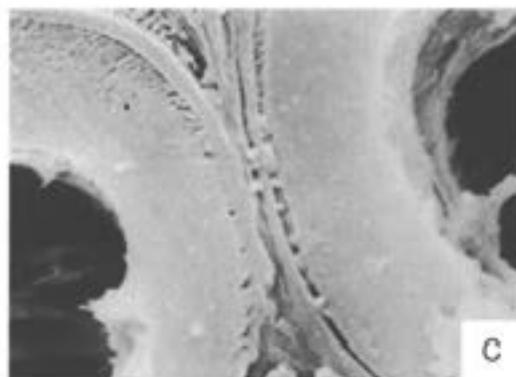
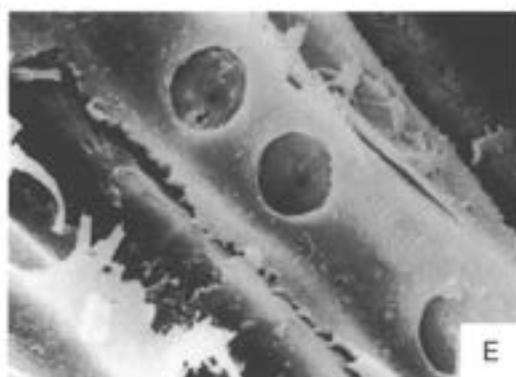
E: Longitudinal section showing the arrangement of bordered pits; the S2 layer has become detached during sectioning (mag. 3200 \times).

F: Longitudinal section showing a degraded pit where the torus has disappeared (mag. 5600 \times).

Samples were examined using both scanning and transmitted electron microscopy by Mark Jones. With these methods it was possible to see that the yew withes were still in good condition with most of the cell walls still intact (*see* Fig 17.2), but the oak had examples of all three types – good, transitional and highly degraded. In some of the highly degraded areas, the secondary wall layers were breaking away from the middle lamella, or were porous due to bacteria or fungal decay (*see* Fig 17.3). In all the oak samples the tyloses (bladder-like expansion of parenchyma cell wall) were intact, which means that the ingress of PEG and the egress of water would have to be through the tangential and radial surfaces, rather than the early-wood vessels.
