The Dover Bronze Age Boat

edited by Peter Clark

Edited by Peter Clark

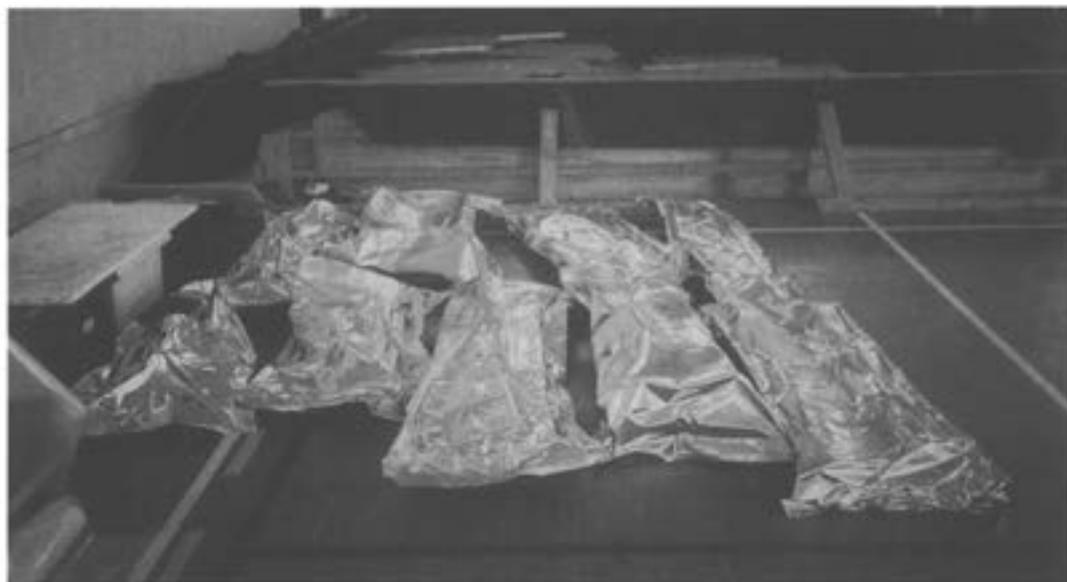
Figure 17.4
Sections of the boat,
including cradles, that have
been vacuum-sealed in
barrier foil in preparation
for transport from Dover to
Portsmouth.

At the end of the pretreatment stage, all the sections were vacuum-sealed in barrier foil on their cradles for transporting to the Mary Rose Trust in Portsmouth (see Fig 17.4). With this method, all the component parts were held securely but gently in place, and stopping them being excessively shaken

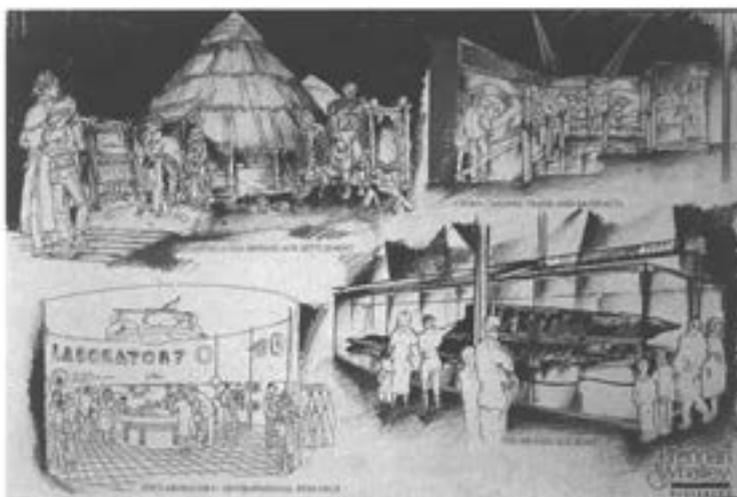
Figure 18.1
An early draft for the gallery design.

The outline designs and costings for the gallery were submitted to the Heritage Lottery Fund in January 1996. Five themed display areas surrounding the boat were proposed for a gallery of about 425m², at an estimated cost of £550,000 (Fig 18.1).

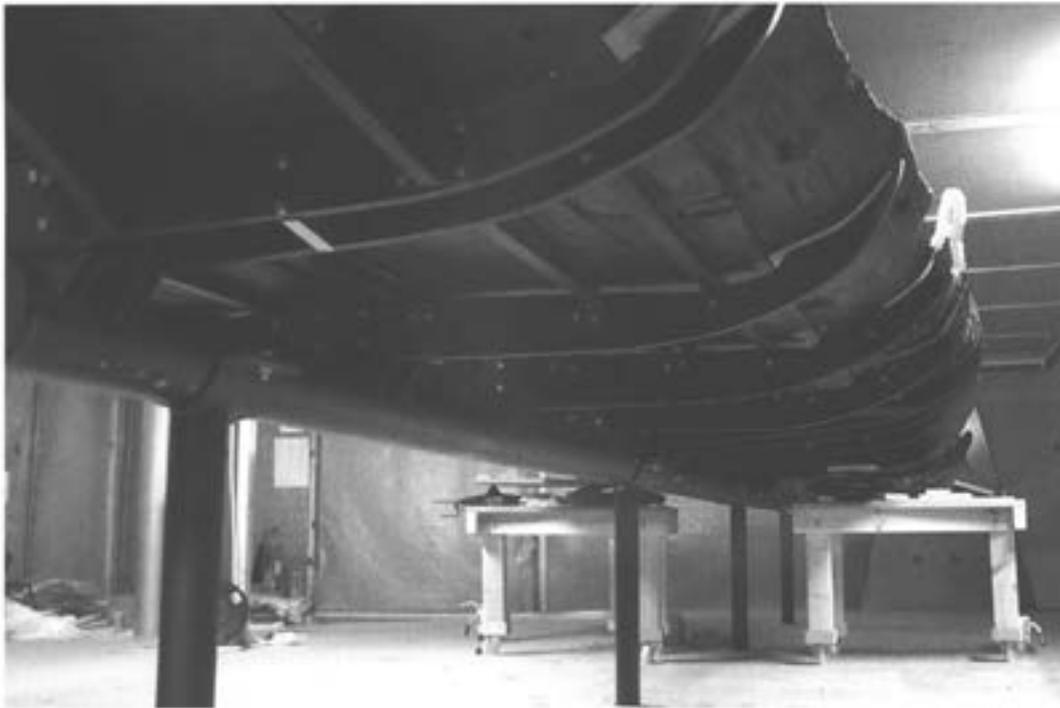
Figure 18.2
The support cradle, showing the cradle spine, transverse ribs and rib plates, and the longitudinal 'trimmers', which together supported each boat piece individually.

- four 750mm-long tubular legs, with a cup at the top of each;
- a three-section tubular spine, 9.50m long, onto which were welded vertical plates at pre-determined positions; and
- a number of shaped half ribs, fitted with grub-screws to take subsequent fittings.

The cradle to support the boat – designed by Dr Edwin Gifford and the reassembly team – was delivered in pieces ready for assembly. The cradle consisted of a central spine to which transverse 'ribs' were bolted (Fig 18.2). These were positioned to provide support to each of the boat pieces; longitudinal support was provided by metal 'trimmers' or struts between the ribs. The ribs were initially conceived as two-piece structures, with a primary, central piece designed to support the flat bottom planks, onto which a curved, secondary section could be bolted that would support the sides of the boat. This would avoid the need to lift the central sections over the supports for the sides, diminishing the possibility of damage to the boat pieces. The secondary rib sections could then be bolted in place once the side sections had been propped in the correct position. Set on the upper surfaces of the ribs were metal 'rib plates' which could be bent to follow the exact contour of the outboard surface of the boat. Grub screws set into the body of the ribs supported the rib plates. The boat timbers would be kept from contact with the metal rib plates by Volara, an archival-grade foam plastic strip.

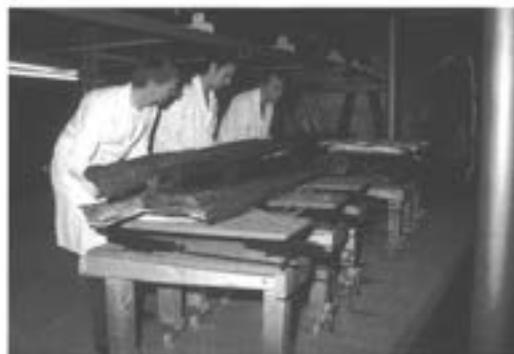
Figure 18.3
The reassembly team placing one of the boat pieces onto the support tables. The tables could be bolted together to provide support for timbers of different sizes, allowing them to be offered up to the boat cradle without fear of damage.

Six adjustable, wheeled tables were commissioned (to a design by Dr Gifford) for use in positioning the fragile boat pieces (Fig 18.3). These were roughly triangular in plan and consisted of a baseboard on wheeled legs, surmounted by three car scissor jacks, one at each corner, onto which was bolted the tabletop. By adjusting the height of the jacks, variations could be achieved for individual pieces as they were being positioned. Unfortunately, a glazing flange, welded to the base of the display case, meant that the tables could not be wheeled directly into the case, and a tempo-

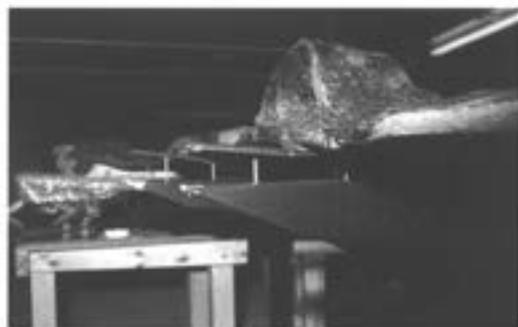
Figure 18.4
Detail of a rib plate supported on grub screws set into one of the main support ribs. As the boat was pieced together, it became apparent that the outboard surface of the boat was more distorted than originally thought, resulting in the rib plates being bent much more than planned; the result was the boat timbers were supported on long lengths of grub screws, a potentially unstable arrangement.

the rib, offered most of the support that the boat required (Fig 18.4). This was covered with Volara. The rib plates could be bent to follow the curvature of the boat's outboard surface. As the boat timbers were gradually lowered towards the rib plates, it became clear where each plate needed bending. The original rib plates delivered were made of pre-tensile aluminium, whose strength was such that they required several hundred pounds of pressure just to make a slight kink, and these were unsuitable for the detailed bending that was required here. Further rib plates of a softer aluminium were ordered; these could be bent 'over the knee' for gentle curves, or in a vice for more demanding angle changes. The bending of the rib plates was more of a visual application, shaping and reforming, noting and accommodating all of the subtle deviations until the correct contour was achieved. On completion of the four plates, the grub screws were raised or lowered accordingly and the boat timbers were gently lowered almost into their final position, but still supported on the tables. The exact trimmer positions were decided at this stage and, once placed exactly where support was required, were drilled and bolted between the ribs. As the trimmers were solid structures and the outboard surfaces of the boat undulated to differing degrees, the variations were filled with Volara. A similar procedure was used for the other half of piece T, and for the adjacent piece U (Fig 18.5). Using the 1:1 drawn profiles and plans from the study phase, adjustments to the levels and attitude of the pieces were made until the correct position was attained.

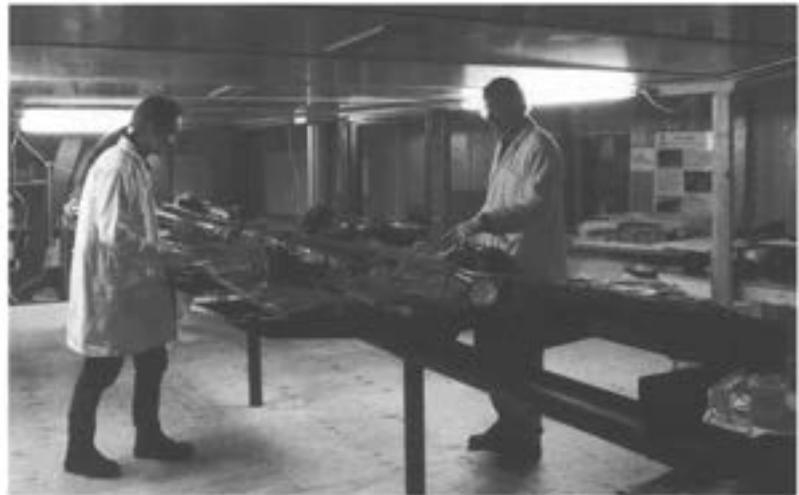
Figure 18.5

The first boat pieces placed on the cradle; the bottom of the boat was reassembled first, with the more complex side pieces and southern end added subsequently.

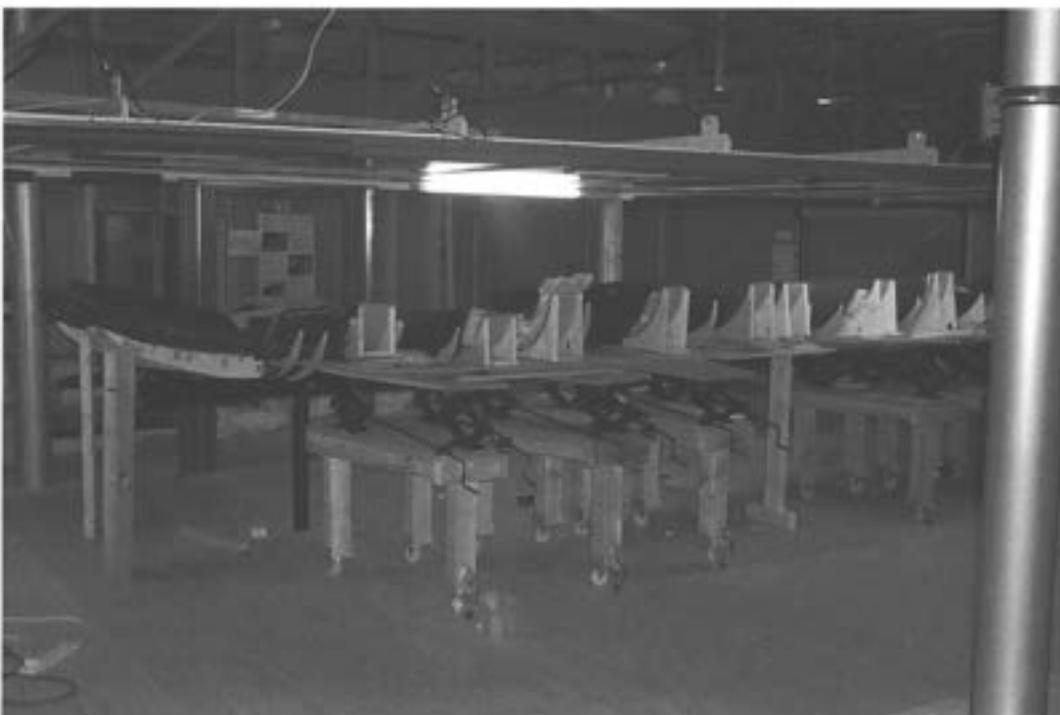
Figure 18.6

The pieces constituting the eastern ile plank propped in position; borne on the adjustable support tables and a series of curved plywood supports, a great deal of trial and adjustment was required to obtain a satisfactory fit.

so that each piece could be directly related *in situ* (Fig 18.6).

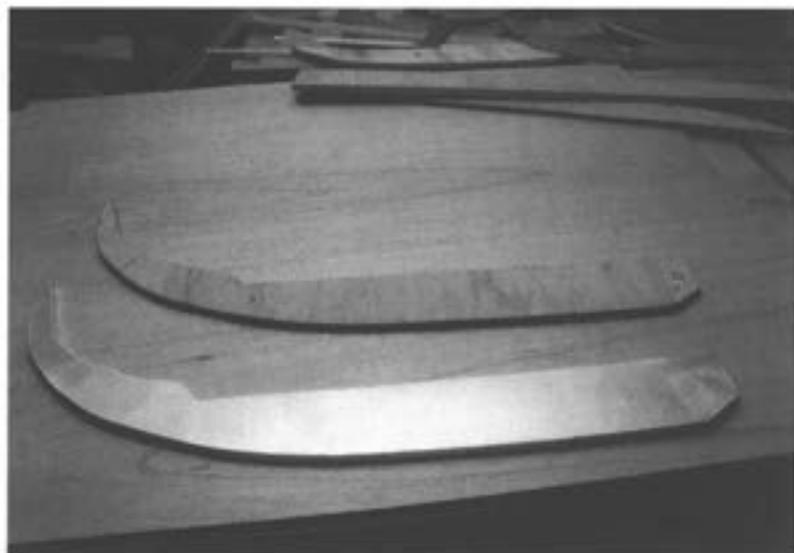
Figure 18.7
Final design for support ribs. The unevenness of the outboard surface of the boat meant that individual customised ribs had to be cut for each station along the cradle spine. A plywood former (above) was cut for each rib, which was used as a pattern for cutting the aluminium rib (below). These were anodised before bolted onto the cradle spine.

This would address the unsatisfactory gap between the ribs and the rib plates, unsteadily supported on long grub screws. Some clearance for the grub-screw adjustment (as originally intended) would be included. It was then a matter of scribing the outboard shape and creating a plywood former on a band saw, complete with additional grub-screw positions for the required ile support. These could then be sent to the fabricators along with a pattern for new ile rib plates (Fig 18.7). They would need to be shorter than those used previously, and, to prevent an excess coverage of the ile's outboard surface, cutouts either side of the top were added (similar in shape to that of a cricket bat).

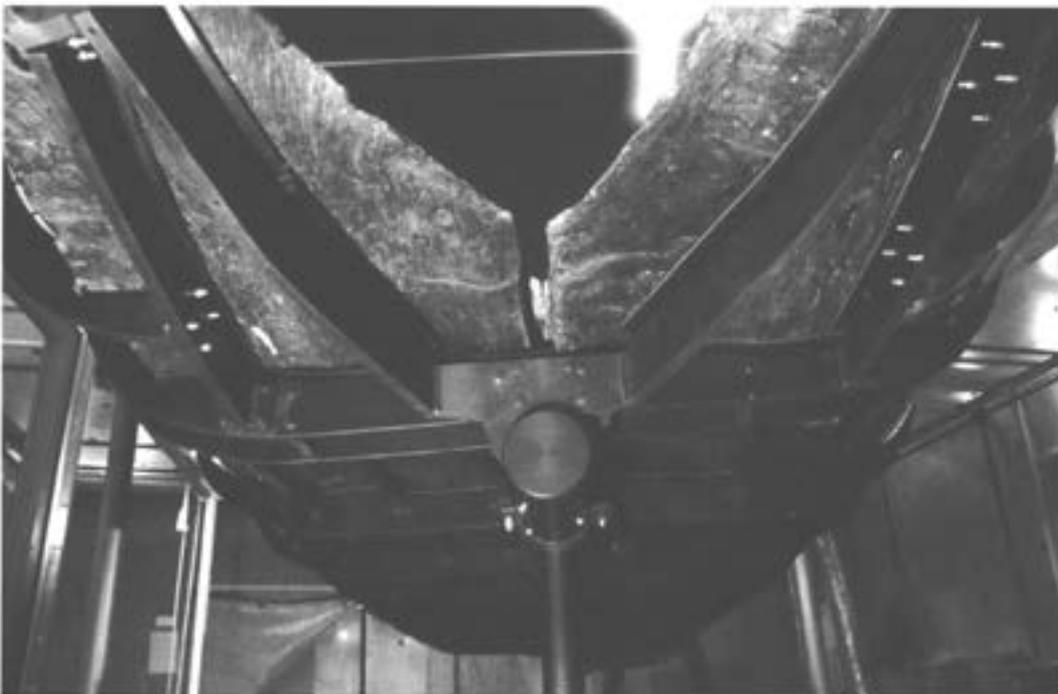
Figure 18.8
The support for the southern end; a complex one-piece welded support bolted onto the main spine plates.

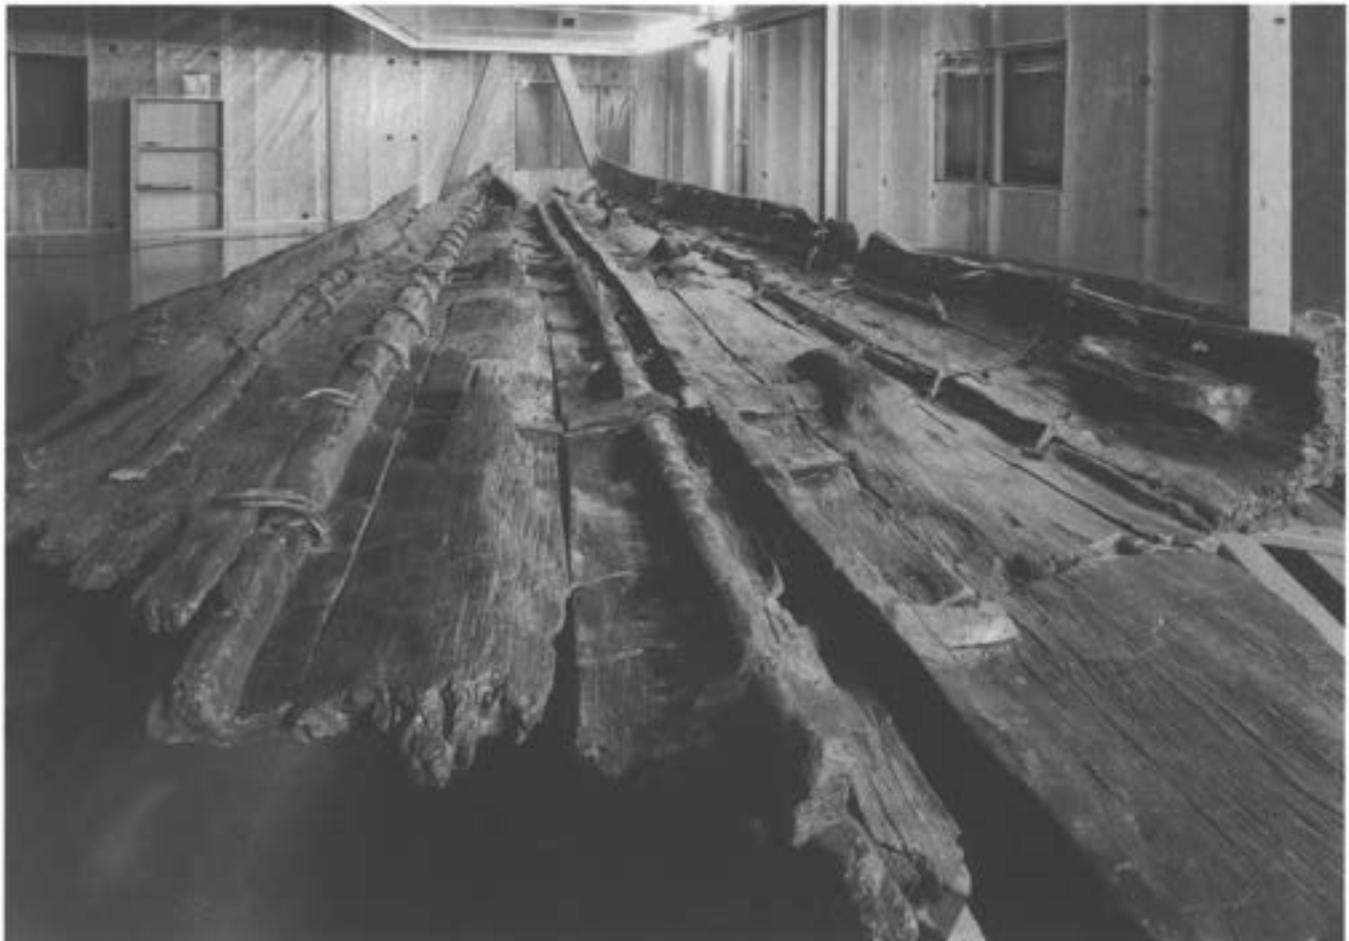
Figure 18.10
The reassembled boat. After completion, the case was glazed and the temporary environmentally controlled workspace dismantled before the rest of the gallery could be fitted out.

a guide for the conservator, Sue Bickerton, to complete this final stage. It is difficult to conceive how this could have been achieved with traditional photographic techniques. After a final surface treatment of the reassembled timbers, the job was complete (Fig 18.10).

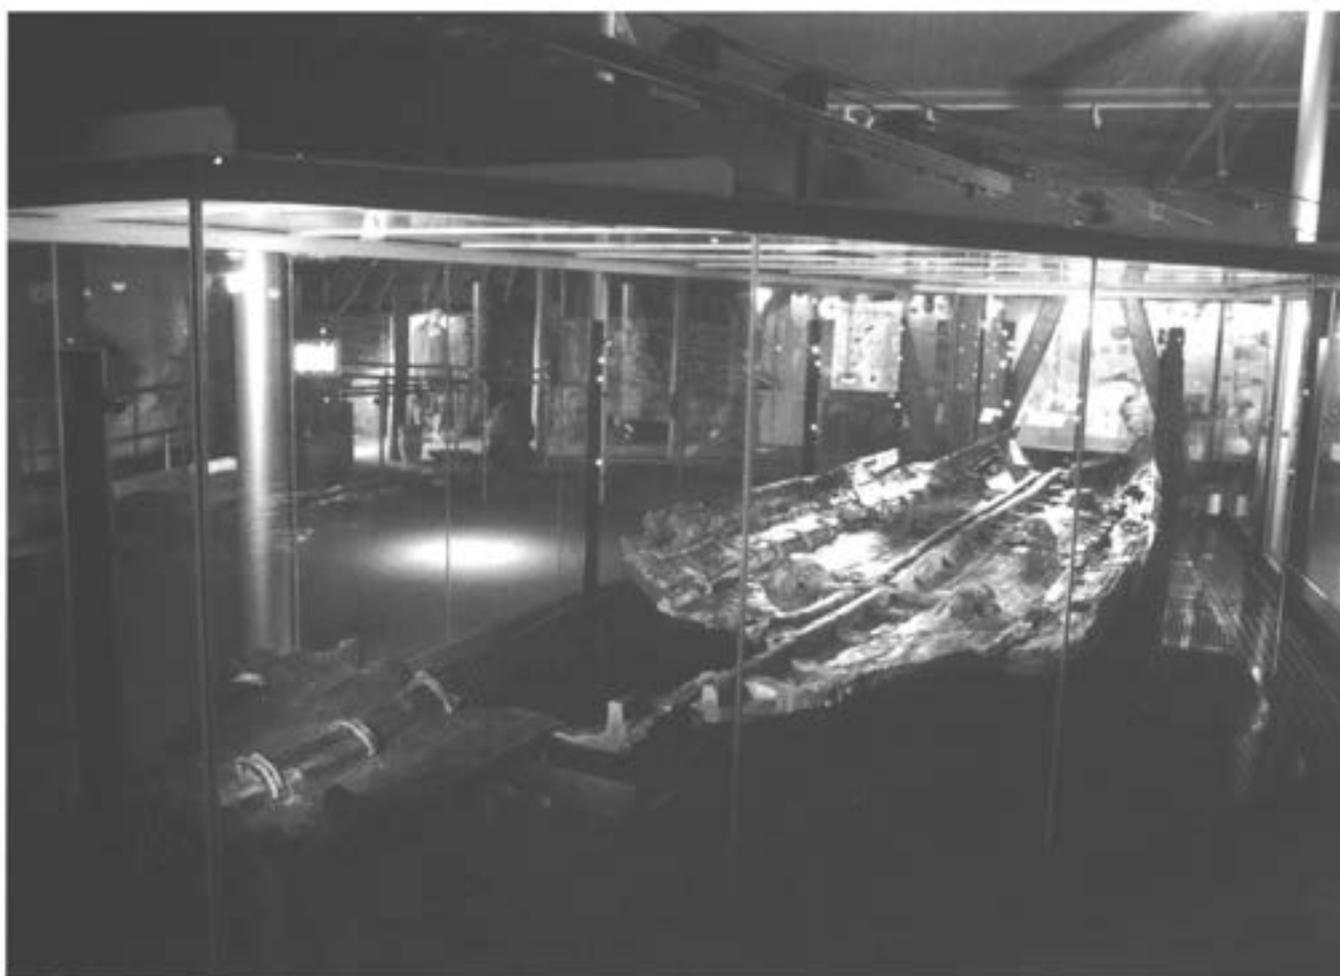
Figure 18.11
The completed gallery, with the reassembled boat as its centrepiece. The gallery has proved extremely popular, and has won many awards since it opened.

The boat has been reassembled on a 9.5m-long steel cradle inside a 10.5m steel case fitted with eighteen toughened-glass panels (Fig 18.11). The absence of glazing bars allows an uninterrupted view of the boat from either side of the gallery. A steel-framed glass door allows access for inspection and maintaining the monitoring devices in the case.

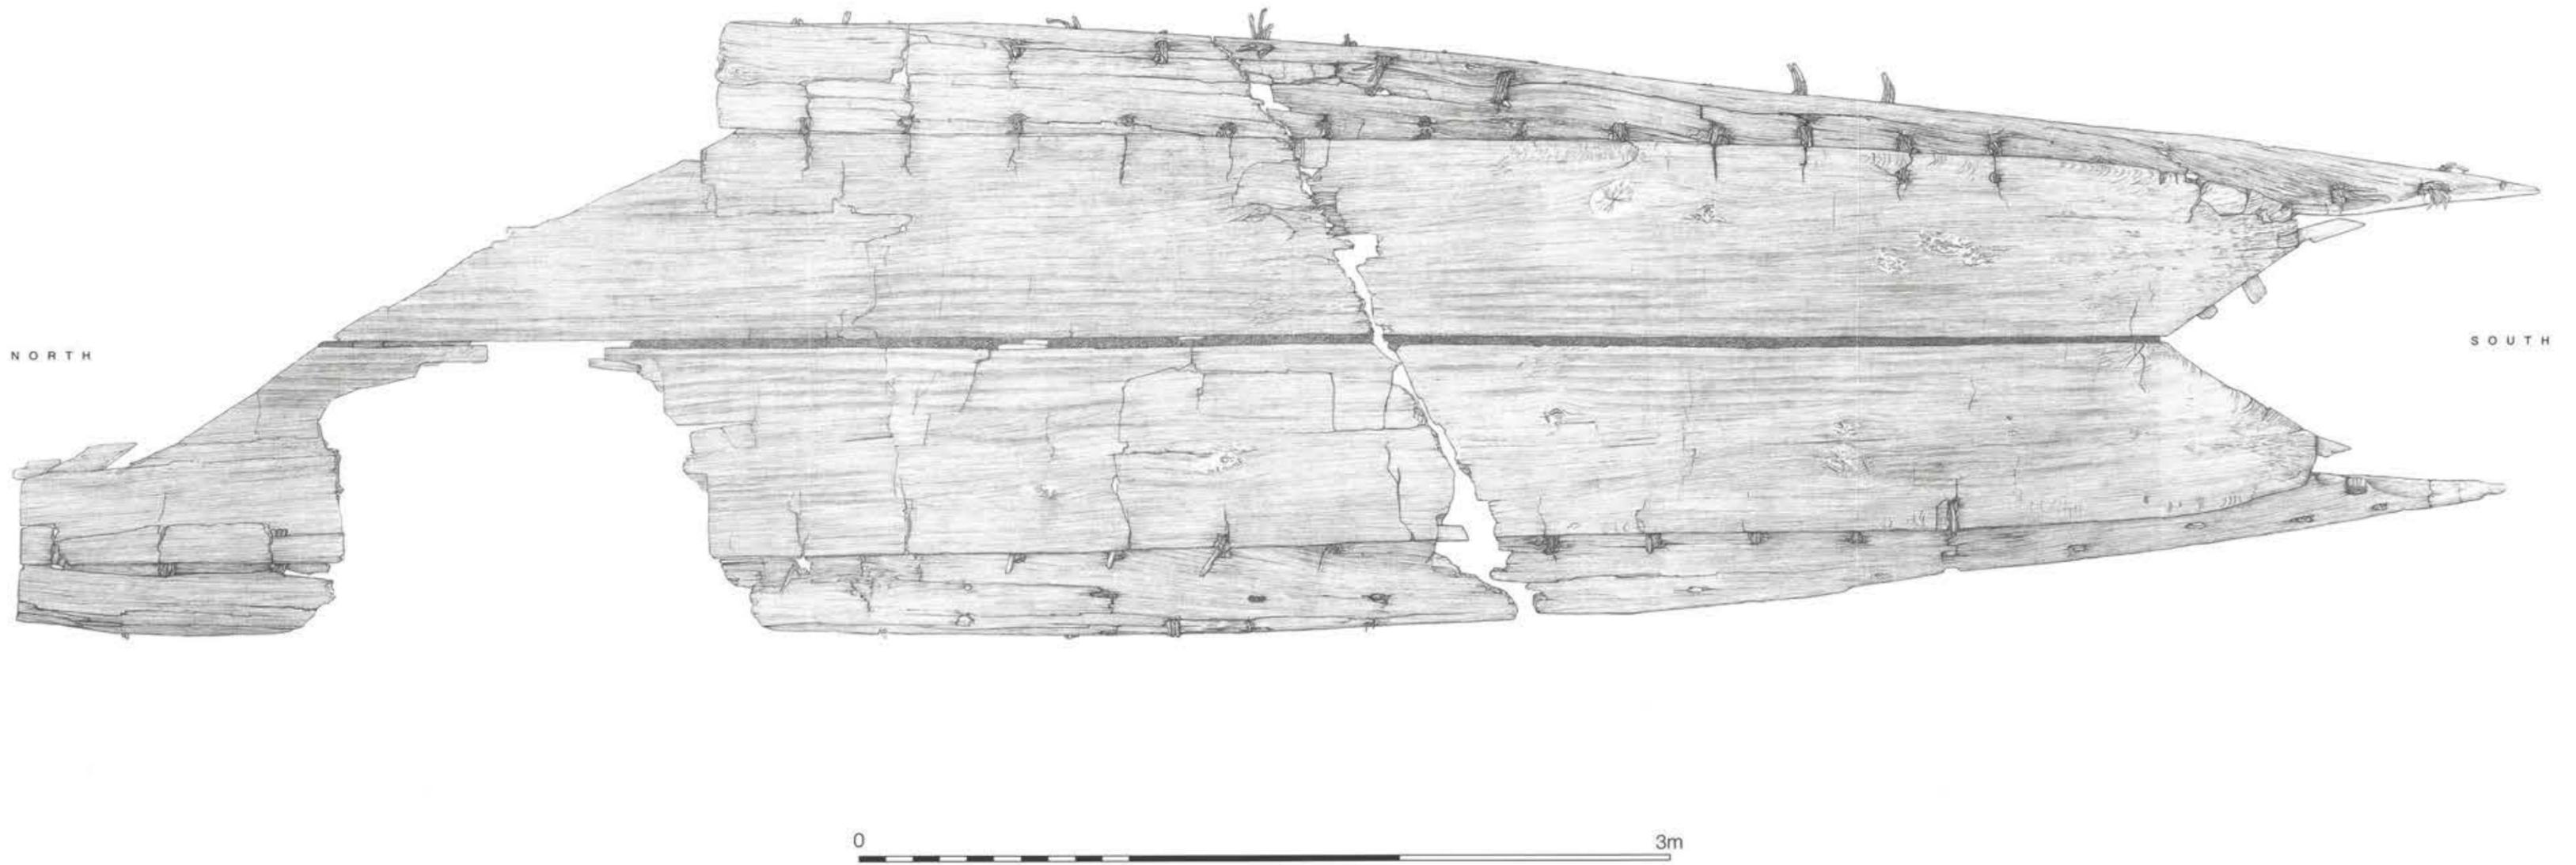
Figure 5.18 The outboard surface of the boat.

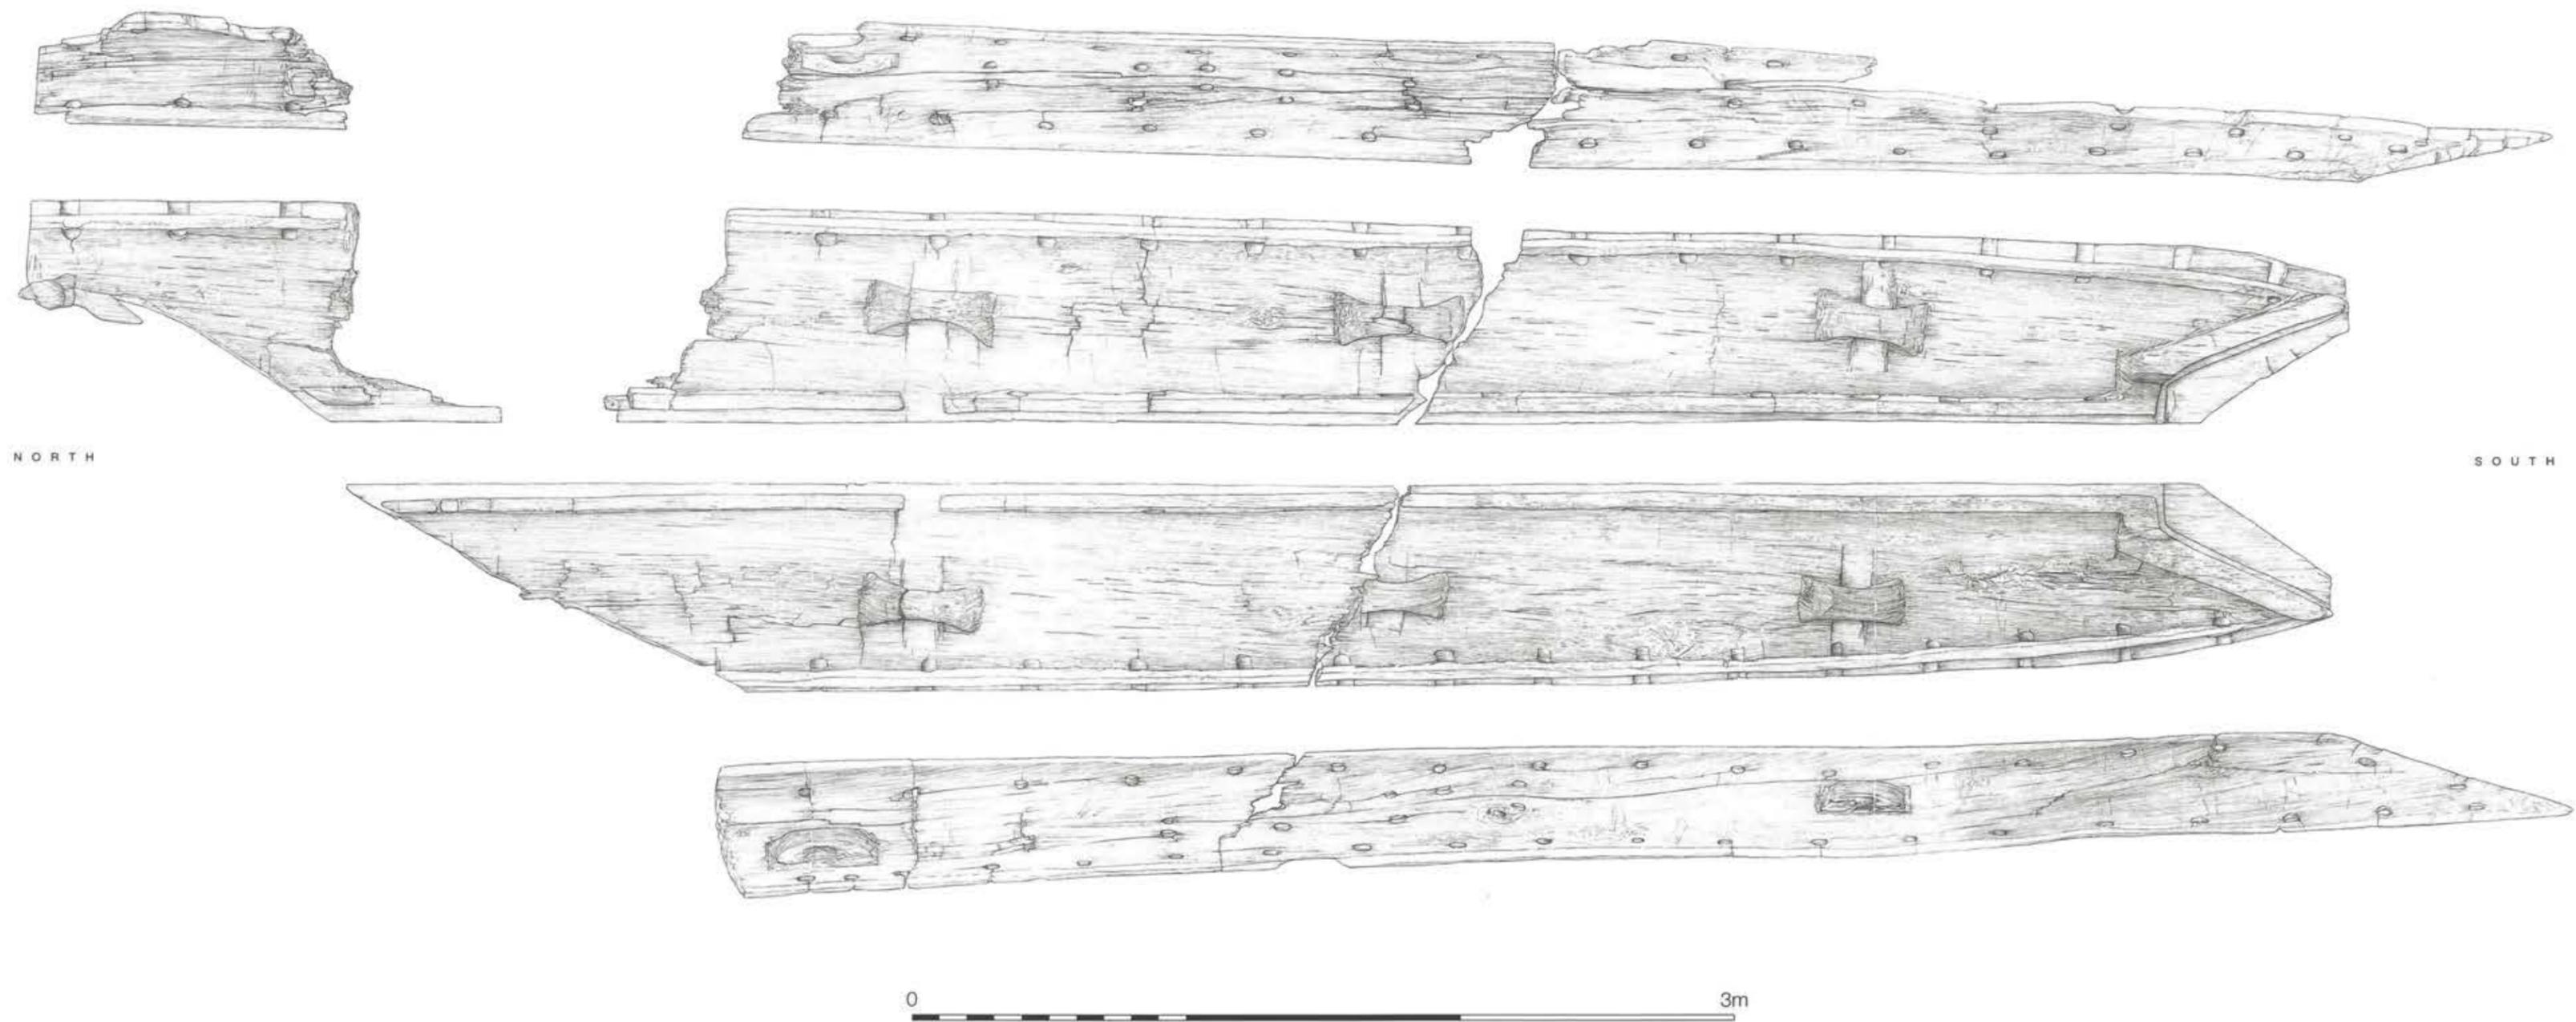
Figure 5.20 Plans of the inboard surfaces of the major component timbers of the boat.
