**CONDITION ASSESMENT OF  
NEW WEIR IRON WORKS  
SYMONDS YAT WEST  
HEREFORDSHIRE  
SO 55838 15534**

**Herefordshire Archaeology Report No. 228**

**New Weir Ironworks**  
**Symonds Yat West**  
**Herefordshire**  
**Herefordshire Archaeology Report No. 228**  
Herefordshire Archaeology, March 2007.

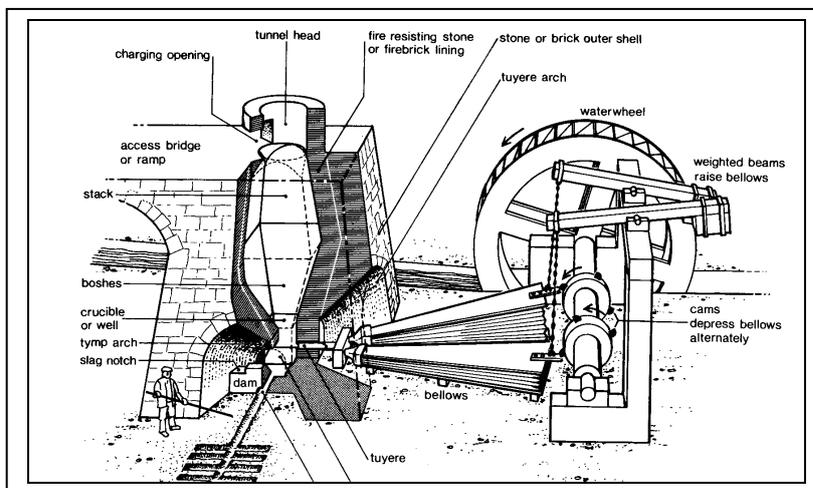
*Fig 1. A charcoal blast furnace showing the bellows arrangement on the right (source: Neil Cossons 'The BP Book of Industrial Archaeology' 1975, Fig 19)*

Charcoal furnaces were almost always built into a bank for ease of charging with the raw materials from the top – charcoal (stored in a large building to keep it dry), iron ore and limestone to act as a flux (Fig 1). Charcoal furnaces were generally square in section tapering from the top to about two-thirds down (at the boshes). From here they narrowed into the crucible where the molten metal gathered. Air was blown into the crucible through twyeres or nozzles – bellows for this 'blast' were driven by waterwheels. Thus we can expect to find three features where furnaces might be located – a platform for the furnace to stand on, a bank for charging and a water supply. Around every 24 hours the iron was drawn at the base and the slag or waste higher up where it floated. Slag is also another prerequisite for identifying the site of a furnace. This generally has flow marks set in it caused by the high temperatures which reduced the slag to a molten state A feature which can survive and is often later

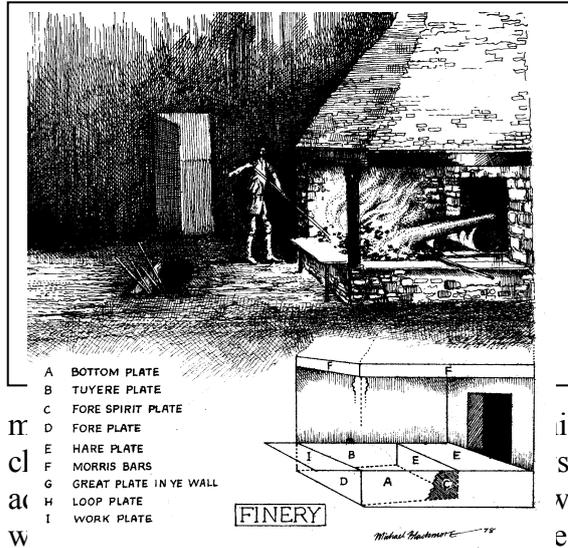
Fig 2. A finery with named cast-iron plates (source: van Laun 1979)

The forge was in three parts. In the first stage of the process (finery) the pig iron was melted and carbon content burnt out in (Fig 2) a water-blown hearth which made it malleable. For the second part the hearth was larger (chafery Fig 3) and here the nowies<sup>17</sup> Both hearths would have needed a s required counterpoises to lift them up (wing stroke) was made by tappets on the e cast-iron plates as shown in Figs 2 and 3.

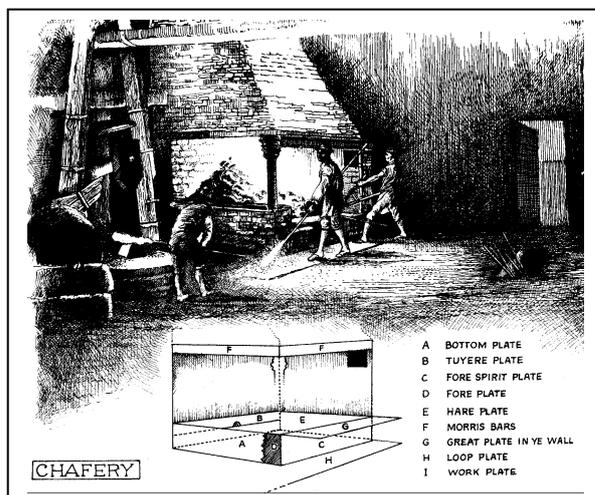
Fig 3. A chafery with named cast-iron plates (source; van Laun 1979)

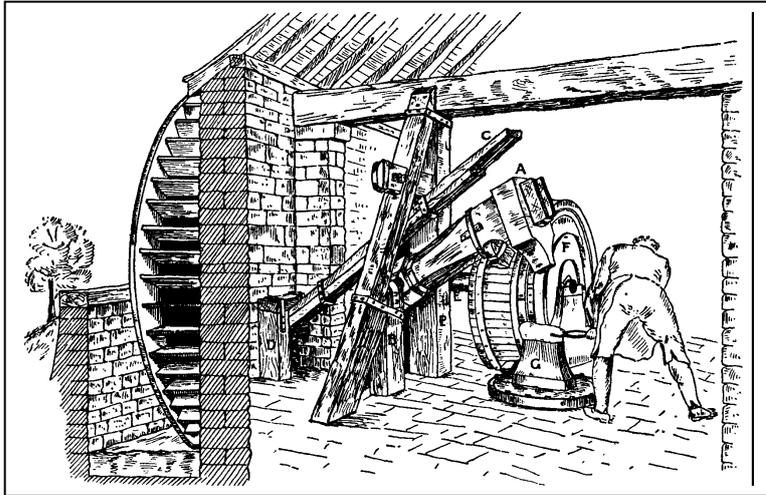
*Fig 4. A water-powered helve hammer (source: Straker 1931, 87)*

Finally the iron was hammered under a water-driven helve to weld it into a homogeneous mass (Fig 4). Chafery and helve hammer would be worked in conjunction with each other. The cast-iron hammer head was lifted at the head end by tappets set on the waterwheel axle and once these had passed its weight would bring it down onto the work piece on the anvil. The anvil was subject to enormous vibration and was therefore mounted on timber baulks buried down into the ground to absorb the shock. Much of the hammer slag would accumulate around the base of the anvil and drop through the timber baulks and is like to have survived as layers with a proportion of iron. The solid cast-iron hammer was set at the end of a wooden handle which passed through a cast-iron 'hurst'. The hurst had pinions cast into it which lay between wooden 'arms' which were secured to a beam above. Extra force in the working stroke was applied by a 'rabbit' or wooden spring which was placed above the hammer.

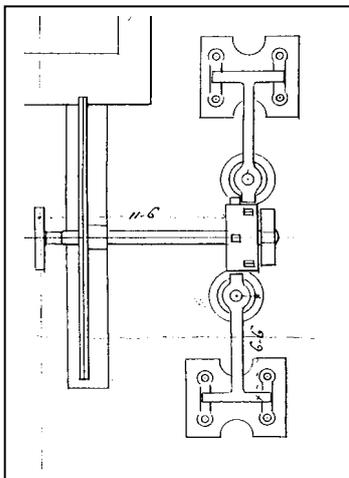
*Fig 5. Helve hammers at Wilsontown Lanarkshire 1789. A flywheel lies to the left with the axle running through to the cam box. The noses of the hammers face each other with their tails are secured to a bracket (source: Birmingham Reference Library Boulton & Watt Collection MS3147/5/539) reduced.*

Two hammers might be worked by a single cam box and waterwheel (Fig 5). Here the 'noses' would be placed opposite each other and worked alternatively. Generally the power generated by the waterwheel was now waist and two lumps at the end for ease of

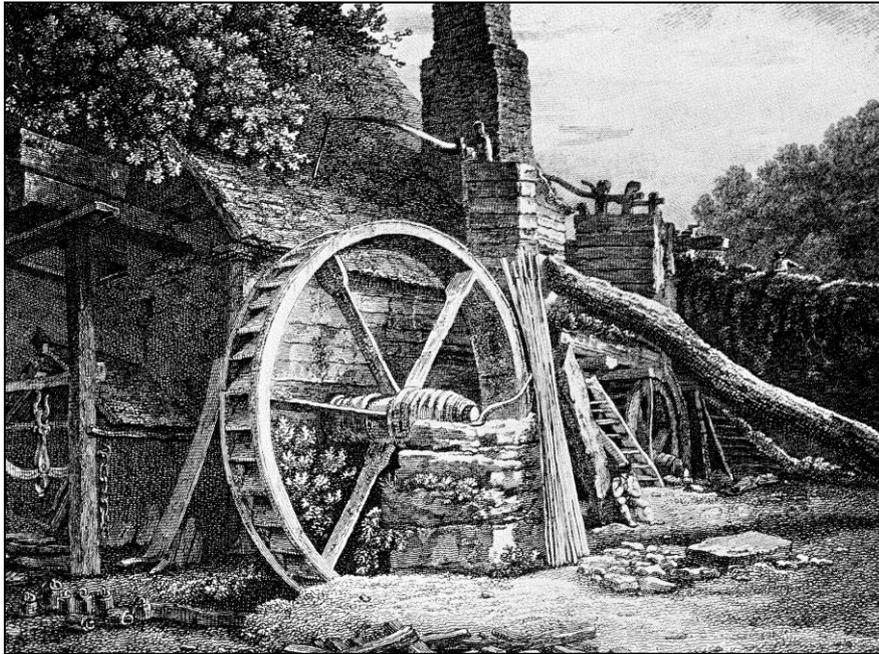
*Fig 6. 'Iron Forge at Tintern, Monmouthshire' (Tintern Lower Forge) drawn in 1794 by Thomas Hearne and engraved by B T Pouncey 1798 (source: Rees 1968, 644 – 45).*

wheels in tandem.<sup>18</sup> The Tintern Lower Forge, which was working in conjunction with New Weir in 1707, may give an idea of how parts of New Weir may have looked (Fig 6). The larger wheel probably drove a helve hammer and the smaller a set of bellows for one of the two fineries (upper and lower) known to have been refitted in 1693 – 94. At the same time the hammer had a ‘rabbit’ refitted - a wooden spring which returned the helve to the anvil with additional force.<sup>19</sup> The finery chimneys lay either side of the smaller wheel and were controlled from inside by ramshackle dampers. - the large chimney at the far end would have served the chafery. The bundle of rod-iron resting against the waterwheel may have been awaiting shipment from the nearby tidal dock – the weigh-beam lies to the left.

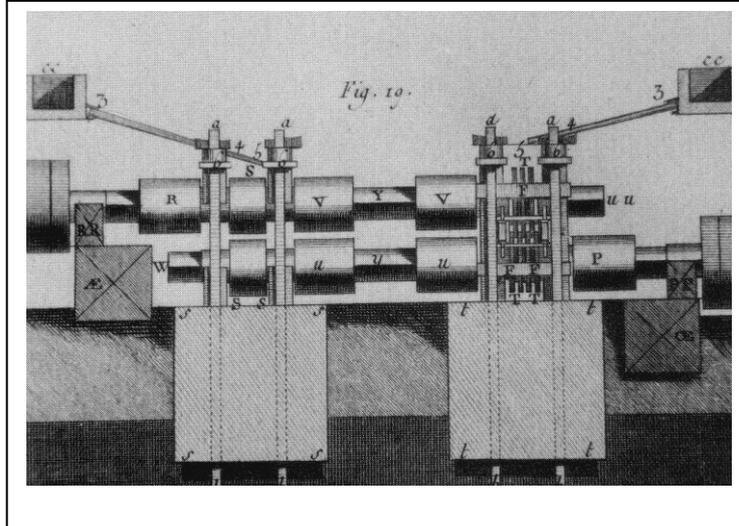
*Fig 7. A Rolling and Slitting Mill from Didérot Encyclopédie. The plate rolls lie to the left with the cutters to the right. The narrow bars between join the 'wobblers' which allowed the rolls to part slightly to allow the plate through. To stop the plate melting and slicking to the rolls they were water-cooled by the tanks to the top left and right.*

In the mid-18<sup>th</sup> century New Weir was operating a slitting and rolling mill. The end product; strips of malleable iron used for a number of smithying products including nail making, was produced in two stages and had been around since the 1590s. Both required power-driven rolls. After heating the malleable iron was passed through a set of flat rolls, rather like an old-fashioned laundry roller, to produce plate. After re-heating it was passed through a set of revolving cutters where the opposing set were larger which cut the plate into strips (Figs 7 and 8). Fig 7 shows that the rolls were held down by bolts passing through baulks of timber or possibly blocks of stone – the pits for these should have survived.

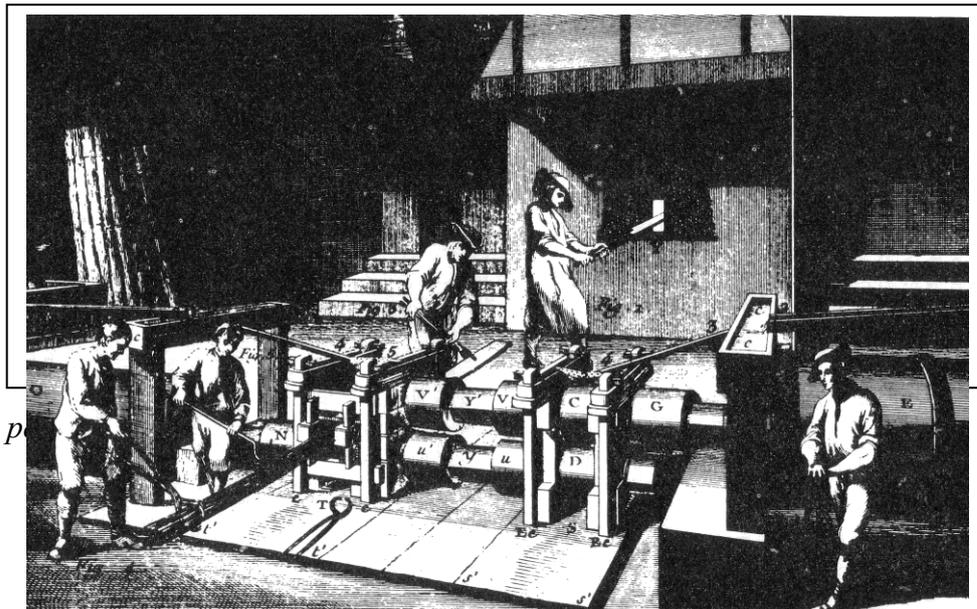
*Fig 8. A Rolling and Slitting Mill c1760 from Didérot Encyclo*
