Victoria Iron Foundry, Possilpark, Glasgow

Archaeological Trial Trenching

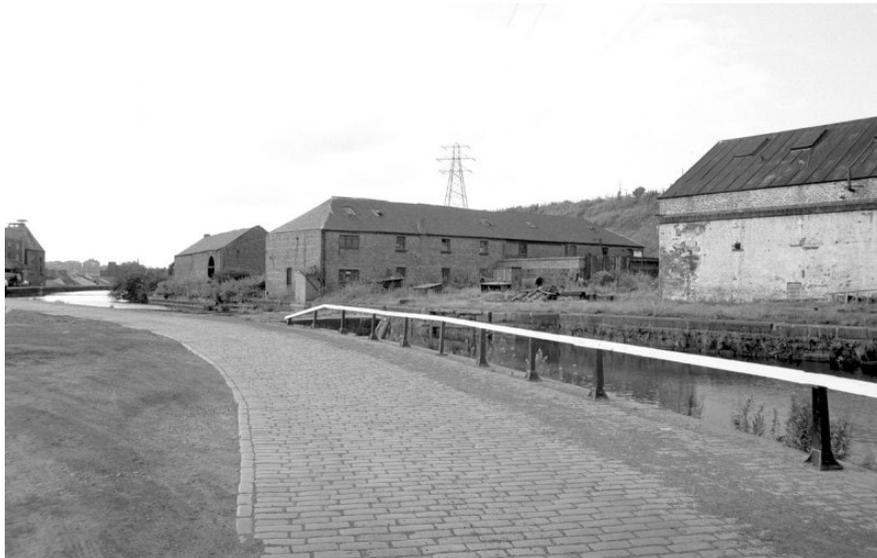
Plate 1 – Canmore Image SC712938 © RCAHMS

1.2.6 One of the photographs shows a view of the foundry taken from the south east and shows the front of the eastern block of the foundry complex, with the foundry itself shown behind (see Plate 1).

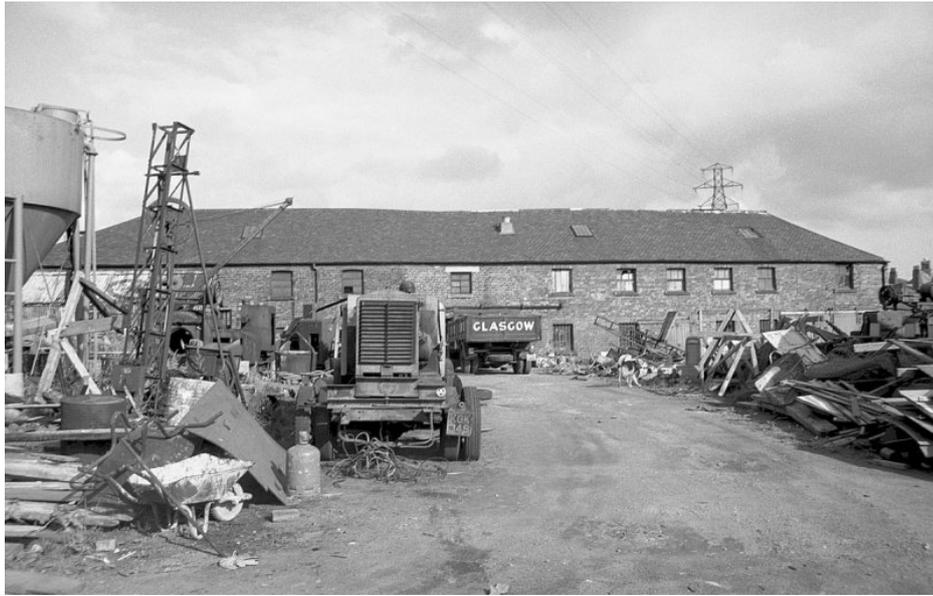
Plate 2 – Canmore Image SC712932 © RCAHMS

1.2.7 A second photograph taken from the west-north-west from inside the foundry yard shows the west-north-west facing elevation of the eastern block of the foundry complex (see Plate 2).

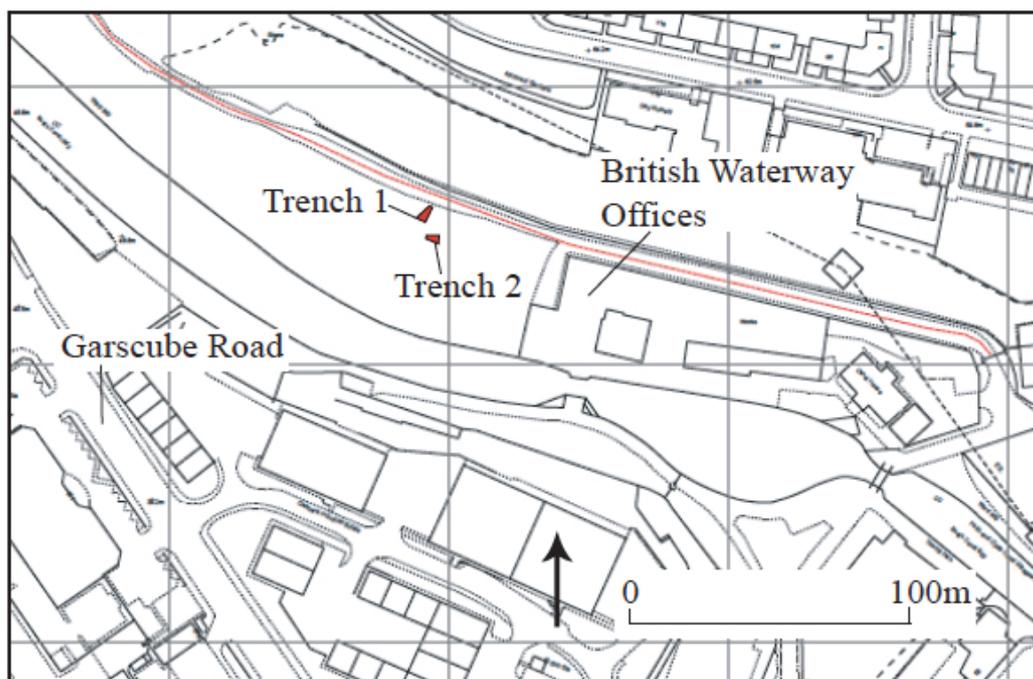
Figure 2 – Trench Location Plan

2.2.1 Two small trial trenches were excavated on the site of the old Victoria Iron Foundry and were located within the bounds of the main foundry building of the foundry complex (see Fig. 2).

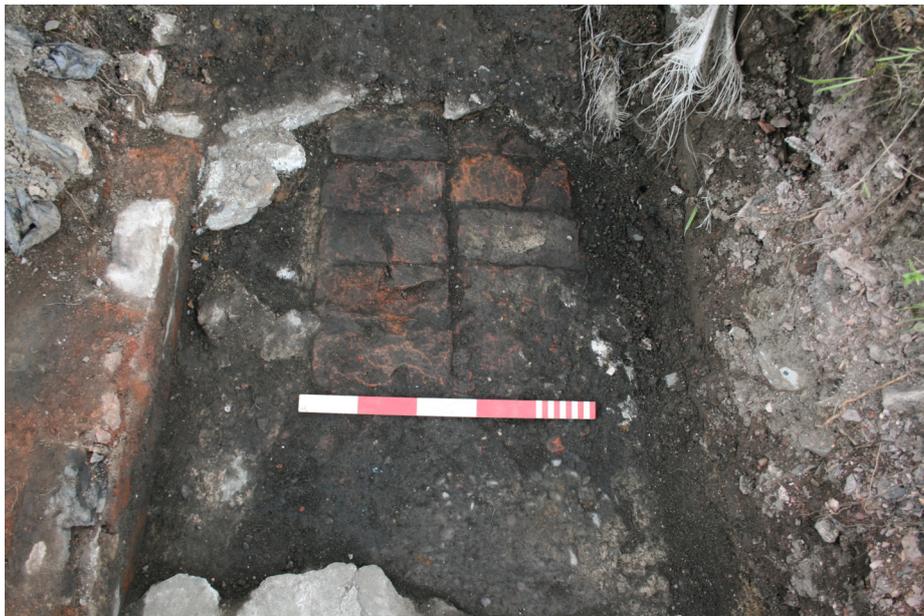
3.2.5 Beneath the concrete surfaces (014) and (018) was a thin layer of mid-orange sand, likely representing a ground levelling event prior to the construction of the first concrete floor (014). The layer of sand was found to seal an earlier episode of concrete (017) and brick (016) construction.

3.2.6 It is unclear at this stage what both (016) and (017) represent, but they may form part of an earlier brick wall and concrete foundation, or a brick laid floor.

Plate 3 – Brick surface (016) with later concrete surfaces (014), (018) and wall (020)

3.2.4 The foundations (019) and wall (020) were overlain by a series of concrete surfaces. The earliest concrete surface (014) to overly (019) was located at the northern end of the trench. (014) consisted of a thin layer of concrete that was subsequently overlain by a later re-skim of concrete (018). This later re-skim abuts wall (020) and contains a vertical iron pipe (021) that also abuts wall (020).

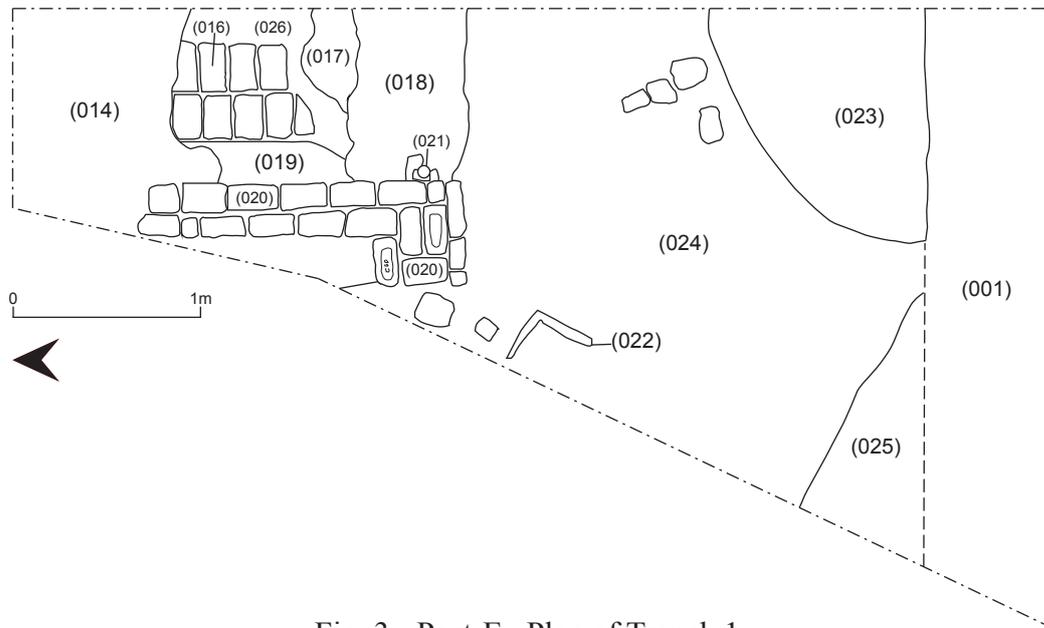
Fig. 3 - Post-Ex Plan of Trench 1

3.2.1 Trench 1 was roughly triangular in shape; 5m long and 3.2m wide at the southern end, 1m wide at the northern end (see Fig. 3). It was orientated north to south and it was located on what was believed to be the north western corner of the foundry building. Excavation revealed up to 0.4m of mixed modern overburden, mainly consisting of sand and clay with a mixed rubble and debris demolition deposit (**024**).

3.2.3 Adjacent to the east of wall (020) was a concrete foundation layer set into a foundation cut (019). The visible remains of this cut lay 0.22m to the east of wall (020) and was aligned the same as the wall.

3.2.7 Towards the southern end of the trench further concrete remains **(023)** were revealed, however no direct relationship with the features at the northern end of the trench could be identified. There was also evidence of a modern pit **(025)** that was partially revealed in the south western corner of the trench, and has likely caused disturbance to the remains of the building in this area.

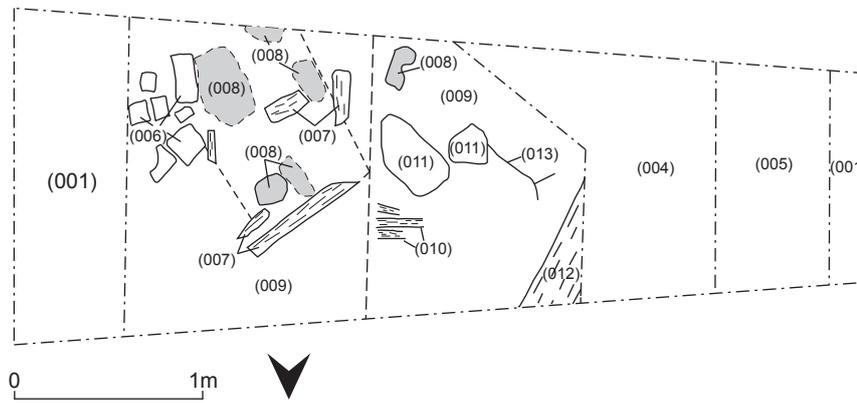
Fig. 4 - Post-Ex Plan of Trench 2

3.3.1 Trench 2 was roughly rectangular in shape. It was 4.5m long, 1.8m wide at its eastern end and 1.1m wide at its western end (see Fig. 4). It was aligned east to west and was positioned to south east of trench 1 in order to investigate the likely interior of the foundry building.

3.3.6 Context **(007)** consisted of some remnant wooden planks aligned both NE-SW and NW-SE. They appeared to form a square shape approximately 0.8m by 0.8m and surrounded very rusted and corroded iron remains **(008)**. The iron and wood remains are possibly the remnants of a machinery stantion.

3.3.8 Other remains within trench 2 consisted of a large wooden beam **(012)** and some concrete debris **(011)** with steel wire reinforcement **(013)**. These deposits were all found to lie on top of the likely floor remains and are likely representative of debris or collapse following the buildings destruction.

- 4.1.3 Trench 2 revealed a probable wooden floor and possible brick and metal machinery settings in the interior of the foundry building. The destruction deposits above suggest that the building was deliberately demolished and burnt prior to a series of ground levelling events. As with Trench 1, Trench 2 will require further excavation to determine the extent of the possible floor and machinery settings in order to determine their exact function.

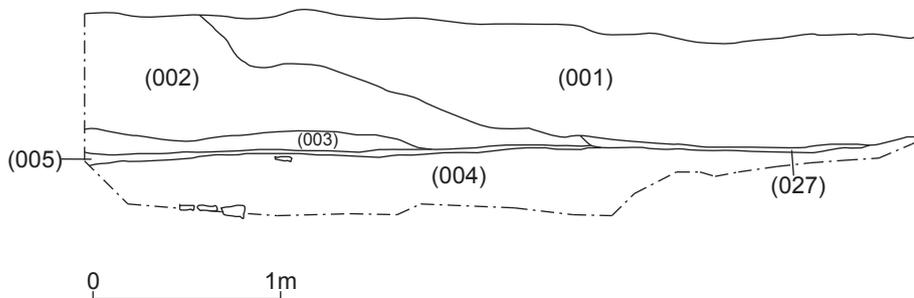
Fig. 5 - North Facing Section of Trench 2

3.3.3 Below **(002)** were three deposits of black sand and ash **(003)**, **(005)** and **(027)**. These deposits were thin, levelling deposits up to 0.06m deep and were found to seal an earlier destruction deposit **(004)**. **(003)**, **(005)** and **(027)** likely represent an episode of levelling and sealing of the ground after the potential destruction of the building (see Fig. 5).
