An Archaeological Excavation at Cabin Hill, Formby, Sefton. Site Code 125

Prepared for Sefton Coast Landscape Partnership

C. Ahmad and M. Adams

December 2015

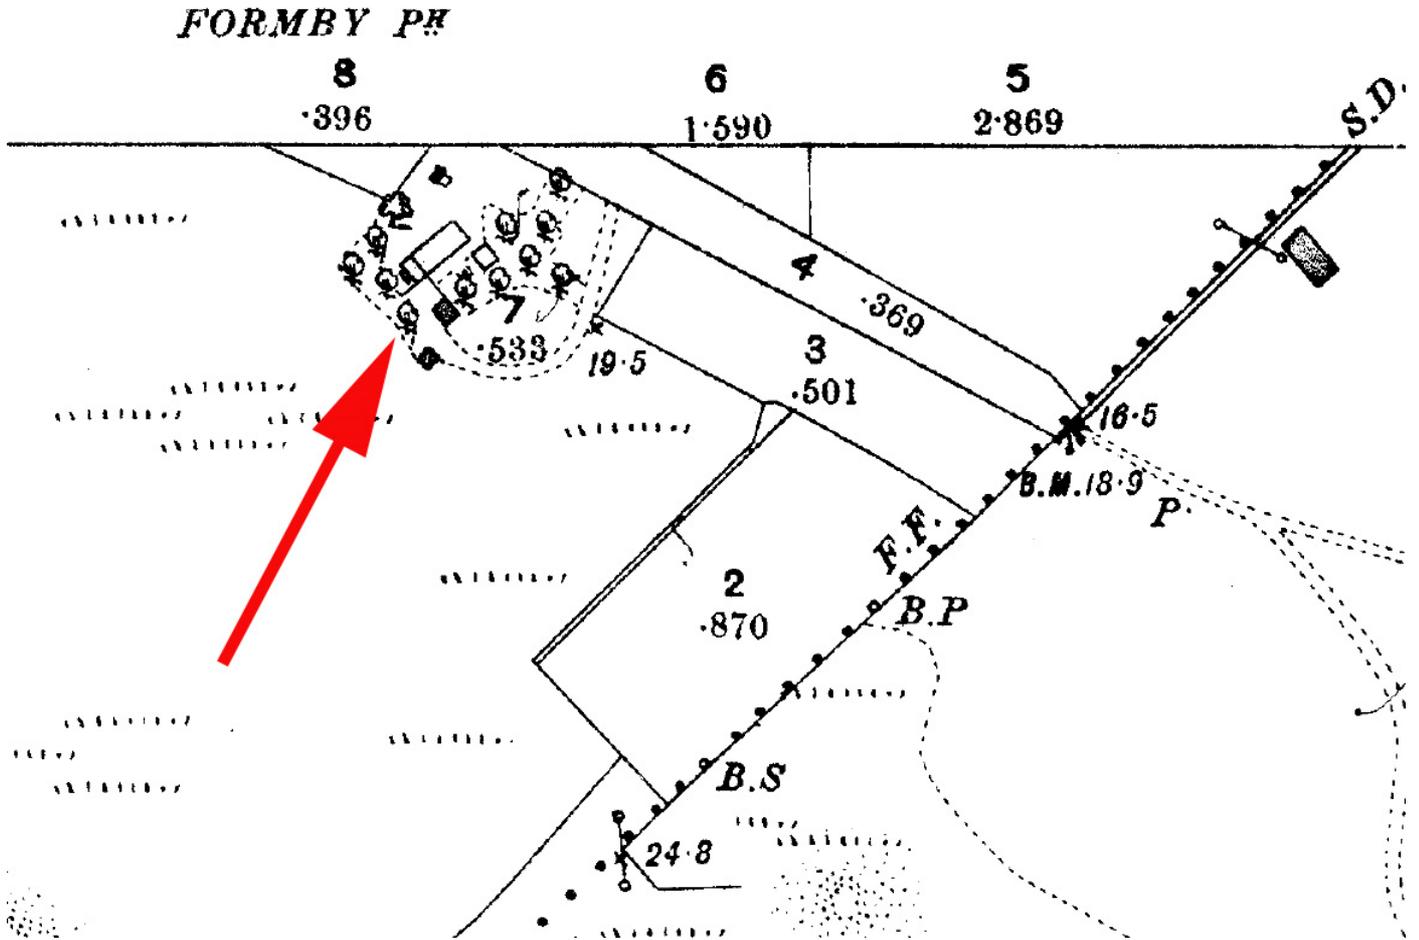
Fig. 3. Part of the 1st Edition 25 inch to the mile OS sheet surveyed 1892, published 1893, showing plan of Cabin Hill farmhouse and associated outbuildings. Not to scale.

The enclosure surrounding the site is shown on the 1st Edition OS 6 inch to the mile sheet, surveyed 1845 – 6, published 1848, although no buildings are shown (Fig. 2) and it does not appear on the Formby Tithe Map of 1850. The later 1st Edition 25 inch to the mile OS sheet, surveyed 1892 and published 1893 clearly shows the farmhouse and associated outbuildings (Fig. 3) and this remained largely unchanged until the site was abandoned.

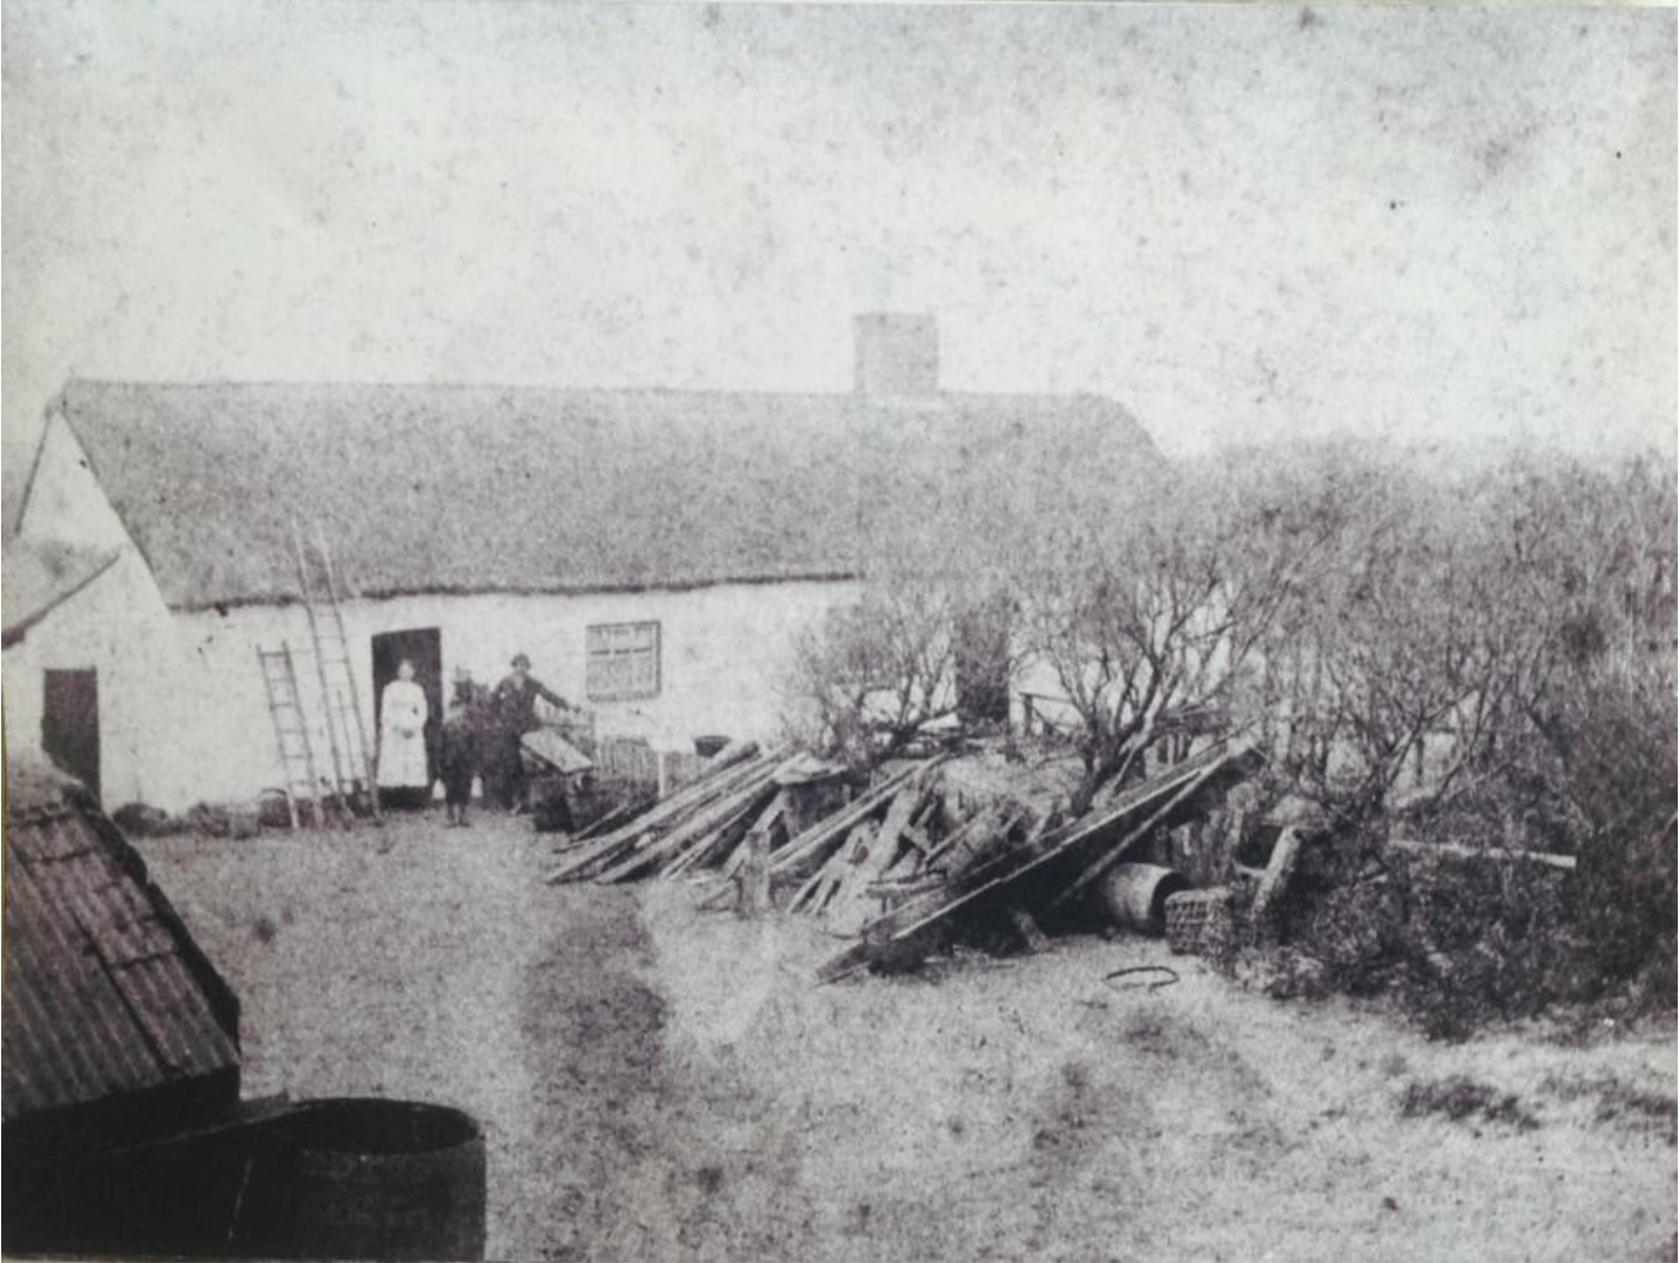
Fig. 4. Cabin Hill farmhouse c. 1900. From the south. (Photograph supplied by Mrs Towse).

The Formby's continued to occupy the site until at least c. 1900 -1910 when the photograph in Fig. 4 was taken. This shows the then occupiers of the house, Joseph Formby, a woman presumed to be his wife, and a child. The house is a rendered single storey 'long-house' form with a chimney stack at the northern end and what appears to be a thatched roof. There are two doors, one at the north end, one to the south and it is possible that the unheated southern end was used as a barn or byre.

A gap in the southern wall corresponds with the entrance visible to the right of the building on Fig. 4.

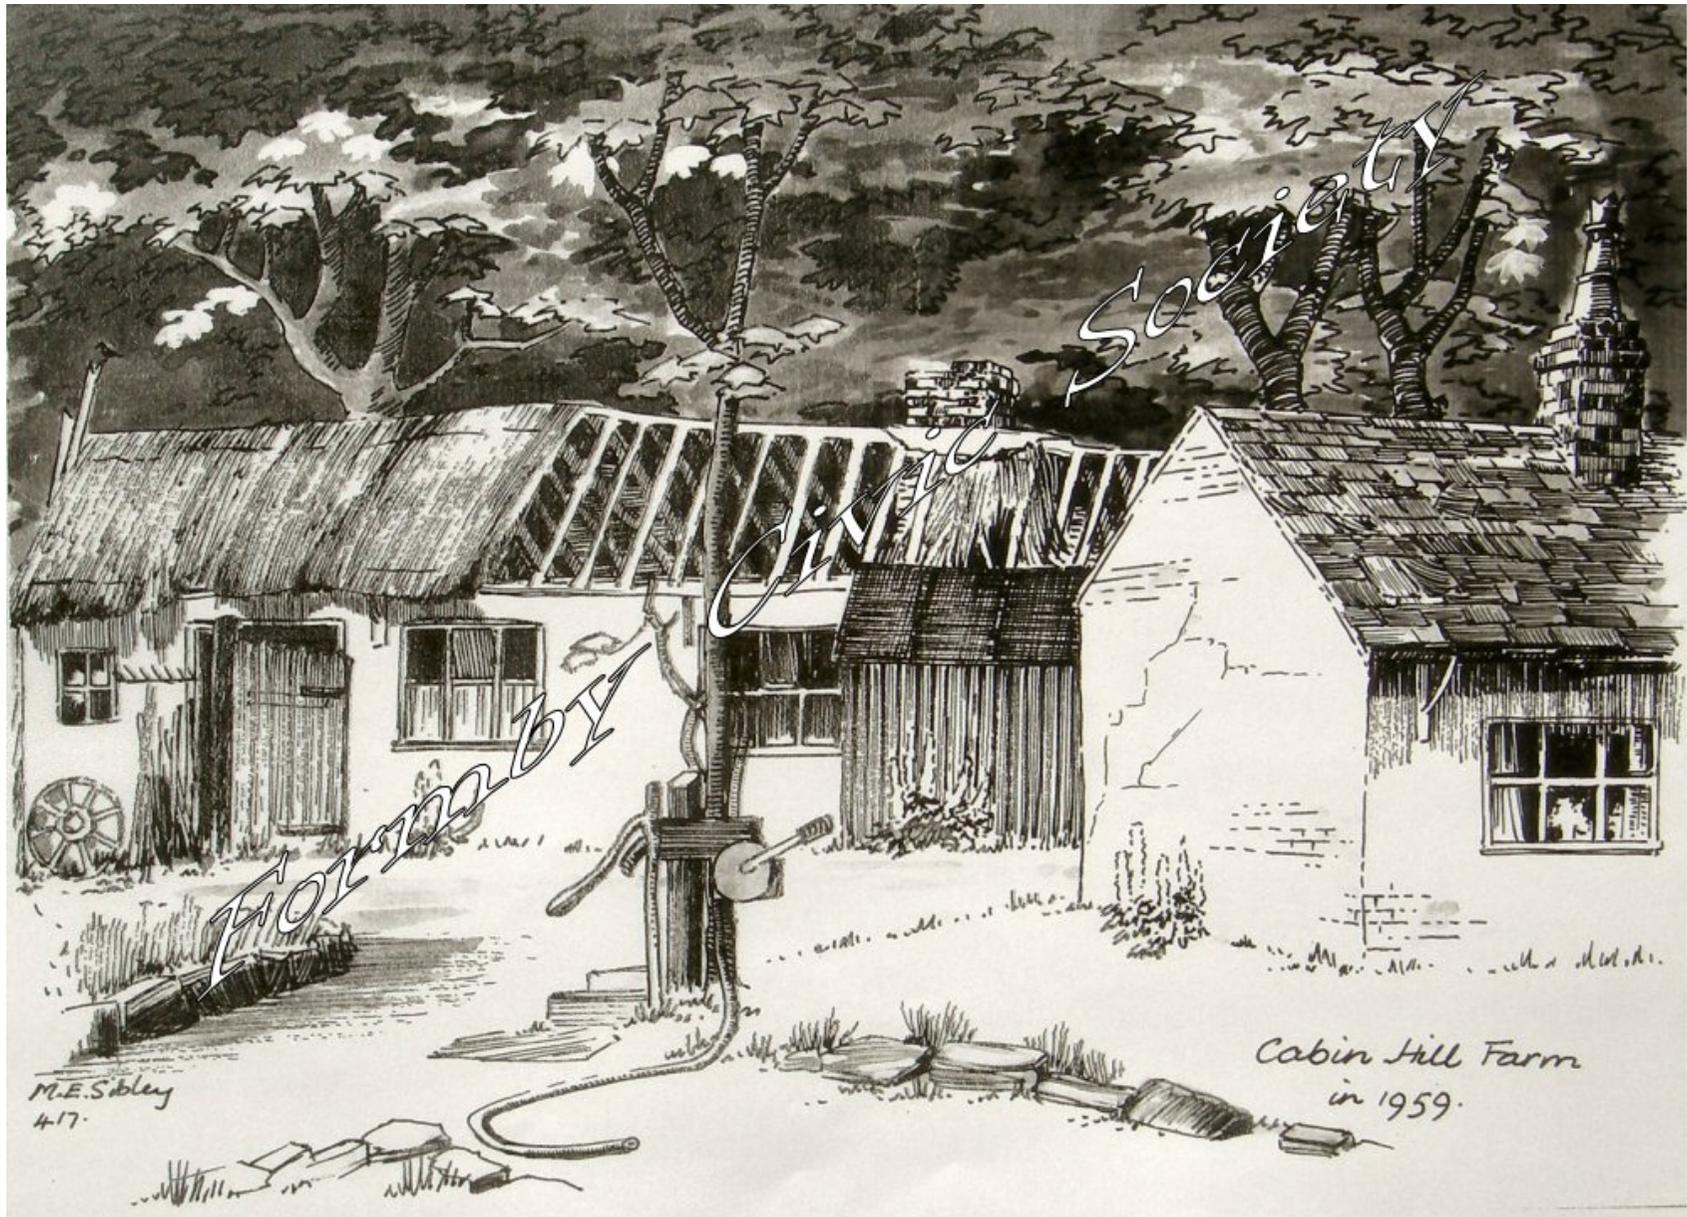
Fig. 5. Sketch of Cabin Hill farmhouse by Muriel Sibley, 1959. From the south-east. (Image supplied by Formby Civic Society)

During World War II the area around the farm became heavily militarised. The farm lay on or close to a 'Starfish' decoy site used to divert bombers from Liverpool's Docks. A sketch by Murial Sibley in 1959 (Fig. 5) suggests the farm had been abandoned around this time as it shows the eastern end cottage roofless. A pump in the foreground is likely to be for water and a roofed structure is shown in the foreground. However, it is difficult to reconcile the perspective of this drawing with that of the photograph in Fig. 4 and it is possible that this is a composite view.

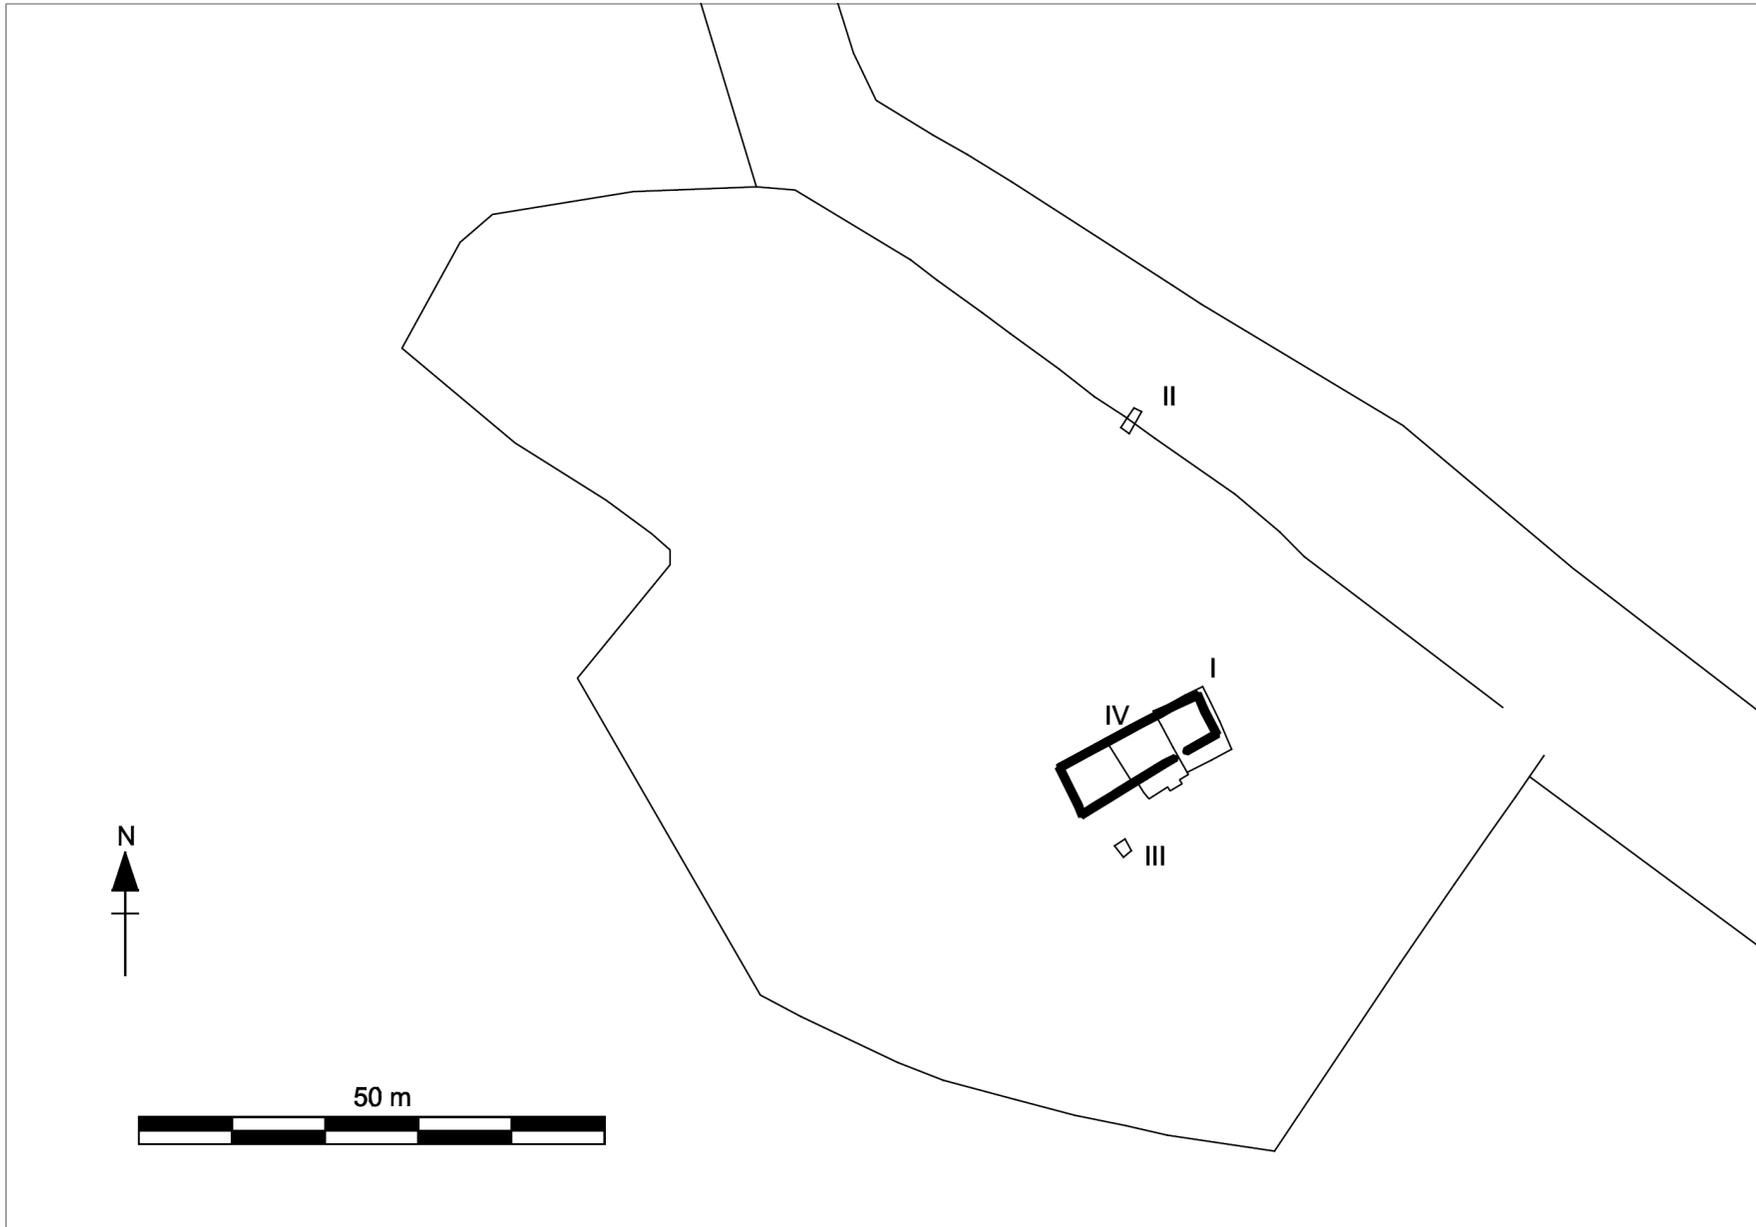
Fig. 6. Trench Locations.

The locations of trenches are given in Fig. 5 though deposits are only referenced to trenches for the purposes of location.

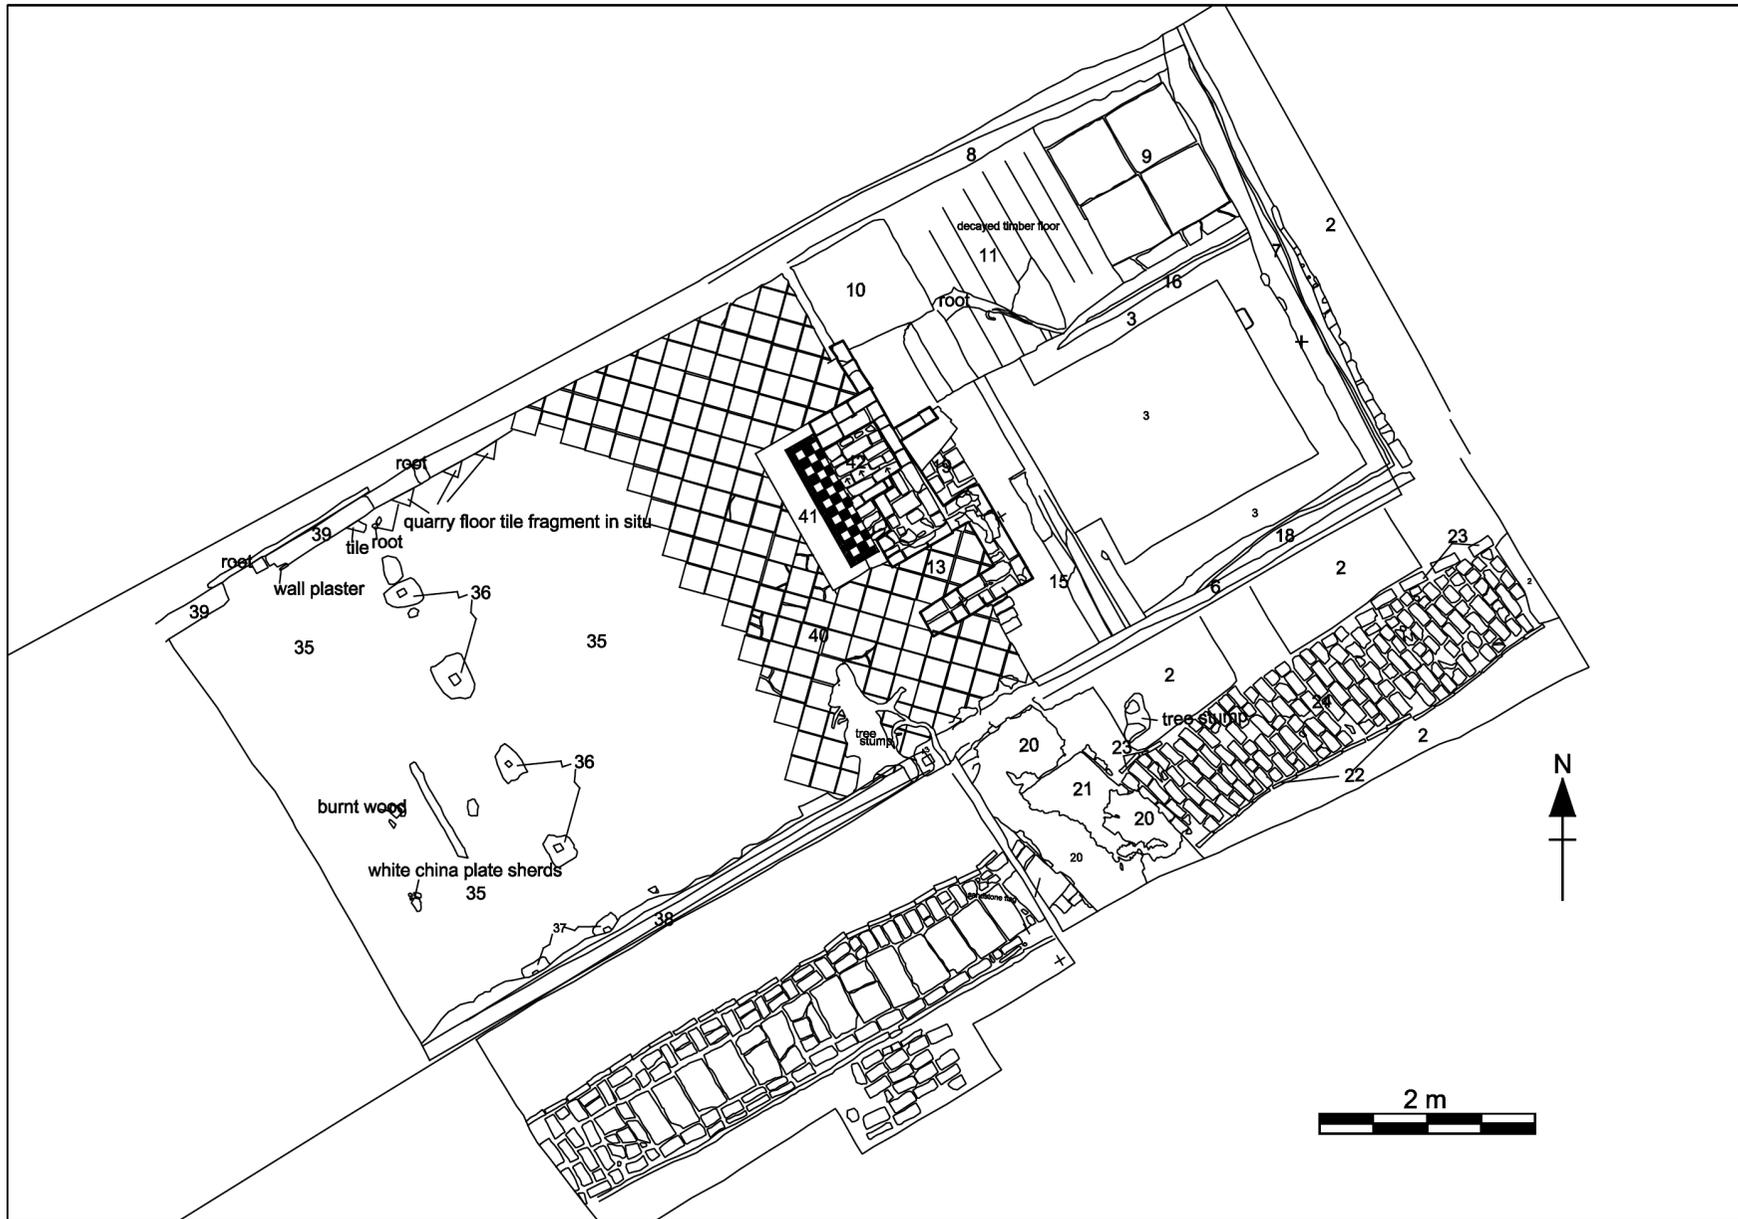
Fig. 7. Features in Trench I/IV.

Trenches I & IV directly abutted each other and are shown on Fig. 7 as a single entity.

of dark grey and red and were bonded with portland cement. The tiles on average measured 0.23 m² by c. 0.10 m depth (Fig. 7 & Plate 10).

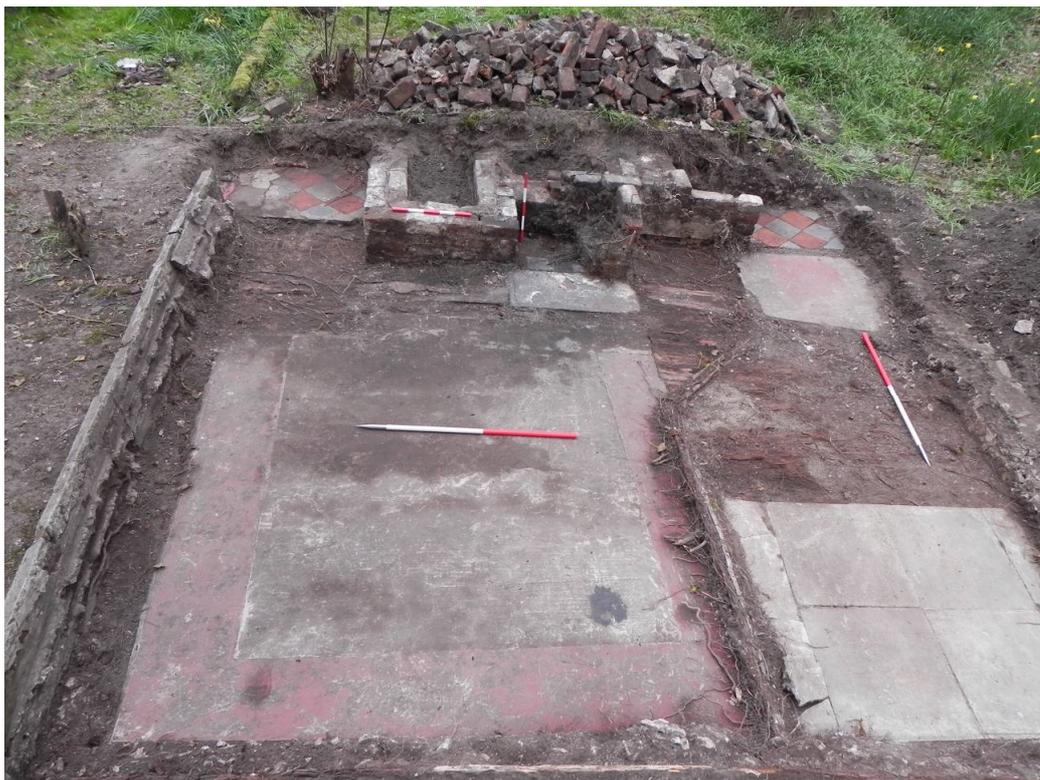
Plate 1. Trench I. Area of excavation after the removal of context 1 showing internal floor surfaces and brick chimney stack foundation to the eastern end of the farmhouse. From the east.

A number of internal floor surfaces and a complex of brick wall features were exposed after the removal of context 1 (Plate 1).

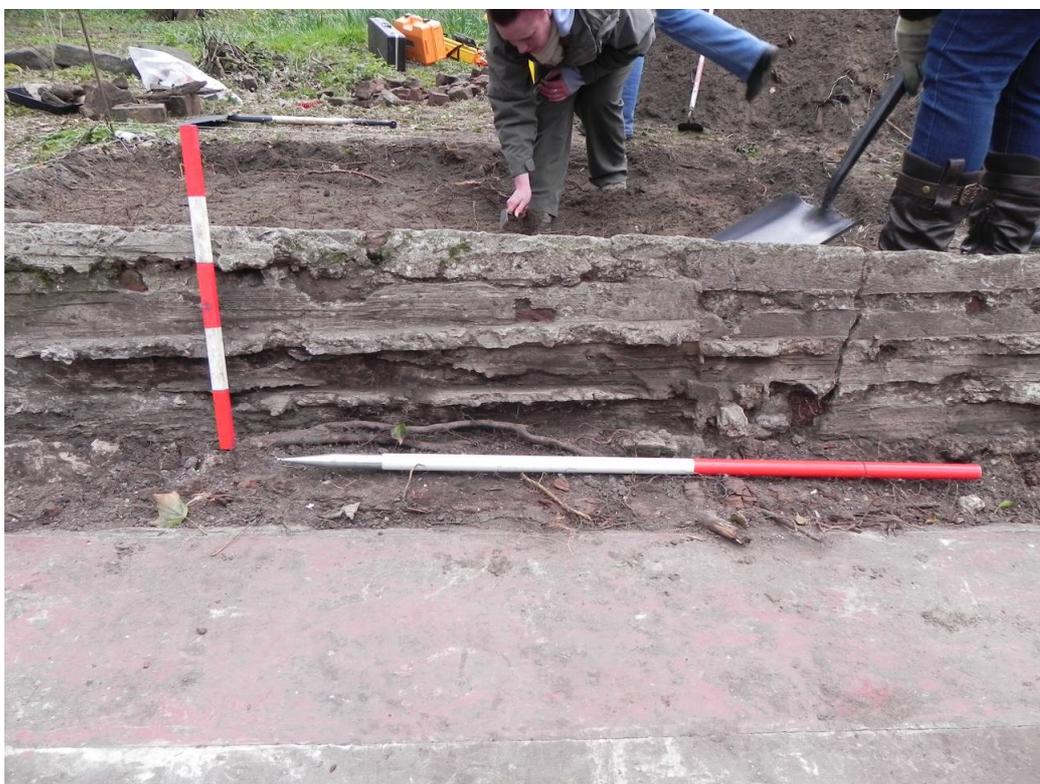
Plate 2. Trench I. Interior of the southern wall to farmhouse (context 6) showing timber impressions in render. From the north.

The walls of the east end of the farmhouse consisted of contexts 6, 7, 8, 38 and 39. Context 6 consisted of the stub of a portland cement wall with occasional half bricks. The cement was in fact a render which retained the impressions of the wall's timber framework which had decayed away. The timbers had been laid horizontally and measured c. 1.25 m (length) by 0.07m (thick) (Plate 2). It was not clear if the timber was just cladding or part of a frame. The *in situ* render of context 6 measured 3.60 m (length) by 0.36 m (height) by 0.06 m (thick). Context 7 butted wall 6 and was of a similar construction and measured 4.50 m (length) by 0.32 m (width) by 0.20 m (height). The northern wall context 8 butted wall 7 and was constructed using the same materials. It measured 5.00 m (east to west) by 0.20 – 0.35 m (width, widening to the east).

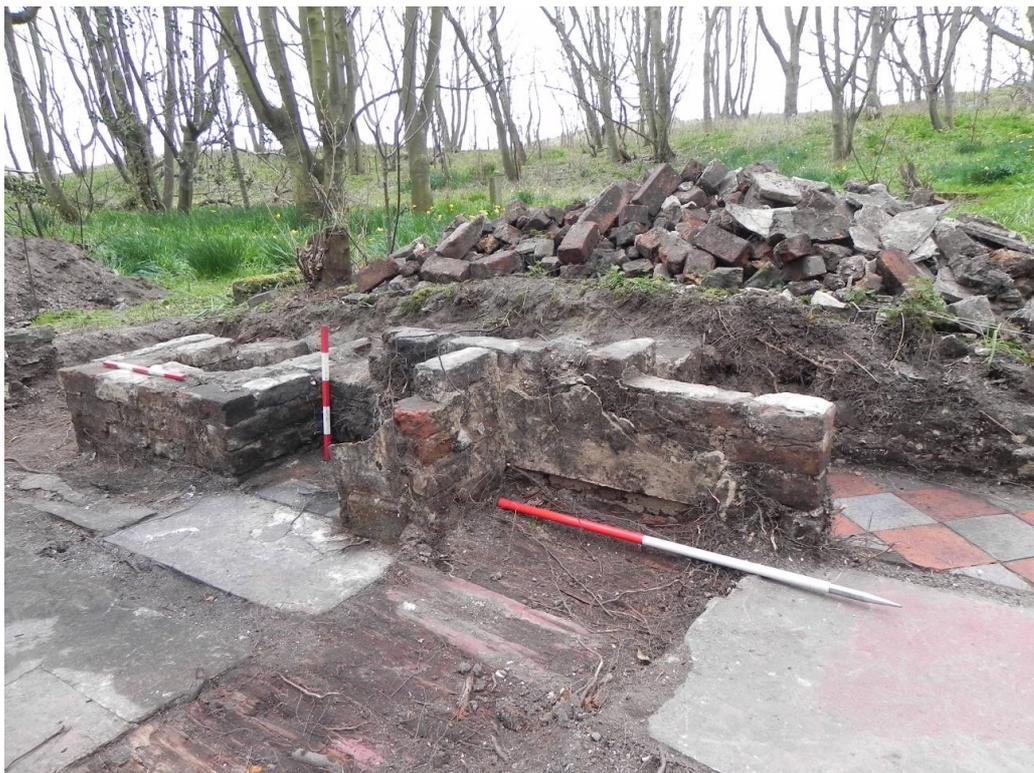
Plate 3. Trench I. Detail shot of chimney stack foundation showing remains of cast iron fire place and hearth. From the north-east.

The best preserved structural feature was the base of a brick chimney stack with the remnants of an *in situ* cast iron fireplace and a tiled hearth (contexts 17, 19 and 12) (Plate 3). The partial base of a cast iron fireplace context 12 was still attached to the base of the stack and measured 0.26 m width by 0.02 m thick. Immediately behind context 12 lay a hearth context 17 consisting of fine grained sandstone and black tiles measuring a total area of 0.87 m (length) by 0.60 m (width).

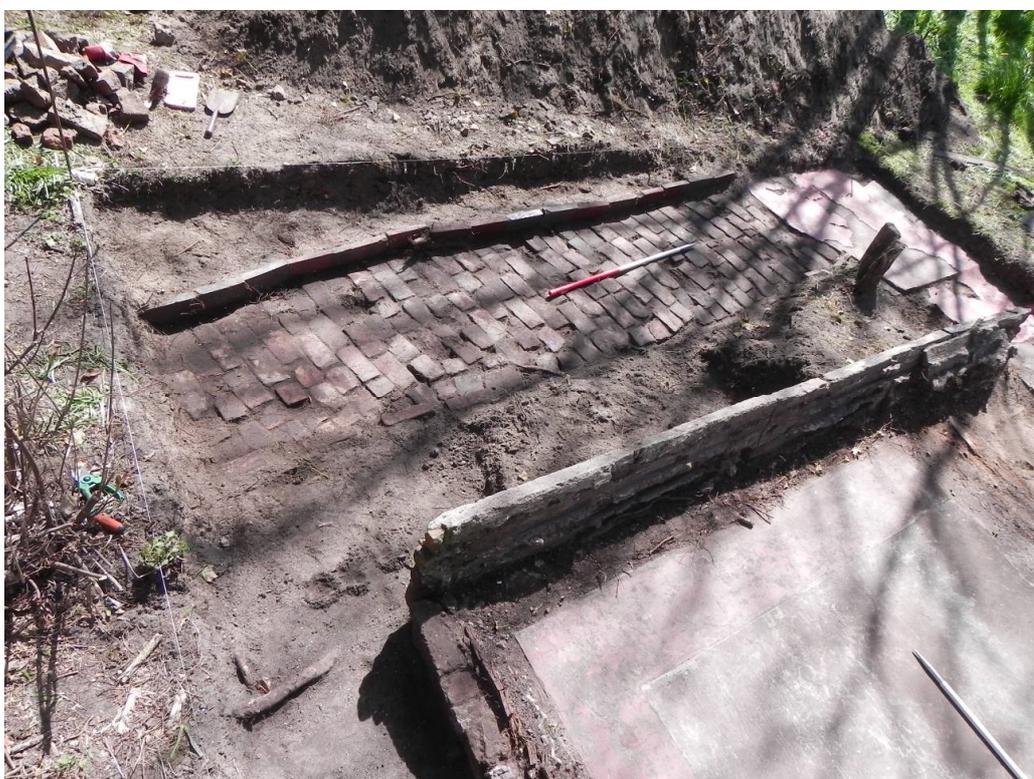
Plate 4. Trench I. Exterior garden path located along the southern side of the farmhouse. From the north.

Immediately east of contexts 20 and 21, and also lying directly below context 2, was a red brick garden path, context 24, running east to west, parallel to the south wall context 6 (Plate 4). The path was not fully exposed and appeared to continue into the eastern trench section. The path measured 4.05 m (length) by 0.87 – 1.01 m (width) and consisted of a single layer of bedded bricks. The handmade bricks measured on average 0.22 m by 0.10 m. The path was edged with a line of quarry tiles and bricks to the north and south contexts 22 and 23. The tiles were laid on edge to form a kerb and ran in an east to west alignment. Context 22 to the south side ran the full exposed length of the path and had remained more intact than context 23 to the north where only two tiles and four bricks in total lay at either end of context 24.

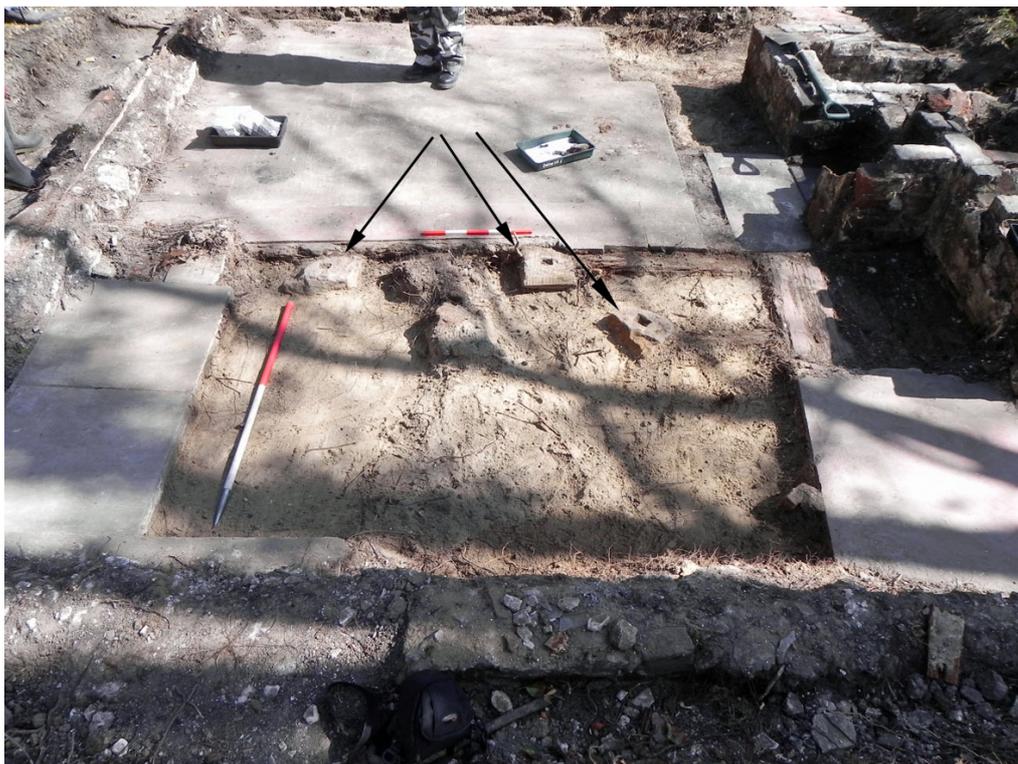
Plate 5. Trench I. Three *in situ* pad stones after the removal of floor surfaces [9] and [15]. From the north.

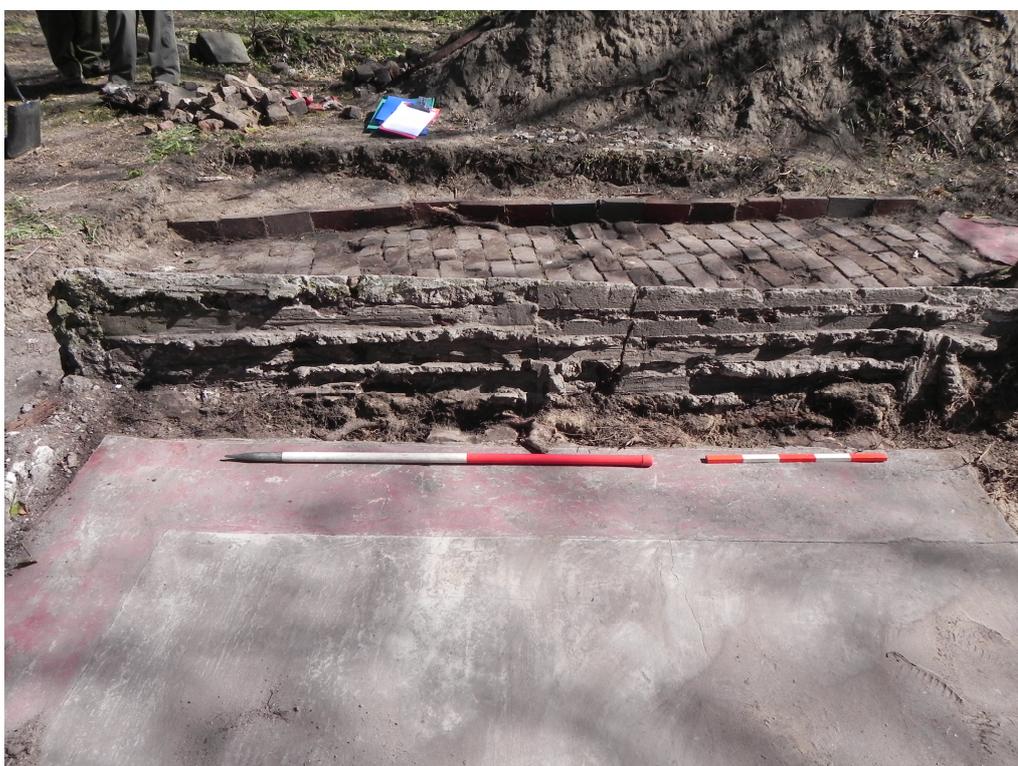
Plate 6. Trench I. Showing position of further three padstones between wall 6 and floor 3. From the north.

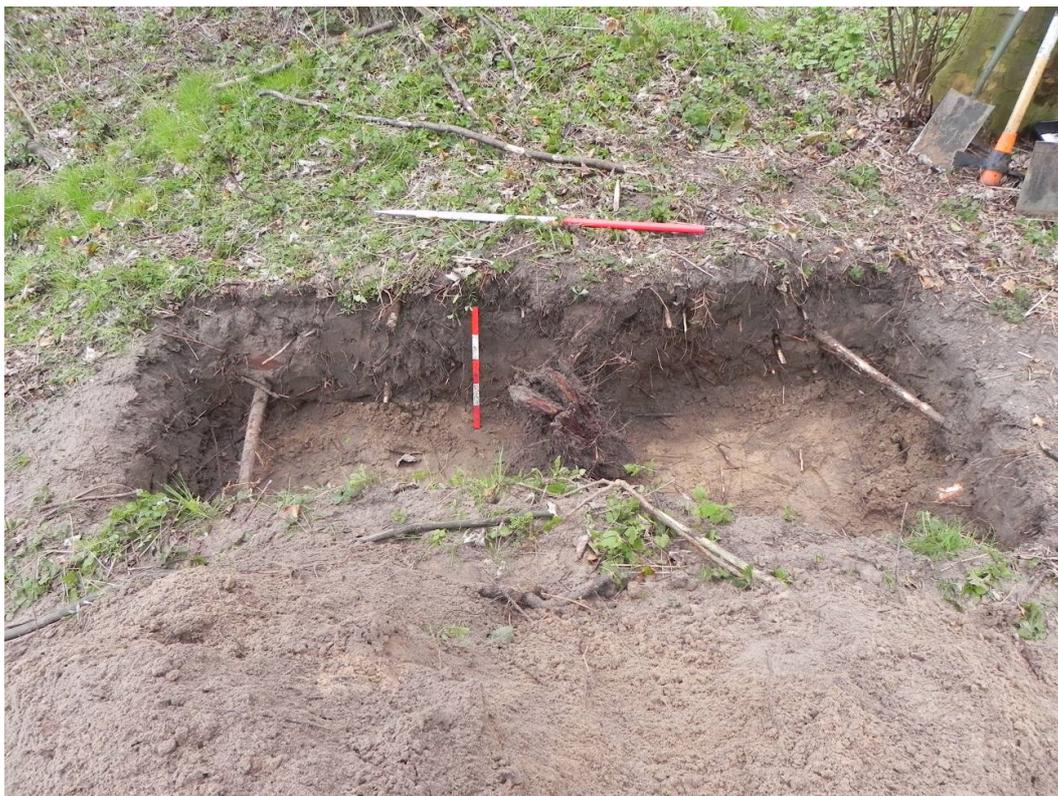
Plate 7. Trench II. Section across eastern bank showing loose grey/yellow sand and rotted fence post *in situ*. From the north.

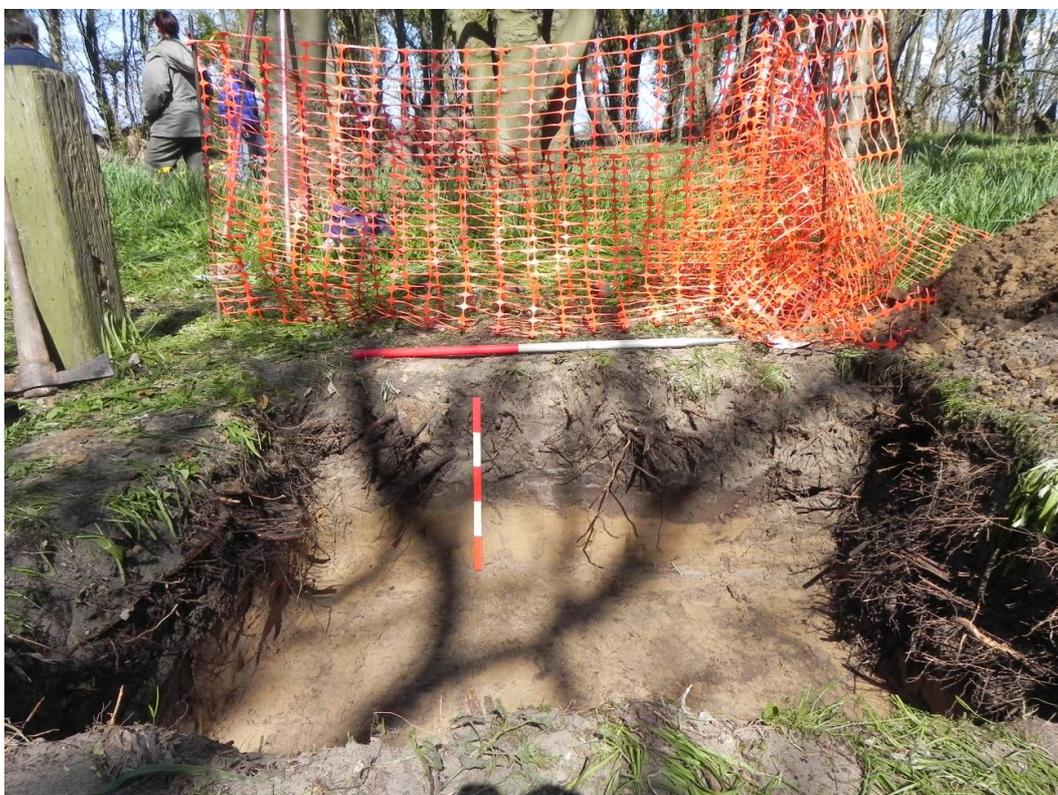
Plate 8. Trench III. Section showing topsoil and natural golden yellow sands. From the south-west.

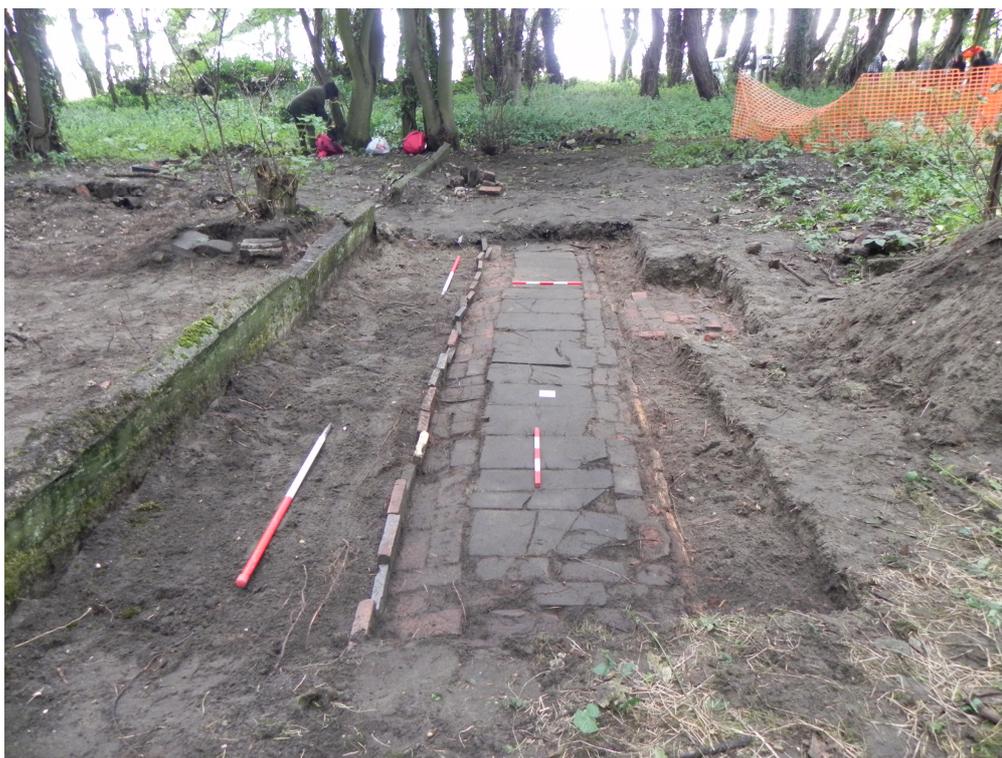
Plate 9. Trench IV. Westward continuation of the path exposed in Trench I. From the west.

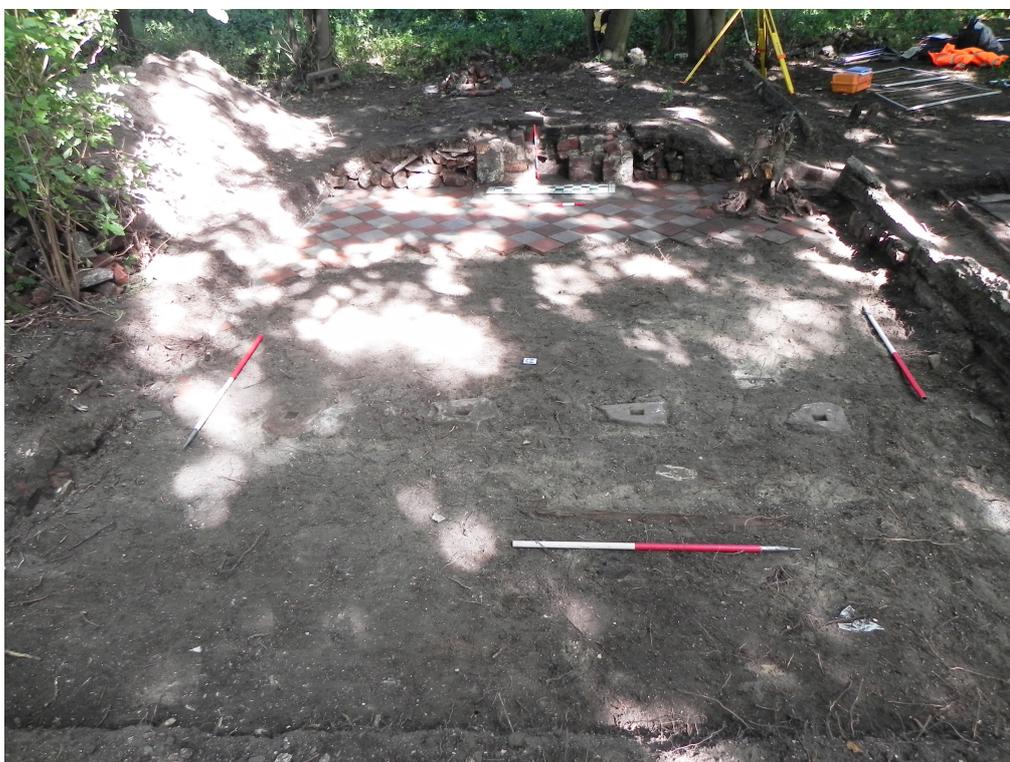
Plate 10. Trench IV. General view across exposed western side of the cottage showing internal features. The padstones for the internal wall run left to right across the view. From the west.

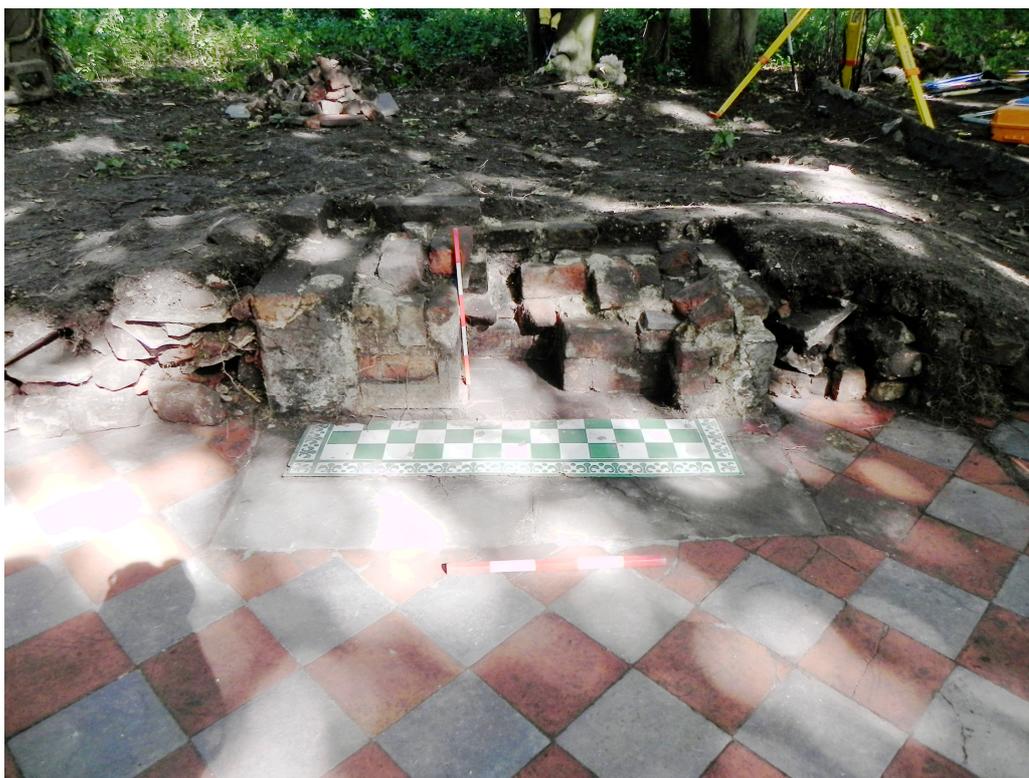
Plate 11. Trench IV. Detail of the partially exposed fireplace and tiled floor surface. From the west.

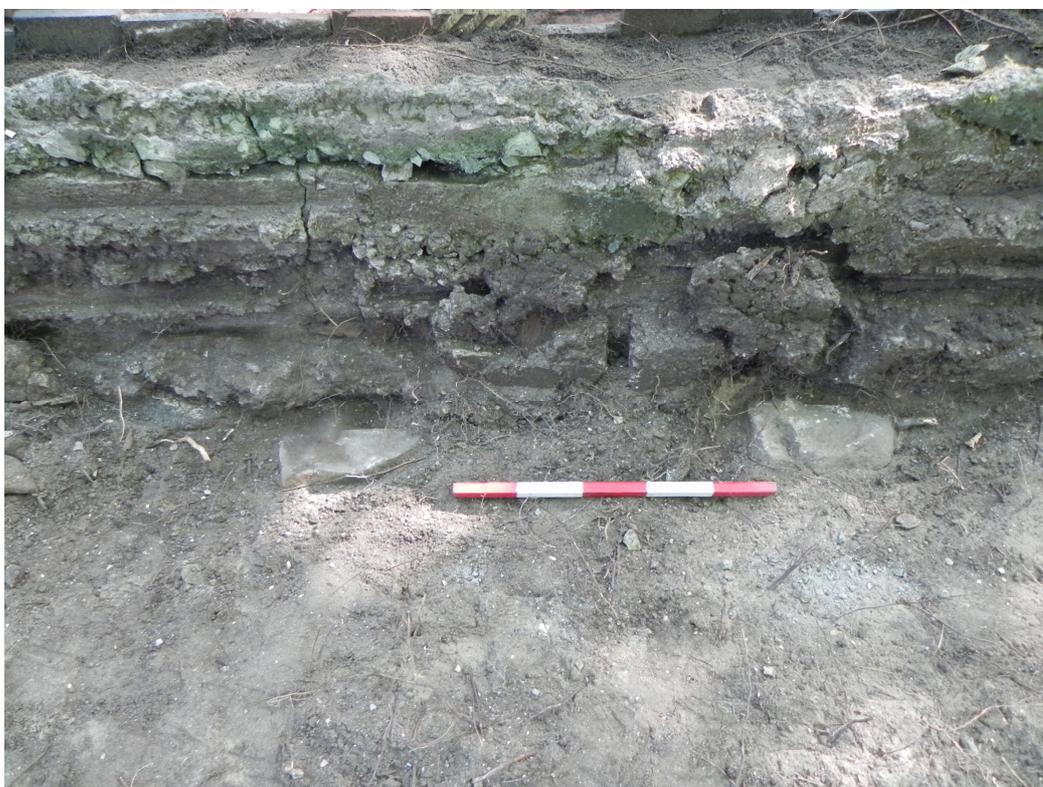
Plate 12. Trench IV. Detail of two padstones (context 37) identified below wall 38. From the north.
