Parish Church - Fgirmont - Cumberland :

ART. XVI.—*The Parish Church, Egremont.** By T. LEWIS BANKS, A.R.I.B.A., Finsbury Circus, London.

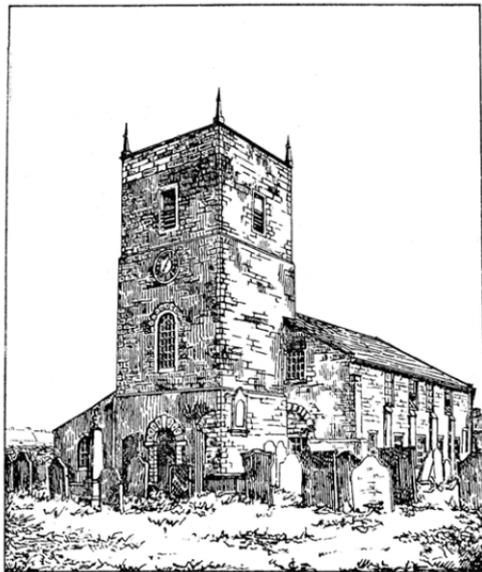
1.

View of Modern Church from SW
showing Norman Chancel - West of N

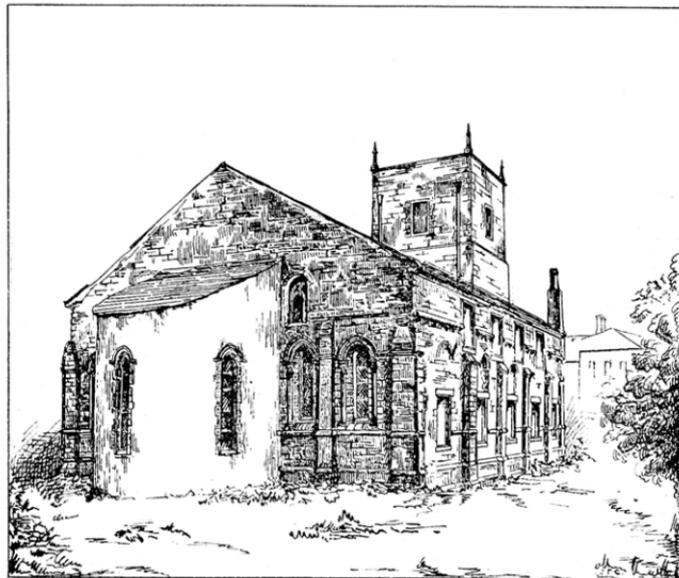
3.

Sketch shewing Modern Church East end
Chancel built in 1752 : Windows in some of later date

The semi-circular arch spanning the chancel is made of stones of irregular sizes and detail.* The chancel having been built in 1752, these arch stones must have been used for other arches previous to that date. The tradition that the church was once a double chantry or chapel, being divided by an arcade down the centre, seems to be so far corroborated. Further evidence of such an arcade is sought for by excavating down the middle of the building. Instead of finding the foundations for columns as anticipated, there are exposed to view the foundations of a wall, about four feet thick, extending from the west end about thirty feet. At this distance all traces of foundations cease. The rough foundation walling ends with one worked stone with square angle, set back about a foot from the north face of foundations. This sudden termination of the wall, and this stone evidently in position, were inexplicable. The inside of the building fails to supply any further clue to a probable arcade, and the meaning of this centre foundation.

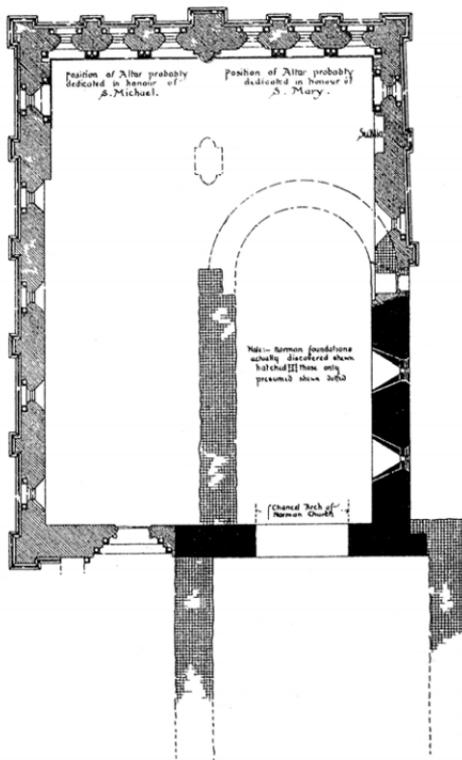
2.

Probable Plan of Early English Church :

Early English work shown hatched
 Walls & Foundations of Norman Church shown in Black

The remains of an arch in the southern portion of the west front, although walled up, are distinctly visible.* This arch, in size and detail, precludes the idea of its having been at any time an entrance to the church. It has every appearance of a Norman chancel arch. If so foundations may still exist of the ancient church. Commencing at the angle buttress the old foundations are soon reached, and the return wall or south wall of this church, which was followed for some distance. Much of the foundation has been removed in the process of interment. The corresponding wall on the north side was cut through when preparing the trenches for the new church. This, then, fully explains the foundation of a wall in the middle of the church.

This double early English chapel had for its basis a Norman chancel. All efforts to find traces of foundations of an apsidal termination proved fruitless, but when pulling down the south wall the last few courses of masonry showed the junction between the Norman and early English exactly, and supplied the missing link, giving us the radius of the apse, showing the apse to join the middle wall at the point where the hewn stone referred to was.†

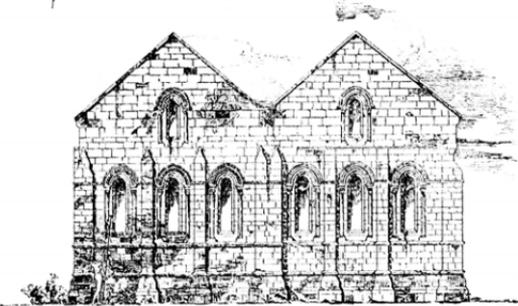
1.

Probable East End of Early English Church :

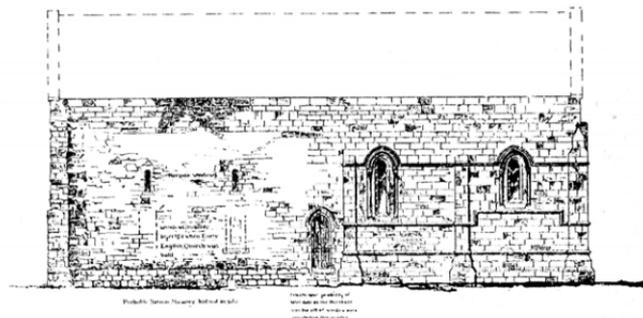
3.

Probable South Elevation of Early English Church :

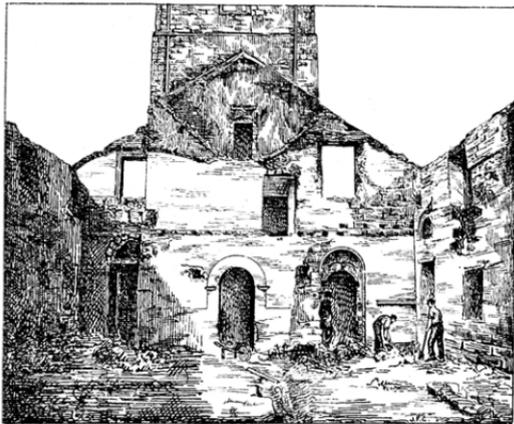
1.

Sketch shewing West end (interior)
with line of the double roof distinctly marked & upper arch of West door

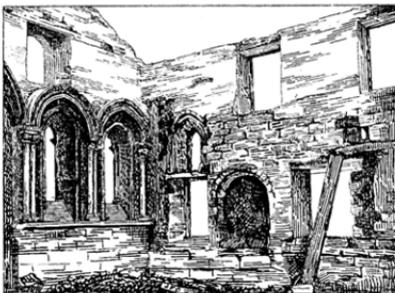
2.

Sketch shewing Norman Scaillies
which had been built-up

With respect to the arcade, it seems more than doubtful whether it extended the length of the church. The contract speaks of a wall remaining, although it is true the faculty refers to a main pillar. But the fact that the circular end of the Norman chancel had its foundations grubbed up, while those of its side walls remained, seems to point to the conclusion that the wall also remained. One or more arches would then be thrown from the end of it to unite it with the east wall.* However, whether all or only part of this wall remained cannot easily be determined now. The base, and one stone of the respond pier, were found in the foundations of the modern chancel.† A number of smaller stones, of the same shape, were found, but where they were used it is impossible to say. Stones of exactly the same form are found in the respond column in St. Bees Abbey Church. It is also interesting to note that the windows, buttresses, plinths, and string courses, are almost identical with the best portions of St. Bees Abbey.

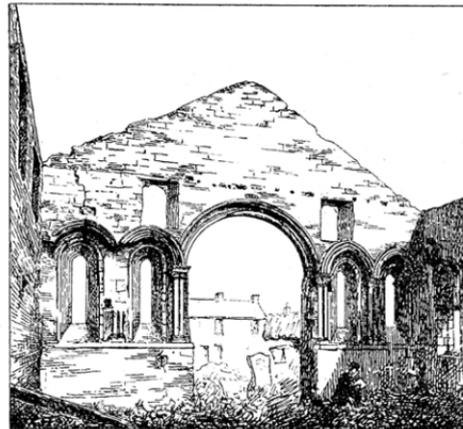
3.

Sketch showing Early English East End Windows
& Chancel Arch built in 1292 out of the old Norse Arcade Scaillies

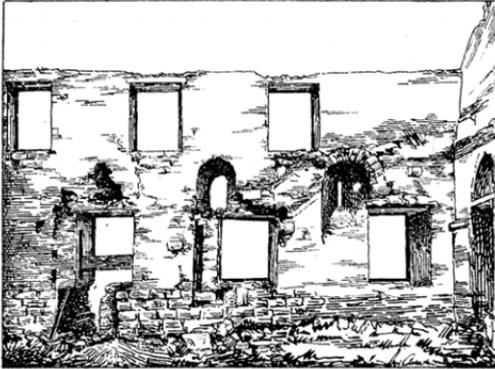
1.

Sketch showing Norman windows
(interior view)

In the south wall, amongst the rubble, was observed a stone with a semi-circular piece cut out of the bottom of it. This proved to be the head of a small window. It had been filled up at the date of the early English portion, and the mortar was so hard, that it almost defied tools to remove it. A second window, not quite so perfect, was also found. The shape of the windows, and the way in which they were constructed, point to very early Norman period.‡ There is a window cill low down, under the second Norman window. It is the same as the early English cills, and taken in connection with the reveals which could not be

understood on the inside, seems to indicate that the early English architect did not consider the Norman windows gave sufficient light, so added other windows under them. The splayed reveal was perfectly plain inside, and there is nothing to show that it had anything more than a lintel for window head. A similar window seems to have been formed a few feet further east. But this window, at some subsequent period, was altered into a door. The cill was lowered to within eight inches of the floor level, and used as a threshold, as its worn appearance testifies. Probably this was the priest's entrance.*

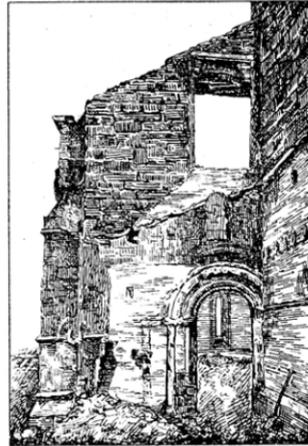
2.

West door with backing to Niche over for Eastern Choir

north side, but stopping at the spring of the arch on the south.* It was generally supposed that this was at one time an entrance to the church, but no one suspected there was here walled up, and plastered over, an exceedingly beautiful Early English—almost transitional Norman—doorway.† Over the lintel of the vestry door was observed a semi-circular crack in the plaster, which at first was thought to indicate a relieving arch only, but when the filling in was cleared from under it, it proved to be the sub-ring of a richly moulded arch. Thus encouraged, the work of bringing to light all that remained of the doorway was speedy and interesting. On one side a shaft with cap and base still remained, and sufficient marks to indicate where the others had been. Over the doorway were remains of a heavy projecting hood. Some of these stones were found in the tower, and one of them had enrichments on it of an earlier date. Above the centre of the door were stones which had formed the back of a niche, probably for the Patron Saint.

The character of this entrance seems unsuited to a porch, but a roof of some kind, and at some time or other, had evidently abutted on the building here, as evidenced by the raking joint of the ashlar and the string passing through the angle buttress, dipping to the level of the eaves of this roof. Later on, when pulling down this doorway, was found in position a long stone trough for oaken bar to bolt the door.‡ This clearly showed it to have been the *outer* door. In the north-west angle, on the level of the floor of the church, one stone attracted attention by its differing from the rest of the paving. Upon excavating, it proved to be the one solitary stone remaining of a stone seat that had extended about two-thirds of the length of the north wall, so far as the break. That it extended so far was clearly shown by pieces of slate wedges under the course

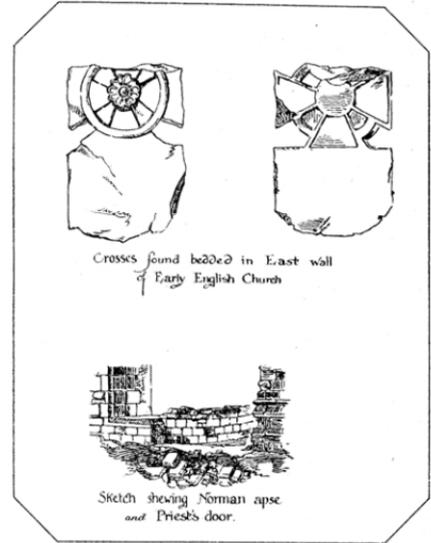
3.

Crosses found bedded in East wall
of Early English Church

Some crosses and sides of graves of early and late Norman work were found in the walls of the church. None that can certainly be pronounced Saxon. The tower had a number of stones which evidently never belonged to the church, and which most likely came from the castle, for the castle seems to have been the common quarry about the time the steeple was built. These were castellated battlement stones, tracery windows of fifteenth and sixteenth century, a gurgoyle, etc.
