Cambridge Archaeology Field Group

Excavation of cold and forcing frames in the  
walled garden yard

Wimpole Hall

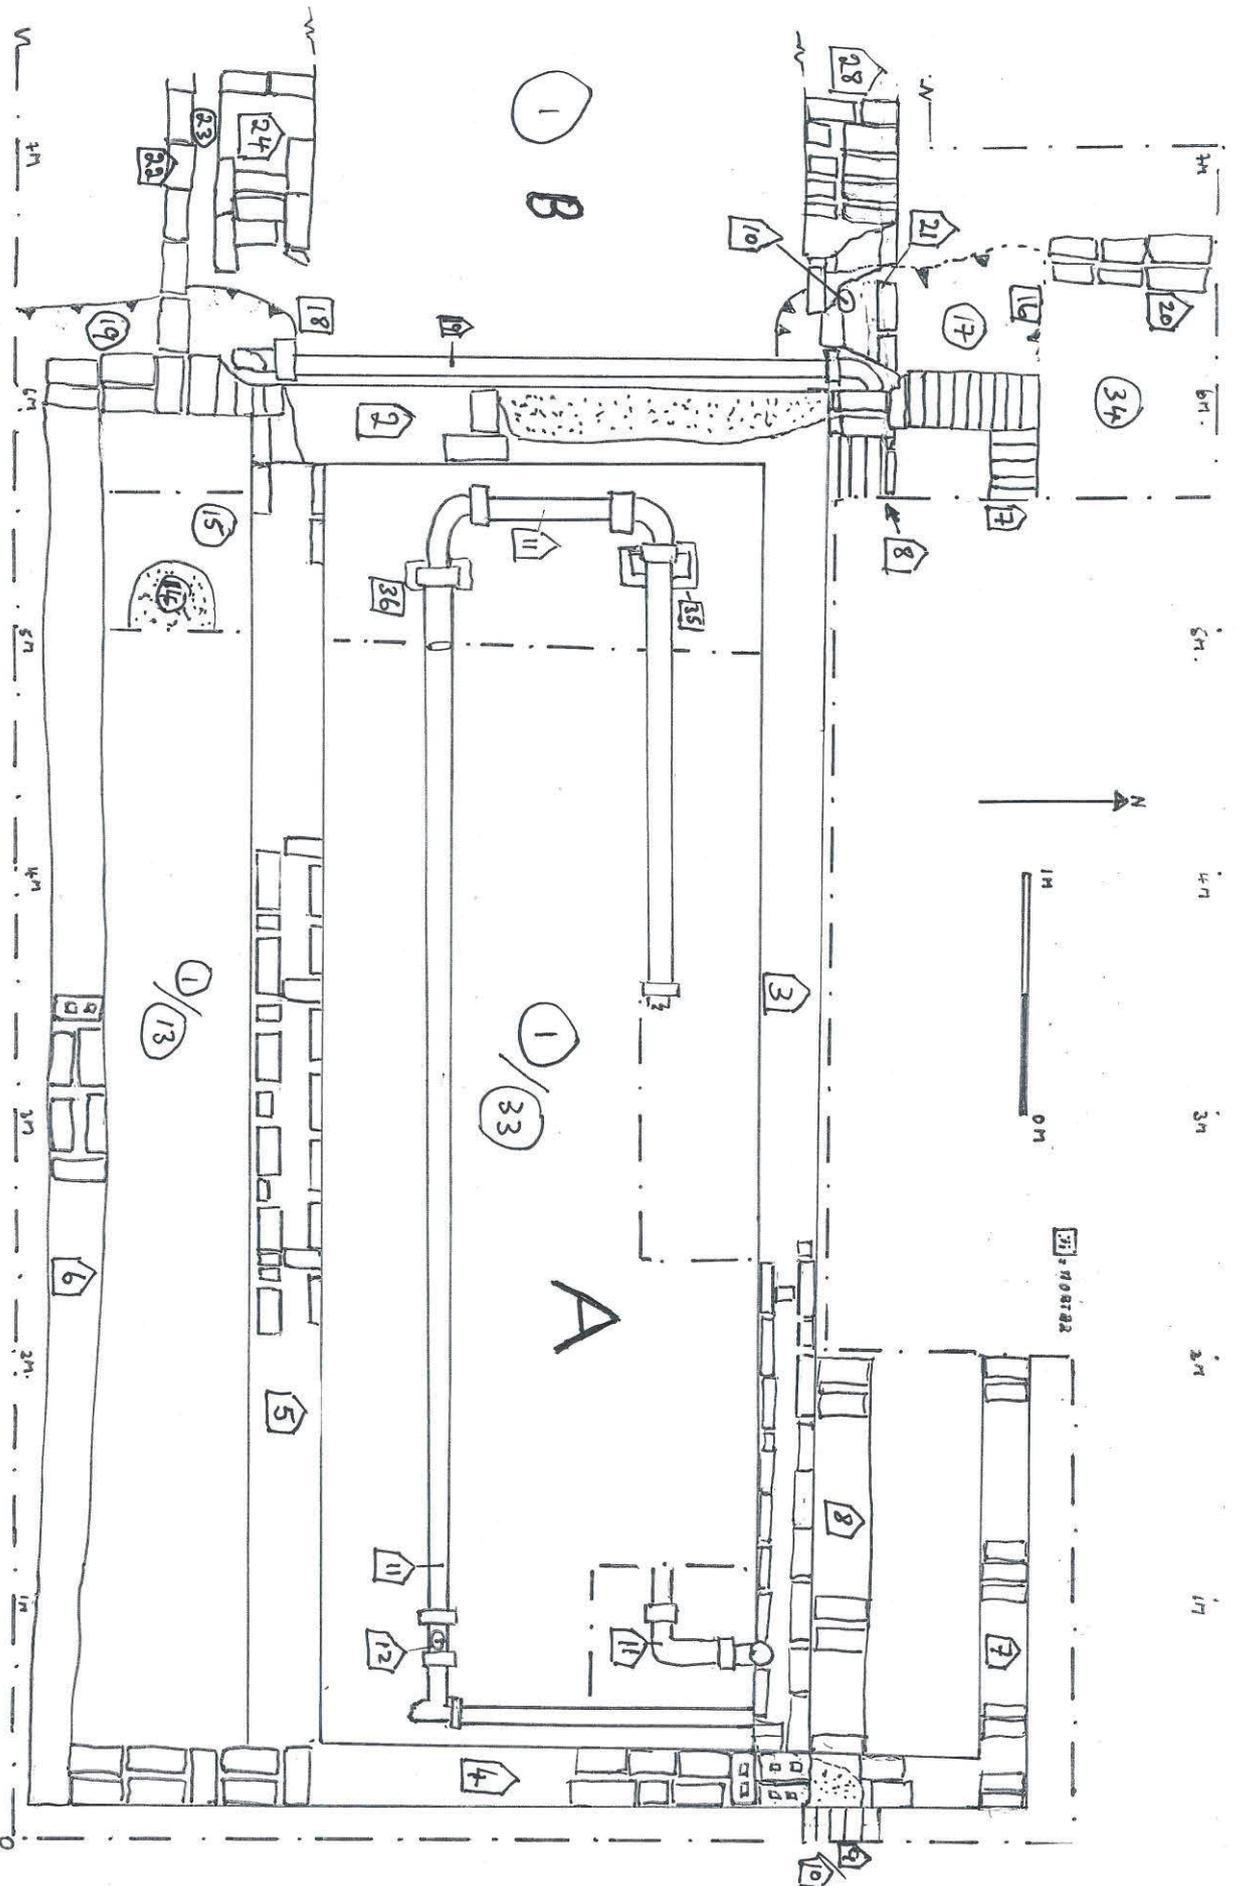
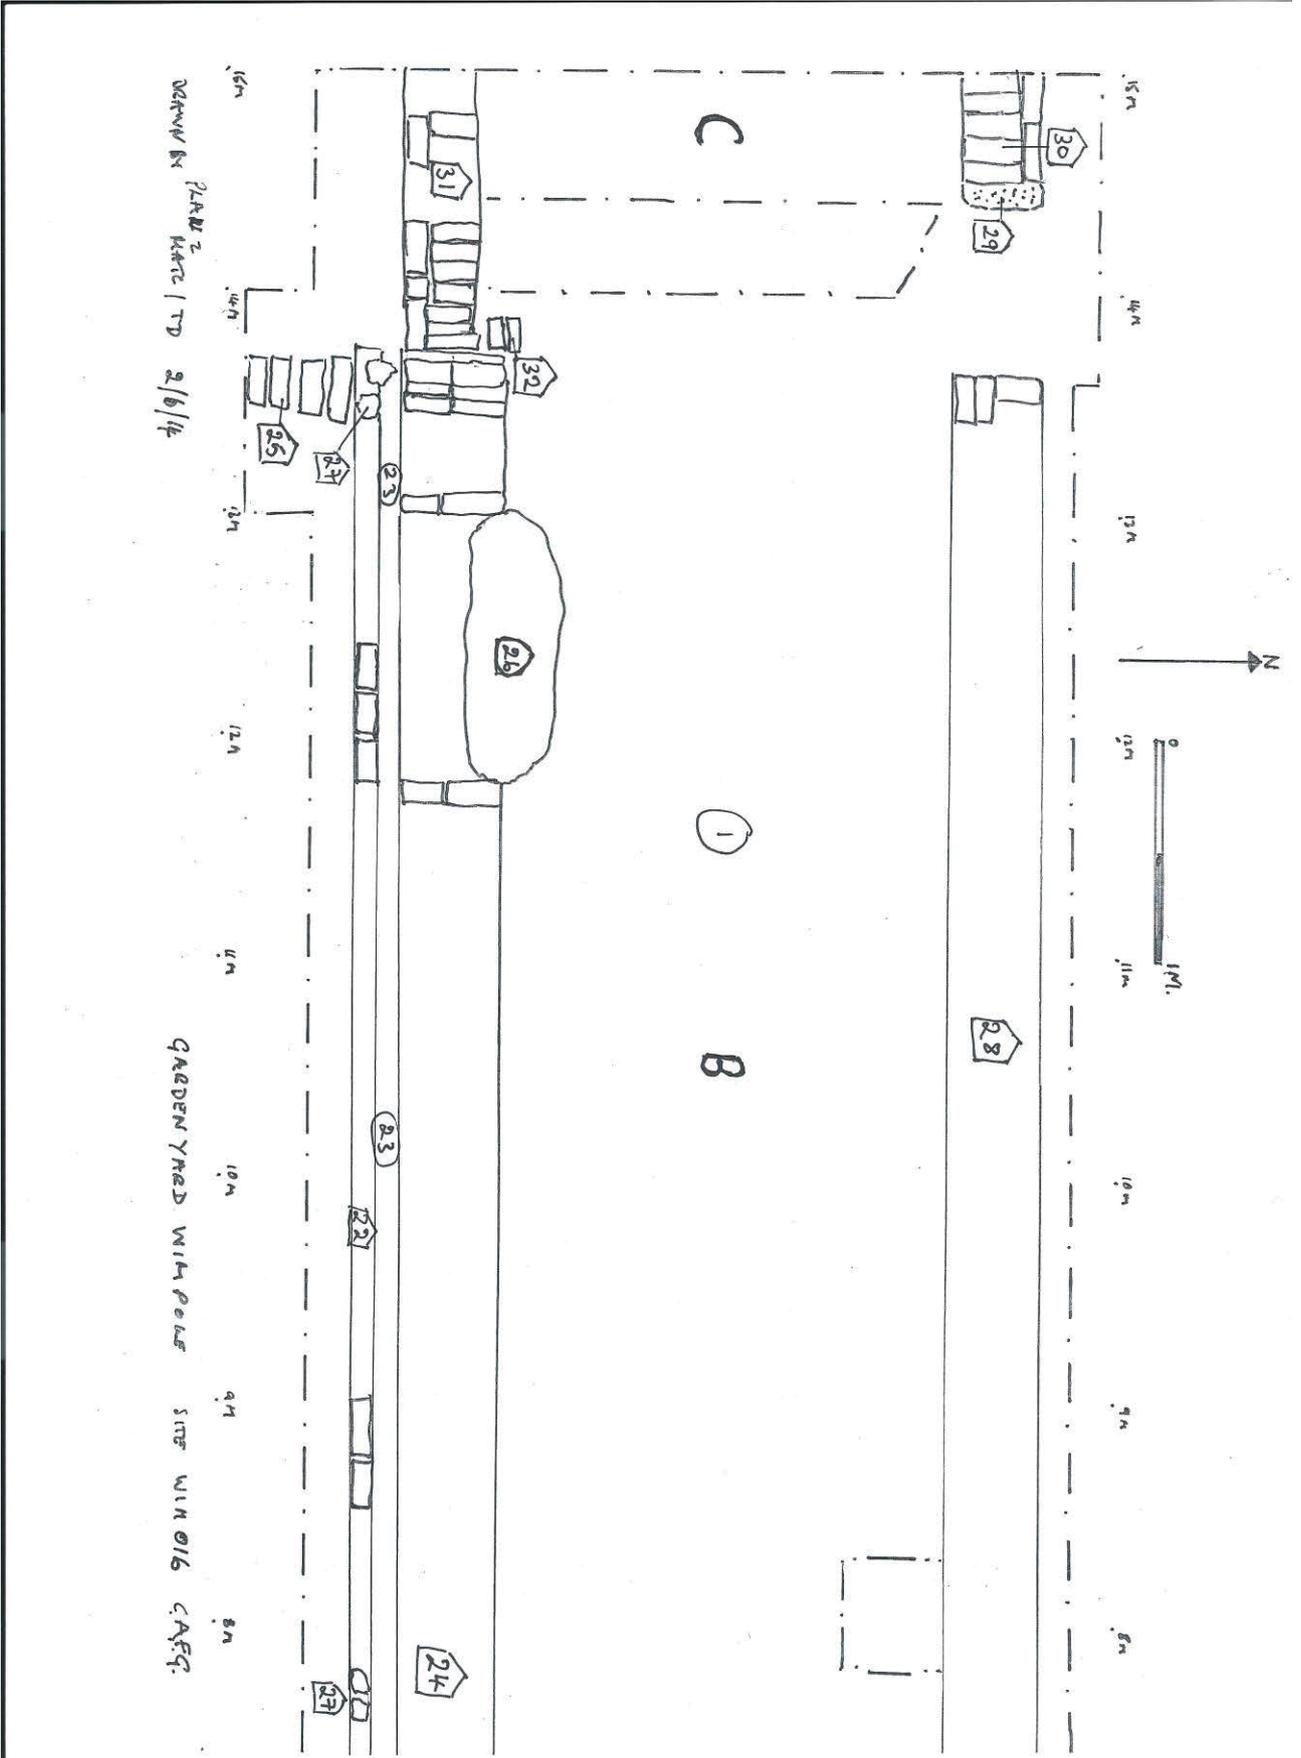
PLAN. I.  
DRAWN BY MATC/TD 2/6/14

GARDEN YARD WINDPOLE  
SUN WINDOUB CAFE

The foundations of three brick built structures, A, B and C, were uncovered, B and C are represented by their north and south brick walls, now one or two courses but A has more substantial foundations. The nature of the junction of the south walls [24] and [31] suggests the C was built after B and there is slight evidence [32] that there was north south wall built at the same time as C.

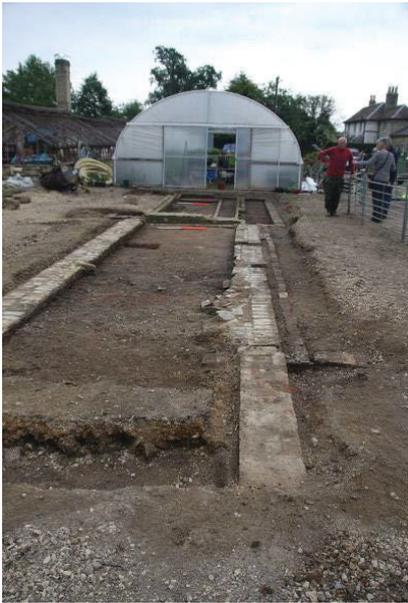
Site from west

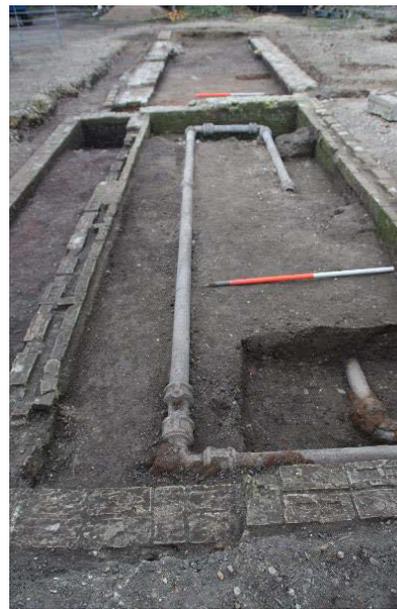
Site from east

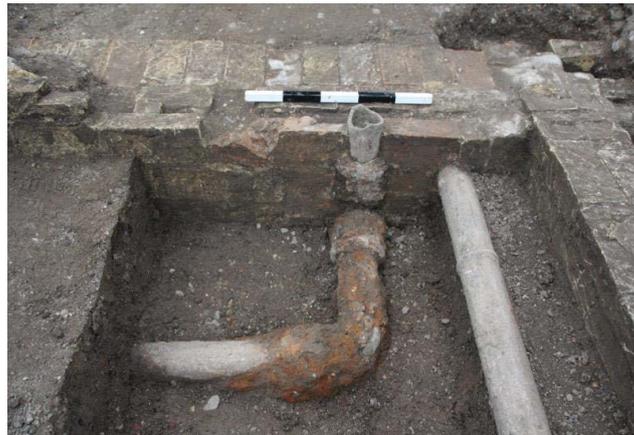
Structure A north east corner from south – pipe [11]

Within the inner chamber of structure A a cast iron pipe [11] which enters in the north east corner at a high level goes around inside the chamber and although broken appears to leave at a lower level. The brick work where this pipe enters and leaves is a reddish colour and is later than the original building. Pipe [11] has a valve [12] near the south east corner and has an open end, much corroded, pointing south. The pipe is supported on brick piers [35] and [36]. This pipe was in part buried in the dark black soil [33] filling the chamber of structure A.

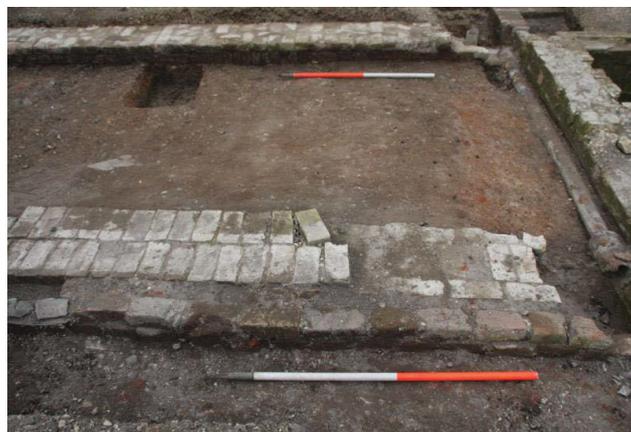
East end of structure B from south – south and north wall

The north [30] and south [31] wall foundations were uncovered to a depth of about 20cm. Both walls were well built of yellow brick of one course, resting on a shallow mortar foundation [29]. Between the north wall and structure B to the east [28] there was a break in the brickwork, probably damaged and removed fairly recently. The southern wall [31] abutted that [24] of structure B and although they were of different quality and build the end of [31] seemed to share a brick with [24]. This suggested that they stood at the same

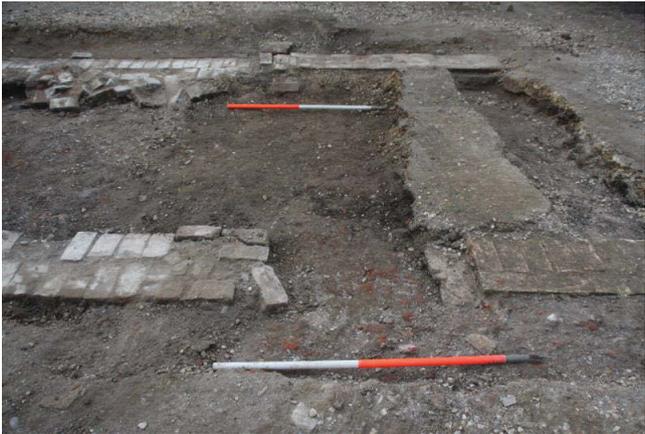
Junction of structure B – on left- and structure C from north

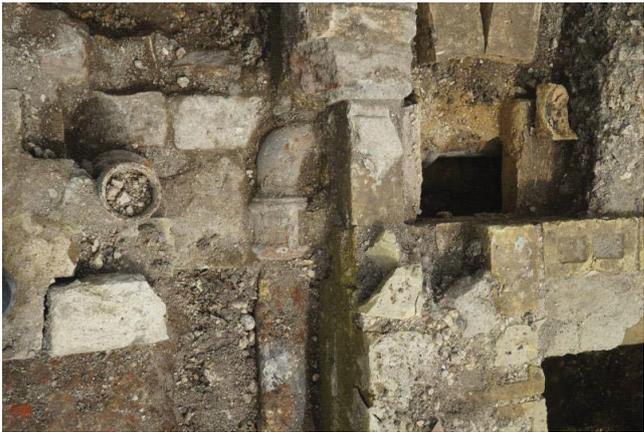
North east corner of Structure A from south showing vertical pipe [10] and pipe [9] entering duct on north side of wall [3]

The cast iron water pipe running west of the wall [2] of structure A was broken at its south end but appeared to turn up vertically. This pipe [9] at its northern end turned sharply east just to the north of wall [2/3] of structure A and then ran east parallel to that wall in a purpose built brick duct [8].

At some time after the building of structure A, a cast iron heating pipe system was installed. This was fed by two pipes, one above the other, entering from the east in a brick built duct along and outside the north wall of the inner chamber, cutting through the walls of the outer north chamber. There are likely to be T junctions off these pipes to feed the pipes which go around inside the inner chamber [11], but the intact brick work was not destroyed to prove this. The vertical pipe [11] in wall [3] may have been a return connected to the corroded open end of the pipe [11] next to wall [4]. Likewise the vertical pipe in wall [28]/[8] may have connected to the open end of pipe [9] at the south end of wall [2].
