PETERBOROUGH CATHEDRAL: THE NAVE CEILING

PHASE 3: ROWS 18 - 27

CONDITION SURVEY AND CONSERVATION TREATMENT

VOLUME II PLATES

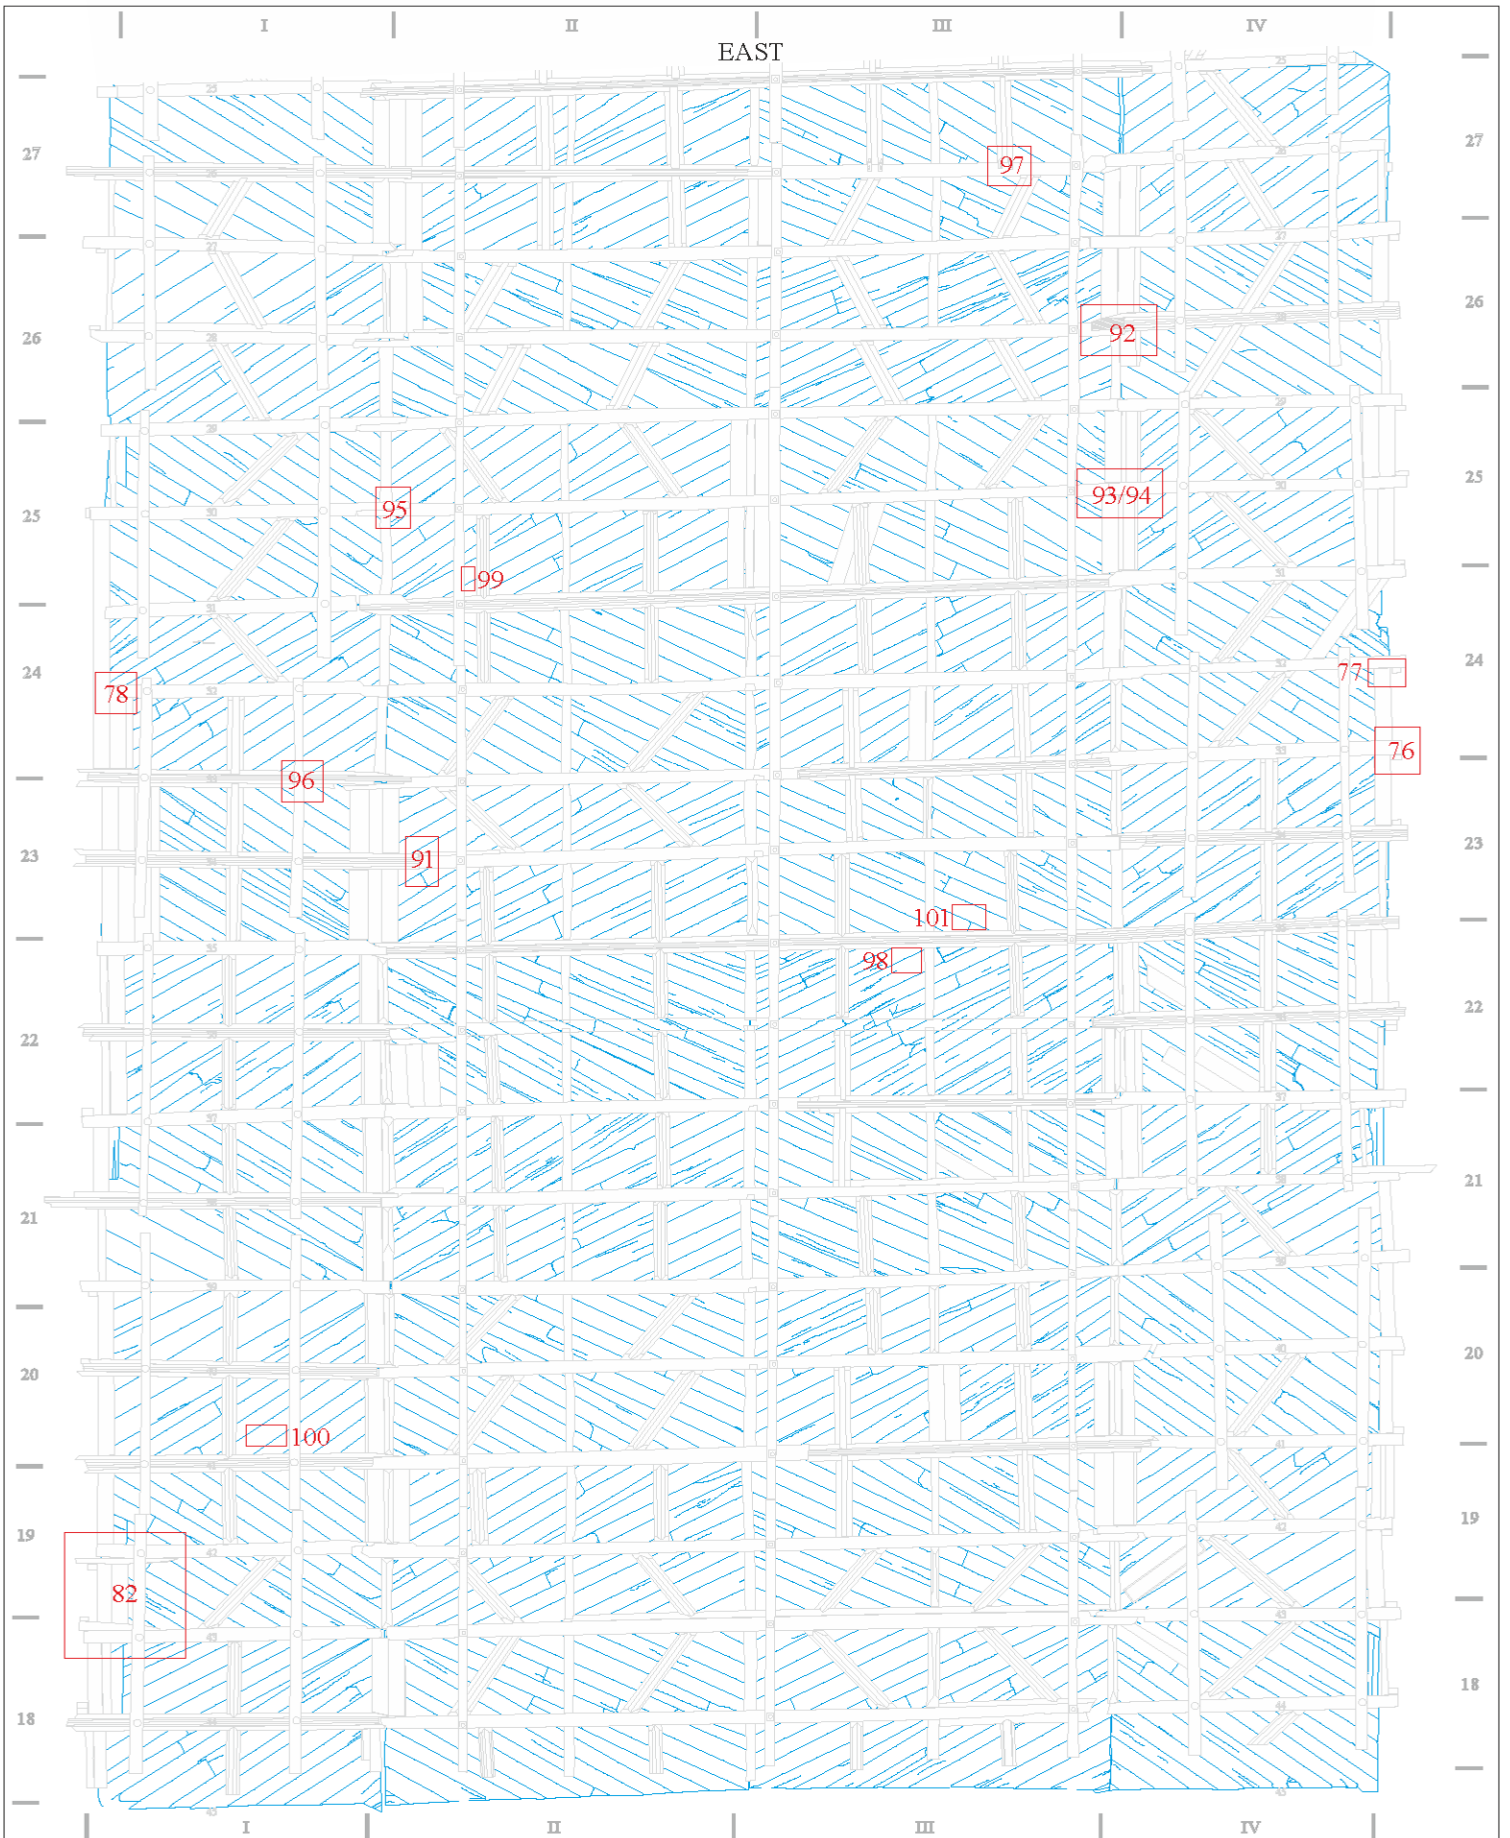
Sheet Number: 2

Plates are in before and after treatment sequence. Ultraviolet (UV) illumination photographs taken before treatment.	TITLE PETERBOROUGH CATHEDRAL - NAVE CEILING Conservation Programme Phase 2 (May - October 2000)		PHOTOGRAMMETRY COURTESY OF ENGLISH HERITAGE SURVEY TEAM & PHOTARC SURVEYS LTD. THE PERRY LITHGOW PARTNERSHIP 1 LANGSTON LANE, STATION RD, KINGHAM, OXON OX7 6UW Tel. 01608 658067
	STAGE CONDITION SURVEY AND TREATMENT	DESCRIPTION PLATE REFERENCE SHEET

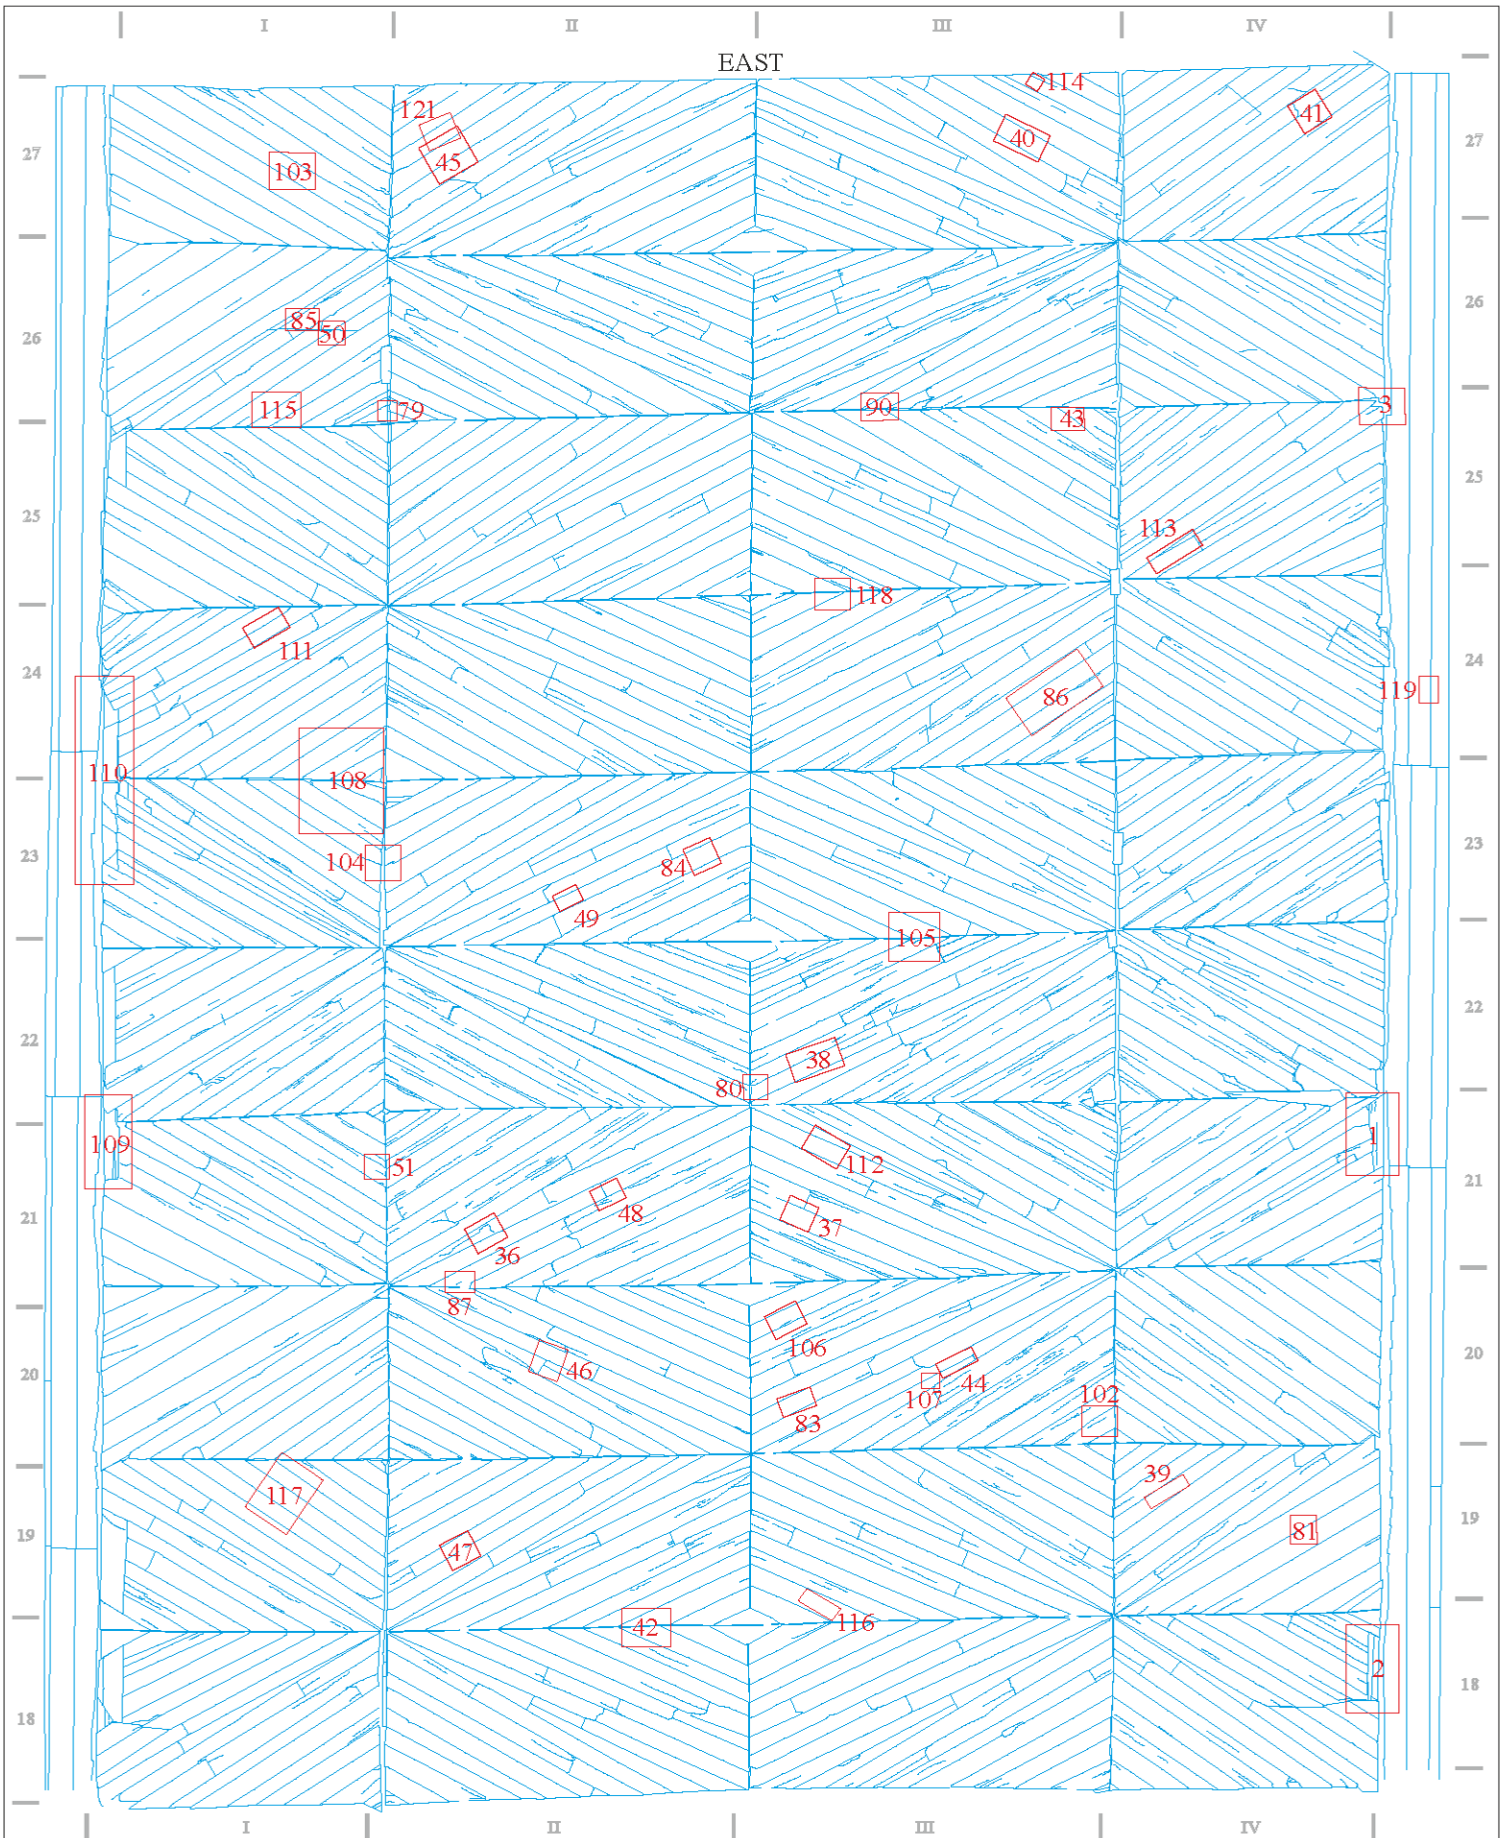
Sheet Number: 3

Plates are in before and after treatment sequence. Ultraviolet (UV) illumination photographs taken before treatment.	TITLE PETERBOROUGH CATHEDRAL - NAVE CEILING Conservation Programme Phase 2 (May - October 2000)		PHOTOGRAMMETRY COURTESY OF English Heritage Survey Team & Photarc Surveys Ltd.
	STAGE CONDITION SURVEY AND TREATMENT	DESCRIPTION PLATE REFERENCE SHEET	THE PERRY LITHGOW PARTNERSHIP 1 Langston Lane, Station Rd, Kingham, Oxon OX7 6UW Tel. 01608 658067

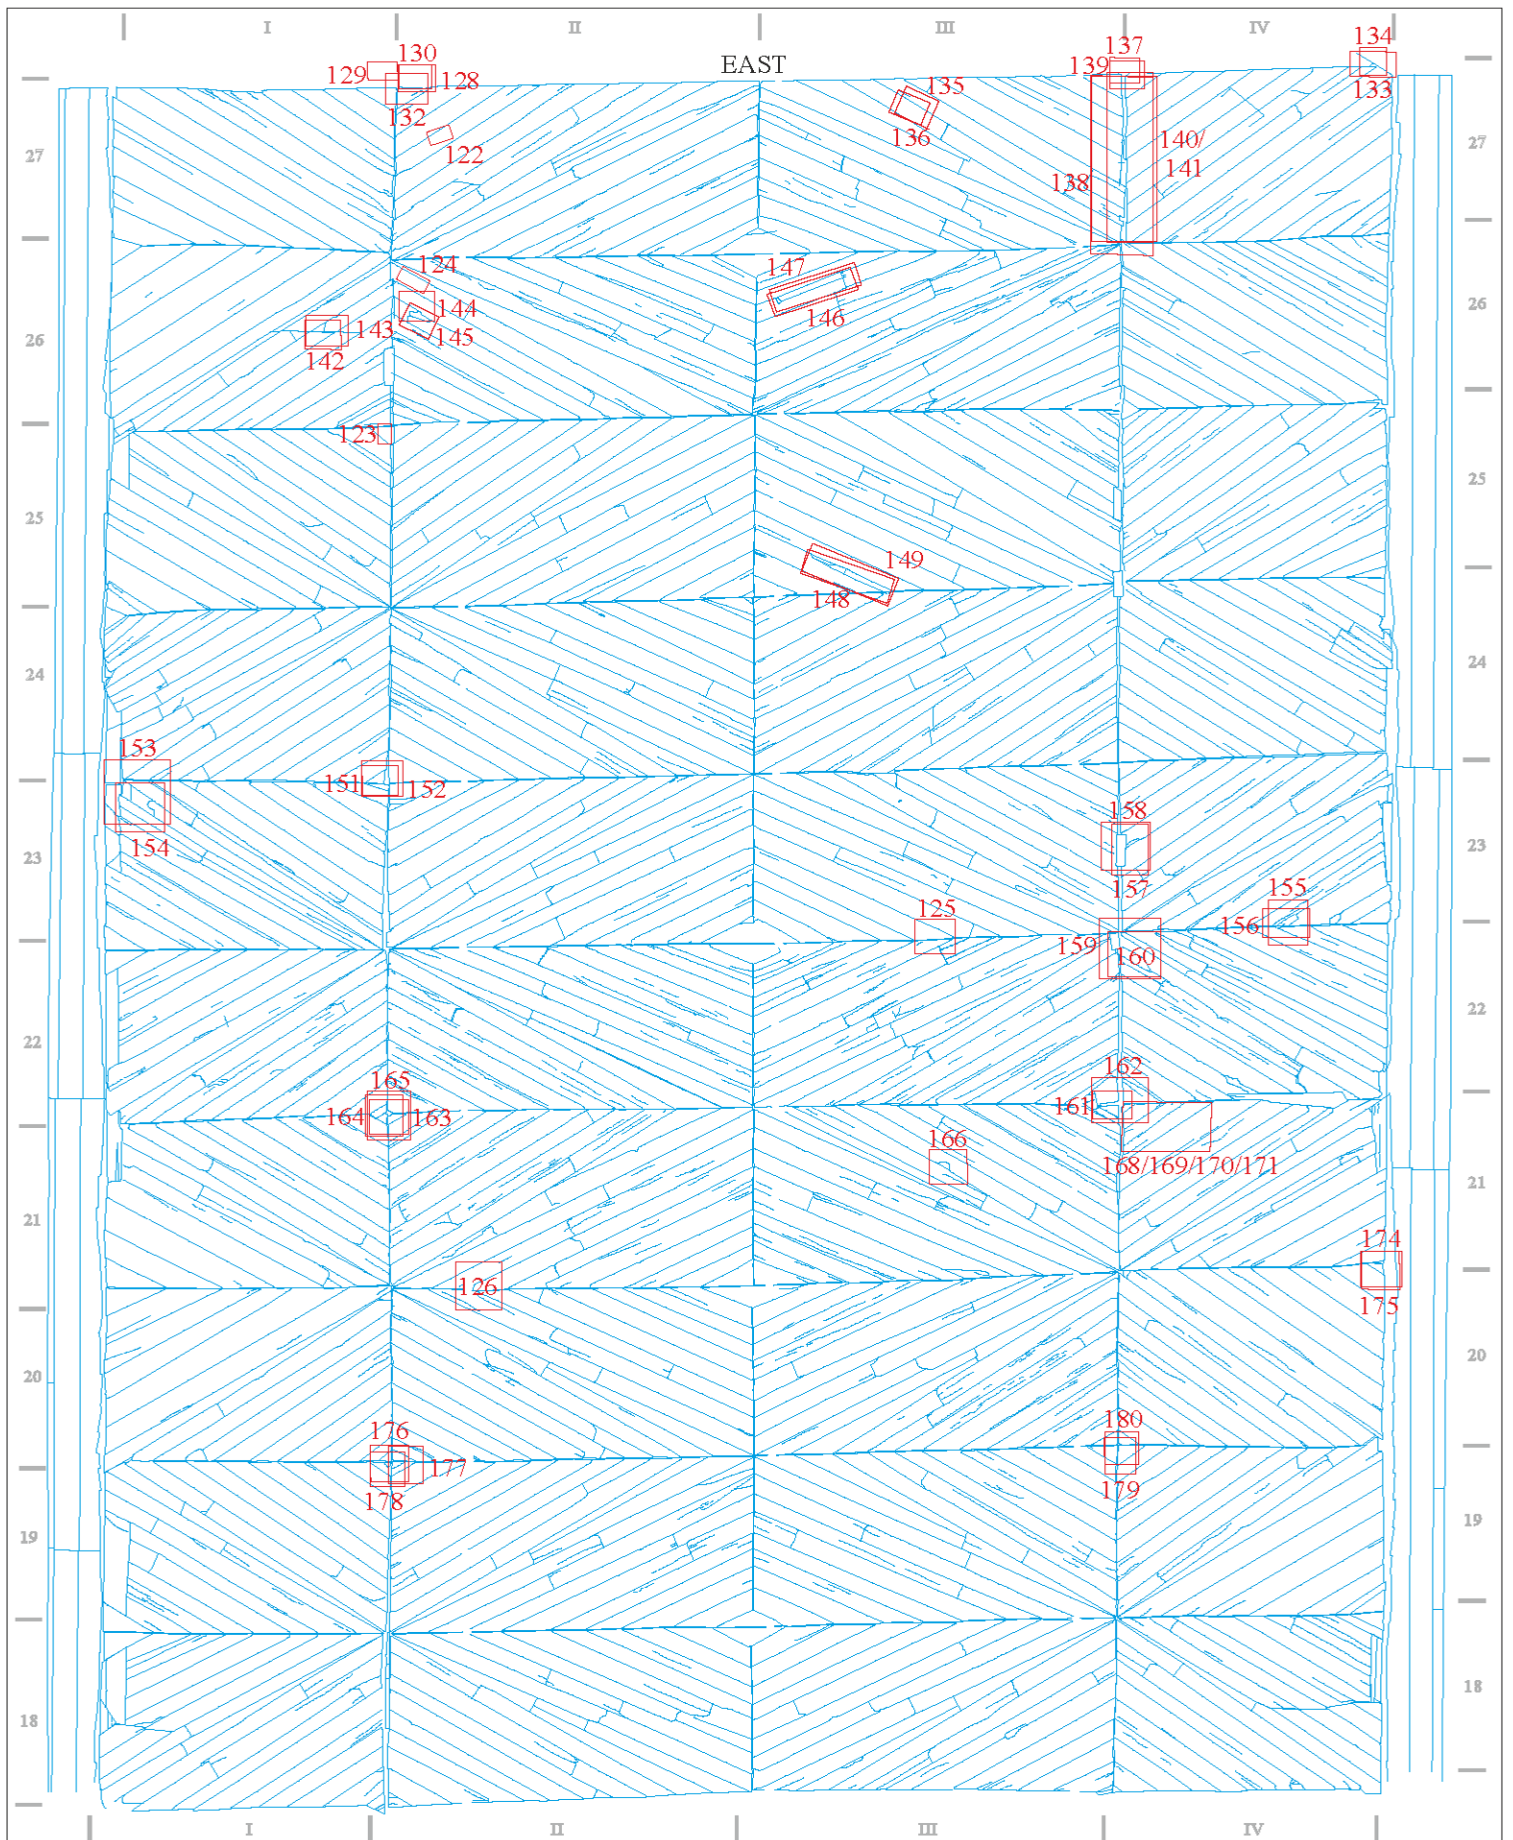
Sheet Number: 4

Photogrammetry courtesy of English Heritage Survey Team & Photarc Surveys Ltd. The Perry Lithgow Partnership 1 Langston Lane, Station Rd, Kingham, Oxon OX7 6UW Tel. 01608 658067	
	STAGE CONDITION SURVEY AND TREATMENT	DESCRIPTION PLATE REFERENCE SHEET

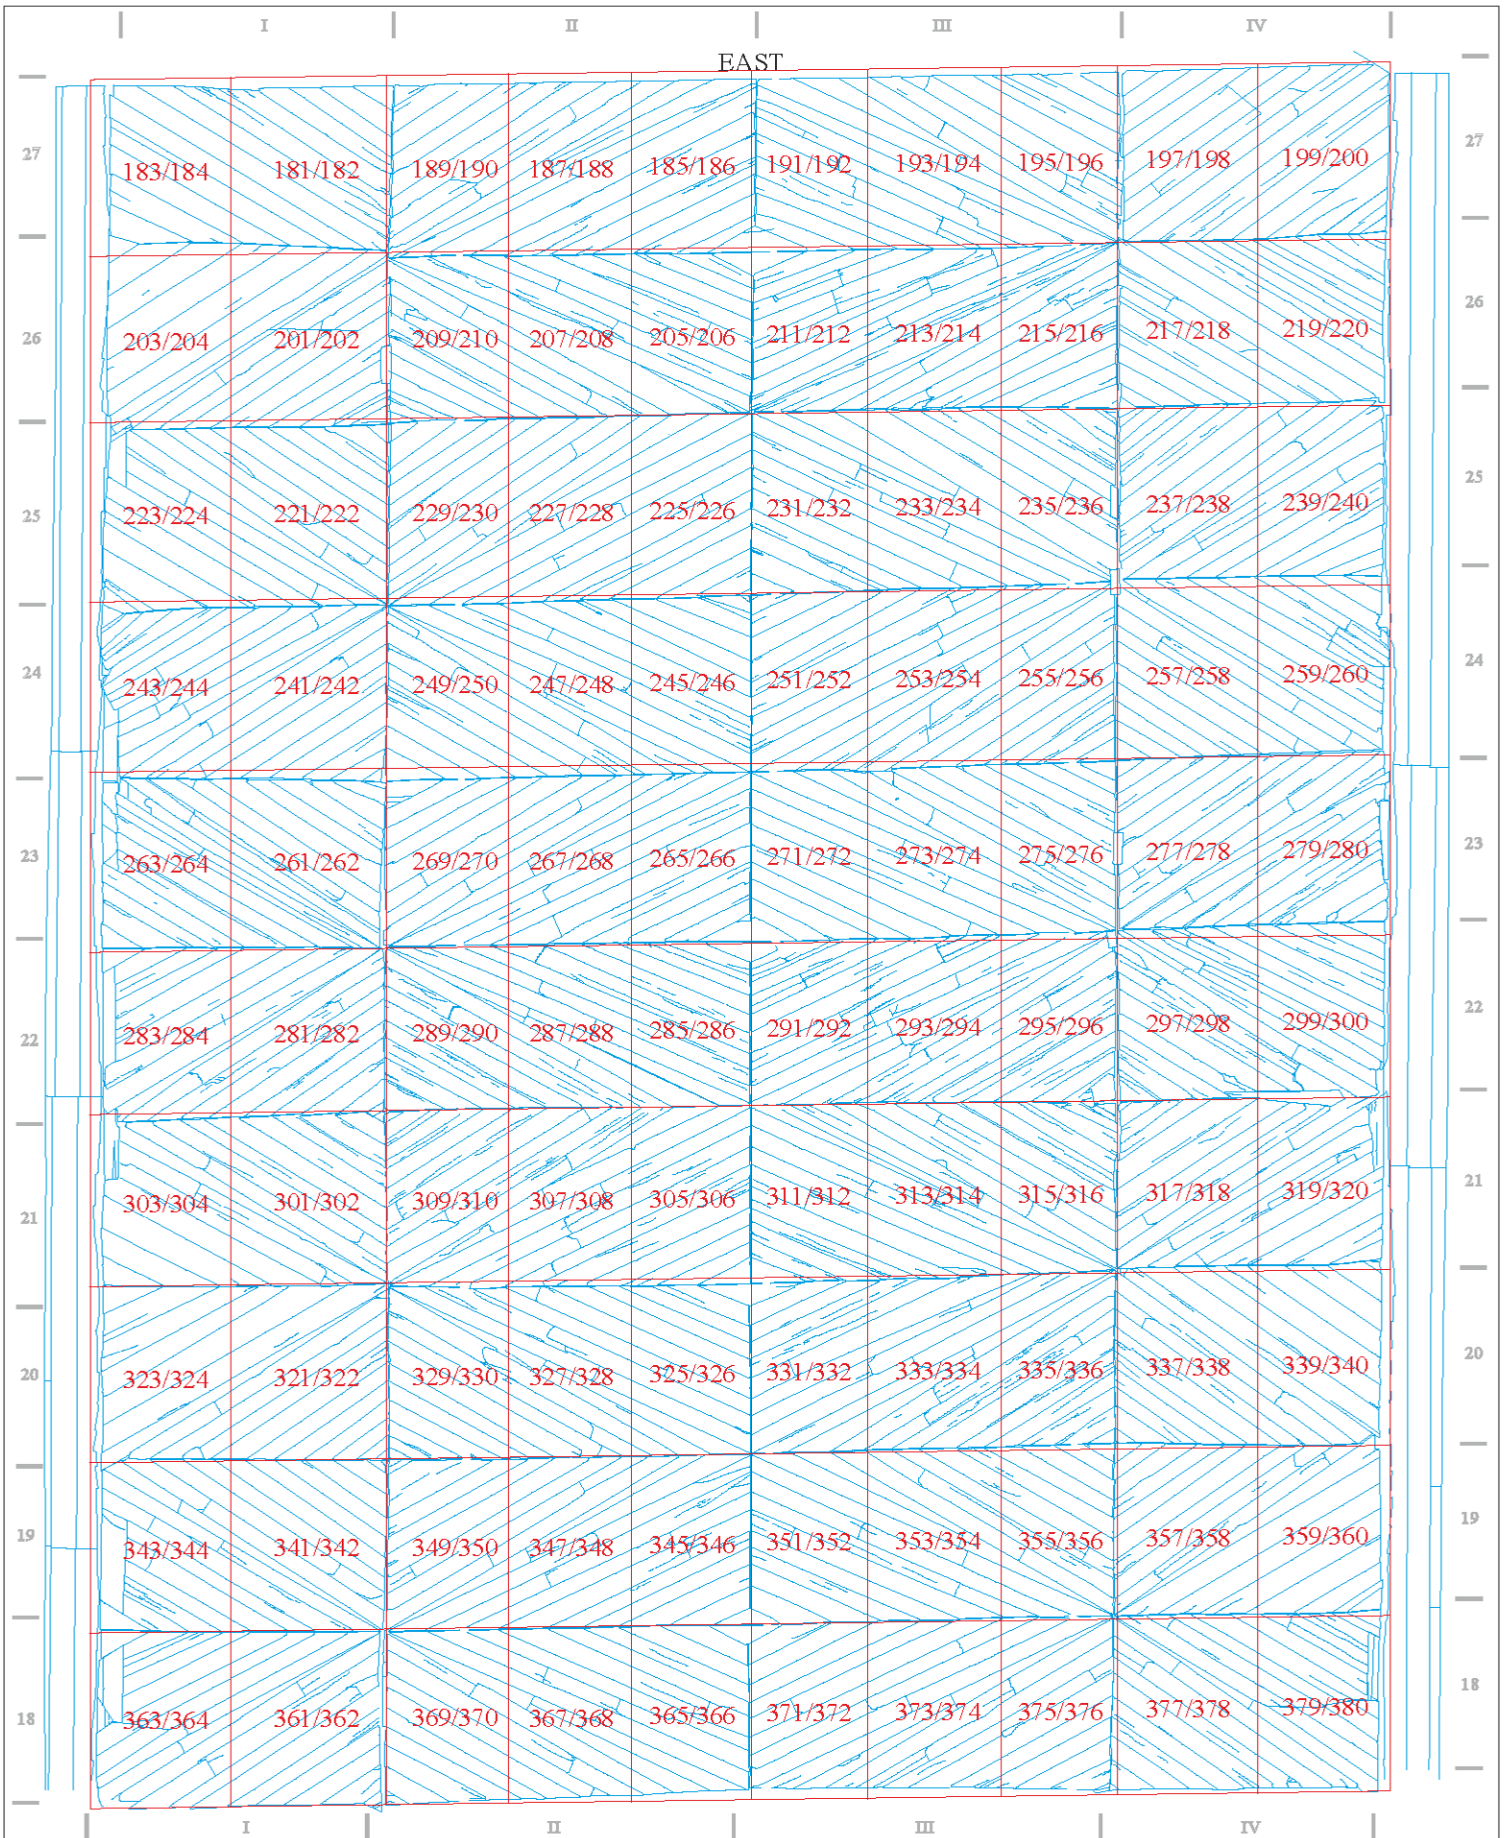
Sheet Number: 5

Plates are in before and after treatment sequence. Ultraviolet (UV) illumination photographs taken before treatment.	TITLE PETERBOROUGH CATHEDRAL - NAVE CEILING Conservation Programme Phase 2 (May - October 2000)		PHOTOGRAMMETRY COURTESY OF ENGLISH HERITAGE SURVEY TEAM & PHOTARC SURVEYS LTD. THE PERRY LITHGOW PARTNERSHIP 1 LANGSTON LANE, STATION RD., KINGHAM, OXON OX7 6UW Tel. 01608 658067
	STAGE CONDITION SURVEY AND TREATMENT	DESCRIPTION PLATE REFERENCE SHEET

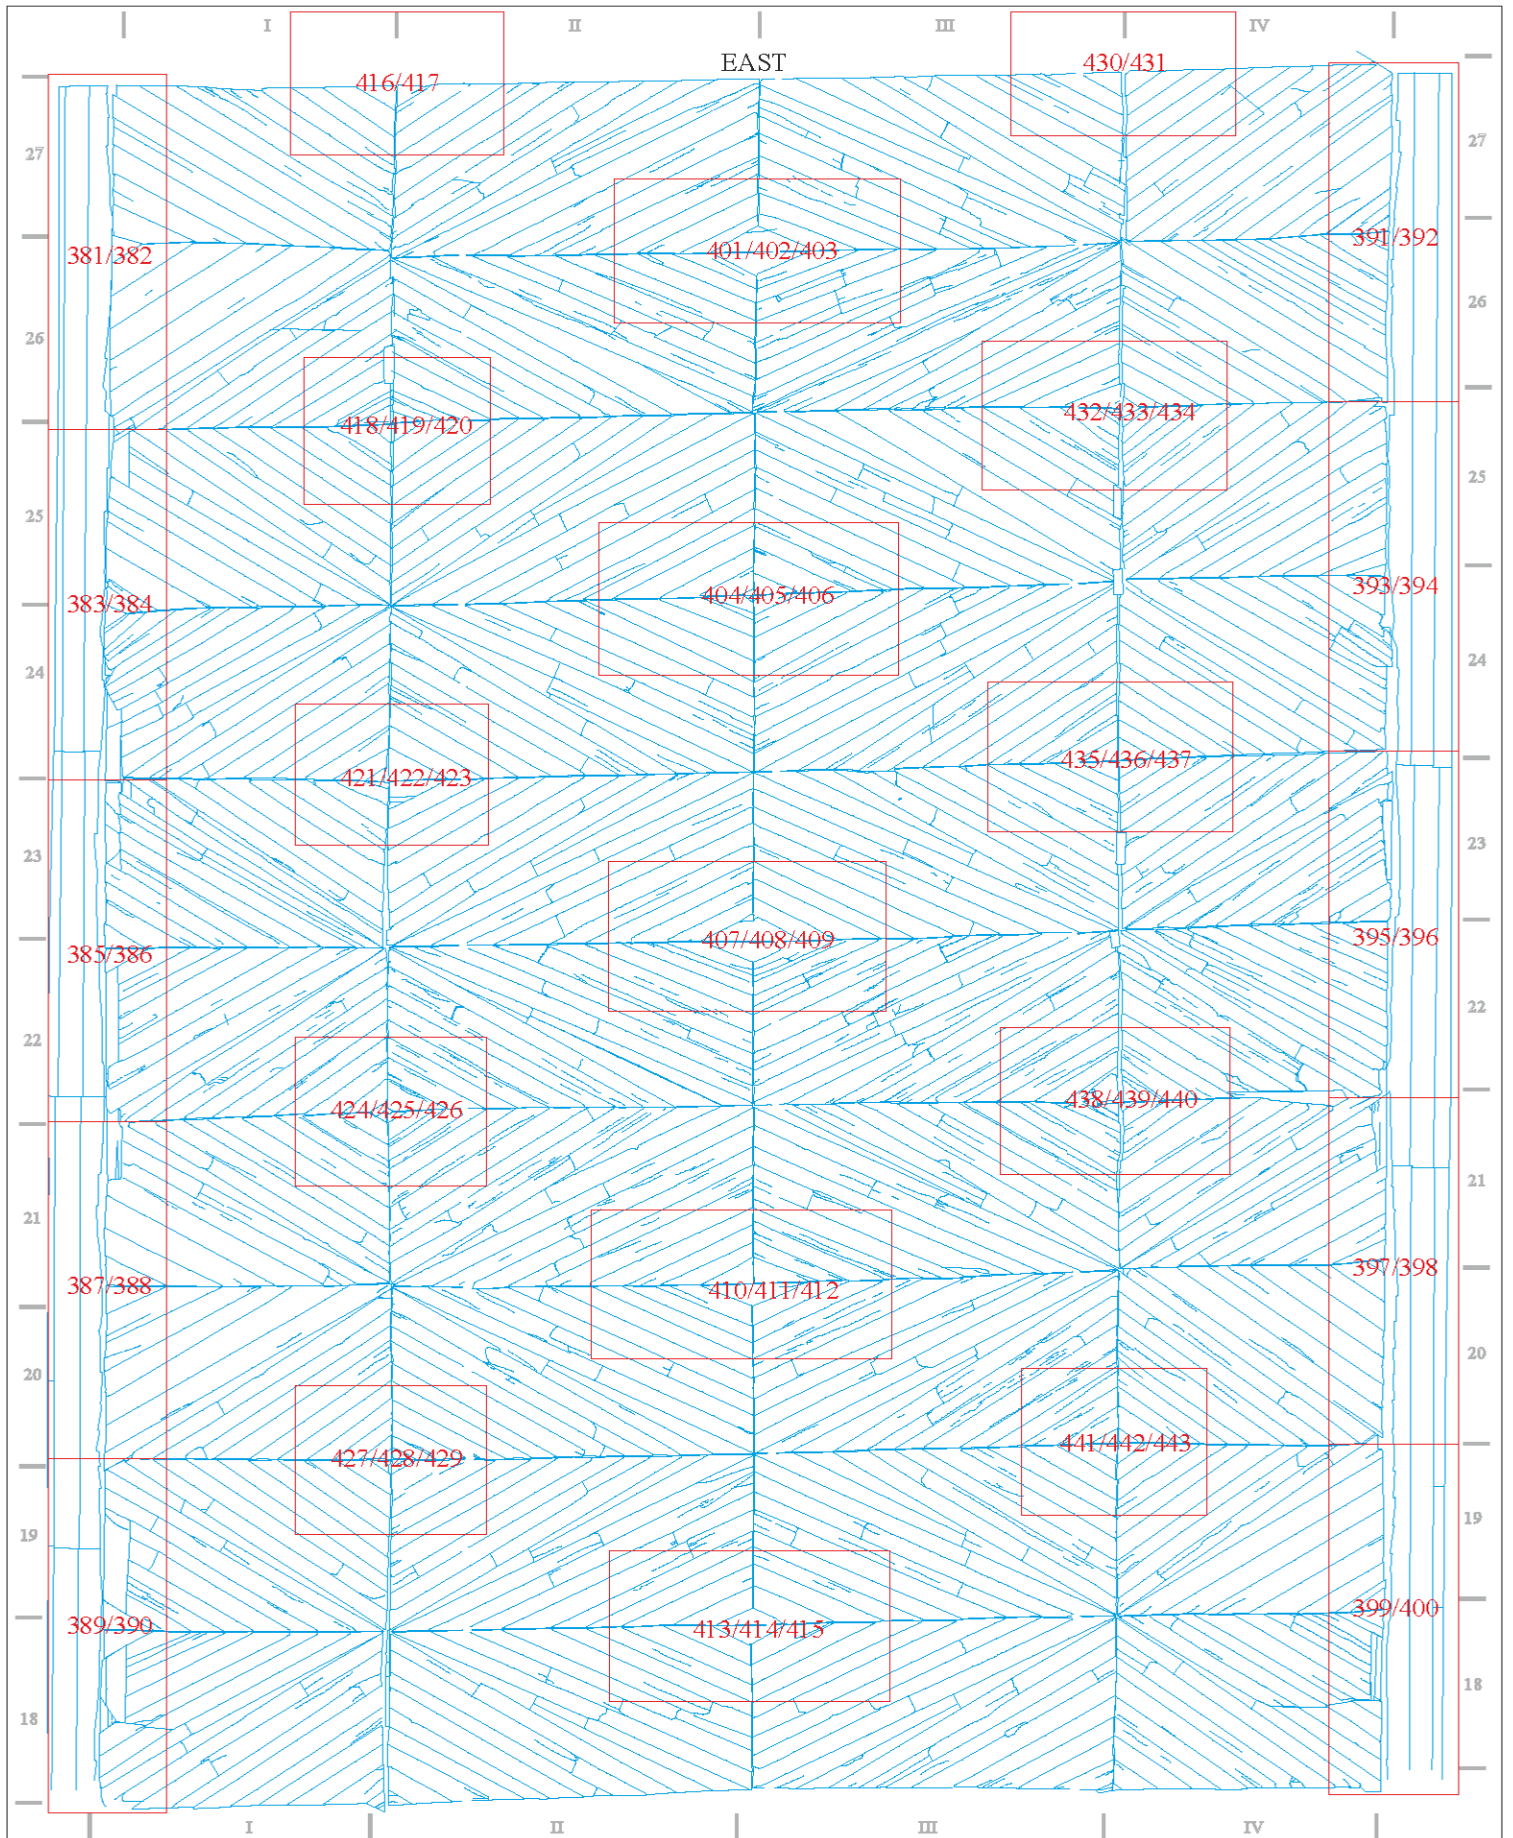
Sheet Number: 6

Plates are in before and after treatment sequence. Ultraviolet (UV) illumination photographs taken before treatment.	TITLE PETERBOROUGH CATHEDRAL - NAVE CEILING Conservation Programme Phase 2 (May - October 2000)		STAGE CONDITION SURVEY AND TREATMENT
		DESCRIPTION PLATE REFERENCE SHEET	Photogrammetry courtesy of English Heritage Survey Team & Photarc Surveys Ltd. The Perry Lithgow Partnership 1 Langston Lane, Station Rd, Kingham, Oxon OX7 6UW Tel. 01608 658067

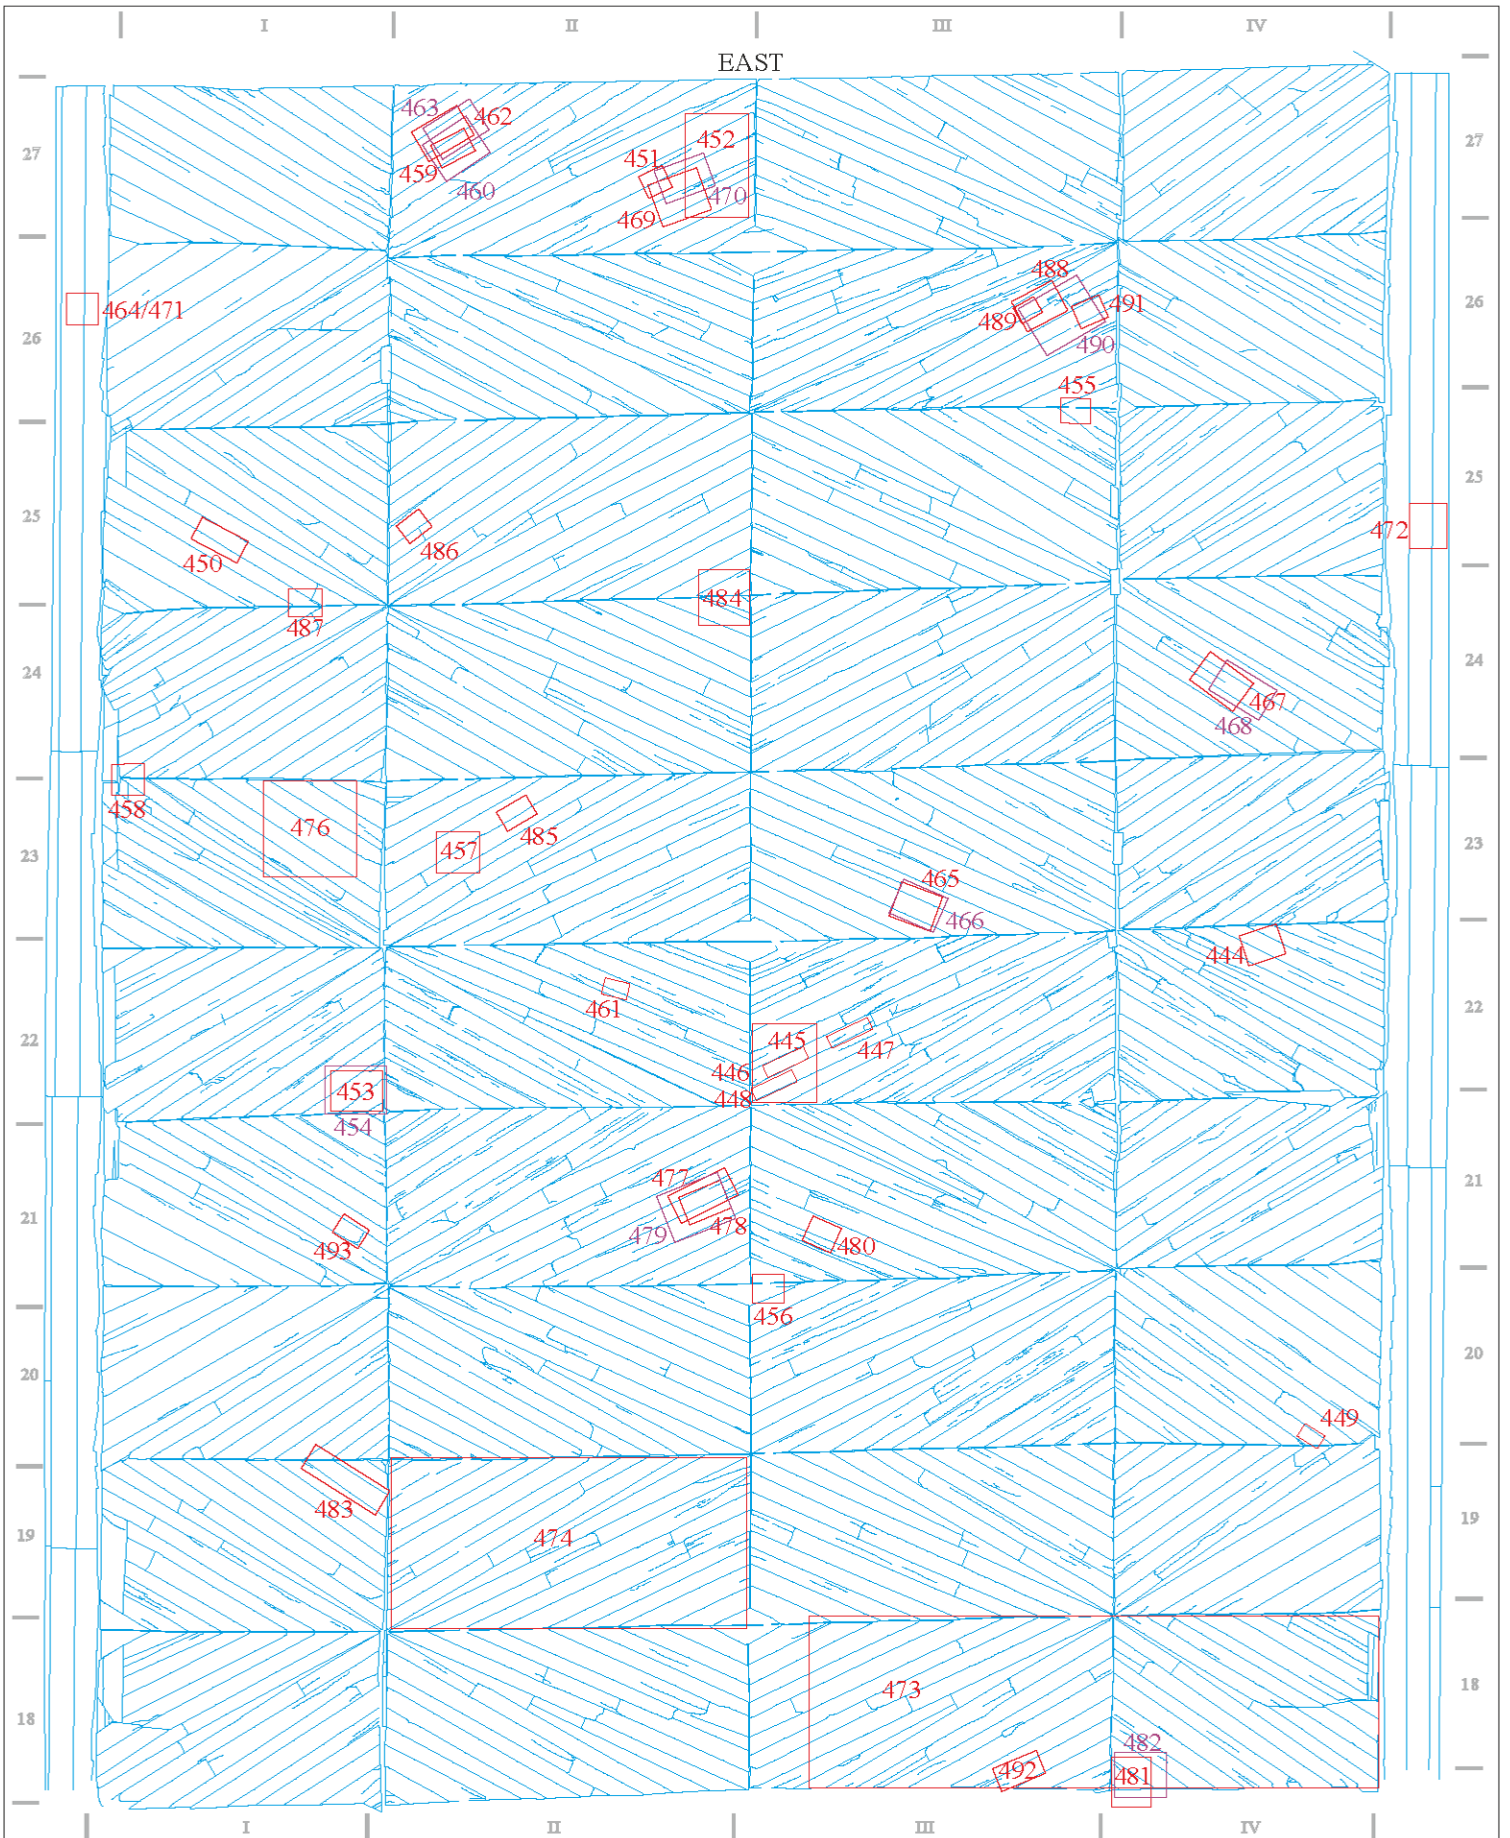
Sheet Number: 7

Plates are in before and after treatment sequence. Ultraviolet (UV) illumination photographs taken before treatment.	TITLE PETERBOROUGH CATHEDRAL - NAVE CEILING Conservation Programme Phase 2 (May - October 2000)		PHOTOGRAMMETRY COURTESY OF ENGLISH HERITAGE SURVEY TEAM & PHOTARC SURVEYS LTD. THE PERRY LITHGOW PARTNERSHIP 1 LANGSTON LANE, STATION RD, KINGHAM, OXON OX7 6UW Tel. 01608 658067
STAGE CONDITION SURVEY AND TREATMENT	DESCRIPTION PLATE REFERENCE SHEET
