Figure 2.49: 2002 - Recording of Old House Cone, Nailsea – Figure 1A from 2002 report.

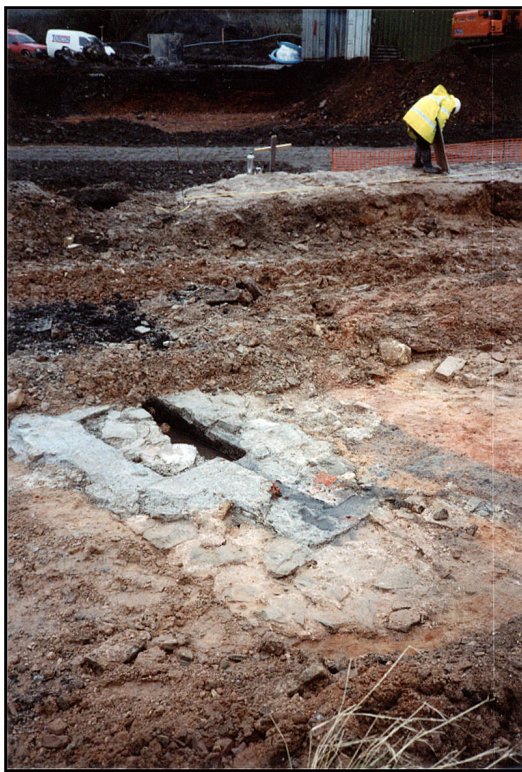
Figure 2.50: Old House Cone South furnace box?

From the context sheets both features, shown above in Figures 2.50 and 2.51 from the east and south-east respectively, were virtually identical in size and construction. The southernmost had a “main fill of black cinder/?fuel waste (sampled)” under “brick and sandstone demolition rubble”, and was “>250mm deep”. The other feature again contained demolition material some of which appeared to adhere to the internal surface in one corner, with a water-filled void of unknown depth below.

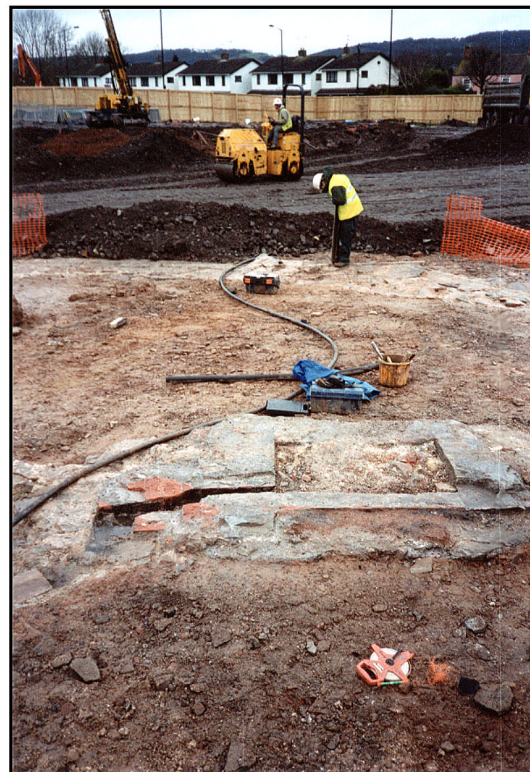
Figure 2.51: Old House Cone North furnace box?
