THE NETHERFIELD ANNEXE, PENISTONE GRAMMAR SCHOOL, PENISTONE, SOUTH YORKSHIRE: AN ARCHAEOLOGICAL BUILDING RECORD

For Barnsley Metropolitan Borough Council

CS Archaeology September 2008 On behalf of: Barnsley Metropolitan Borough Council

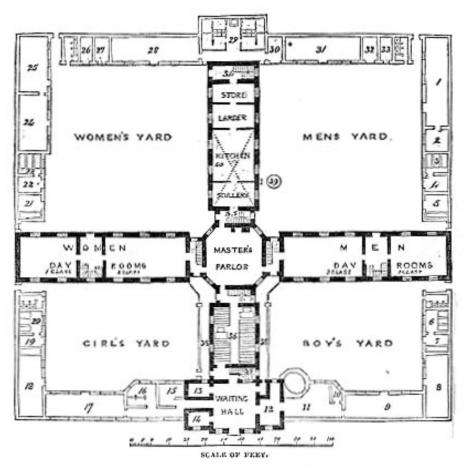
Kempthornes 'cruciform or square' design for the ground floor

When the Penistone Union workhouse was built in 1859 it followed the 'cruciform or square plan', apart from Penistone's reception/administration block (Building 1) which was detached, this was situated at the entrance to the complex, just off Huddersfield Road. The use of the 'cruciform or square plan' is at odds with most of northern England's new build workhouses (i.e. the 200-pauper-plan: Higginbotham 2006, 16) in that it retained the central supervisory octagonal hub, a feature of Kempthorne's cruciform or square plan design which had been generally adopted after the 1930s, and the introduction of the New Poor Law.

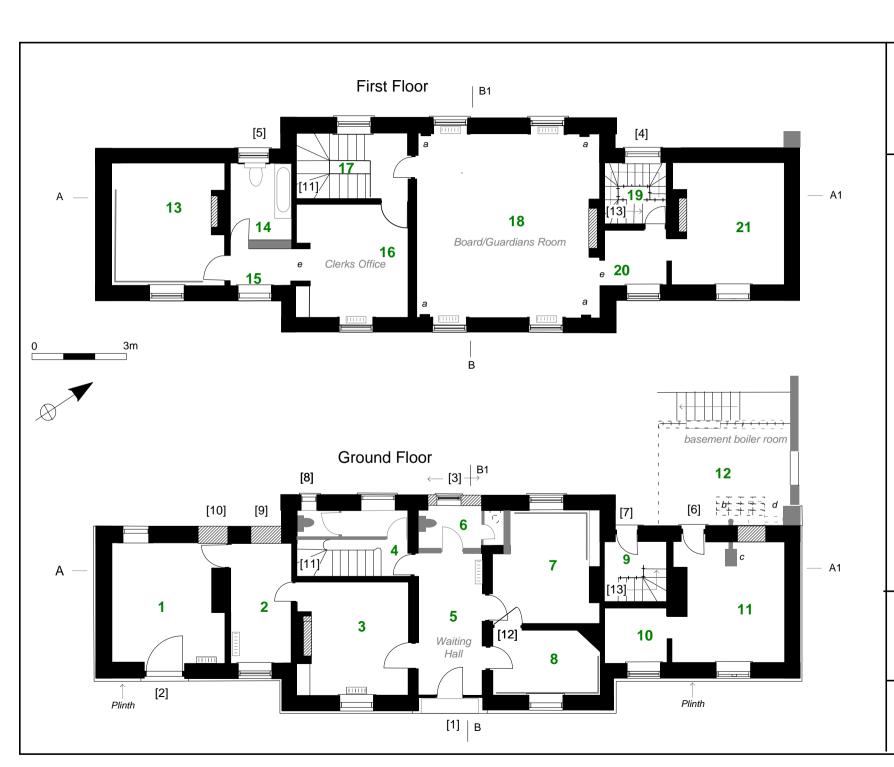
Figure 8: Building 1, Floor Plans

- [8] window
- [9] doorway
- [10] doorway with original door
- [11] main staircase
- [12] internal door
- [13] staircase
- a decorative ventilators
- b glass floor tiles to illuminate boiler room (Room 12)
- c modern boiler
- d inserted early 20th century boiler
- e inserted doorways

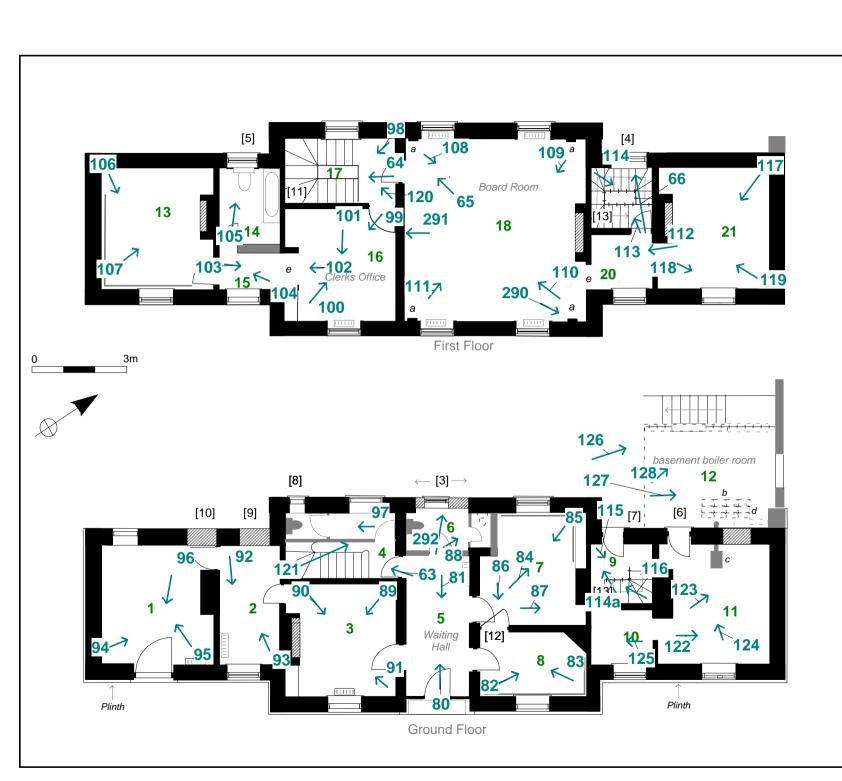
Figure 9: Building 1 floor plans with photographic positions

- [1] front door with decorative light boss above
- [2] arch headed door
- [3] arched doorway (blocked)
- [4] Building 1 original arched stair window
- [5] arched window
- [6] doorway with original door
- [7] doorway
- [8] window
- [9] doorway
- [10] doorway with original door
- [11] main staircase
- [12] internal door
- [13] staircase
- a decorative ventilators
- b glass floor tiles to illuminate boiler room (Room 12)
- c modern boiler
- d inserted early 20th century boiler
- e inserted doorways

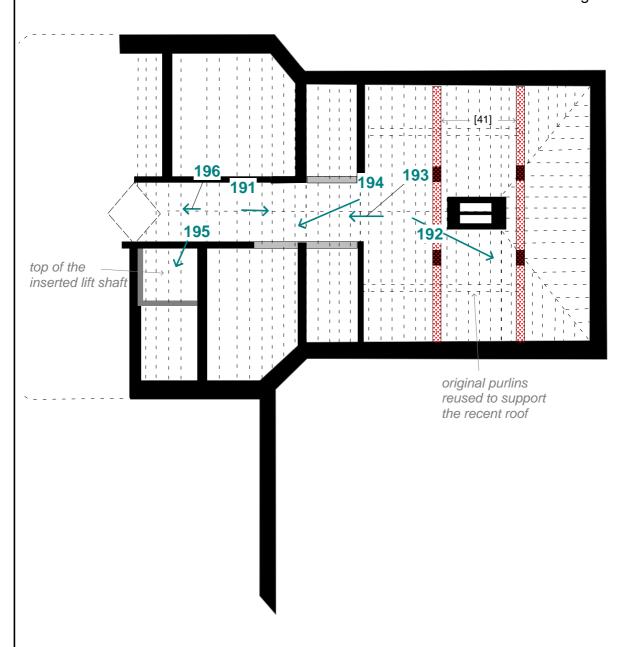
Netherfield Annexe, Penistone South Yorkshire: An Archaeological Building Record Figure 20: Building 3, the attic

The Attic over the North-east Wing

removed sections of wall probably associated with the re-roofing and insulation of the attic

original queen post trusses with struts to the principal rafter (below the purlin)

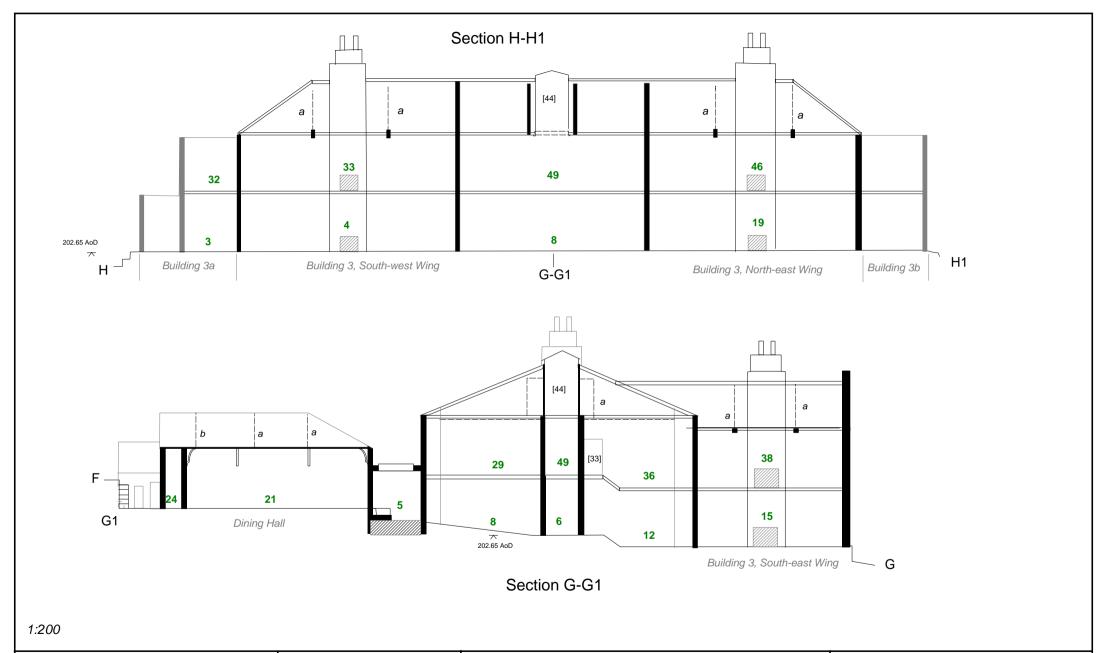
Figure 21: Building 3, Longitudinal Sections (H-H1 and G-G1)

Netherfield Annexe, Penistone, South Yorkshire: An Archaeological Building Record blocked openings
phase 1 Building
subsequent phasing
projected features
a queen post roof trusses

b king post roof truss

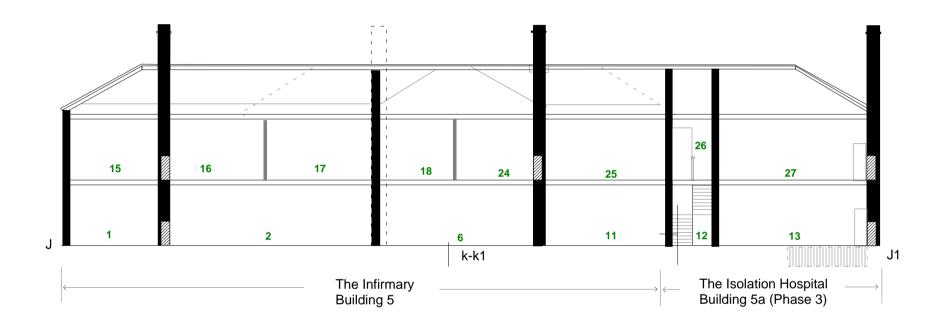
Figure 24: Buildings 5-5a, Sections (J-J1 and K-K1)

cellar (unknown extent)
later inserted walls
Phase 1 Building
room numbers
removed chimney stack
original/early roof line

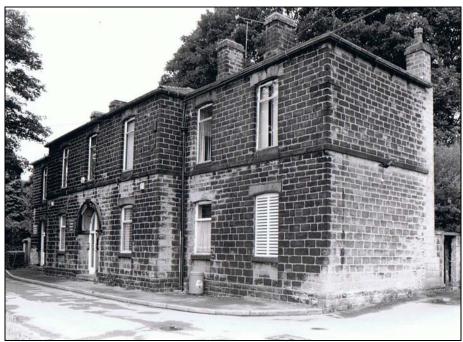
Plate 1: oblique view of the front south-east facing elevation of the Reception/Administration Block (Building 1), from the east

- 7.2.1.2 The front *south-east elevation* is largely symmetrical in design (Plate 1, 5: Figure 10). There are with seven type 1, first floor windows with recessed sills and 6 ground floor windows with flush sills. All the front windows have carved arched lintels (arch headed). The ground floor windows are also shorter and designed with privacy from the adjacent foot path and service road in mind. The central

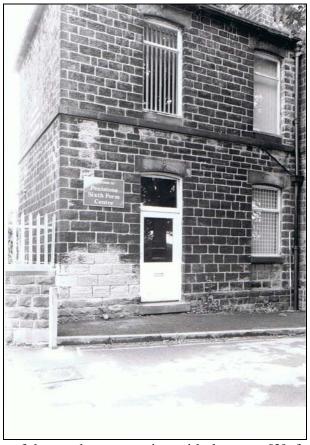
Plate 2: view of the south-west section with doorway [2], from the south

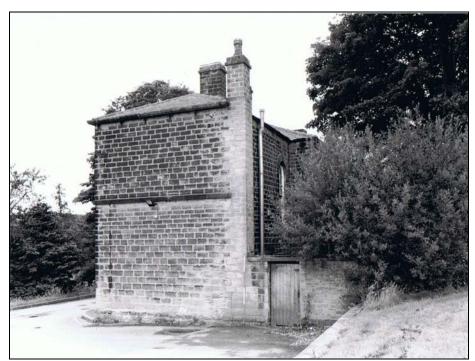
Plate 3: general view of the side, north-east gable wall (Building 1), from the north north-east

- 7.2.1.4 The side *north-east elevation* has no openings but still retains the decorative string course and plinth (Plate 3, 13). The inserted chimney has been keyed into the adjacent masonry apart from a butt join at the lower wall. The inserted chimney forms part of a curtain wall with an associated gateway that delineates the block's rear yard area and has been associated with the phase 2 building.

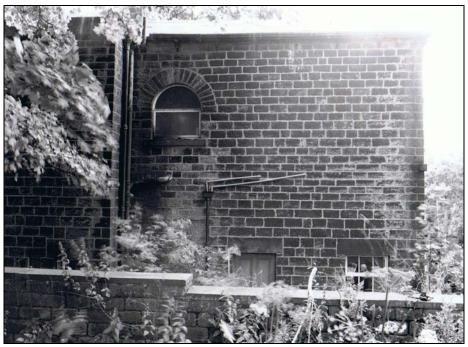
Plate 4: view of the arched and partially blocked window [5] to the rear north-west elevation (Building 1), from the north north-west

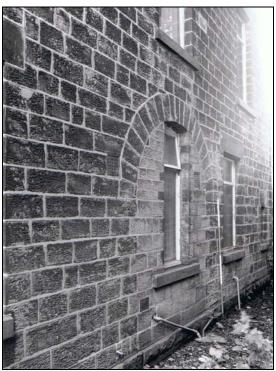
Plate 5: detail view of the blocked arched doorway [3] to the rear north-west elevation (Building 1), from the north-east

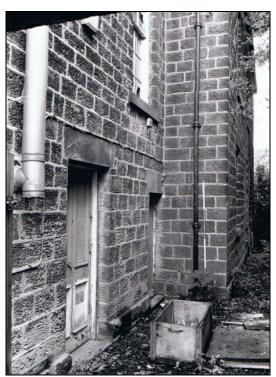
Plate 6: oblique view of the rear north-east facing elevation of the Reception/Administration Block (Building 1), from the north-east

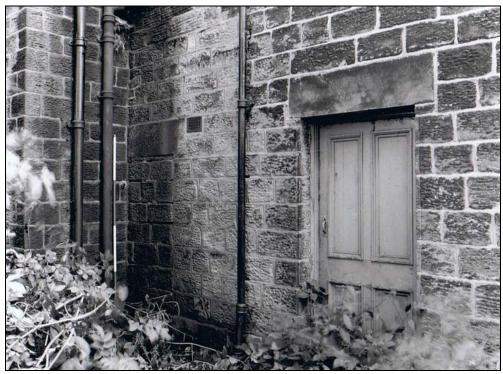
Plate 7: detail view of the blocked doorway [9 and 10] to the rear north-west elevation (Building 1), from the north-west

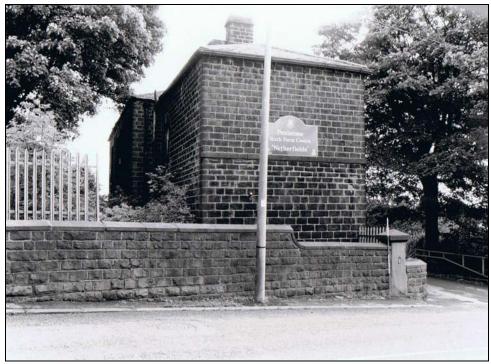
Plate 8: view of the south-west gable wall of the Reception/Administration Block (Building 1), from the west

- 7.2.1.7 The south-west elevation, is parallel with Huddersfield Road and like the north-east elevation has no opening to either the first or ground floor levels (Plate 8, 2).

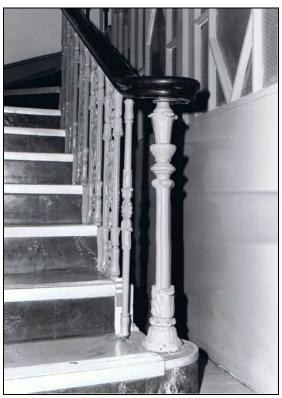
Plate 11: detail of the newel post at the base of the staircase [11], from the east

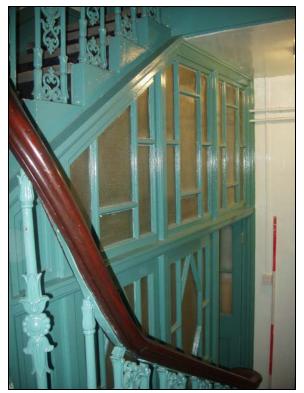
Plate 12: view of the inserted glazed partition, from the south

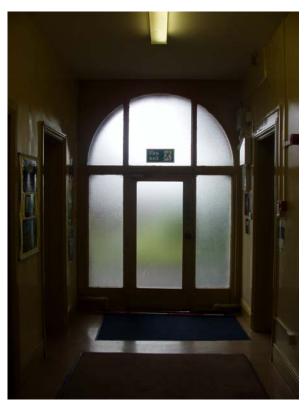
Plate 13: general view, from the north-west

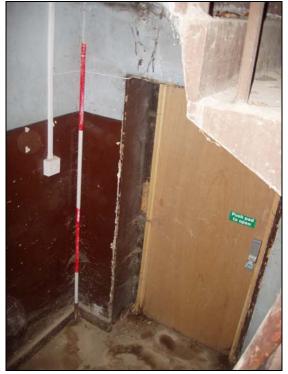
Plate 16: view towards the rear door [7], from the east

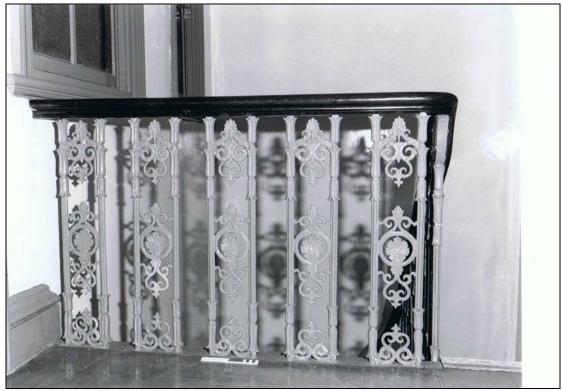
Plate 20: detail of the balusters [11] to the landing, from the north-east

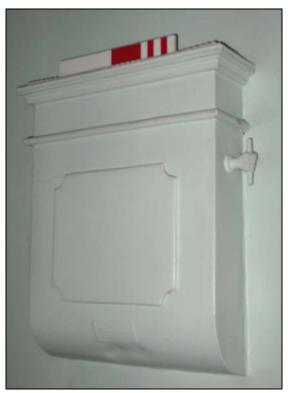
Plate 22: Detail of the ventilator (a:1 of 4) to the south-east wall, from the south-west

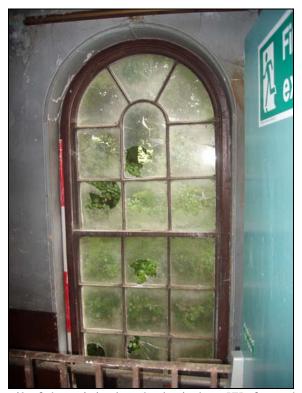
Plate 24: detail of the original arched window [7], from the south-east

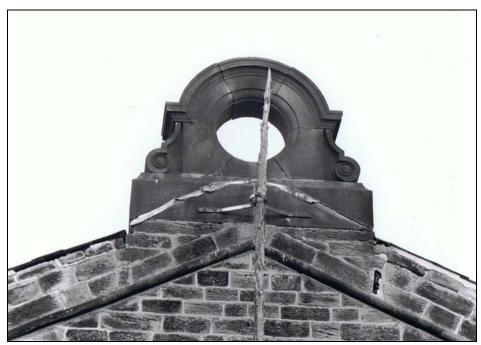
Plate 31: detail of the circular acroterion [21], from the south south-east

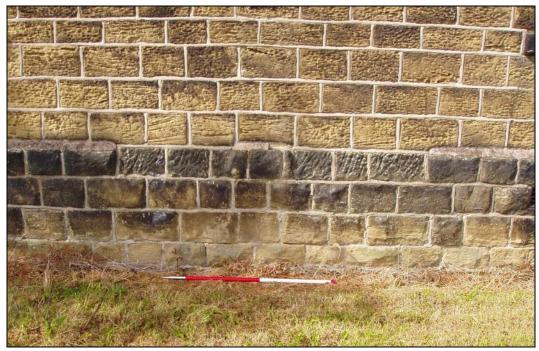
Plate 32: view of the chamfered plinth to the SE elevation of the SE Wing (Blg.3), from the south-east

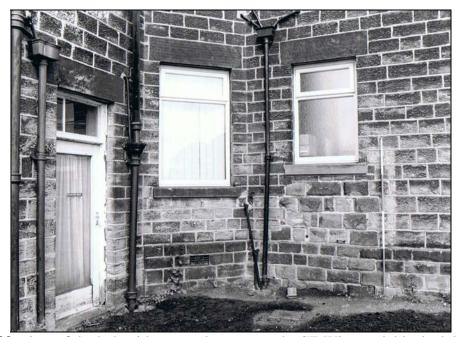
Plate 33: view of the hub with extant doorway to the SE Wing and blocked doorway [22]to the NNE Wing, from the south-east

- 7.4.1.5 The *North-east Wing* is similar to the *South-west Wing* in general design, fenestration and access arrangements and would have probably been the Men's Wing. The south-east elevation features a blocked doorway [21] (Plate 33, 20). There is a hipped slate roof, which features a stepped chimney. The north-east elevation has been extended via the insertion of a Phase 4 two storey toilet block,

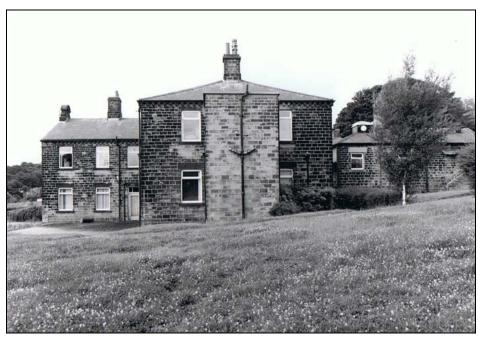
Plate 35: general view of Building 3 and the extension 3b, from the north-east

Building 3b, with a flat roof. This extension can be relatively dated as it had not been built c.1917 (Figure 2, H1). This extension has left the original windows, 2 ground floor and 2 first floor, extant (Plate 35, 22). The north-west elevation (Plate 36, 26) features the standard arrangement of door and windows.

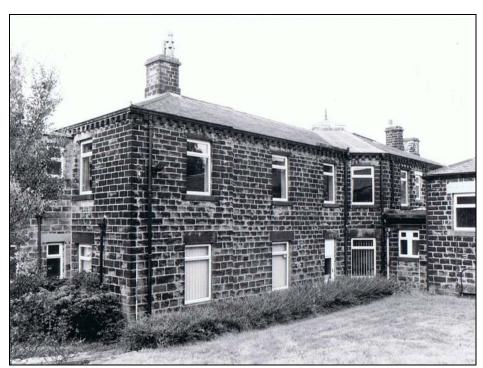
Plate 36: view of the North-east Wing, north-west elevation, from the north-east

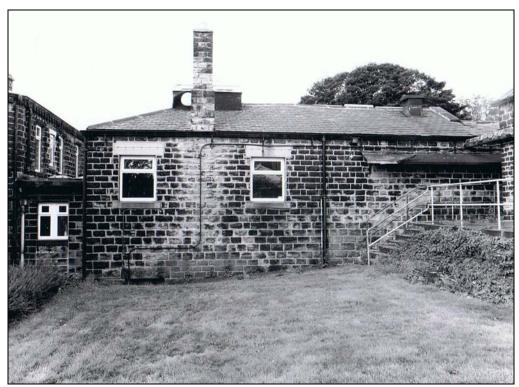
Plate 37: View of the original kitchen's north-east elevation with chimney [23] flanked by a pair of modern inserted windows, from the north-east

7.4.1.6 The North-west Wing contains the dining and service rooms and is a double pile building with slate twin gabled roofs. There is an original chimney [23] to the north-east elevation (Plate 37, 28), evidenced externally by weathered sandstone along the line of the flue [23]. Flanking the chimney flue are two inserted windows. There is an original blocked doorway [24] (Plate 38, 27) that opposes a blocked doorway [25] to the south-west elevation. The remaining elevation is devoid of features apart from a protruding external chimney stack [26] towards the north-west end of the north-east elevation, which has been inserted. This stack is now redundant but appears to have related to an inserted boiler/possible Laundry. Because the stack was constructed externally, in contrast with the flush appearance of the chimney [23] it was probably inserted into the Phase 1 building. The upper part of this chimney [23] has been demolished and is extant up to eaves height (c.2m). The north-west elevation (Plate 39, 32) is symmetrically stepped down both in roof height and building width to include an open rear yard area (Plate 40, 34) that accesses the two rear stores via an external flight of stone steps (Plate 41, 35). The gable walls of each store feature loading doors [27 and 28] which would have provided off loading access from the rear service road into the stores. Both loading doors [27 and 28] (Plates 42, 239 and 43, 238) feature stone surrounds with interrupted door jambs, and are fitted with plank and braced doors. The south-west elevation (Plates 44, 37) features a central doorway, which directly accesses the *Dining Hall*, and is flanked by three large windows. The blocked doorway [25] was visible and has had a window inserted into the opening (Plate 45, 38).

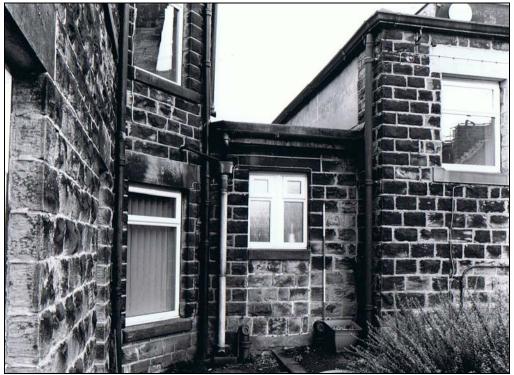
Plate 38: view of the blocked doorway [24] with inserted window, from the east

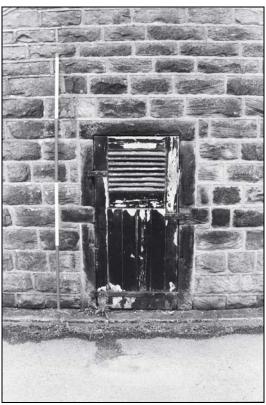
Plate 43: view of the loading door [28] to the storeroom (Rm. 25), from the north-west

- 7.4.2.24 Room 25 currently serves as a general store. It is accessed by a doorway from the rear service yard and a loading door from the rear service road. There is a timber under drawn ceiling, lime washed walls and a solid floor. The loading door [28] to the north-west wall features interrupted jambs (also a feature of the outside doorway). There is an occasional nail inserted to the walls but nothing resembling shelves or racking. The room has no original or inserted light sources. Therefore it originally served as a store probably for foodstuffs which were easily off loaded and stored before use in the kitchen. The doorway to the service yard (Plate 49, 143) has had a replacement plank and battened door but the coursed door jambs and lintel have a deep rebate which suggests an original more heavy duty secure door.

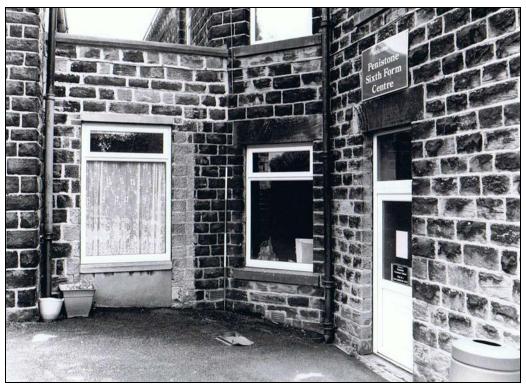
Plate 45: view of the octagonal hub with blocked doorway [25], from the south-west

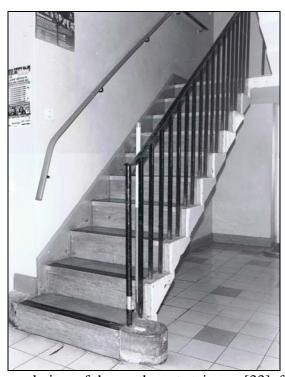
Plate 46: general view of the north-east staircase [33], from the east

- 7.4.2.16 Room 17, the *North-east Corridor and Staircase*, (*l* 6m *x* w 2.05m *x* h 3.05m) features the original staircase [32], which is similar to the South-west Staircase (Room 1) and features utilitarian iron balusters and a plain mahogany handrail (Plate 46, 202). The solid floor is covered by linoleum, walls are plastered and painted, and the ceiling is under drawn. The original corridor through the *North-east Wing* has been annexed by room 17a which features a blocked doorway [22] to the south-east wall.

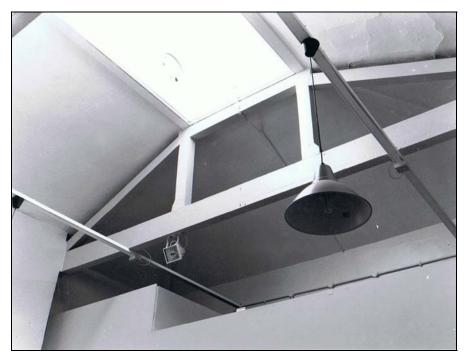
Plate 47: view of the queen post truss [37] (1 of 2), from the south-west

- 7.4.2.22 Room 23 currently houses an extensive modern kitchen featuring stainless steel fixtures and fittings. There is a linoleum covered timber floor, the walls are plastered and have been painted. The ceiling is open to the rafters which allows views of the king post³ roof truss [37] (Plate 47, 74). Along the south-east wall is the original cellar door (Plate 48, 133).

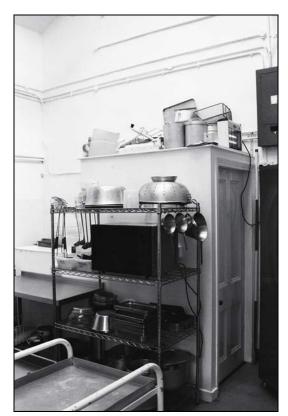
Plate 48: view of the 4 panelled cellar door, from the west

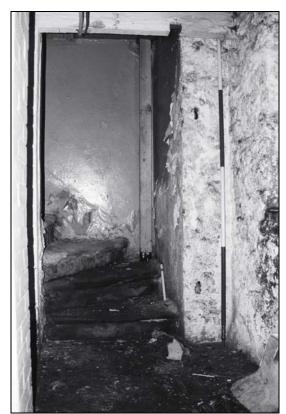
Plate 51: view of the lower staircase [38] with evidence for an internally hinged door, from the south-east

- 7.4.2.26 Room 27 is accessed via a stone straight flight staircase [38] with worn steps, at the bottom of the steps a door has been removed leaving a pair of in situ hinges (Plates 51, 141). The room is in very good original condition and was built directly below the workhouse *Kitchen*. Original cellar fixtures include the central sandstone table [46] (Plates 52, 138) and the side tables to the north-east wall [47] (Plates 53, 76). The sandstone rubble walls and the exposed timber ceiling is are lime-washed. The ceiling still features a series of iron meat hooks. There is an exposed flagstone floor interrupted by the brick plinths for the tables and the inserted brick columns. The kitchen floor has been re-supported by the insertion of brick columns and a timber lintel. The centre of the north-east wall are two protruding brick plinths supporting a timber lintel. The lintel has been reenforced by a brick arch.

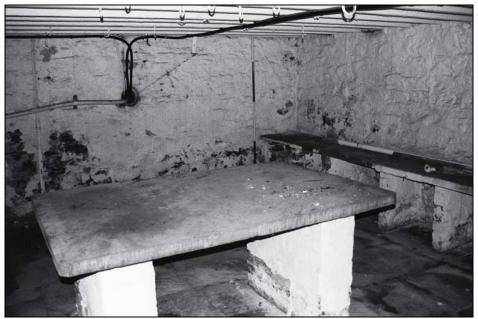
Plate 52: view of the central cellar table [46], from the south-west

- Plate 52: view of the central cellar table [46], from the south-west
- Plate 53: view of the side tables and meat hooks [47], from the north-east
- Plate 54: general view with ceiling beams (truss tie-beams), from the south-west

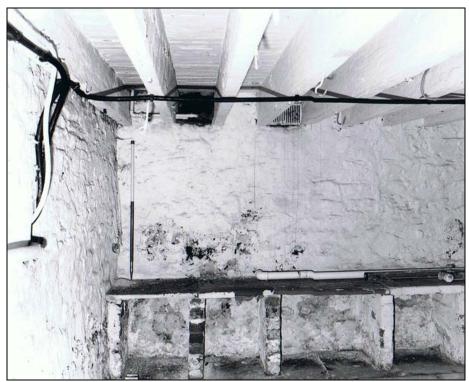
Plate 53: view of the side tables and meat hooks [47], from the north-east

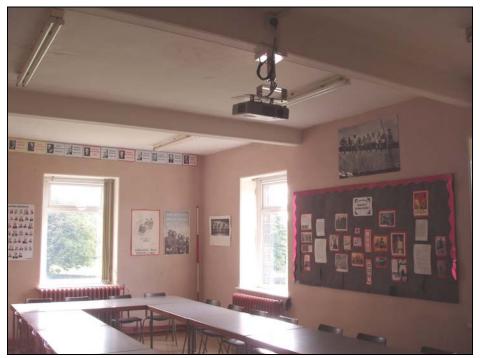
Plate 54: general view with ceiling beams (truss tie-beams), from the south-west

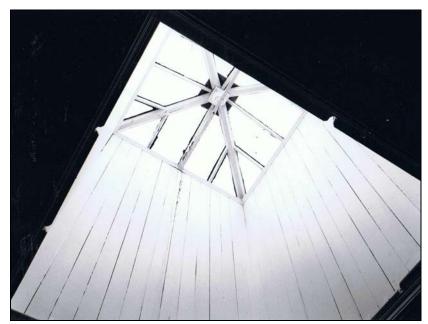
Plate 55: view of the central pyramidal roof light and boarded light well, from the south-west

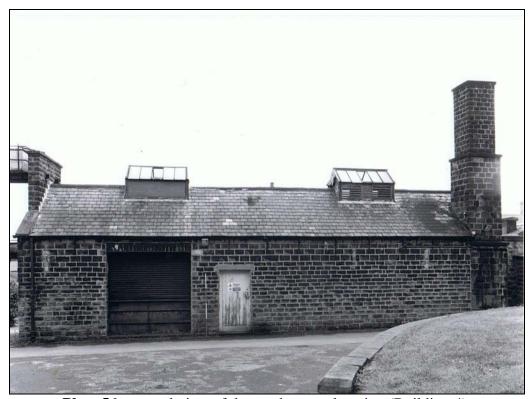
Plate 56: general view of the north-west elevation (Building 4), from the north north-west

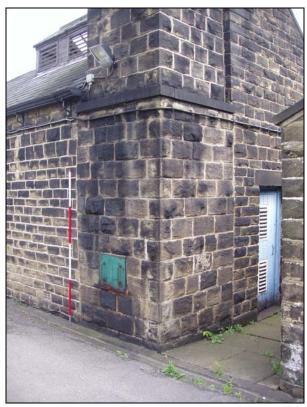
Plate 57: view of the base of chimney [42], from the south-west

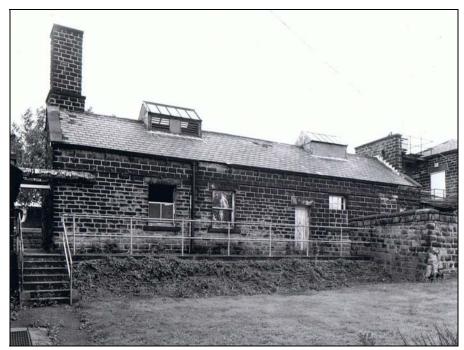
Plate 58: general view of the south-east elevation of Building 4, from the south

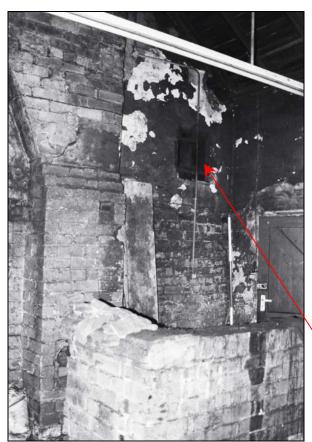
Plate 60: view of the south-west wall with chimney breast and a cast iron insert [49], from the east

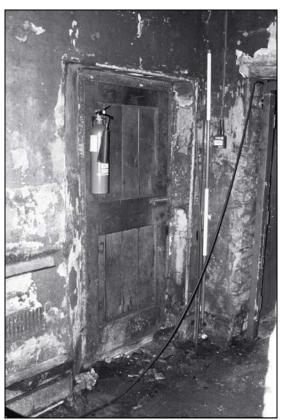
Plate 61: view of the front door to the south-east wall, from the north

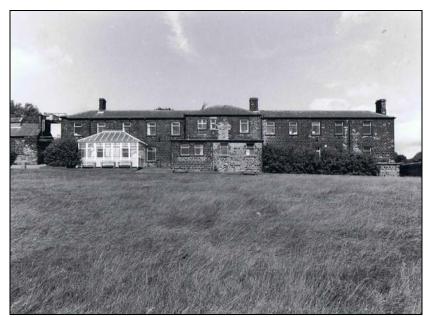
Plate 62: general view of the front south-east elevation, from the south-east

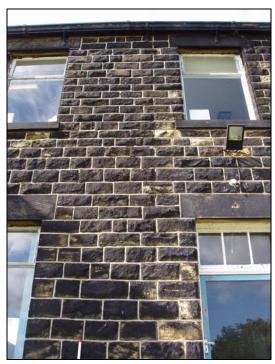
Plate 63: view of the building line between the *Infirmary* (Blg. 5) and the *Isolation Hospital* (5a), from the south-east

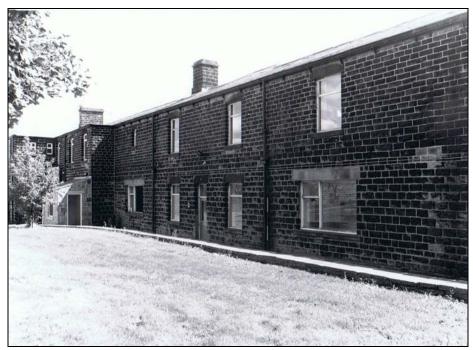
Plate 64: oblique view of the north-west elevation (Building 5), from the west

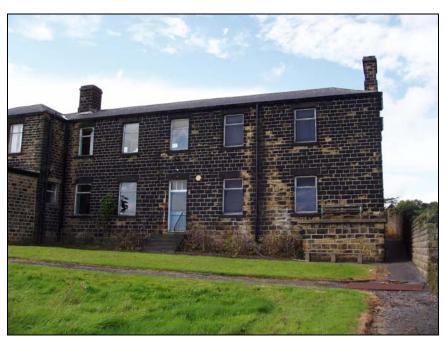
Plate 65: view of the *Isolation Hospital's* south-east elevation (Building 5a), from the south-east

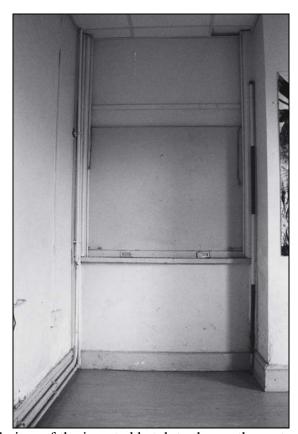
Plate 66: Detailed view of the inserted hatch to the north-west wall, from the south

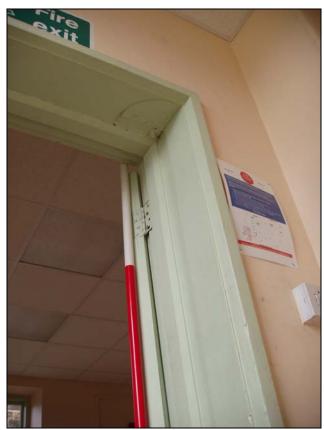
Plate 67: detail of the circular grove from a swing door, from the north-east

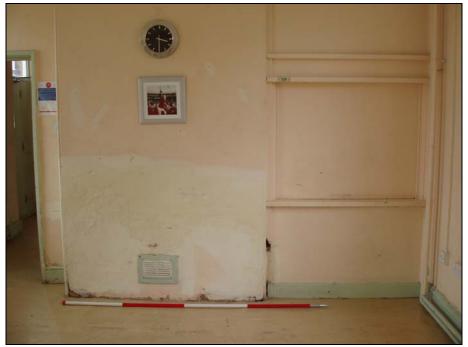
Plate 68: view of the south-west wall with blocked fireplace and inserted stud wall and large hatch, from the north-east

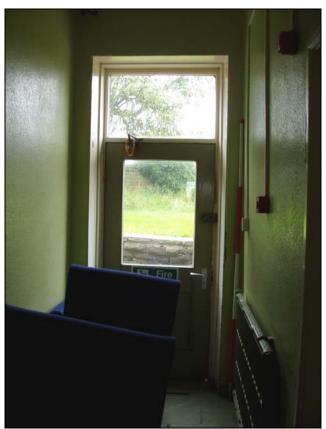
Plate 69: general view of the rear door to the north-west wall, from the south-east

- 7.6.2.8 Room 13 (*l* 8.25m w 6.04m x h 2.23m) is currently used as a computer room, it is in good condition but obscured by modern furniture (Plate 69, 243). Access is from the hall via a central doorway to the south-west wall and a further doorway leads to what was a small toilet (building 5b). There is a carpet covered timber floor, plastered walls and an under drawn ceiling which features two transverse beams. Modern lighting is provided by boxed multi-light fittings. Originally heated the blocked fireplace and chimney breast is extant to the centre of the north-east wall and has chamfered plasterwork to the edges. Natural light is provided by four original windows, two to the south-east wall and two to the north-west. Recent pelmets have been fitted above the windows.

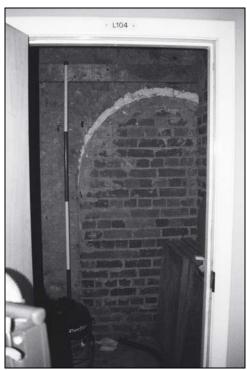
Plate 71: detail of the blocked arched probable stair window [53], from the north-west

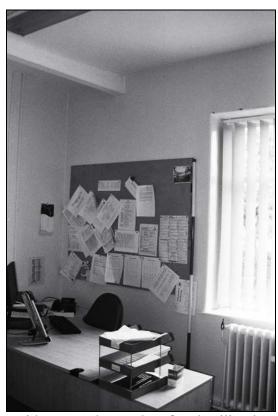
Plate 72: general view with exposed stop chamfered ceiling beam, from the north-east

- 7.6.2.14 Room 24 (*l* 3.5m *w* 2.9m *x h* 3.05m) currently functions as office accommodation. There is a carpet covered timber floor, plastered and papered walls and an under drawn ceiling with protruding, stop chamfered transverse beam (Plate 72, 272). To the north-east wall is a blocked fireplace set in an extant chimney breast with an inserted adjacent cupboard (Plate 73, 271).

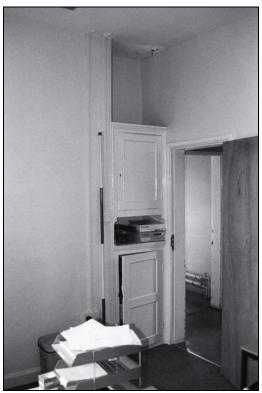
Plate 73: general view towards the fitted cupboards, from the south-west

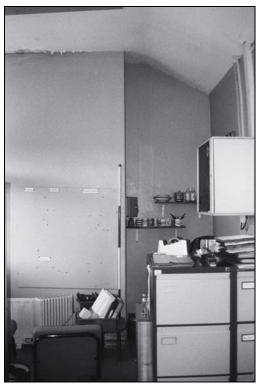
Plate 74: general view, from the north-east, from the south-west

- 7.6.2.15 Room 25 (*l* 6.1m *w* 4.5m *x h* up to 3.58m) has been annexed to form a corridor and offices but originally served as a heated *Ward* room. This is evidenced by a blocked fireplace and extant chimney breast to the south-west wall (Plate 74, 269). There is a linoleum covered timbered floor, plastered and painted walls with an under drawn ceiling with exposed beams. The beams reflect a hipped roof arrangement similar and reflecting the Room 17 ceiling. Unlike room 17 this room did form the end of the Infirmary (Building 5) and a hipped roof would therefore be expected.

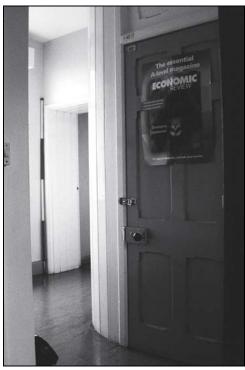
Plate 75: general view of the storage cupboard, from the north

- 7.6.2.16 Room 26 (*l* 2.05m *w* 6m *x h* 2.88m) currently and originally served as the first floor corridor and staircase [51] and is illuminated by windows to the south-east and north-west walls. It currently features a timber storeroom [57] to the landing. The storeroom is accessed via an original 6 paneled door with stop chamfer decoration, and has 3 tiers of shelves and internal dimensions of 0.98m x 1.37m. Its eastern corner is rounded to facilitate easy access around the landing and into timber stud wall and is externally finished with painted vertically placed tongue and grooved boards with skirting boards to complete (Plate 75, 267).

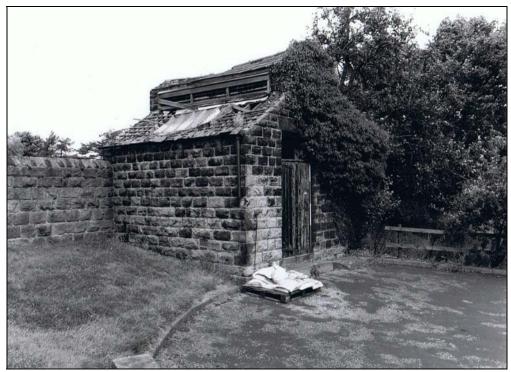
Plate 76: the gabled roofed mortuary house (Building 7) with a central ventilator and roof lights, from the south-west

reduce potential disease, avoiding dirt gathering ledges. Above the door is a door light. There are no other major openings, apart from the air bricks to the lower south-west and north-east walls. The slated gabled roof features top ventilator, the louvers were still in situ, and this was part of the original design. Internal illumination is provided by two 5-light skylights to the roof and featured clear in situ glass (Plate 76, 59). Close examination of the rear wall confirmed that the adjacent wall abutts the Mortuary house.

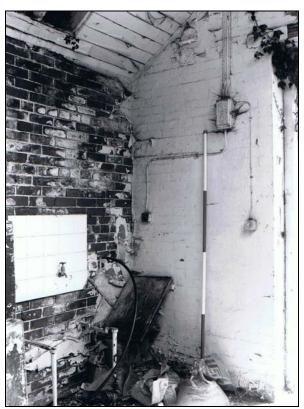
Plate 77: detail of the removed sink with drainage board, from the north-west

- 7.7.2.1 Room 1 (*l* 3.68m *w* 3.35m *x h* 3m) this is the building's only internal space and featured a mortuary slab along the south-west wall. The walls are lime washed brick which formed the original surface treatment. To the lower walls are four air ducts, two to the south-west wall and two to the north-east wall, all furnished with cast iron vertical grills. The ceiling is still in situ and consists of lime washed timber boards beneath the rafters and across the . To the north-east wall a sink had been inserted, the remains of which are still extant (Plate 77, 60). The solid floor has a cement skim which has been painted red, underlying the skim is a concrete base. This has been removed but the horizontal wall rebate and brick plinth scars to the south-west wall can still be discerned (Plate 78, 61). There was no original heating but electricity was connected and a fuse box and associated wiring is still extant to the south-east wall (Plate 77).

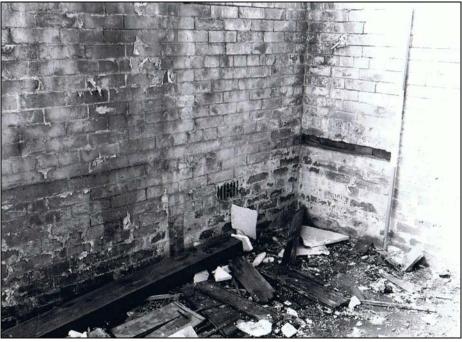
Plate 78: view of the removed stone mortuary table from the south-east

- 7.8.1 Building 7, the External Elevations
- 7.8.1.1 It has coursed sandstone walls with arrissed corners, and a slate gabled roof (Plate 78, 57). The only opening is to the front south-east elevation, and consists of a garage style double plank and Z battened doors with a door lights above. Either side of the doorway were two sets of hinge stone, these were examined but no evidence for a mortices or hinges was found.

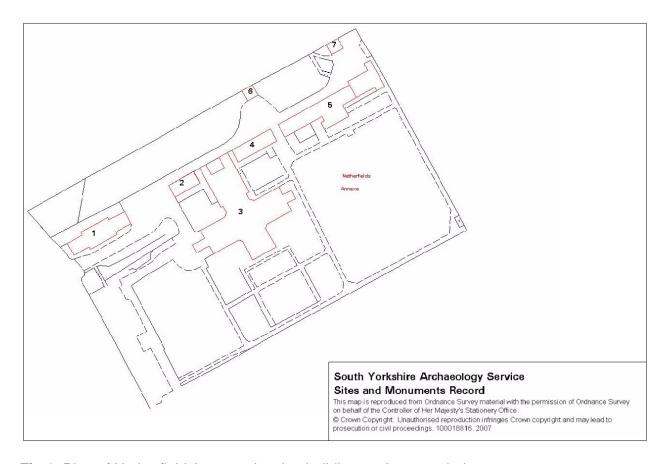
Fig 1: Plan of Netherfield Annexe showing buildings to be recorded

(See **fig. 1** for building plan)
