ST WILFRID'S CHURCH, BRAYTON,  
SELBY, NORTH YORKSHIRE

ARCHAEOLOGICAL ASSESSMENT  
OF PROPOSED EXTENSION

Report no	2000/121 R01
Version	Final
Date	January 2001

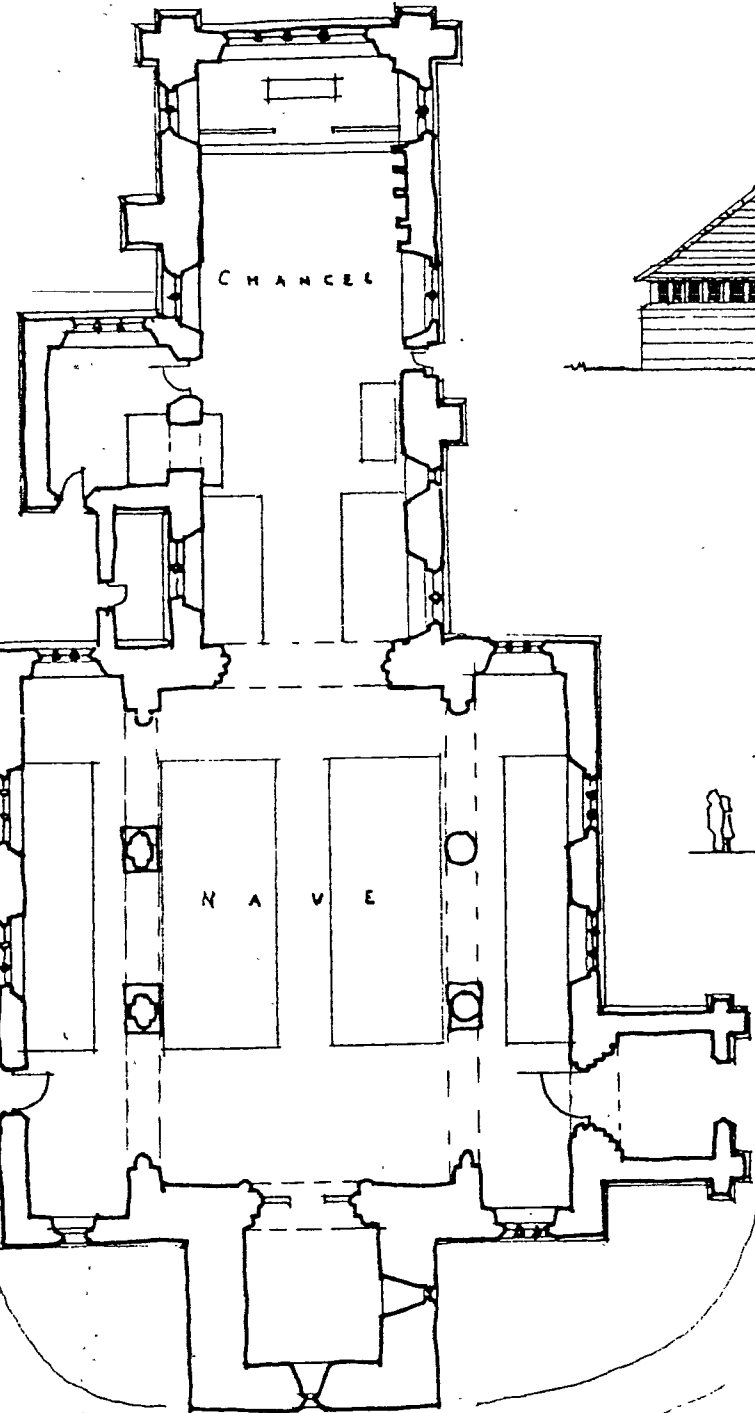
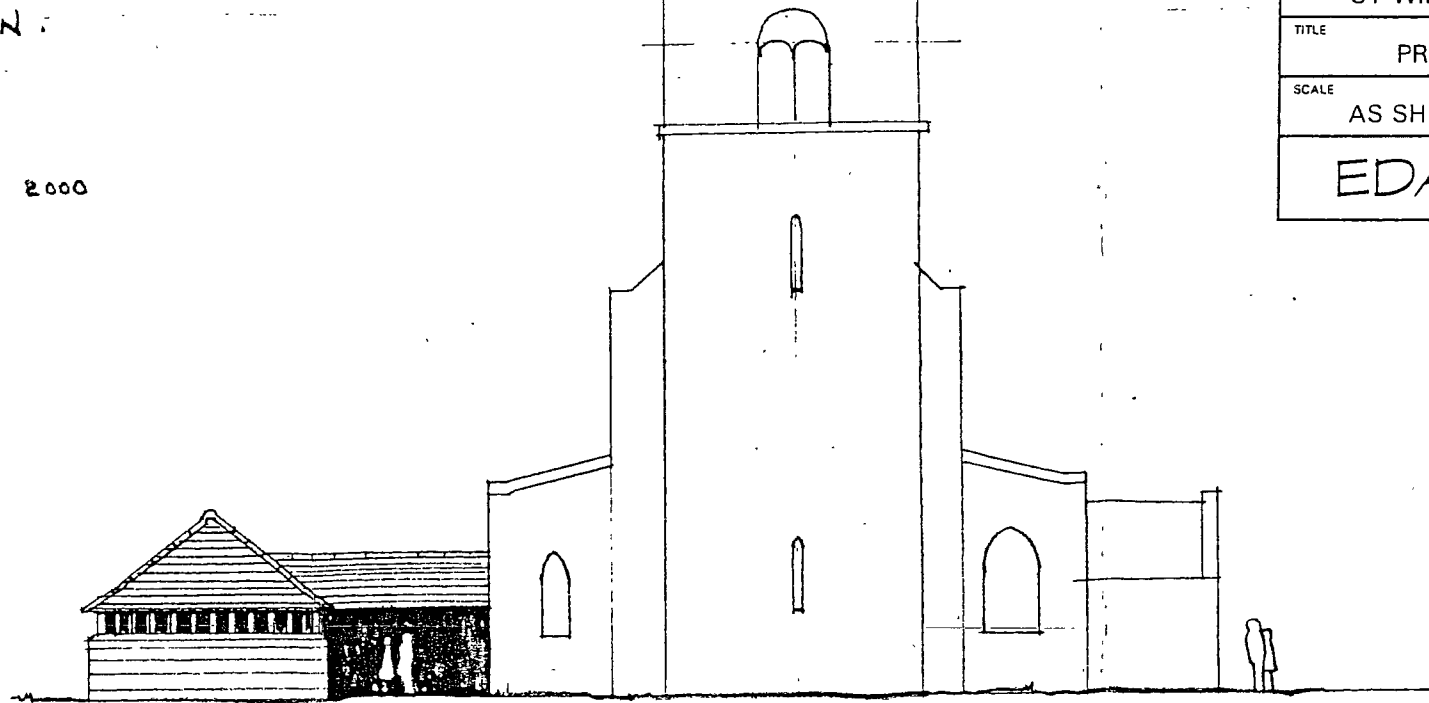
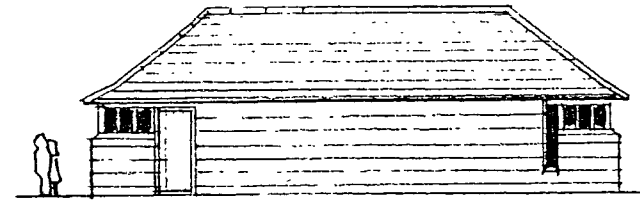
PROJECT		ST WILFRID'S CHURCH, BRAYTON	
TITLE		PROPOSED DEVELOPMENT	
SCALE	AS SHOWN	DATE	JAN 2001
EDAS		FIGURE	4

ST. WILFRID'S CHURCH BRAYTON.  
 PROPOSED EXTENSION CHURCH HALL.  
 PETRA GAZE PACE AADIP: FSA. RIBA.  
 SCALE 1:200 MARCH 2000. REVISED MAY 2000

GROUND PLAN.

WEST ELEVATION

NORTH SIDE OF HALL.

- PROPOSED HALL:
- WALLS IN MAGNESIAN LIMESTONE TO MATCH CHURCH
- ROOF WELSH SLATE TO MATCH NAVE ROOF
- WINDOW FRAMES IN OAK
- FULL DISABLED FACILITIES.
- AMPLE CAR PARKING ADJACENT THE RECTORY.
- NEW BUILDING NOT VISIBLE FROM MAIN ACCESS TO CHURCH.
- GLASS LINK BETWEEN EXTENSION AND NORTH AISLE OF CHURCH.

- 7 1 The proposed works involve the construction of a new hall on the north side of the church (see figure 4 and plates 3 and 4) This new building will be single storey, aligned parallel to the church and will measure approximately 14m by 6m It will be constructed of Magnesian limestone to match the church and the hipped roof will be of Welsh slate to match that of the nave Access from the church will be achieved through the existing doorway at the west end of the north aisle (see plate 2) via a single storey glazed link some 4m long In addition to the hall the new building will contain an office kitchen and WC facilities

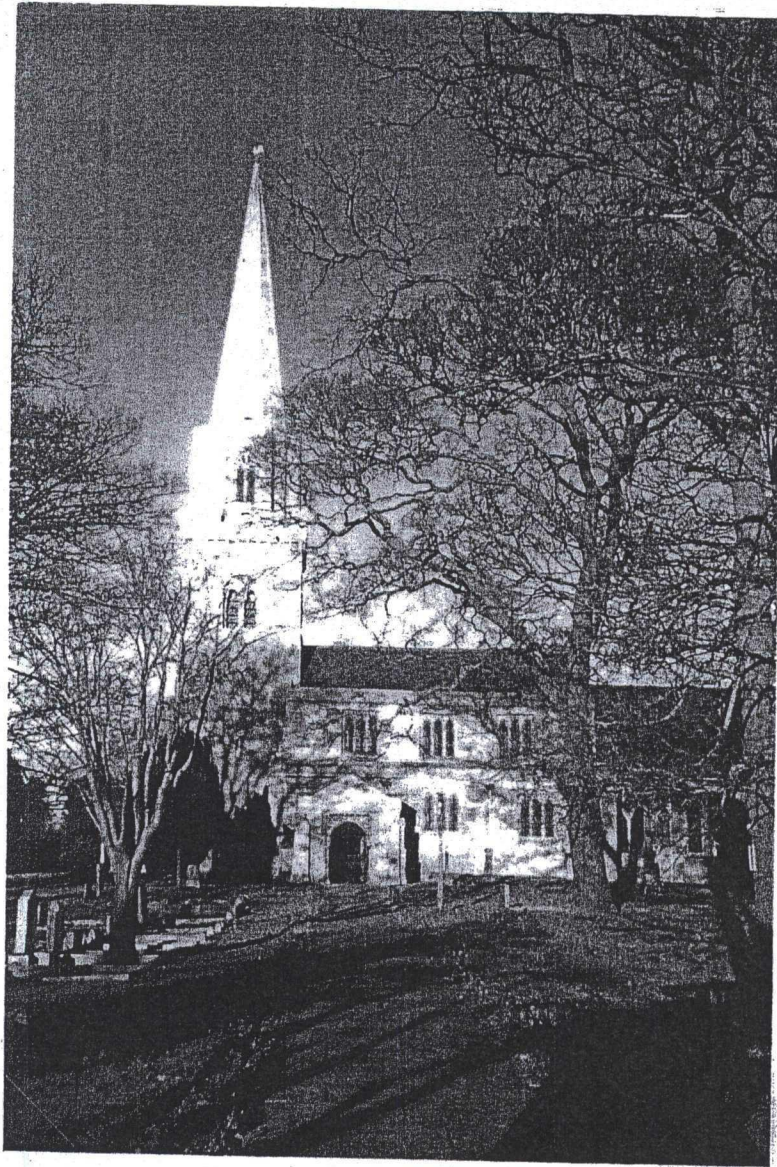
Plate 1: General view of St Wilfrid's church,  
looking north

- 5 2 The three stage crenellated unbuttressed Norman tower at the west end of the church has central slit windows in the lower and central stages of the west elevation. The upper stage has two-light belfry windows to all four elevations, and a continuous billet frieze at impost level rises above the belfry windows to form hood-moulds. The tower is surmounted by a 15th century octagonal lantern with narrow two-light belfry windows in four of the eight sides (see plate 1). The lantern itself is crowned by a slender octagonal stone spire.

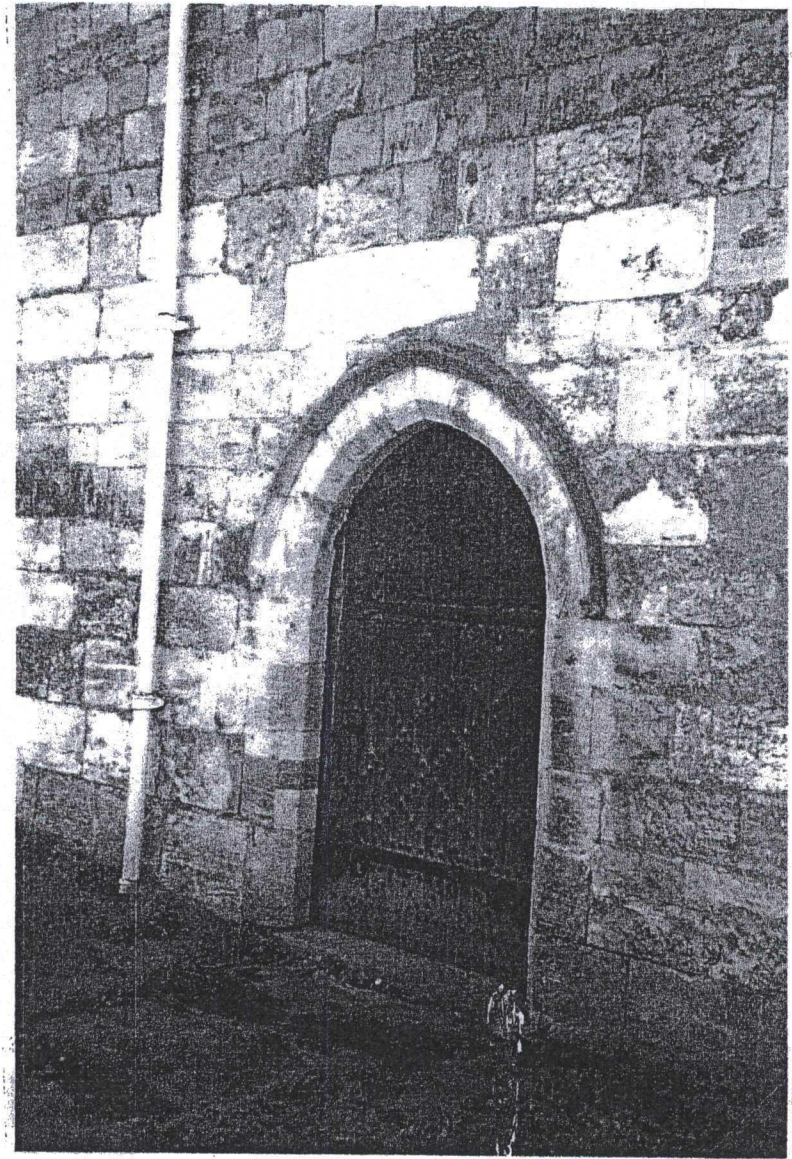
Plate 2: External doorway at west end of  
north aisle

- 8 6 The proposed access to the new building will use the existing doorway in the west end of the north aisle (see plate 2). It is understood that no significant disturbance to this fabric will be required and so no pre-development recording is considered necessary at this stage.

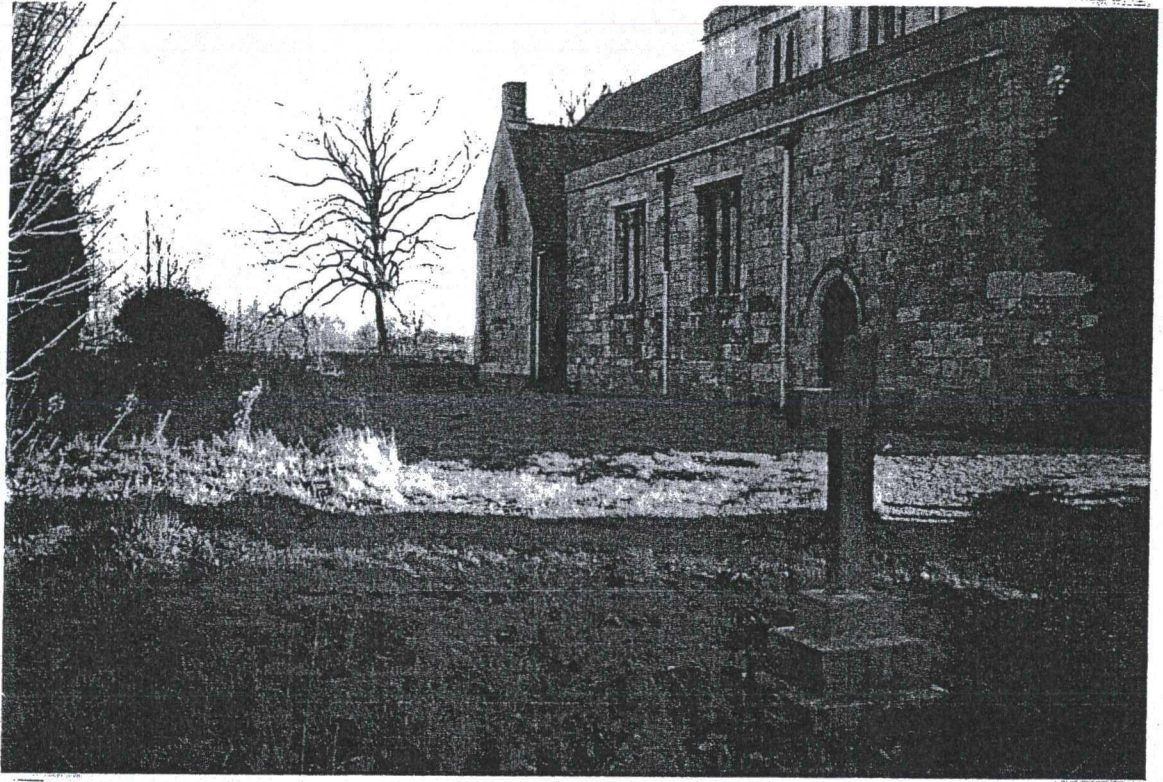
Plate 3: Location of proposed extension, looking south-east

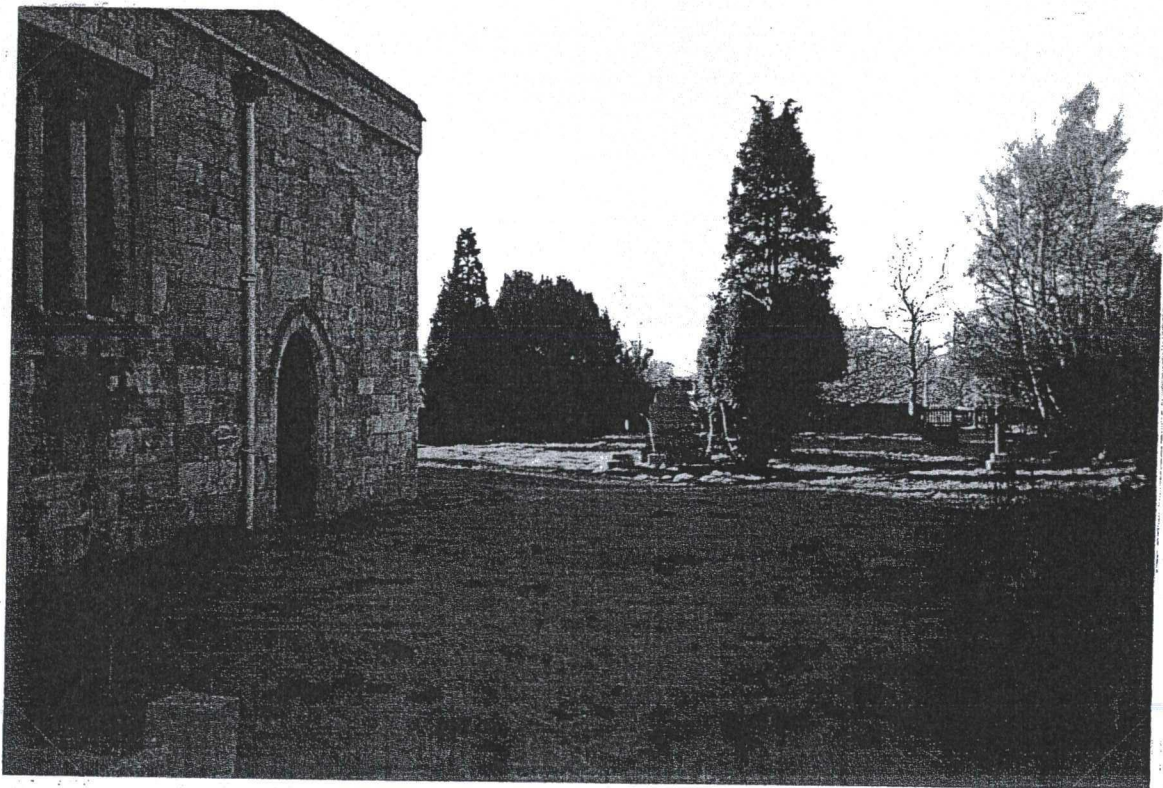
Plate 4: Location of proposed extension, looking south-west
