## 6. 1994 - (2)

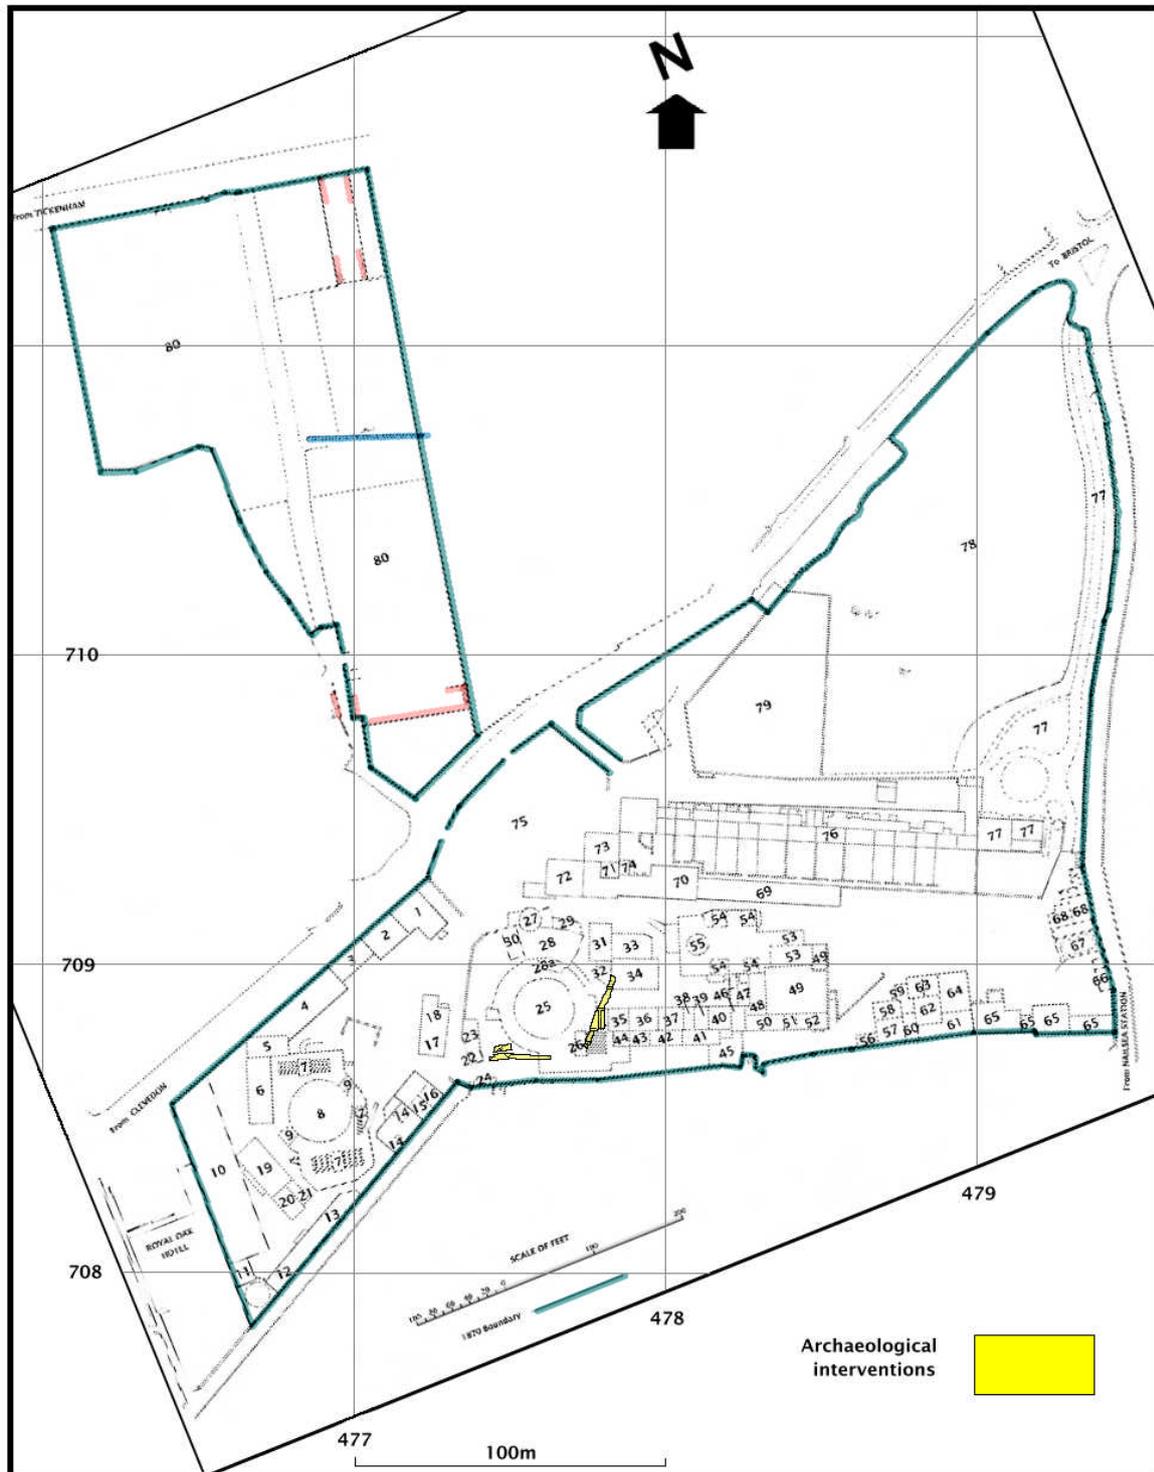
Figure 2.24: 1994 evaluation superimposed on 1870 plan

no evidence for something similar in Trench 2. The 1870 drawing does seem to be reasonably accurate, both when compared with later OS maps and with the archaeology found so far.

For ease of plotting the 1870 plan used has been reduced from its original size of approximately 1.2m square to a 1:1500 scale, but it is felt, by boundary comparisons, that any error is still

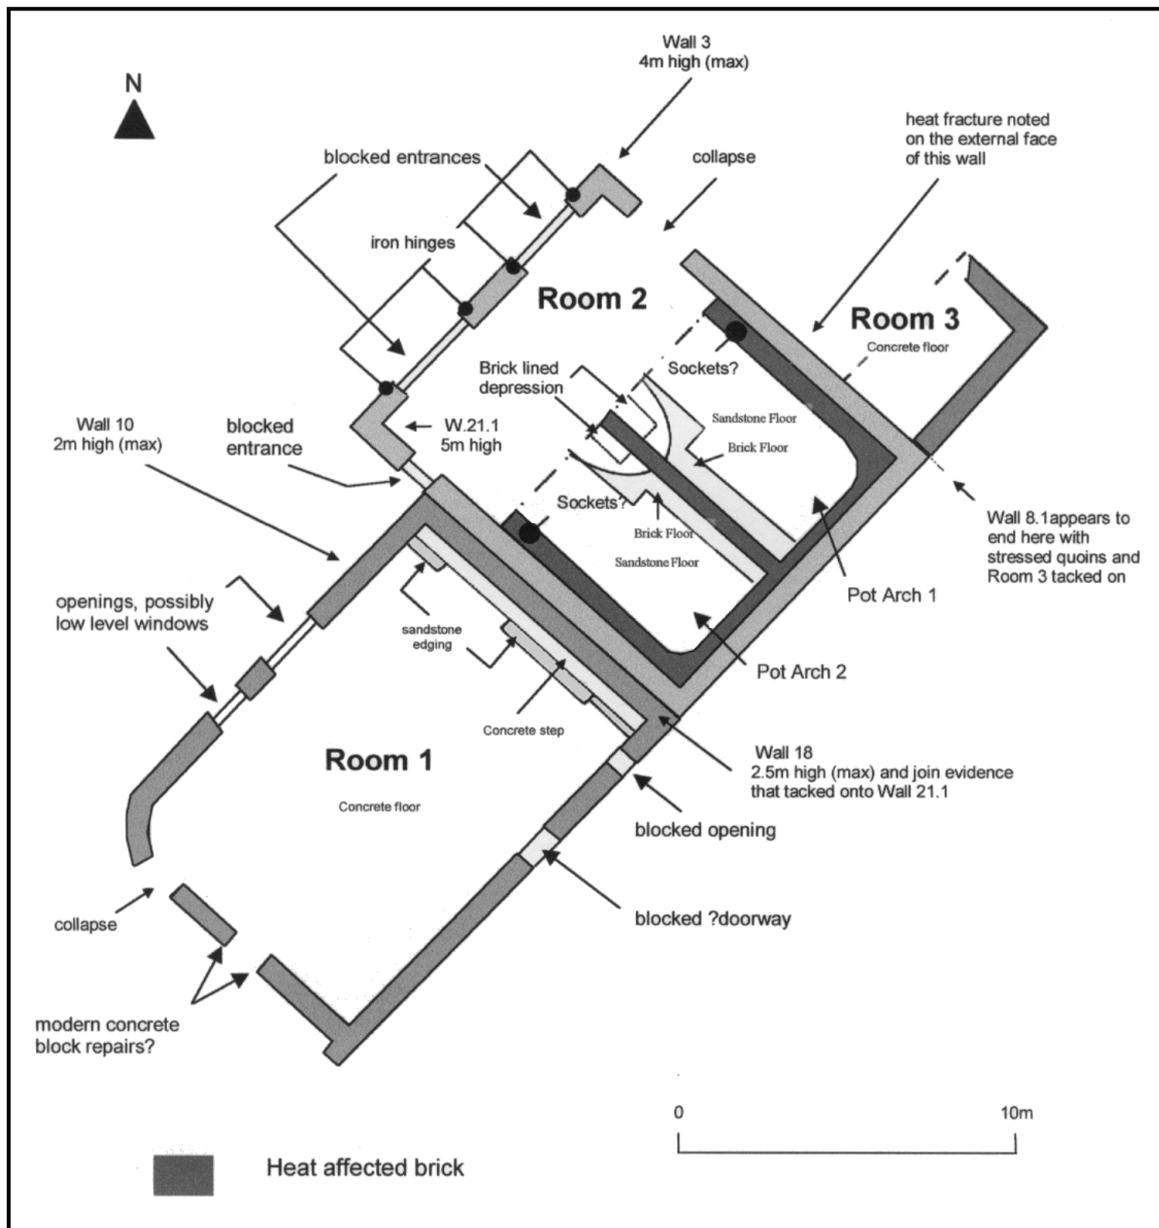
corner, other than being identified as an individual wall, but this would appear merely to be part of the recording technique, in which each section of wall is given a different identifier for both the external and internal faces.

**Figure 2.25: Schematic Plan of Rooms 1 - 3, detailing blocked openings (from Figure 3 in original report)**

Room 1 seems to have been cleared to floor level, and it was noted that, “A small area of sandstone slabbed edging, located along the western face of Wall 18 (figure 3) [see Figure 2.25 below], appeared to indicate that the floor had originally been paved throughout. These sandstone flags, however, appear to have been superseded at a later date by a simple concrete floor. N.B. Although this room is supposed to be a ‘French Kiln’ room, no surviving indication of these structures was observed.”

From what was left of the building it was difficult to determine phasing, but it appears from the discontinuities, both vertical and horizontal, as well as from blocked openings that the buildings had been altered probably more than once during their lifetime. There is further detail in the report regarding blocked window, door and other openings. Room 1 was described as having been a “workshop” in one of the early reports, but it also seems to have been a dump for spoil as well, at a later stage. There was, for example no comment on the “chamfered” western
