PYE WAREHOUSE, FLEET SQUARE, LANCASTER, LANCASHIRE

Archaeological Building Recording

Client:
Lancaster and District YMCA

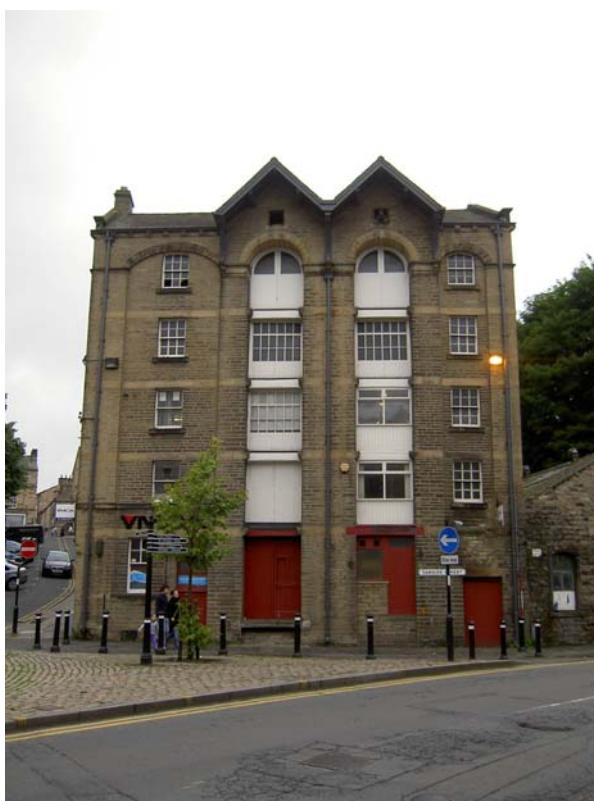
Plate 11: North elevation, Fleet Square

4.2.1 **North elevation:** this five-storey elevation of the building fronts onto Fleet Square (Plate 11; Fig 2). This side of the building is dominated by two rows of loading doors arranged in pairs on each floor. There are moulded kneelers at sill level of most of the loading doors on the upper floors, which presumably originally supported a timber footplate or shelf. The loading doors are set within two recessed areas either side of central cast iron drainpipe with square hoppers. There are windows located either side of the recessed areas on the top four floors of the building and doorways on the ground floor, as described in more detail below.

4.2.2 On the ground floor, the north-east corner of the building is chamfered with 'lamb's tongue' finish. To the east of this there is a five-light (four-over-one) sash window with horns. The window frame has a continuous lintel and chamfered sill, which turns into the lintel for a doorway with a timber door to the west. The door has two moulded and chamfered panels below a three-light over-light. There is a loading door centrally located within the eastern recess, to the west of this door. This has a timber lintel and sill with rounded corbels projecting from the stringcourse at lintel level. The doorway now houses a double door, one half of which is made from small planks and the other a mix of planks and panels. The timber sill has a step below it forming the lintel to the entrance to the basement, which is blocked with brick and concrete blocks. There is a further opening to the basement below the east window covered with an iron grill. A stone-lined opening to the basement in the pavement in front of the loading door has been filled with concrete. There is a cast iron drainpipe with square hoppers at either side of the elevation, extending to the roof. To the west, there is a second loading doorway, which has been mostly in-filled (to the basement) leaving a plain door and a very modern single-light window with a timber lintel. There are no rounded corbels above this loading doorway. There is an iron sign for 'DAMSIDE STREET' attached to the ground floor to the west of the loading doors. There is a further small door at the far west end of the north elevation on the ground floor with a plain dressed lintel and tongue and groove plank door.

4.2.3 On the first floor there is a small two-light window on the east side of the loading doors. It has a sliding sash casement with horns and stone sill and lintel bands. Attached to the building below this window is a modern, moulded lettering spelling out 'YMCA'. There are two central loading doorways with timber lintels, one of which has wear marks, presumably caused by rope or chains from the hoists on the top floor. Both loading doors have rounded corbels from the lintel band. The door in the eastern doorway is plain and made from small planks. Planks also form the lower part of the door in the west doorway with a four-light fixed casement window forming the top section. To the west there is a small 12-light sash window with horns, stone sill and lintel band.

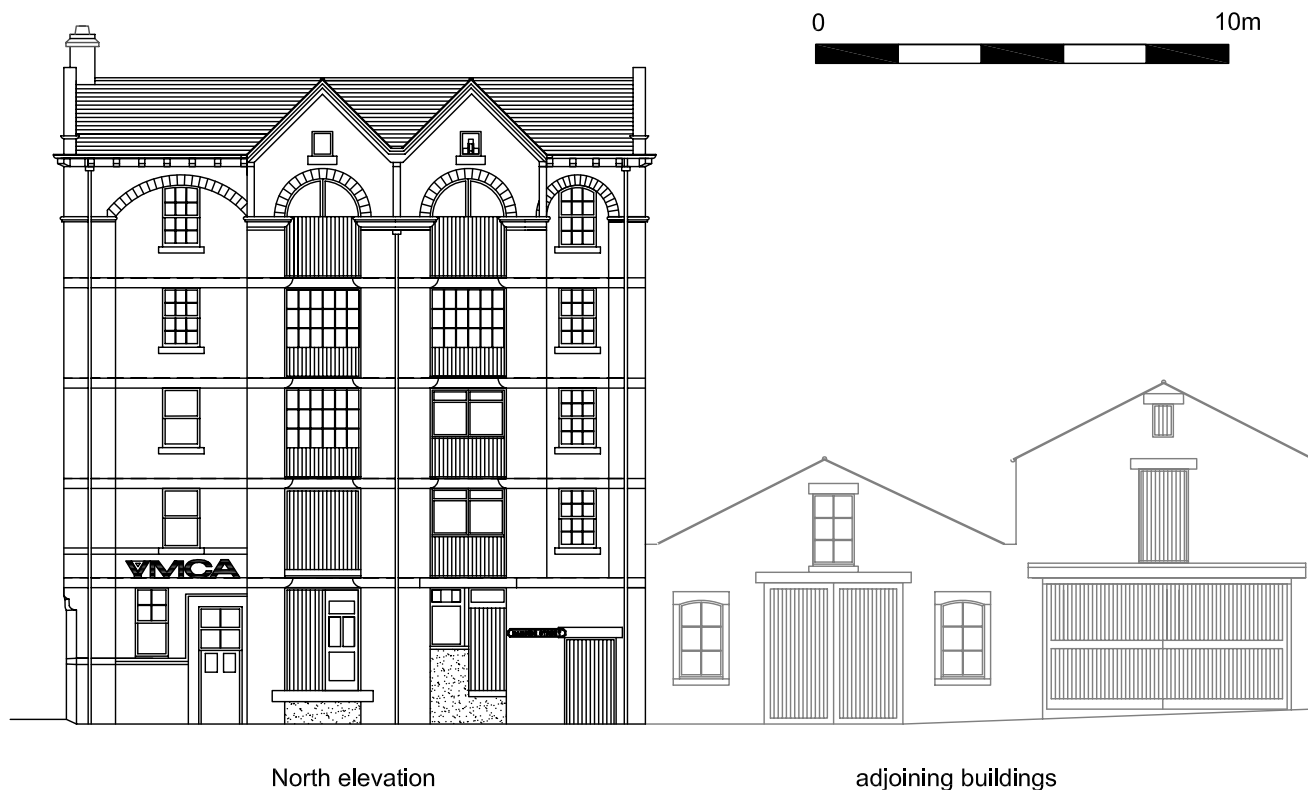
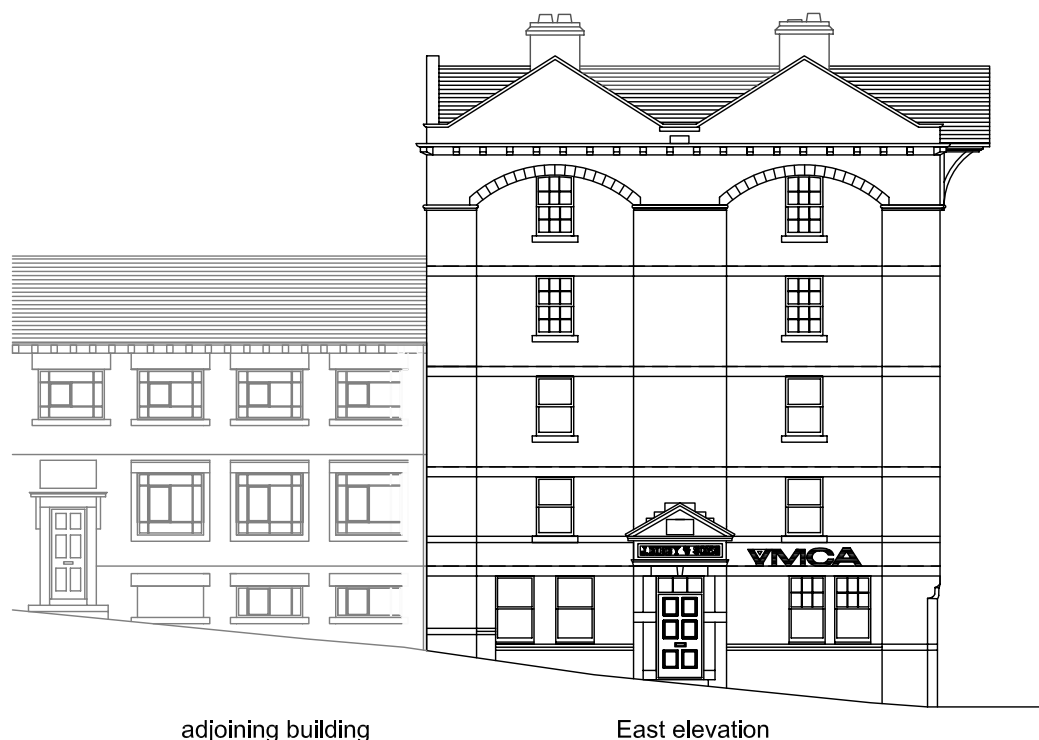
North elevation

East elevation

4.2.7 **East elevation:** again, five storeys of the building are visible on the east elevation. There are two recessed areas with rounded, arched tops and a cavetto-

moulded band either side of centre. The recessed areas contain windows, which face onto New Road (Plate 12; Fig 2).

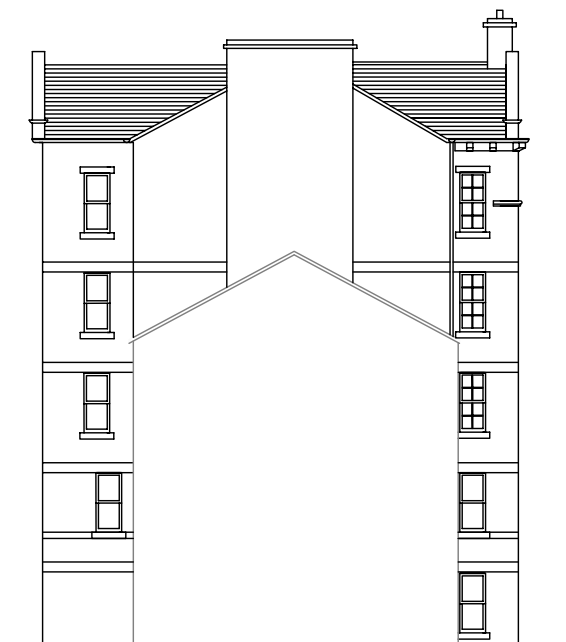
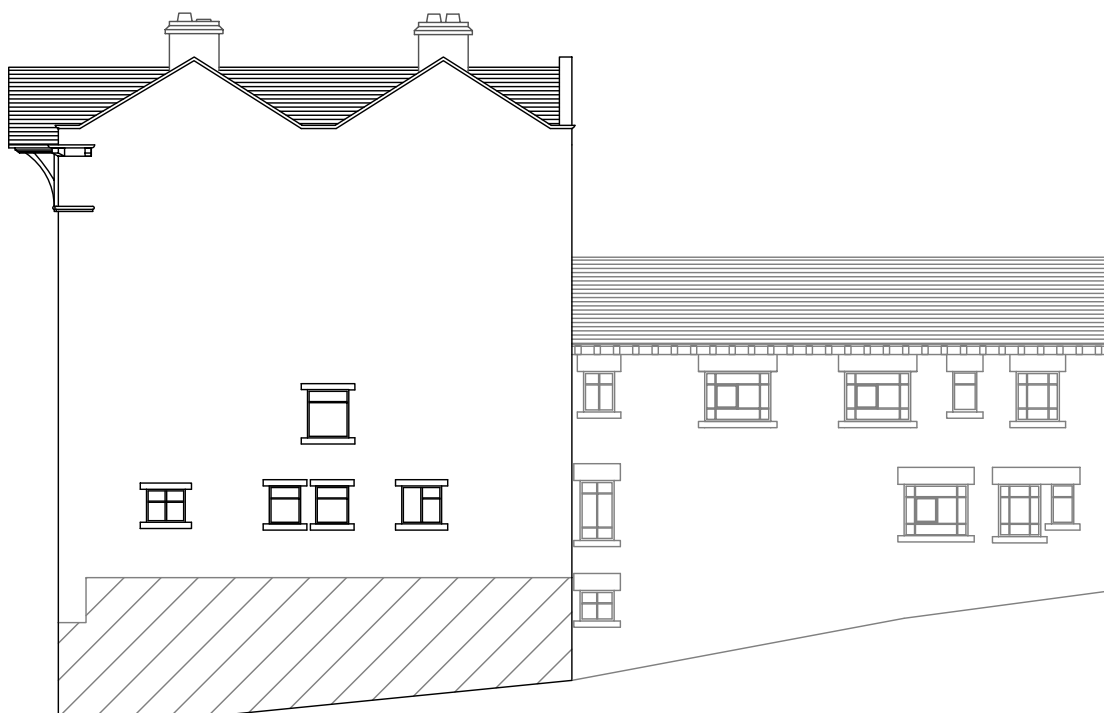
Figure 3: South- and west-facing elevations

South elevation

West elevation

4.2.10 **South elevation:** most of the lower three storeys on the south elevation of the warehouse are obscured by an adjoining building, and it was not possible to access the western side of this part of the building (Plate 14; Fig 3). The roofline forms a single large gable with flat coping and has a central large chimneystack, also with flat coping, coming down onto the centre of the adjoining building's gabled roof. There is a row of narrow windows, one per floor on the east side of the south elevation. The ground floor window is covered by metal mesh. The first floor has a two-light, fixed, frosted window. The second floor has a two-light sash window with horns. There is a four-light sash window with horns on each of the third and fourth floors. There are flush neatly-dressed lintel bands up to the third floor. There is a moulded band extending around part of the fourth floor and moulded guttering on two

semi-circular corbels. The west side of this elevation was not accessible during the building recording but apparently has a single two-light window with a relatively modern hinged timber casement on each floor (Fig 3).

4.2.11 **West elevation:** a garage butts against and obscures the ground floor and much of the first floor of the building when viewed from street level (Plate 15; Fig 3). There is partial continuation near the roofline and on the fourth floor of the string coursing in the north elevation. It does not continue all the way round the building, perhaps suggesting that originally another building might have butted against this elevation, although it could simply be matching the opposing elevation. There is no evidence externally for what were thought to be blocked doorways and windows when the building was viewed from the inside (see *Section 4.3.7*). There are no other structural details such as windows or guttering on either the third or fourth floors. There is a single two-light hinged window visible on the second floor, which has a squared, worked sandstone lintel and a plain timber frame. There are four more windows on the first floor, two with three-light hinged casements and two with two-light hinged casements, all of which are relatively modern. The double gables forming the west elevation are not symmetrical and are towards the south. The gable has a flat coping with ovolo-moulded lintel and there are kneelers to the north elevation.

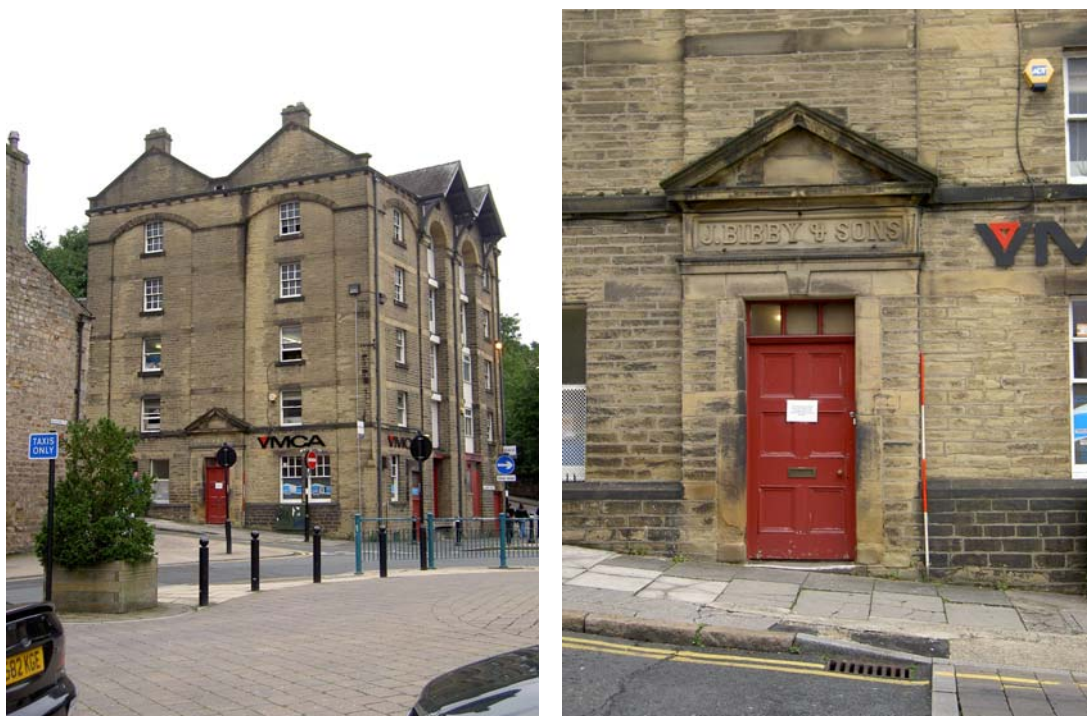
Plate 12: (left) East elevation, facing onto New Road

Plate 13: (right) The main entrance onto New Road

4.2.8 There are two pairs of windows either side a central door on the ground floor. The windows have neatly dressed lintels forming a continuous band with chamfered sills rising up on the south side to form the sill of the ground floor window in the south elevation. The windows on the south side are two-light sash windows with mesh over the lower light and there are iron spikes on the sill. The windows on the north side are seven-light (six-over-one) sash windows with horns. The central door has a moulded pediment and carved plaque reading 'J. BIBBY & SONS' below (Plate 13). The doorway has rounded neatly dressed jambs and a lintel incorporating a triangular keystone. The moulded six-panel door is possibly original. There are moulded plastic letters spelling 'YMCA' attached to the wall over the north window.

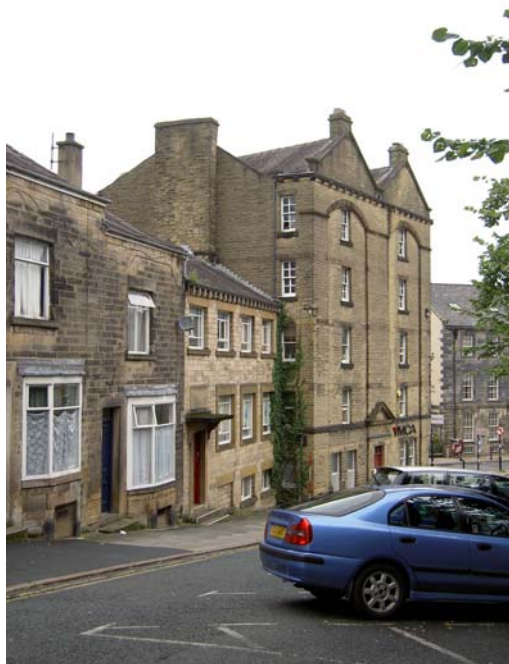
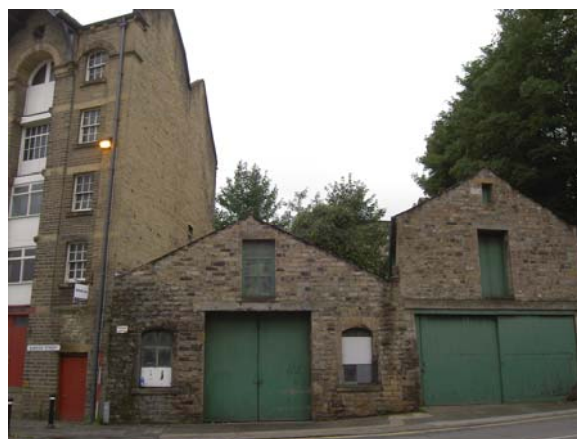
Plate 14: (left) South and east elevations, with adjoining buildings to the south

Plate 15: (right) The west elevation is partially obscured by garages when viewed from street-level

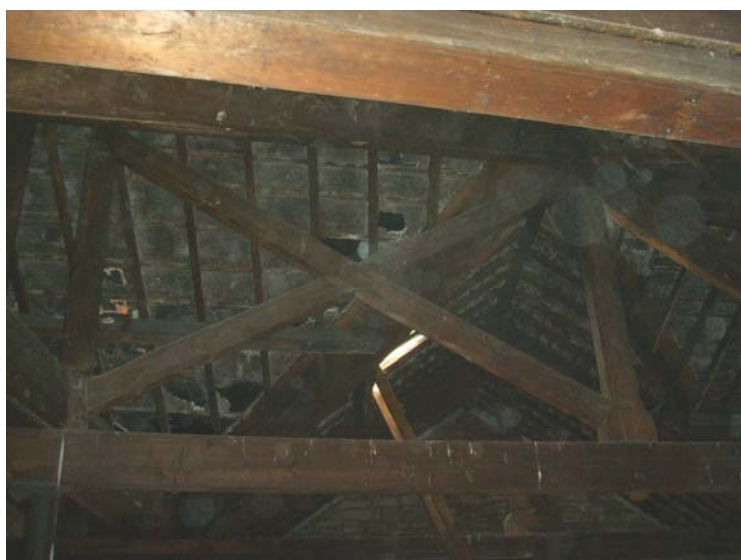
Plate 18: Crossed angled braces within the roof structure

not used as such in most cases, which are bolted to the beams and slightly joggled to meet the principal rafters, which are also bolted to the beams (Fig 7). In each case the paired trusses share a single beam (Plate 16). The beams in turn are supported by a single iron column (Fig 7), which is very plain, with a rectangular plate on the top and bottom bolted to the tie beam and through the floor to the beam below (Plate 17). The central truss has additional crossed angled braces providing a type of 'scissor brace' (Plate 18).

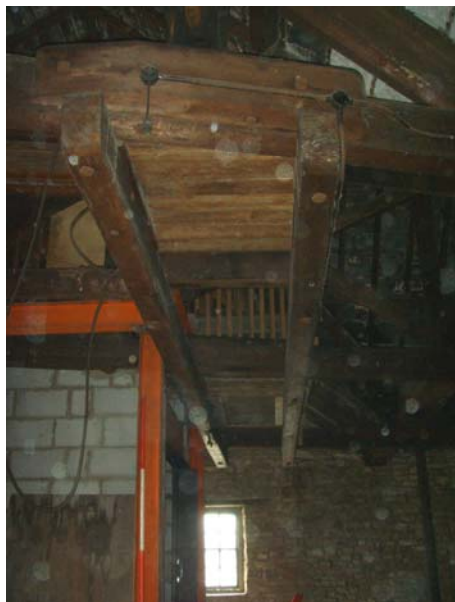
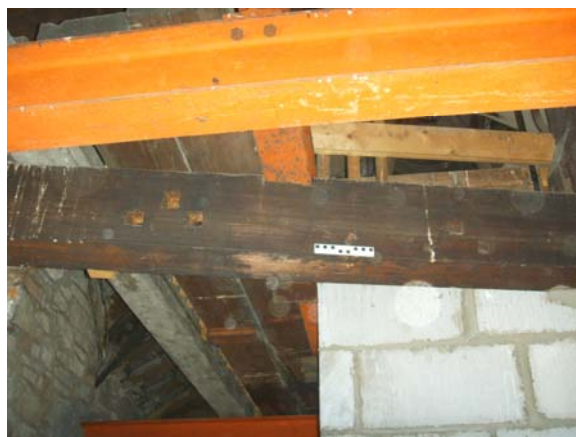
Plate 19: (left) Pair of east/west beams supporting a wheel and drum

Plate 20: (right) North/south beams where the main wheel of the pulley system might originally have been located

4.3.3 There is a complex arrangement of timbers attached to the roof structure on the north side of the room. On the west side there is a pair of beams orientated east/west supporting a wheel and drum (Plate 19), which would have formed part of the hoist or winching system. In the centre is a pair of simpler beams orientated north/south, which possibly originally supported the main wheel of the pulley system but which are now incorporated into the structure supporting the lift mechanism.

There are two groups of three holes visible to the west side of these beams, perhaps indicating where the main wheel was attached (Plate 20). On top of the east/west beams a small iron wheel with an attached timber drum (with iron chain wrapped around it) remains *in situ* (Plate 21); this has an associated iron release lever and a timber plank chute leads the chain from the drum to a pulley wheel that projects through a hole in the north elevation (Plate 22).

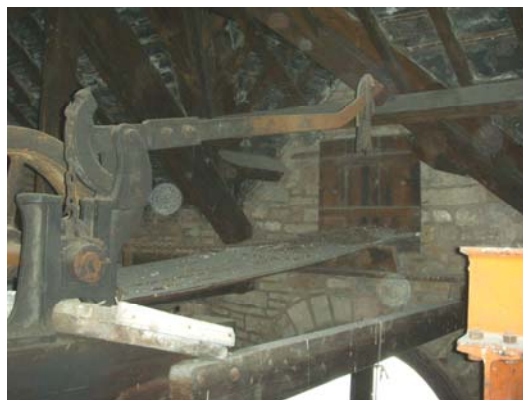
Plate 21: (left) *In situ* pulley wheel

Plate 22: (Right) Small hatch above the loading door through which chains would have passed for the pulley system

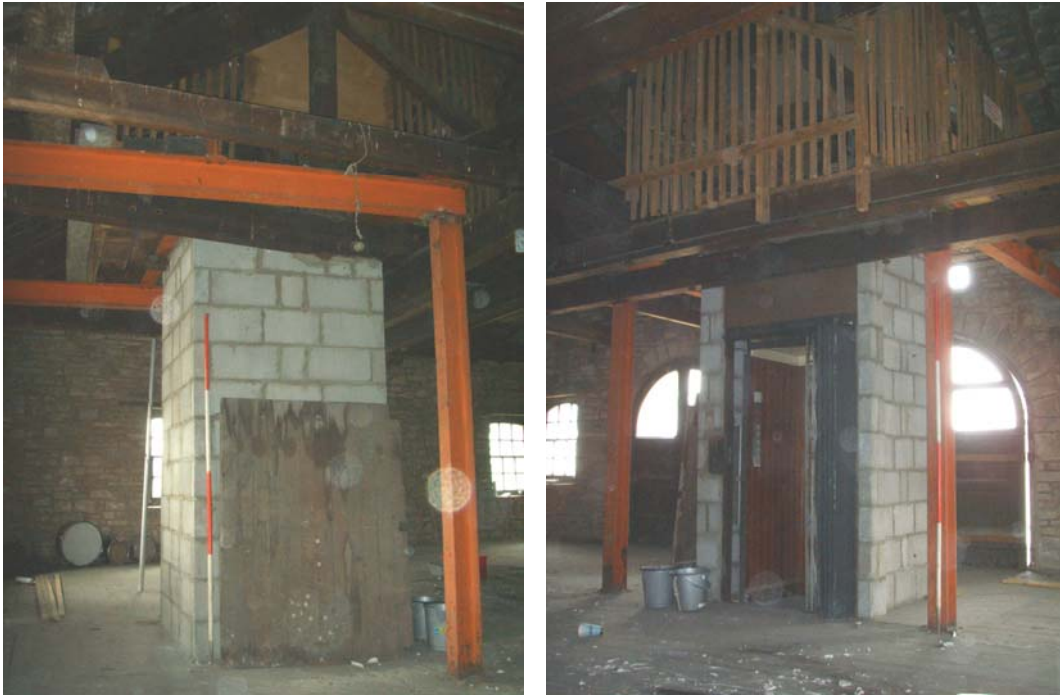
Plate 23: (left) I-beam structure built around the lift shaft

Plate 24: (right) Timber construction housing the lift motor

4.3.4 The lift shaft is a concrete block structure with a folding metal door on the south side. A sign inside the lift reads; 'ELECTRIC LIFT FOR 4 PERSONS OR 6 CWT LOAD HERBERT MORRIS LTD LOUGHBOROUGH ENGLAND'. There is an additional I-beam structure attached to the north wall, which is built around and supports the lift (Plate 23). On top of this is a timber structure of rather random construction with a 'fence' housing the lift motor (Plate 24).

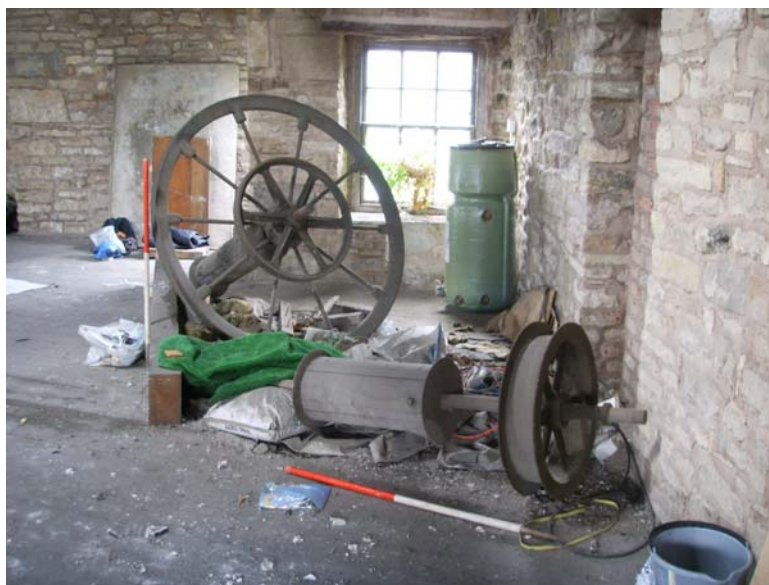
Plate 25: Loose pulley wheels from the hoist

4.3.5 There are two pulley wheels from the winching mechanism lying loose on the floor in the south-west corner of the room (Plate 25; Fig 8). The larger comprises two wheels attached to the same iron axel; the larger with a channel running around its entire circumference and ten spokes with fattened ends at the junction with the wheel rim, while the smaller has six spokes with slightly flared ends. There is a large timber drum attached behind these two wheels with metal plates at either end. The smaller wheel is attached to a separate iron axel and identical to the one still *in situ* (see Section 4.3.3 above). The smaller wheel has a wide wheel with five spokes with a flattened area, presumably to take a band, and a shorter drum behind.

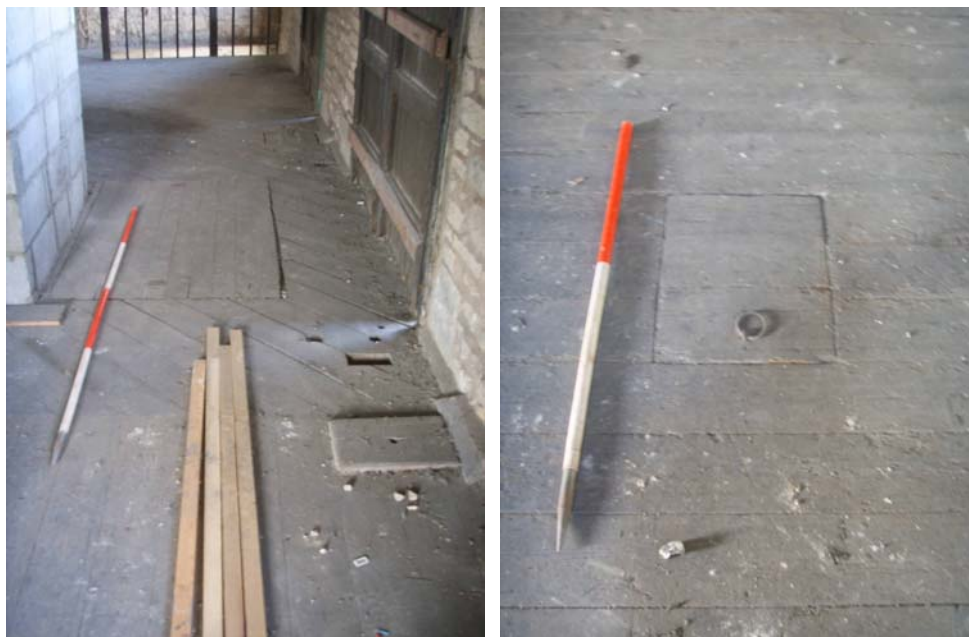
Plate 26: (left) View of the tongue and groove floorboards and large hatch on the north side of the fourth floor

Plate 27: (right) Small floor hatch on the south side of the fourth floor

4.3.6 There are several holes and hatches in the floor, including a larger one on the north side of the room (Plate 26) and a small one with an iron loop handle on the

south (Plate 27). The larger one has been partially utilised for the installation of the lift. Against the north elevation, in front of the loading doorways, a large area of the floorboards is set at a different orientation (north-east/south-west) to the rest.

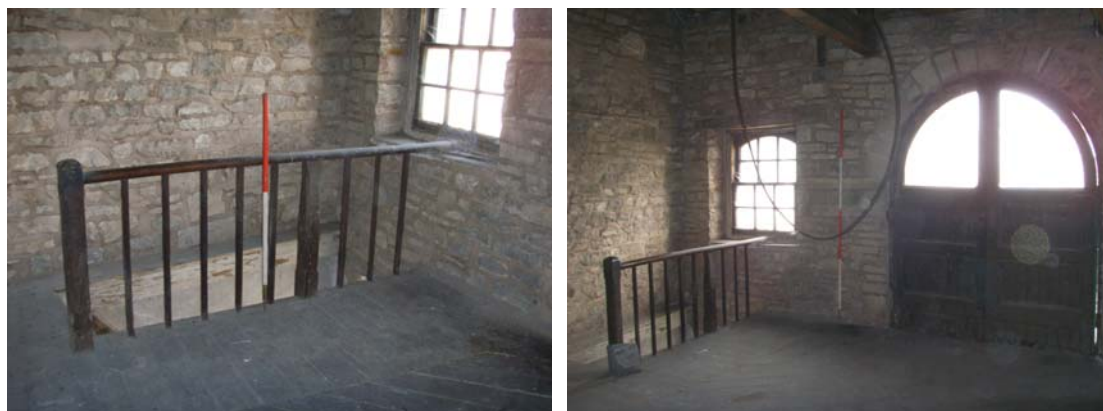
Plate 28: (left) Detail of the banister and spindles

Plate 29: (right) View of the west side of the north elevation showing the stairs, a window and a loading doorway

4.3.7 The stairs in the north-west corner of the room have a quite plain banister with square section spindles (Plate 28). The stairs have a rounded hand rail plinth, with a stop-chamfered post at one end and an additional fatter stop-chamfered post towards the centre.

4.3.8 All the walls are made of stone which is exposed and has been recently re-pointed. There are a small number of modern and earlier electrical fittings attached throughout. The north elevation has two 12-light sash windows at either end, either side of the two central loading doorways (Plate 29). The windows have a rounded head and beaded and ovolo-moulded surround and the sawn timber lintel has the remains of laths attached. The loading doors each have a rounded top and segmental arch doorway. The double plank doors have chamfered and stop-

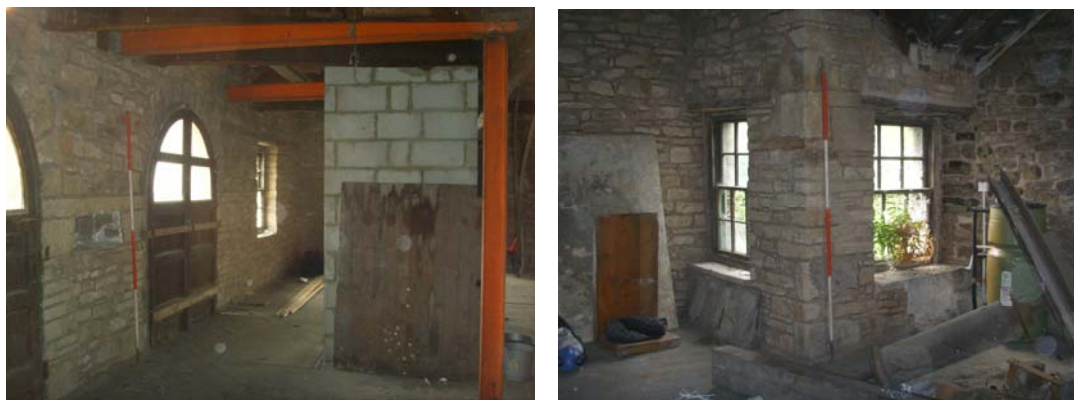
Plate 30: (left) Detail of the loading door and alcove in the north elevation

Plate 31: (right) Detail of the windows in the south-west corner

chamfered battens and the original bolts and bar supports (and one bar on the east one) (Plate 30). In the wall between the two loading doors is a shallow but long alcove with the remains of the original plaster and whitewash finish. In this area the floor changes to being diagonally set, north-east/south-west (Plate 30). There is a small hatch slot through to the hopper below.

4.3.10 The south elevation is relatively plain, although there is a small window on the east side with an eight-light sliding sash casement. In the centre there is a large alcove extending the full height of the wall, with some extremely neatly-dressed stone at floor level, and at the west side it returns and there are two windows in this section, both with 12-light sliding sash casements (Plate 31).

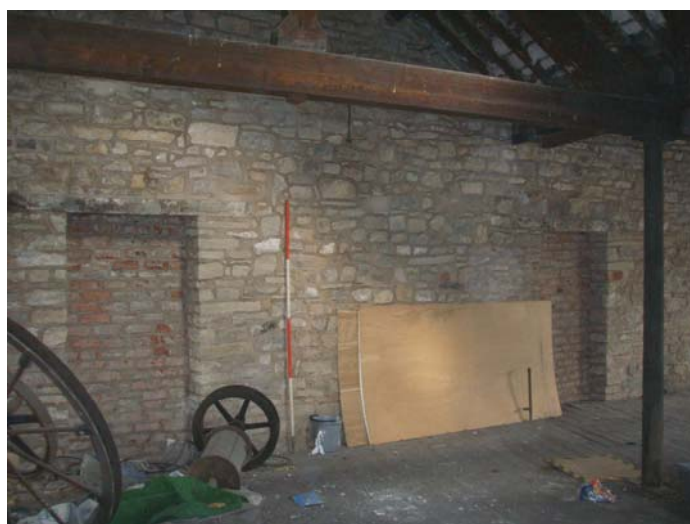
Plate 32: West elevation showing blocked 'apertures'

4.3.11 The west elevation is plain apart from two apertures, with sawn timber lintels, which have been blocked with handmade brick (Plate 32). The bricks are quite rough, dark orange-red in colour and typically measure 0.21m by 0.07m. Their sawn timber lintels again have laths attached to the undersides.

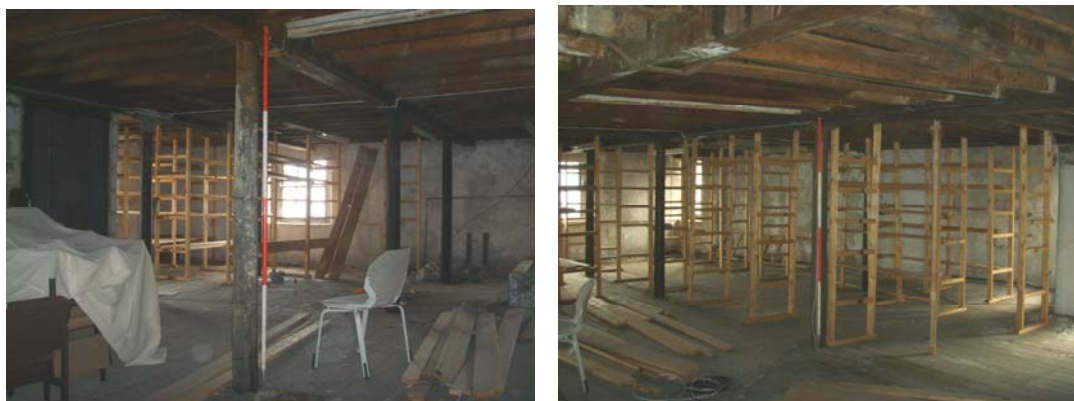
Plate 33: (left) General view of the north-east corner of the third floor showing the modern shelving and columns

Plate 34: (right) General view of the south-east corner of the third floor showing the modern shelving and columns

4.4.1 There is one main room on the third floor, which is currently filled with modern timber shelving attached to the ceiling and floor (Plate 33 and Plate 34). There are three main beams, running east/west, which support joists orientated east/west, which in turn support the floorboards of the floor above. There are a considerable number of joists visible in the ceiling, possibly twice as many as might have been expected, presumably as a result of the need to support particularly heavy loads on the fourth floor and to cope with the weight of drive-shafts at one time attached to the ceiling.

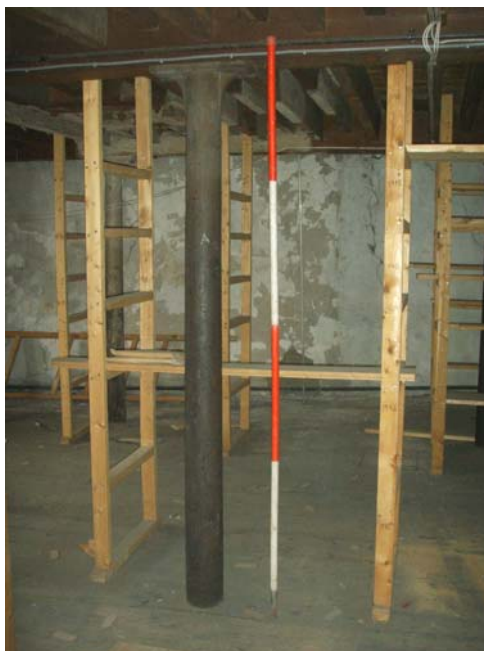
Plate 35: Detail of an iron column on the third floor

4.4.2 The beams rest on and are bolted to simple iron columns which in turn are bolted to the floor (Fig 4). The iron columns are similar but not the same as those on the fourth floor, with a similar diameter and length but with curved flanges at the top (for comparison, compare Plate 17 and Plate 35; Fig 8).

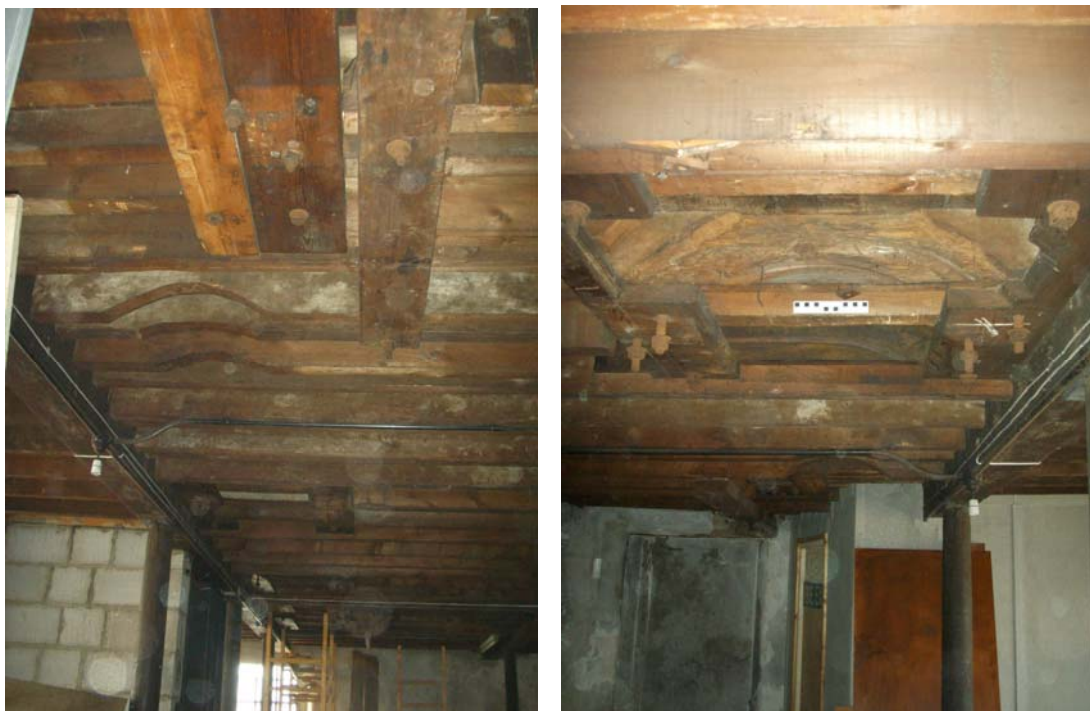
where drive shafts have been attached. There are scars visible within each pair of rows, where the wheels have rubbed against the joists: elsewhere the joists have purposefully been cut through to accommodate the band wheels. The north pair of rows is situated near to the south side of the lift shaft (Plate 36). It is made of two lines of short lengths of timber and bolts which are attached to the ceiling and run most of the width of the room. Some of the north/south joists have been cut in order to attach these modifications and there is an arch-shaped cut in the joists near the north-westernmost column on the front row of the metal columns, which is most likely to have been to accommodate a band wheel. There is some scarring on the joists almost immediately to the south-west of the lift shaft (Plate 37), again probably caused by a wheel rubbing against it.

Plate 36: (left) The front (north) row of attachments and scarring to accommodate a drive shaft, showing where the joists have been purposefully cut

Plate 37: (right) Scarring on the joists caused by rubbing band wheels

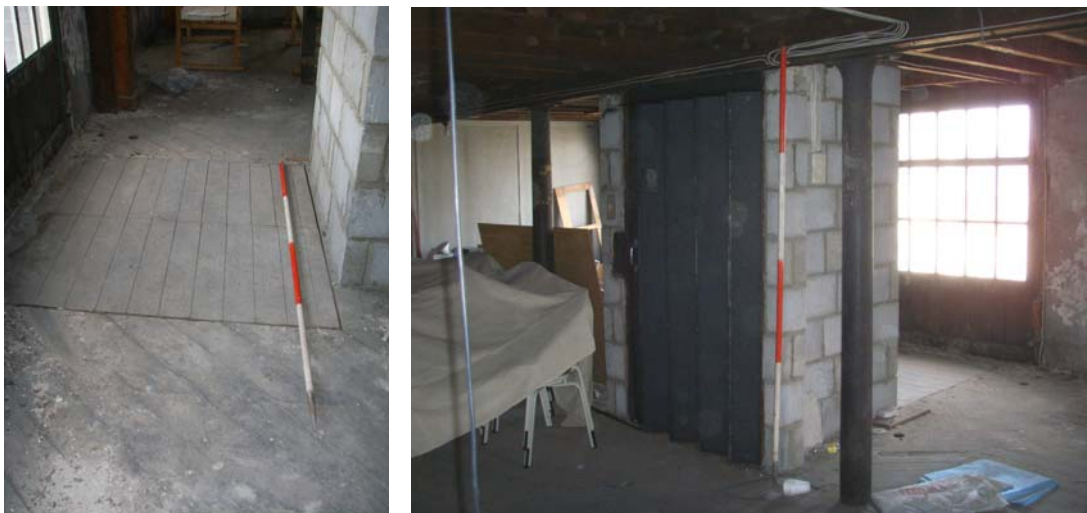
4.4.5 There is a very regular tongue and groove board floor (Plate 39), running east/west across the length of the room, similar to that which was observed on the fourth floor. Again, as on the fourth floor, there is an area of the board floors near to the two loading doors on the north wall and extending to the front of the lift shaft where the boards are diagonally, north-east/south-west. The lift shaft, which is constructed from concrete blocks, cuts through this area (Plate 40). A single, metal, folding partition door covers the lift entrance, which has a plaque attached to it that reads, 'BOLTON SHUTTER DOOR: PATENT NOS: 397,546 464,984 710,520. KEEP WELL OILED TO ENSURE SATISFACTION'. There are several small square holes in the floor where machinery is likely to have been situated and attached.

Plate 39: (left) Detail of the floor

Plate 40: (right) The lift shaft with metal shutter door

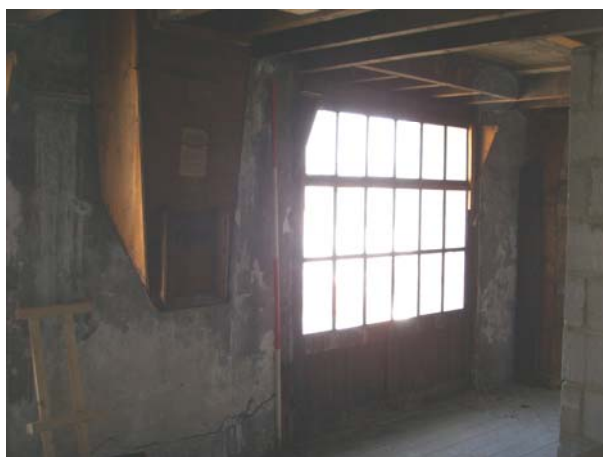
Plate 42: An 18-light window above vertical wooden slats fills the loading doors in the north elevation

4.4.8 The bottom section of each of the two large central loading doors on the north elevation is made of vertical wooden planks, above which is an 18-light, timber framed window (Plate 42). There is a 12-light timber sliding sash window to the east. Between the loading doors there is a hopper built from timber planks, which leads up to the floor above (Plate 43). There is an advert for evening addresses at St Nicholas Street Chapel in Lancaster dated 1918 (Plate 44) and various clippings - one a newspaper article about a record compensation payment paid to an injured joiner in Blackburn, another about the 51st Highland division - stuck to the front, below which is an opening with a sliding door. The hopper is approximately located above a hatch to the floor below, perhaps indicating that it originally ran from ceiling to floor. There is another timber chute to the east of the loading doors, which passes from the floor above to the floor below without opening on this floor (Plate 45).

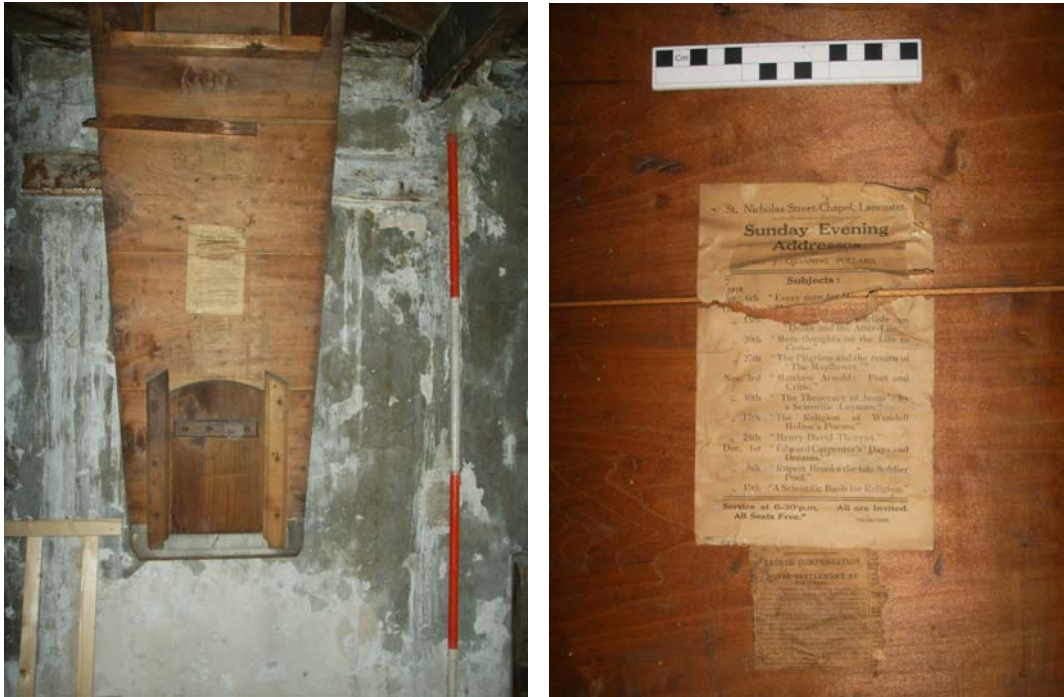
Plate 43: (left) Centrally-located timber hopper

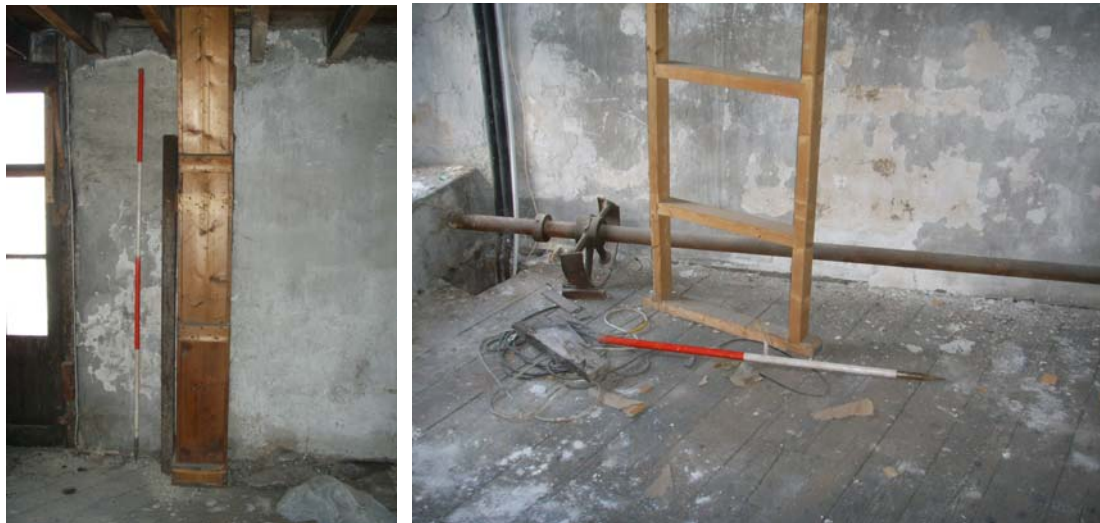
Plate 45: (left) Timber chute located to the east of the loading doors

Plate 46: (right) Remains of an iron drive shaft with broken band wheel at one end lying on the floor against the west elevation

4.4.9 There are several windows in this room: two 12-light wood sliding sash windows on the east elevation, the uppermost pane of each has been partially obscured by a timber beam; an eight-light timber frame sliding sash window in the south-east corner of the room; a four-light sliding sash window in the west corner of the south elevation, and a six-light timber framed sliding sash window on the south side of the west elevation. There is a small alcove, possibly once a doorway that has been plastered over, near to the stairwell within the west elevation. Lying loose on the floor against the west elevation is a long iron drive shaft with a broken band wheel at the south end (Plate 46).

5.1.3 On the third floor there is considerable evidence for the position of the line shafting (including a loose piece of the line shaft itself), which formed two rows, although this was evidently modified and may relate more closely to Phase 2. On the second and first floor the original arrangement and use is uncertain as modernisation has obscured much of the early fabric, although it is likely that similar processes to the floor above took place. There were undoubtedly some offices on the 1st floor, and the ground floor was evidently also largely used for offices from an early date, and it is entirely possible that these existed during this phase. The presence of fireplaces in ground floor **Room 5** and **Room 6** and first floor **Room 3** are indicative of this, as is the presence of decorative finishes to the ceilings and walls and grilled vents. The small aperture that originally existed in the west wall of **Room 6** probably formed a small 'window' for the recording of goods as they were brought into the building or even the paying of wages. The presence of two large early safes on the first floor also indicates that money was kept on the premises and that sales were dealt with on site.

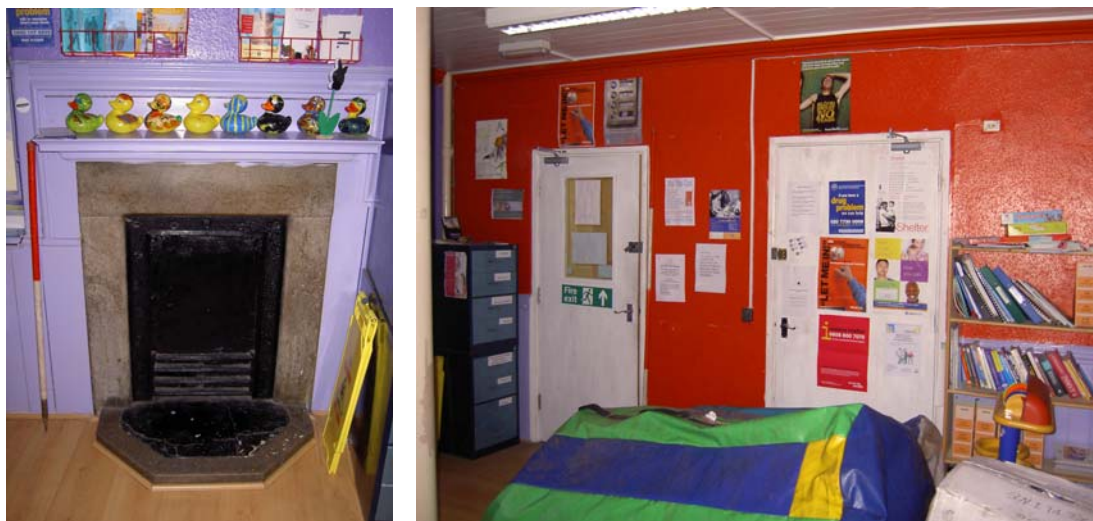
Plate 64: (left) *Room 6*, the decorative fireplace

Plate 65: (right) *Room 6*, the south elevation

4.7.13 There is a fireplace in the south-east corner of the room, which has a polished stone surround and a decorated cast iron back plate (Plate 64). The mantelpiece is also decorative and ovolo- and cavetto-moulded. There are two doors in the south elevation, both with plain timber frames (Plate 65). One of the doors, the fire exit to the east, has a single window light; the other is plain. The timber panelling and rail does not continue between the two doors on this elevation, and the wallpapering is also absent in the area between the two doors, indicating that a recent modification

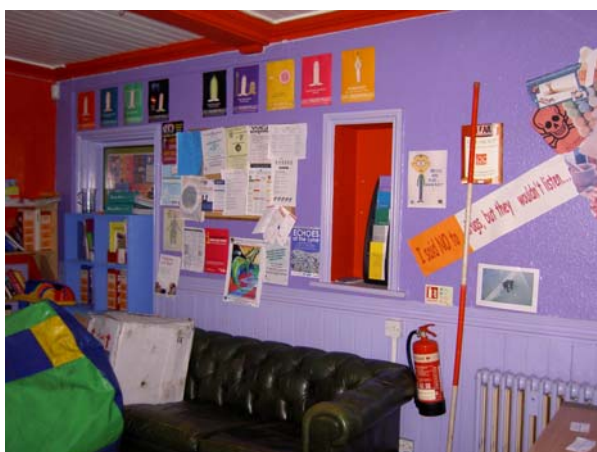
Plate 66: *Room 6*, blocked doorway and window in the west elevation

has been made to the wall. There is timber panelling and railing along the west elevation and wood chip wallpaper to the ceiling. There is a blocked doorway to the south (indicated by a remaining alcove and surround) and, to the north, a blocked aperture, both with moulded surround (Plate 66). The floor is covered with wood effect vinyl flooring.

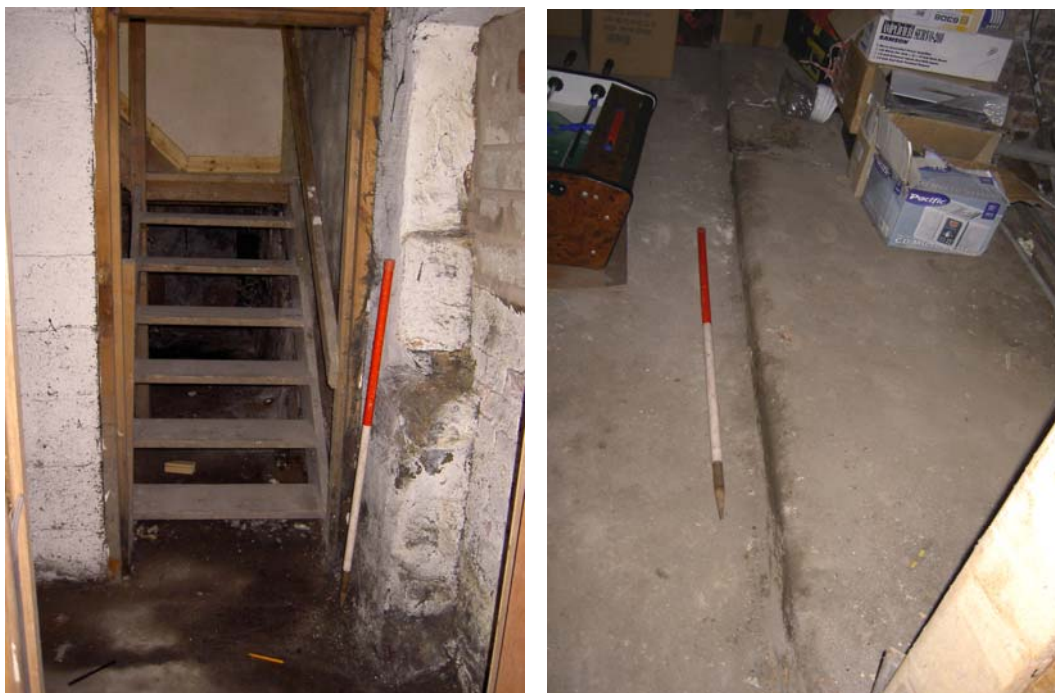
Plate 67: (left) Stairwell to the basement (*Room 1a*)

Plate 68: (right) Long concrete plinth originally forming the engine bed in *Room 2*

constructed in an approximately English garden wall bond, at a ratio of six or seven rows of stretchers to one row of headers, but somewhat mixed. The bricks are very thin and some are wedge-shaped, and the majority are a pale orange-yellow colour and typically measure 0.23m by 0.11m by 0.06m. This wall butts the west elevation. The west elevation is rough plaster over stone. The north elevation, below the stairs, is also stone with a finish of rough plaster. There is a doorway, which is blocked with concrete blocks and yellow bricks below the sill, and which continues above and to the east of the stairs. The north elevation of the lobby (**Room 1b**) has another brick-blocked aperture, leaving an alcove. The east elevation is a stud partition wall with a plain doorway on the north side, with a modern timber surround and door. The south elevation is made of concrete blocks, which return on the west side. The west elevation is constructed from concrete blocks with a door to the stairs (Plate 67).

4.8.2 **Room 2:** the main room of the basement has a concrete floor which is raised on the west side to form a long plinth (Plate 68), evidently an engine bed as there are several large iron bolts projecting from it, and on the east side to form an irregular area surrounded by a low concrete block wall (Plate 69). There are various other concrete blocks and plinths in the room (as shown in Fig 6; see also Plate 74 and Plate 75).

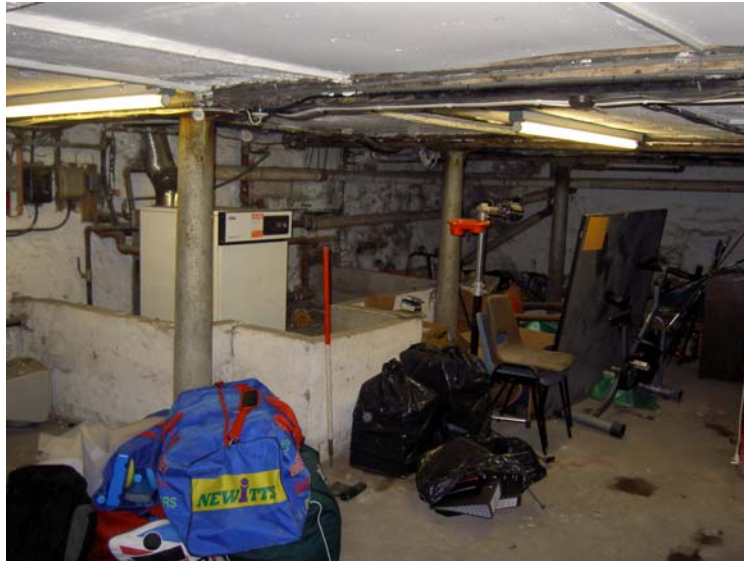
Plate 69: Low concrete block wall on east side of Room 2

4.8.5 The east elevation is stone with rough plaster and is plain except for concrete plinths on the north side and a brick plinth in the centre (Plate 69).

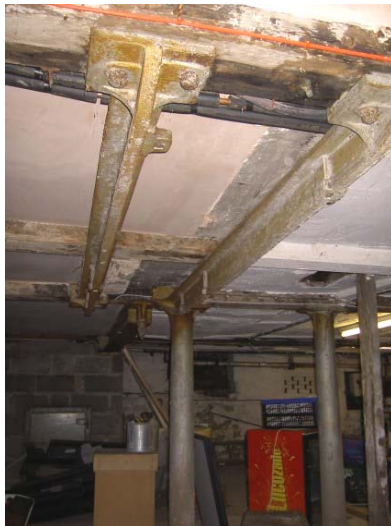
Plate 70: (left) Iron I-beams in a Y-shaped arrangement

4.8.3 The ceiling in the basement is very low with three east/west beams supported by iron columns with flanges as per the floors above, although in a different arrangement. There is a group of additional iron I-beams, orientated north/south, in the centre of the room in a Y-shaped arrangement (Plate 70; Fig 6); a pair of fish-bellied type I-beams to the south (Plate 71; Fig 8) and a square one to the north (Plate 72). The iron crossbeams are bolted between the main beams and support an additional east/west timber beam. The east end of this beam is supported by an upright timber post (Plate 73), and there are two similar-sized upright timber posts located slightly to the north and east of this beam.

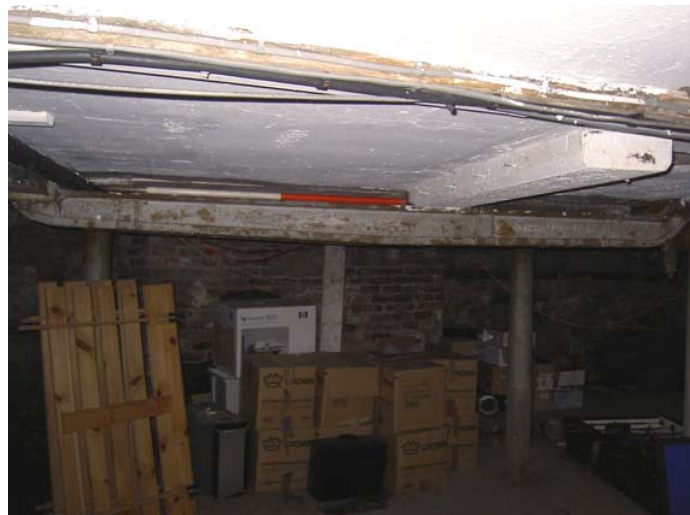
Plate 71: (right) Fish-bellied iron beam

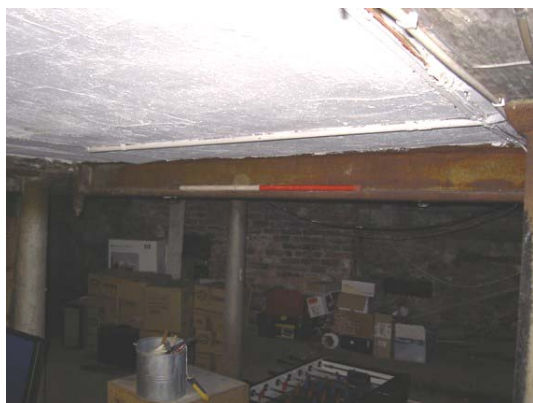
Plate 72: (left) Square iron I-beam

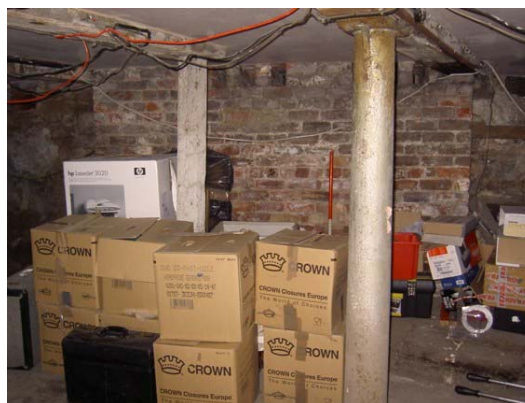
Plate 73: (right) One of the timber supports below the additional east/west beam
