PYE WAREHOUSE, FLEET SQUARE, LANCASTER, LANCASHIRE

Archaeological Building Recording

Client:
Lancaster and District YMCA

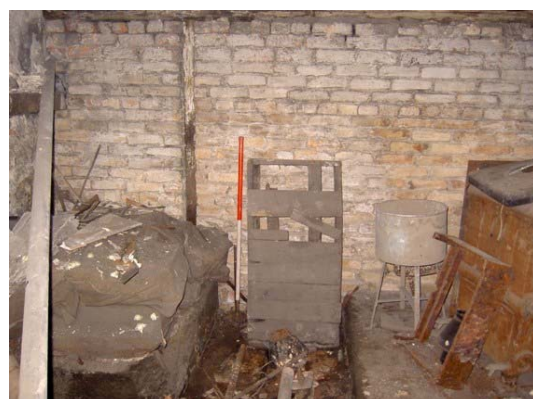
Plate 74: (left) North elevation to the west of Room 1

4.8.4 Concrete blocks and brick walls have been added in the centre of the north elevation forming the lift shaft attached to which are the partition walls around the stairwell in the north-west corner of the room. To the west of **Room 1** there is brick wall below a timber beam (Plate 74), as per **Room 1a**. This wall incorporates an upright post on the west side and to the east before being butted by the concrete block walls of **Room 1**. To the east of **Room 1** there is a stone wall with an alcove formed by a blocked aperture (Plate 75). There is a further aperture to the east with a stone sill and possibly what remains of a timber door, which is blocked with brick but leaving a perforated 'diaper' ventilation.

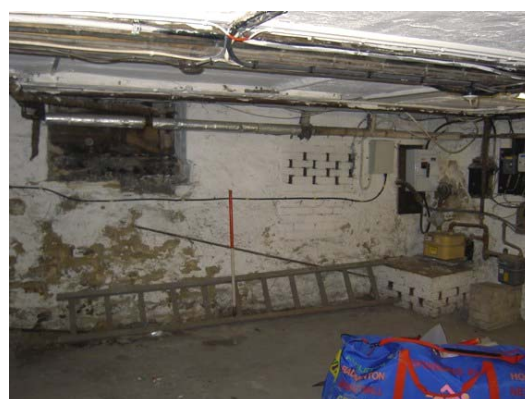
Plate 75: (right) North elevation to the east of Room 1

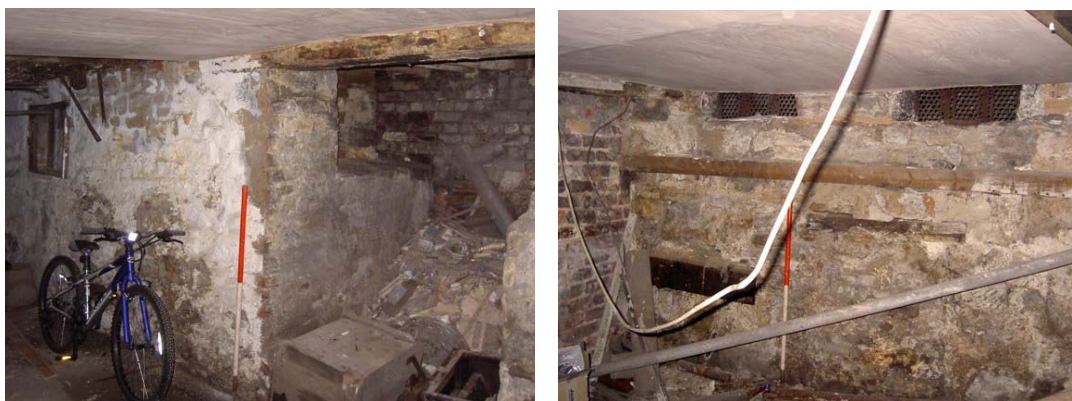
Plate 76: (left) Projecting area on the south elevation of Room 1

Plate 77: (right) West elevation of Room 1

4.8.6 The south elevation is built of stone and there is a central projecting area with a small hatch (Plate 76) into a crawl space (**Room 3**) on the west side. The west of this projecting area is a return forming a deep alcove into the wall, the west wall of which is slightly angled. There is a brick wall at back of this deep alcove butting the wall on the west side.

4.8.7 The west elevation has the same rough stone and plaster finish as the other walls of the basement but with a slight plinth at the top. There is a projecting red brick built section in the centre, which appears to be a chimneybreast or flue that butts against the main wall. The bricks are dark red, appear to be machine made, and each measures 0.23m by 0.105m by 0.07m. There is a row of slots towards the top of this brick section (see Plate 73), which run through to a vented opening beyond, to the passage on the ground floor. To the north of this projecting brick section there are two further grilled vents in the wall and a chamfered bracket attached to the wall (Plate 77). There is also what appears to be a rough timber lintel in the wall to the north of this bracket (although if it is a lintel any associated aperture could not be identified), and a later timber 'trough' attached, with what appears to be a water pipe sat in it.

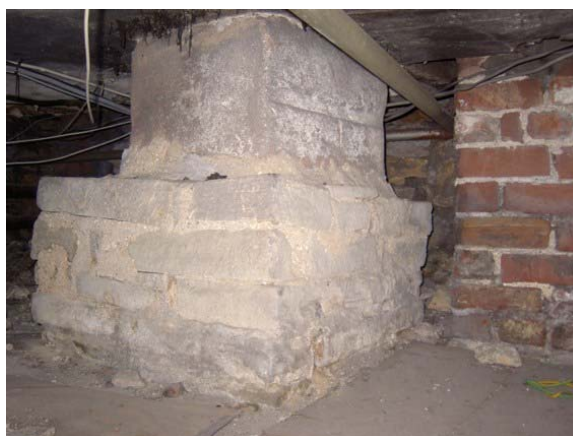
Plate 78: Stone-built column in the small crawl space (Room 3)

4.8.8 **Room 3:** this is a small crawl space to the south of the main room (**Room 2**). It is a small, raised, level chamber with a concrete floor. The original ceiling joists are exposed with the floorboards of the floor above visible on the west side and lath and plaster over the east. There is a large apparently stone column built on a stone base to the east of the centre of the room, which seems to at least partially support the ceiling (Plate 78; Fig 7). The north elevation of this room is plain, but for the aperture hatch through to the main room, and is built from stone. The west elevation is plain and built from red brick with a slight return. It was not possible to closely examine the east elevation, but it is likely to be one of the main walls to the structure, and built from stone. The south elevation is built from brick and is notably thicker at the west end where it returns. The thicker western end has a slightly projecting course of brick.
