# TYTUP FARM, NR LINDAL-IN-FURNESS, CUMBRIA

## Archaeological Building Recording

Client: John Rawlinson

Planning ref.: 41/2007/0400

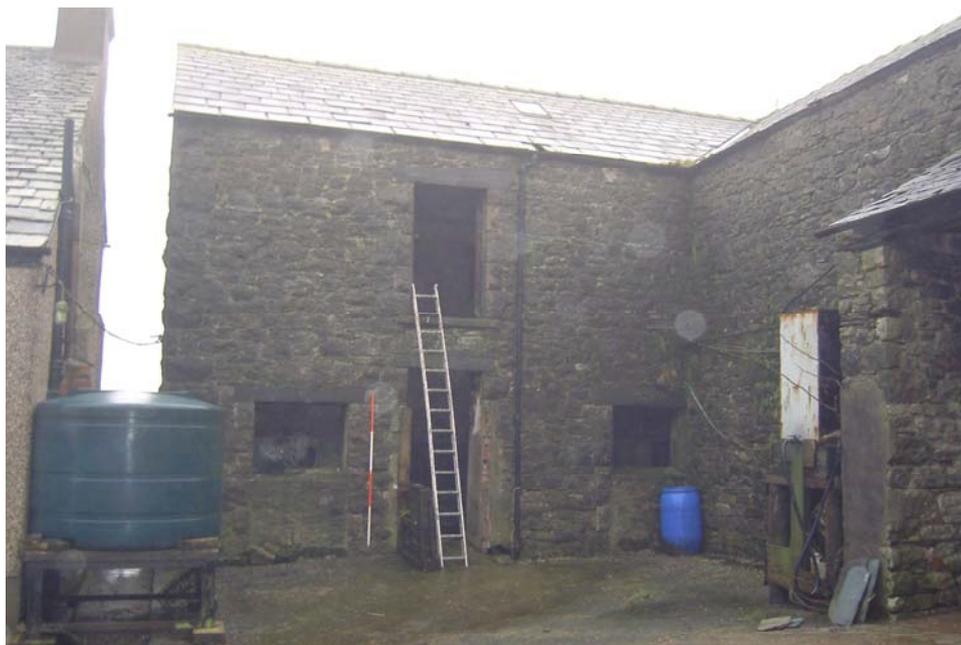
Plate 9: North elevation of Building 1

4.2.2 **Building 1, north elevation:** the west half of this elevation is the south internal elevation of Building 2 and is discussed in *Section 4.3.11*. The east part contained two windows and a pedestrian doorway on the ground floor and a central pitching door on the first floor (Plate 9). The two ground floor windows were originally doorways, and the doorway in between was originally a window, which can be seen on the 1891 plans for the proposed re-build (Plate 6). The lintels for all these openings were made from local slate slabs and the jambs were quoined in limestone with the exception of the lower part of the doorway where the lower part of the jambs were created from red brick when it was converted from a window. The upper pitching door was original and had a sandstone threshold stone. The lower parts of the original doorways were blocked with limestone rubble.

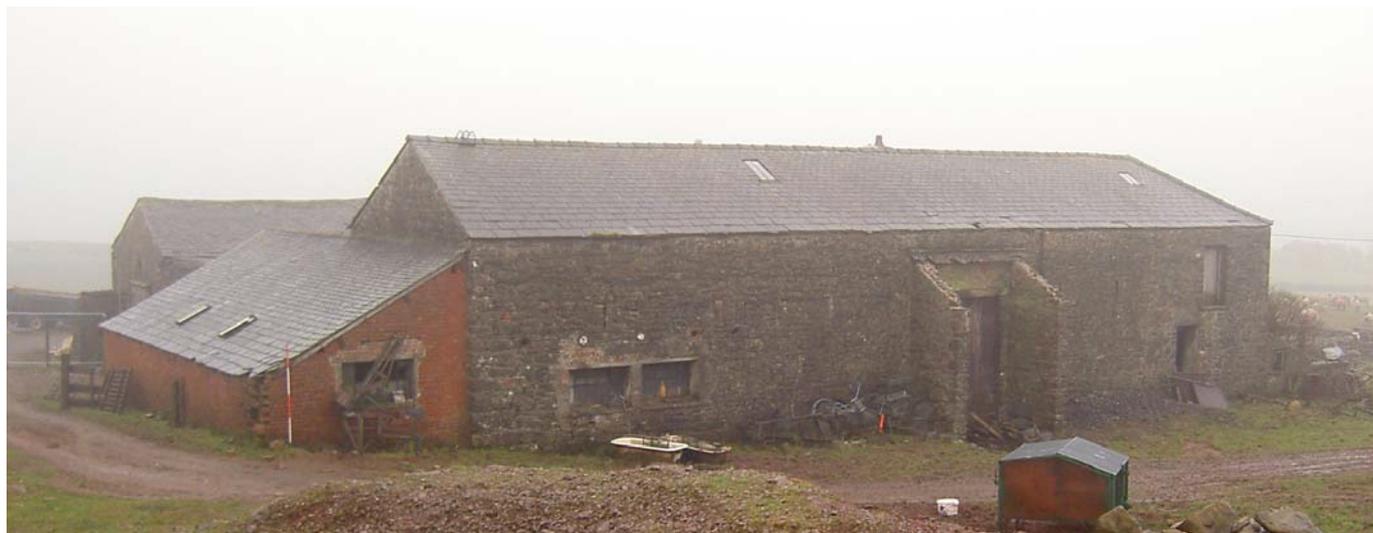
**Plate 10: West elevation showing Buildings 3, 2a, 2 and 1 from left to right**

4.2.10 **Building 2/2a, west elevation:** there was a large wagon doorway in the centre of Building 2 that opposed that in the east elevation; this was the same construction although the porch roof had recently collapsed (Plate 10). This collapse revealed the square sawn timber lintel that was set over the doorway and below a stone relieving arch. To the south of the doorway there were two upper floor level winnowing slots. Two of the three slots to the north of the doorway had been filled with brick and limestone rubble. Set immediately below these northern slots was a row of five ceramic pipe vents that were just under the ceiling level of Building 2a, two of which had been blocked with plastic sacks. Below the pipe vents there was a pair of inserted windows to permit light to the ground floor shippon (Building 2a); the brick infill and jambs had been cement rendered as had the sills. The lintels were stone, and set either side of a slightly higher slate lintel that suggested that there was originally a pedestrian doorway in this area. This doorway would have matched that on the east elevation, providing access through the central dung passage of the shippon.

4.2.11 **Building 3:** this building was a tall, mono-pitched, brick built, six-stall shippon (Plate 10). Its construction post-dates 1919 (see *Section 3.2.8*). The construction of this building had utilised the north gable end of Building 2a, as well as the north side of Buildings 5 and 6 whose rear elevations had been raised by approximately 1m. The roof of this structure was clad in neat slate tiles laid in diminishing courses, and that element of the roofline to the east of Building 2a was crowned with ceramic bonnet tiles.

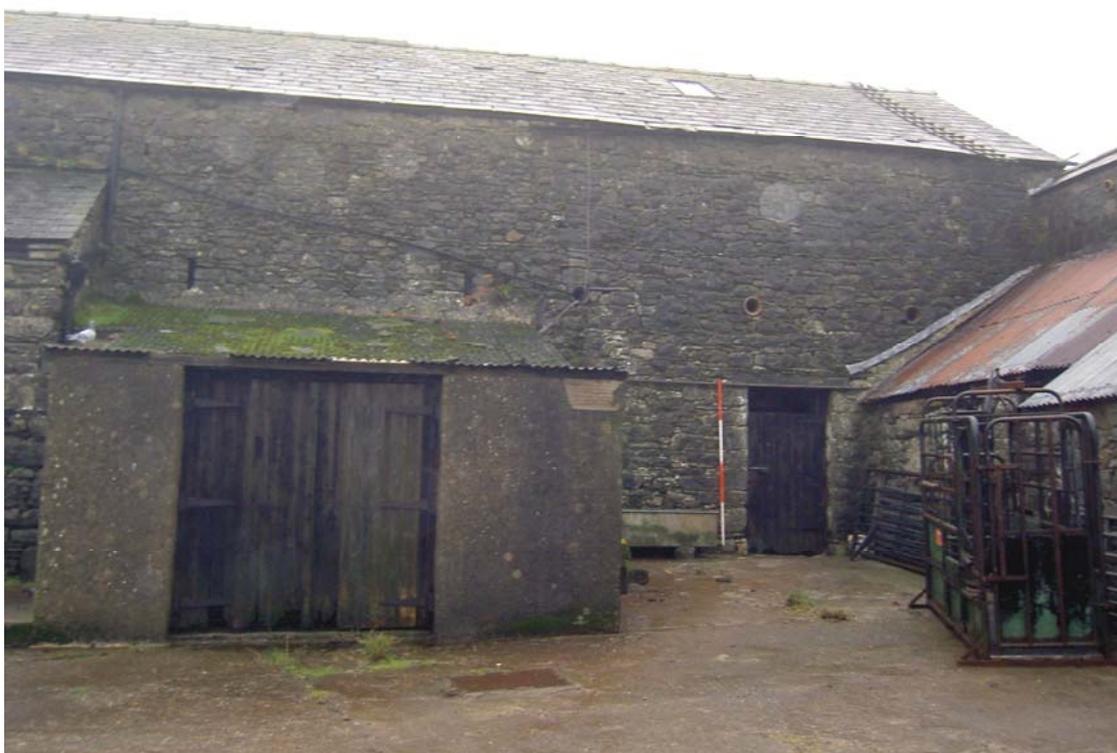
**Plate 11: Building 4 viewed from the east, with Building 2/2a in background**

4.2.16 **Building 4:** this building comprised a single storey mono-pitch which utilised the middle part of the east elevation of the pre-existing barn (Building 2/2a). The structure was constructed from brick and concrete block, which had then been coated in cement render, and the roof was corrugated asbestos sheeting (Plate 11). It would appear that the structure had been extended eastwards by one to two metres, and the roof over this part was almost flat. There was a pedestrian doorway in the north elevation with a simple timber plank latched door, and a double loading door in the east elevation. Both the doors were hinged to simple timber frames and hung below timber lintels.

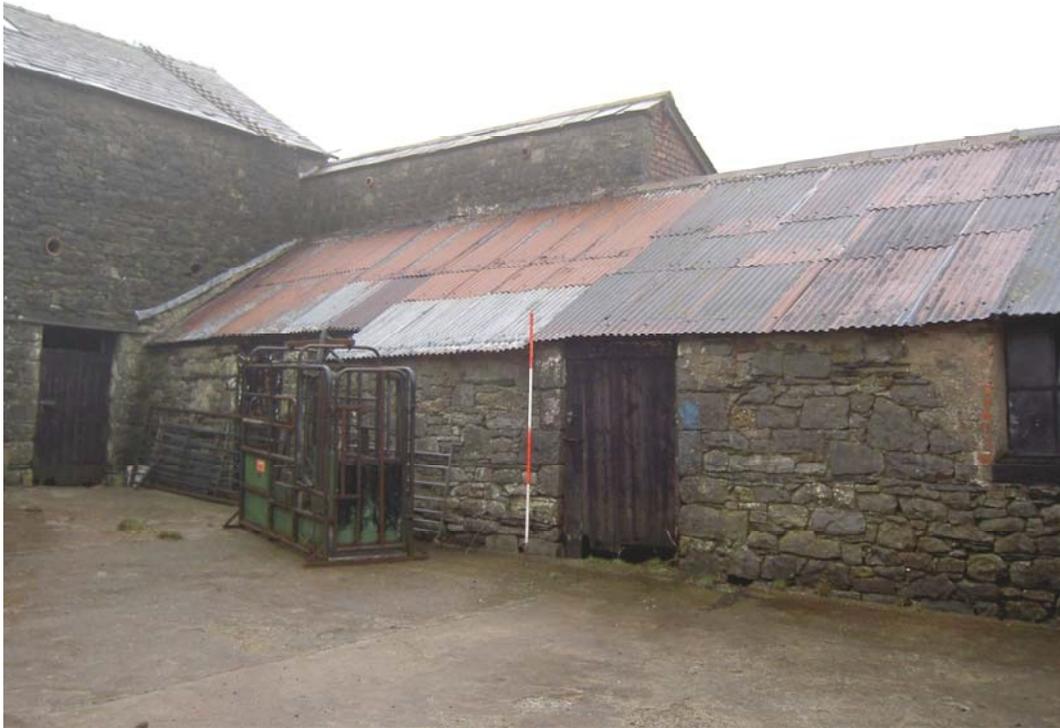
**Plate 12: Cattle sheds (Buildings 5, 6 and 7) viewed from the south-west**

4.2.17 **Building 5:** this building formed part of the range of mono-pitched cattle sheds running from Building 2a at the west, to Building 9 at the east (Plate 12). Each of these small individual sheds shared the same north elevation formed by a continuous wall that had stone built partitions running south from it. All but the south elevation of this building formed an internal elevation of other adjacent buildings, which will be discussed in *Section 4.3*. The only exterior elevation was to the south, which comprised a short stub of wall butting the east side of Building 2a. There was a doorway at the east end of this wall, before the dividing wall with a passageway (part of Building 6). The door was of simple plank and batten construction and the rest of the elevation was featureless, with corrugated iron sheeting used to roof the structure. The south elevation of this building was slightly further north than those of the rest of this range. This alignment appears to respect the doorway into Building 2a, which might suggest that Building 5 was constructed later than the main L-shaped barn range. However, as Building 5 was already apparently present when Building 2/2a was re-built during the c1890s (see Plate 6), it is possible that the buildings which had originally occupied the footprint of Building 2/2a also had a doorway located in a similar position; the re-build of Building 2/2a was evidently very closely similar to the original layout of the buildings which had stood before the fire. It seems likely that Building 5 was constructed after the original L-shaped barn range, but this cannot be confirmed by any of the early site plans.

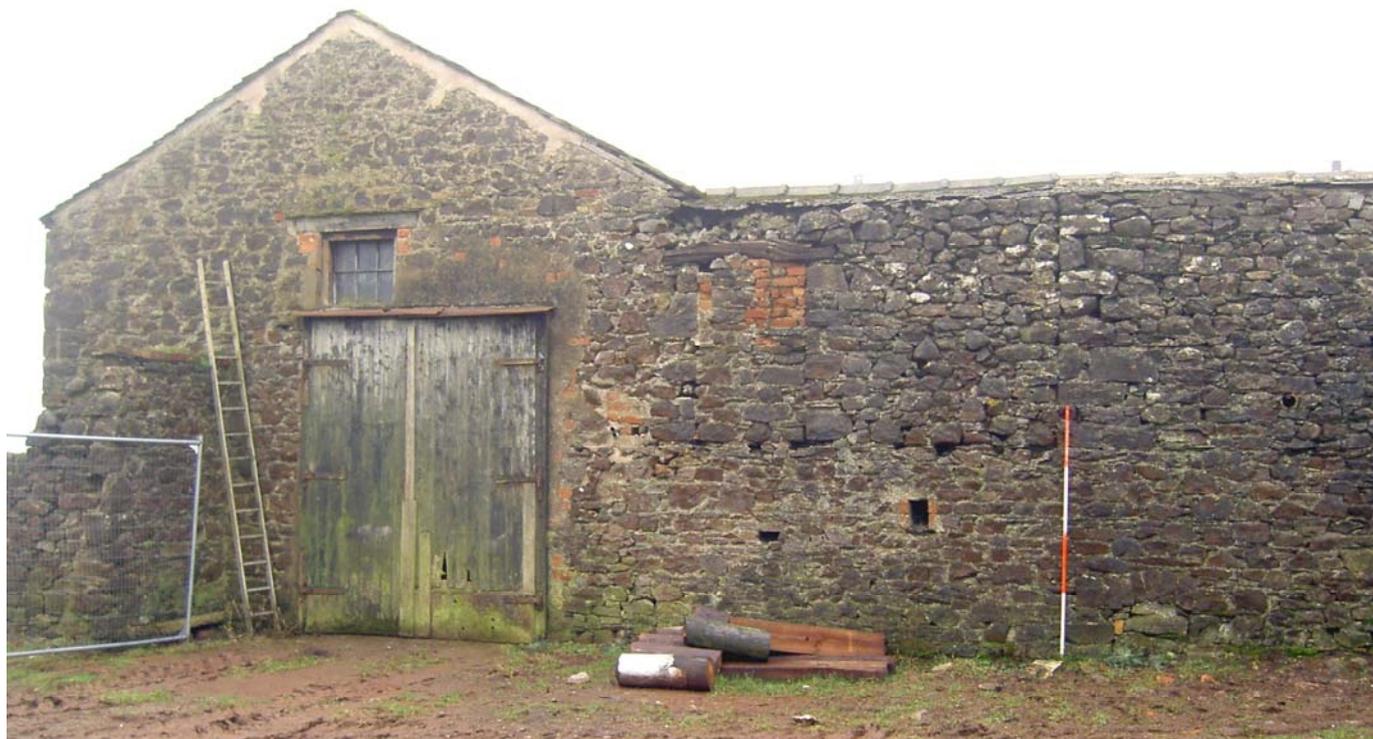
**Plate 13: North elevation of Buildings 9, 8 and 7 (to the right of the ranging rod)**

**4.2.22 Building 9, north elevation / Building 9c:** the north elevation of Building 9 appeared to be continuous with the entire of the north wall of the east/west range of buildings, although the quoins at the east side of the wide aperture in the north elevation of Building 8 do not quite line up with the north-west corner of this building as they are slightly too far west. In the centre of the elevation there was a wagon door that has either been inserted or at least widened and raised (Plate 13). There was considerable re-build above it and down the west side, which incorporated red brick, and the east side lacked quoins. There was a basic iron drip hood over the black painted tongue and grooved double doors; these were affixed to a basic timber frame by three hinges each. Directly above the doorway there was a small square window that had been inserted, it comprised a six-light casement in a plain timber frame set into red brick jambs. It seems likely that this window related to the more recent use of the building as a garage, this is perhaps also true of the double doors which were the only access point for vehicles. Building 9c comprised a north/south wall approximately 1.70m in length which returned to the east for a similar length, both these elevations were plain and it appeared that this structure represented a simple mono-pitch shelter. The 1891 plan (Plate 5) shows a building abutting the west side of this structure, although this had gone by 1913 and no visible traces of it could be detected.

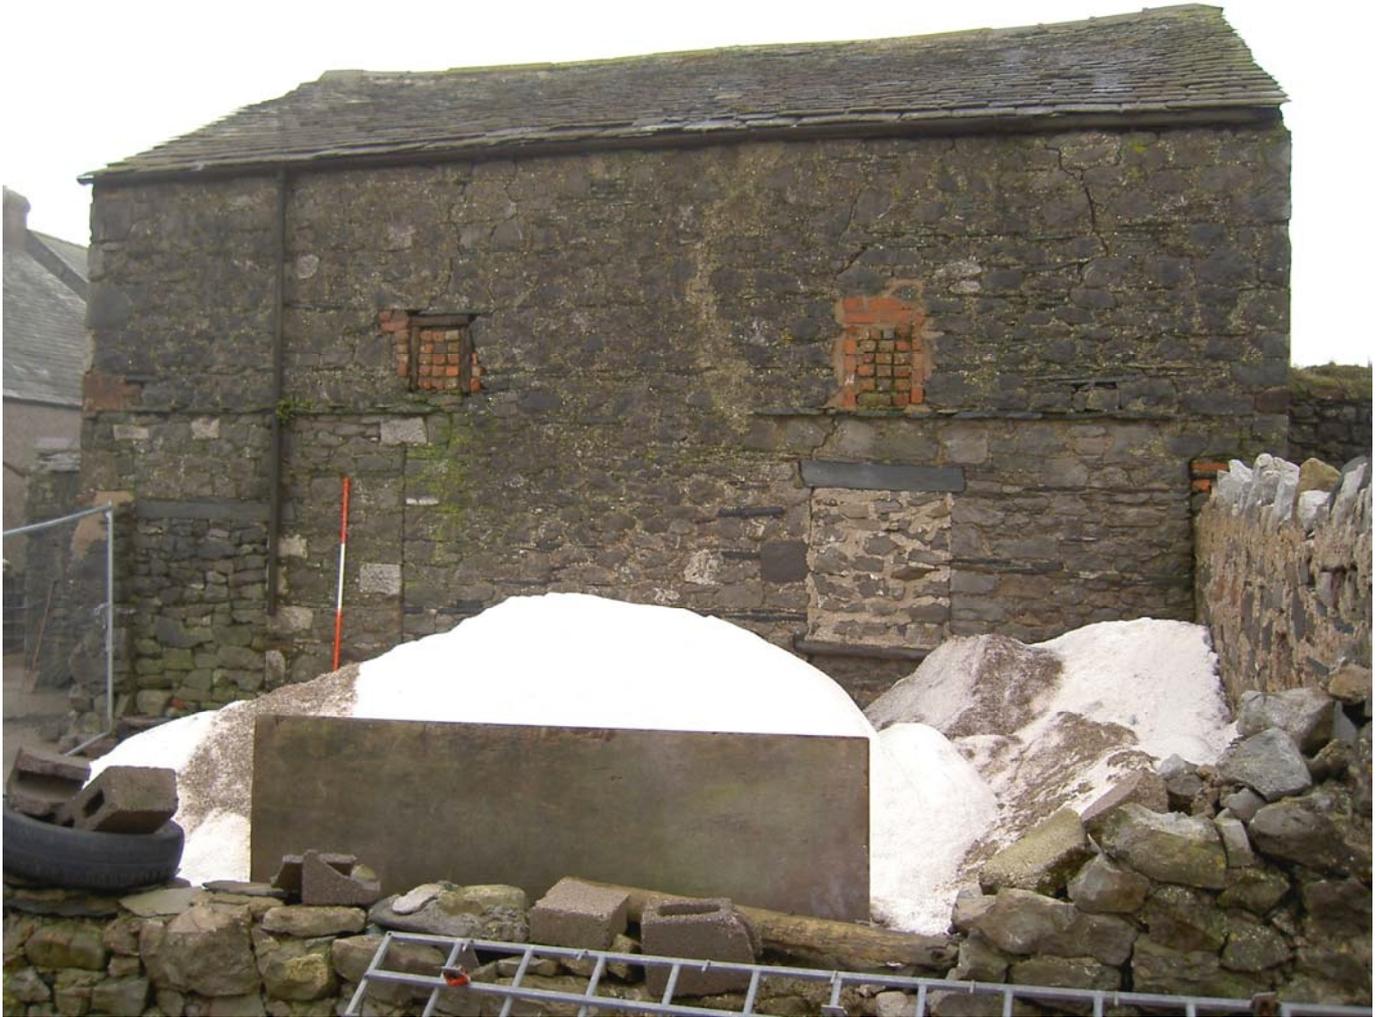
Plate 14: West elevation, Building 9

**4.2.23 Building 9, east elevation / Building 9a:** the east elevation of Building 9 housed two wagon doors on the ground floor level and two small square apertures on the upper floor, all of which had been blocked (Plate 14). The southern wagon door had been blocked by limestone rubble, both its height and width having been reduced to form a pedestrian sized doorway, which had subsequently also been blocked. The original lintel of the wagon doorway had been removed, but its original location could be detected below a slate drip course. The slate lintel of the pedestrian doorway was still in place within the blocking. The northern wagon doorway was identical except that the pedestrian doorway formed within it had subsequently been partially blocked to form a window. This too had also eventually been blocked, but the slate lintel and sill were still in place. The two square apertures at first floor level had been inserted, and then blocked at a later date with red bricks. The south aperture still had a rough timber

frame in the jambs and a slate lintel while the aperture to the north was brick lined. The position of these two apertures would suggest that they were added after the upper floor was removed. The construction of the yard wall was integral to the north and south elevations of Building 9a, and quoins were only present in the east elevation of Building 9 above the height of this wall (Plate 13). The south end of the yard wall was almost flush with the south elevation of Building 9 and although earlier maps show it as being continuous it appeared to have been truncated (Plate 4, Plate 5, Plate 7 and Plate 8).

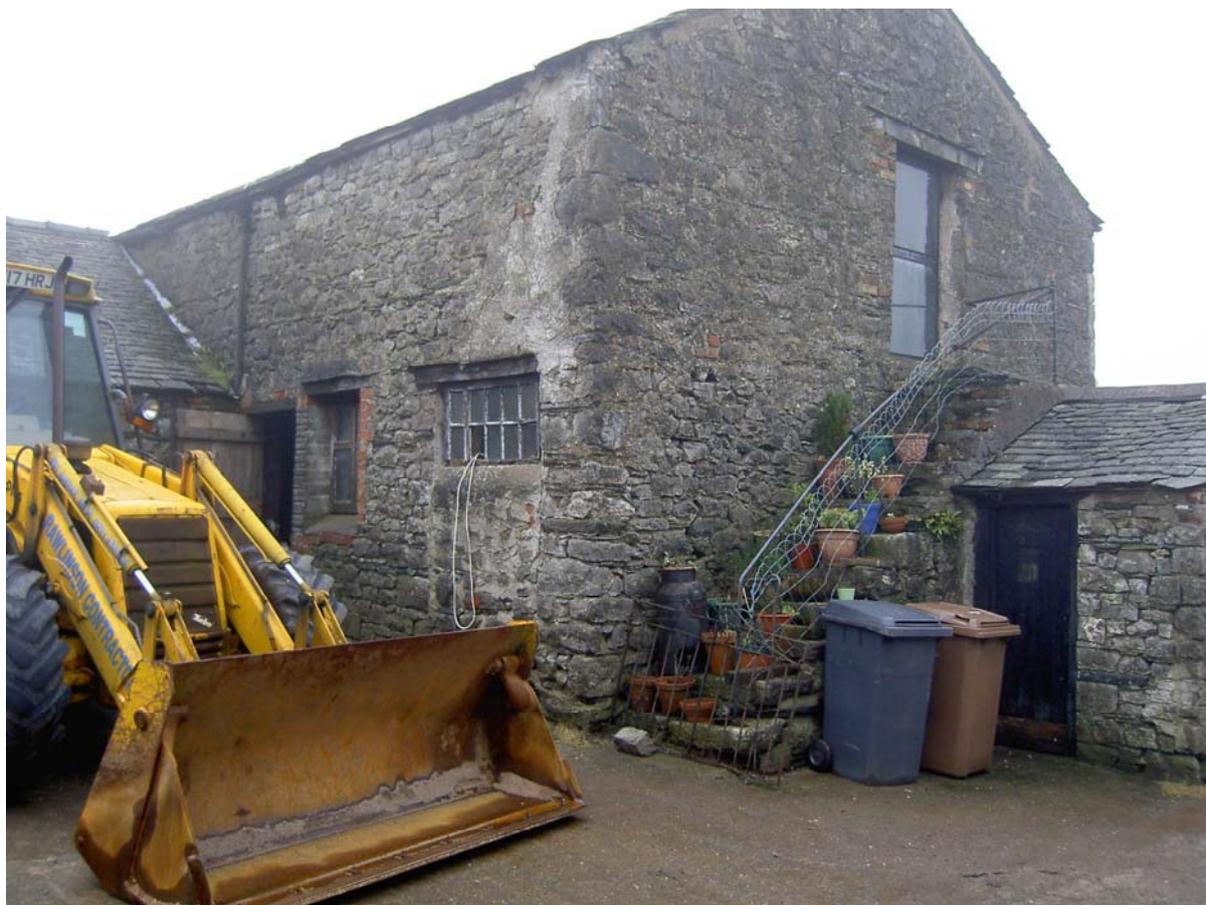
**Plate 15: South-west corner of Building 9**

4.2.24 **Building 9, south elevation / Building 9b:** the lower south-east part of this gable elevation was hidden by steps (Building 9b); the remaining part was plain except for a window at the top of the steps (Plate 15). The two lights had been added into what was a doorway, and they appeared to have come from a tractor cab and were bonded directly into the jambs in their black plastic or rubber casement. There was a slate lintel over the doorway, and occasional red and yellow brick in the doorjambs which suggests minor re-building. It seems probable that the steps are original to Building 9, and are clearly evident on the 1891 Ordnance Survey map (Plate 5). They had been constructed against the south side of Building 9 and at a later date a toilet had been added to their south side (Building 10).

4.2.25 **Building 9, west elevation:** the north end of this elevation was obscured by Building 8. Immediately to the south of this there was an inserted doorway and window (Plate 15). The jambs of these apertures were constructed from red brick and concrete blocks and the lintels were modern creosoted timber. The original pedestrian doorway into this elevation was at the south end and this had been part blocked to form a window. The window had a timber lintel and a 10-light fixed casement.

4.2.26 **Building 10**: the elevations of this stone mono-pitched structure are all plain (Plate 15). It is not evident on any of the maps consulted so it was probably added in the mid part of the 20<sup>th</sup> century. The roof was clad in slates that were very similar to those on the roof of Building 8, and may therefore have been re-used from an earlier structure.

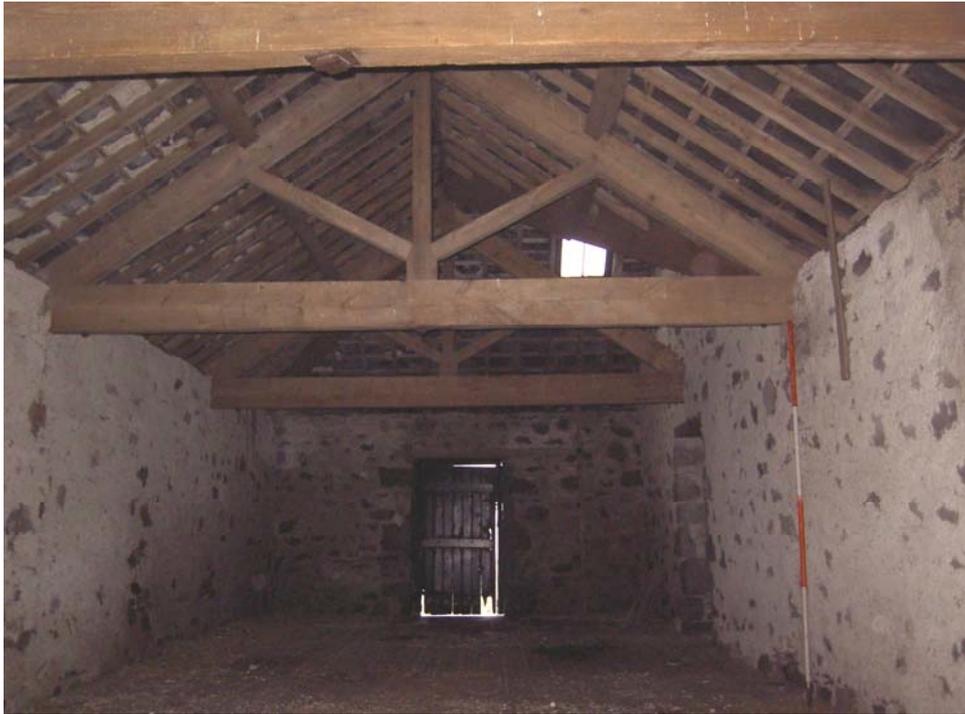
**Plate 17: Roof timbers in Building 1, looking west**

4.3.6 **Building 1, roof timbers:** the roof was supported by three king post trusses that had joggled braces; there was a single purlin per pitch and a much smaller ridge purlin (Plate 17). All the roof timbers were machine sawn softwood and were in very good condition. The roof was clad in slates laid in diminishing courses.

4.3.13 **Building 2/2a, roof:** the roof structure of Building 2 was supported by six king post trusses that had joggled braces and a single purlin per pitch, these seemed to be identical to those in Building 1 which suggests that these two structures were part of the same build. All the roof timbers were machine sawn softwood and were in very good condition. The roof was clad in slates laid in diminishing courses. The truss located to the south of the loft/partition had painted graffiti on its north side featuring the initials 'J.G.' and 'T.T' with the date '14 JUNE 1892' (Plate 20); this is likely to represent the date that this structure was re-built after a fire destroyed the original building (see *Section 3.2.6*).

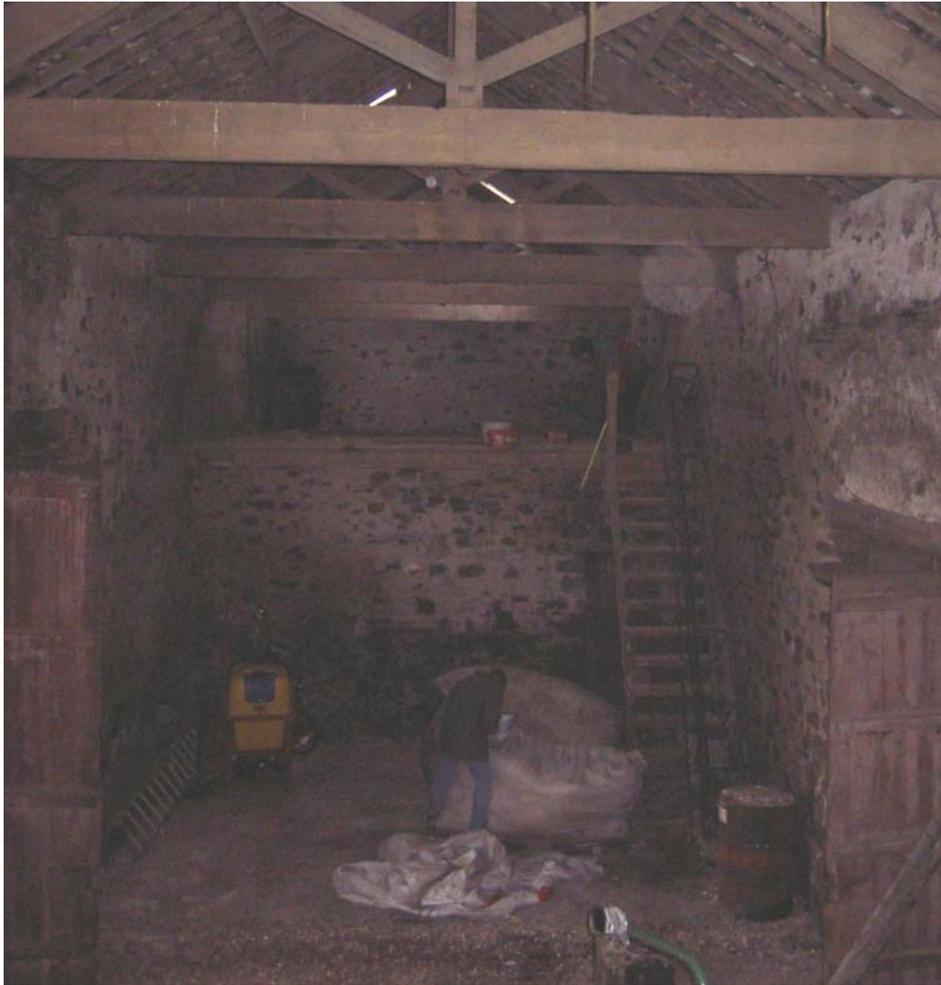
**Plate 18: Building 2/2a, looking north**

4.3.9 **Building 2/2a, partition:** the partition between Buildings 2 and 2a (see Figure 4) was entirely plain except for a doorway at the east end that accessed the shippon to the north (Building 2a). The door was constructed from tongue and groove boards and set below a square sawn softwood lintel, the jambs were clearly quined and suggest the door was original even though the plan (Plate 6) suggested that it should be on the west side. The timber stairs that permitted access to the loft (Building 2a) also ran up against the east side of the partition (Plate 18).

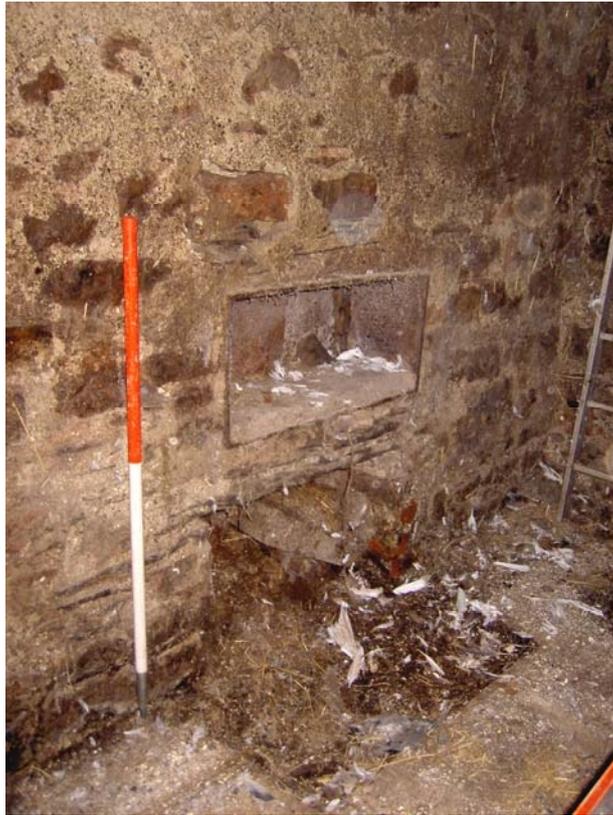
**Plate 19: Bearing box in the west internal elevation of Building 2**

4.3.12 **Building 2/2a, west elevation:** this elevation had two higher level winnowing slots to the south of the wagon doorway, and one to the north. There was also a rectangular alcove in the wall between the wagon door and the partition that appears to have been a bearing box; this was probably part of a steam powered engine that may have been used to thresh crops and/or process feed. The alcove had a slate sill and was lined with iron sheets; there was also a similar sized alcove below, close to floor level (Plate 19).

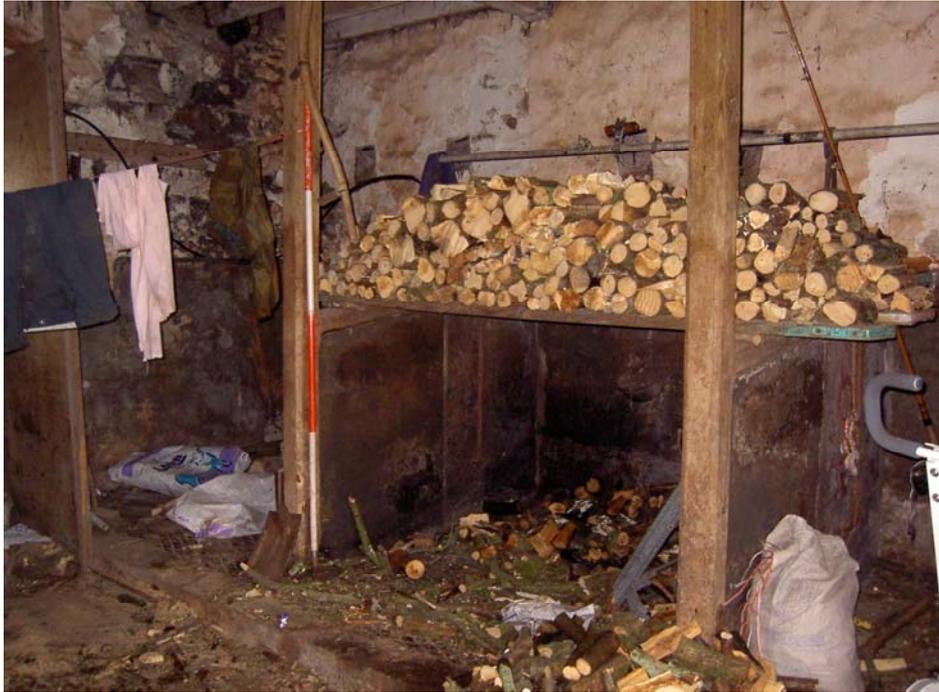
Plate 21: Re-use of stalls in shippon, Building 2a

4.3.15 **Building 2a, ground floor:** this building was being used as a wood store at the time the building recording was being carried out, but it did however retain the stalls and partitions indicative of its former use (Plate 21). There were three stalls against the north elevation, which were set on top of a concrete plinth; this arrangement was mirrored on the south elevation. The stall posts were fashioned from chamfered oak and were keyed into the underside of an east-west orientated beam, which was also constructed from oak; the partitions were constructed from slate slabs. There was a doorway in the east elevation that corresponded to the east-west dung channel; its lintel was square cut timber. There were two 10-light windows in the west elevation that had been inserted, possibly in the place of a second doorway; the casements were iron and the upper row of panes hinged open inwards.

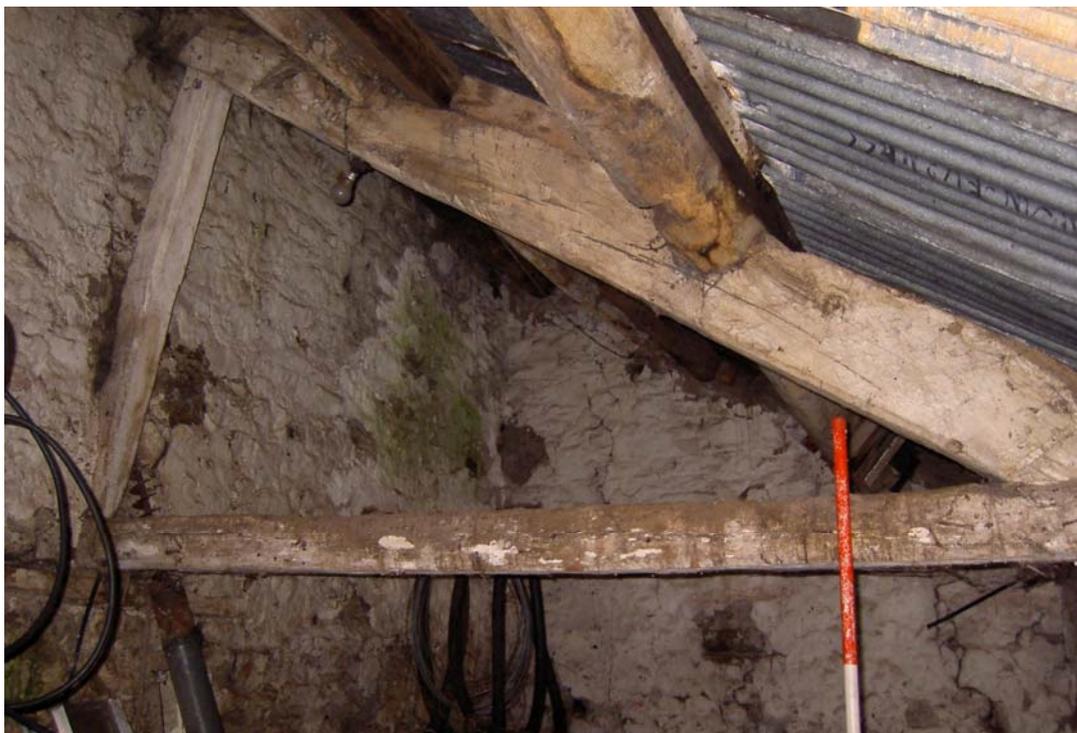
**Plate 23: Re-used cruck blade in Building 7, viewed from the east**

4.3.20 **Building 7**: this twin bay room shared the same corrugated iron sheet roof as Building 6, and was also part of the same range as Buildings 5 and 8. The north elevation was white washed to the full height of the wall, which appeared to be a single phase of building. The tie-beam of the half-truss was keyed into the middle part of this wall, and sat upon a timber board that had been built into the wall. There was an oak lintel close to the floor at the east end of this elevation which related to a blocked aperture, possibly another manure drain. The east elevation appeared to butt the north wall, although it is possible that they were still a contemporary build. A vertical timber post was attached to the wall at the south end and this held a small water trough, suggesting this room was another loosebox. The south elevation appeared to be butted on to the north/south wall that formed the east elevation. There was a window at the east end that had brickwork in the jambs and had been inserted or widened, it contained a 10-light iron casement, the middle lights of the upper row hinging open inwards. There was a doorway at the west end of this elevation that was quoined and an original feature. There appeared to be a blocked window in the west elevation that was below a substantial re-used oak lintel, this feature was also evident in Building 6 to the west. At floor level the blocked manure drain was also evident; this feature would suggest that one of these rooms existed before the other, as would the blocked window. The drain had red brickwork in the jambs and a slate sill; it had also been blocked by red bricks. The flooring in this building was a mixture of red brick and cobbles, the cobbles occupying the north east quarter. The roof timbers were once again a mixture of old and new; the half-truss was oak and the principle rafter was a re-used cruck blade that had chamfered edges (Plate 23).

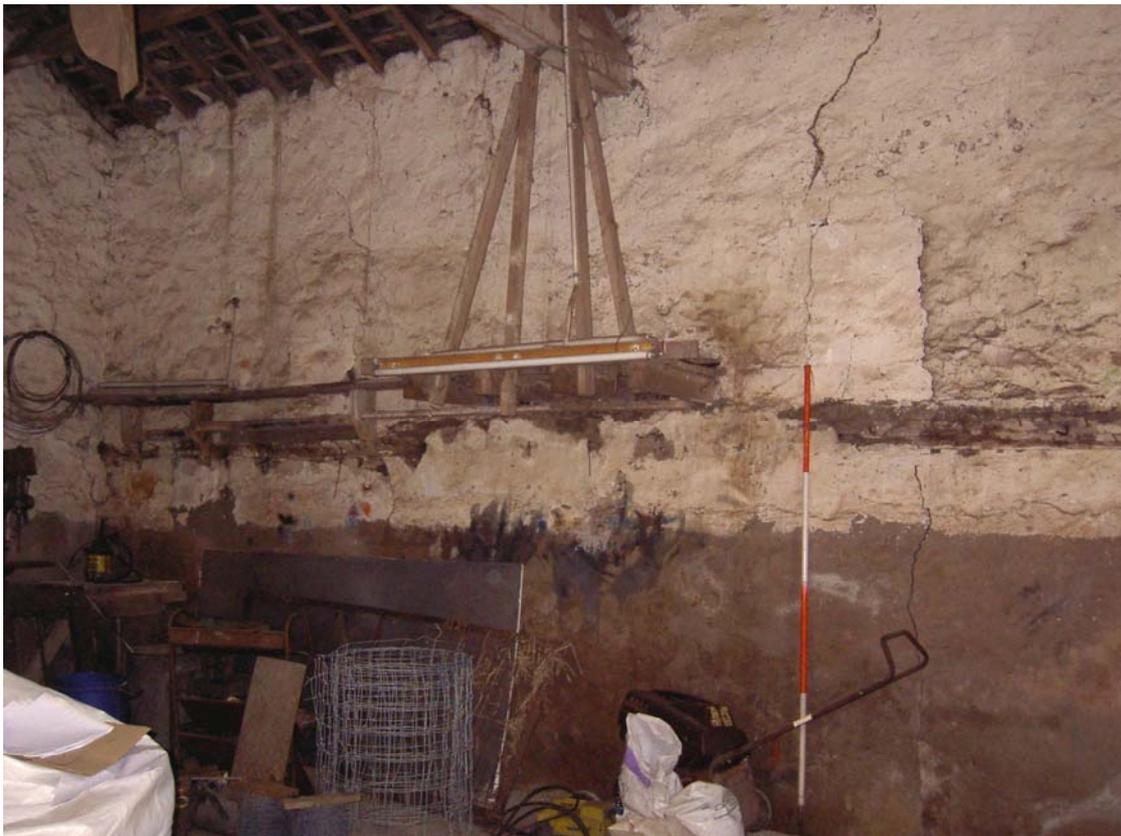
Plate 24: Relict upper floor, east elevation of Building 9

4.3.22 **Building 9:** this large structure comprised a single space, which was open to the rafters, although it had evidently originally had a first floor; most recently it had been used as a vehicle workshop. Each elevation had a concrete skim up to approximately 1.5m in height and had been whitewashed above that. There was a large wagon door under a small square window in the north elevation; both of these apertures had been inserted and had red brickwork in the jambs and around the

lintels. The window frame was an iron fixed casement and held six-lights, this was situated below a whitewashed oak lintel that was possibly older. The doorway had a square sawn modern looking timber that had been creosoted. The walls of this elevation had been whitewashed and evidence for earlier phases may have been obscured. Four sawn joists extended 1m from the east wall and retained their sawn boards; the loose ends of this first floor were braced to the single east/west orientated truss (Plate 24). Its purpose seemed to be primarily to hold a strip light, as well as acting as a small shelf. Just above the first floor level the outlines of the two square blocked windows were evident through the whitewash, and just below them two large horizontal timbers that were the lintels of the two blocked wagon doors which were rather more evident on the exterior (Plate 14). The lower part of the south elevation was obscured by a continuous row of workbenches above which cables and a fuse box had been added to supply sockets and more strip lighting. In the centre of the upper part of this elevation there was a doorway that had been converted to a window that held two lights and appeared to have been taken from a tractor cab. This doorway was originally accessed by exterior stone steps (Building 9b) and may well have been an access way to an upper floor granary. The west elevation had a pedestrian doorway at the south end which had been part blocked to form a window that had 10 small lights in two rows of five. Further to the north, at the junction with Building 8, a doorway and a window had been inserted, the jambs being constructed from red bricks and concrete blocks. There were various cable ducts and switches running along the elevation just above door height, which may help explain, in combination with the whitewash, why there was no evidence for joist holes on this side of the room. The floor was concreted, and a deep vehicle inspection pit had been constructed just inside the west doorway. As well as motor repairs the room was also being used to store animal feed that was moved in and out by tractor through the inserted wagon door at the north end. The roof structure was supported by a single king post tie-beam truss fashioned from deep section sawn softwood timbers as were the two purlins per pitch that overlapped at the truss. The rafters and battens were also sawn softwood and the slates were laid in diminishing courses.
