Moy Castle, Mull, Scheduled Ancient Monument
Archaeological Works for
Waterproofing Upper Floor Level

**MOY CASTLE, MULL, SCHEDULED
ANCIENT MONUMENT
ARCHAEOLOGICAL WORKS FOR
WATERPROOFING UPPER FLOOR
LEVEL**

ABSTRACT

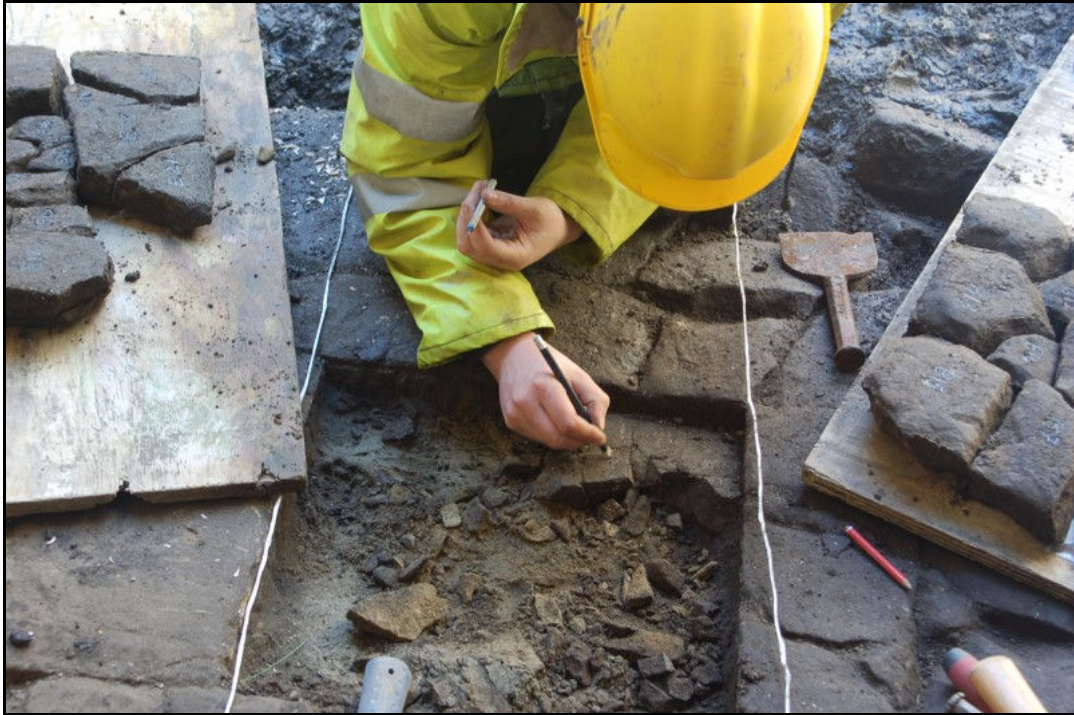
Title Page Plate: Excavation of Pipe Trench East Embrasure

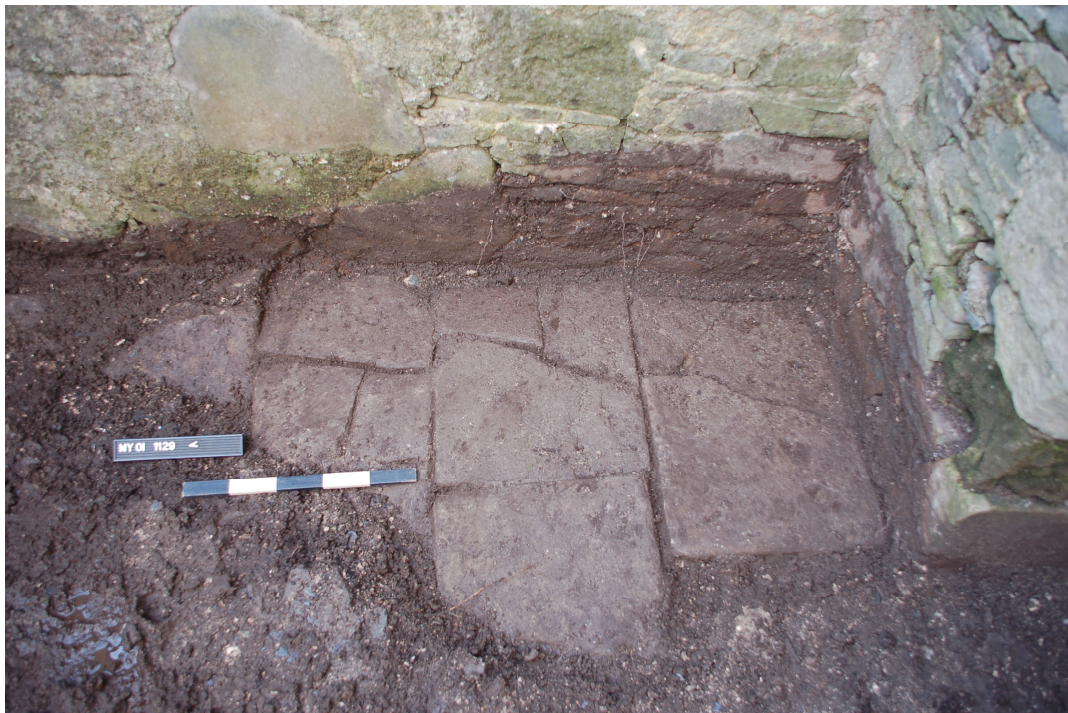
Slab floor (1129) revealed below deposit (1117), SE corner of chamber

This high area was located in the SE corner of the chamber and extended northwards to the S side of the E window embrasure. The mound was highest in the corner at 0.38m, and comprised a large number of fragmented stones mixed in with black silt. Finds included 10 small nails and six very large nails, a sherd of clear window glass and 2 sherds of bottle glass. Interestingly, below (1117), a number of mortar bonded floor slabs (1129) had survived virtually intact except for some cracking. These slabs were of the same type as those exposed in the window embrasures. The slabs extended along the base of the E wall to the S side of the window embrasure and along the S wall to the chamber doorway. The slab floor was slightly dipping down the W and NW. The slabs were rectangular (examples of size were 0.44 X 0.50m and 0.66 X 0.48m). The area of slabbing was not fully exposed. Also found here was an iron fitting 0.09m long by 0.05m wide, apparently set into or corroded into the stonework of the E wall at floor level. The fitting was not removed and its function was not ascertained.

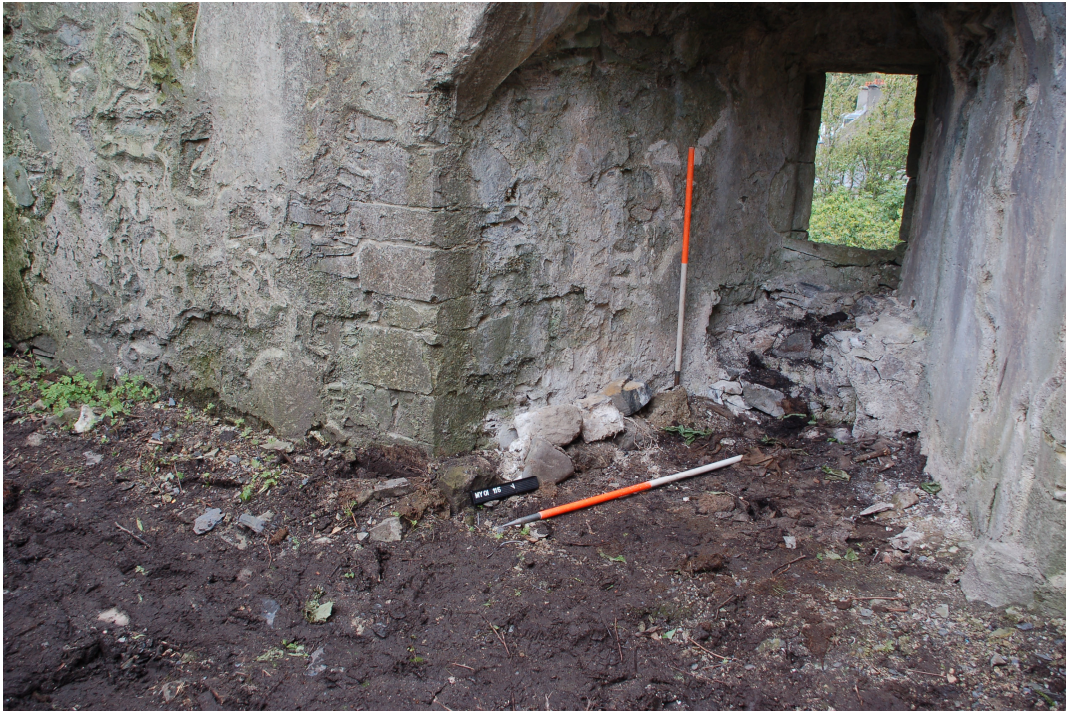
West window embrasure, pre excavation

Arranged along the base of the W embrasure's S wall was a pile of stone fragments and rounded stone (115) 1.10m long and 0.26m wide. Fragments of roofing slate were found below these stones. The stones within (115) came from the wall core below the window and must have been placed there after the roof was removed. The west window embrasure upper floor deposit, (113) comprised a loose thin layer of grit and sand with some recently burnt sacking. Below (113) was a more compact deposit (118) of silt and sand with some slate fragments and debris from rubble eroded out of the wall core below the window. Finds from (118) included bottle and window glass, fish bones, and one sherd of tin glazed ware. Deposit (119) comprised rounded stones and

mortar at the E edge of the embrasure wall, and elsewhere, showing below slabs (1112). Deposit (119) was part of the fabric of the castle main W wall, exposed when the window embrasure was slapped through the W wall and not fully covered over by the subsequent slabbing of the embrasure floor.

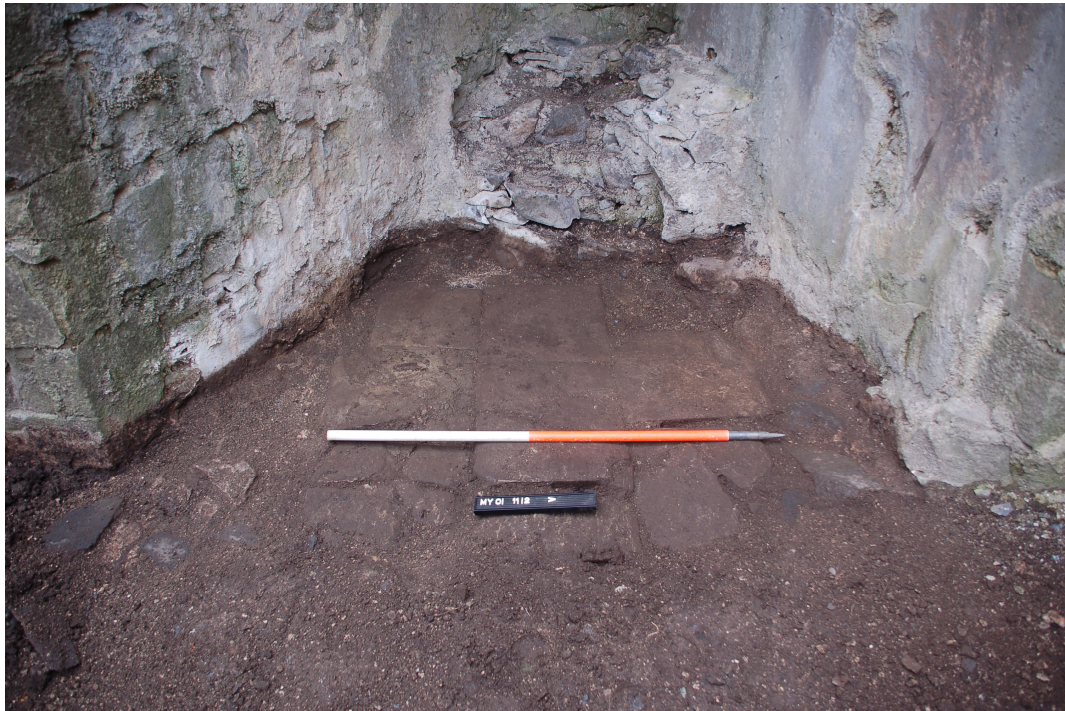
West window embrasure, post excavation, slabs (1112)

The sandstone floor slabs (1112) of the embrasure were exposed and cleaned. The slabs were rectangular and 0.045m thick. Examples of floor slab size are 0.34 X 0.44m and 0.36 X 0.38m.

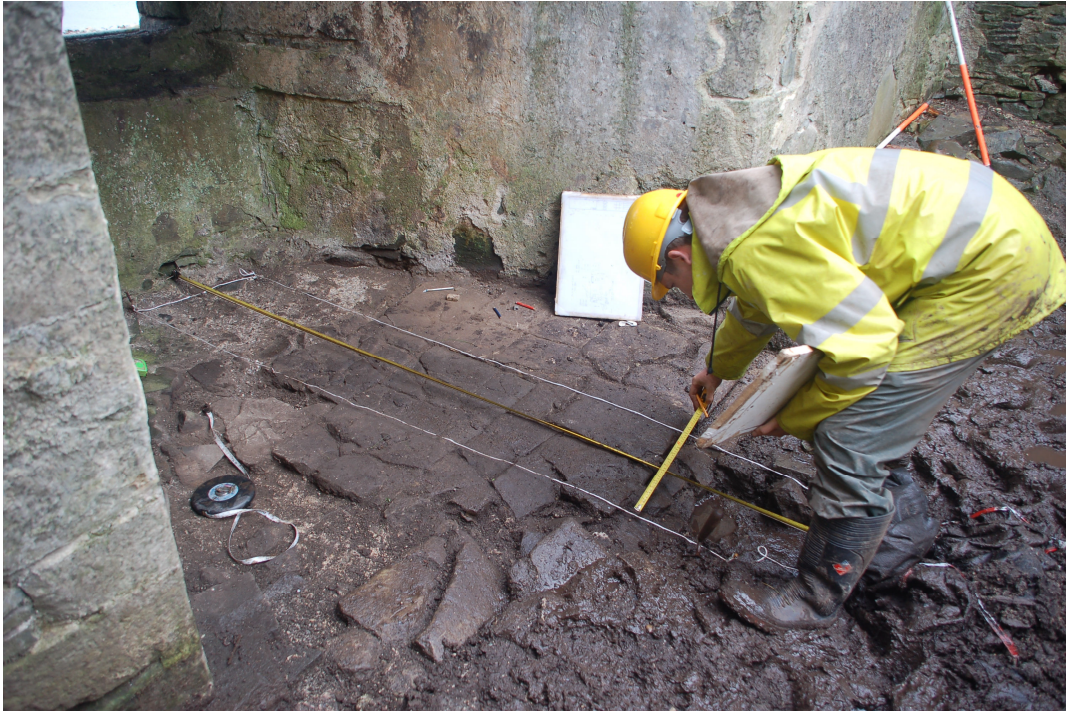
East window embrasure, recording slabs (1119)

The embrasure's floor slabs (1119) were revealed below deposit (114). The slabs, each measuring about 0.44 X 0.40m, were of sandstone and badly cracked. The slabs of (1119) do not cover the entire embrasure floor. The easternmost part of the floor, directly below the window, comprises the mortared over core (1121) of the E wall of the castle where rectangular slabs have not been laid. The same applies to the N and S edges of the floor which also have no finished edges. There is a large gap between the slab and the wall on N side, where silty mortar (1122) had accumulated over the wall core; it appears that at this location had at least one slab is missing.

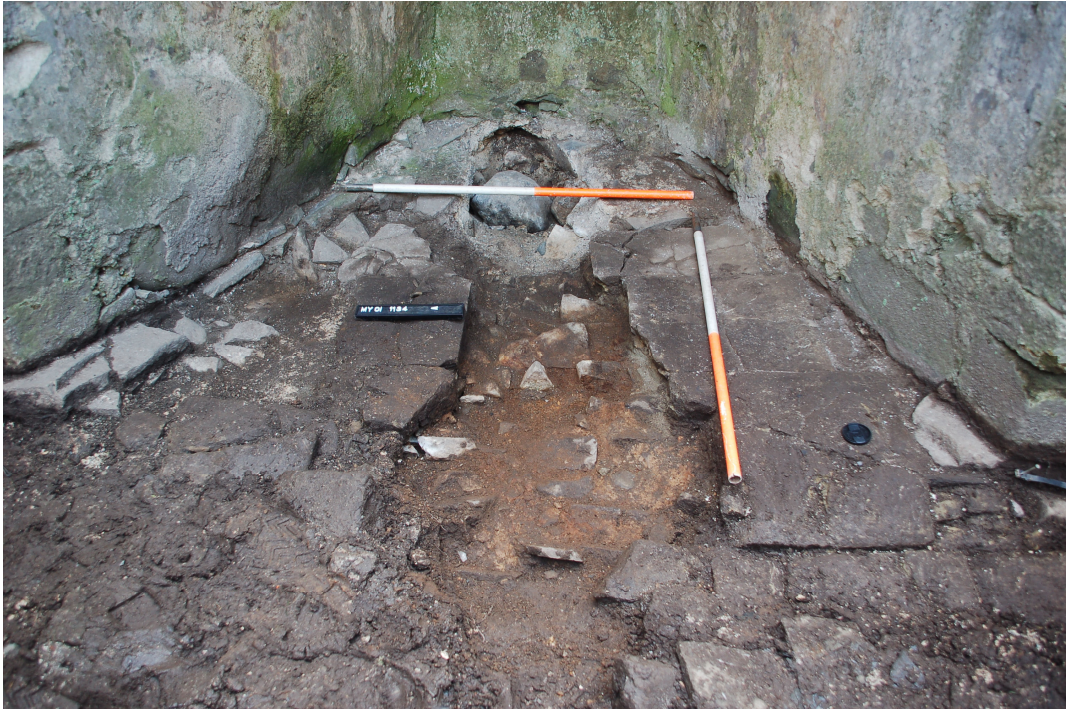
Cut for drainage pipe trench showing deposit (1132) and vault stones (1134)

Below (1131) was a thicker deposit (1132) to the W of silt packing (1127) which comprised a packing or fill of orange sand and grit, between the protruding in-situ stones (1134) of the vault forming the roof of the entresol chamber below.

Excavation of the pipe trench was halted for safety and structural reasons when a small void appeared at the base of the trench revealing the entresol chamber below. Any further excavation that may be required here would be undertaken by the mason.

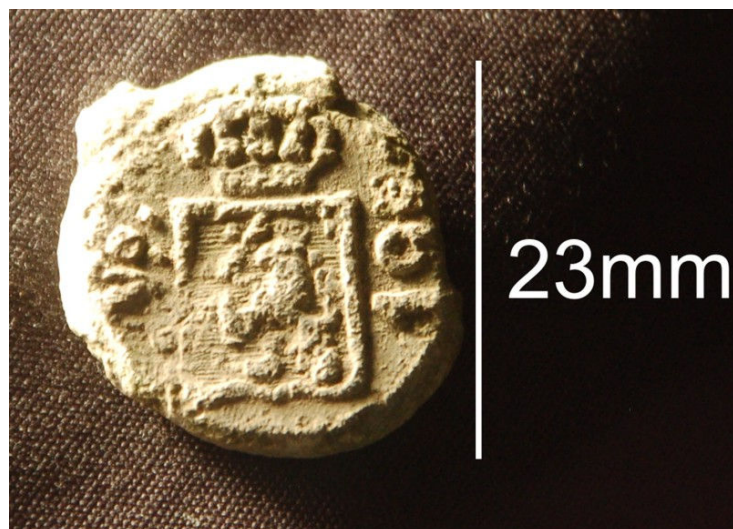
Lead Seal from upper deposit of east window embrasure

The lead seal found in the upper deposit (114) of the E embrasure has a diameter of 21mm. The obverse depicts the crowned shield bearing the rampant lion of the royal coat of arms of Holland. To the right of the shield can be seen what appears to be the number 19 which may be the customs control number. To the left of the shield some markings can be seen but not deciphered these marks are most likely to be 'R & A' for Dutch customs and excise. The reverse appears to be blank. The seal is a Dutch customs seal dating from the 19th or early 20th centuries. These seals were attached to all manner of Dutch exported goods and finds are not uncommon.

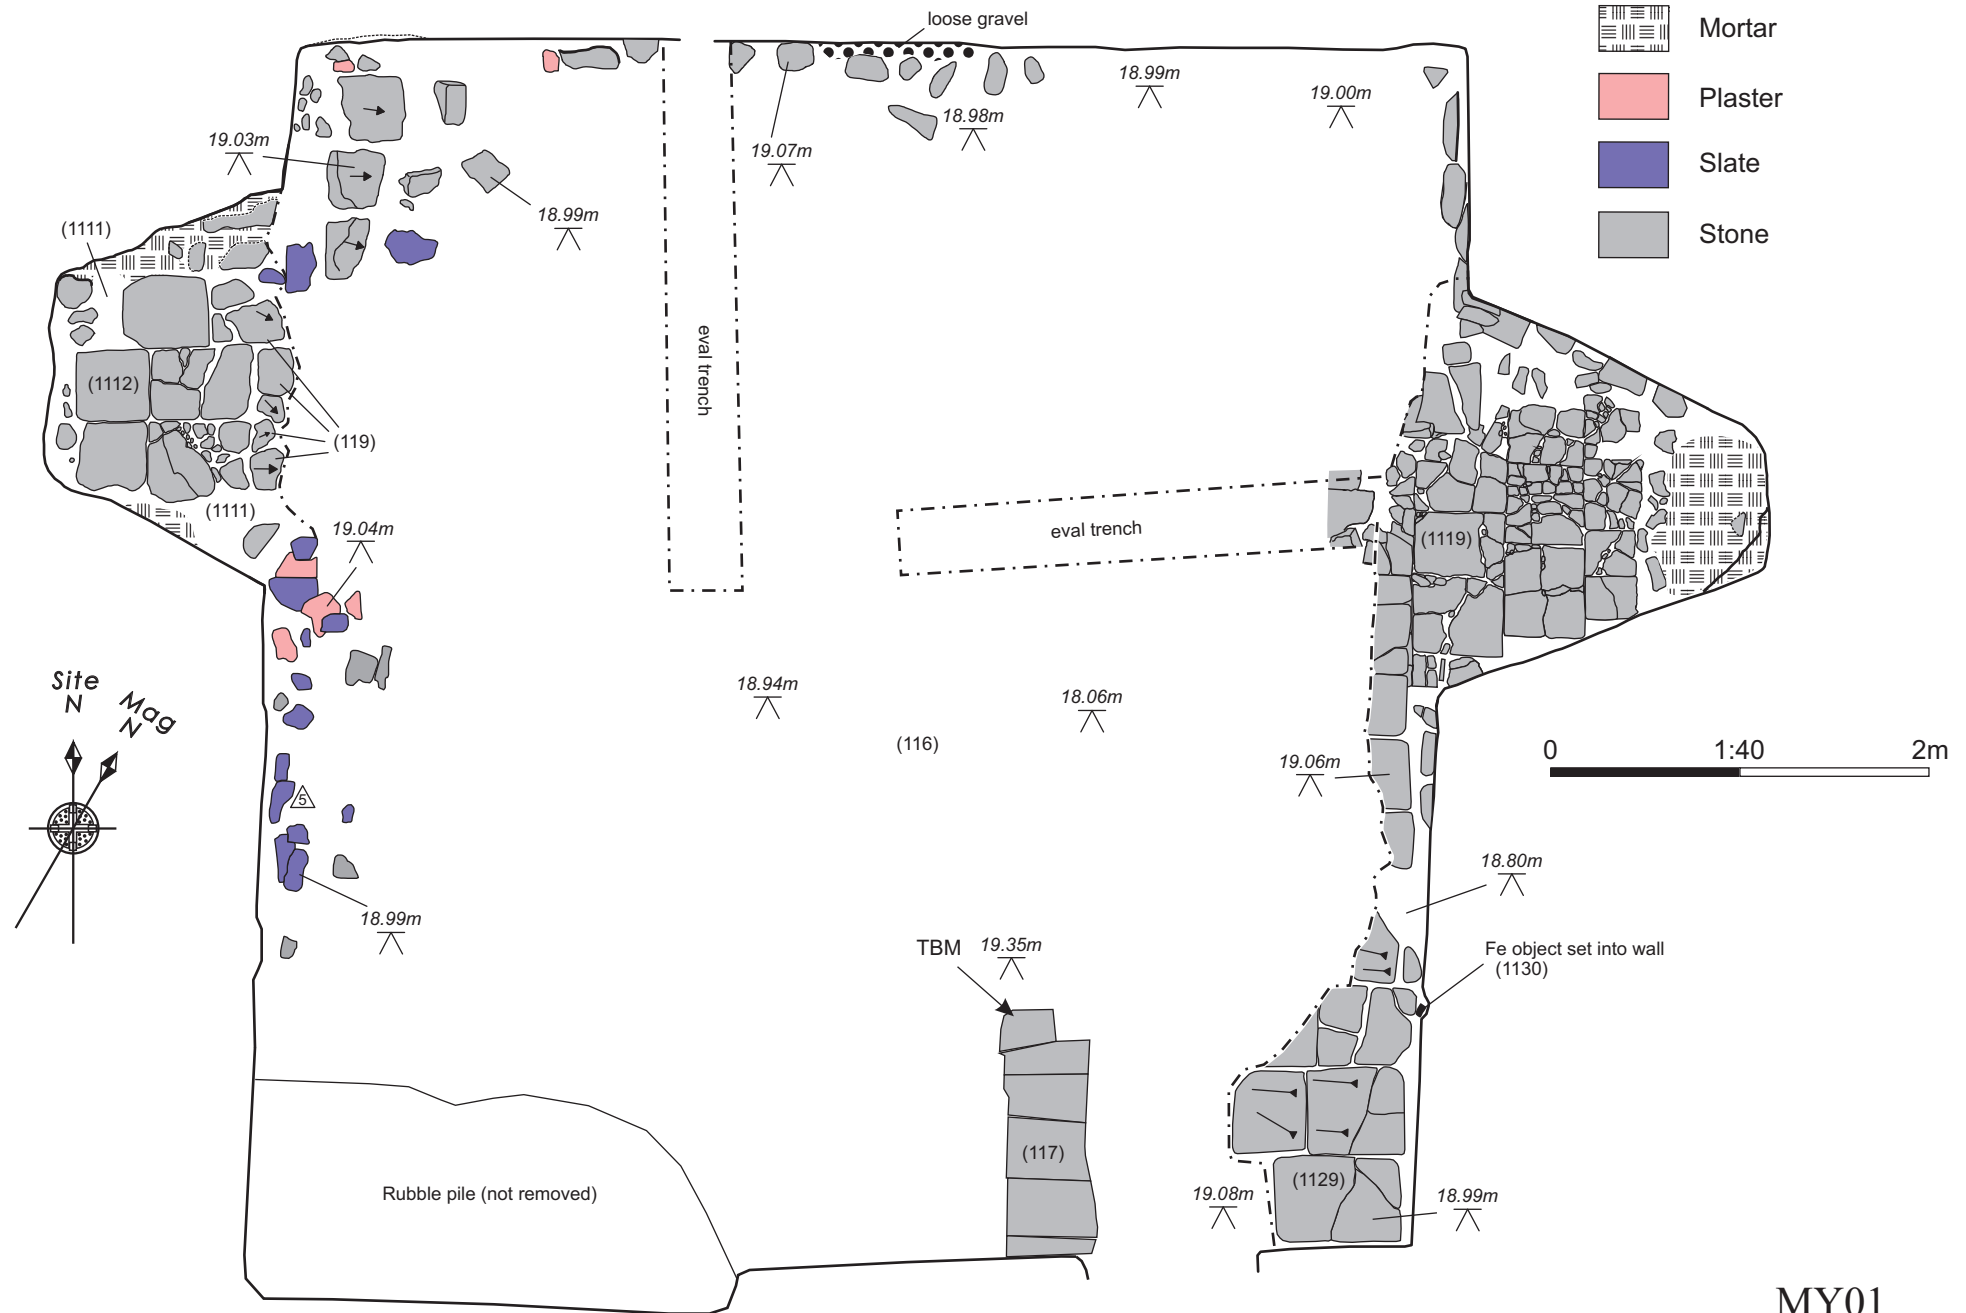
Illus 3

Detailed Plan after levelling mounds

Illustration 3: Detailed Plan after levelling Mounds

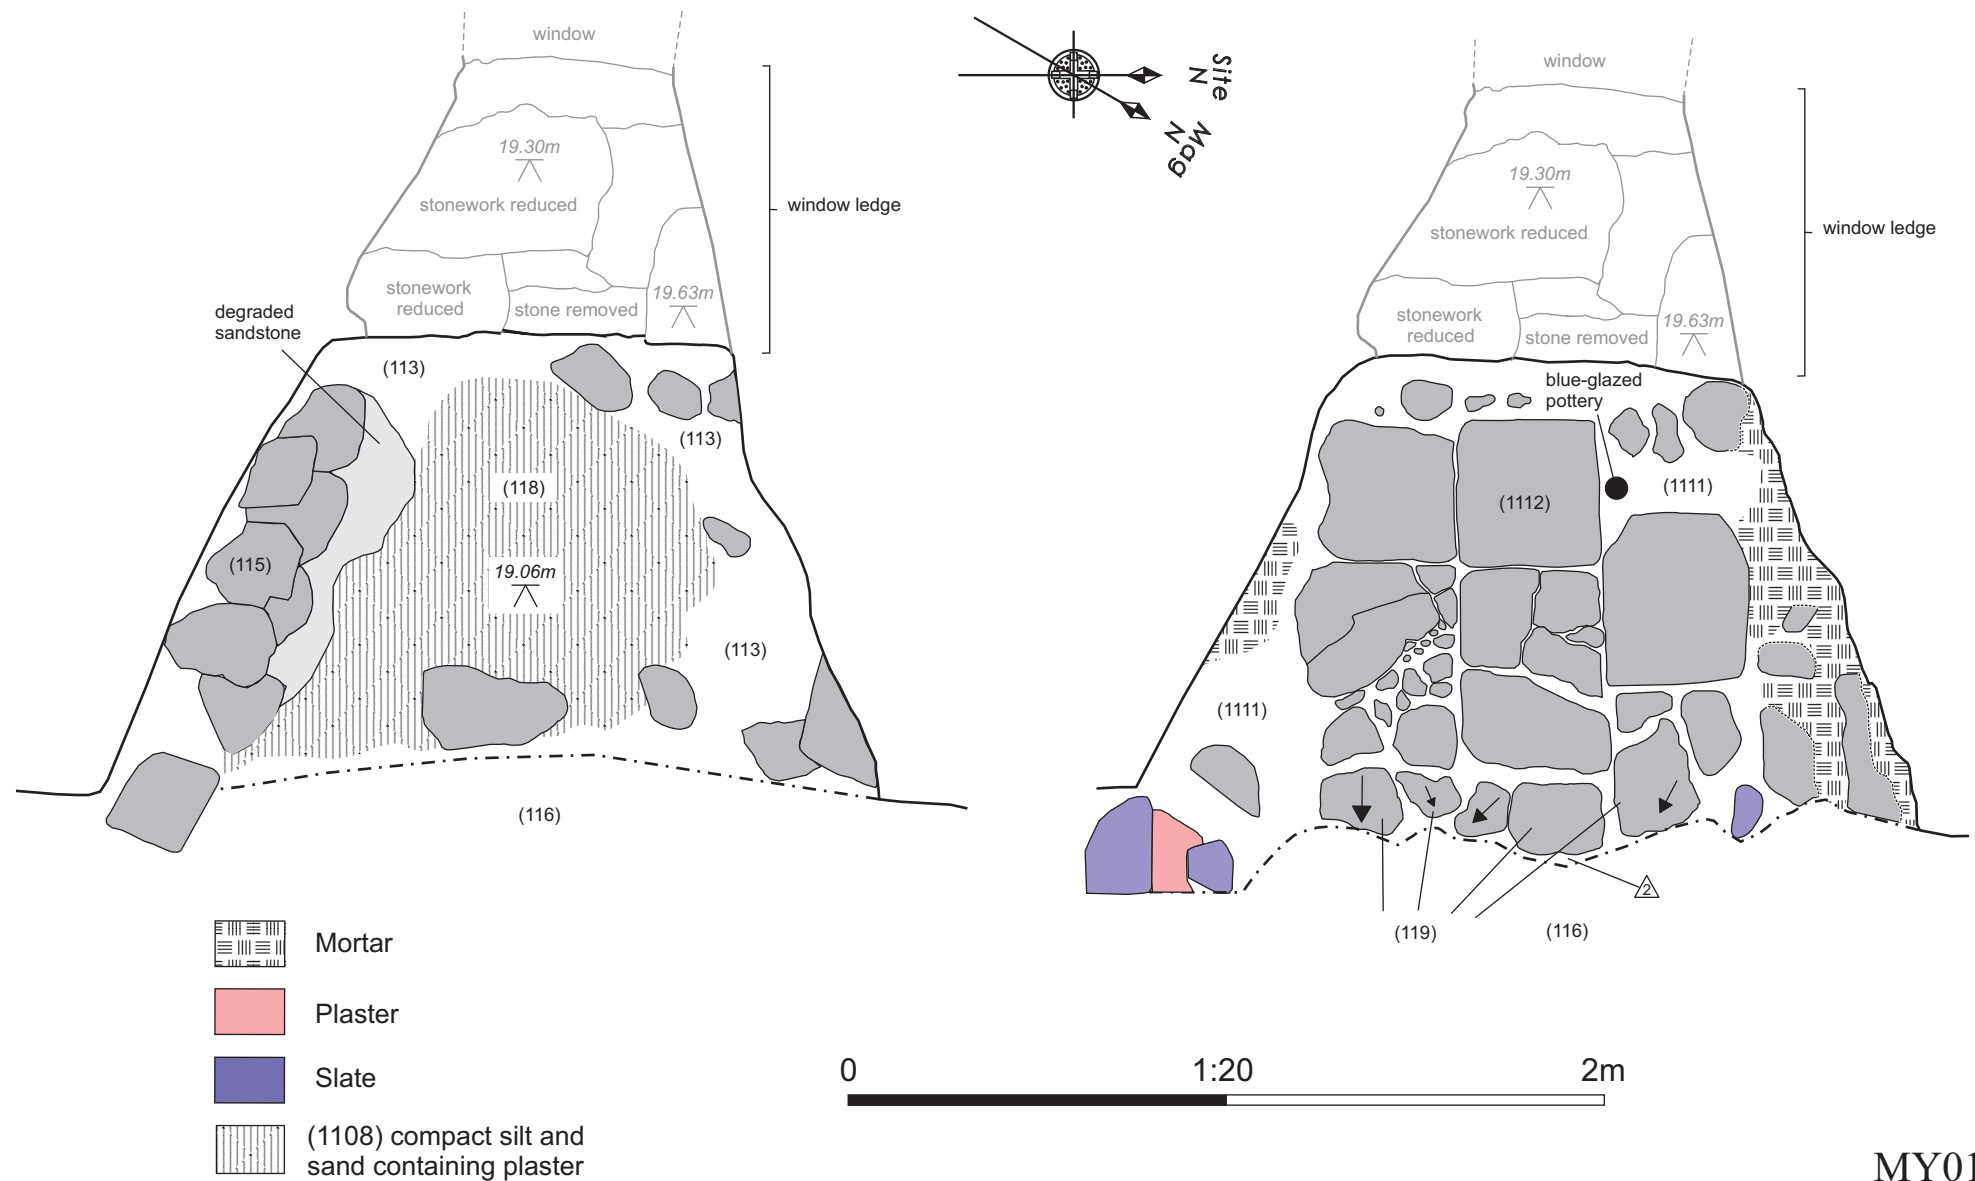
Illus 4

Plans showing upper deposits and stone slabs (1112) in W Embrasure

Illustration 4: Plans showing Upper Deposits and Stone Slabs (1112) in W Embrasure

2.4.2 West Window Embrasure (Illus 4)

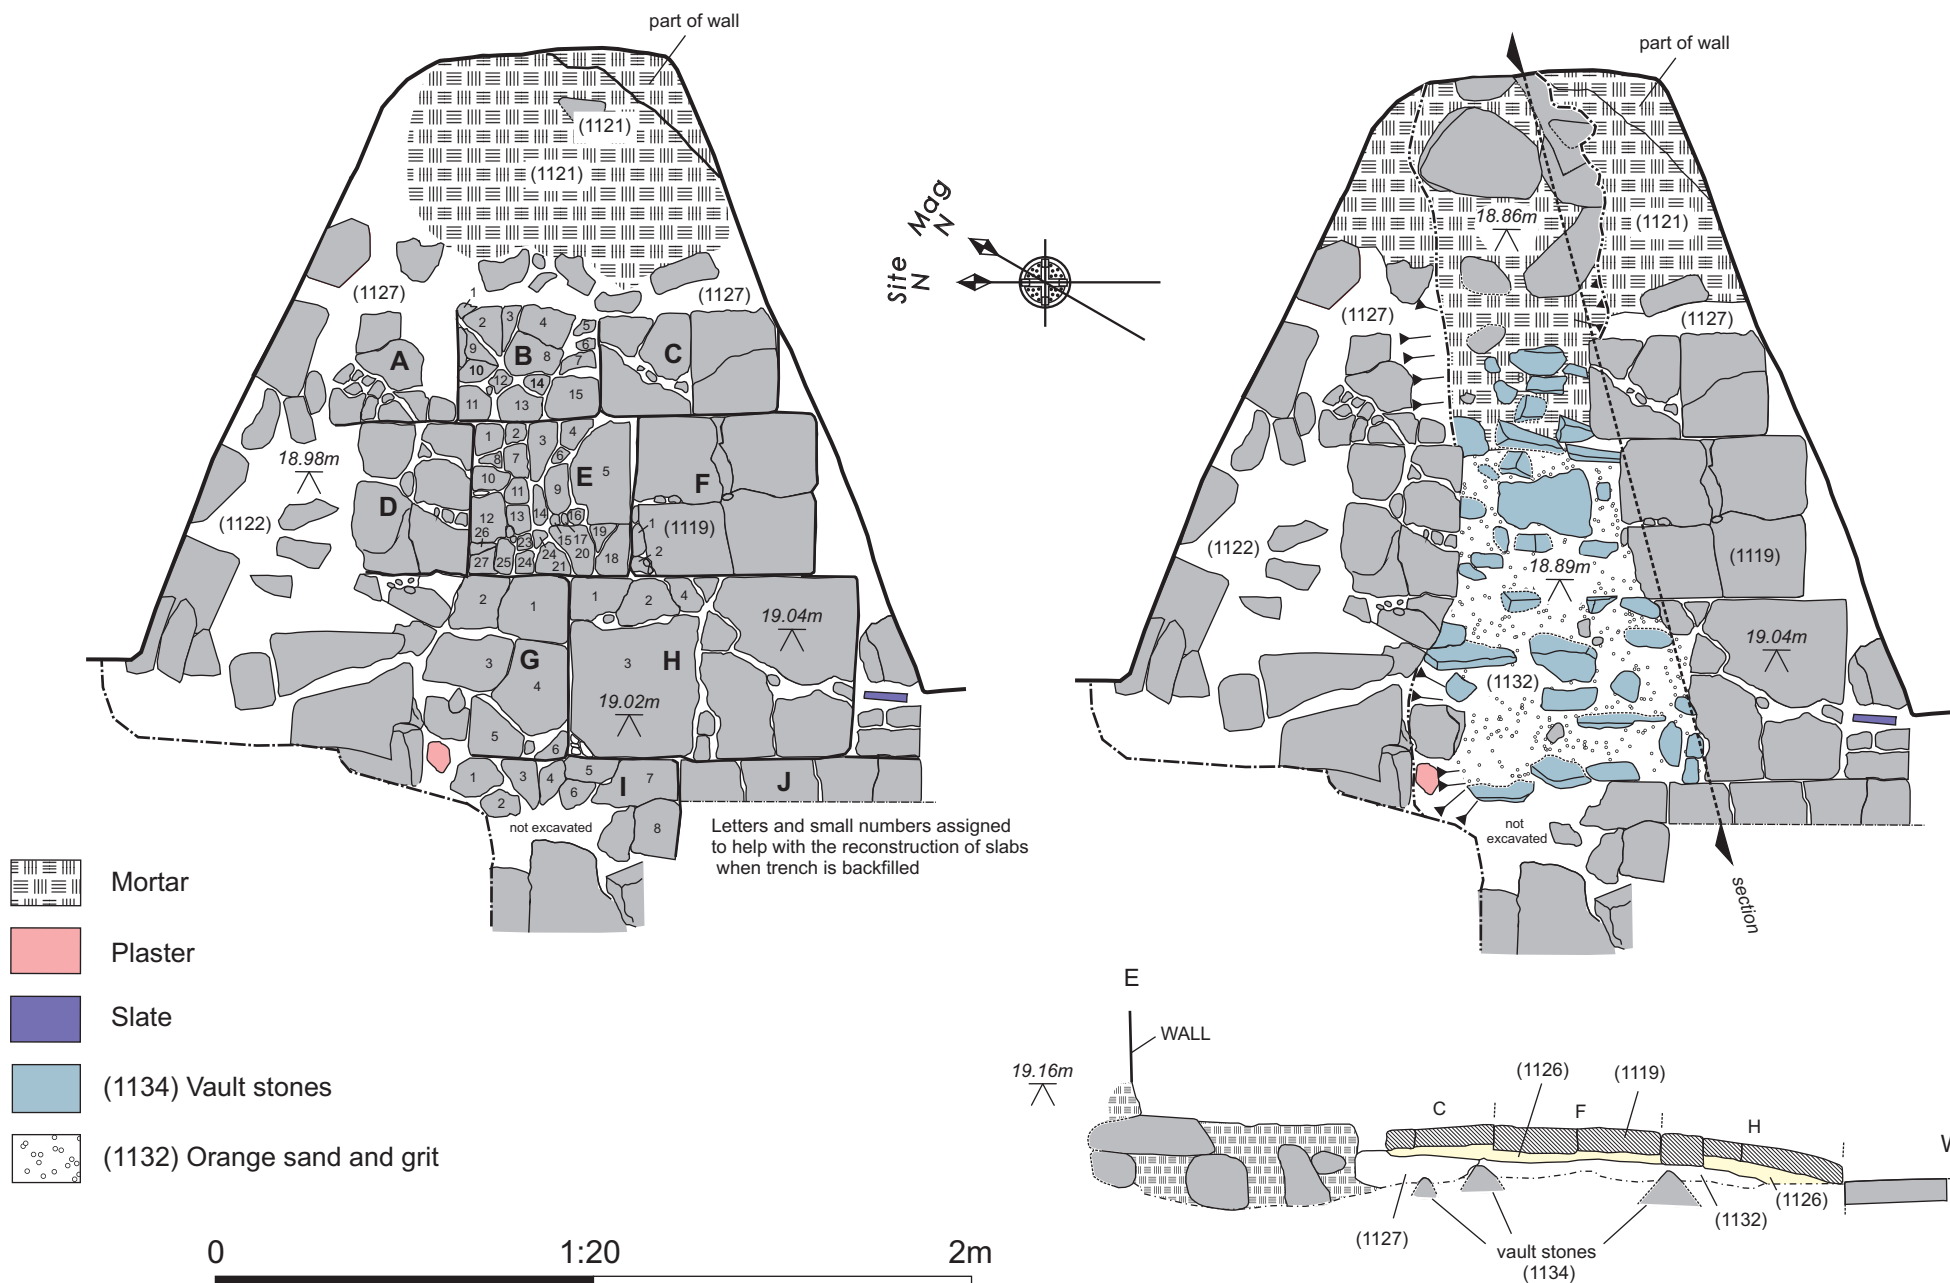
Illus 5 Plans showing stone slabs (1119) in E Embrasure and trench excavated down to the top of vault below

*Illustration 5: Plans showing Stone Slabs (1119) in E Embrasure and Trench excavated down
to top of Vault below*

2.4.3 East Window Embrasure (Illus 5)

2.4.4 Drainage pipe trench (Illus 5)
