Historic Building Record
Waverley Hotel
York Place
PERTH
PE61

**HISTORIC BUILDING RECORD
WAVERLEY HOTEL
PERTH
PE61**

Alder Archaeology undertook an Historic Building Record survey of the former Waverley Hotel at York Place, Perth, on 30th November 2016. The requirement was to create a permanent photographic and textual record of the building prior to demolition work. The hotel consisted of three linked buildings, two south-facing three-storey converted villas and a four-storey, purpose-built hotel, all dating from the later nineteenth century. The hotel complex was C-listed and constituted a notable local landmark. Although both Victorian and art deco elements were noted during the survey, later re-use of the hotel as temporary accommodation had resulted in most decoration being stripped out. Following the closure of the site in 2009, a fire had caused severe damage to the roof in the west villa and extensive water damage in other areas of the complex, rendering some parts of the building unsafe.

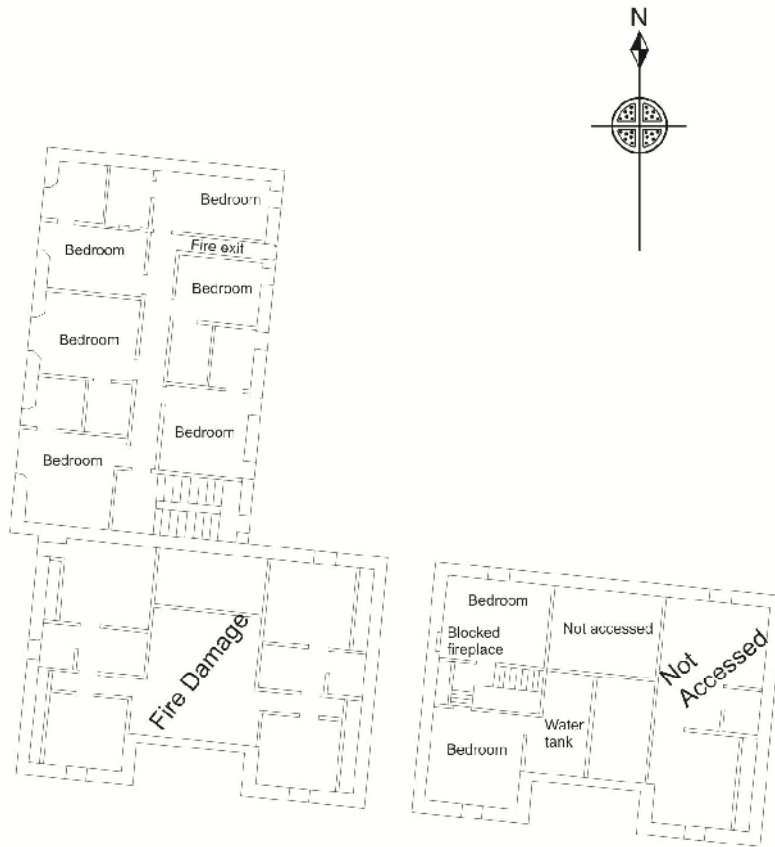
Illus 4

Waverley Hotel, Second Floor Floorplan

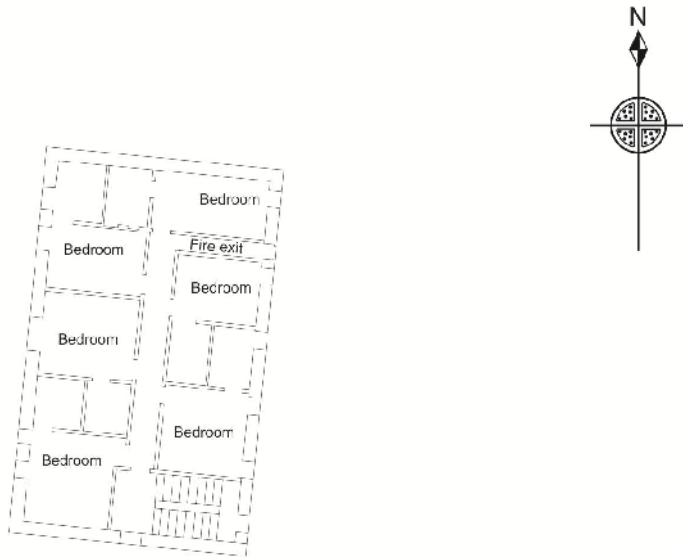
Illus 5

Waverley Hotel, Third Floor Floorplan
