Archaeological Monitoring
Abernyte Parish Church
Perth and Kinross

**ARCHAEOLOGICAL MONITORING,
ABERNYTE PARISH CHURCH,
PERTH AND KINROSS
JH09**

Alder Archaeology monitored the formation of an access ramp and rainwater soakaway at Abernyte Parish Church, site code JH09, in the period 13th – 16th December 2016.

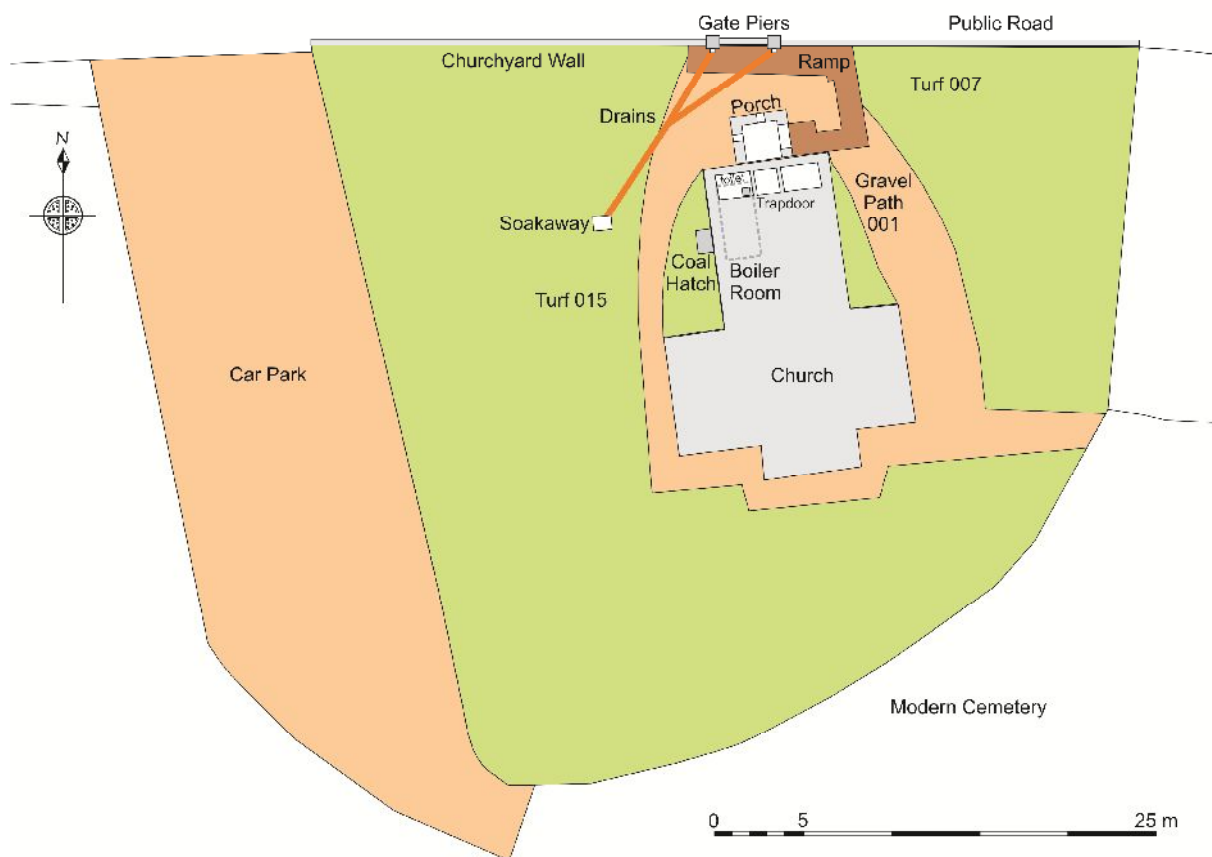
Illus 2

Archaeological Monitoring, Abernyte Parish Church

At the E edge of the ramp area it was necessary to extend beyond the existing gravel path, removing a layer of turf 007, about 100 mm deep. At the N boundary of the ramp, the foundations 008 of the churchyard wall were exposed to a depth of about 0.3 m, and also the foundation 013 of the W gate pier. No foundation cuts were seen.
